**AGENDA ITEM EXECUTIVE SUMMARY**Agenda Item number: **4a**

Recommendation to Approve an Ordinance Authorizing the Sale of Item of Personal Property Owned by the City of St. Charles

We are asking for approval to sell the said obsolete item to the highest respective bidder:
Decommissioned Substation #6 34.4 KV Transformer.

S/N:	A5969	ID#:	6T1
MFG.:	Asea	Location:	SUB 6
MFG. Date:	1979	kV:	34.4 - 12.47/7.2
		MVA:	10/12.5/15//16.8

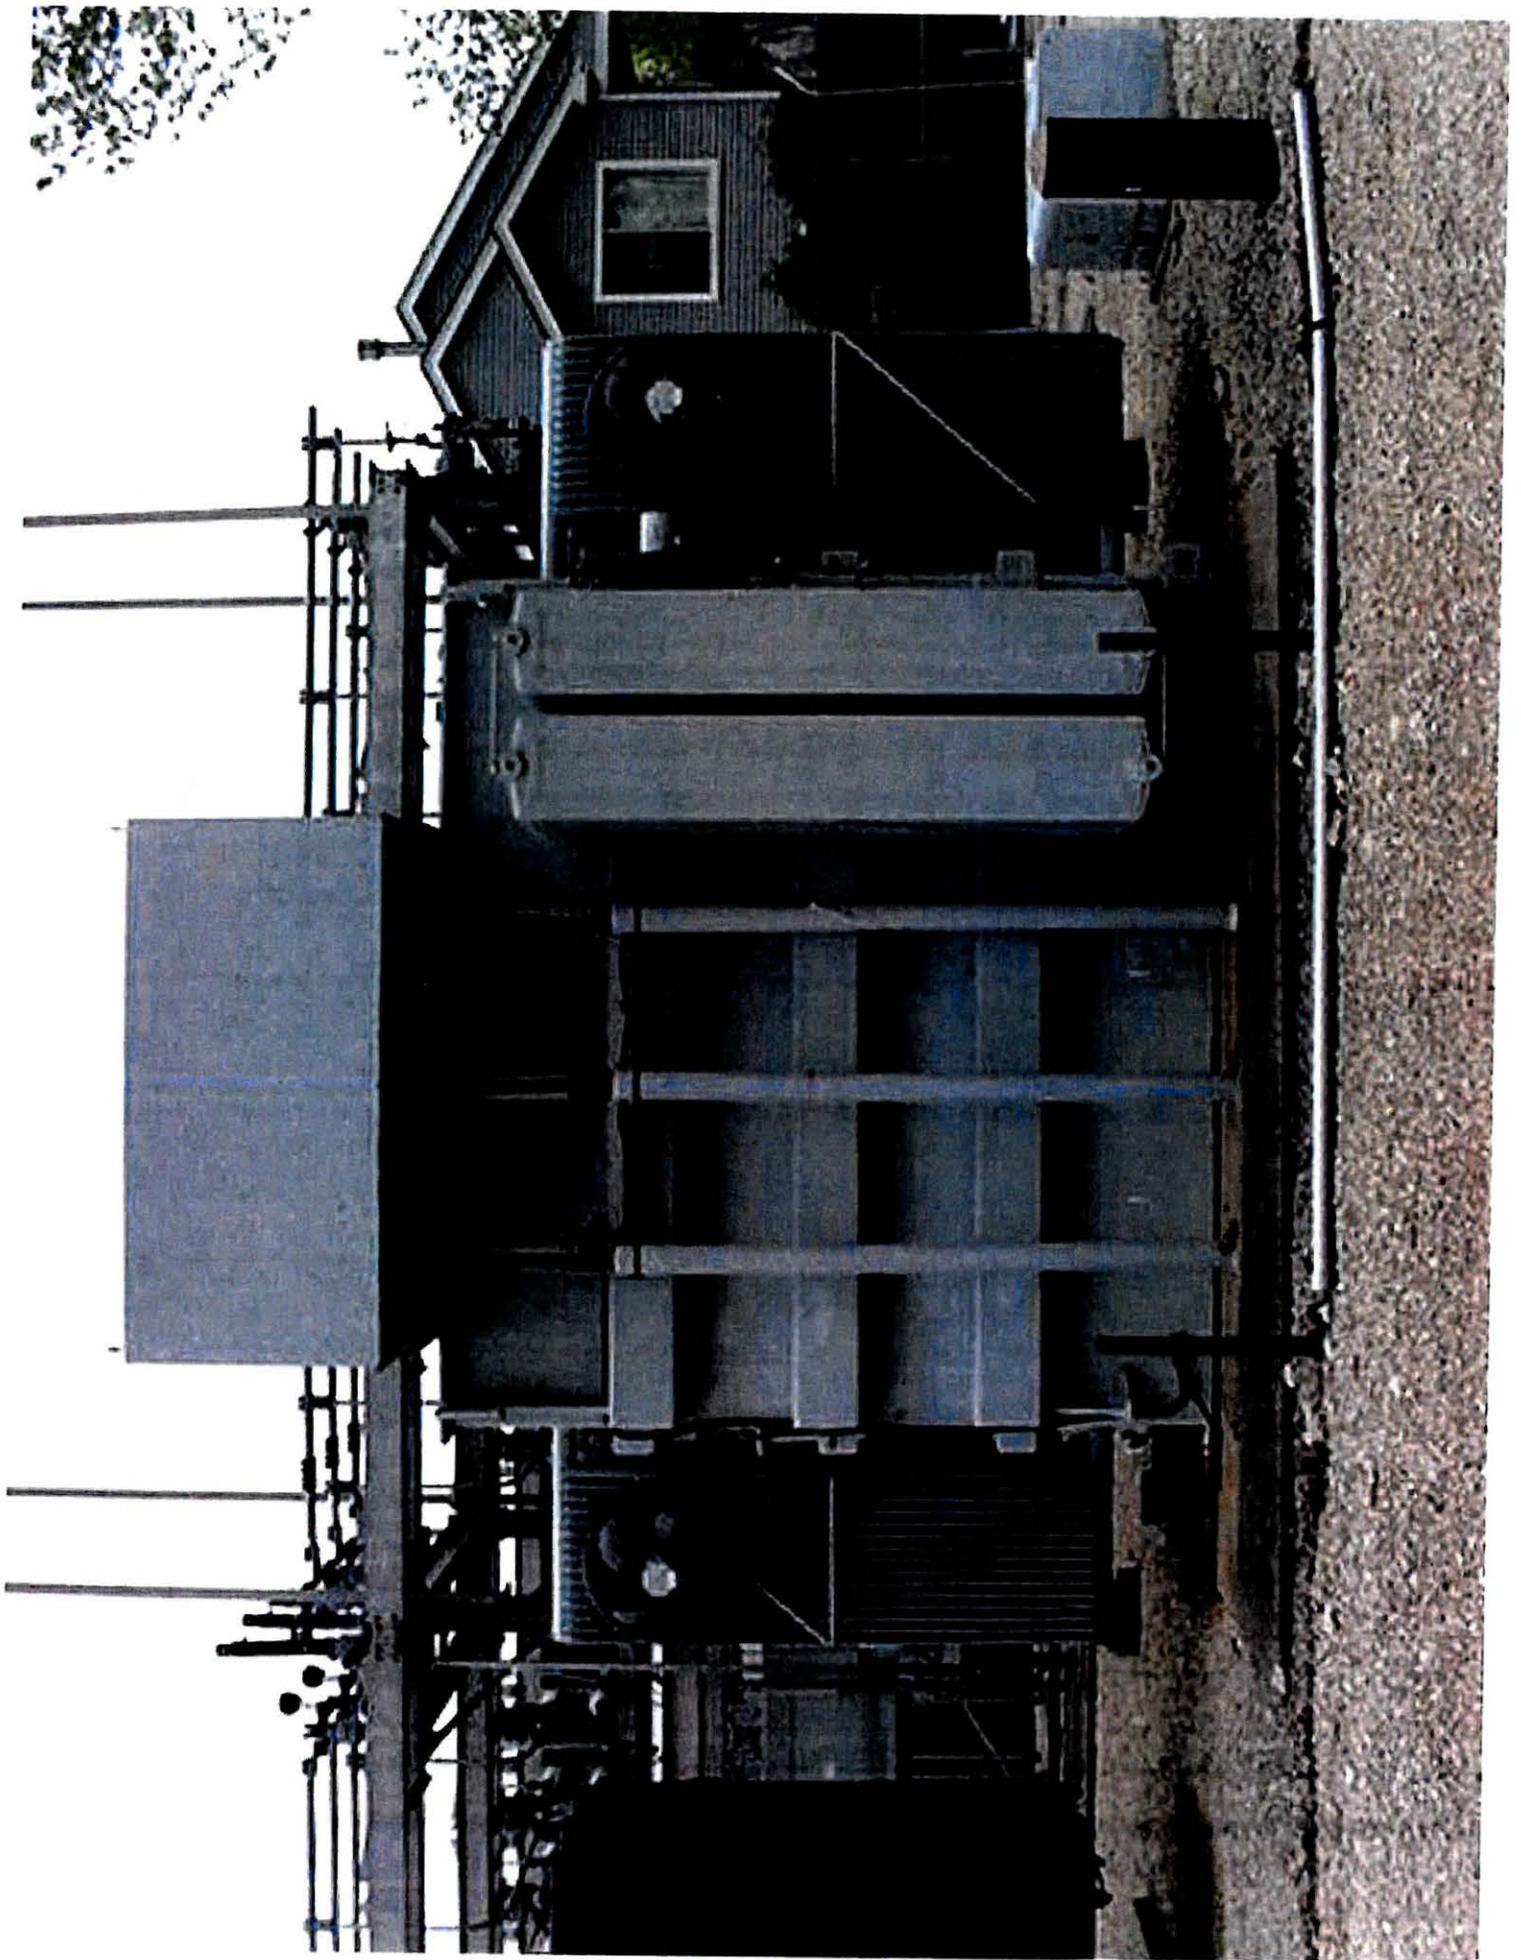
Based on the oil and electrical test data the transformer is downgraded from a rank of 3 to a rank of 1 out of 5, with 1 being the worst and 5 the best. The ranking for the oil data was downgraded from a Code 3 to a Code 2 due to the high moisture content and subsequent low oil dielectric breakdown. The electrical test data of this transformer is assigned a code 3 out of 5 since the measured watts loss of the bushing hot collar tests for the X0, X1, X2 and X3 bushings are all above the recommended limit and should be investigated. It is recommended to clean and retest the bushings to verify the results. It is recommended to update the electrical test data in one year to enable a better assessment of the transformer's present condition.

The overall transformer code is downgraded to a Code 1 due to the reported lack of oil in the H1 bushing. The note from testing on 11/8/2014 states that the "H1 bushing appears to be empty, Center H2 bushing is about 1/2 full, & the south H3 bushing is about 1/2 full". This condition should be confirmed as soon as possible since this indicates a possible leaking bushing. Bushings can leak into the transformer, making it difficult to confirm a leaking bushing by looking for oil on the external surfaces of the bushing and transformer. If the oil level cannot be detected because it is too low to verify through the sight glass, it should be replaced as soon as possible since a low dielectric fluid in the bushing can result in a dielectric failure that can cause damage to the transformer or other equipment in the area.

Based on data from 2014 the oil test data summary is assigned a code 2 as the high moisture is verified and the relative saturation of the oil is in excess of 20 % which indicates the insulation is wet. The dielectric breakdown strength of the oil was unacceptable and this is likely caused by the high moisture content.

The moisture in oil is elevated on all of the recent samples with an average relative saturation of over 30%. Free water was noted in many of the recent samples. Care should be taken to flush enough oil when sampling to ensure the sample tested is representative of the bulk oil. An estimate of the moisture in paper cannot be made as the top oil temperature at time of sampling is not high enough. If the transformer runs above 55 °C for three consecutive days a reasonable estimate of the moisture content in paper can be made. From the available test data, it appears that the insulation is wet.

The electrical test summary rating of this transformer is assigned a code 3 out of 5 since the measured watts loss of the bushing hot collar tests for the X0, X1, X2 and X3 bushings are all above the recommended limit and should be investigated. It is recommended to clean and retest the bushings to verify the results. It is recommended to update the electrical test data in one year to enable a better assessment of the transformer's present condition. Exciting current, SFRA, Leakage Reactance, and surge arrester tests should be included and should be performed on a routine basis to enable a more thorough assessment of the transformer's condition.

The grounded specimen test watts loss of the bushing hot collar tests for the X0, X1, X2 and X3 bushings are all above the Doble recommended limit of 0.1 watts. It is recommended to clean and retest the bushings to verify the results. The UST watts loss results are within recommended limits but the measured current indicates that the X0 bushing may have low liquid or compound level which should be verified. All of these tests should be repeated to challenge or confirm results.

If the H1 bushing lack of oil problem is resolved then the overall transformer code would be expected to be upgraded from a Code 1 to a Code 2 due to the verified high moisture content in the transformer. If then the problem of high moisture in the transformer is resolved the overall transformer code would be expected to be upgraded from a Code 2 to a Code 3 due to the LV bushing high watt loss problems.

Based on the oil data provided this transformer was assigned a code 3 due to the elevated moisture content. This should be verified with a sample taken in a ground glass syringe after flushing a gallon of oil through the valve. If possible the transformer should be sampled when the transformer has been operating at a temperature greater than 55 °C for several days to get an estimate of the moisture in the paper.
