JOHNSON WILBUR ADAMS, INC.

June 14, 2017

**Re: 306 W Main Street – St Charles, IL
Structural Condition Assessment
JWA Project No. 2017229**

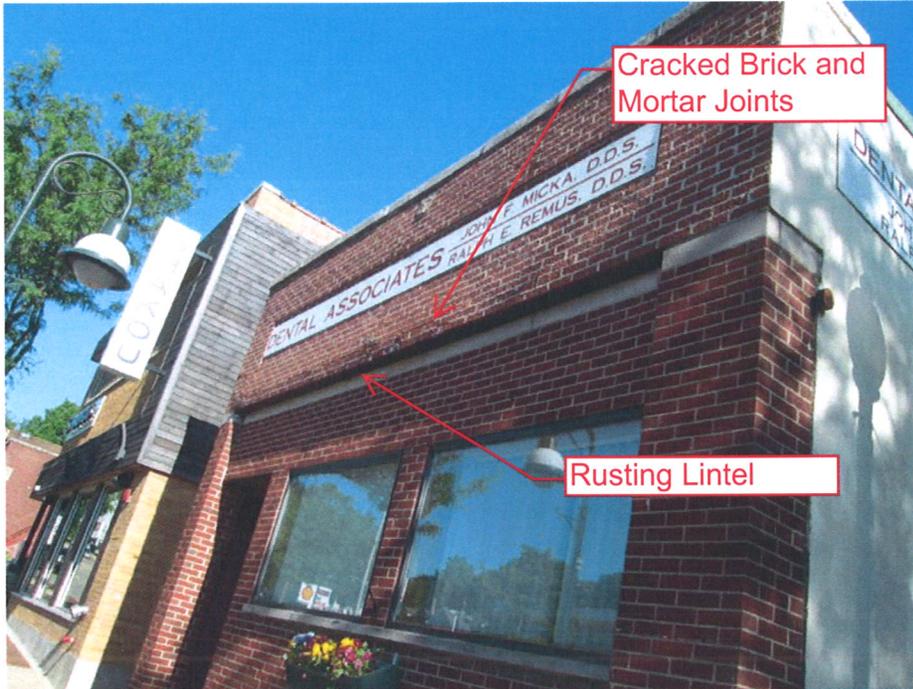
Photo 1 South Elevation

The exposed portions of the lintel on the south elevation were observed to have significant rust and in some locations the steel has started to delaminate as a result of the rusting. The worst location was observed at the west end of the lintel. Cracks were observed in the brick at each lintel end bearing as well as just above the bottom of the lintel. The rusting lintel and subsequent brick cracks appear to be the result of the long term exposure to exterior moisture over time.

It is our opinion that due to the severity of the rust on the lintel the lintel needs to be replaced or repaired as soon as practical. The extent of the repairs or possible replacement is not known at this time until more exploratory demolition can be performed to expose the entire lintel. Once the required repairs are determined sealed sketches will be prepared to assist the contractor in developing the scope of work.
