<b>HISTORIC PRESERVATION COMMISSION AGENDA ITEM EXECUTIVE SUMMARY</b>			
	<b>Agenda Item Title/Address:</b>		Preliminary Review: 306 W. Main St.	
	<b>Proposal:</b>		Façade Repair	
	<b>Petitioner:</b>		Jim Farley	
<b>Please check appropriate box (x)</b>				
<b>PUBLIC HEARING</b>			<b>MEETING 8/16/17</b>	<b>X</b>
<b>AGENDA ITEM CATEGORY:</b>				
	Certificate of Appropriateness (COA)		Façade Improvement Plan	
X	Preliminary Review		Landmark/District Designation	
	Discussion Item		Commission Business	
<b>ATTACHMENTS:</b>				
Minutes from 6/21/17 Structural Assessment Photos of building				
<b>EXECUTIVE SUMMARY:</b>				
<p>Structural issues have been identified on the front façade of the building. Issues include rusting of the lintel and cracks in the brick and stone band.</p> <p>The Commission previously discussed this project on 6/21/17 and asked the applicant to return with a scope of work and/or consider a façade improvement grant to enhance the front elevation of the building.</p> <p>The applicant would like to discuss potential options for the façade repair.</p>

**Re: 306 W Main Street – St Charles, IL  
Structural Condition Assessment  
JWA Project No. 2017229**

**306 W Main Str

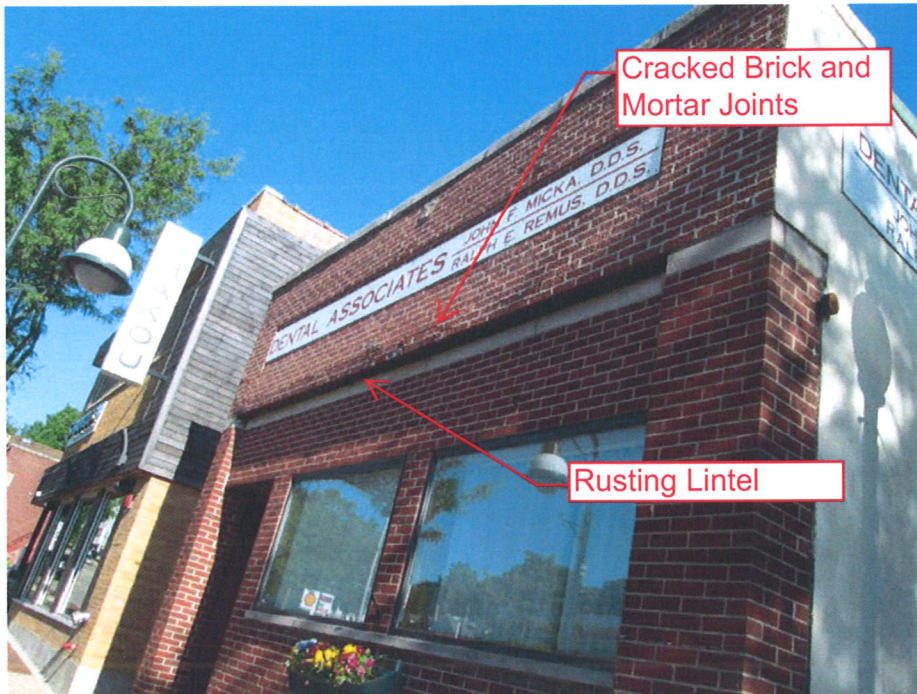
Photo 1 South Elevation

At the time of the site visit the building was observed to be a single story brick building with a flat roof that pitches down from south to north. Although not visible for observation, the roof structure is believed to be wood joists spanning in the east west direction between the exterior brick walls. A steel lintel was observed on the south elevation supporting what is believed to be the original exterior brick wall of the building. The lintel was only partially visible from the exterior of the building and the exact size and configuration is not known at this time. The lintel spans almost the full front width of the building. At some point during the building's history it appears that new brick exterior walls, window and doors were installed below the original steel lintel.

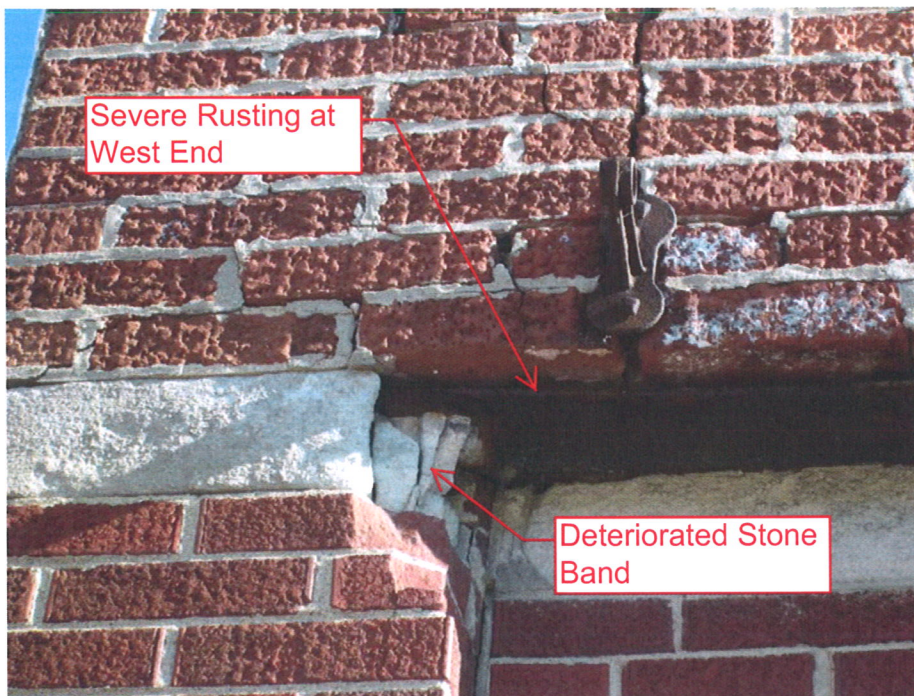
Photo 2 West End of Lintel

The exposed portions of the lintel on the south elevation were observed to have significant rust and in some locations the steel has started to delaminate as a result of the rusting. The worst location was observed at the west end of the lintel. Cracks were observed in the brick at each lintel end bearing as well as just above the bottom of the lintel. The rusting lintel and subsequent brick cracks appear to be the result of the long term exposure to exterior moisture over time.

It is our opinion that due to the severity of the rust on the lintel the lintel needs to be replaced or repaired as soon as practical. The extent of the repairs or possible replacement is not known at this time until more exploratory demolition can be performed to expose the entire lintel. Once the required repairs are determined sealed sketches will be prepared to assist the contractor in developing the scope of work.
