<b>HISTORIC PRESERVATION COMMISSION AGENDA ITEM EXECUTIVE SUMMARY</b>				
  <b>CITY OF ST. CHARLES</b> ILLINOIS • 1834	<b>Agenda Item Title/Address:</b>	COA: 217 Cedar Ave		
	<b>Significance:</b>	Contributing		
	<b>Petitioner:</b>	Baker Memorial Church		
	<b>Project Type:</b>	Doors		
	<b>PUBLIC HEARING</b>		<b>MEETING 2/15/23</b>	<b>X</b>
<b>Agenda Item Category:</b>				
	Preliminary Review		Grant	
X	Certificate of Appropriateness (COA)		Other Commission Business	
	Landmark/District Designation		Commission Business	
<b>Attached Documents:</b>		<b>Additional Requested Documents:</b>		
Application, door information, photo, architectural survey				
<b>Project Description:</b>				
<ul style="list-style-type: none"> <li>A man door was installed in the middle of the garage door.</li> </ul>				
<b>Staff Comments:</b>				
Work was done without a permit. Commission tabled the item at the last meeting until the applicant could be present. Commission discussed adding siding to the garage door to make the building look more like a shed.

Re: 217 Cedar Avenue, St. Charles, IL 60174  
To whom it may concern,

### SCOPE OF WORK

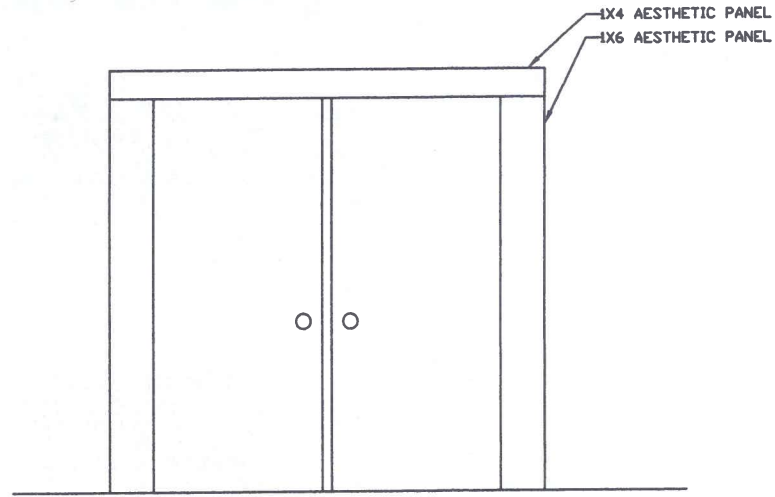
EXTERIOR

- EXISTING GARAGE DOOR WAS HANGING BROKEN AT TOP AND NEEDED REPAIR IN ORDER TO CLOSE PROPERLY AND REDUCE FALL RISK. WORK PERFORMED INCLUDED REPLACING A BROKEN SPRING, REPLACING WHEEL GUIDES, BROKEN HINGES, AND DOOR JAM.
- EXISTING DOOR WAS IN EXCESS OF 200 LBS AND POSED A SAFETY RISK, NEEDING IMMEDIATE REPAIR.
- GARAGE IS NOT USED TO PARK CARS AND IT WAS DECIDED TO INSTALL A DOOR TO SERVE PEDESTRIANS AND SMALL YARD VEHICLES/EQUIPMENT.
- ALL WORK WAS PERFORMED BY VOLUNTEERS.
