<p>CITY OF ST. CHARLES ILLINOIS • 1834</p>	HISTORIC PRESERVATION COMMISSION AGENDA ITEM EXECUTIVE SUMMARY			
	Agenda Item Title/Address:	COA: 8 Indiana St.		
	Significance:	Landmarked		
	Petitioner:	Kelsey Shipton		
	Project Type:	Windows		
PUBLIC HEARING			MEETING 11/1/23	X
Agenda Item Category:				
	Preliminary Review		Grant	
X	Certificate of Appropriateness (COA)		Other Commission Business	
	Landmark/District Designation		Commission Business	
Attached Documents:			Additional Requested Documents:	
Application, Project Details, Architectural survey,				
Project Description:				
<ul style="list-style-type: none"> Proposed is to remove the non-historic storm windows and replace them with in-kind custom African Mahogany storm windows to match. 				
Staff Comments:				
Recommendation / Suggested Action:				
<ul style="list-style-type: none"> Provide feedback and recommendation on approval of the COA

HISTORIC PRESERVATION "CERTIFICATE OF APPROPRIATENESS"

As we shared with you earlier this year, Preservation Partners of the Fox Valley (PPFV) has embarked on a multi-year capital improvement campaign for the historic landmarked 1850 William Beith House at 8 Indiana Street in downtown St

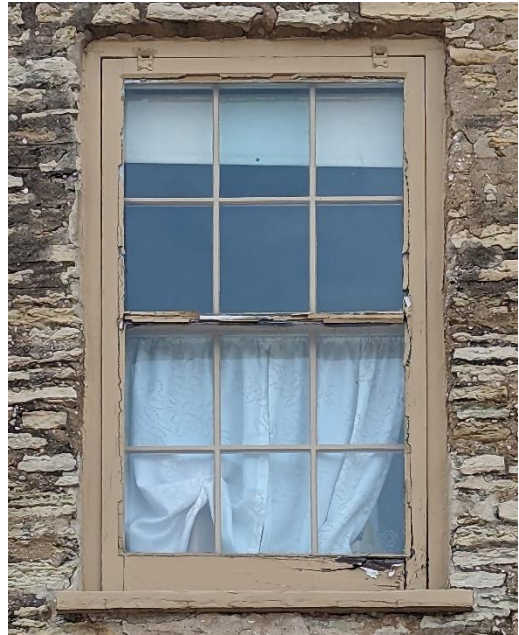
This phase of work will consist of the removal and replacement of the existing, deteriorated, non-historic storm windows on all elevations. The existing windows date from the 1980s at the oldest, some having been replaced within the last 20 years. All of the storm windows are poorly sealed, preventing effective protection of the historic windows and negating any thermal performance increases that properly-sealed storm windows provide.

East elevation, second floor storm window.

As with recently completed work, we have contracted with Miller's Millwork out of Aurora for the custom fabrication of the new storms. Each will match the existing in size, configuration, and detail. New hardware will be used to secure the storms to the building but will match the existing in scale and appearance. The storm windows will be replaced based on current condition; the most deteriorated (pictured at right) will be replaced first, with the most intact being the final storm for replacement.

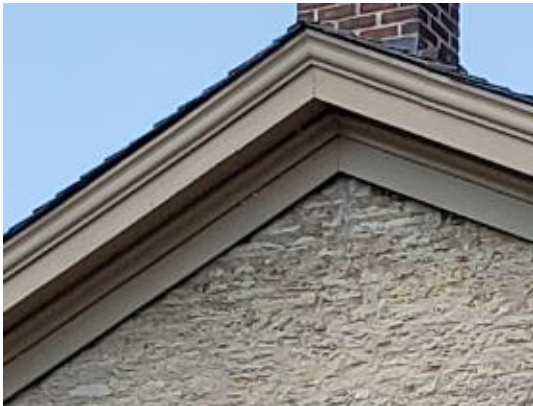
Deteriorated trim, prior to removal.

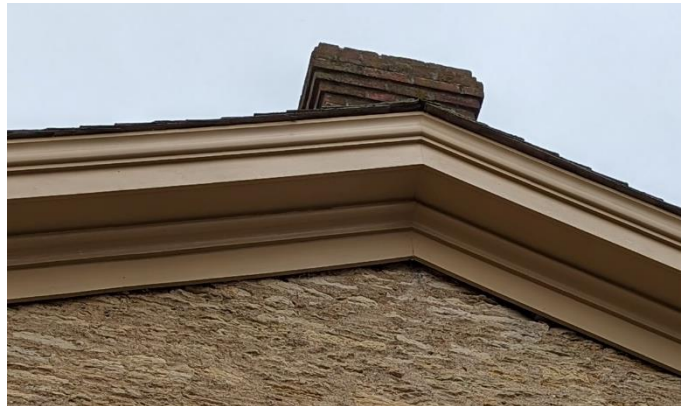
Replacement trim after completion.
