HISTORIC PRESERVATION COMMISSION AGENDA ITEM EXECUTIVE SUMMARY Agenda Item Title/Address: Proposal: Window replacement Petitioner: Please check appropriate box (x) PUBLIC HEARING MEETING 8/7/13 AGENDA ITEM CATEGORY:

Windows on the house at 120 N. 4th St. were replaced without a permit. By the time the Building Division was alerted, all of the windows had already been installed and the contractor was completing the installation.

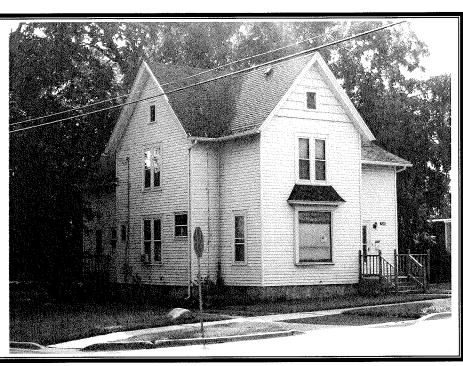
Photo: Aug. 2003

Attached is a photo of the building from 2003 showing the previous windows, which appear to have been covered in aluminum storm windows.

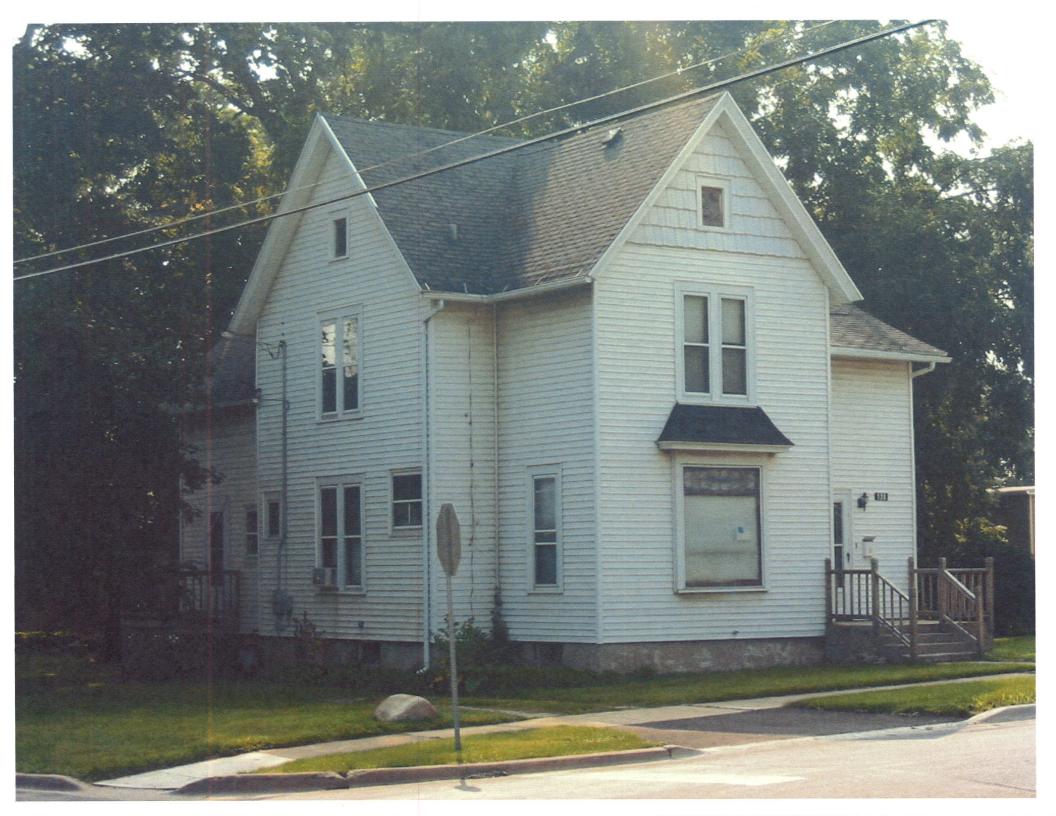
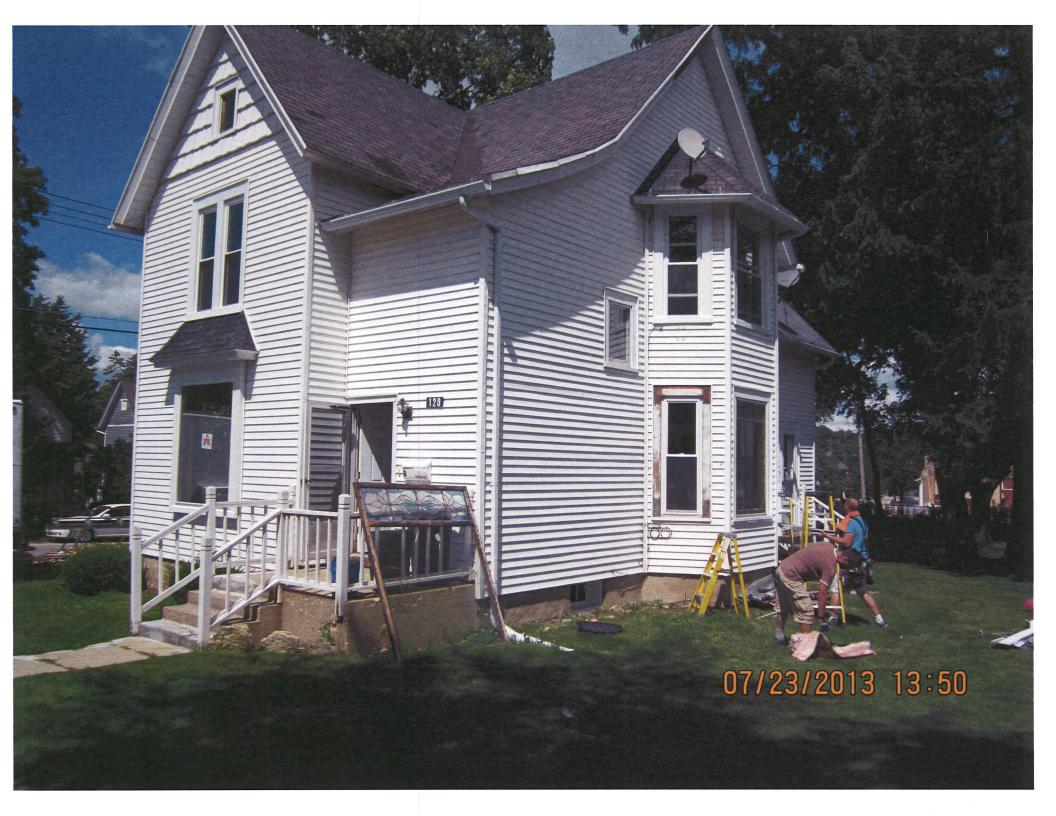
The replacement windows appear to be vinyl double hung, with the exception of the front picture window, which is a fixed pane. The property owner has not yet submitted information for a building permit and no further information on the windows has been provided.

Provide feedback and recommendations for approval of the COA.
