ST. CHARLES HISTORIC PRESERVATION COMMISSION

ARCHITECTURAL SURVEY ST. CHARLES CENTRAL DISTRICT ST. CHARLES, ILLINOIS

DIXON ASSOCIATES / ARCHITECTS

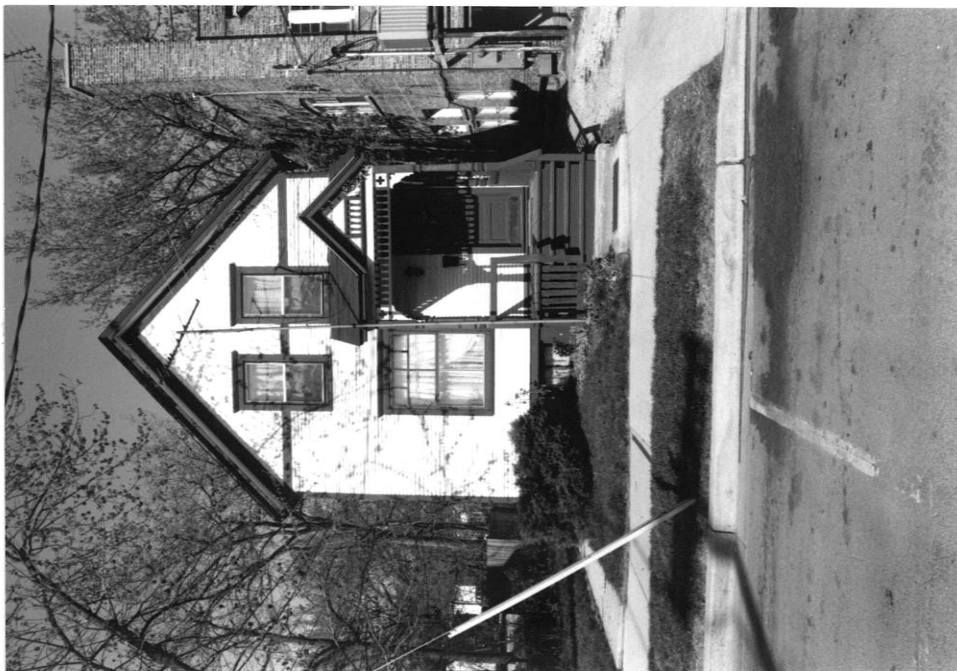
9 South 3rd Street

- ☐ Excellent: Well-maintained
- ☒ Good: Minor maintenance needed
- ☐ Fair: Major repairs needed
- ☐ Poor: Deteriorated

Style: Stick

Gabled roof to front with shingled upper facade above horizontal band separating gable area from clapboard lower facade. Decorative front porch with small gable and spindlework frieze.

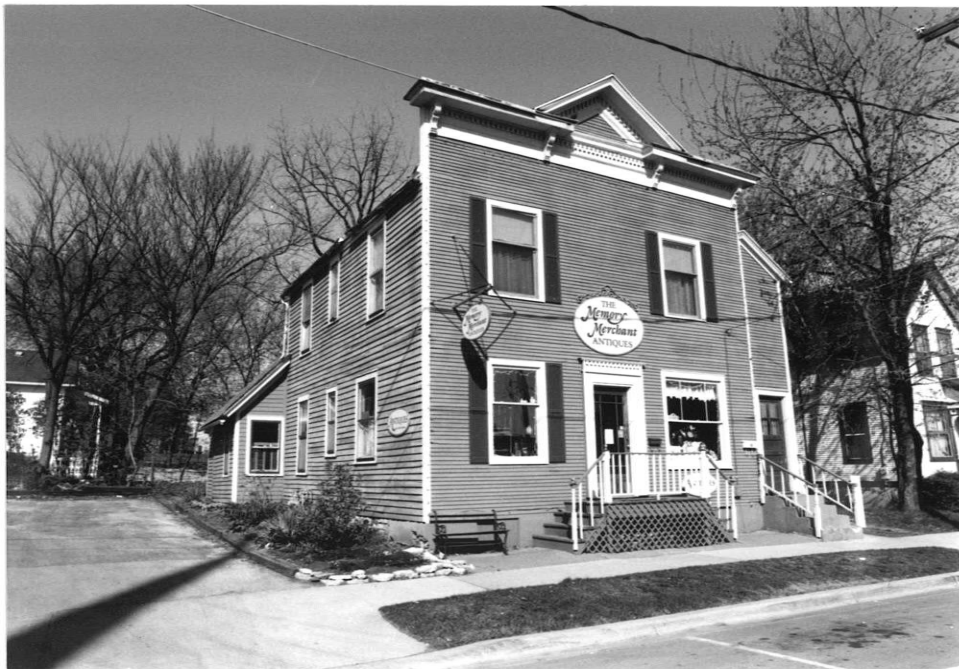
15 South 3rd Street

☒ Good: Minor maintenance needed

Style: Commercial Vernacular

Two story wood clapboard sided building, symmetrical with centered entrance. Front gable exposed above high parapet. Dentils at gable and above door.

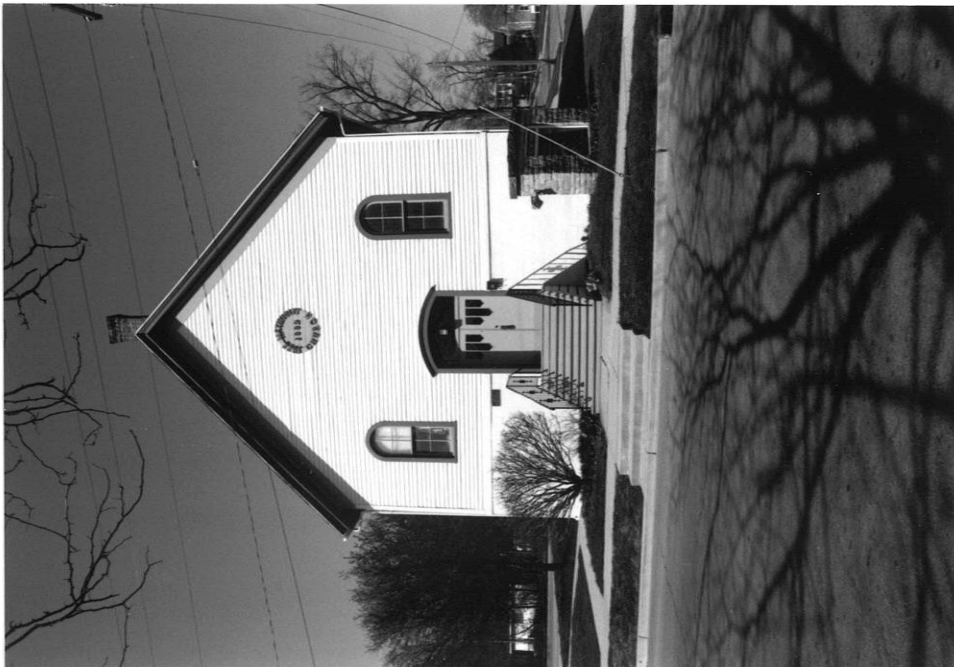
101 South 3rd Street

Style: Romanesque Revival

4" wood clapboard church building, stone foundation with beaded joints on block veneer. Round top windows. Segmented arch over double doors at main (east) entrance. Double doors not original.

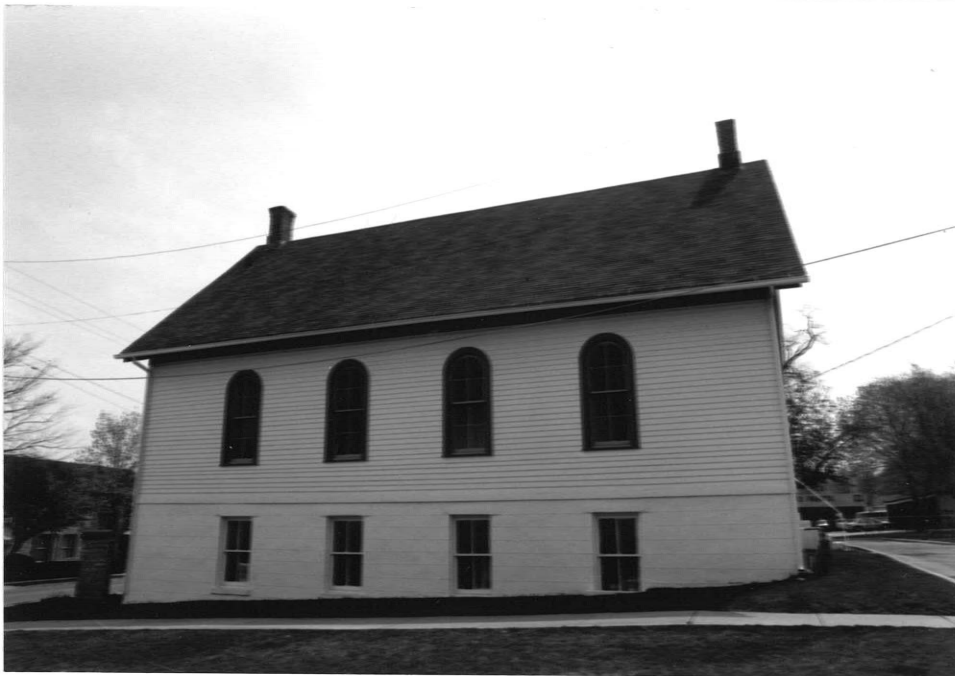
101 South 3rd Street

North Elevation

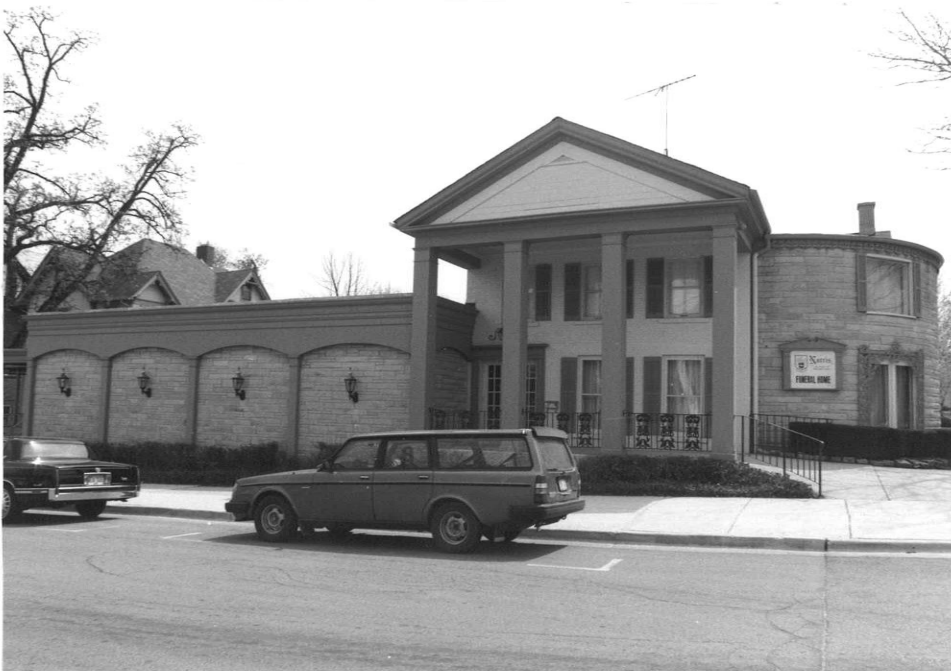
106-110 South 3rd Street

☒ Excellent: Well-maintained

Style: Neoclassical

Greatly modified Greek Revival structure, was once a station for underground railroad activities. Original structure obscured.

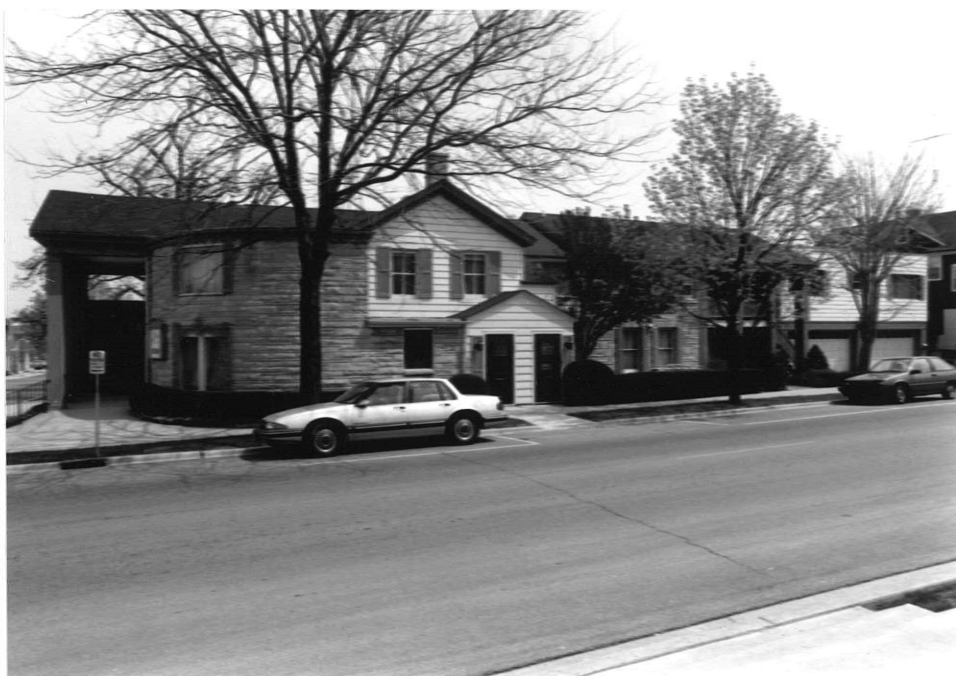
106-110 South 3rd Street

West Elevation

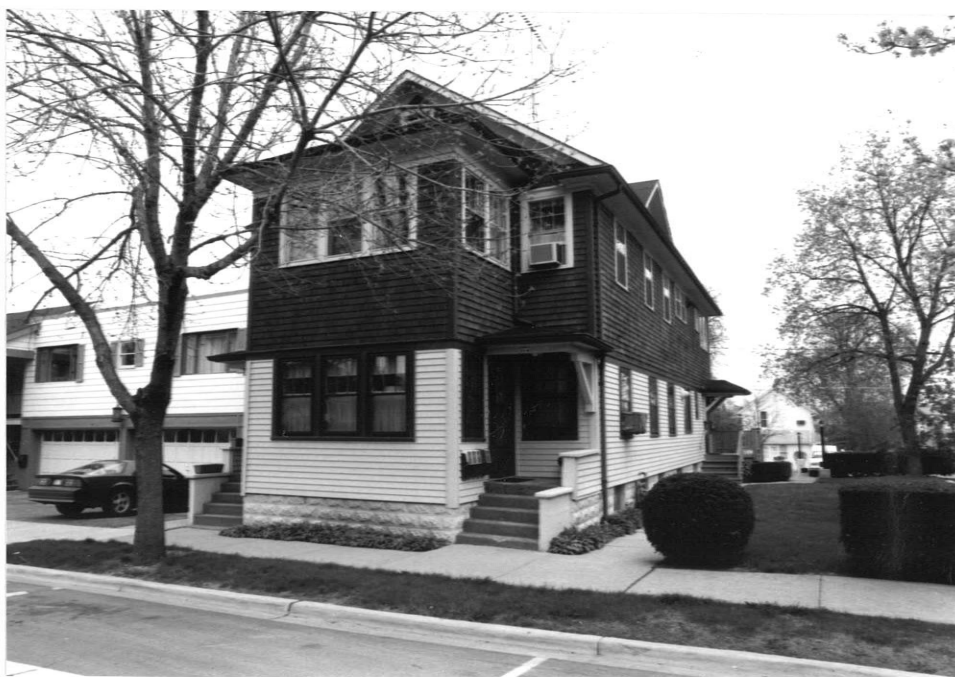
112/114 South 3rd Street

- ☒ Excellent: Well-maintained
- ☐ Good: Minor maintenance needed
- ☐ Fair: Major repairs needed
- ☐ Poor: Deteriorated

Style: Shingle

Shingle texture at second level, clapboard at first level.
Rock face block foundation.

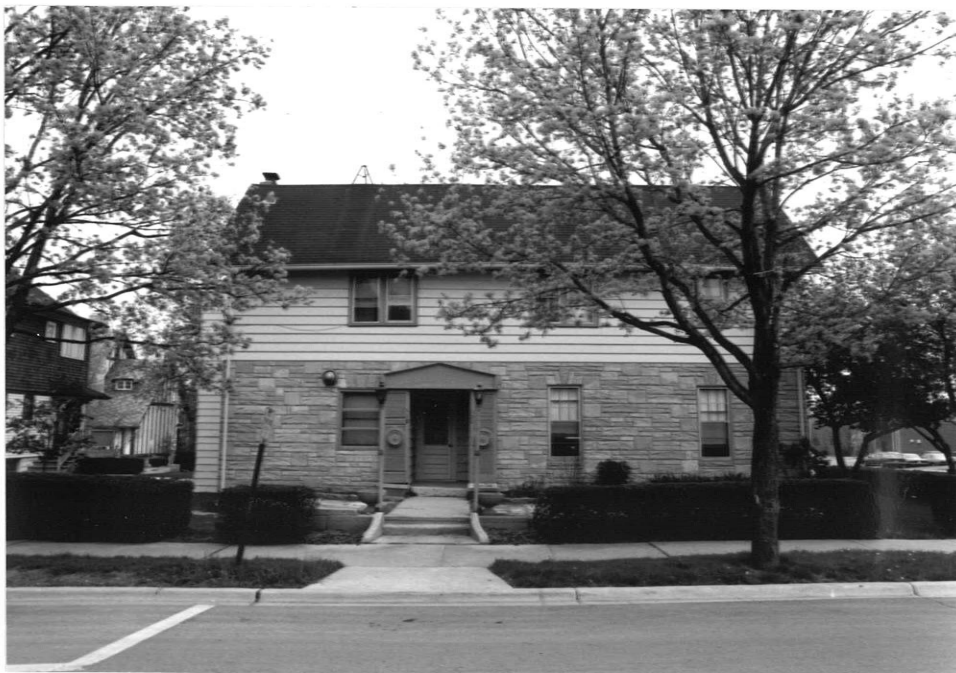
118/120 South 3rd Street
220 West Illinois Street

- ☒ Excellent: Well-maintained
- ☐ Good: Minor maintenance needed
- ☐ Fair: Major repairs needed
- ☐ Poor: Deteriorated

Style: Neoclassical

Lannon stone first floor with large dimension siding at second floor.

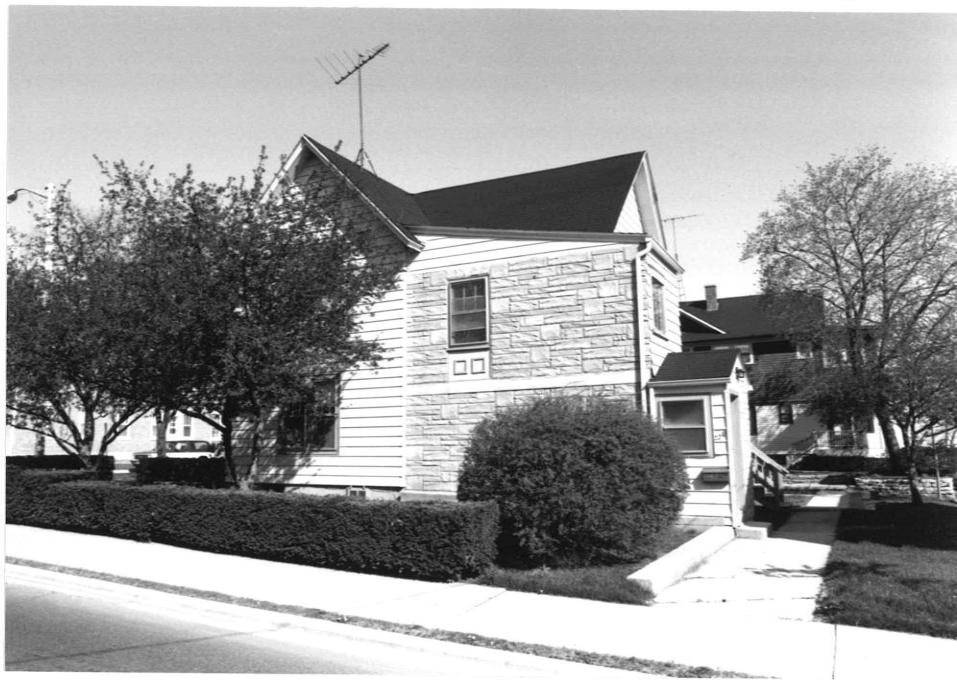
118/120 South 3rd Street
220 West Illinois Street

South Elevation

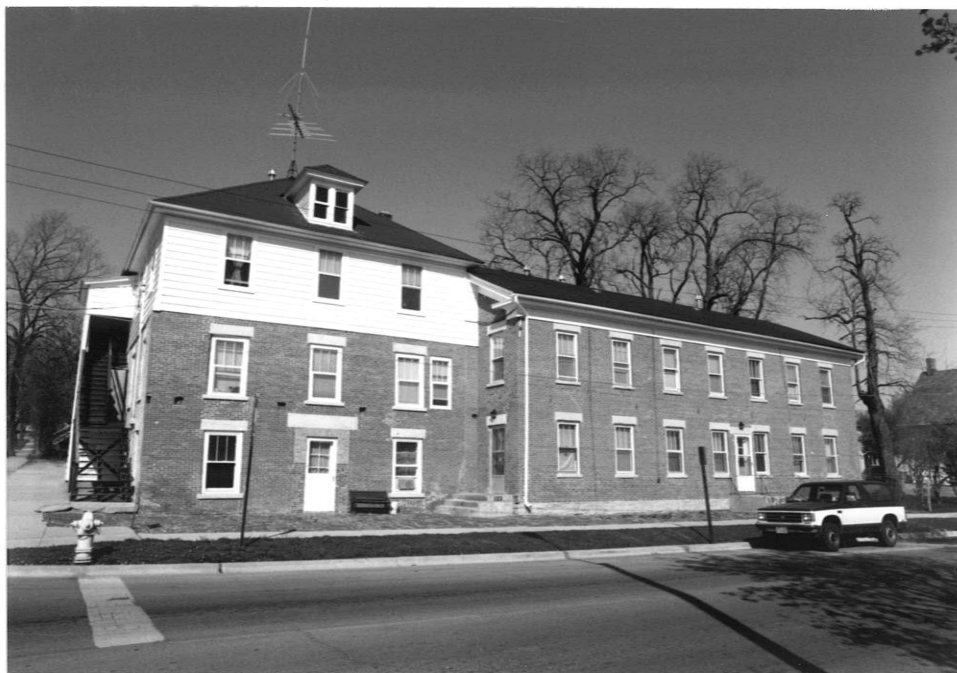
123 South 3rd Street

☒ Good: Minor maintenance needed

Style: Greek Revival

North section built first. South section added in 1850. Evidence of original two level wrap around porch in brick beam pockets. Mary Todd Lincoln stayed here after Abraham Lincoln was assassinated. Called the Howard House. Mrs. Caroline Howard was a psychic.

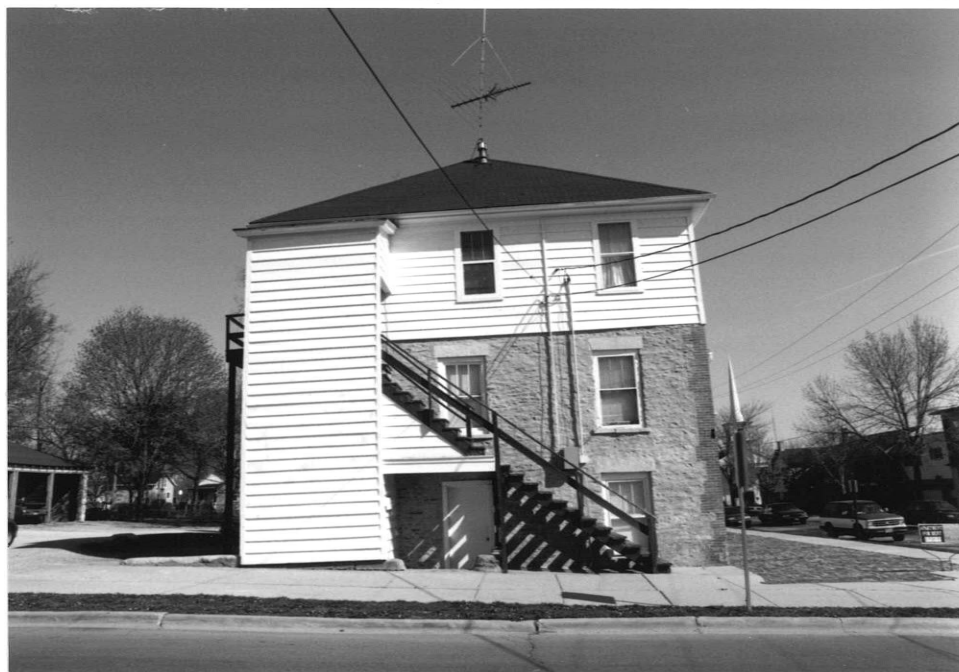
123 South 3rd Street

South Elevation

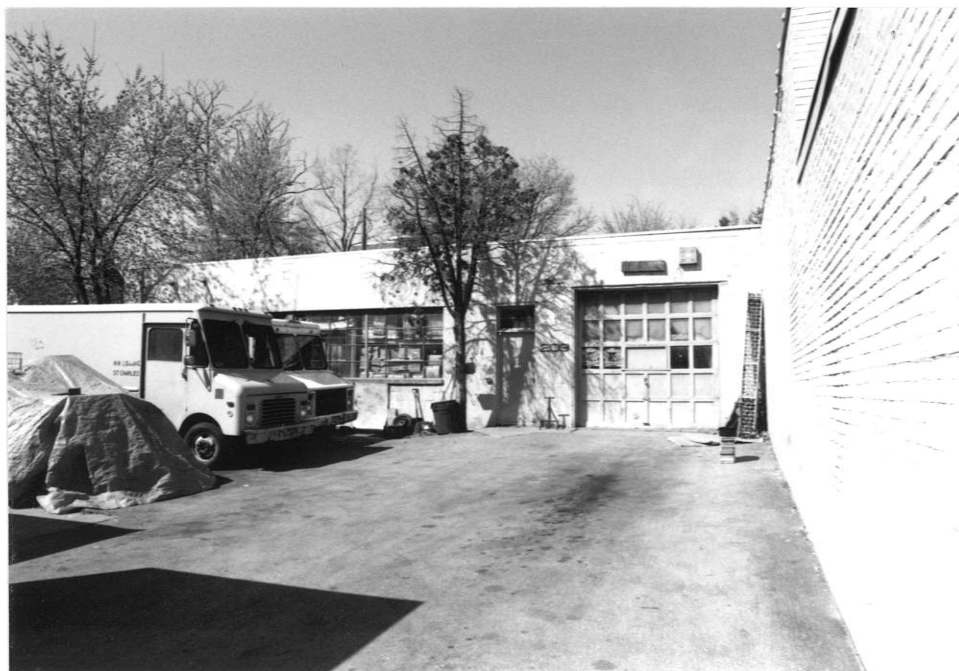
201-203 South 3rd Street

- ☐ Excellent: Well-maintained
- ☒ Good: Minor maintenance needed
- ☐ Fair: Major repairs needed
- ☐ Poor: Deteriorated

Style: Utilitarian

Brick one story building with steel frame windows and garage door.

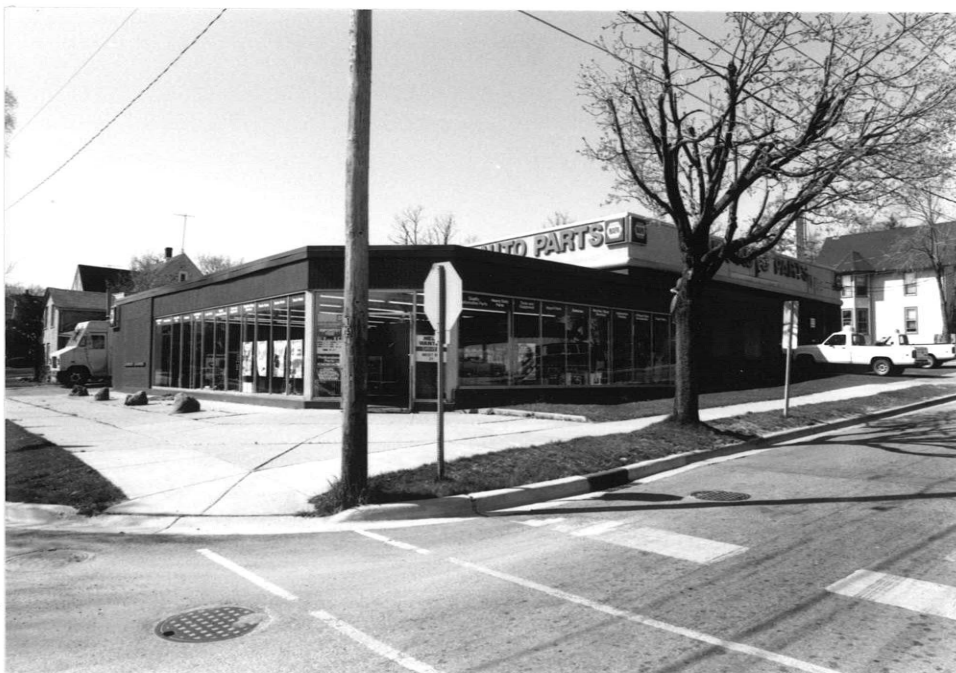
201-203 South 3rd Street

- ☒ Excellent: Well-maintained
- ☐ Good: Minor maintenance needed
- ☐ Fair: Major repairs needed
- ☐ Poor: Deteriorated

Style: Commercial Vernacular

Aluminum and glass storefront in brick building. Taller garage section to the west.

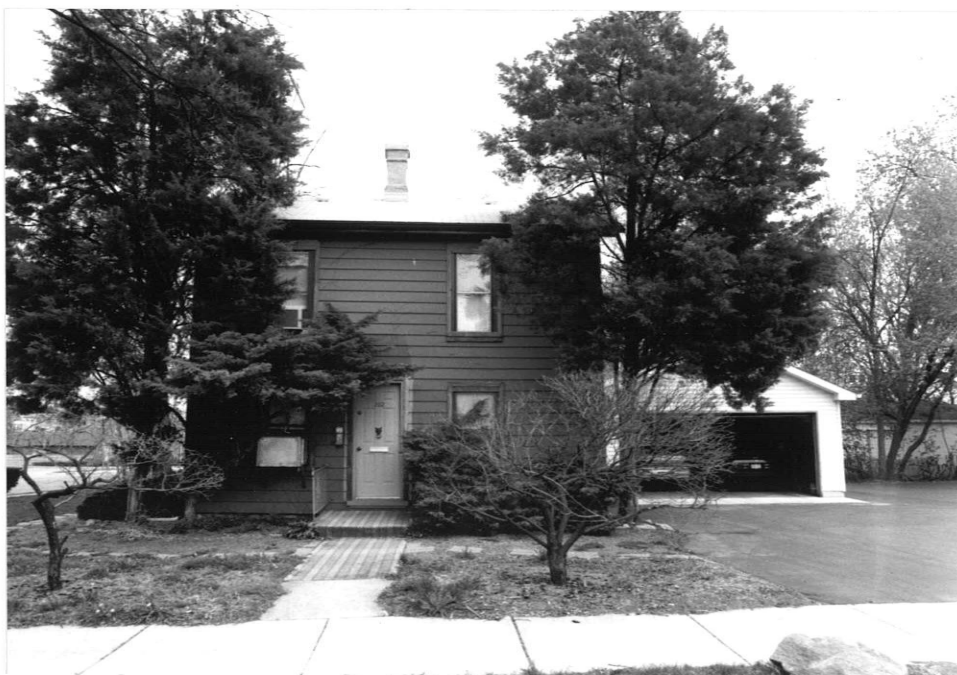
202 South 3rd Street/
217 West Illinois Street

☒ Good: Minor maintenance needed

Style: Neoecclectic

Simple side gable roof on two story house reducing to one story at rear. Wide board siding.

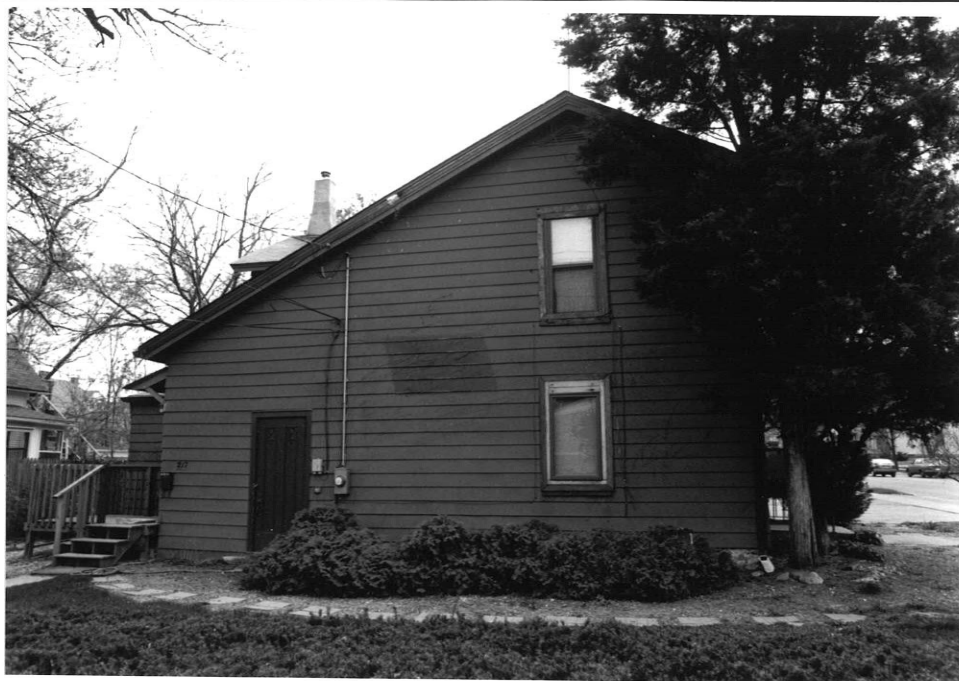
202 South 3rd Street/
217 West Illinois Street

North Elevation

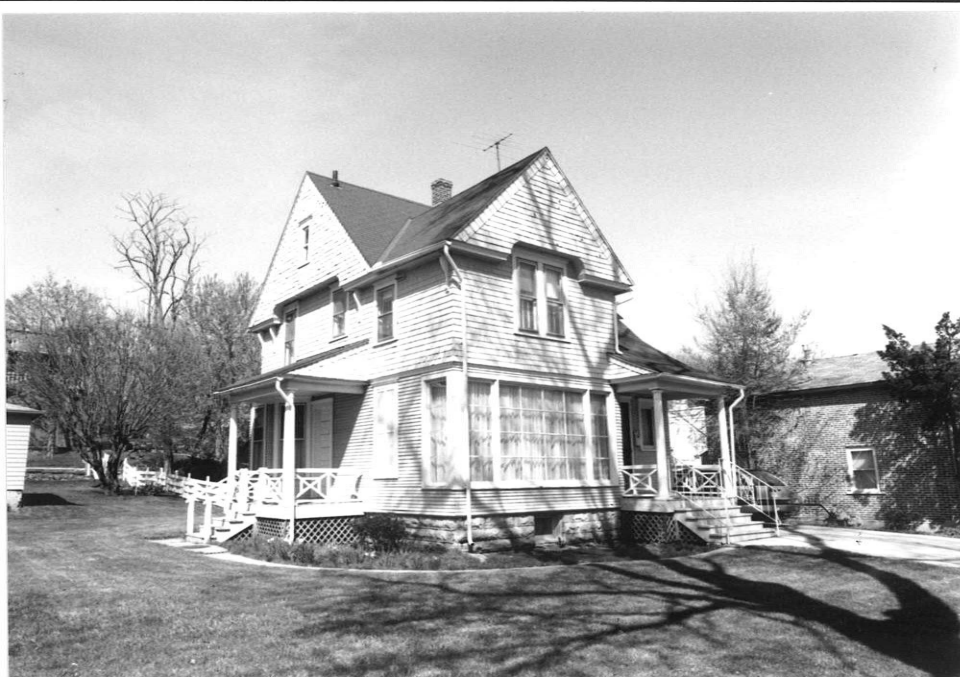
213 South 3rd Street

- ☒ Excellent: Well-maintained
- ☐ Good: Minor maintenance needed
- ☐ Fair: Major repairs needed
- ☐ Poor: Deteriorated

Style: Shingle

Cross gabled roof building with shingle texture in gables, notched over windows at second floor. Large expanse of glass at first floor at front. Wood clapboard at first floor on stone foundation. Porches at east and south sides.

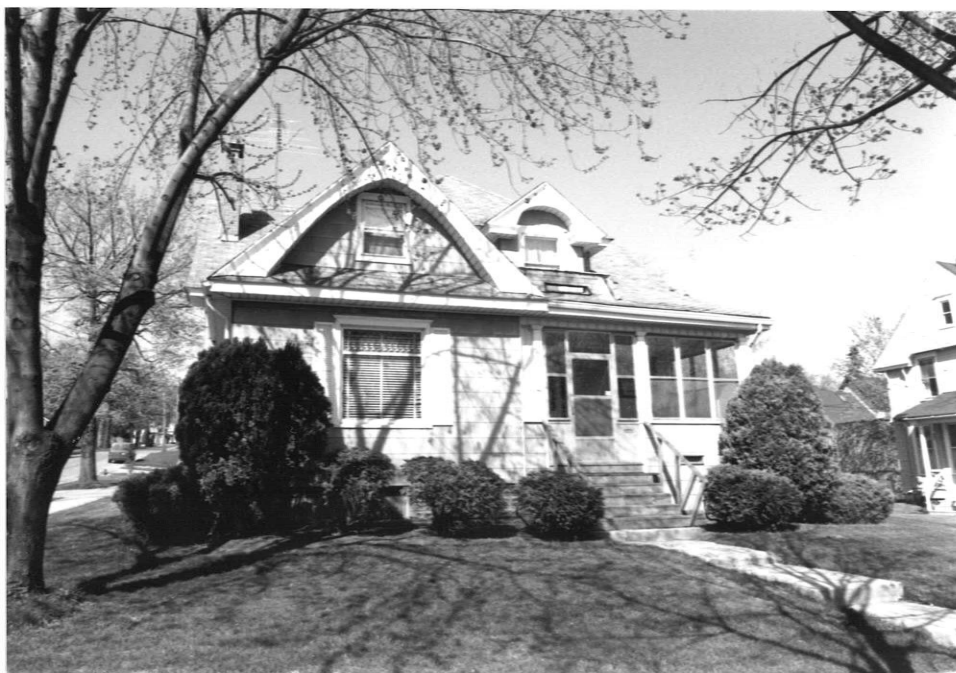
221 South 3rd Street

- ☒ Excellent: Well-maintained
- ☐ Good: Minor maintenance needed
- ☐ Fair: Major repairs needed
- ☐ Poor: Deteriorated

Style: Queen Anne

Irregular, steeply pitched roof line, with cross gables. Synthetic siding. Multi-level eaves. Rock face block foundation. Two gable dormers are distinctive to the east elevation, one with a parabolic arch and the other with a balcony set into the roof.

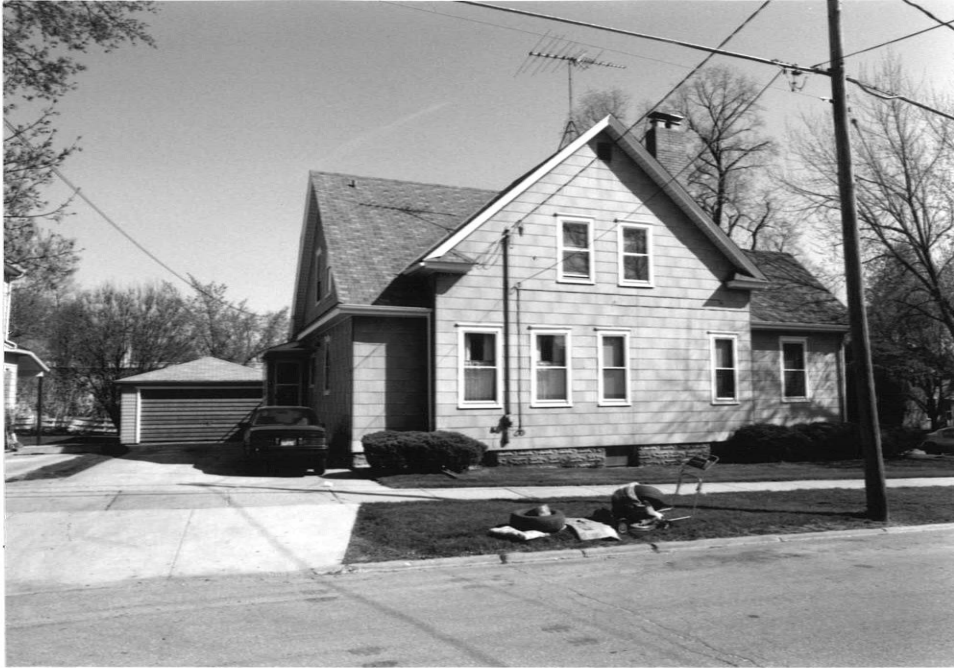
221 South 3rd Street

East Elevation.
