ST. CHARLES HISTORIC PRESERVATION COMMISSION

ARCHITECTURAL SURVEY ST. CHARLES CENTRAL DISTRICT ST. CHARLES, ILLINOIS

DIXON ASSOCIATES / ARCHITECTS

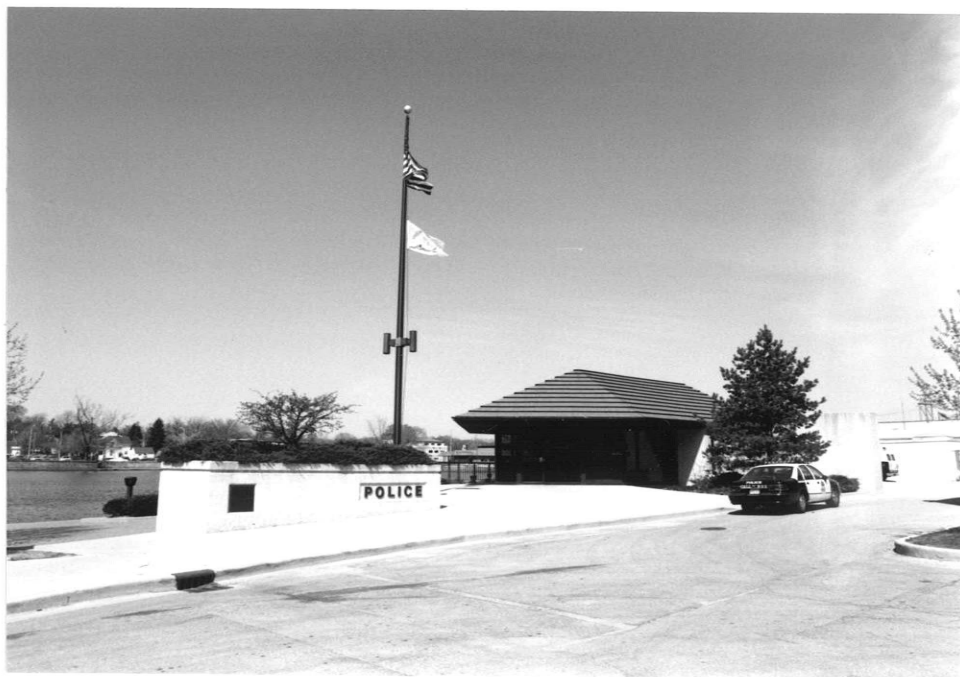
2 East State Avenue

- ☒ Excellent: Well-maintained
☐ Good: Minor maintenance needed
☐ Fair: Major repairs needed
☐ Poor: Deteriorated

Style: Modern

Date of Construction: 1985

One story aggregate finish exterior with metal hip roof.
Large overhanging eaves with horizontal emphasis in
lines of roof.

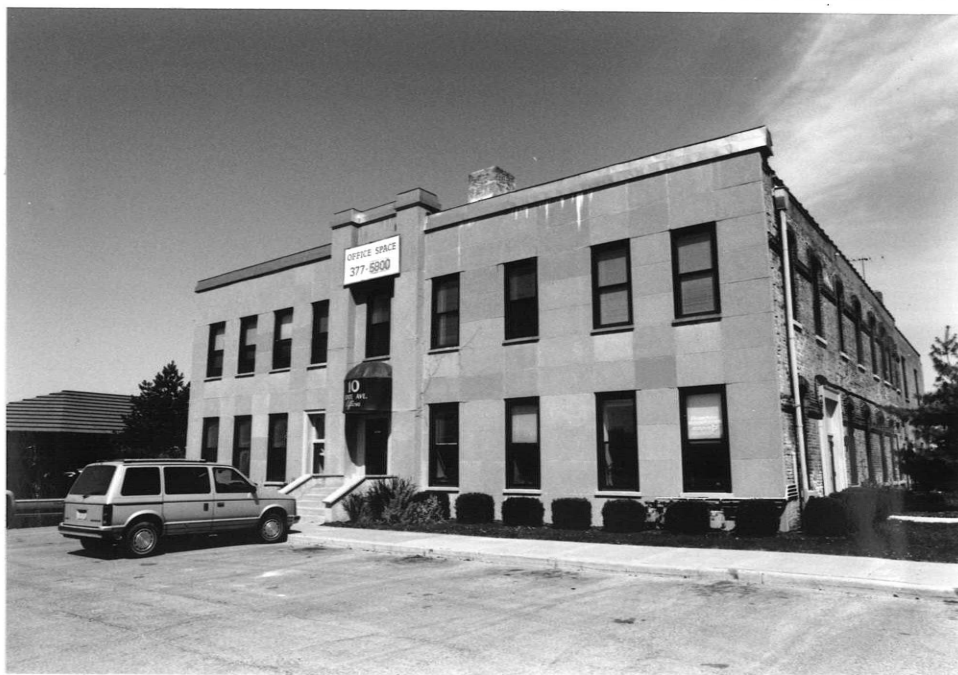
10 State Avenue

- ☐ Excellent: Well-maintained
- ☒ Good: Minor maintenance needed
- ☐ Fair: Major repairs needed
- ☐ Poor: Deteriorated

Style: Substantially altered

Date of Construction: Pre 1900

Original factory building at east side, addition to west. South face clad with limestone slabs in 1930's. East facade shows band of face brick as decorative element in common brick wall.

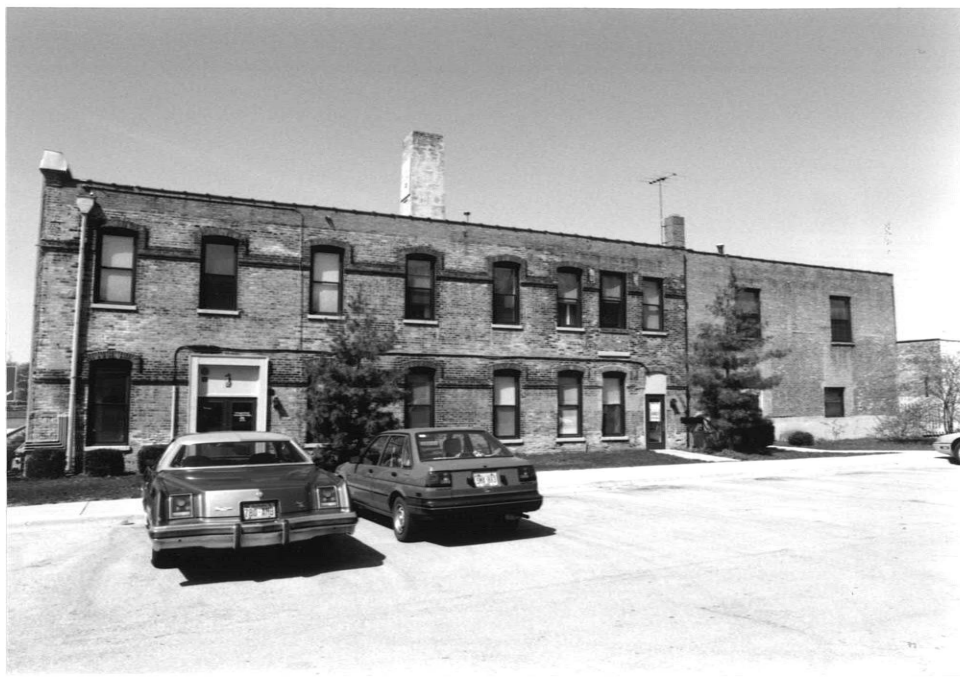
10 State Avenue

East side, showing original
industrial building.

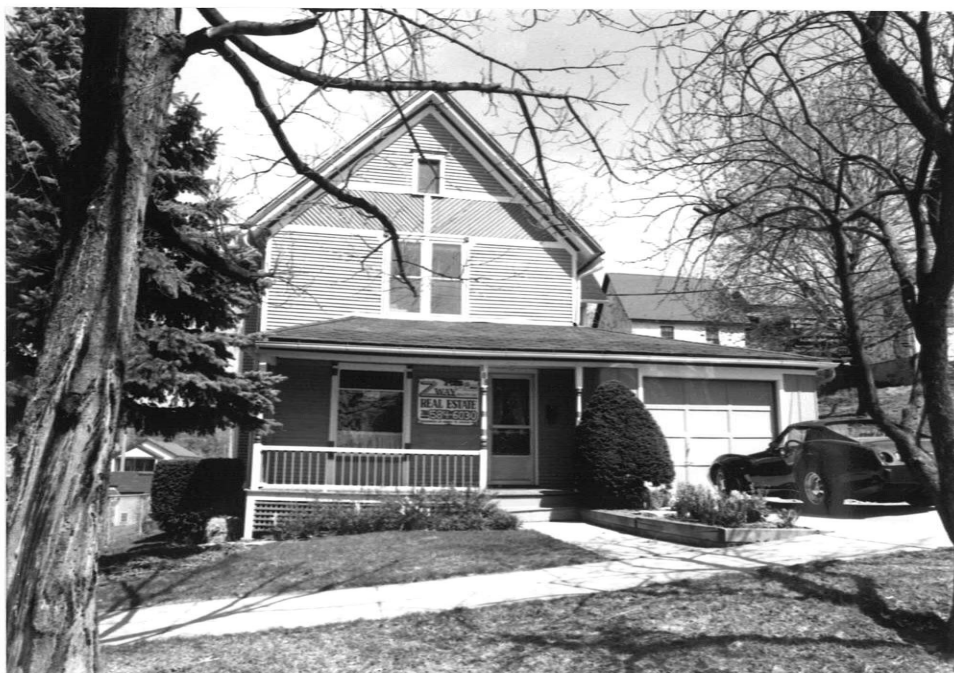
108 East State Avenue

- ☒ Excellent: Well-maintained
- ☐ Good: Minor maintenance needed
- ☐ Fair: Major repairs needed
- ☐ Poor: Deteriorated

Style: Stick

Date of Construction: 1860-1890

Steeply pitched gabled roof. Horizontal and vertical bands in contrasting color to base wall for emphasis. Wood clapboards, horizontal except for diagonal in lower half of gable. Full width front porch.

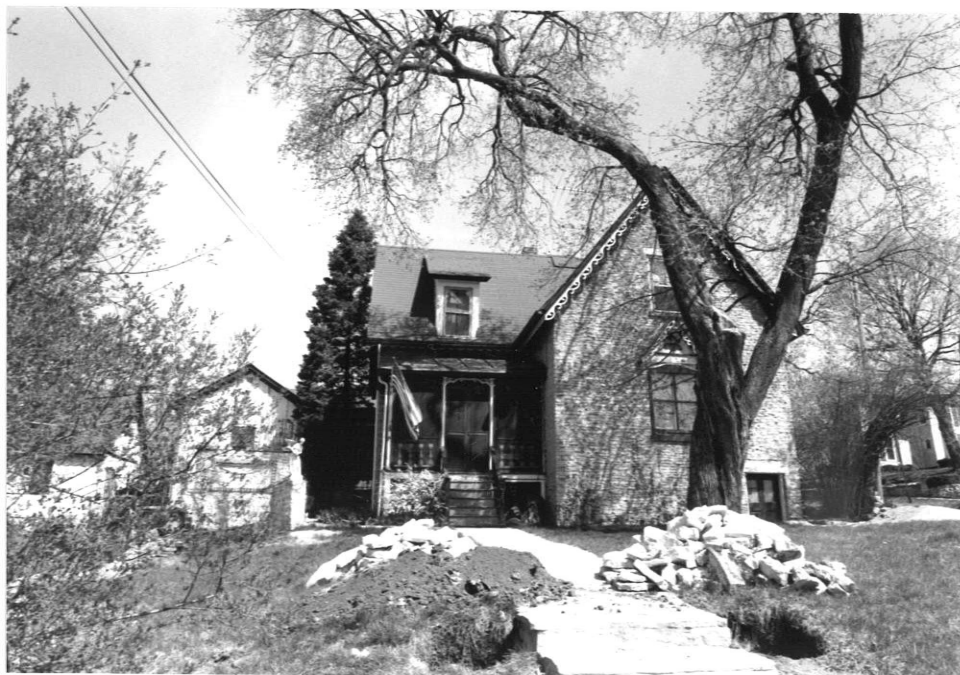
116 East State Avenue

☒ Good: Minor maintenance needed

Style: Gothic Revival

Date of Construction: 1840

Random limestone exterior with steeply sloping roof, cross gabled. Decorated vergeboards at gables. Small gable over first floor window, south side. Enclosed porch at entry. Stone lintels at windows. Two different dormer shapes at east elevation.

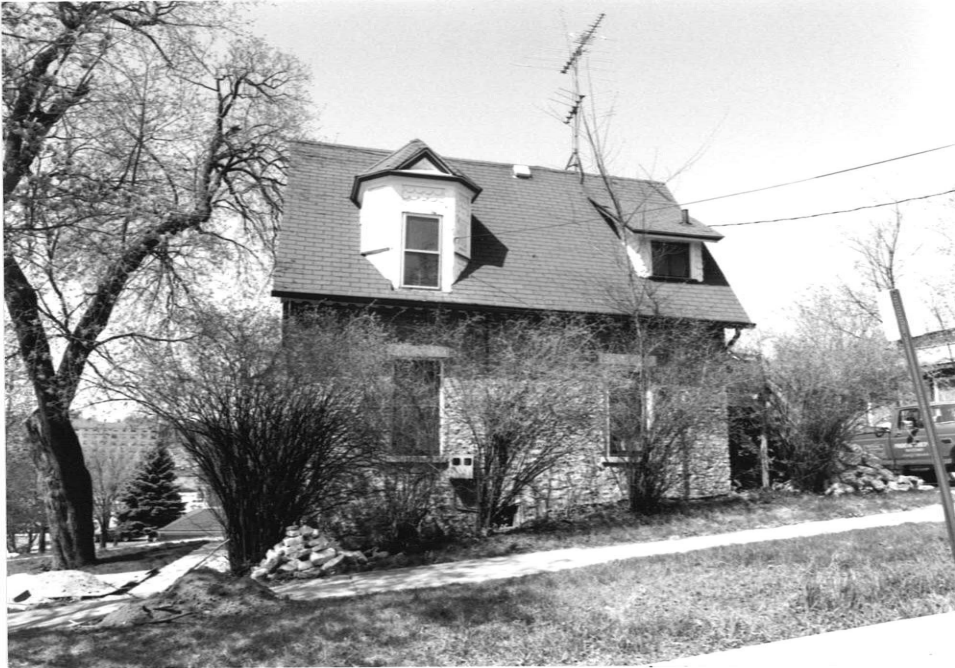
116 East State Avenue

East Elevation.

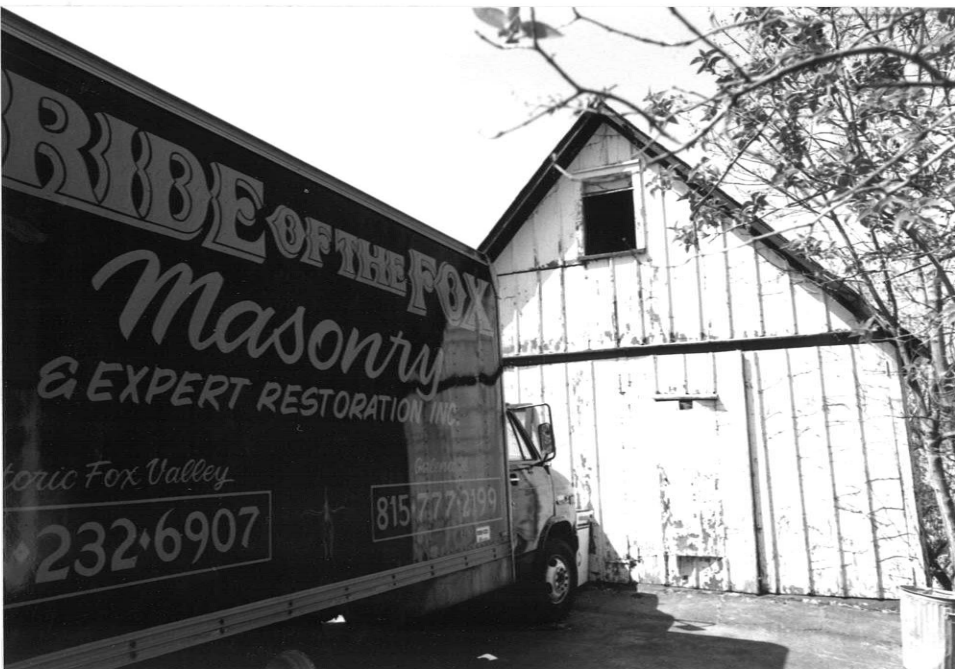
116 East State Avenue

Garage, east side.

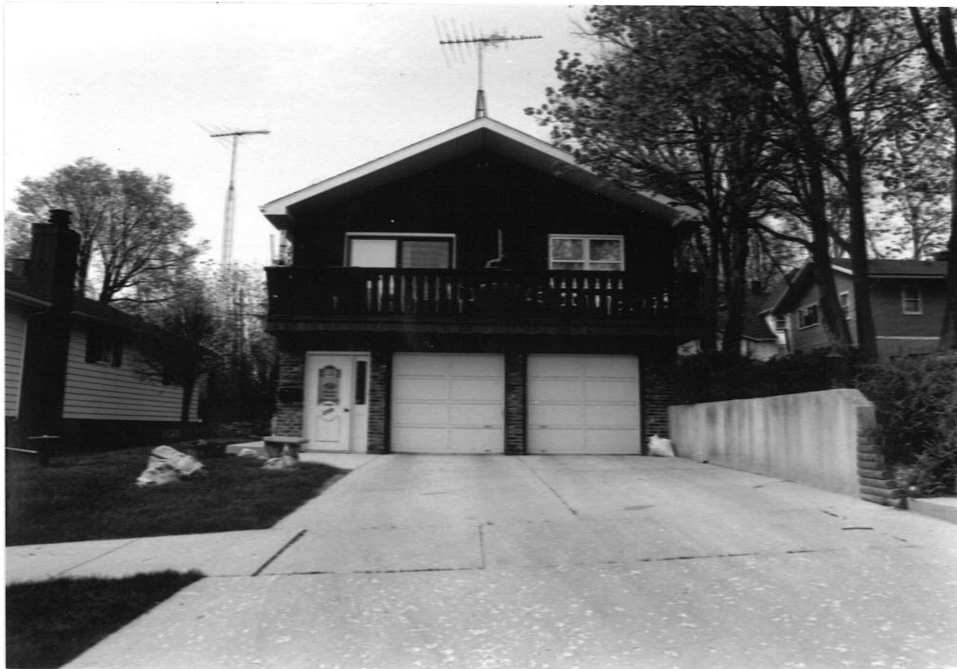
204 East State Avenue

- ☒ Excellent: Well-maintained
- ☐ Good: Minor maintenance needed
- ☐ Fair: Major repairs needed
- ☐ Poor: Deteriorated

Style: Minimal Traditional

Date of Construction: 1960-1980

Front gable two story frame house with brick veneer at lower level. Balcony at second floor full width of front facade over two single car garage doors and single man door with sidelight.

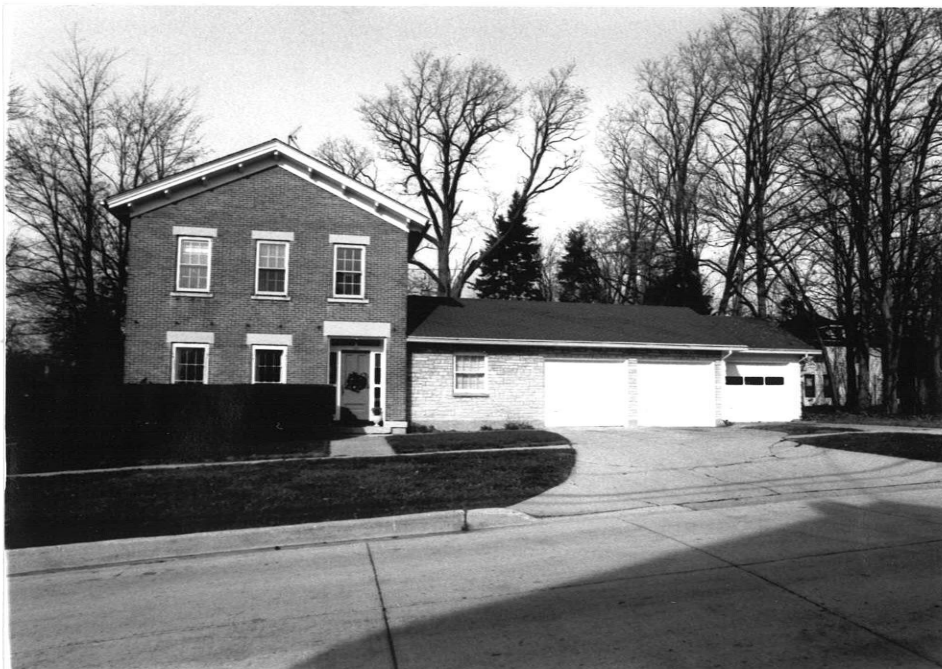
304 East State Avenue

- ☒ Excellent: Well-maintained
- ☐ Good: Minor maintenance needed
- ☐ Fair: Major repairs needed
- ☐ Poor: Deteriorated

Style: Greek Revival

Date of Construction: 1853

Front gable two story brick building with stone lintels.
Addition to east is stone exterior.

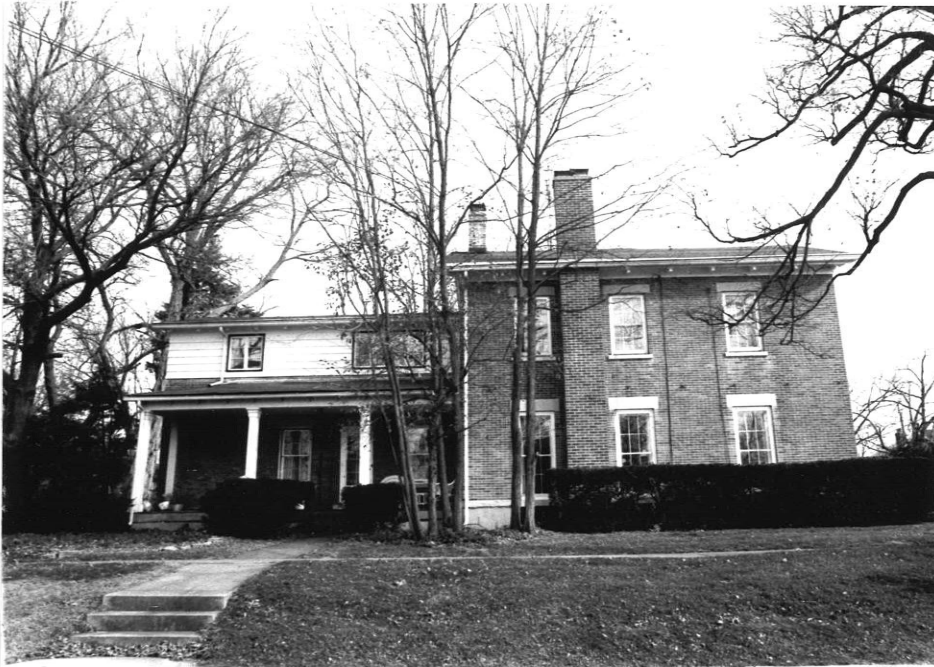
304 East State Avenue

West Elevation, showing
north addition and porch.

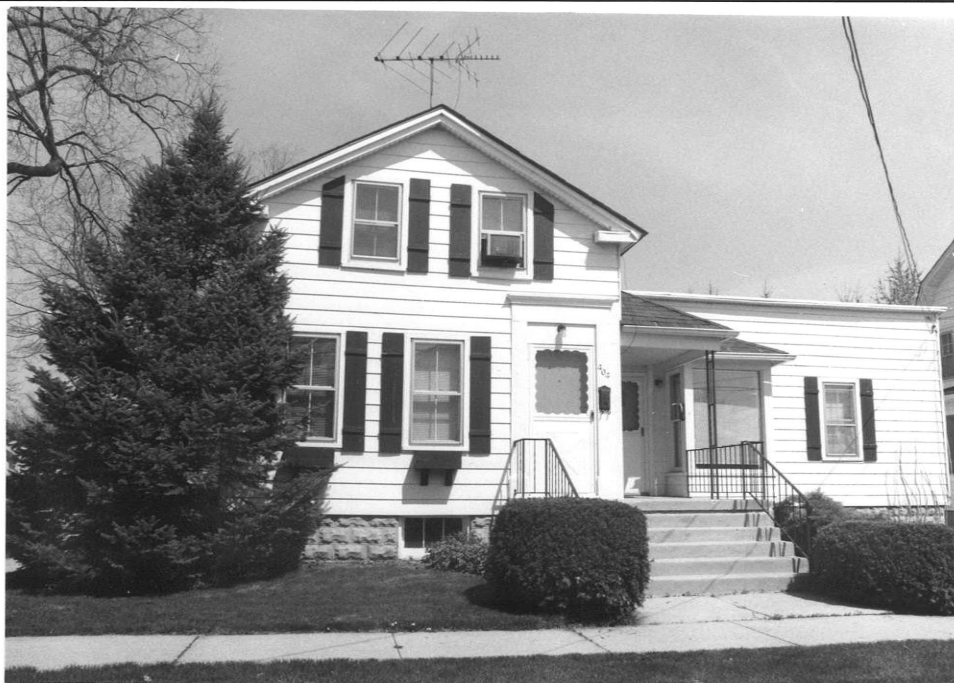
404 East State Avenue

- ☒ Excellent: Well-maintained
- ☐ Good: Minor maintenance needed
- ☐ Fair: Major repairs needed
- ☐ Poor: Deteriorated

Style: National

Date of Construction: 1850-1890

One and one-half stories, wood frame structure on rock face block foundation. Front gabled, synthetic siding.

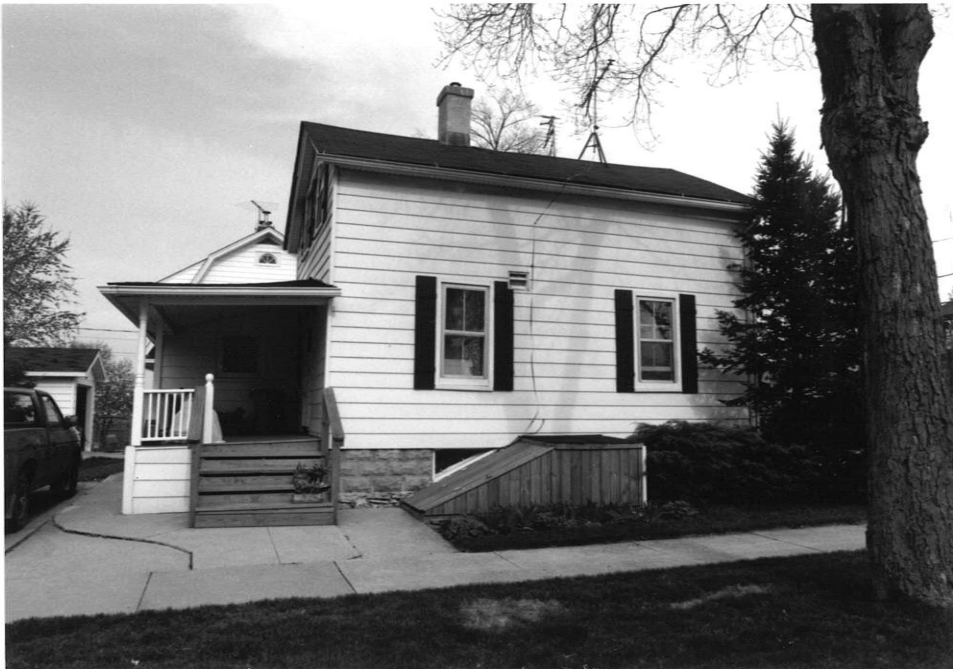
404 East State Avenue

West Elevation.

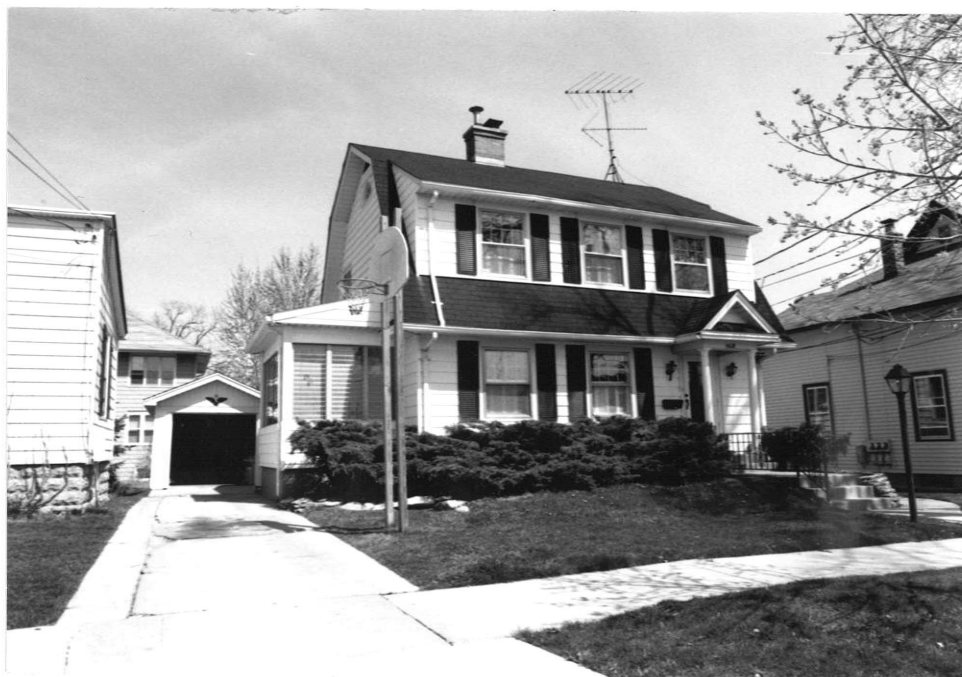
408 East State Avenue

- ☒ Excellent: Well-maintained
- ☐ Good: Minor maintenance needed
- ☐ Fair: Major repairs needed
- ☐ Poor: Deteriorated

Style: Colonial Revival

Date of Construction: 1880-1955

Gambrel roof on two story wood frame structure. Pent roof with gable at entrance door.

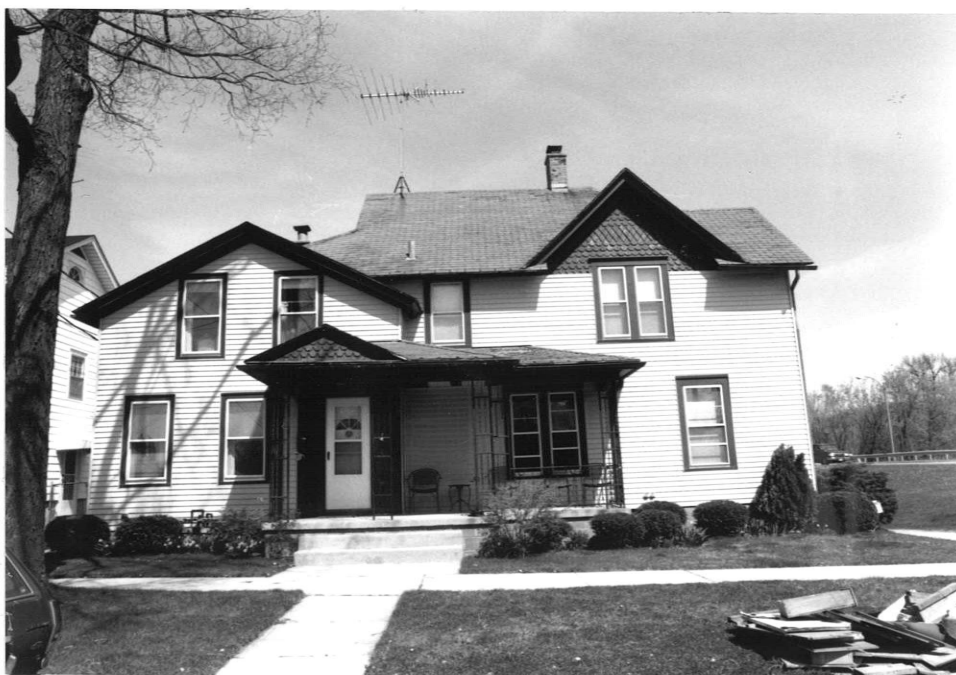
410 East State Avenue

☒ Good: Minor maintenance needed

Style: Queen Anne

Date of Construction: 1880-1910

Steeply pitched roof of irregular shape with three front facing gables. Covered front porch with gable end. Shingle texture at gable end.

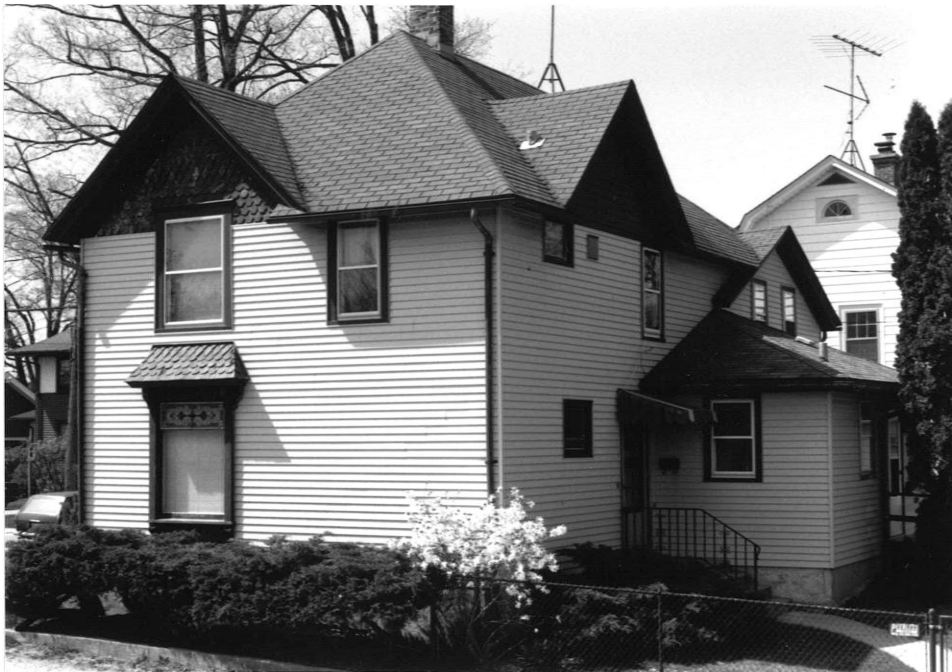
410 East State Avenue

East Elevation.

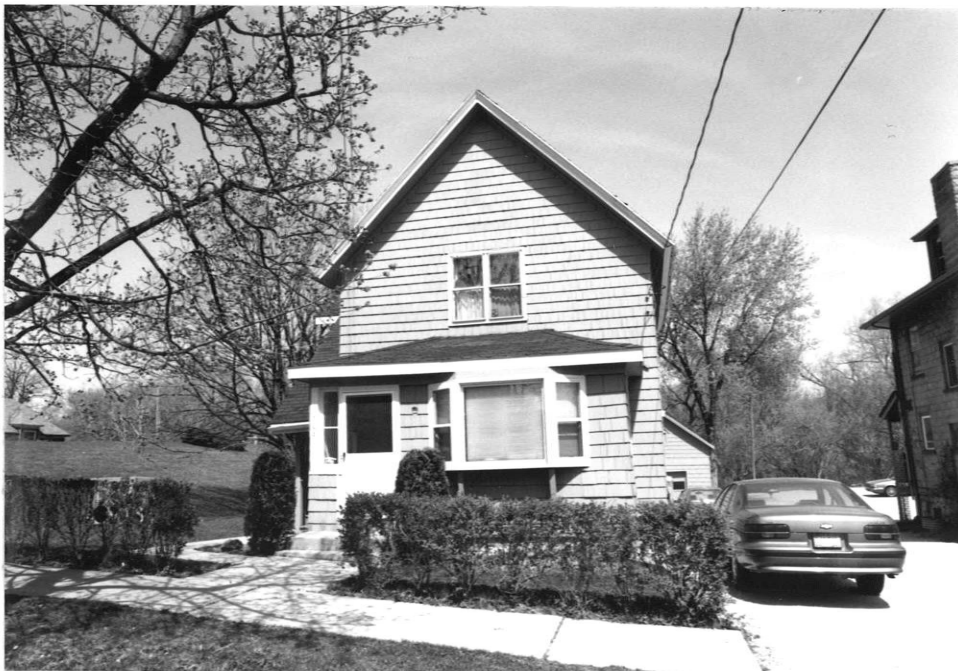
508 East State Avenue

☒ Excellent: Well-maintained

Style: National

Date of Construction: 1850-1890

Front gable, two story shingle sided structure with enclosed front porch with bay window. Enclosed stair added to west side.

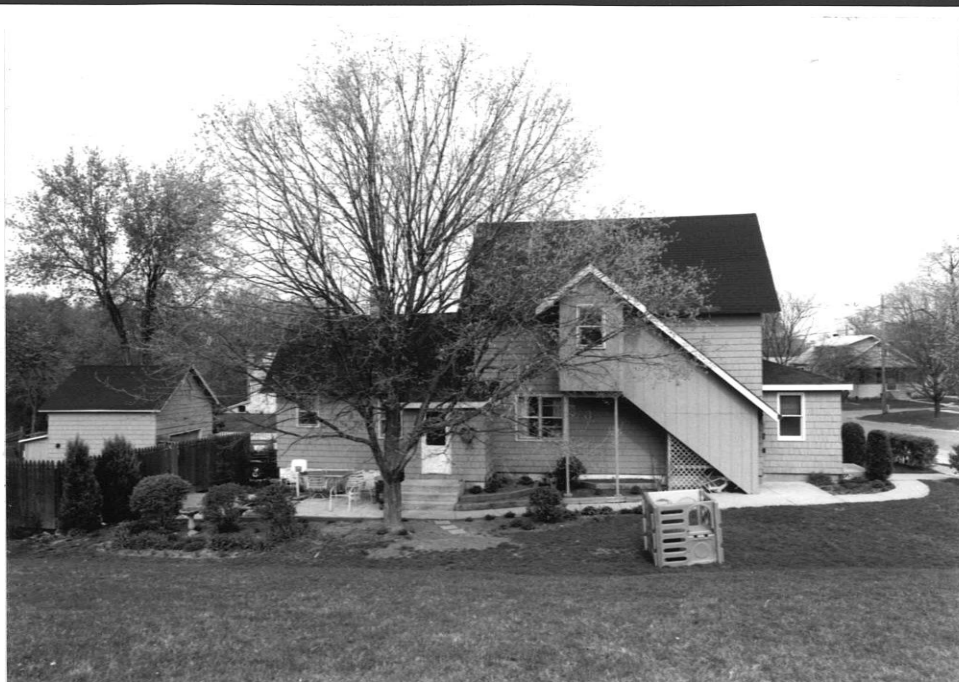
508 East State Avenue

West Elevation.

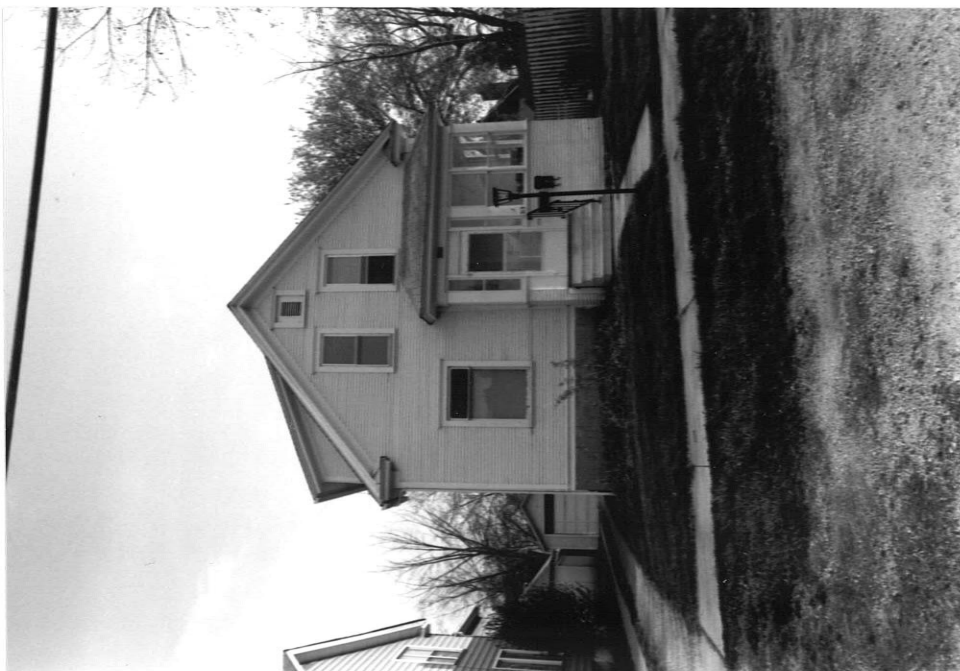
513 East State Avenue

☒ Good: Minor maintenance needed

Style: Greek Revival

Date of Construction: 1825-1860

One and one-half story wood frame clapboard sided house.

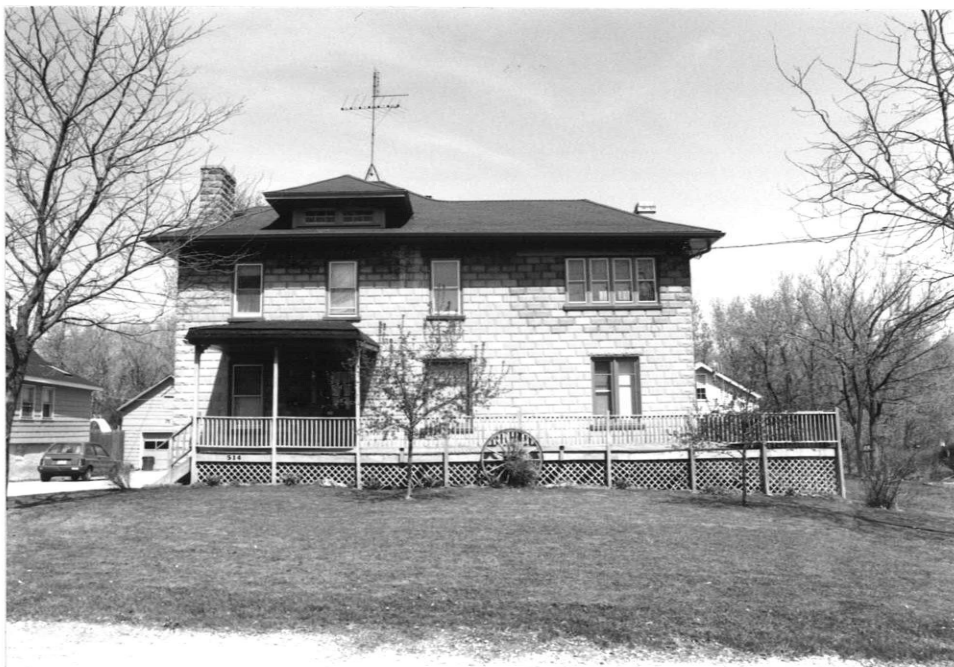
514 East State Avenue

☒ Good: Minor maintenance needed

Style: Prairie

Date of Construction: 1900-1920

Rock face block two story exterior, hipped roof with dormer.

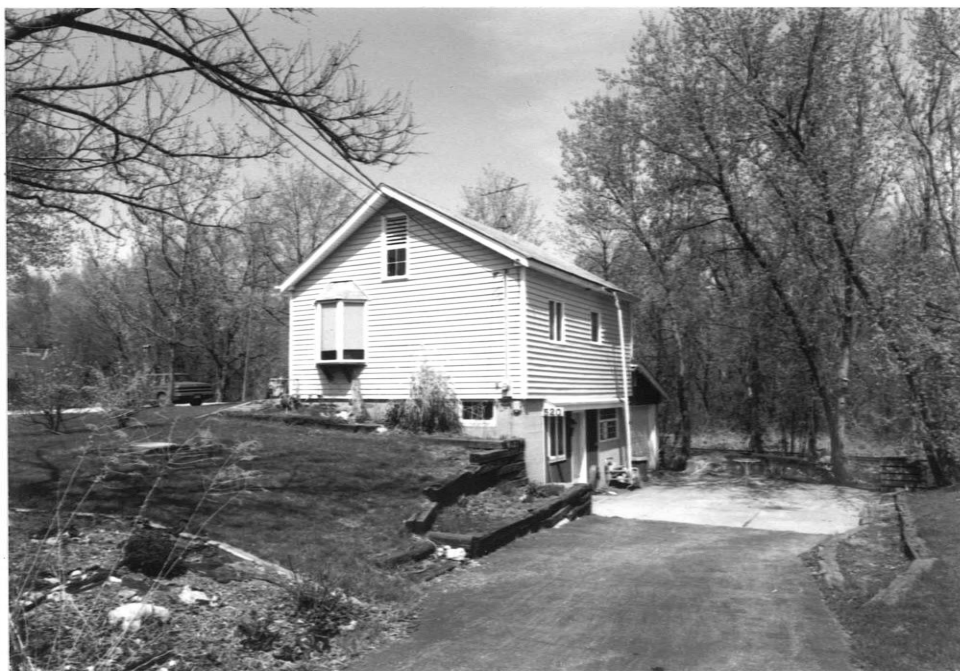
520 East State Avenue

- ☒ Excellent: Well-maintained
- ☐ Good: Minor maintenance needed
- ☐ Fair: Major repairs needed
- ☐ Poor: Deteriorated

Style: Modern

Date of Construction: 1935-1990

One story plus walk out basement, simple, minimal traditional structure. Bay window at south elevation.

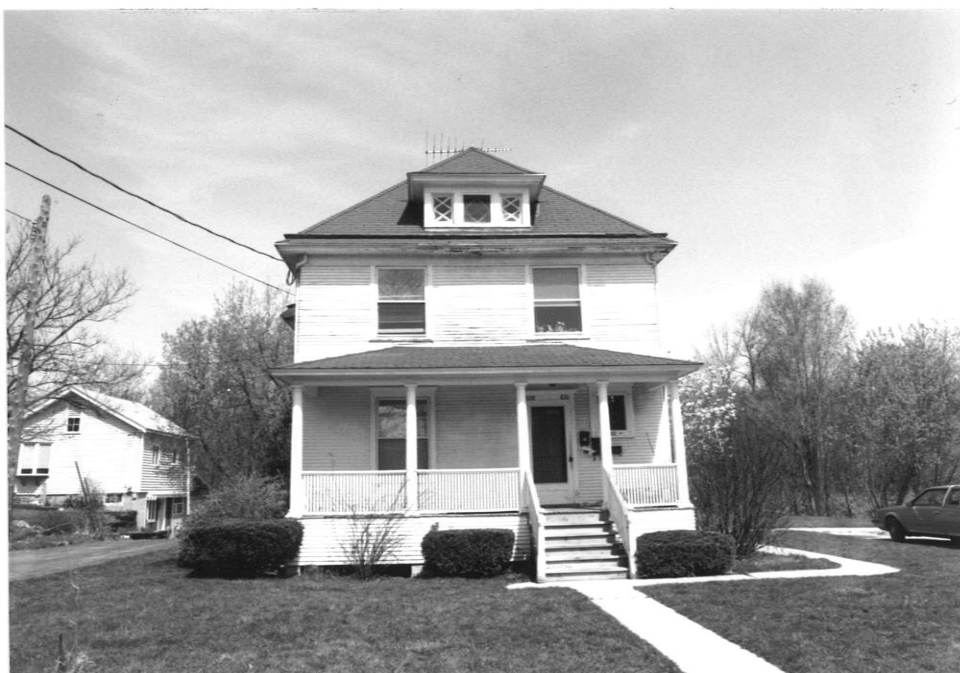
608-612 East State Avenue

☒ Good: Minor maintenance needed

Style: Prairie/American Foursquare

Date of Construction: 1900-1920

Hipped roof, symmetrical, with front entry, full width porch. Two story wood clapboard sided structure. Dormer on hipped roof. Relocated to this site in late 1980's.
