ST. CHARLES HISTORIC PRESERVATION COMMISSION

ARCHITECTURAL SURVEY ST. CHARLES CENTRAL DISTRICT ST. CHARLES, ILLINOIS

DIXON ASSOCIATES / ARCHITECTS

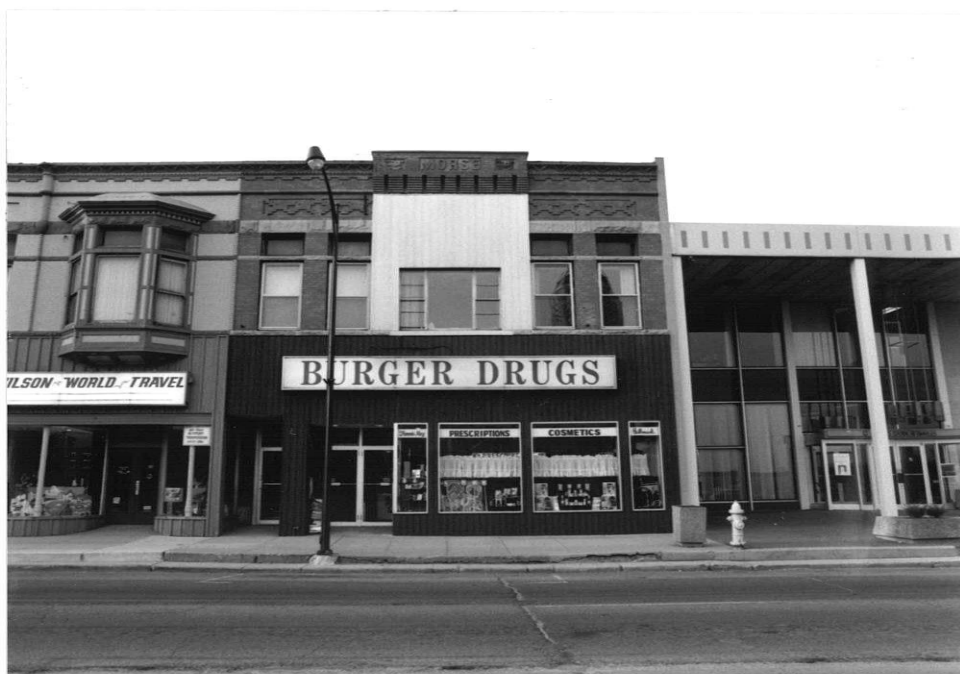
9 East Main Street

Two story masonry structure, brick with stone band at second floor window heads. Elaborate brick cornice with "MORSE" inscription. Aluminum clad center section at second floor. First floor store fronts are greatly modified.

Alterations to the first floor are sensitive to the original.

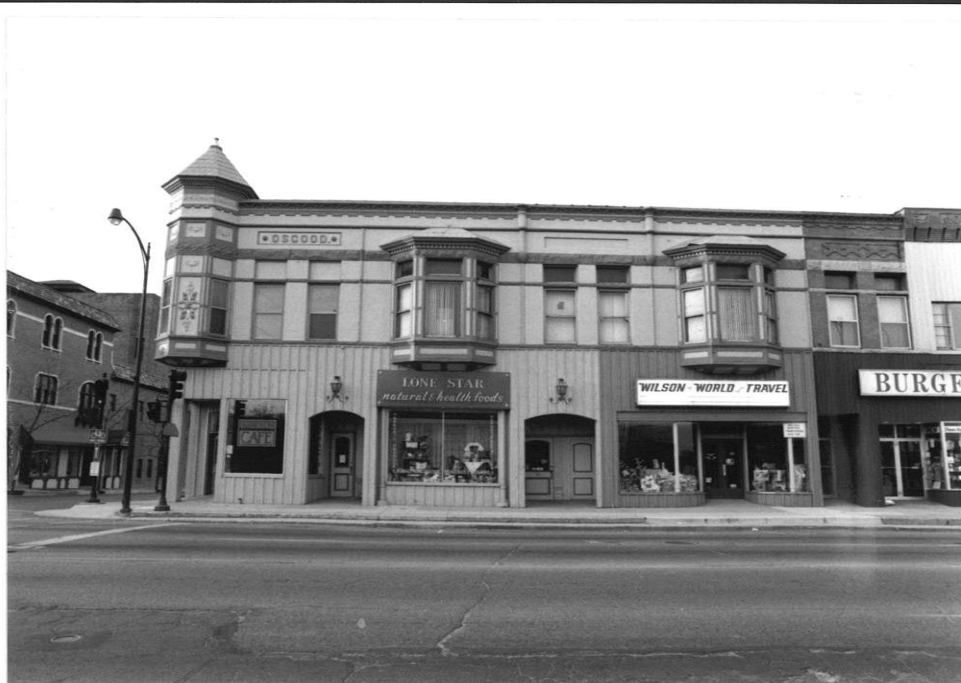
13-15 1/2 East Main Street

Two story masonry structure, brick with stone banding at window heads. Banding changes to textured brick on east elevation. Four bay windows and corner turret at second floor. First floor covered with board and batten wood siding. Greatly modified storefronts. "OSGOOD" inscription at cornice.

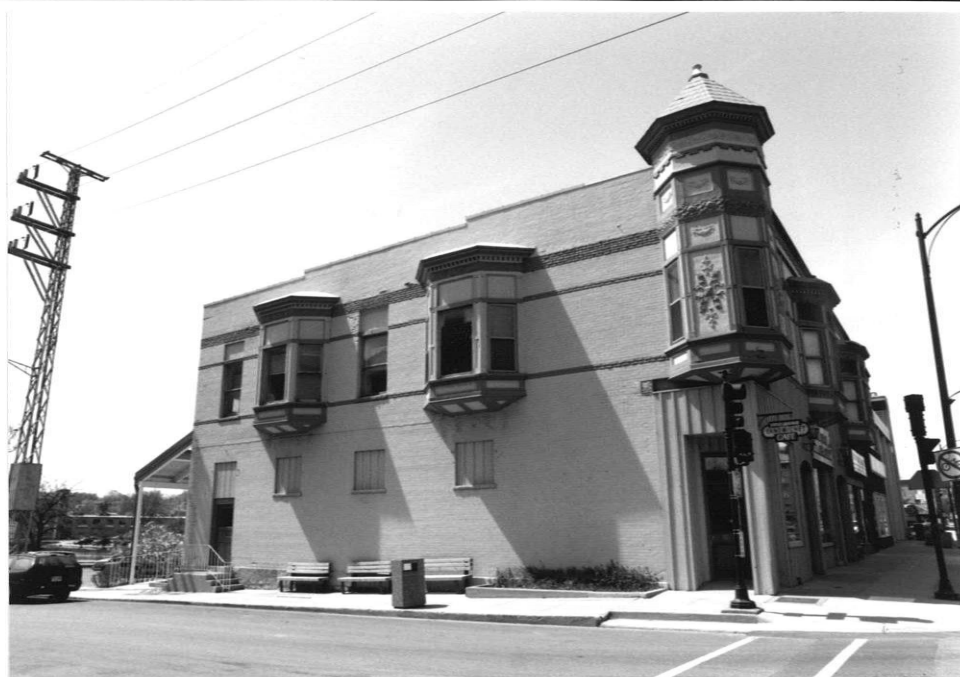
13-15 1/2 East Main Street

East Elevation.

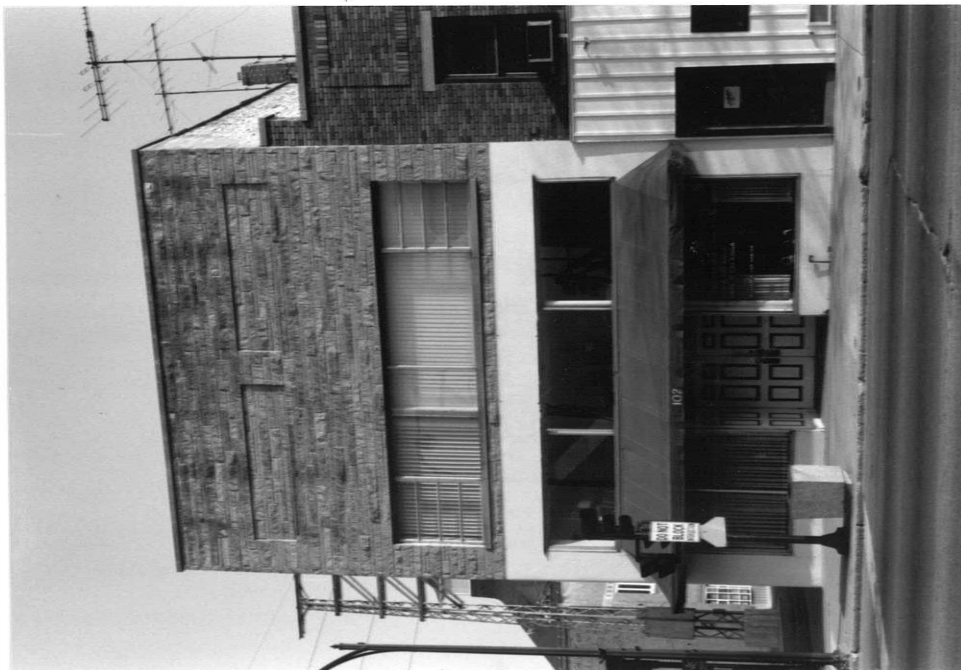
102 East Main Street

Stucco finish at the first floor on the south elevation.
Lannon stone finish on second floor of south elevation.

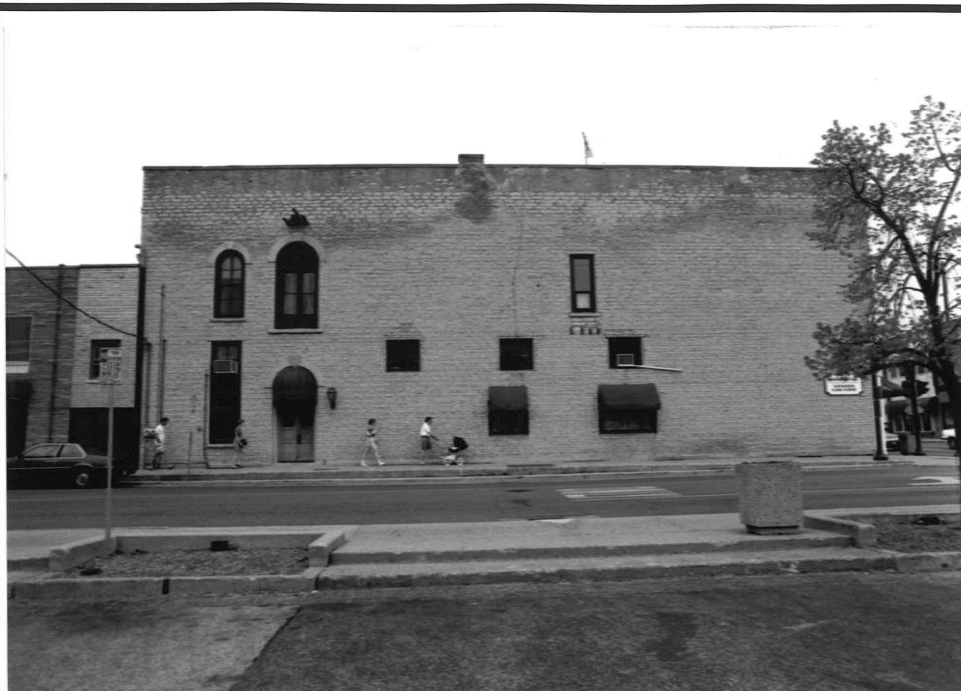
102 East Main Street

West Elevation, showing original stone wall with rounded top windows and cut stone headers.

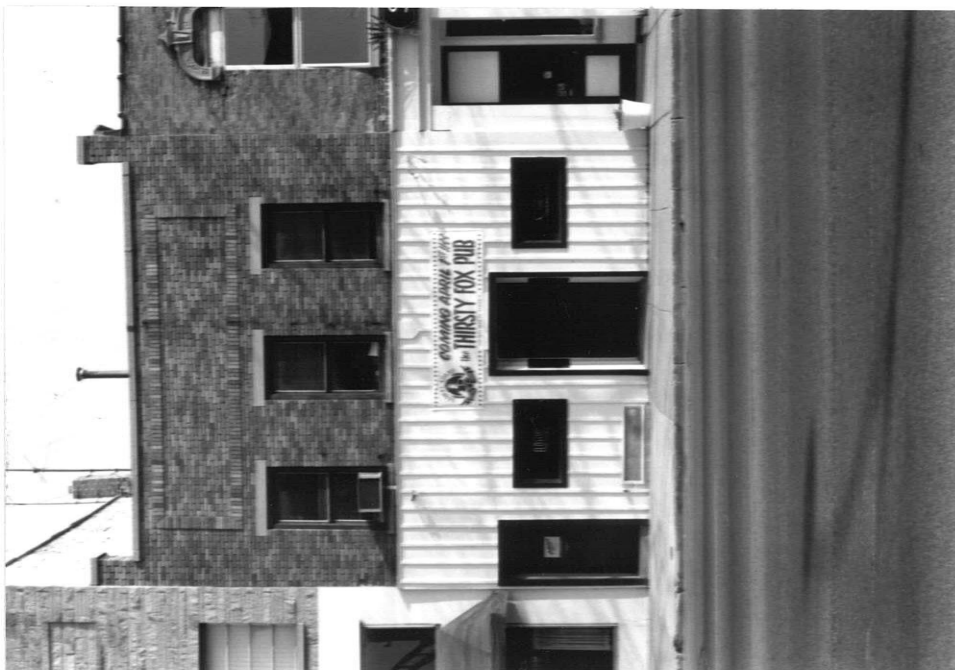
104 East Main Street

Two story brick front with limestone headers at second floor. First floor is clad with wood board and batten siding.

Alterations to the first floor are sensitive to the original.

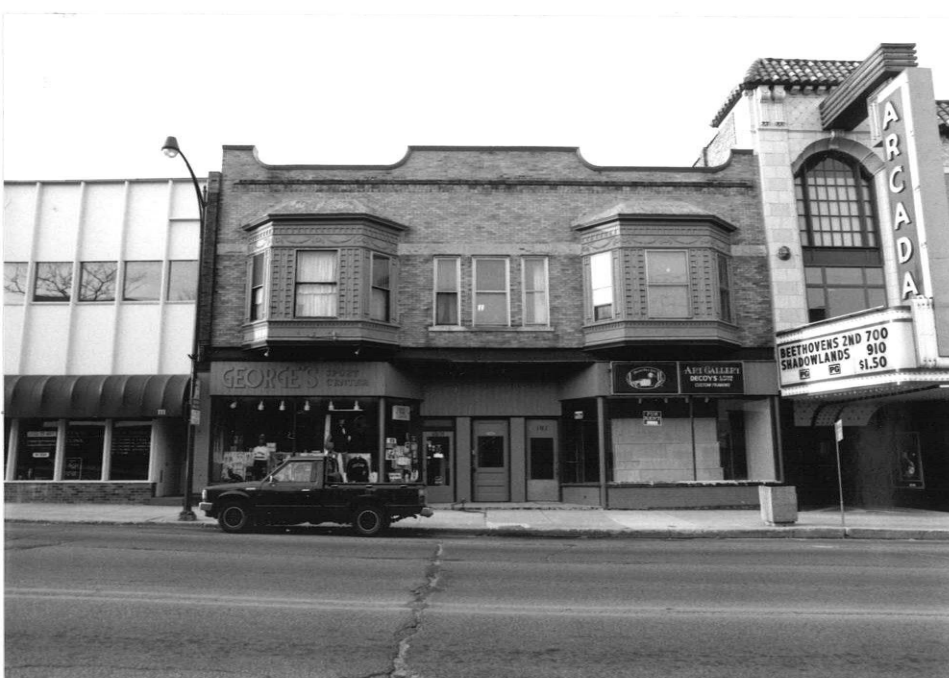
107-109 East Main Street

Two-story masonry structure, brick with stone banding at second floor window heads. Two bay windows with stamped metal ornamentation.

First floor alteration is insensitive to original structure.

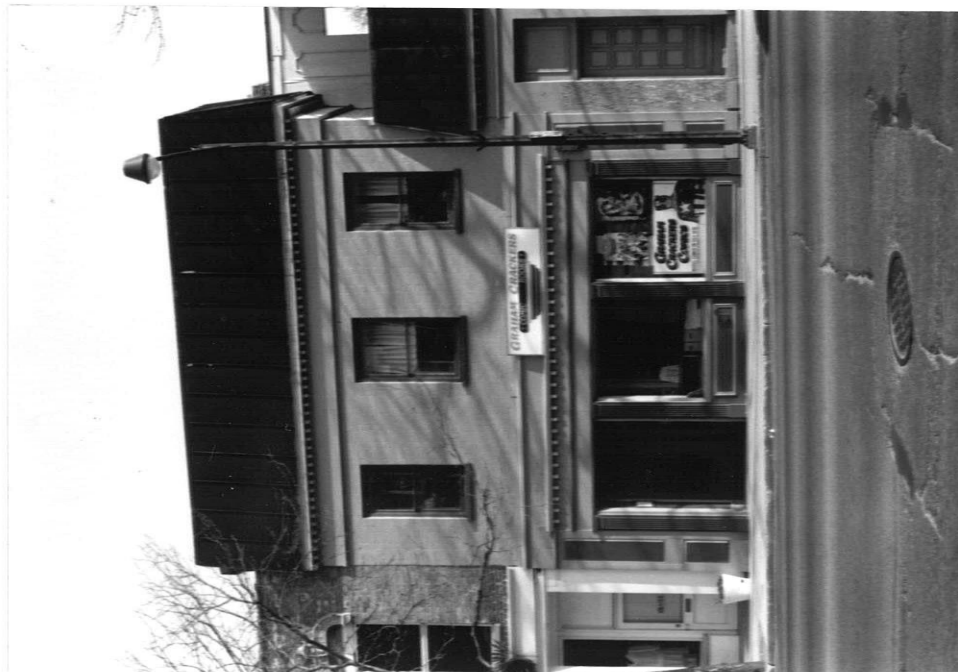
108 East Main Street

Greatly modified storefront.

Underwent extensive facade renovations in the 1990s.
The changes made were sensitive to the original.
Mansard roof that existed in the first survey photo was removed as part of the facade project.

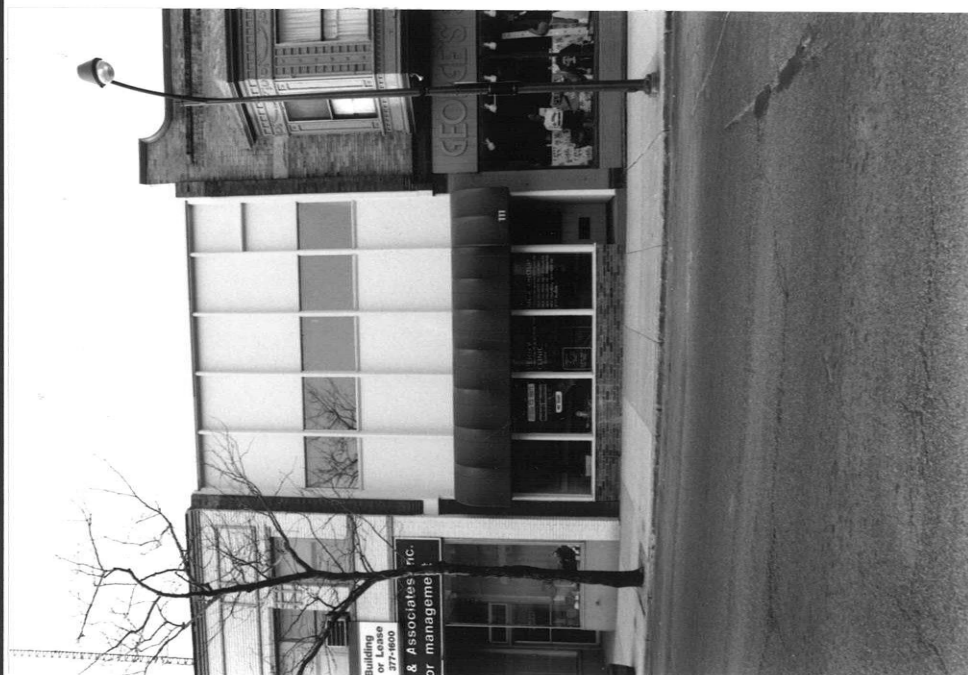
111 East Main Street

Aluminum and glass curtain wall cladding (1950-1960's). Building is greatly altered.

Underwent facade renovation in the 1900s where the the aluminum and glass curtain wall cladding were removed

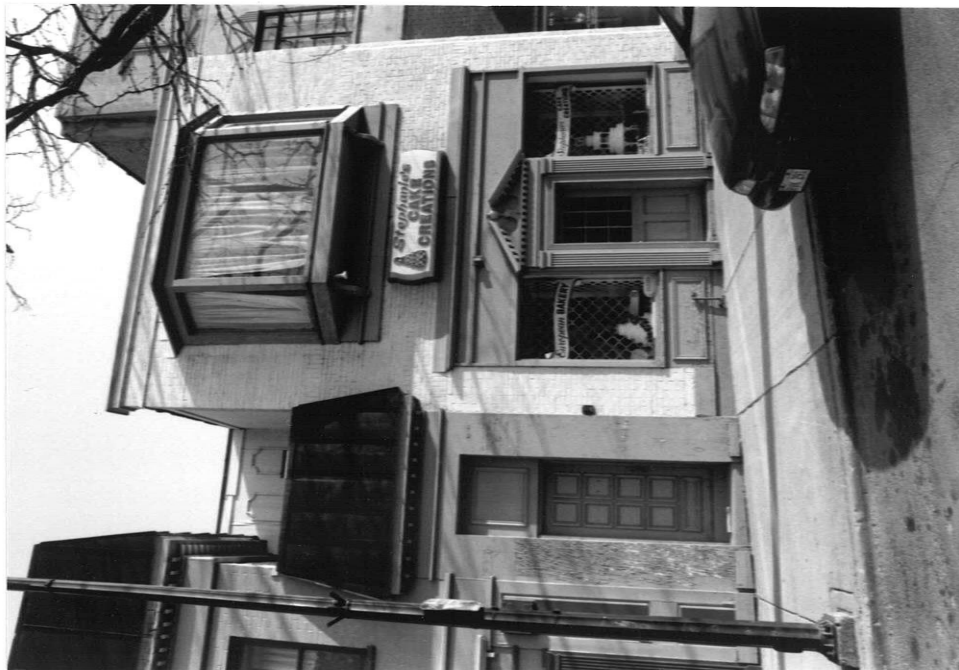
112 East Main Street

Colonial theme at first floor. False bay window at second floor in brick facade.

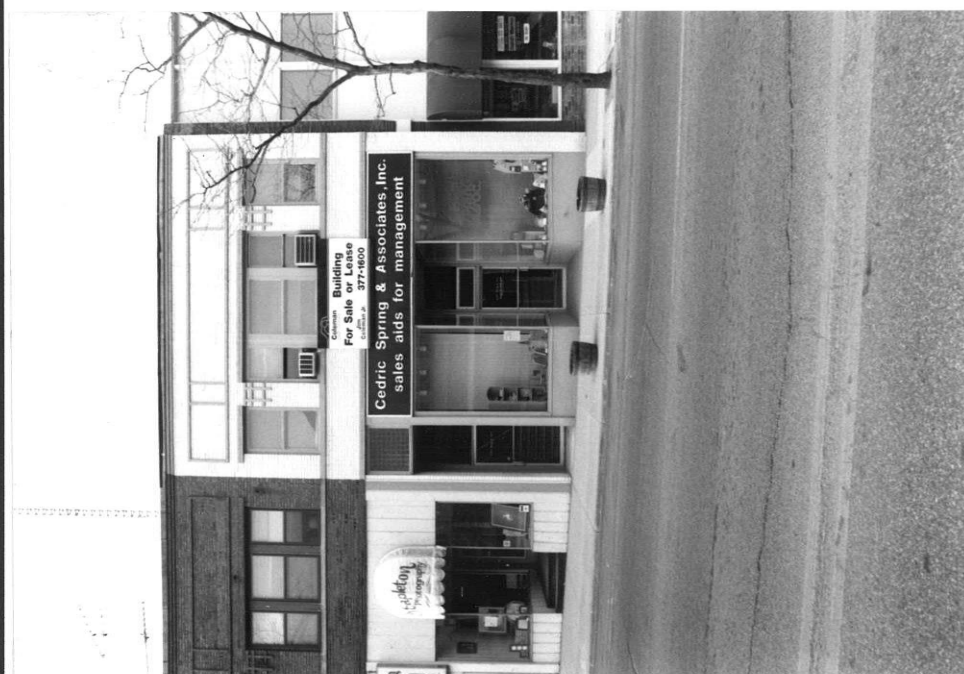
113-113 1/2 E. Main Street

Two-story brick structure, painted brick. First floor slightly altered.

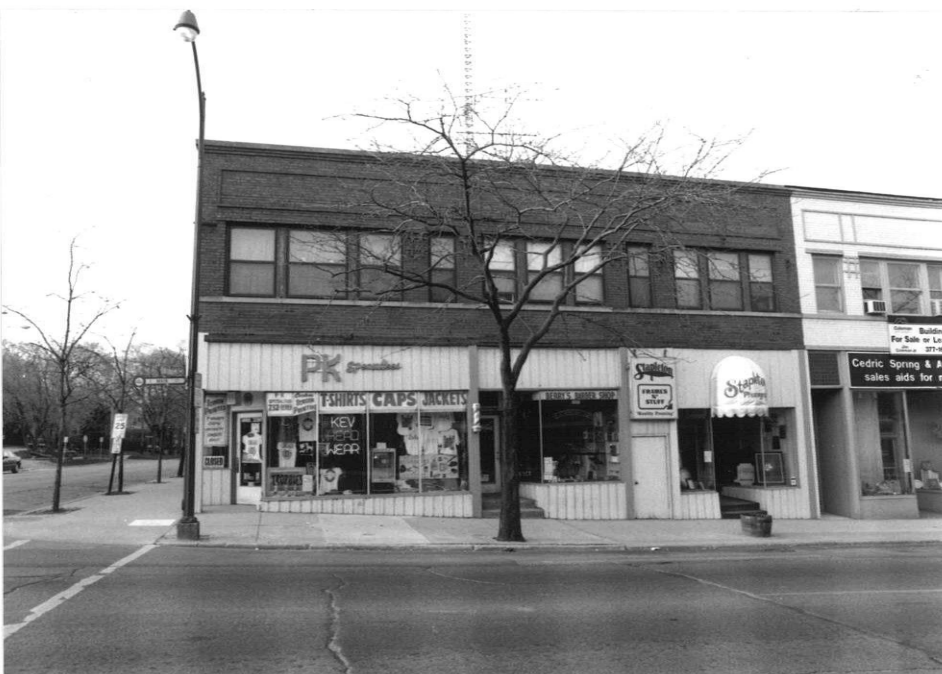
115-119 East Main Street

Two story brick structure. First floor clad with vertical wood siding. Storefronts greatly altered.

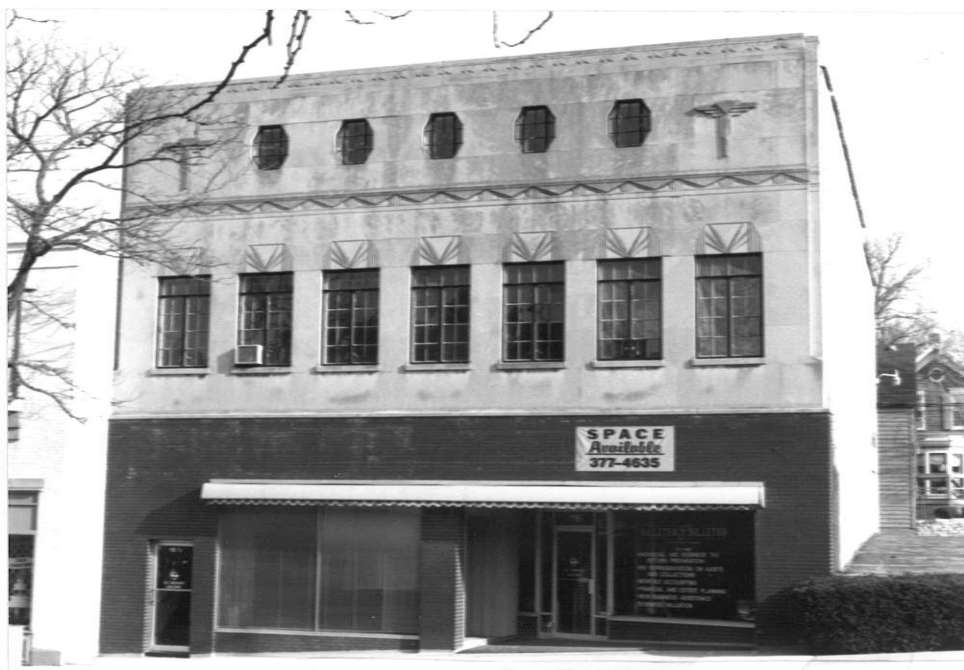
116 East Main Street

Art Moderne facade added over Italianate facade in the 1940's. Brick at lower facade, stone cladding above. Geometric ornamentation at heads of second floor windows.

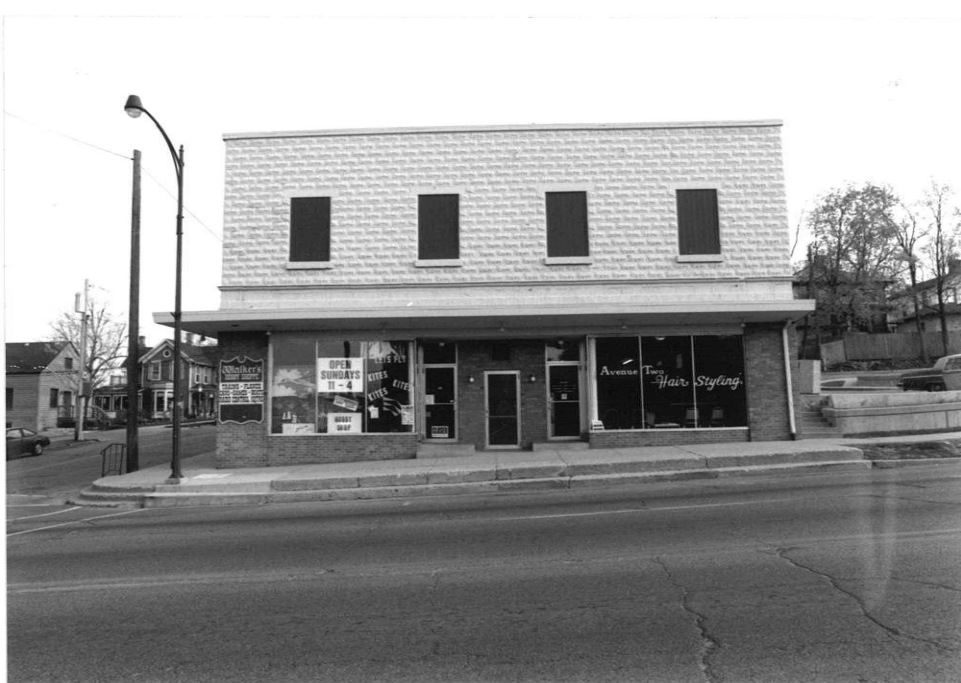
202 East Main Street

Rock face concrete block shows at second floor, south elevation and at both floors at the west and east elevations. Second floor windows boarded up. First floor greatly modified.

Second floor of the building was added as an addition after the original construction of the 1st floor.

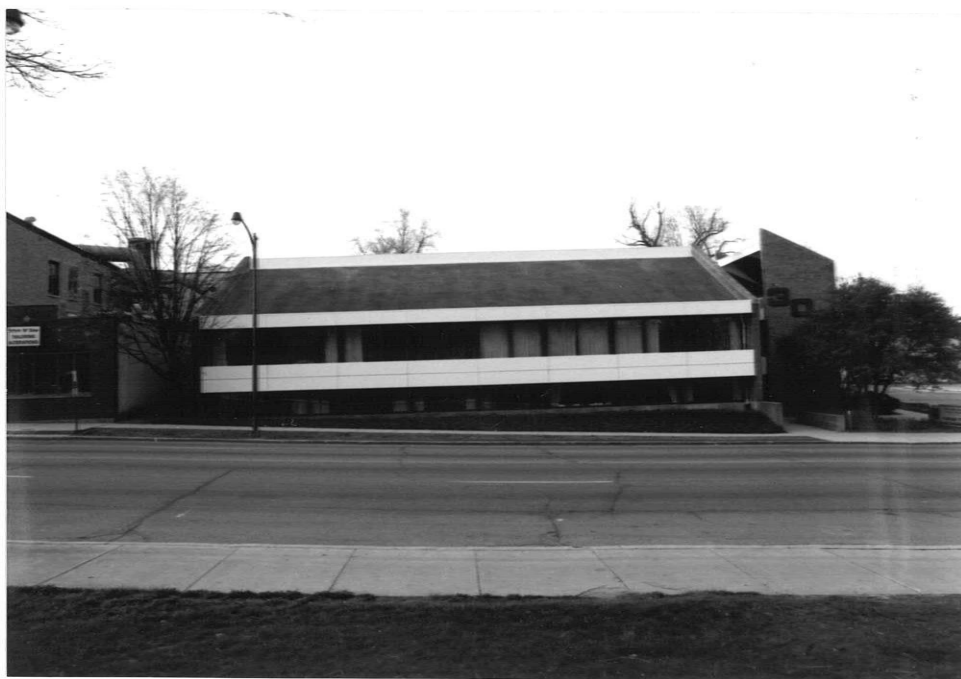
303 East Main Street

Horizontal emphasis with light colored panels in dark brick building. Horizontal bands of windows. Masonry stair tower prominent at west end.

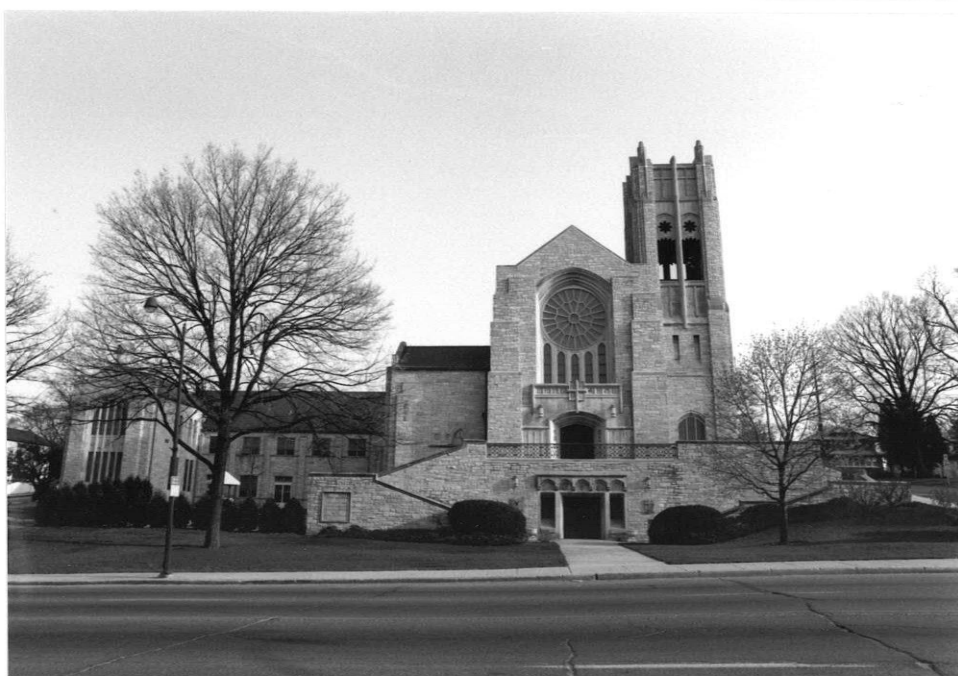
East Main and Third Avenue
307 E Main St.

Features: Baker United Methodist Church

Random ashlar stone church building with fine, cut stone detailing. Prominently sited. Large rose window over deeply recessed entry. Offset square bell tower.

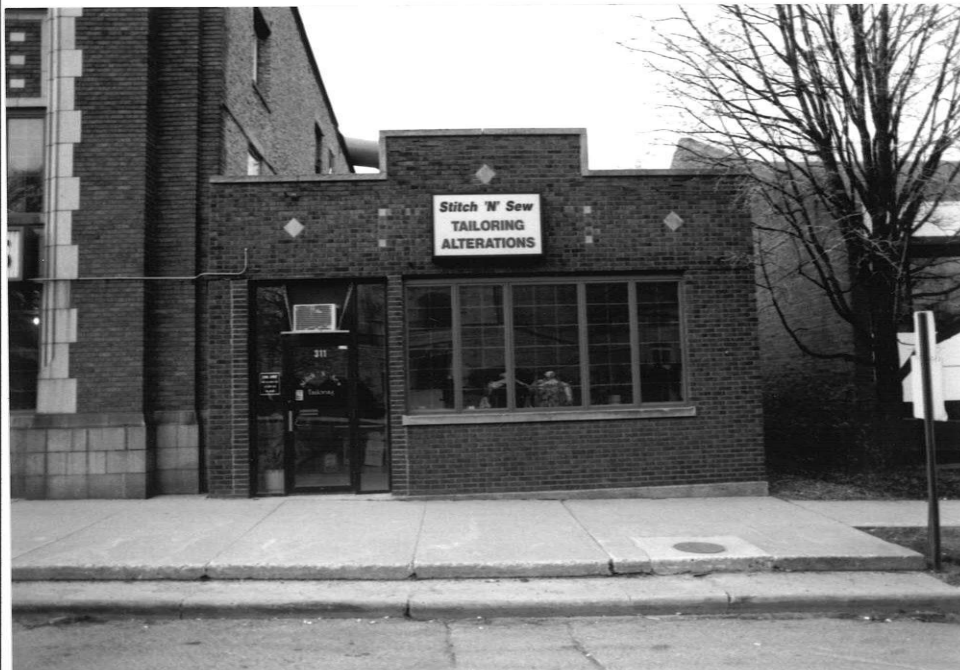
311 East Main Street

Simple brick front building with stone accents and stone parapet cap. Changes made at entrance with dark aluminum storefront door and sidelights.

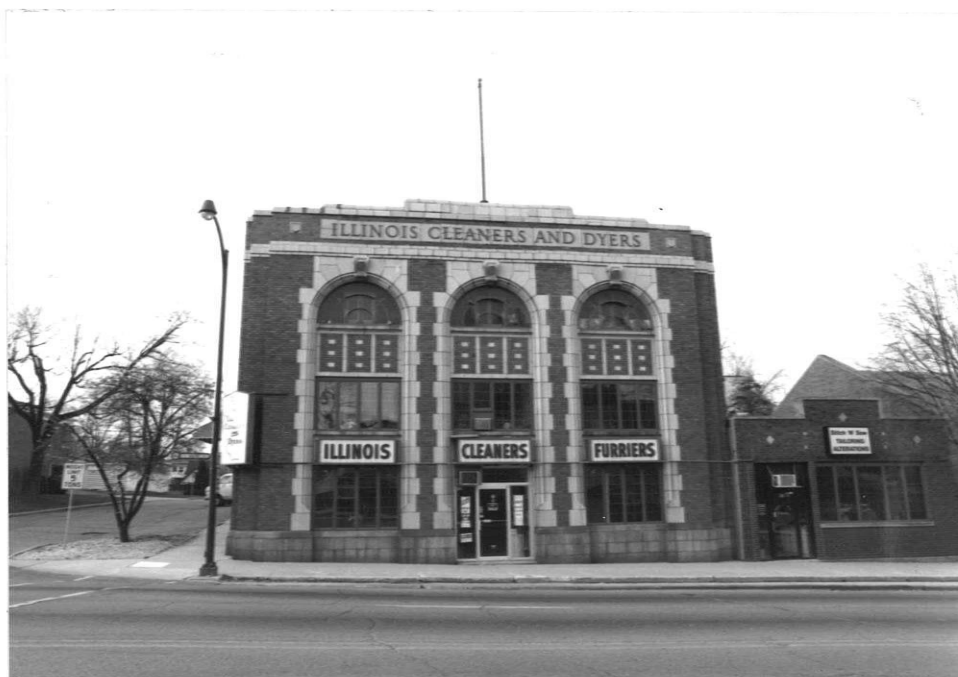
315 East Main Street

Tall two story brick structure with terra cotta quoins at three arches in front, ionic keystones at top. Terra cotta base at front facade. Simple stepped parapet with terra cotta cap. Inscription at parapet reads "ILLINOIS CLEANERS AND DYERS".

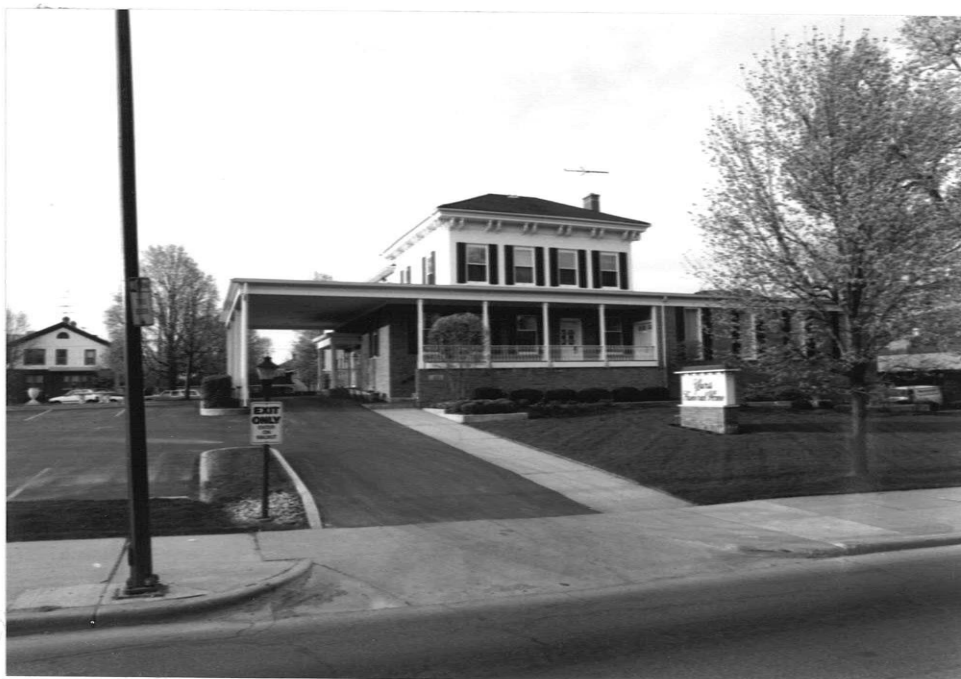
405 East Main Street

1856 Italianate features are evident at second floor, double brackets at soffit and hipped roof.

Originally built by Dr. Thomas P. Whipple as a residence and medical office.

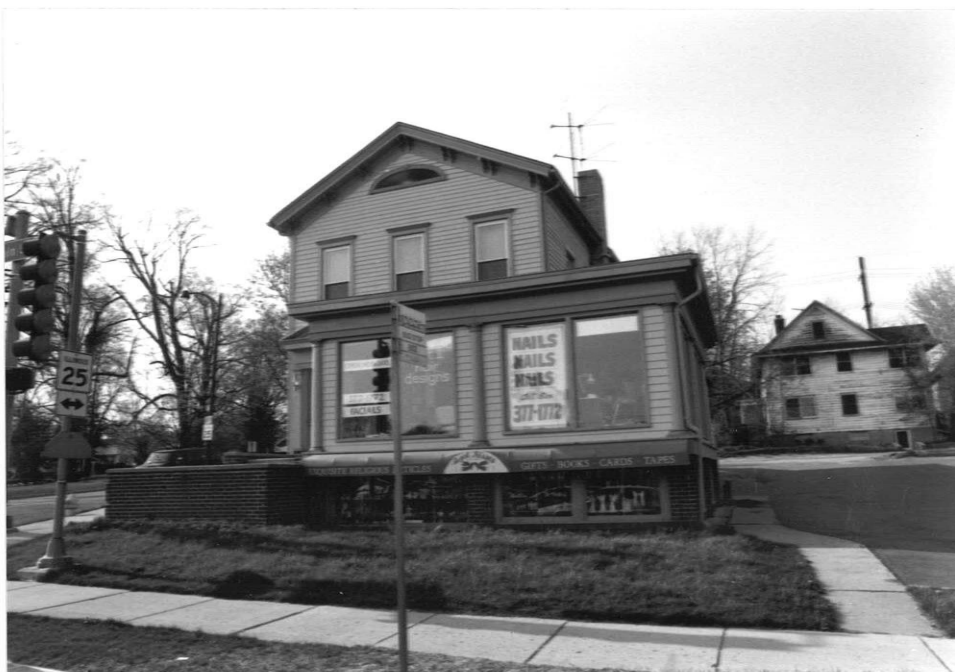
504 East Main Street

Front gable two story structure in Greek Revival style with Italianate influences in the decorative eave brackets. Enclosed wrap around porch at first level.

Building is historically significant due to it being the residence of S.S. Jones and his wife.
