ST. CHARLES HISTORIC PRESERVATION COMMISSION

ARCHITECTURAL SURVEY ST. CHARLES CENTRAL DISTRICT ST. CHARLES, ILLINOIS

DIXON ASSOCIATES / ARCHITECTS

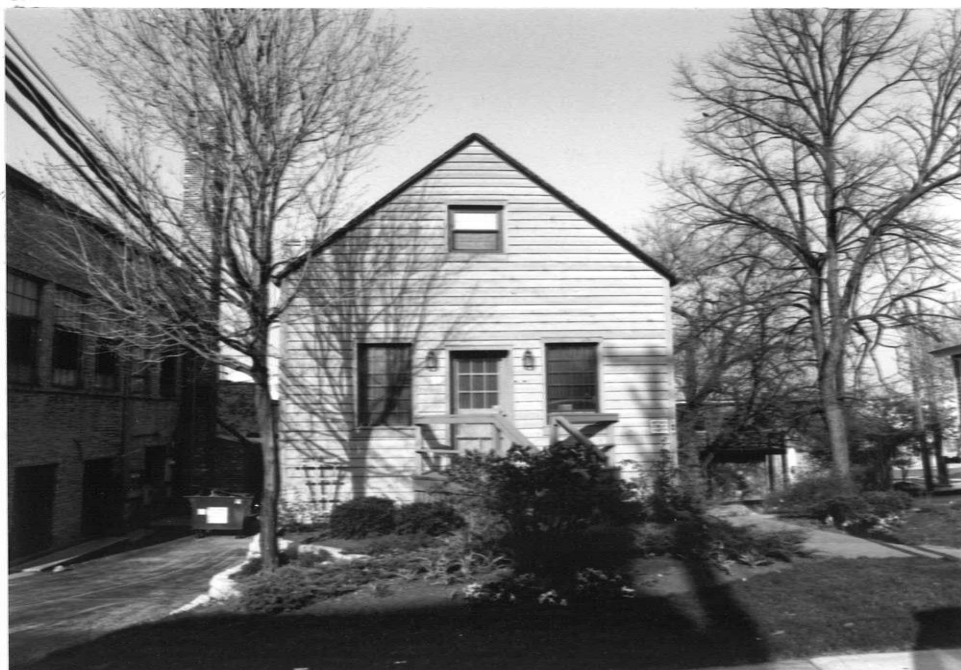
11 North 2nd Avenue

1	2	3
<input type="checkbox"/> Unaltered	<input type="checkbox"/>	<input type="checkbox"/>	<input type="checkbox"/>
<input type="checkbox"/> Minor Alteration	<input type="checkbox"/>	<input type="checkbox"/>	<input type="checkbox"/>
<input checked="" type="checkbox"/> Major Alteration	<input checked="" type="checkbox"/>	<input checked="" type="checkbox"/>	<input type="checkbox"/>
<input type="checkbox"/> Additions	<input type="checkbox"/>	<input type="checkbox"/>	<input type="checkbox"/>
Sensitive to original	<input type="checkbox"/>	<input type="checkbox"/>	<input type="checkbox"/>
Insensitive to original	<input type="checkbox"/>	<input type="checkbox"/>	<input type="checkbox"/>

☒ Excellent: Well-maintained

Style: Commercial Vernacular

Date of Construction: 1920s

Wood clapboard siding on front gabled building.

The structure is made of concrete block and at some point in time veneer was placed over the concrete.

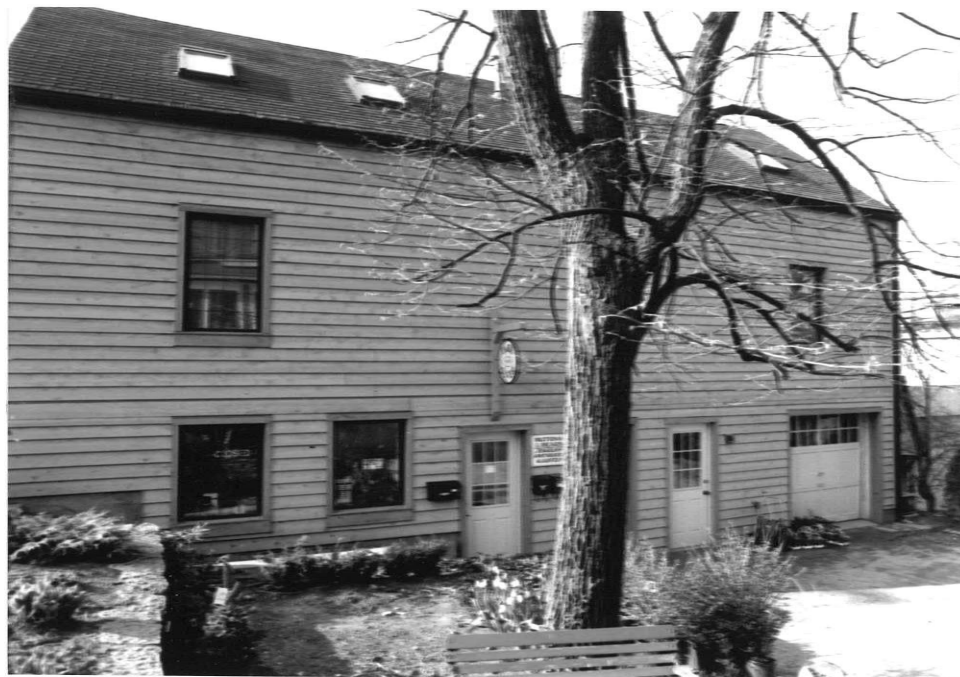
11 North 2nd Avenue

North Elevation.

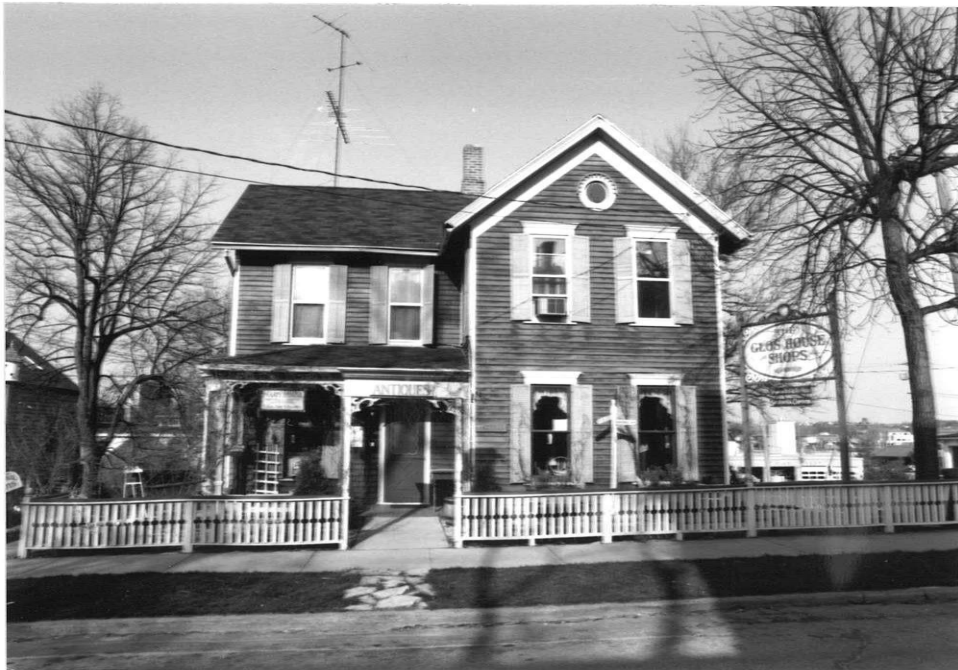
17 North 2nd Avenue

- ☒ Excellent: Well-maintained
- ☐ Good: Minor maintenance needed
- ☐ Fair: Major repairs needed
- ☐ Poor: Deteriorated

Style: Folk Victorian

Date of Construction: 1870

Gable front and wing on two story wood clapboard sided structure. One story porch, classical heads at windows. Circle window at front gable.

Original wood shutters existed at time of 1994 photo.

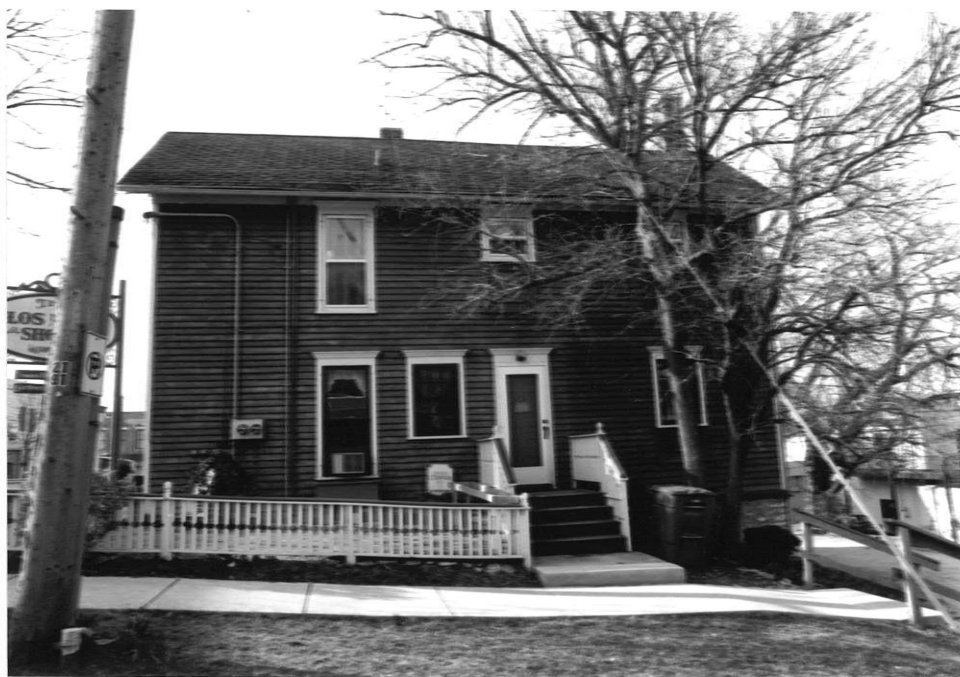
17 North 2nd Avenue

North Elevation.

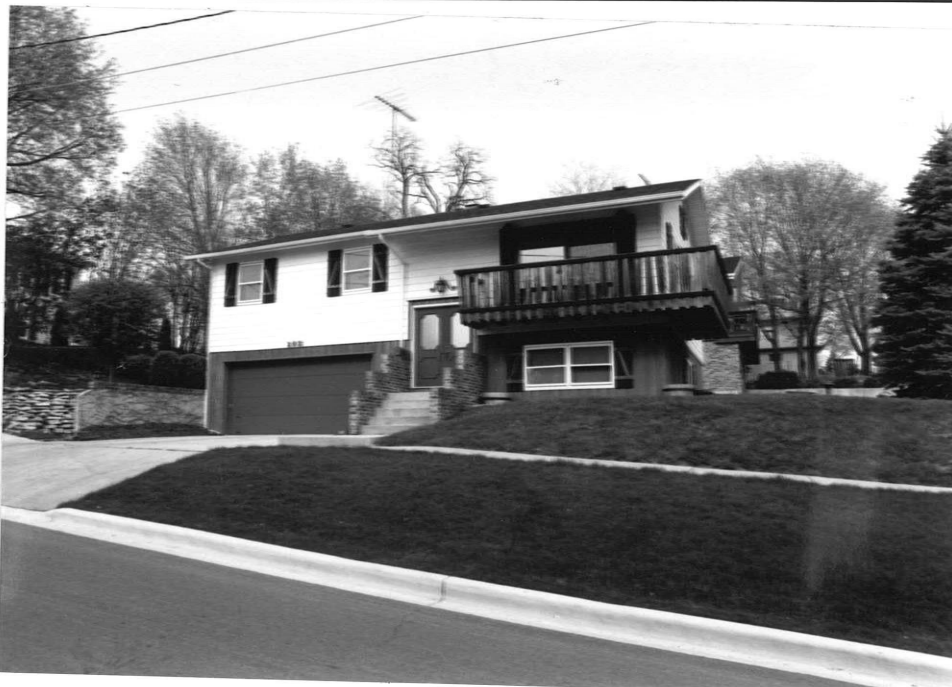
202 North 2nd Avenue

- ☒ Excellent: Well-maintained
- ☐ Good: Minor maintenance needed
- ☐ Fair: Major repairs needed
- ☐ Poor: Deteriorated

Style: Modern/Split Level

Date of Construction: 1955-1975

Double door entrance and wrap around deck predominant at front.
