ST. CHARLES HISTORIC PRESERVATION COMMISSION

# ARCHITECTURAL SURVEY ST. CHARLES CENTRAL DISTRICT ST. CHARLES, ILLINOIS

DIXON ASSOCIATES / ARCHITECTS

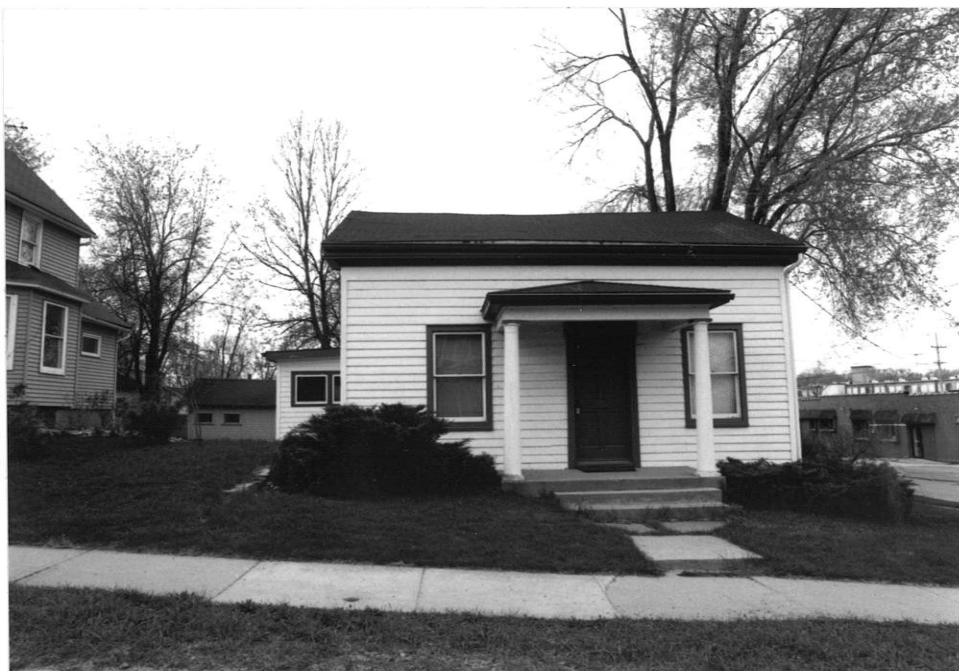
201 East Illinois Avenue

Side gable form. Classical entry porch. Porch details altered.

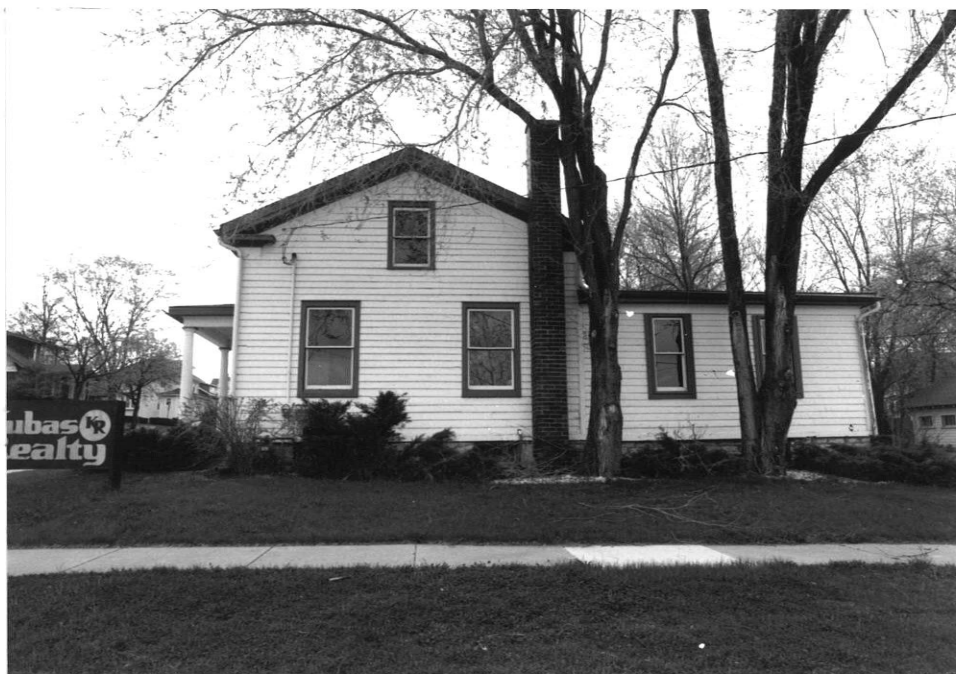
201 East Illinois Avenue

West Elevation

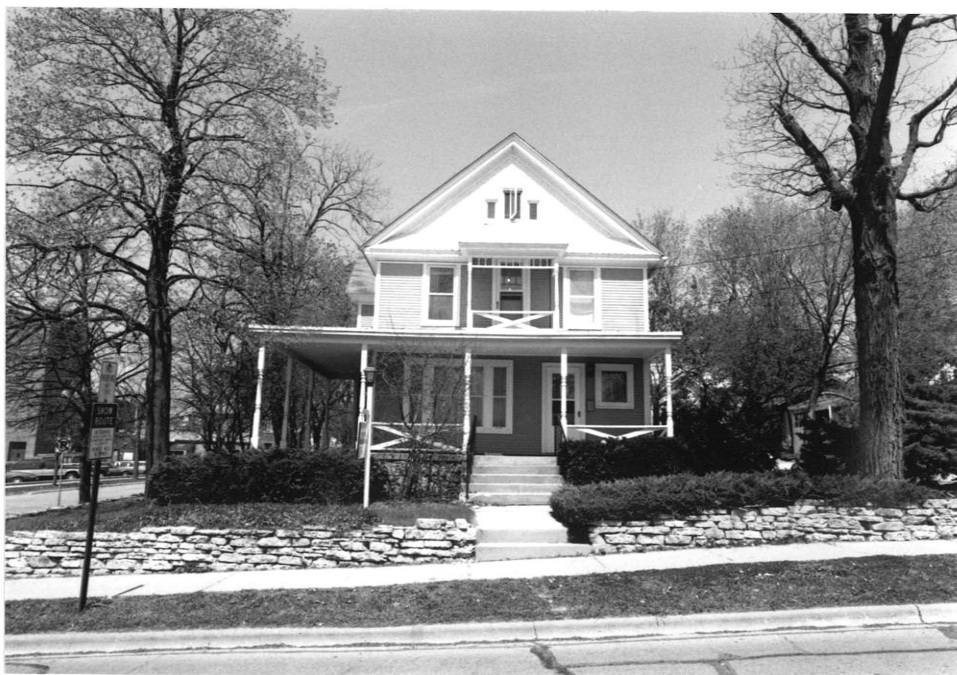
204 East Illinois Avenue

Two-story front gable form. Decorative cut wood shingles at gable end. Second story porch. First floor wrap around porch.

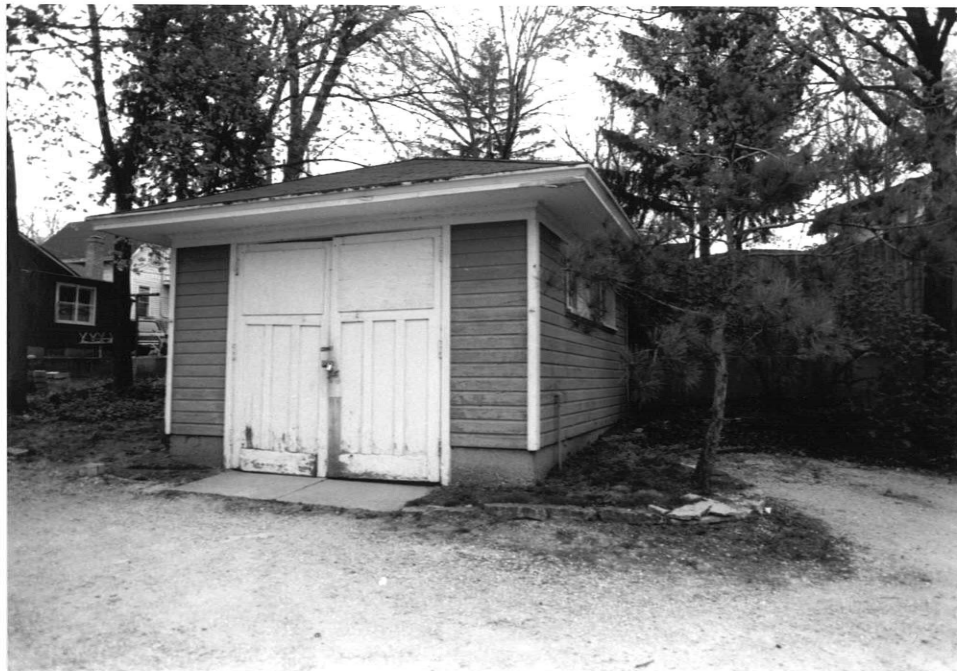
204 East Illinois Avenue

Garage.

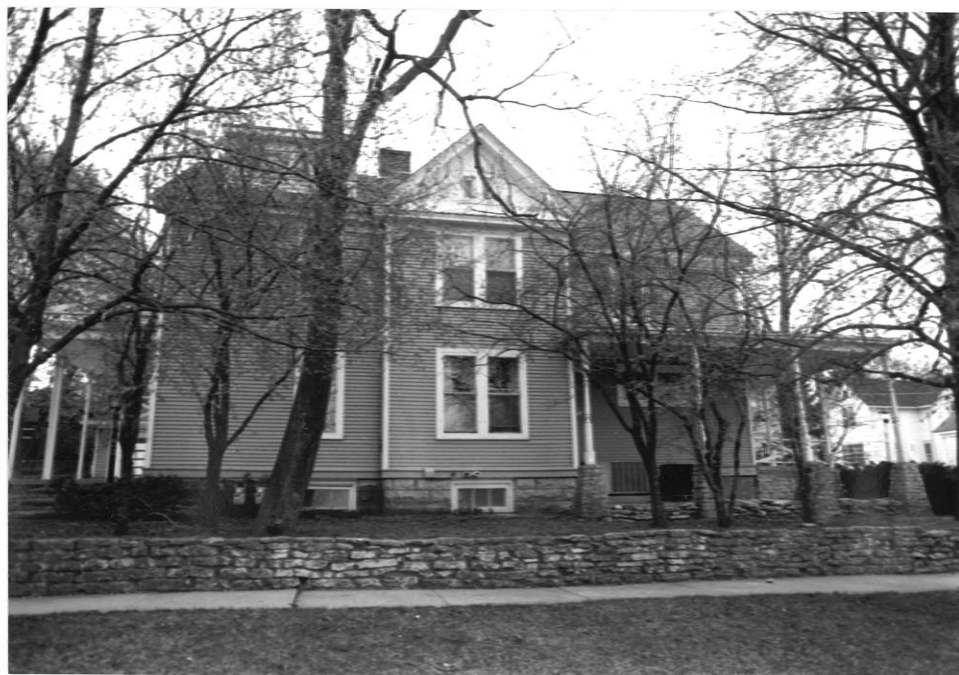
204 East Illinois Avenue

West Elevation. Porch has been altered.

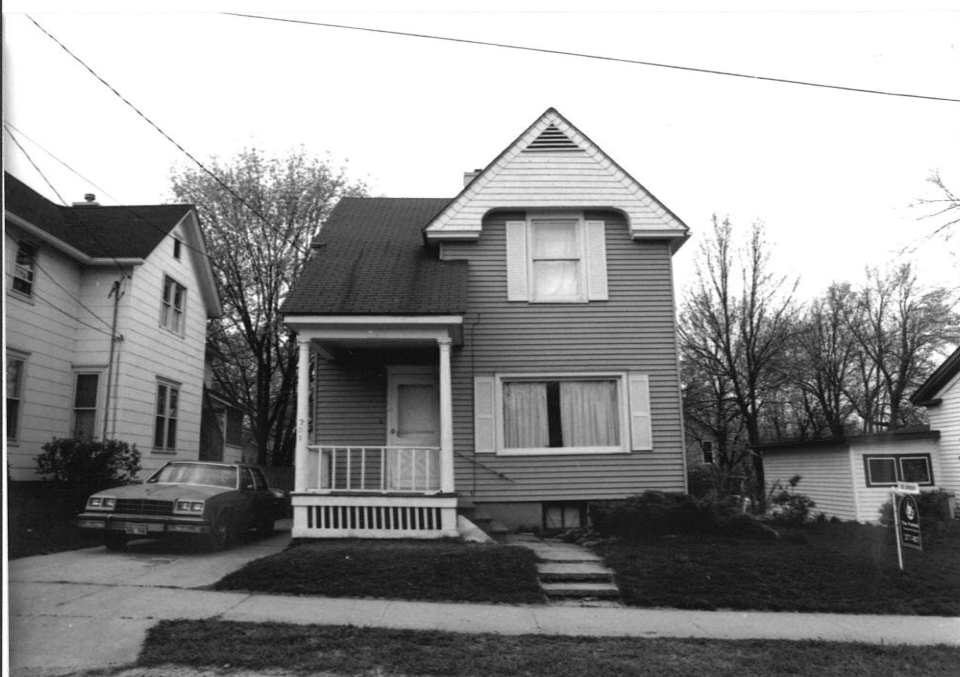
207 East Illinois Avenue

Two-story cross gable structure. Entry porch with shed roof. Projecting gable end with wood shingles.

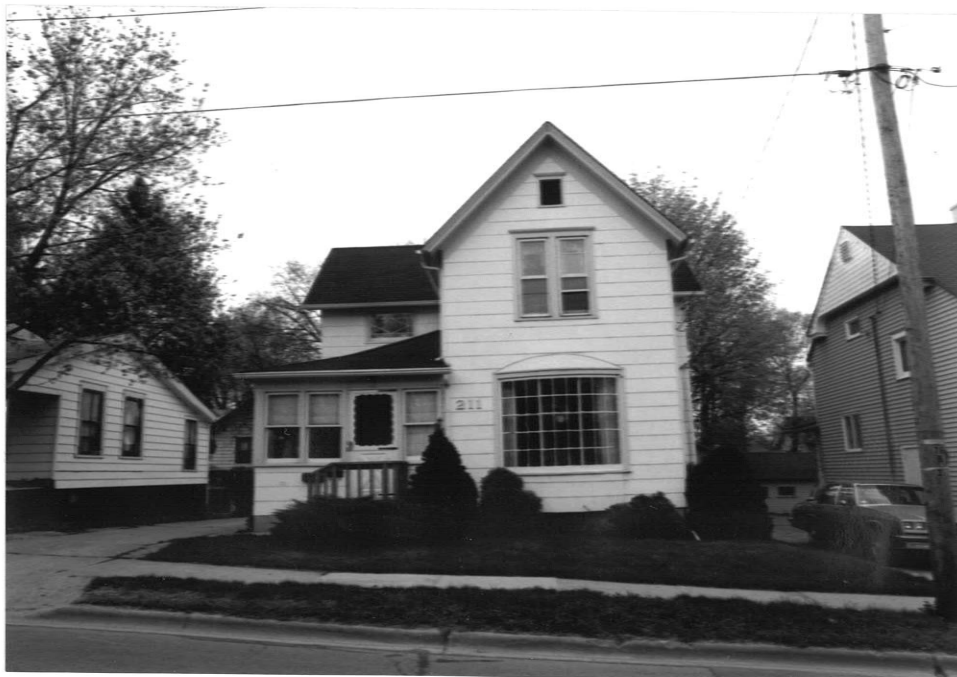
211 East Illinois Avenue

Two-story cross gable structure. Enclosed entry porch.

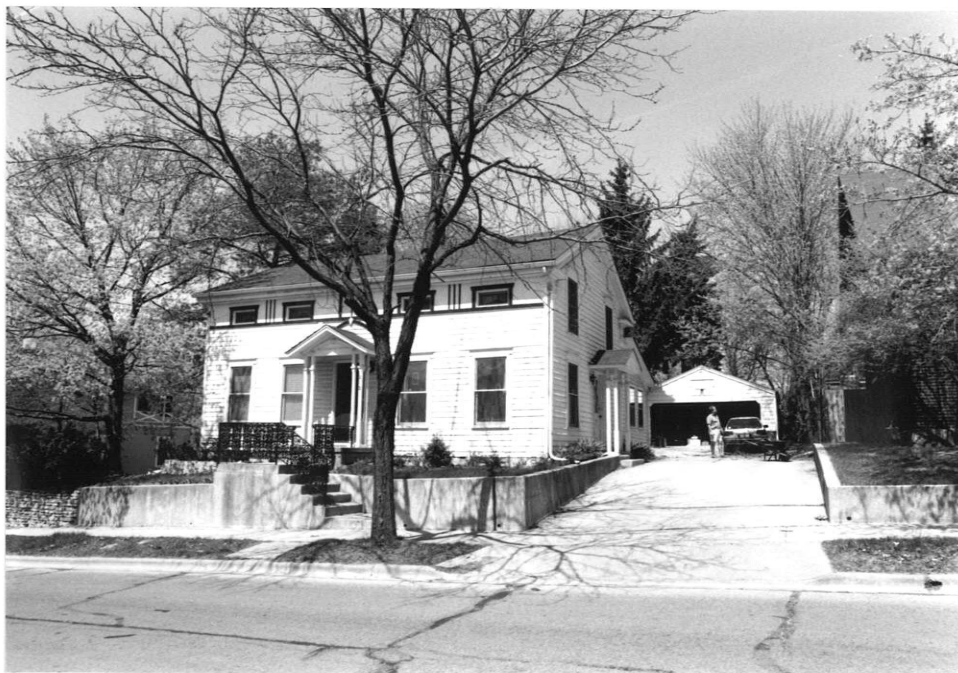
212 East Illinois Avenue

Two story gable end structure. Second floor frieze-band windows. Vertical stripe between windows. Gothic style portico at front and side entry.

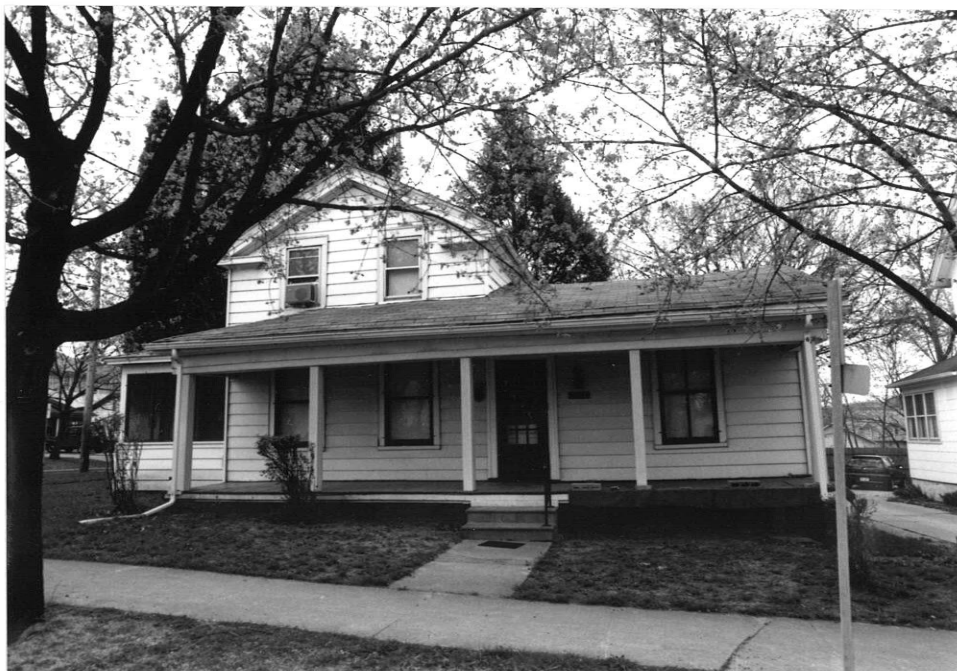
215 East Illinois Avenue

Gable front and wing form. Horizontal siding. Details have been removed or altered. Full width porch with shed roof. One story additions to side and rear.

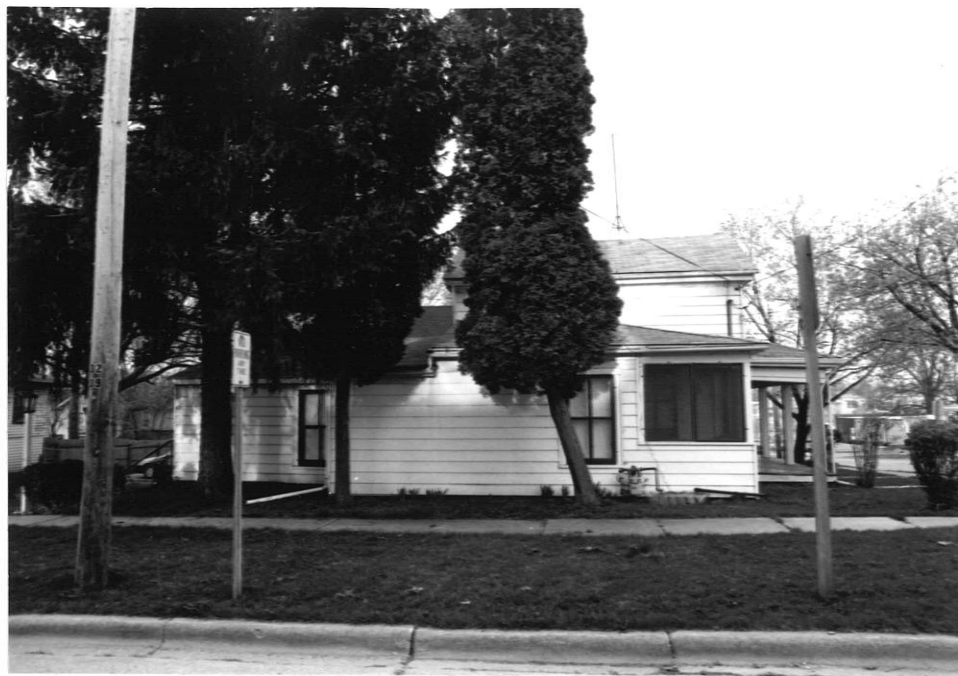
215 East Illinois Avenue

East Elevation

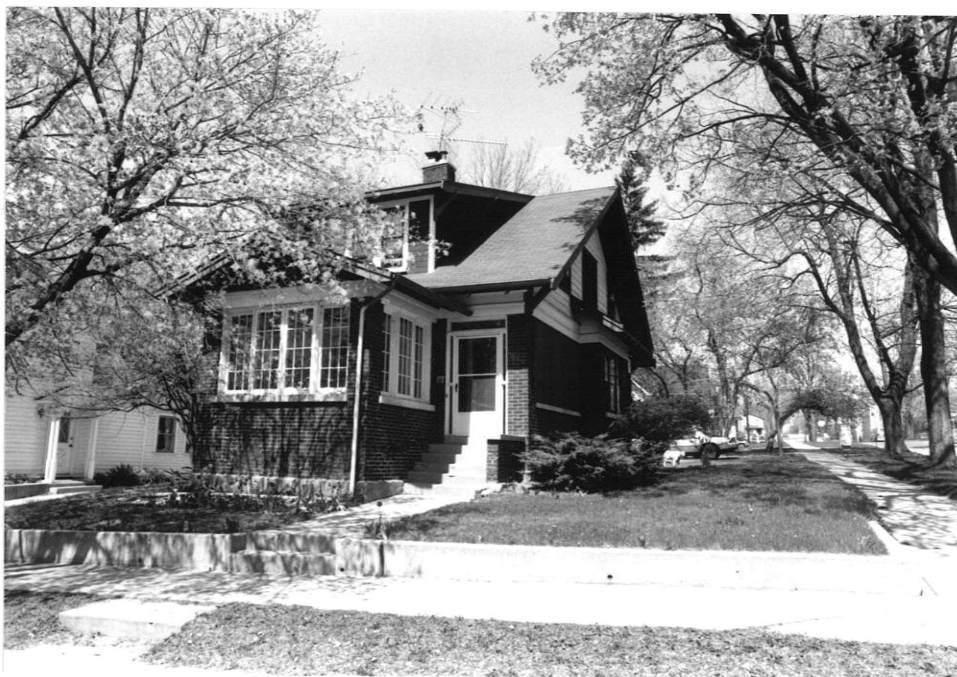
218 East Illinois Avenue

Gable end roof with shed roof dormer. Exposed rafter tails and brackets. Gable roof over enclosed porch. Shed roof over side bay.

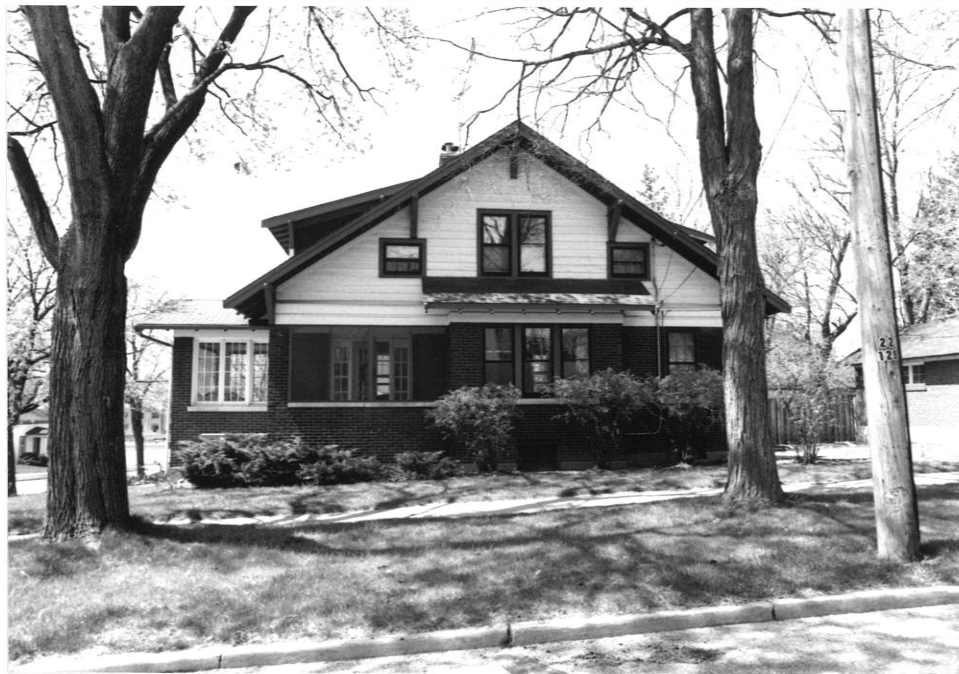
218 East Illinois Avenue

East Elevation.

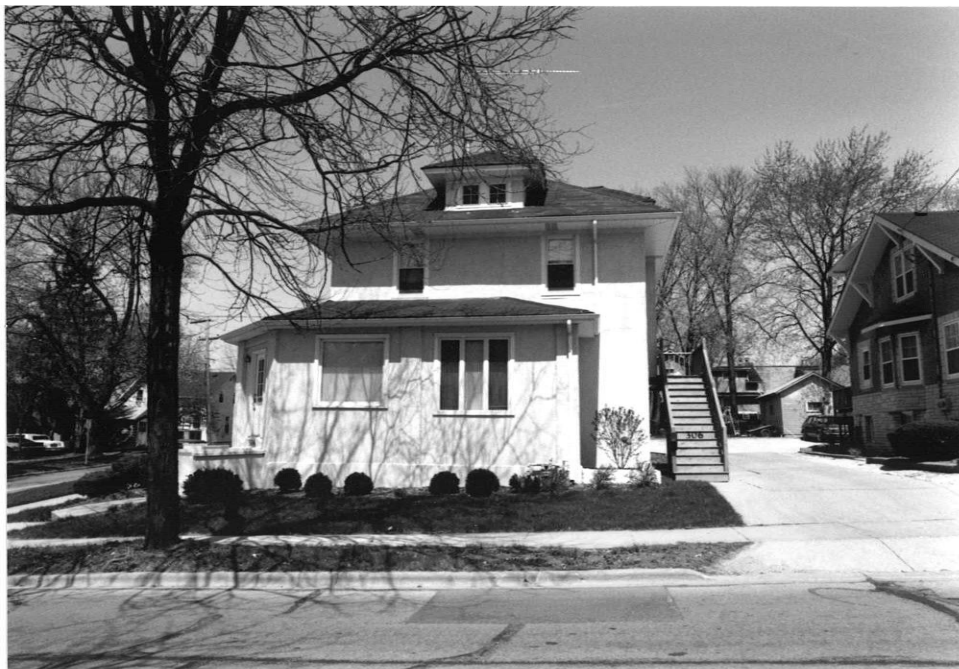
304-306 East Illinois Avenue

Two-story hip roof structure with hip roof dormer. Wide soffits. Hip roof over enclosed entry porch. Entrance at corner. Stucco exterior.

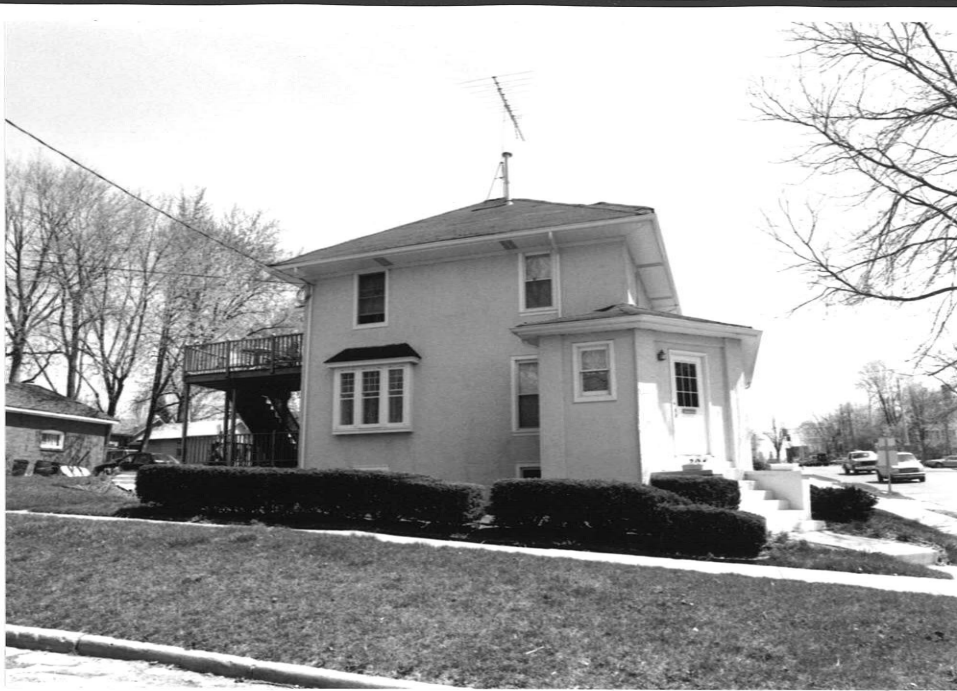
304-306 East Illinois Avenue

West Elevation.

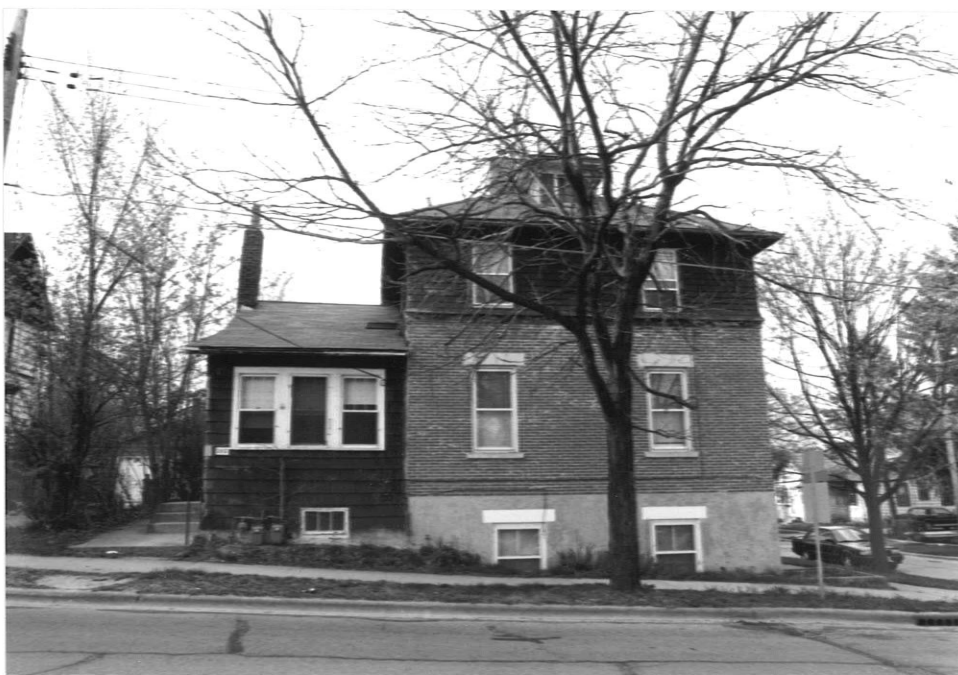
305 East Illinois Avenue/  
202 South 3rd Avenue

Two-story structure with symmetrical hip roof. Hip roof dormer. One story enclosed entry porch. Stone window lintels at first floor. Brick exterior at first floor, wood shingles on porch and second floor exterior.

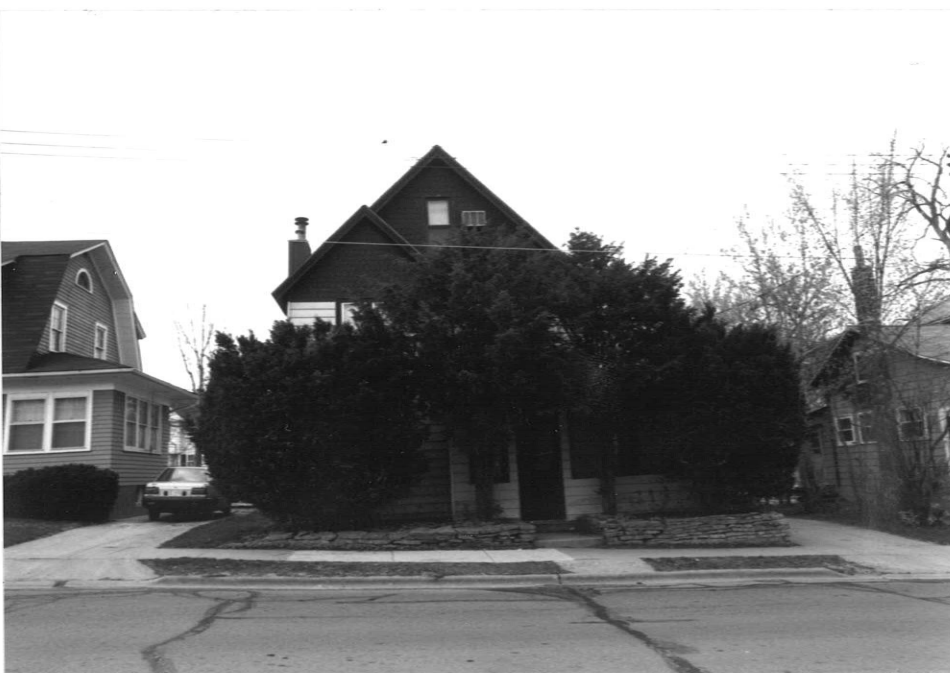
307 East Illinois Avenue

Two-story structure. Multiple gable roof with decorative wood shingles at gable ends. Enclosed porch.

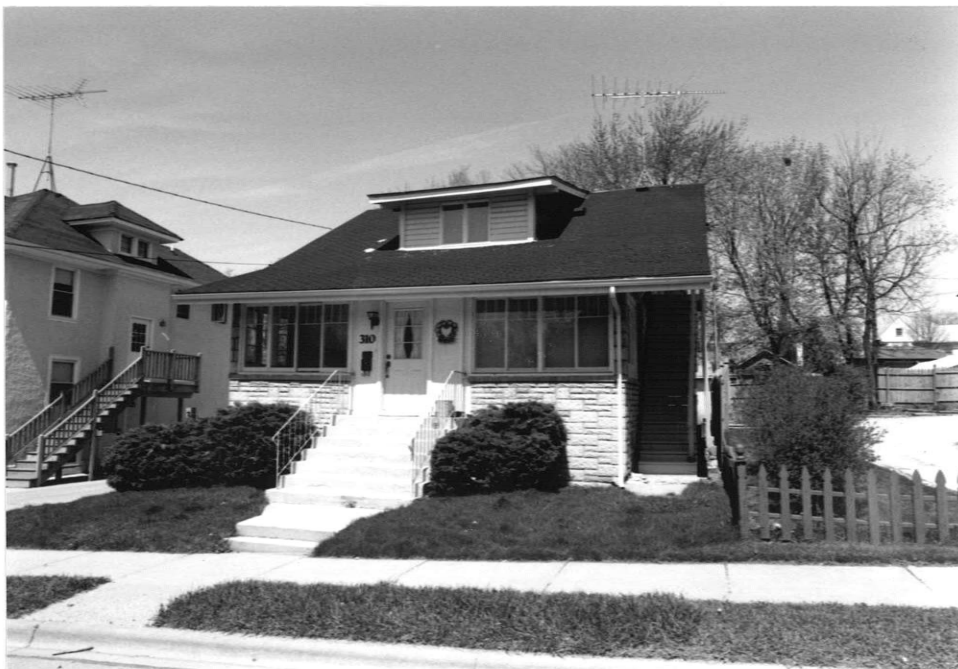
308-310 East Illinois Avenue

Gable roof with shed roof dormer. Enclosed full width porch with shed roof. Exterior stair at side.

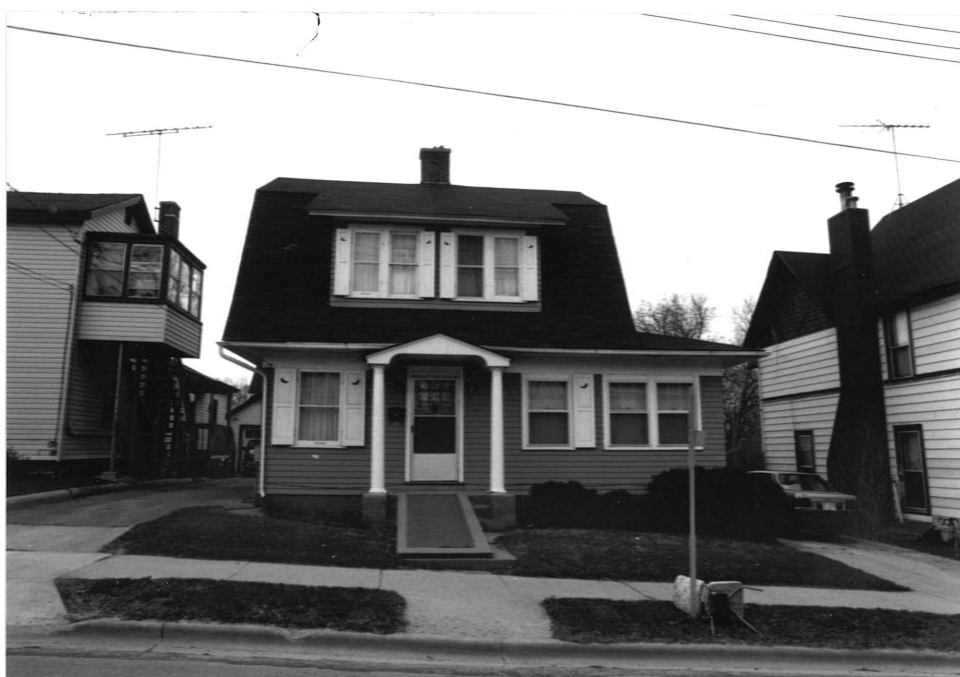
315 East Illinois Avenue

End gambrel roof with shed roof dormer. Hip roof over side wing addition. Decorative cut out in shutters. Classical entry porch.

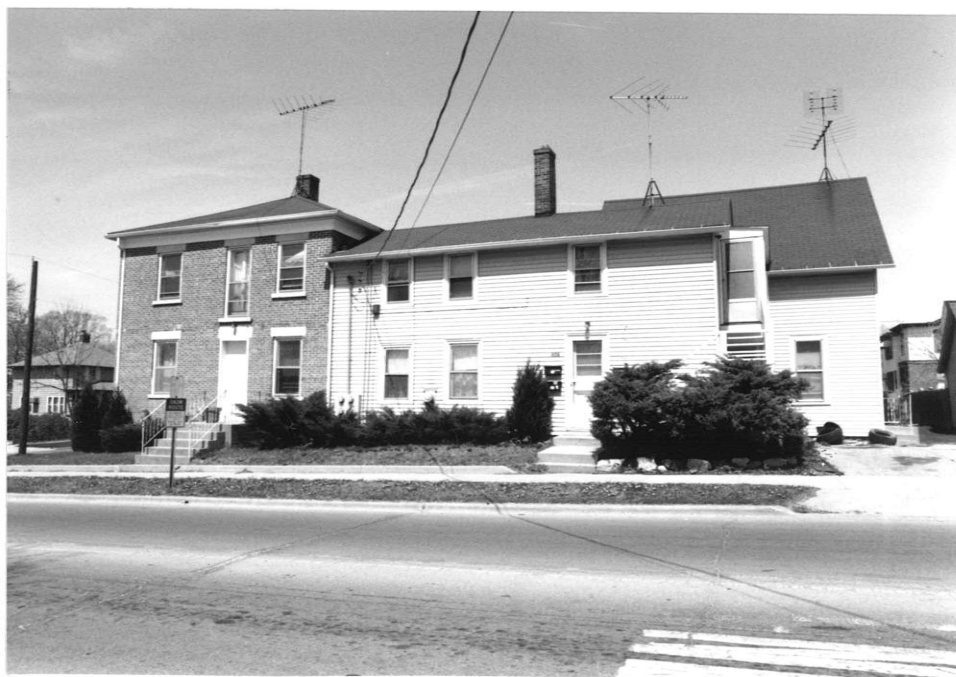
406 East Illinois Avenue

Two-story brick structure with hip roof. Stone lintels.  
Two-story gable addition. Enclosed second floor porch at rear.

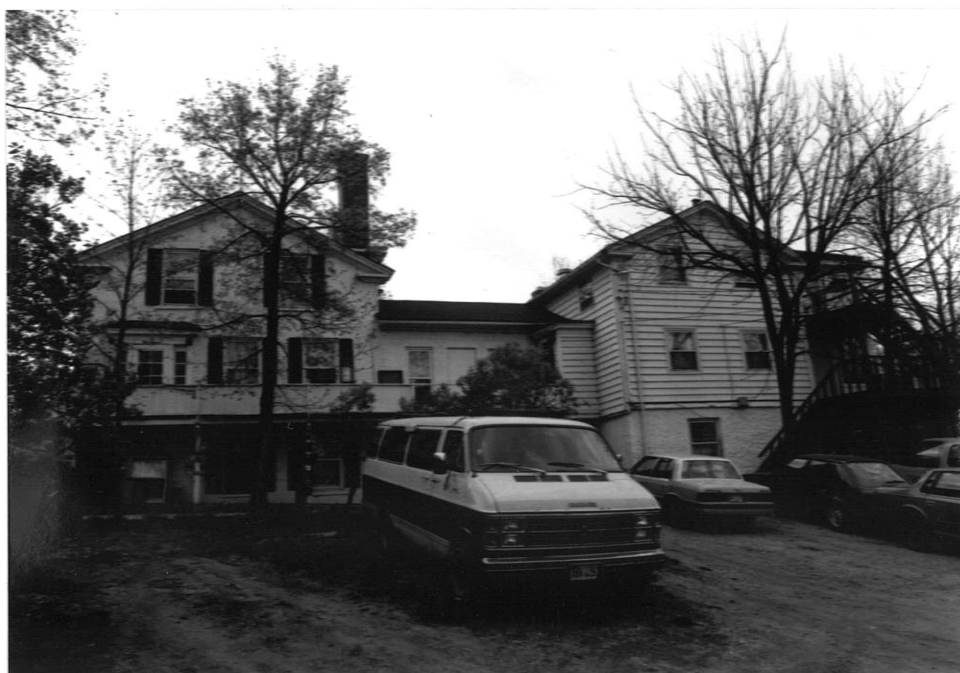
411 East Illinois Avenue

Two-story structure with rough stucco finish. One and two story additions. Raised first floor with wood deck at entry.

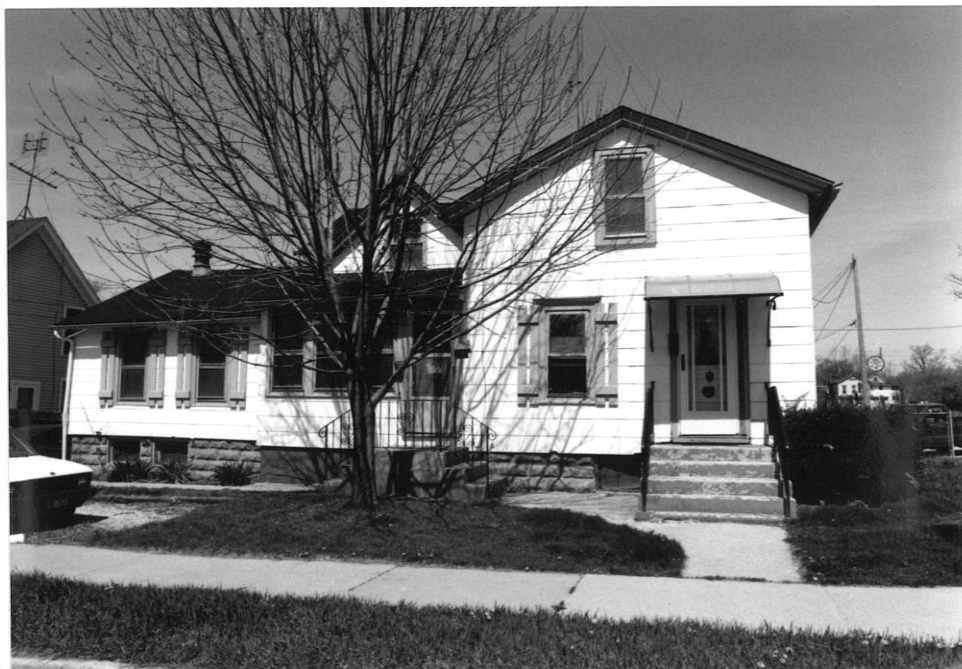
418 East Illinois Avenue

Gable front and one story wing form. Details have been removed and altered. Rock faced block foundation.

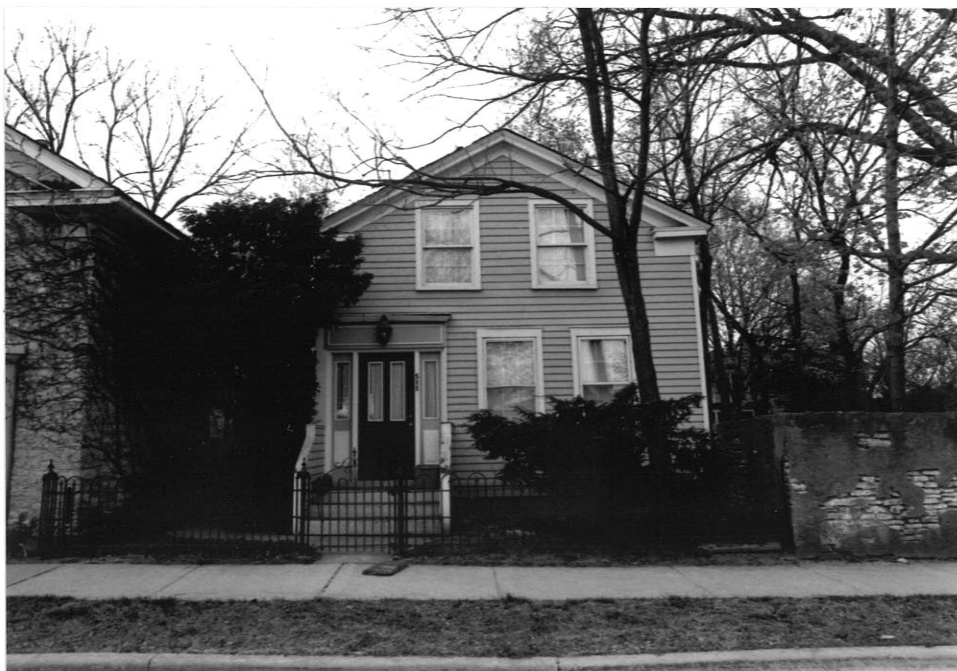
511 East Illinois Avenue

Gable end roof with broken pediment. Classical details at entry may have been altered. Home of Dr. Richards of the Franklin Medical School.

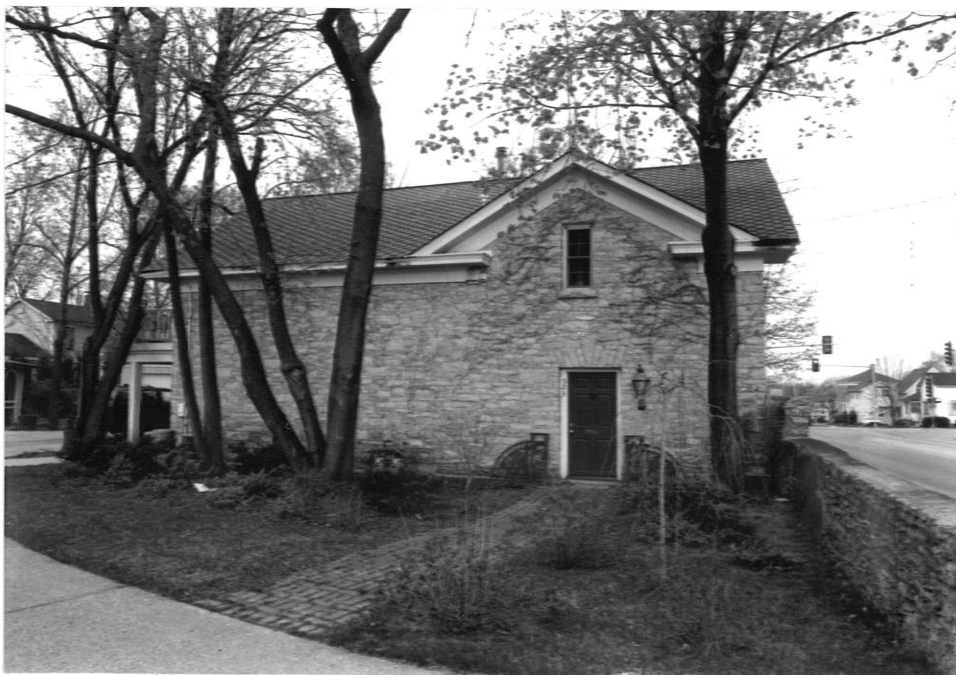
521-523 East Illinois Avenue

Limestone construction. Cross gable roof with broken pediment. Stone lintel details.
