ST. CHARLES HISTORIC PRESERVATION COMMISSION

ARCHITECTURAL SURVEY ST. CHARLES CENTRAL DISTRICT ST. CHARLES, ILLINOIS

DIXON ASSOCIATES / ARCHITECTS

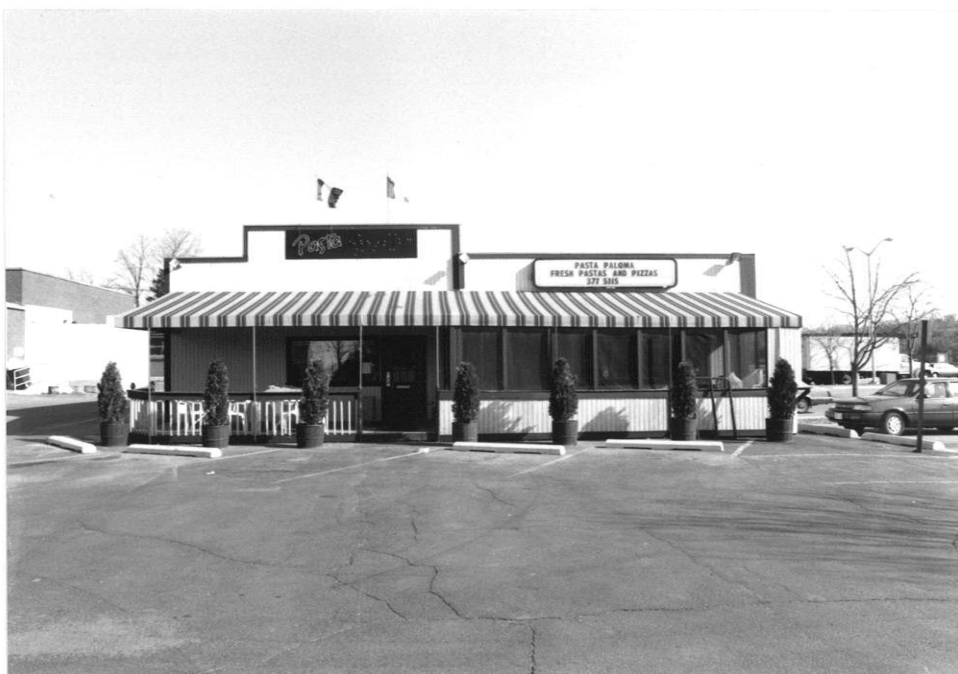
NEGATIVE NO. 33

1	2	3
<input type="checkbox"/> Unaltered	<input type="checkbox"/>	<input type="checkbox"/>	<input type="checkbox"/>
<input type="checkbox"/> Minor Alteration	<input type="checkbox"/>	<input type="checkbox"/>	<input type="checkbox"/>
<input checked="" type="checkbox"/> Major Alteration	<input checked="" type="checkbox"/>	<input type="checkbox"/>	<input checked="" type="checkbox"/>
<input type="checkbox"/> Additions	<input type="checkbox"/>	<input type="checkbox"/>	<input type="checkbox"/>
Sensitive to original	<input type="checkbox"/>	<input type="checkbox"/>	<input type="checkbox"/>
Insensitive to original	<input type="checkbox"/>	<input type="checkbox"/>	<input type="checkbox"/>

☒ Non-Contributing

☒ Excellent: Well-maintained

Style: Vernacular Commercial

Date of Construction: Post 1944

Original building obscured by plywood siding.

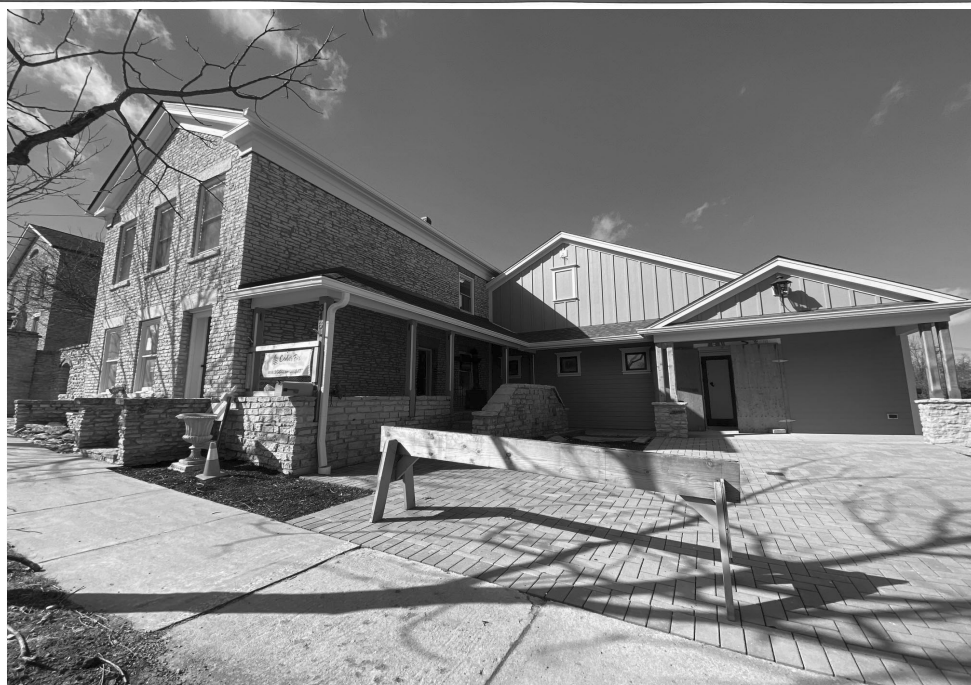
NEGATIVE NO. 29

Garage

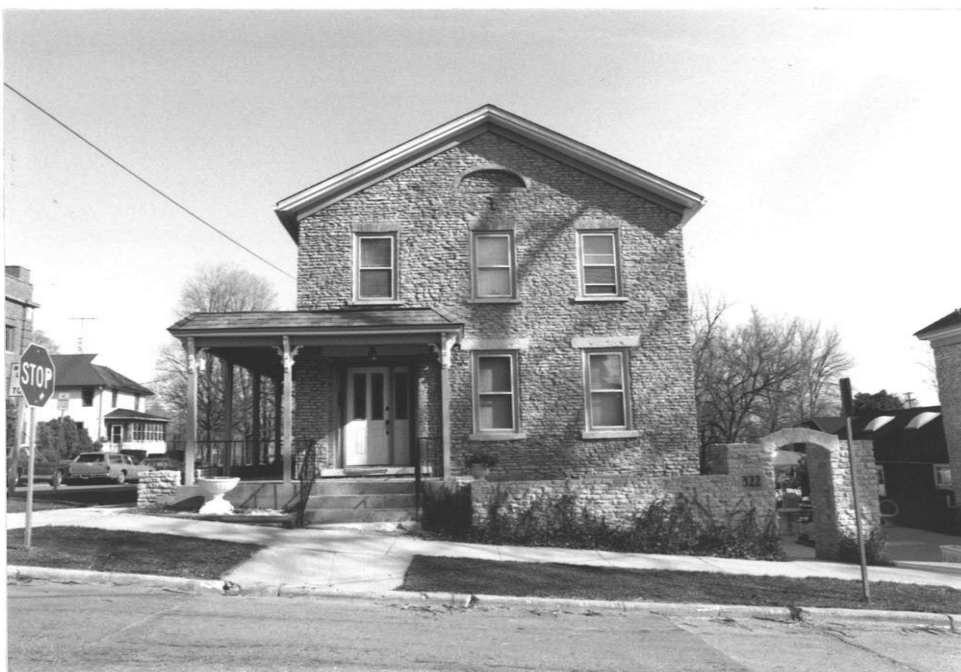
NEGATIVE NO. 27

1	2	3
<input type="checkbox"/> Unaltered	<input type="checkbox"/>	<input type="checkbox"/>	<input type="checkbox"/>
<input checked="" type="checkbox"/> Minor Alteration	<input checked="" type="checkbox"/>	<input type="checkbox"/>	<input type="checkbox"/>
<input type="checkbox"/> Major Alteration	<input type="checkbox"/>	<input type="checkbox"/>	<input type="checkbox"/>
<input type="checkbox"/> Additions	<input type="checkbox"/>	<input type="checkbox"/>	<input type="checkbox"/>
Sensitive to original	<input type="checkbox"/>	<input type="checkbox"/>	<input type="checkbox"/>
Insensitive to original	<input type="checkbox"/>	<input type="checkbox"/>	<input type="checkbox"/>

- ☒ Significant
- ☐ Contributing
- ☐ Non-Contributing

- ☒ Excellent: Well-maintained
- ☐ Good: Minor maintenance needed
- ☐ Fair: Major repairs needed
- ☐ Poor: Deteriorated

Style: National Style

Date of Construction: ca. 1840's

Rough limestone exterior with cut limestone window heads and sills at first floor, brick window heads at south elevation, second floor. Porch and perimeter low stone wall added in 1990's. Fan lite at south gable end filled with stone.

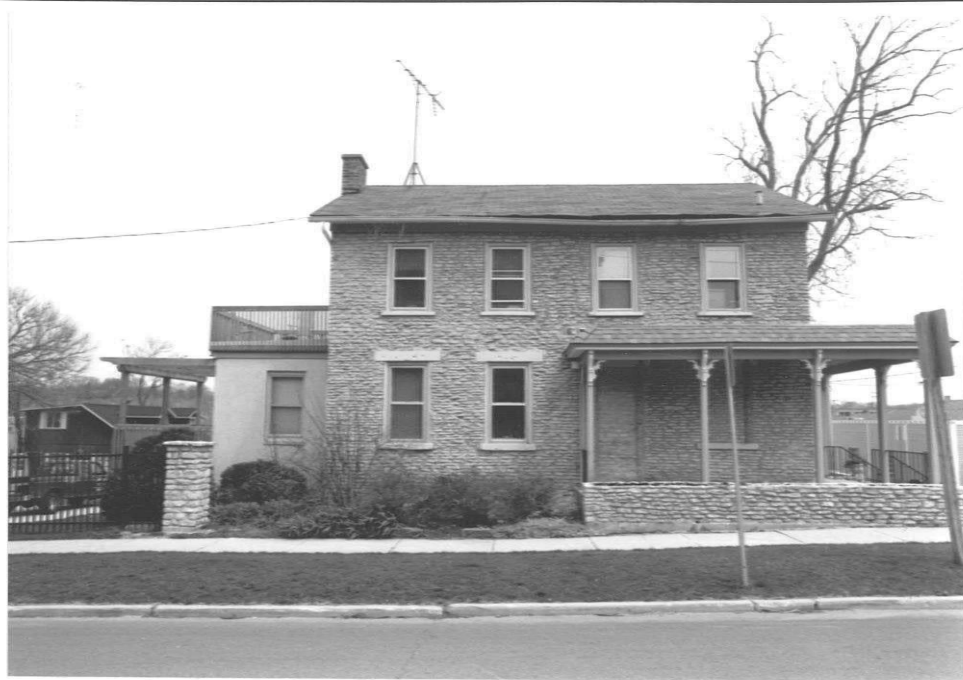
NEGATIVE NO. 27

West side, wrap around porch
added in 1990's.

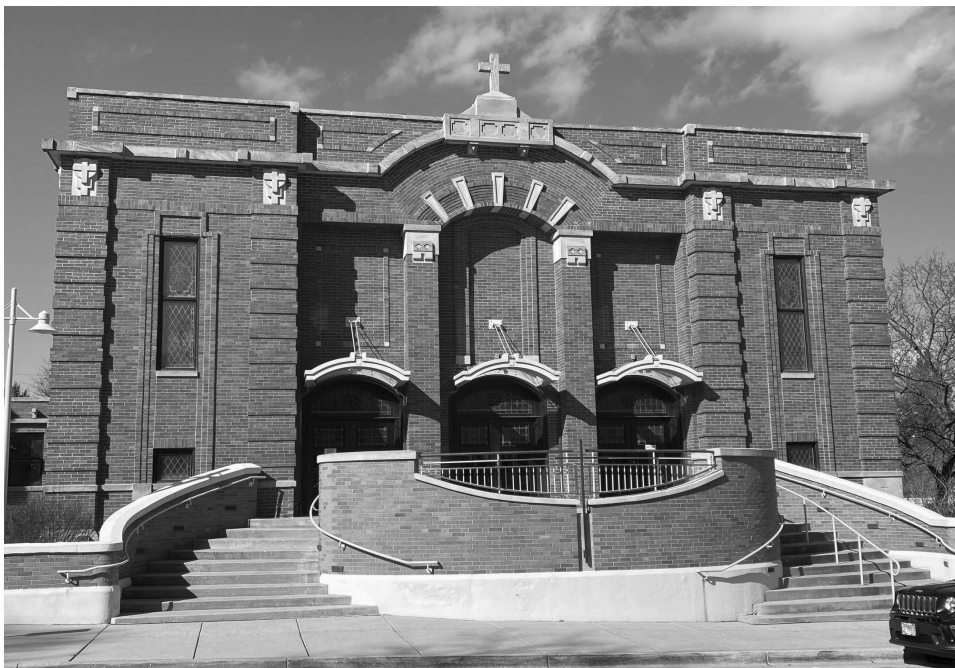
NEGATIVE NO. 25

1	2	3
<input checked="" type="checkbox"/> Unaltered	<input checked="" type="checkbox"/>	<input checked="" type="checkbox"/>	<input checked="" type="checkbox"/>
<input type="checkbox"/> Minor Alteration	<input type="checkbox"/>	<input type="checkbox"/>	<input type="checkbox"/>
<input type="checkbox"/> Major Alteration	<input type="checkbox"/>	<input type="checkbox"/>	<input type="checkbox"/>
<input type="checkbox"/> Additions	<input type="checkbox"/>	<input type="checkbox"/>	<input type="checkbox"/>
Sensitive to original	<input type="checkbox"/>	<input type="checkbox"/>	<input type="checkbox"/>
Insensitive to original	<input type="checkbox"/>	<input type="checkbox"/>	<input type="checkbox"/>

- ☒ Significant
- ☐ Contributing
- ☐ Non-Contributing

- ☒ Excellent: Well-maintained
- ☐ Good: Minor maintenance needed
- ☐ Fair: Major repairs needed
- ☐ Poor: Deteriorated

Style: Eclectic/Italian Renaissance

Date of Construction: 1912

Features: St. Patrick Church

Triple arch entry doors divided by masonry pilasters. Stone accents trim parapet and over central entry door at south. Similar stone detail at east elevation.

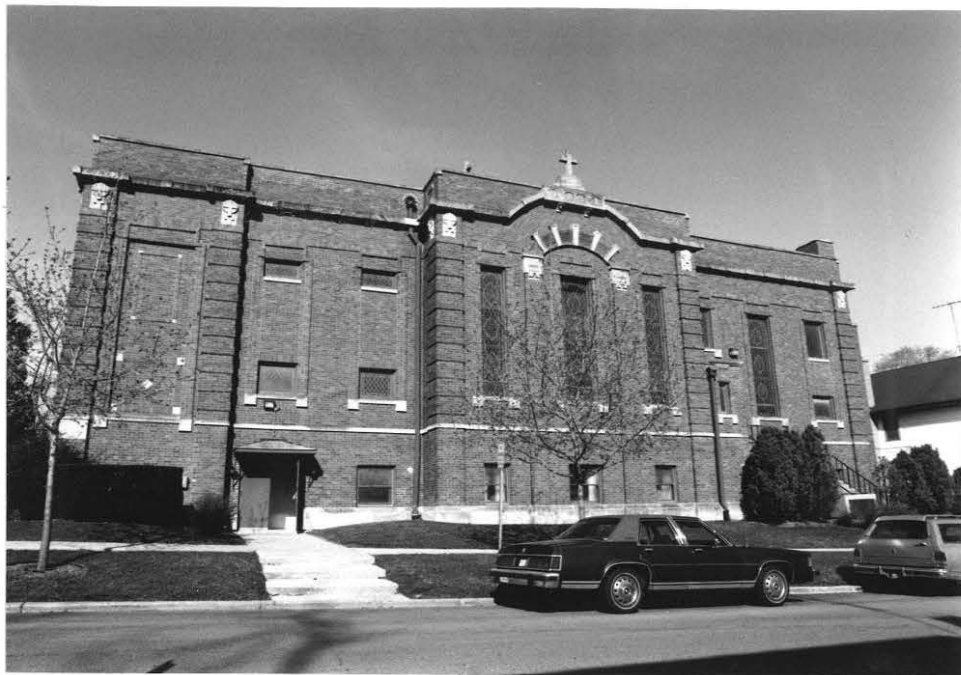
NEGATIVE NO. 26

East side

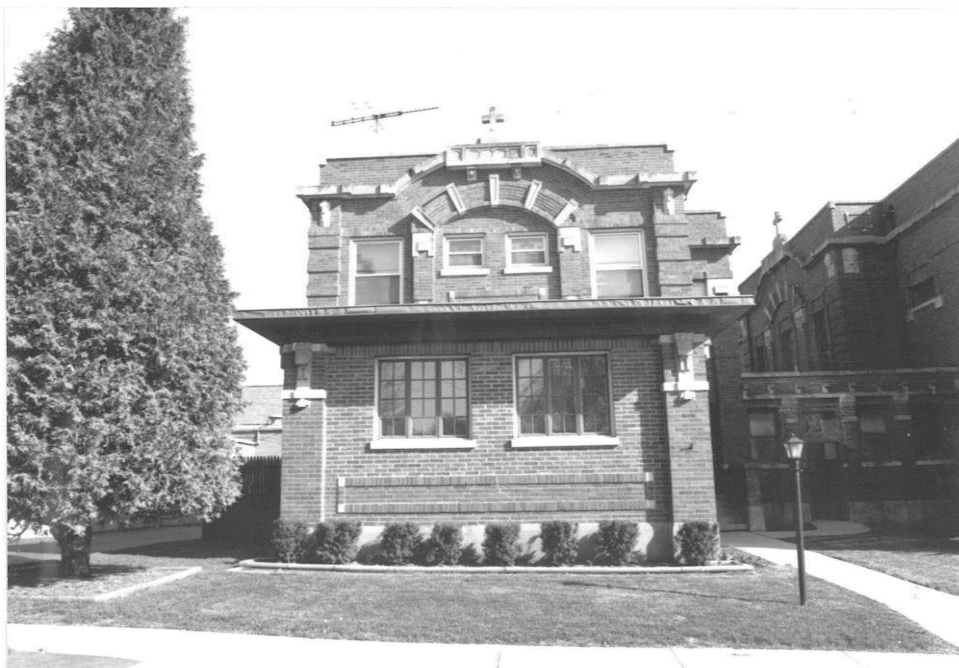
NEGATIVE NO. 24

1	2	3
<input checked="" type="checkbox"/> Unaltered	<input checked="" type="checkbox"/>	<input checked="" type="checkbox"/>	<input checked="" type="checkbox"/>
<input type="checkbox"/> Minor Alteration	<input type="checkbox"/>	<input type="checkbox"/>	<input type="checkbox"/>
<input type="checkbox"/> Major Alteration	<input type="checkbox"/>	<input type="checkbox"/>	<input type="checkbox"/>
<input type="checkbox"/> Additions	<input type="checkbox"/>	<input type="checkbox"/>	<input type="checkbox"/>
Sensitive to original	<input type="checkbox"/>	<input type="checkbox"/>	<input type="checkbox"/>
Insensitive to original	<input type="checkbox"/>	<input type="checkbox"/>	<input type="checkbox"/>

☒ Significant

☒ Excellent: Well-maintained

Style: Eclectic/Italian Renaissance

Date of Construction: 1912

Features: St. Patrick Rectory

Brick structure with significant stone accents. Elaborate stone caps to masonry pilasters on south facade. Stone at upper facade matches church to east.
