ARCHITECTURAL SURVEY
MILLINGTON HISTORIC DISTRICT
ST. CHARLES, ILLINOIS
Date of Survey: 2003

ST. CHARLES HISTORIC PRESERVATION COMMISSION

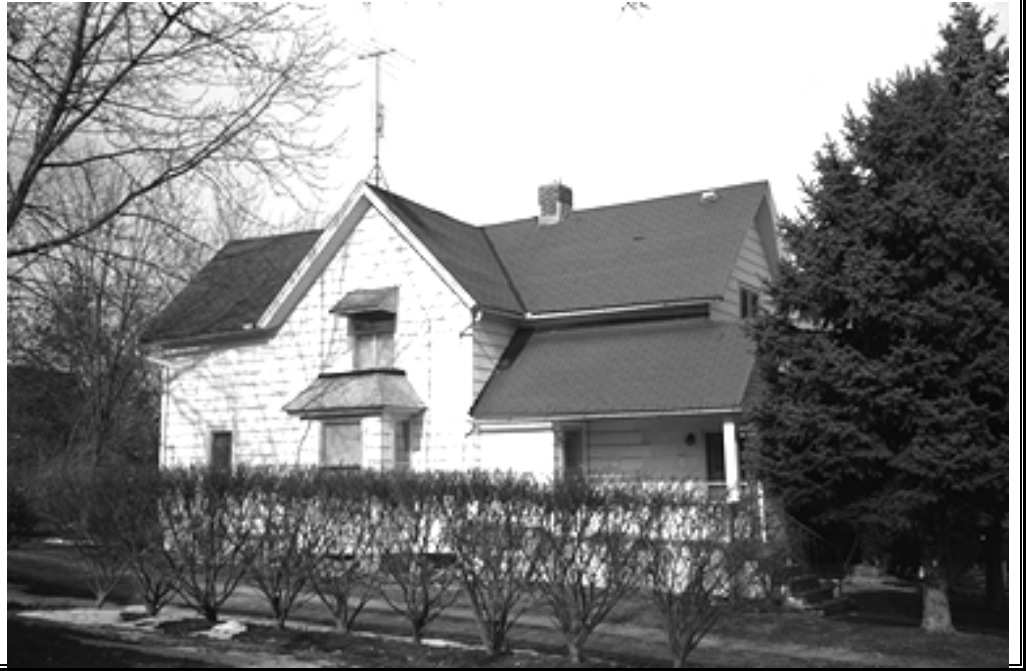
ADDRESS 115 North 5th Street

Architectural Style/Type: Queen Anne

Exterior Walls (Current): Composition shingle

Exterior Walls (Original): Clapboard

Foundation: Parged masonry

Roof Type/Material: Cross gable/Asphalt shingle

ARCHITECTURAL FEATURES: It appears that the front porch was remodeled at some time, as the detailing does not match the side porch. The side porch still retains the original spindle work and turned columns while a single square column supports the front porch and the rail is comprised of square balusters. The front stairs are constructed of wood and has a wrought iron handrail.

ALTERATIONS: The original Victorian era details were removed when the house was resided with the composition shingle siding. The eaves are open and are sheathed with aluminum. The front entry doors are aluminum.

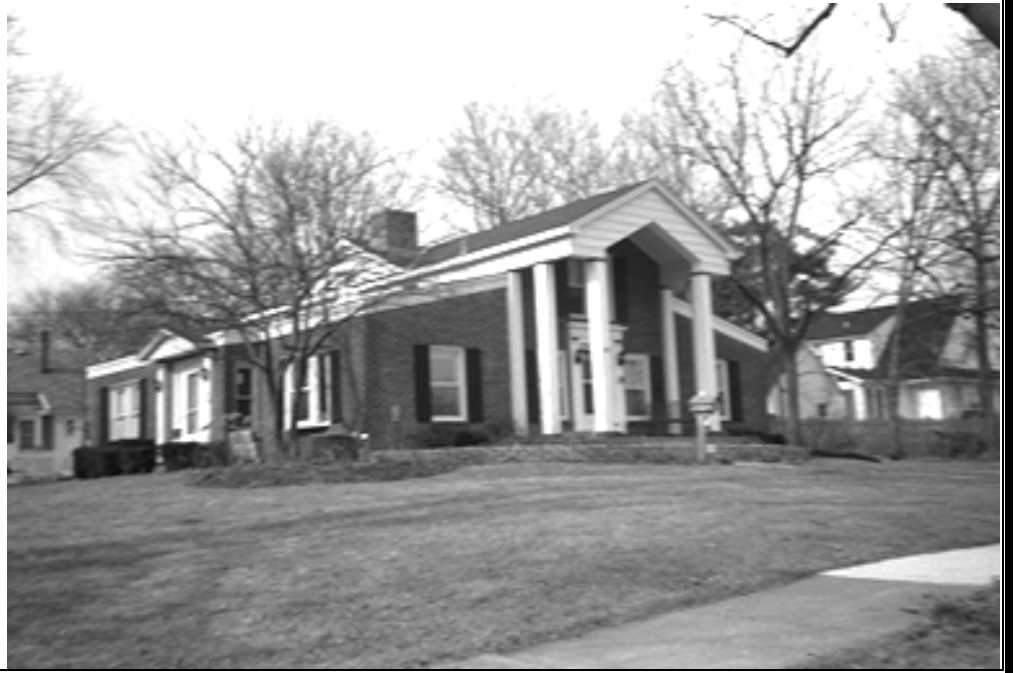
ADDRESS 117 South 5th Street

Architectural Style/Type: <u>Eclectic</u>	Exterior Walls (Current): <u>Brick/Alum</u>
Architectural Features: _____	Exterior Walls (Original): <u>Clapboard</u>
Date of Construction: <u>1930</u>	Foundation: <u>Concrete</u>
Source: <u>Township Assessor's Office</u>	Roof Type/Material: <u>Cross gable/Asphalt Shingle</u>
Overall Plan Configuration: <u>Compound w/ Additions</u>	Window Material/Type: <u>Wd trim/Alum/Dbl Hung</u>

ARCHITECTURAL FEATURES: This is currently a multi-family residence with an address of 500 W. Indiana on the side entrance. The 1 ½ story portico over the 5th Street entrance is the dominant architectural feature. Here large disproportionate square columns support a gabled roof. The gable end is cut out in an almost Post Modern manner expressing no particular stylistic reference. An elaborated surround adds emphasis and interest to what appears to be the main entry. The overall impression is Colonial revival but a lack of appropriate details precludes classification as such.

ALTERATIONS: The original house was a modest structure that is now completely hidden by numerous additions and modifications.

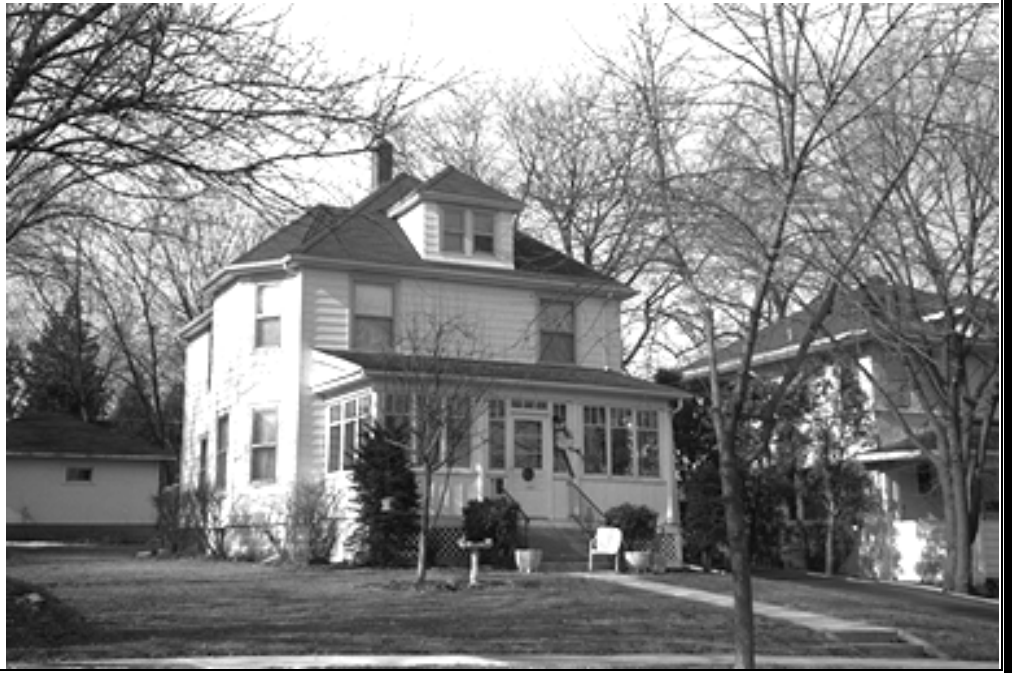
ADDRESS 17 North 5th Street

Architectural Style/Type: <u>Craftsman</u>	Exterior Walls (Current): <u>Aluminum</u>
Architectural Features: _____	Exterior Walls (Original): <u>Clapboard</u>
Date of Construction: <u>1920</u>	Foundation: <u>Textured CMU</u>
Source: <u>Township Assessor's Office</u>	Roof Type/Material: <u>Hipped/Asphalt Shingle</u>
Overall Plan Configuration: <u>4 square</u>	Window Material/Type: <u>Aluminum/DbI Hung</u>

ARCHITECTURAL FEATURES: The eaves of the roof are narrow and ungracious for the scale of the roof and home. A 2 – story bay on the south side articulates the mass of the walls and the roofline. The hipped roof dormer centered on the front of the of the house is another distinguishing feature.

ALTERATIONS: The front porch has been closed in. The windows of the porch do not currently match the rest of the house as the proportions of the openings do not match nor do the muntin patterns. The porch foundation is skirted with a wooden lattice while the deck is accessed by a CIP concrete stoop and a wrought iron railing.

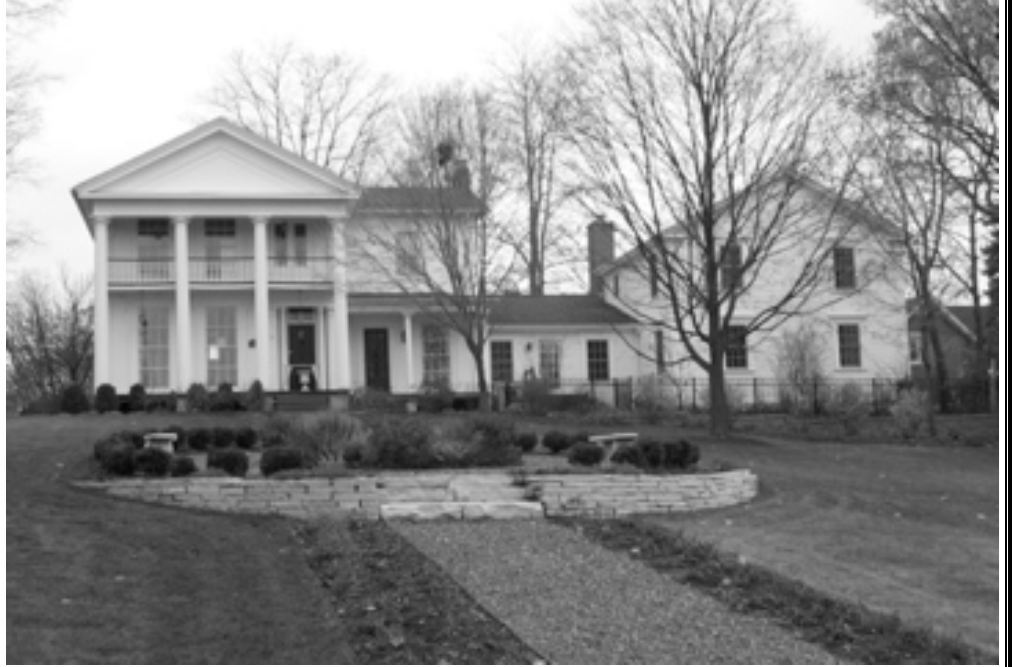
ADDRESS 19 South Fifth Street

Architectural Style/Type: Greek Revival
 Architectural Features: _____

Exterior Walls (Current): Wood clapboard / wood frame
 Exterior Walls (Original): Wood clapboard / wood frame
 Foundation: Stone

Roof Type/Material: Gabled / asphalt shingles

ARCHITECTURAL FEATURES: Features a large 2 story gabled portico supported by stylized Greek Doric columns. There is a 2nd story balcony supported by the portico columns. The portico is designed in the Greek temple form. The house is sited on a hill, also typical of Greek temple planning. The window surrounds exhibit typically simple Greek detailing. The house is sided with narrow wood clapboards with a 5” exposure.

ALTERATIONS: There was a second floor section added over the dining room and parlor. The conservatory off the dining room and the closet off the first floor SE bedroom are also later additions. John A. Brown, who purchased the property in 1885, added French doors to the second floor porch during an extensive interior remodeling. In 2005, a two-story addition was connected to the original structure by a one-story wing. The addition is set back from the original structure and has a lower roof pitch, allowing the original elevation to retain its prominence. Window size and pattern, materials, and architectural style match the original structure, but the details are more simplified.

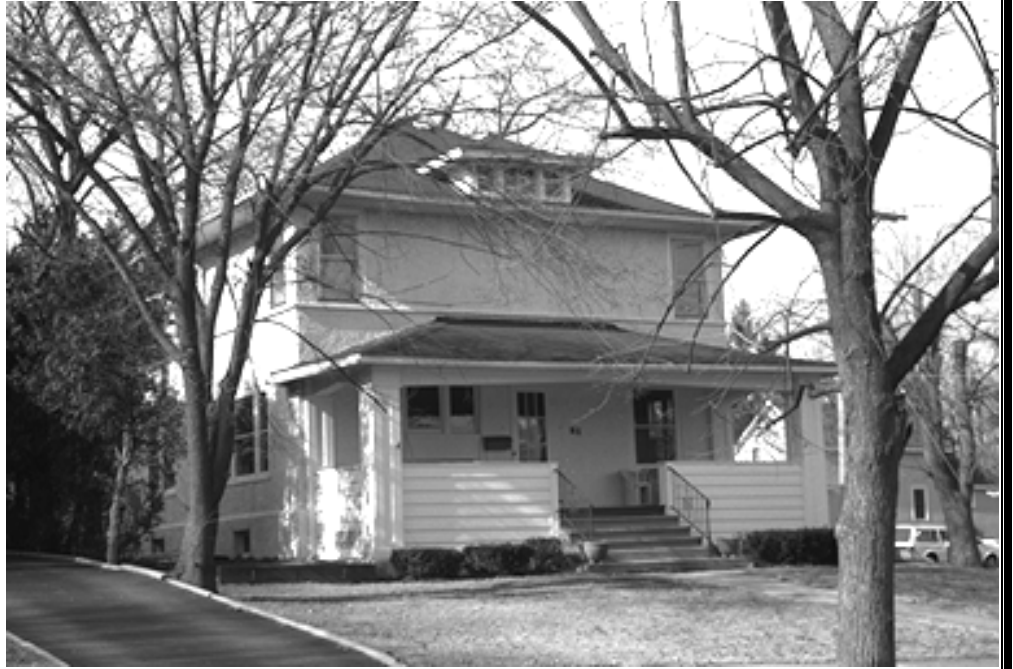
ADDRESS 21 North 5th Street

Architectural Style/Type: Prairie

Exterior Walls (Current): Stucco/Clapboard

Foundation: Stucco over masonry

Roof Type/Material: Hipped/Asphalt Shingle

ARCHITECTURAL FEATURES: The broad eaves and the horizontal trim dividing the ground floor and the second floor are characteristic of the style. Stucco covers the entire house while broad clapboards cover the porch. Columns that start at grade level support the hipped roof of the porch. The bottoms of the porch edge beams are subtly sloped creating an arched effect. The front stoop was rebuilt.

ALTERATIONS: The eaves are boxed in aluminum. A porch and deck are additions that are not sympathetic with the original architectural style. The front stoop is CIP concrete with a wrought iron railing. The original stucco covering the front porch has been replaced with clapboard.
