ARCHITECTURAL SURVEY
MILLINGTON HISTORIC DISTRICT
ST. CHARLES, ILLINOIS
Date of Survey: 2003

ST. CHARLES HISTORIC PRESERVATION COMMISSION

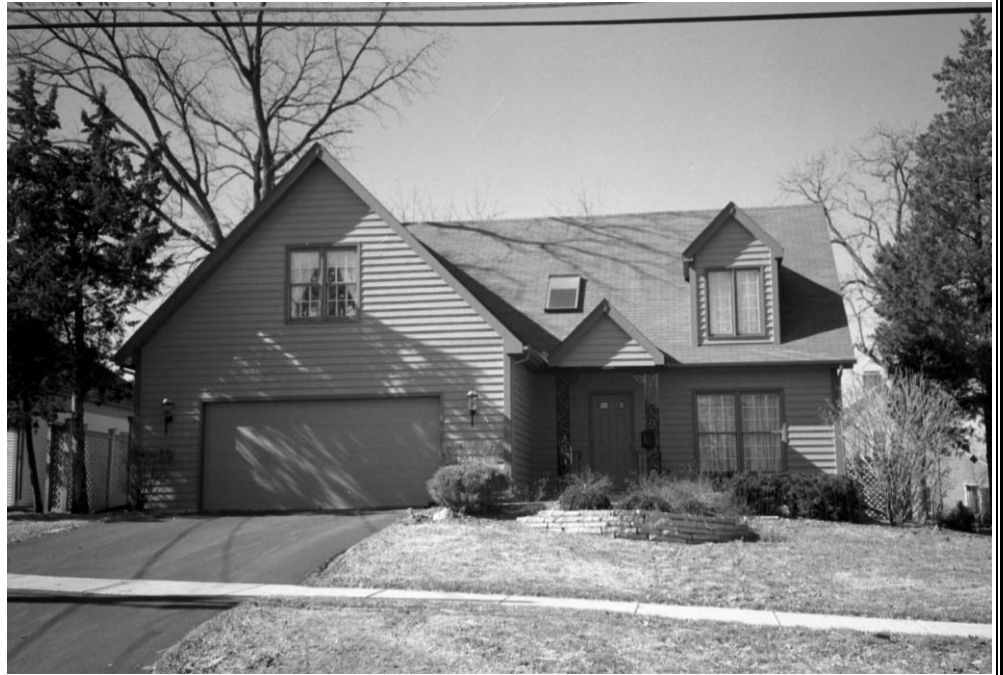
ADDRESS 15 North 6th Street

ARCHITECTURAL FEATURES: This is a 1½ story Cape Cod framed home. The garage "L" component of the plan is not part of the original historical style. The skylight and the small gabled entry cover are also inconsistent with the original style.

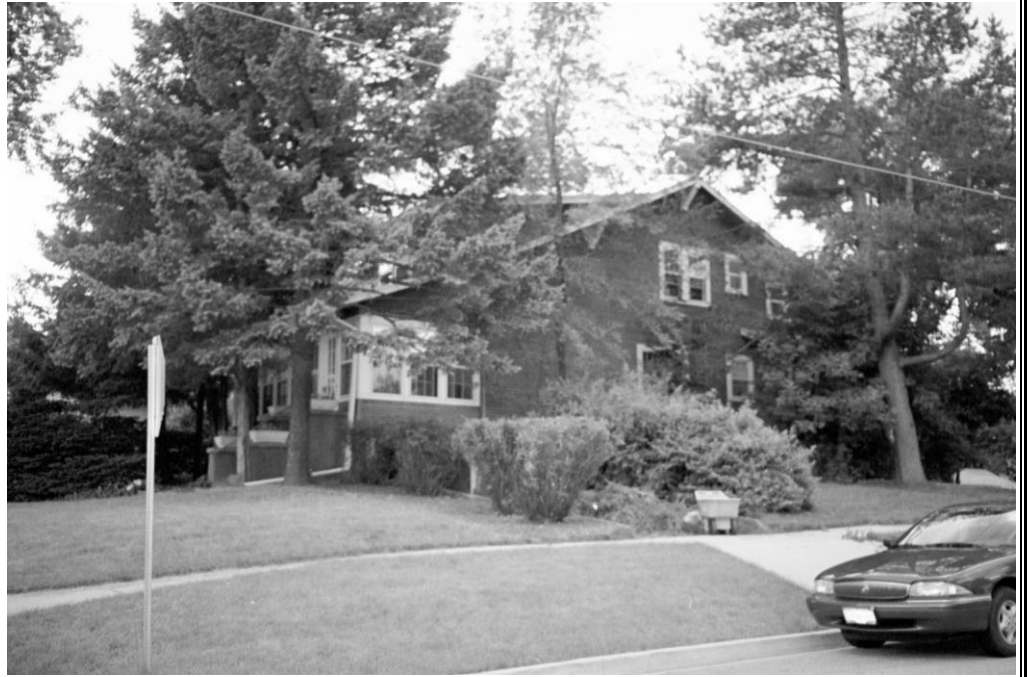
ADDRESS 21 North 6th Street

ARCHITECTURAL FEATURES: This is a very deep house from front to back. The large roof is articulated by the typical details of the style. Wood roof brackets support the wide overhangs, exposed rafter tails are seen at the open eaves, both support soffits sheathed with wooden boards. A small 1-car garage is tucked underneath the front porch. The front entrance is off center and the original wooden front door can be seen from the outside of the porch.

ALTERATIONS: The front porch is closed in a manner sympathetic with the original design. The window openings are trimmed exactly the same as the rest of the windows in the house. There appears to be a small 1-story addition that was added to the north side of the house as a modest room extension. It has a shed roof and blends well with the rest of the house. Another screened porch was added to the rear of the house. It blends well with the rest of the house but has a hipped roof that is tucked under the rear eave of the main roof.

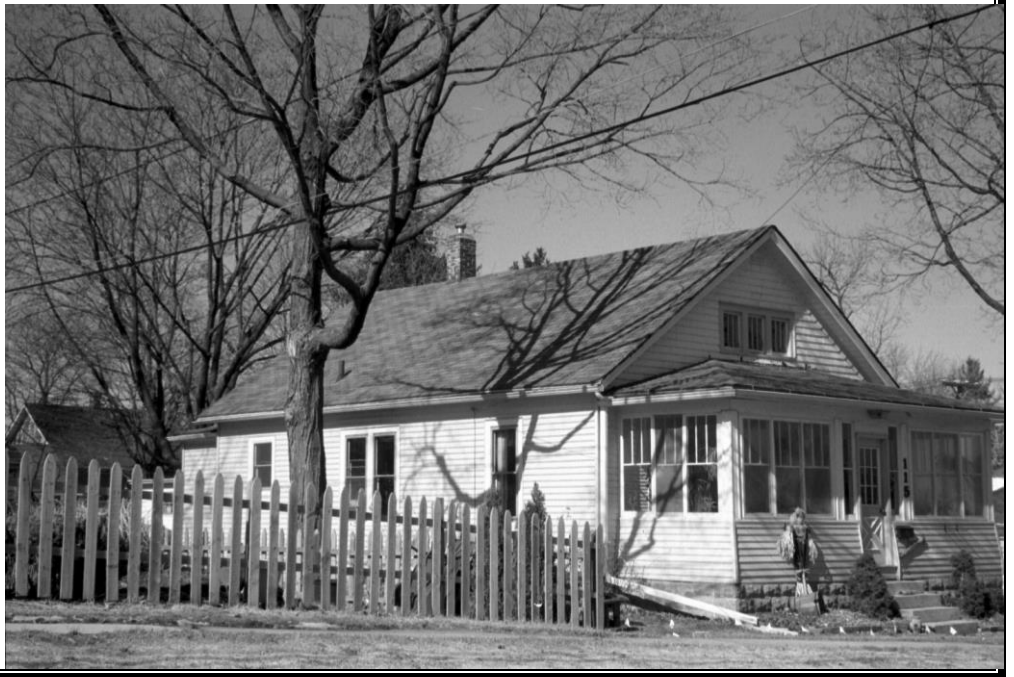
ADDRESS 115 North Sixth Street

ARCHITECTURAL FEATURES: A full-width front porch dominates the front façade. The front gable features a group of three windows that are still trimmed in wood. The gable end is covered with wood shingles.

ALTERATIONS: A one-story addition with a gabled roof was made to the rear of the house. The front porch has been closed in.

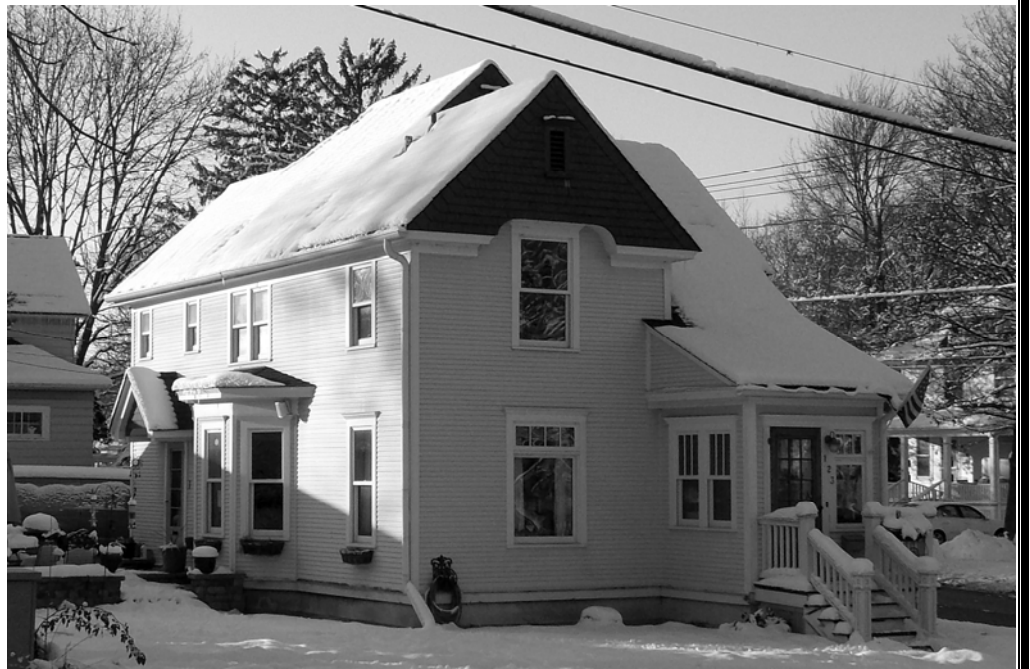
ADDRESS 123 North Sixth Street

ARCHITECTURAL FEATURES: The flat arched cut out of the front gable end is a distinctive detail. It is decorated with wood shingles. A small entry porch is covered by a long sweep of the main roof slope. Both of these features are somewhat characteristic of the Shingle or the Queen Anne styles. A relatively deep frieze board trims the wall/eave juncture. Almost all of the windows feature a crown molding at the head. The original front door is still in place inside the porch. There is a small one-story bay window on the south elevation.

ALTERATIONS: The front entry porch has been closed in. A two-story addition was made to the rear of the house. The detailing and materials match the original structure.

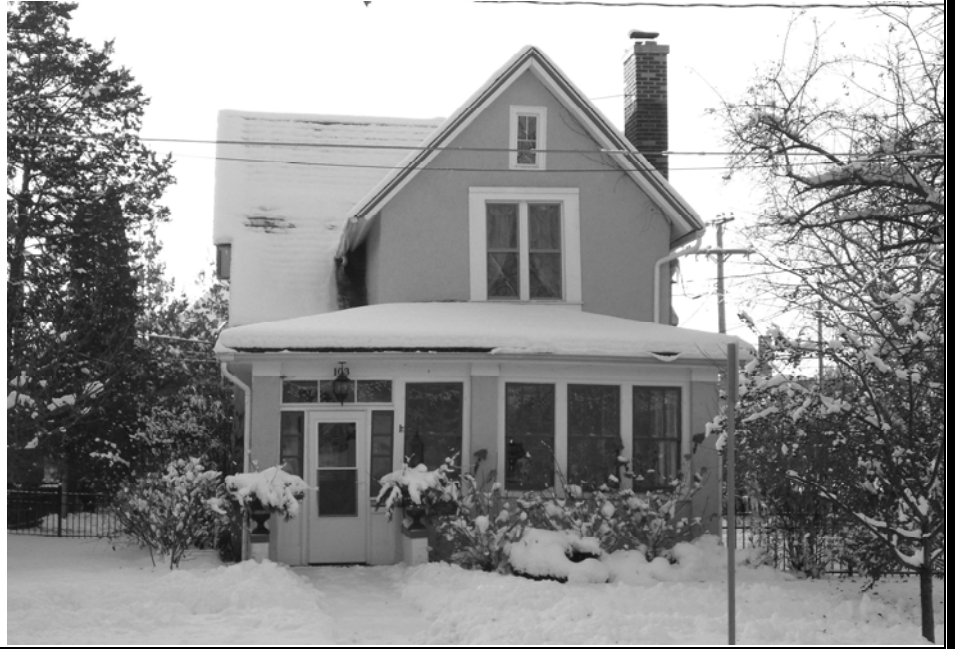
ADDRESS 103 South 6th Street

ARCHITECTURAL FEATURES: Smooth wall surfaces define crisp edges of the façade and angles of the roof. There are few details of note. Small attic windows punctuated the gable ends at the top, while 3:1 muntin patterns are typical around the house. There are a few removable storms still in use around the house.

ALTERATIONS: The front porch has been closed in and has an aluminum front door. A 1 story addition to the rear features a balcony on the roof of the ground floor accessed through an aluminum door from the second floor. It is built on a brick foundation. The stucco was applied to the house in 1910.

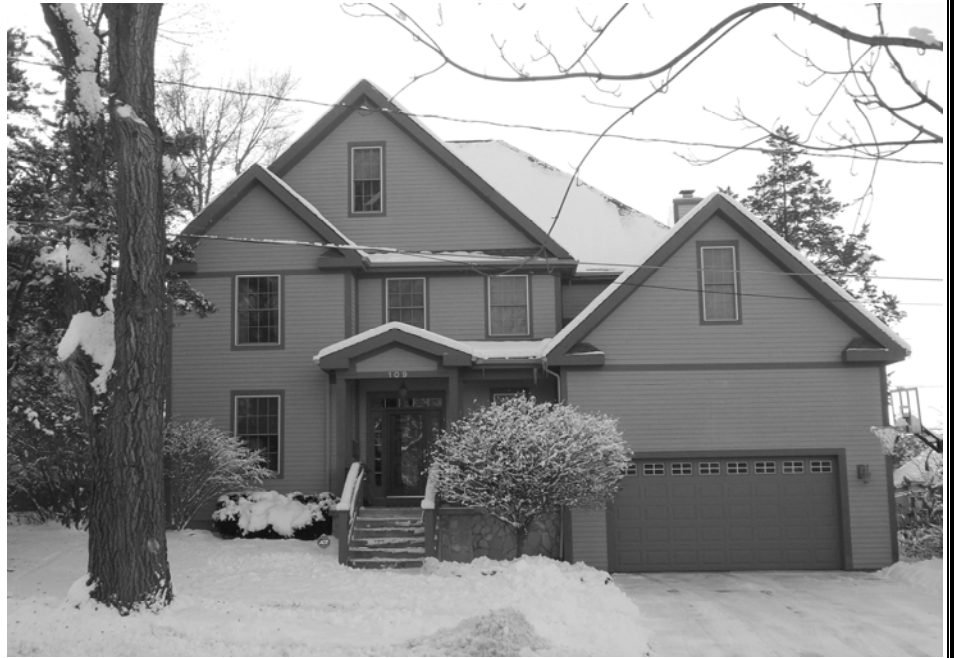
ADDRESS 109 South 6th Street

The multiple front gables, two of which have cornice returns, are the most prominent features of the front elevation, along with the protruding garage "L". A small front entrance porch is supported by a shed roof overhang and gable form over the front door.

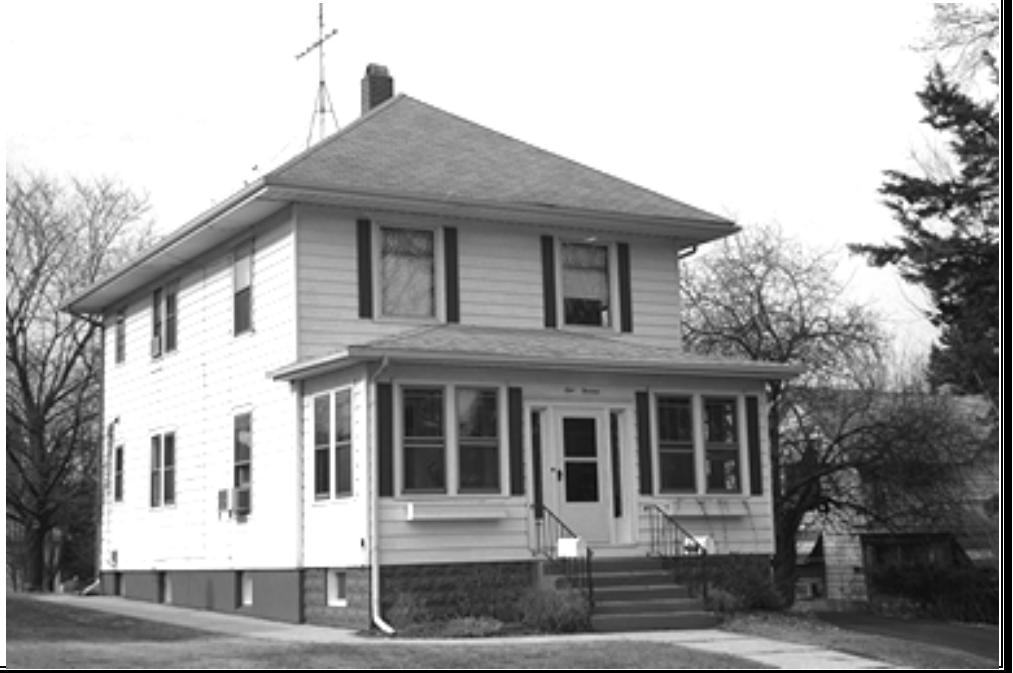
ADDRESS 113 South 6th Street

ARCHITECTURAL FEATURES: There are few, if any, trim details of note. There is leaded glass in the upper sashes of the second floor double hung windows. The soffits are boxed in aluminum.

ALTERATIONS: Aluminum soffits, siding, and windows were changes to the original materials. The front porch was added later. The foundation is textured concrete masonry, unlike the original concrete foundation. The windows of the porch room feature a 3:1 muntin pattern unlike the original windows.

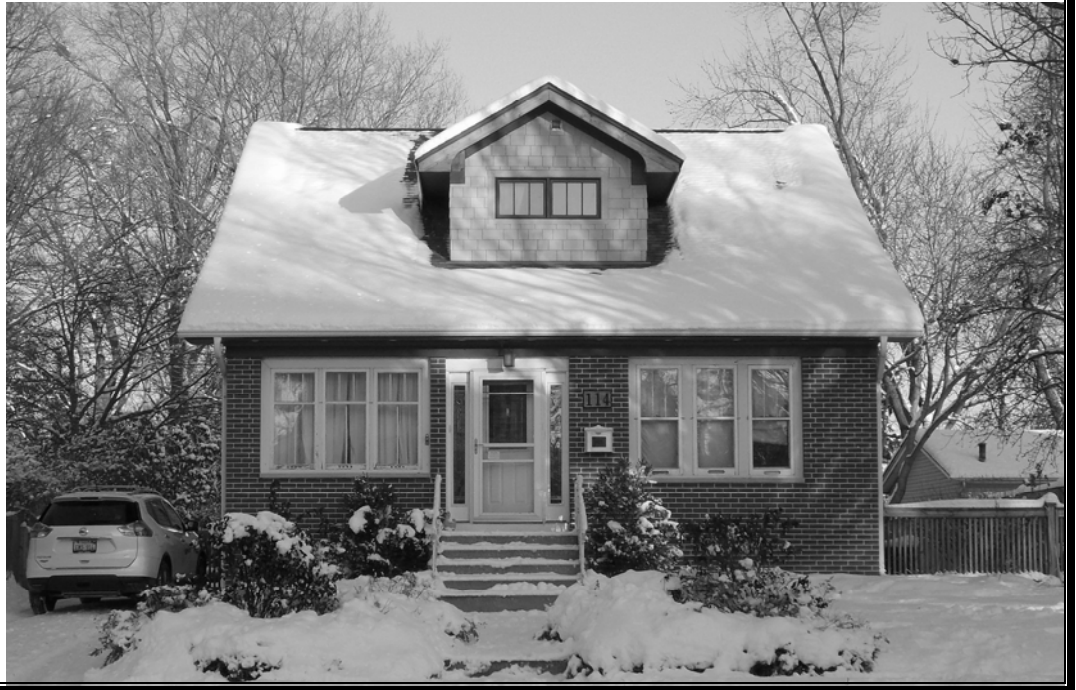
ADDRESS 114 South 6th Street

ARCHITECTURAL FEATURES: This house appears to be symmetrical at first glance, but is not. The entry is off center and the windows to the right and left of the entry are different. It appears that this could have been a Craftsman bungalow at one time judging from the overhangs and massing. The roof dormer on the front elevation is also somewhat typical of the style.

ALTERATIONS: Any original wood details that might have been are gone. A brick veneer was added to the front and wrapped around to what was probably the back of the front porch. The soffits are open and covered with plywood. The front

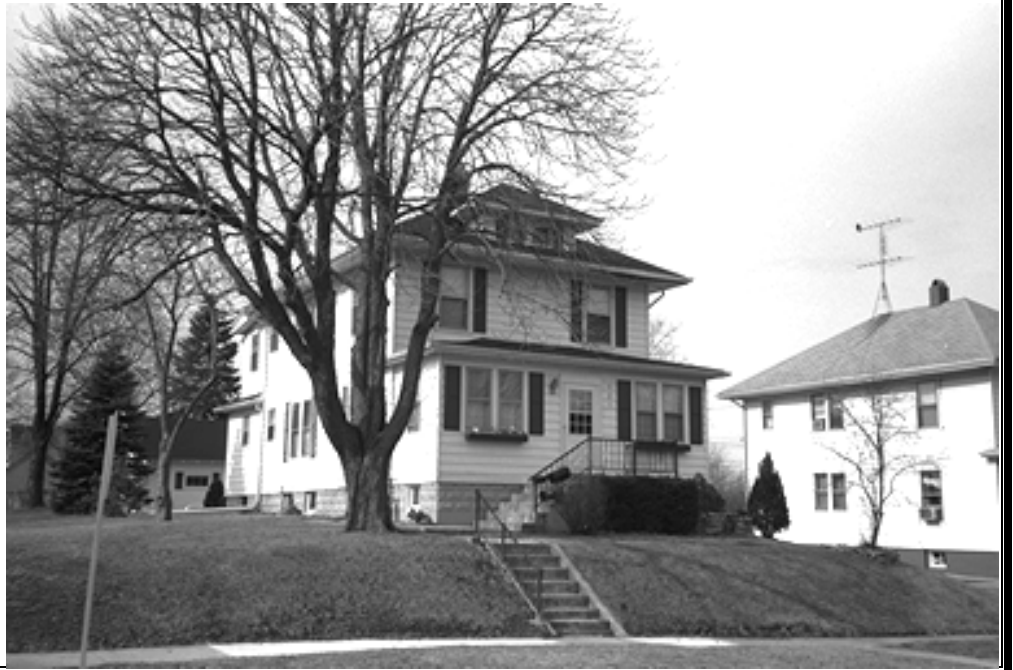
ADDRESS 121 South 6th Street

ARCHITECTURAL FEATURES: The eaves are relatively wide and are boxed in aluminum. A large hipped roof dormer is centered on the front on the front elevation. The front porch is full width and features paired windows that flank each side of the entrance.

ALTERATIONS: The front porch has been closed in. The entire house has been covered in aluminum siding, soffits, windows, and front door. There is a large 2-story addition at the rear of the house that is covered with a shed roof that is not sympathetic with the original design. The front stoop is cast in place concrete and has a wrought iron handrail.

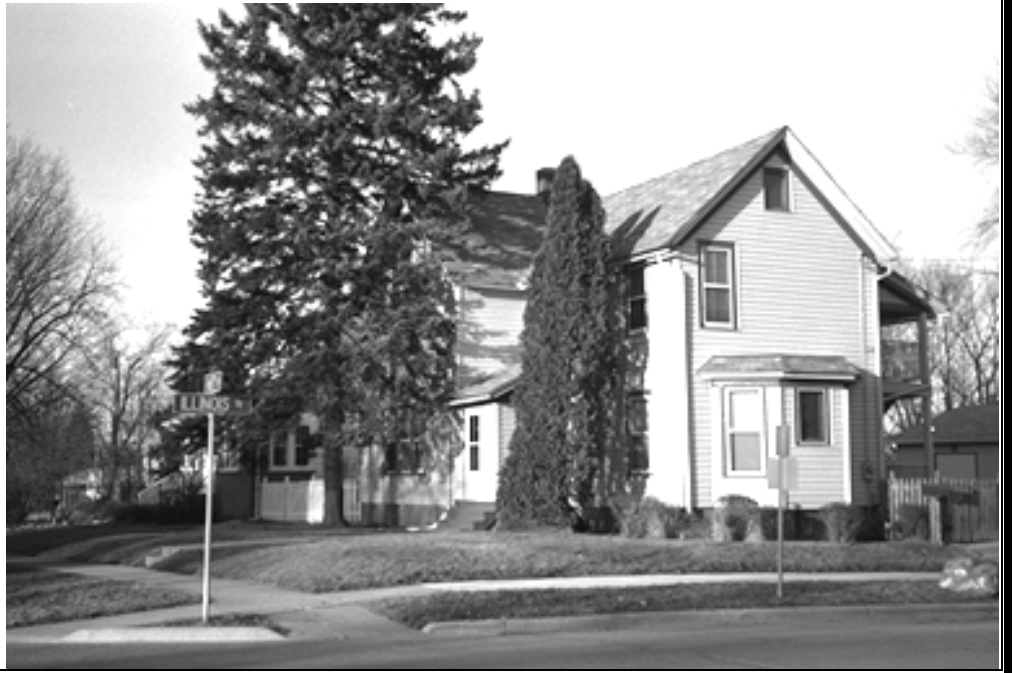
ADDRESS 122 South 6th Street

ARCHITECTURAL FEATURES: A 1 story bay window is a prominent feature of the south elevation of this simply designed house that features few interesting details. The entrance is off center and relatively inconspicuous.

ALTERATIONS: A 1 story addition to the north side of the house is not sympathetic to the original design. A 2 story bare wood addition was made to the rear of the house. A shed roof covers a second floor balcony. Nether the materials or design are sympathetic with the original design. A small front porch was closed in and is used an entry vestibule that has an alum. door.
