ARCHITECTURAL SURVEY

NEAR WEST HISTORIC DISTRICT

ST. CHARLES, ILLINOIS

ST. CHARLES HISTORIC PRESERVATION COMMISSION

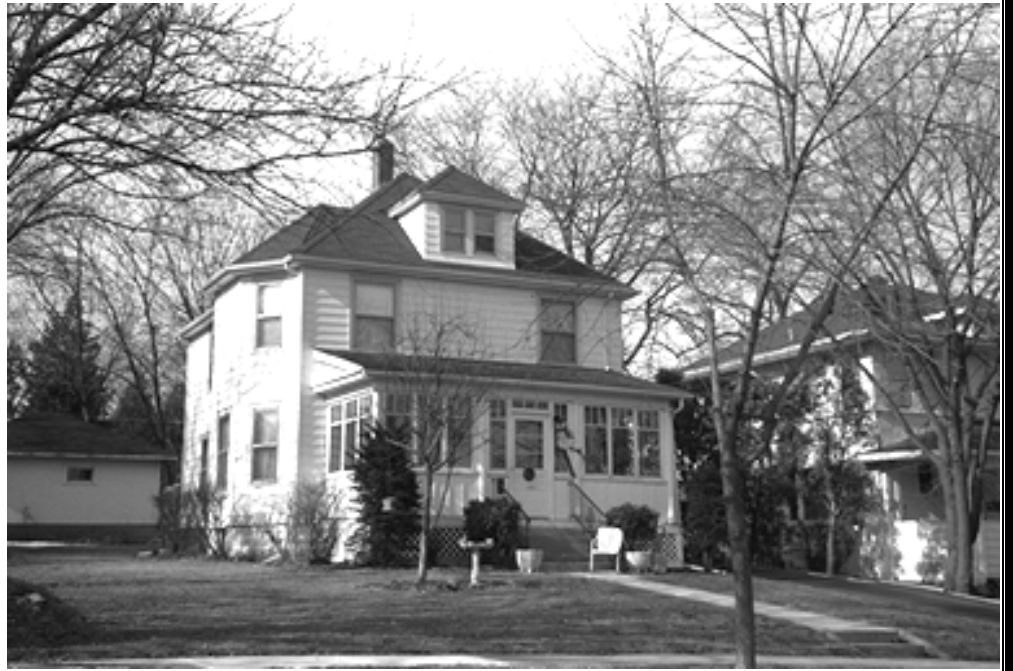
ADDRESS 17 North 5th Street

- ☐ Excellent
- ☒ Good
- ☐ Fair
- ☐ Poor

ARCHITECTURAL FEATURES: The eaves of the roof are narrow and ungracious for the scale of the roof and home. A 2 – story bay on the south side articulates the mass of the walls and the roofline. The hipped roof dormer centered on the front of the house is another distinguishing feature.

ALTERATIONS: The front porch has been closed in. The windows of the porch do not currently match the rest of the house as the proportions of the openings do not match nor do the muntin patterns. The porch foundation is skirted with a wooden lattice while the deck is accessed by a CIP concrete stoop and a wrought iron railing.

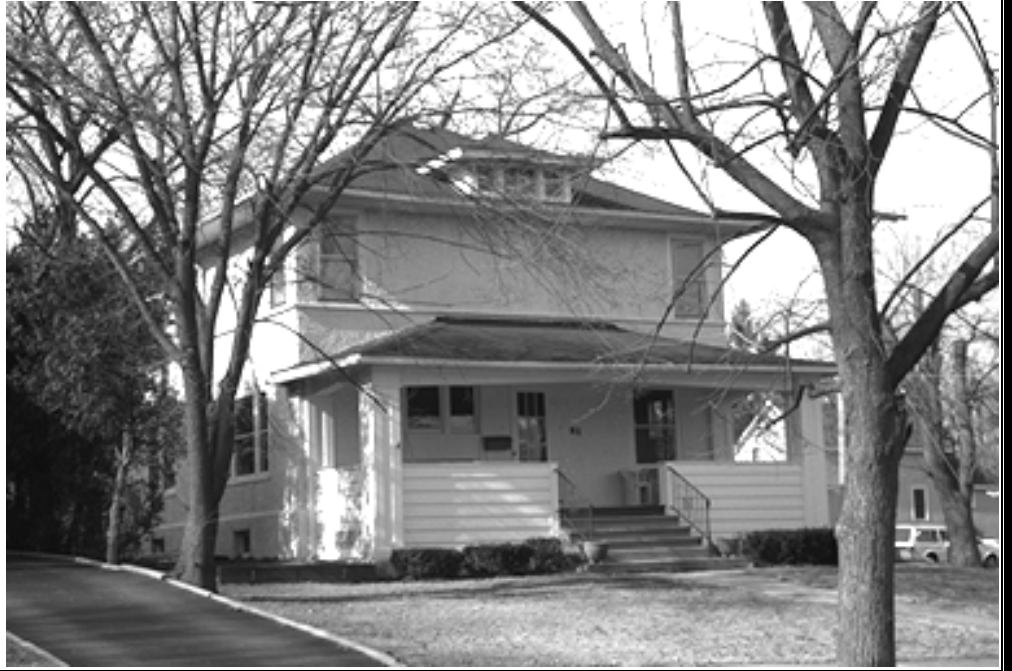
ADDRESS 21 North 5th Street

- ☐ Excellent
- ☒ Good
- ☐ Fair
- ☐ Poor

ARCHITECTURAL FEATURES: The broad eaves and the horizontal trim dividing the ground floor and the second floor are characteristic of the style. Stucco covers the entire house while broad clapboards cover the porch. Columns that start at grade level support the hipped roof of the porch. The bottoms of the porch edge beams are subtly sloped creating an arched effect. The front stoop was rebuilt.

ALTERATIONS: The eaves are boxed in aluminum. A porch and deck are additions that are not sympathetic with the original architectural style. The front stoop is CIP concrete with a wrought iron railing. The original stucco covering the front porch has been replaced with clapboard.

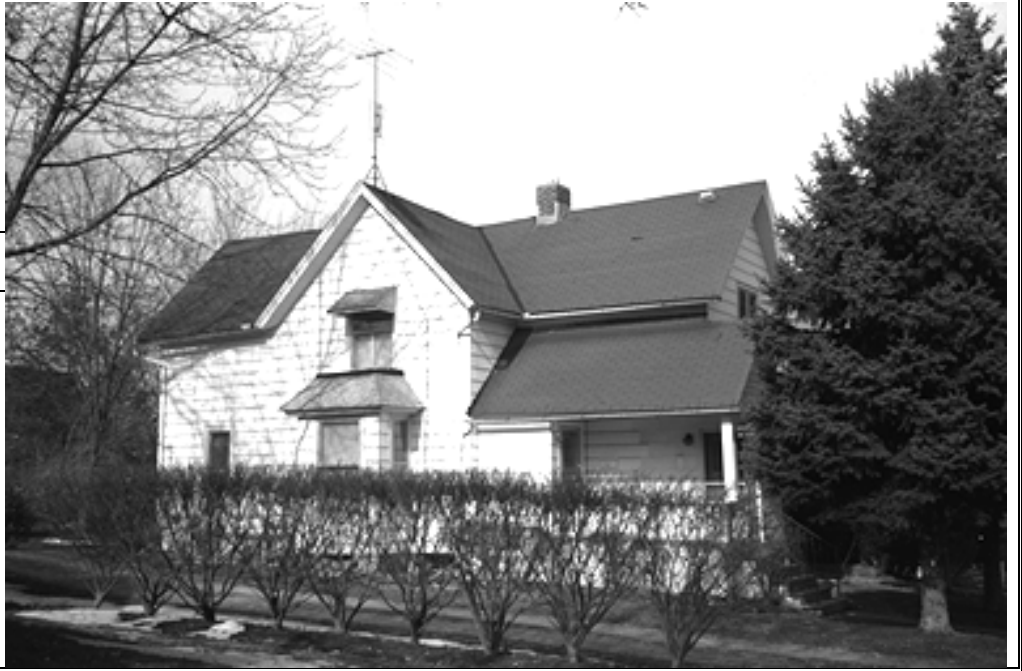
ADDRESS 115 North 5th Street

- ☐ Excellent
- ☒ Good
- ☐ Fair
- ☐ Poor

ARCHITECTURAL FEATURES: It appears that the front porch was remodeled at some time, as the detailing does not match the side porch. The side porch still retains the original spindle work and turned columns while a single square column supports the front porch and the rail is comprised of square balusters. The front stairs are constructed of wood and has a wrought iron handrail.

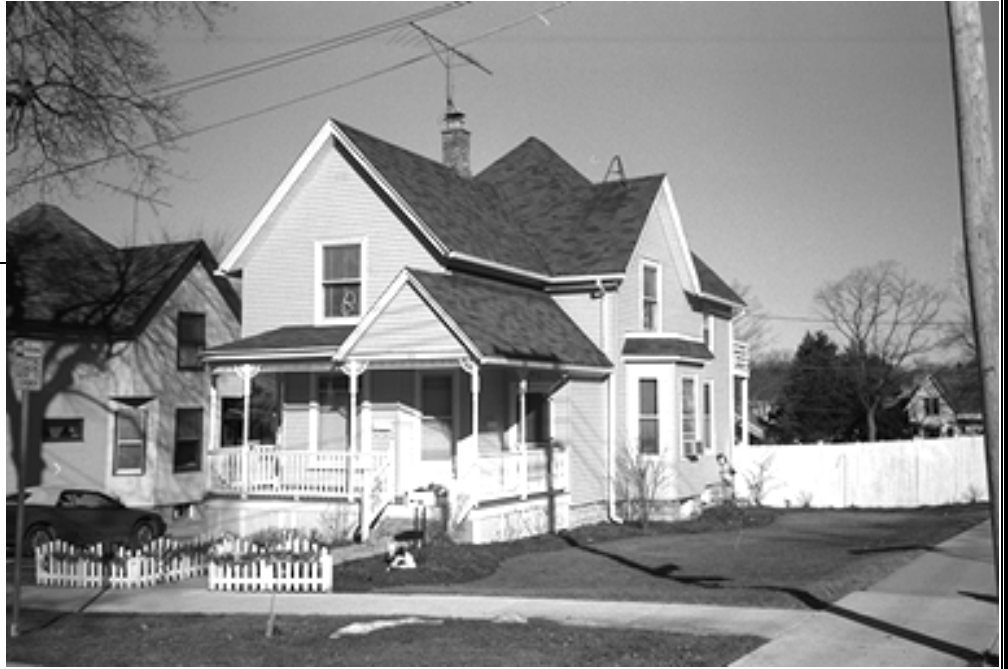
ROLL-IMAGE # 3432 - 8

ARCHITECTURAL FEATURES: The spindle-work detailing on the porch is the most striking feature of the house. The turned columns that support the porch roof appear to be thin in proportion to their function. The porch end is gracefully curved as it returns to the main mass of the house. The front gable has cutaway corners on the ground floor somewhat concealed by the roof of the porch. There is also a leaded glass transom on the ground floor bay on the porch. The eaves re open. The stone foundation is an important feature contributing to the historic character of the facades.

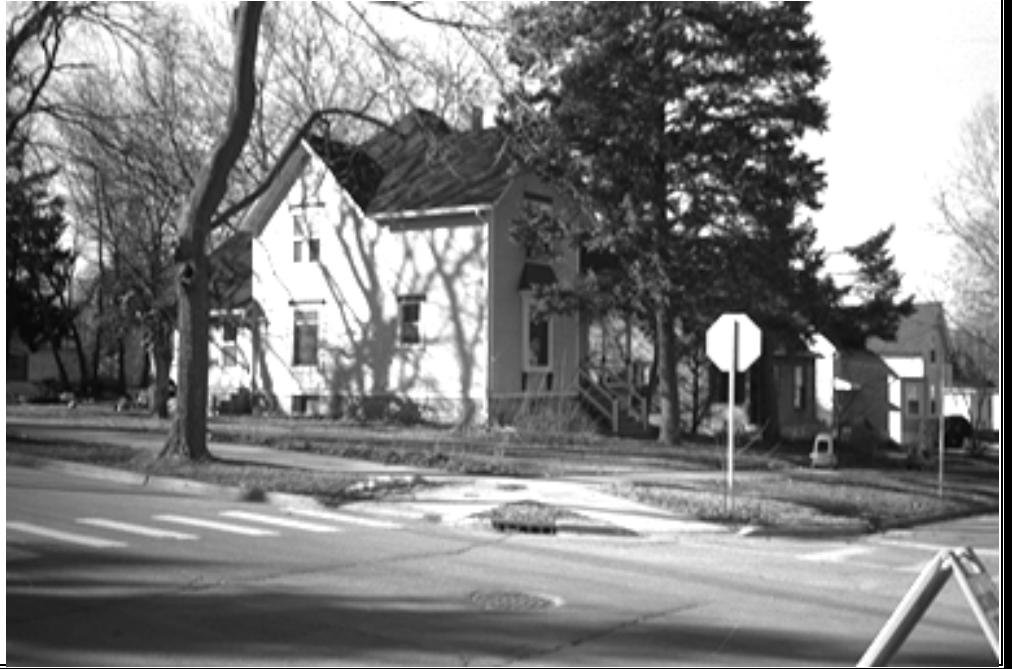
ROLL-IMAGE # 3432 - 7

ARCHITECTURAL FEATURES: There is a noticeable absence of imbrication in the gable ends – which could mean that the house was re-sided. The heads of the window trim appear to have been removed as brackets that would have supported them remain. Original spindle-work details remain on a small entry porch asymmetrically placed on the front elevation. Fish-scale shingles were used on the small roof covering the ground floor window of the front gable end. This window project slightly and is supported by two wooden brackets. The stone foundation contributes to the historic character of the house. The eaves are open and are sheathed in wood.

ALTERATIONS: A 1 ½ story addition was made to the rear of the house that maintains the character of the original style. The siding appears to have been replaced stripping some of the details of the original house.

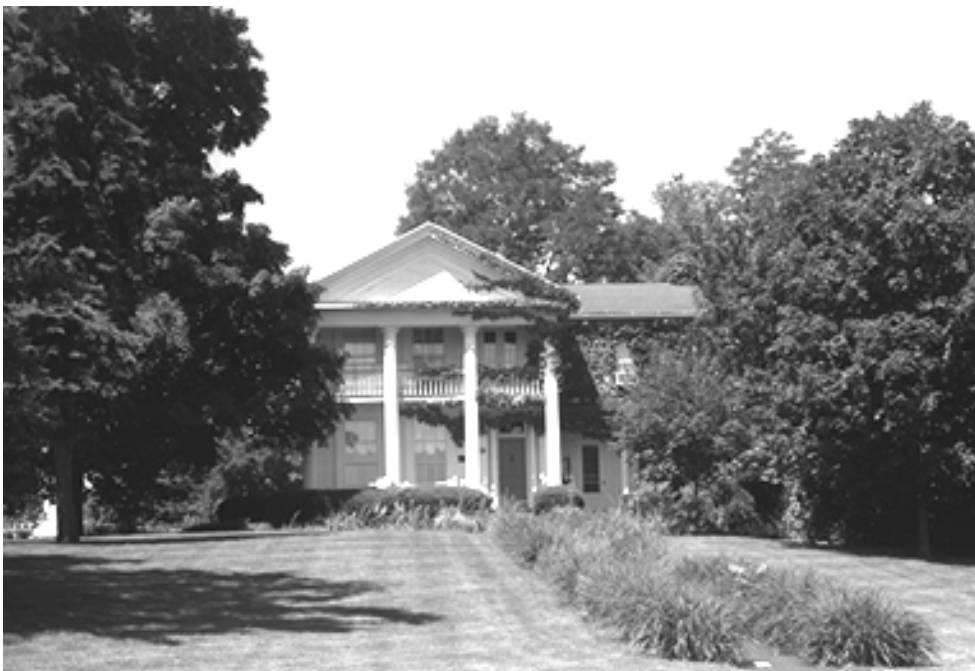
CD-IMAGE # 4405 - 17

- **Significant**
- ☐ Contributing
- ☐ Non-Contributing
- **Designated on the National Historic Register**

Foundation: Stone

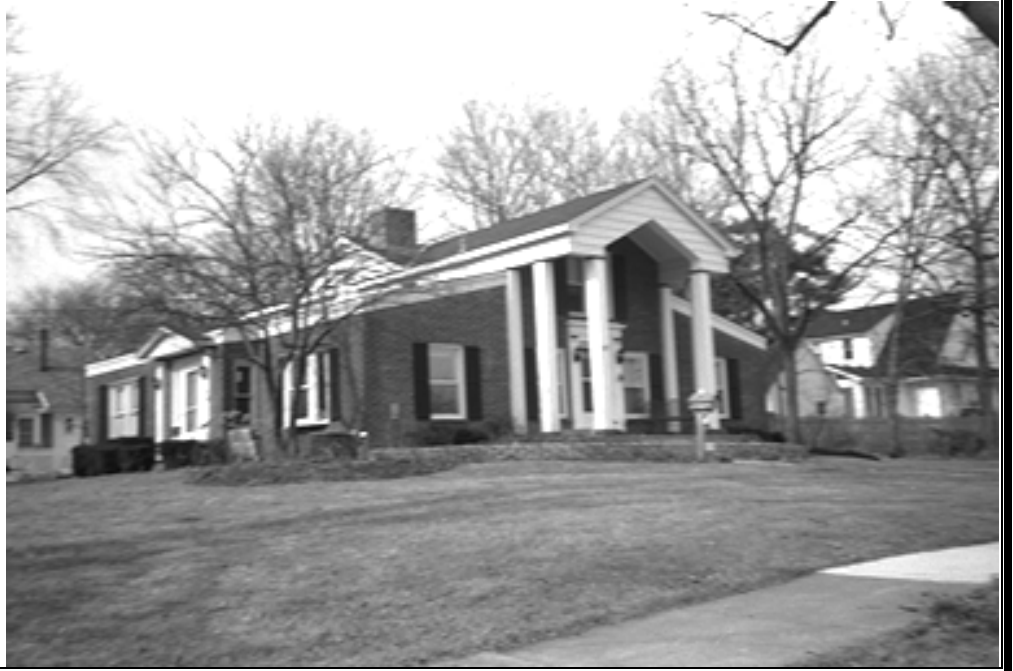
CD-IMAGE # 4369 - 27

- ☐ Significant
- ☐ Contributing
- ☒ Non-Contributing
- ☐ Potential for Individual National Register Designation

Foundation: Concrete

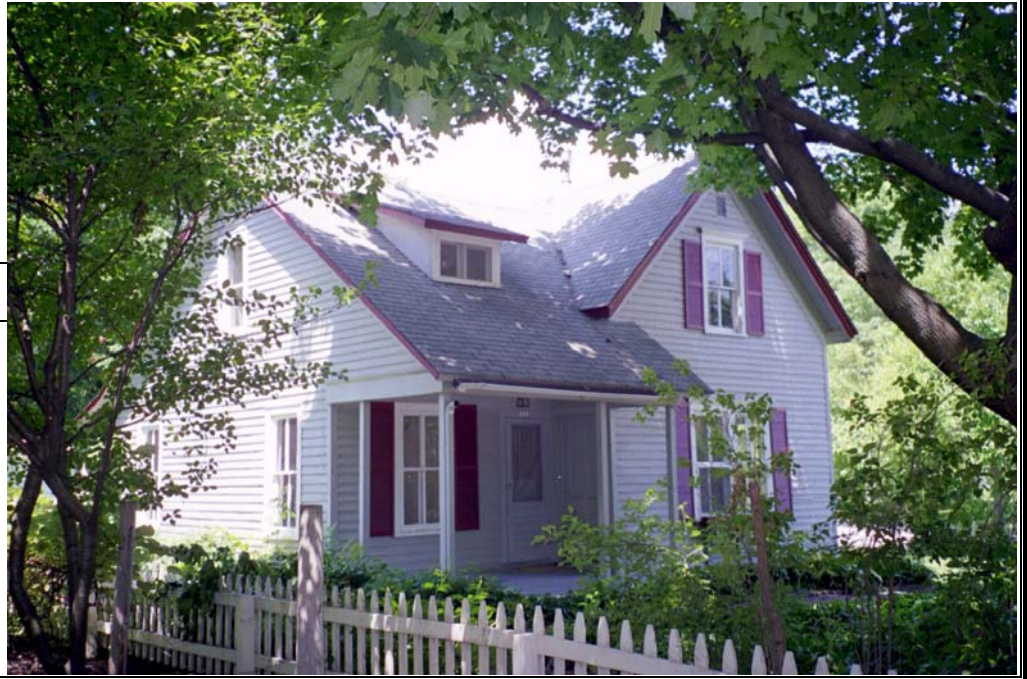
CD-IMAGE # 032D - 1

- ☐ Significant
- ☒ Contributing (Orig.)
- ☒ Non-Contributing (Current)
- ☐ Potential for Individual National Register Designation

Architectural Style/Type:	<u>Eclectic – Modified</u>	Exterior Walls (Current):	<u>Clapboard</u>
	<u>Cape Cod</u>		
Architectural Features:	<u></u>	Exterior Walls (Original):	<u>Clapboard</u>
	<u></u>		
Date of Construction:	<u>1910</u>	Foundation:	<u>Concrete</u>
Source:	<u>Township Assessor's Office</u>	Roof Type/Material:	<u>Cross gable</u>
	<u></u>		
Overall Plan Configuration:	<u>Simple - L</u>	Window Material/Type:	<u>Wood/Dbf Hung</u>

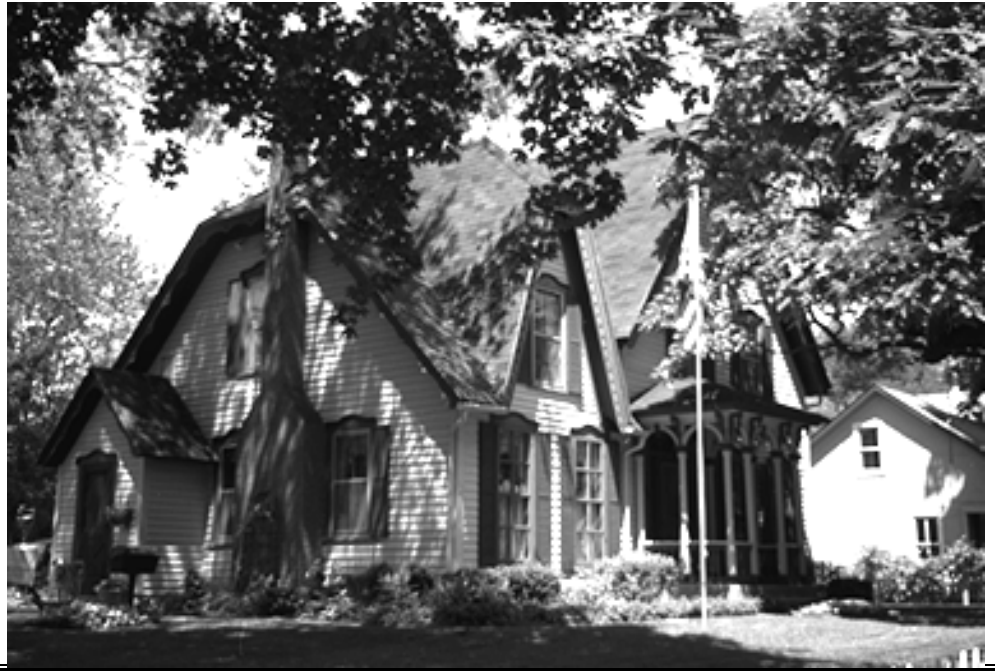
CD-IMAGE # 0601 - 36

- Significant
- ☐ Contributing
- ☐ Non-Contributing
- ☐ Potential for Individual National Register Designation

Architectural Style/Type:	<u>Romantic/gothic revival</u>	Exterior Walls (Current):	<u>Clapboard</u>
Architectural Features:	<u></u>	Exterior Walls (Original):	<u>Clapboard</u>
Date of Construction:	<u>1900</u>	Foundation:	<u></u>
Source:	<u>Township Assessor's Office</u>	Roof Type/Material:	<u>Cross gable/Asphalt shingle</u>
Overall Plan Configuration:	<u>Simple w/irregularities</u>	Window Material/Type:	<u>Wd/dbl. hung</u>

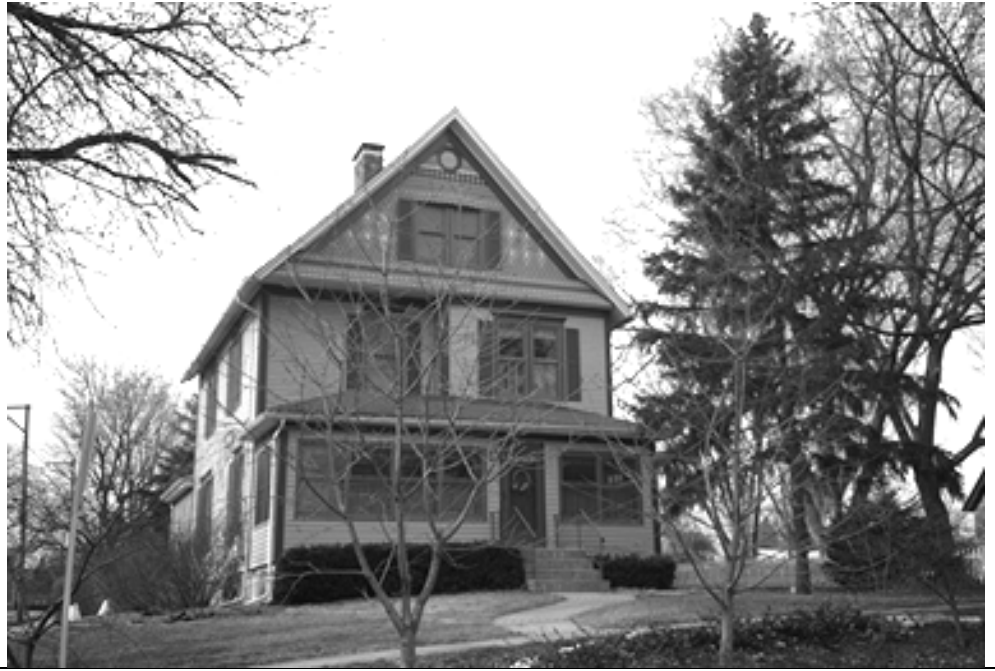
CD-IMAGE # 4369 - 28

- ☐ Significant
- ☒ Contributing
- ☐ Non-Contributing
- ☐ Potential for Individual National Register Designation

Architectural Style/Type: <u>Victorian – Queen Anne</u>	Exterior Walls (Current): <u>Vinyl drop style siding</u>
Architectural Features: <u></u>	Exterior Walls (Original): <u>Clapboard</u>
Date of Construction: <u>1900</u>	Foundation: <u>Parged masonry</u>
Source: <u>Township Assessor's Office</u>	Roof Type/Material: <u>Front gable/Asphalt shingle</u>
Overall Plan Configuration: <u>Simple rectangle w/ Addition</u>	Window Material/Type: <u>Wd trimmed/Alum/Dbl Hung</u>

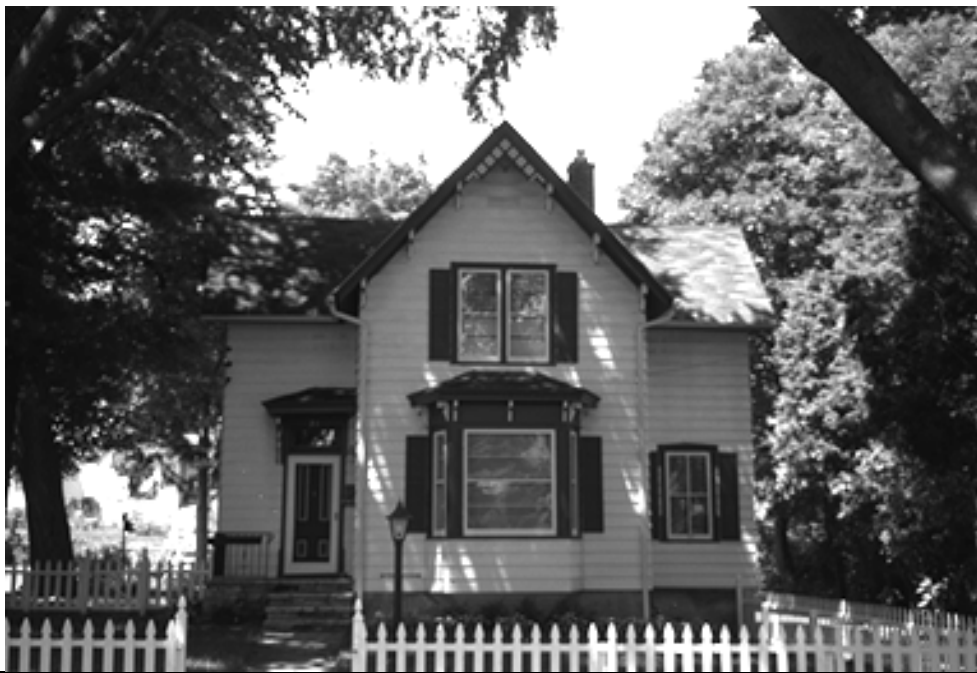
CD-IMAGE # 0601 - 35

- ☐ Significant
- ☒ Contributing
- ☐ Non-Contributing
- ☐ Potential for Individual National Register Designation

Foundation: Parged masonry

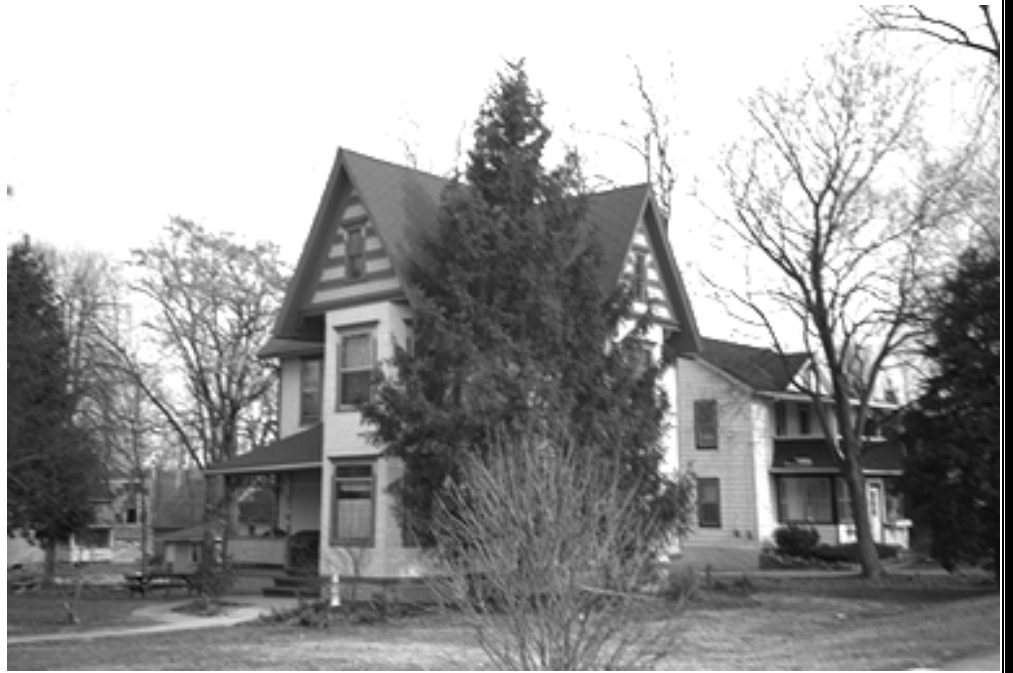
ROLL-IMAGE # 3435 - 29

ALTERATIONS: The porch railing has been replaced. The entry has an aluminum storm door. All of the original wood windows have been replaced with aluminum.

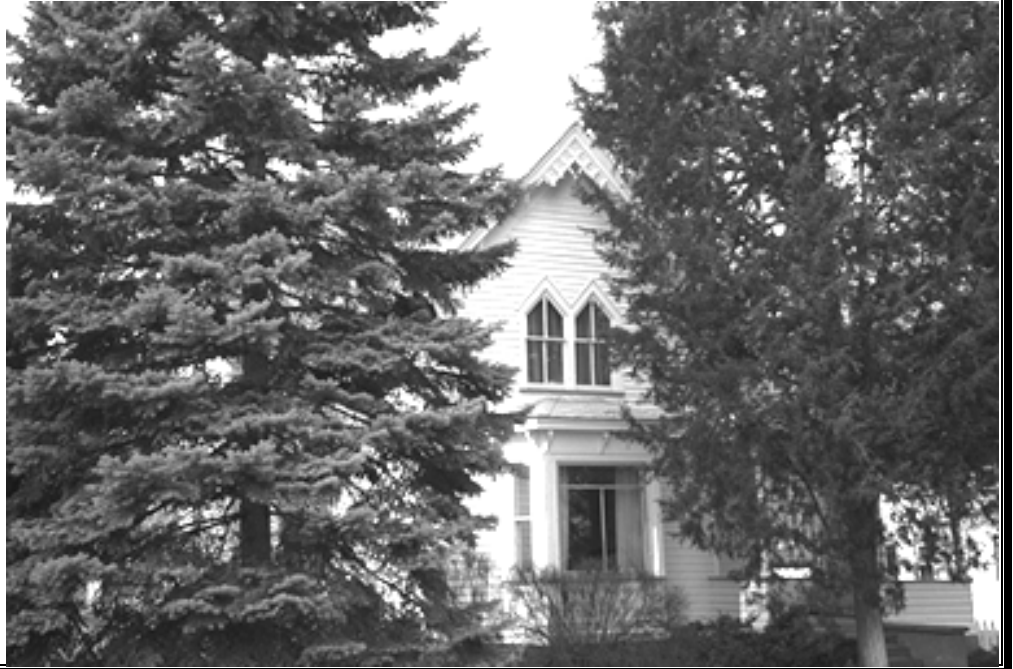
CD-IMAGE # 4189 - 12

- ☒ Significant
☐ Contributing
☐ Non-Contributing
☐ Potential for Individual National Register Designation

Architectural Style/Type:	<u>Gothic Revival</u>	Exterior Walls (Current):	<u>Clapboard</u>
Architectural Features:	<u></u>	Exterior Walls (Original):	<u>Clapboard</u>
Date of Construction:	<u>1890</u>	Foundation:	<u>Concrete</u>
Source:	<u>Township Assessor's Office</u>	Roof Type/Material:	<u>Cross gable/Asphalt shingle</u>
Overall Plan Configuration:	<u>Compound – Cross w/adds.</u>	Window Material/Type:	<u>Wd/DbI Hung/Rmvble.storms</u>

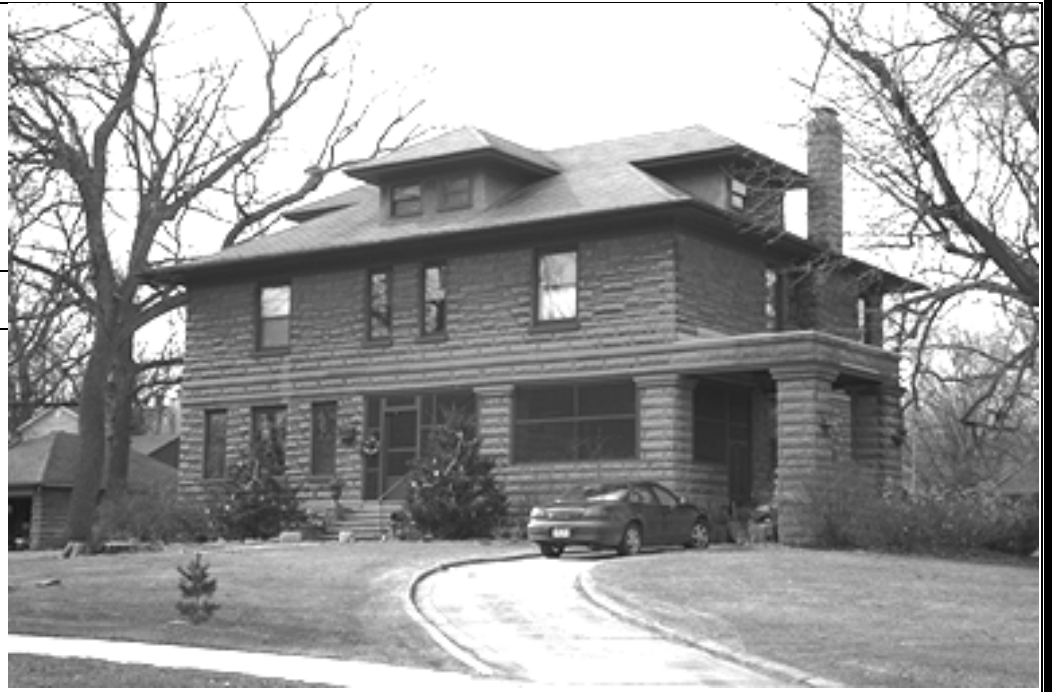
ROLL-IMAGE # 3436 - 13

ALTERATIONS: Aluminum windows replaced the original wooden units.

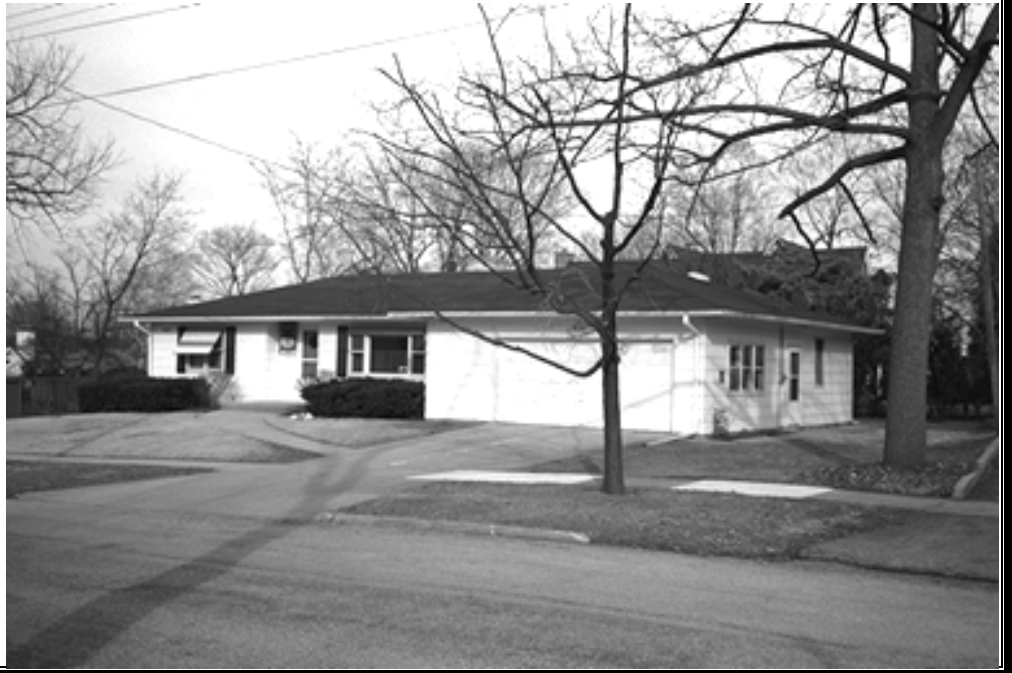
CD-IMAGE # 4368 - 25

- ☐ Significant
- ☐ Contributing
- ☒ Non-Contributing
- ☐ Potential for Individual National Register Designation

Foundation: Concrete

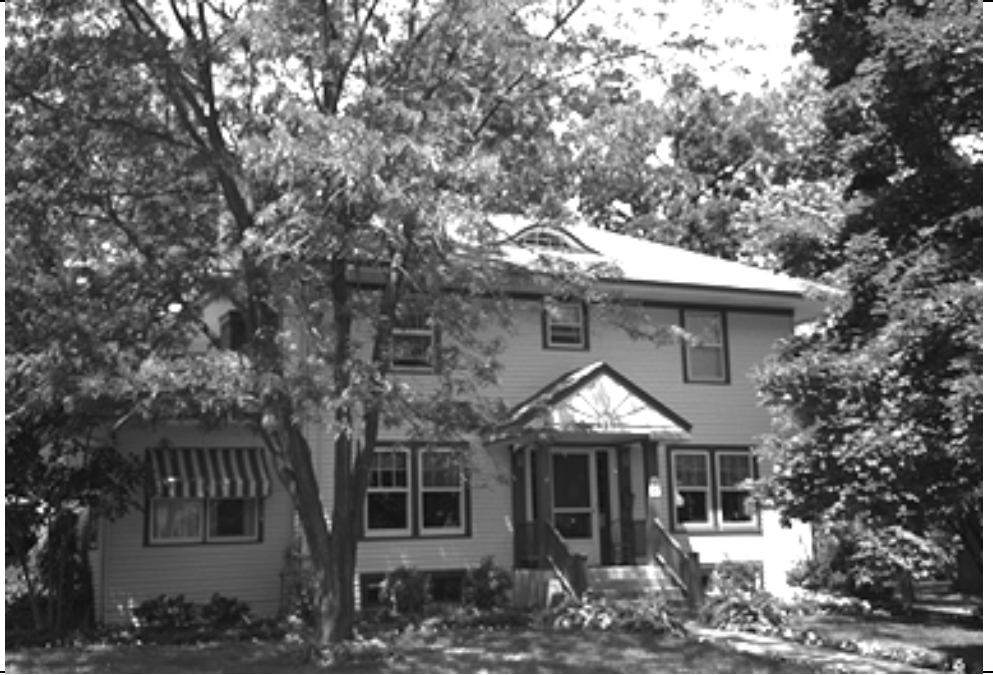
ROLL-IMAGE # 70549 - 32

ALTERATIONS: Aluminum siding replaced the original clapboards. The soffits are boxed with aluminum, the windows and front storm door are aluminum. A small gabled roof shelters the centrally placed front door. This element was remodeled from the original, as it is not in character with the overall design and details. The stoop is CIP concrete with wrought iron railings.

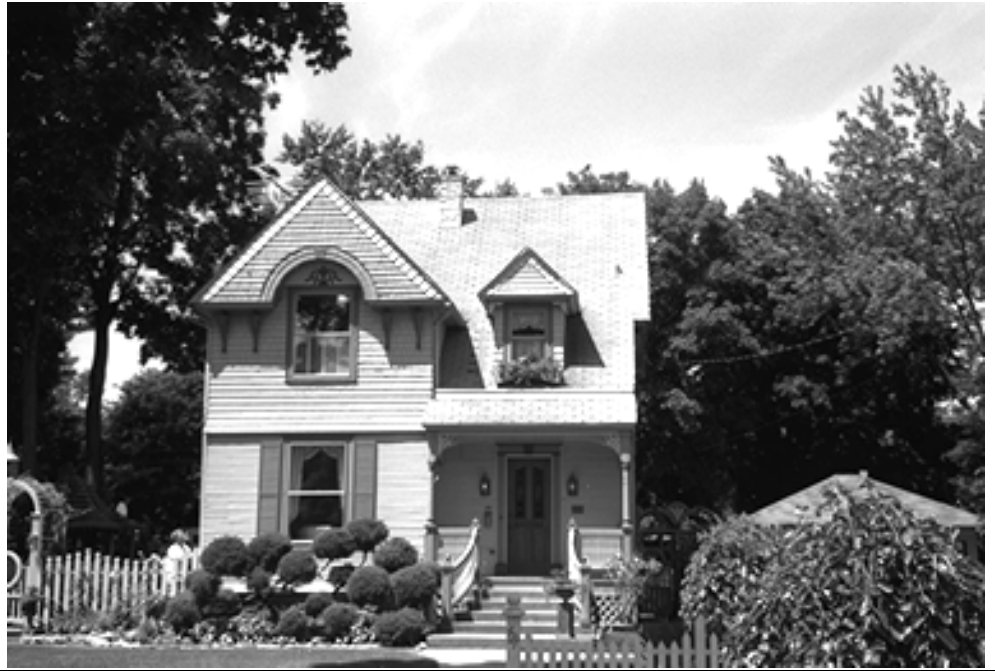
ROLL-IMAGE # 70549 - 33

ALTERATIONS: Two substantial additions have been made to the rear of the house. Both additions have shed roofs that are out of character with the style of the original house. One addition is 1 story and the other is 2-story. The original windows have been replaced with aluminum inserts.

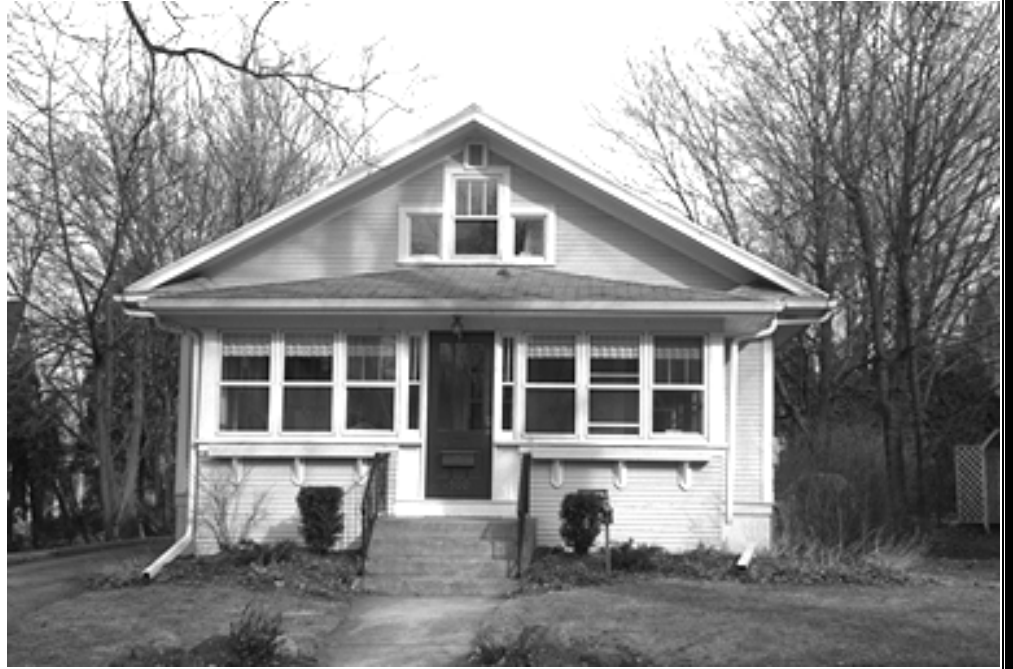
CD-IMAGE # 4368 - 24

- ☐ Significant
- ☒ Contributing
- ☐ Non-Contributing
- ☐ Potential for Individual National Register Designation

Foundation: Concrete

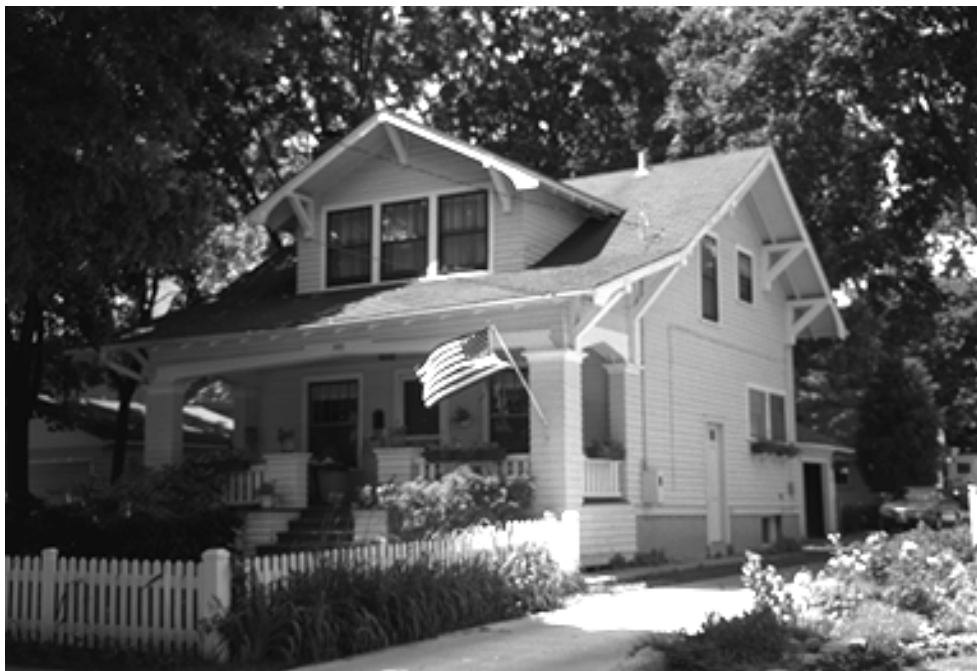
CD-IMAGE # 0601 - 34

- ☐ Significant
- ☒ Contributing
- ☐ Non-Contributing
- ☐ Potential for Individual National Register Designation

Foundation: Concrete

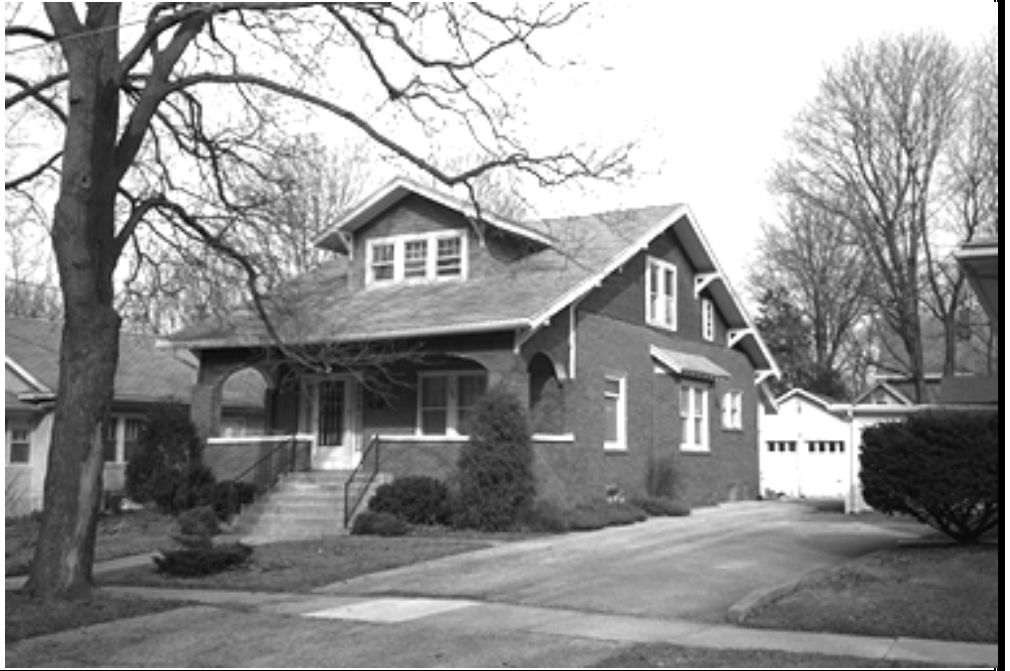
CD-IMAGE # 4368 - 23

- ☐ Significant
- ☒ Contributing
- ☐ Non-Contributing
- ☐ Potential for Individual National Register Designation

Architectural Style/Type: <u>Craftsman Bungalow</u>	Exterior Walls (Current): <u>Brick</u>
Architectural Features: _____	Exterior Walls (Original): <u>Brick</u>
Date of Construction: <u>1930</u>	Foundation: <u>Concrete</u>
Source: <u>Township Assessor's Office</u>	Roof Type/Material: <u>Side Gable/Asphalt shingle</u>
Overall Plan Configuration: <u>Simple rectangle</u>	Window Material/Type: <u>Wd /Dbl Hung/Rmvbl Storms</u>

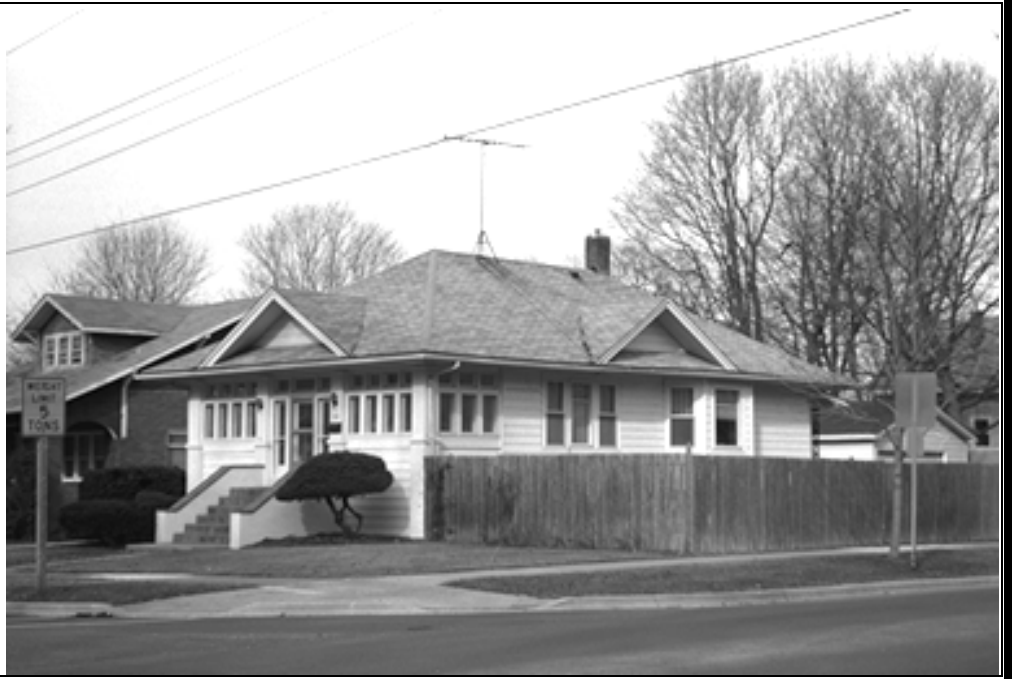
CD-IMAGE # 4368 - 22

- ☐ Significant
- ☐ Contributing
- ☒ Non-Contributing
- ☐ Potential for Individual National Register Designation

Architectural Style/Type:	<u>Bungalow – Orig.</u>	Exterior Walls (Current):	<u>Composite Siding</u>
	<u>4 Square - Current</u>		
Architectural Features:	<u></u>	Exterior Walls (Original):	<u>Clapboard</u>
Date of Construction:	<u>1930</u>	Foundation:	<u>Concrete</u>
Source:	<u>Township Assessor's Office</u>	Roof Type/Material:	<u>Hipped/Asphalt Shingle</u>
Overall Plan Configuration:	<u>Simple rectangle</u>	Window Material/Type:	<u>Wd trim/Alum/Dbf Hung</u>

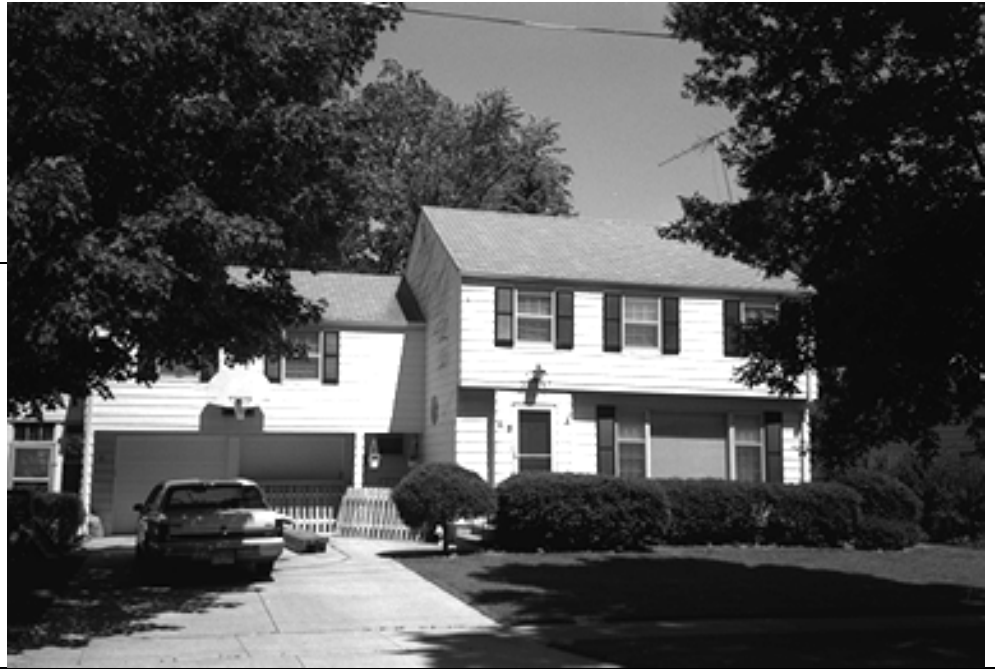
CD-IMAGE # 0601 - 73

- ☐ Significant
- ☐ Contributing
- ☒ Non-Contributing
- ☐ Potential for Individual National Register Designation

Architectural Style/Type:	<u>Colonial revival - Garrison</u>	Exterior Walls (Current):	<u>Aluminum</u>
Architectural Features:	<u></u>	Exterior Walls (Original):	<u>Clapboard</u>
Date of Construction:	<u>1947</u>	Foundation:	<u>Concrete</u>
Source:	<u>Township Assessor's Office</u>	Roof Type/Material:	<u>Side Gable/Asphalt shingle</u>
Overall Plan Configuration:	<u>Simple rectangle w/ adds</u>	Window Material/Type:	<u>Wd trim/Alum /Dbl Hung</u>

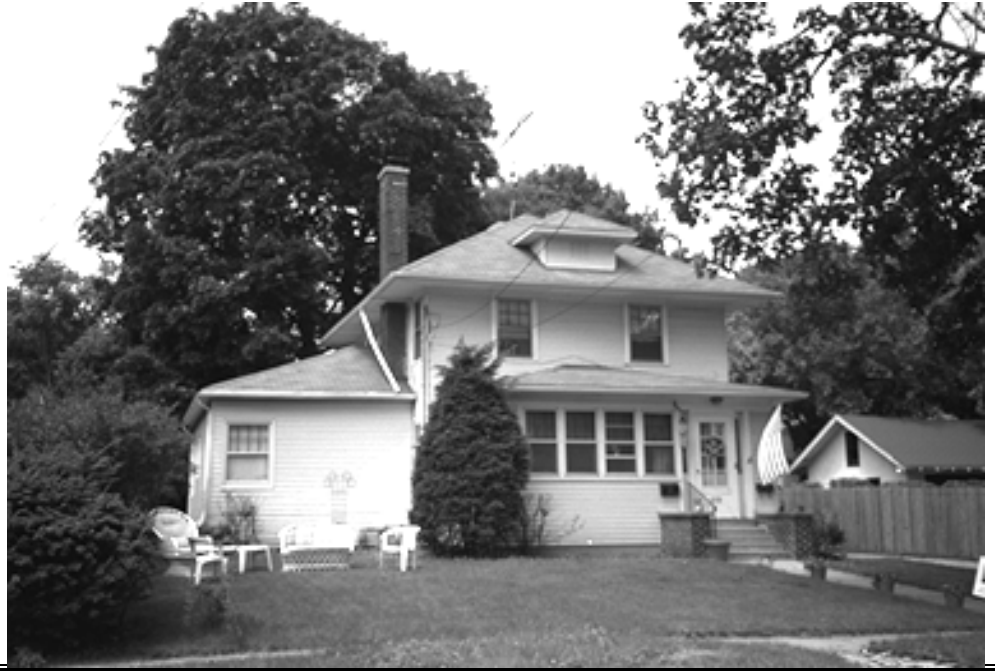
ROLL-IMAGE # 70552 - 29

ALTERATIONS: The 1 story hipped roof addition to the south side of the house is not sympathetic with the original style. It is not tied with any discernible horizontal detail lines to the main part of the house. The window proportions are also off. The front porch has been closed off concealing the structure and any of the decorative detailing that might have existed. Low brick walls and wrought iron railings flank the front stoop. The window in front dormer has been removed and replaced with a louver.

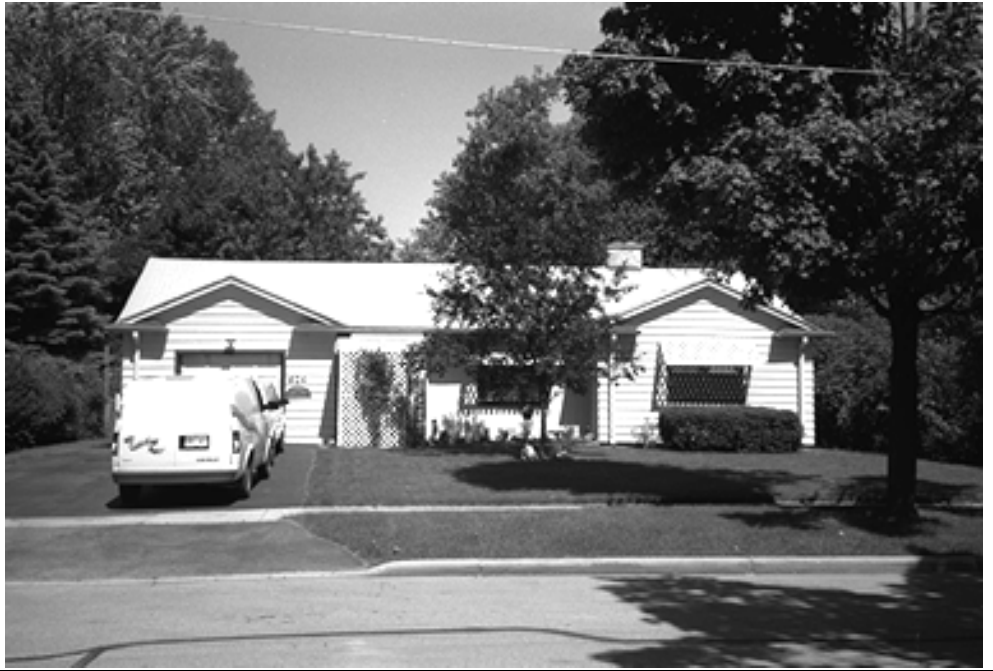
ROLL-IMAGE # 70551 - 2

ARCHITECTURAL FEATURES: Reverse board and batten siding separate the two front gables. The gable ends feature broken pediments. There is a small bow window placed in the center part of the front elevation. The façade is relatively symmetrical.

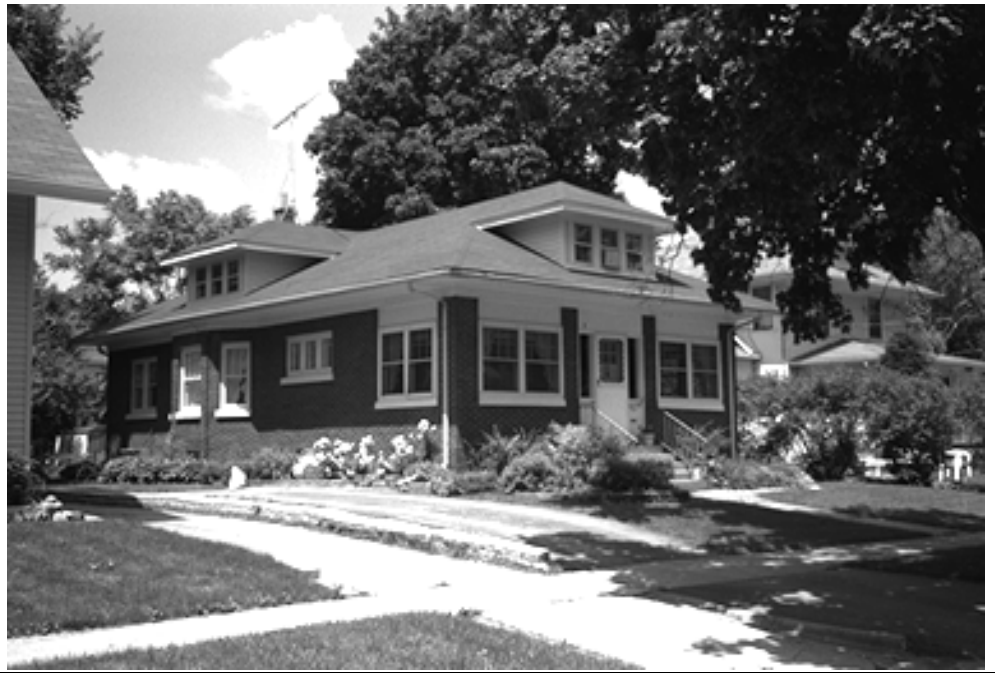
CD-IMAGE # 0602 - 28

- ☐ Significant
- ☒ Contributing
- ☐ Non-Contributing
- ☐ Potential for Individual National Register Designation

Foundation: Concrete

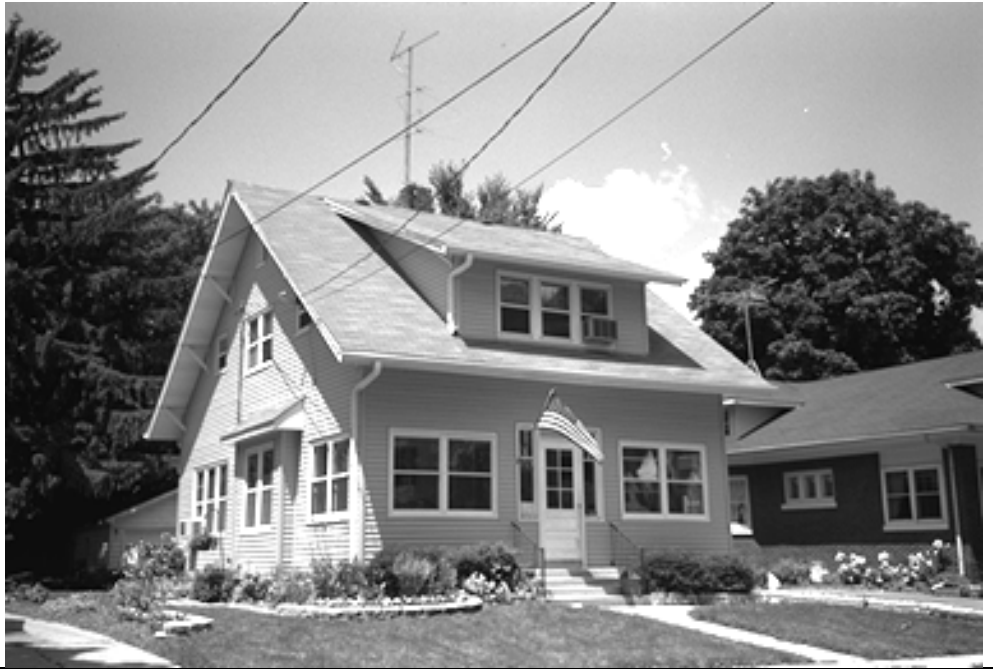
CD-IMAGE # 0602 - 27

- ☐ Significant
- ☒ Contributing
- ☐ Non-Contributing
- ☐ Potential for Individual National Register Designation

Foundation: Concrete

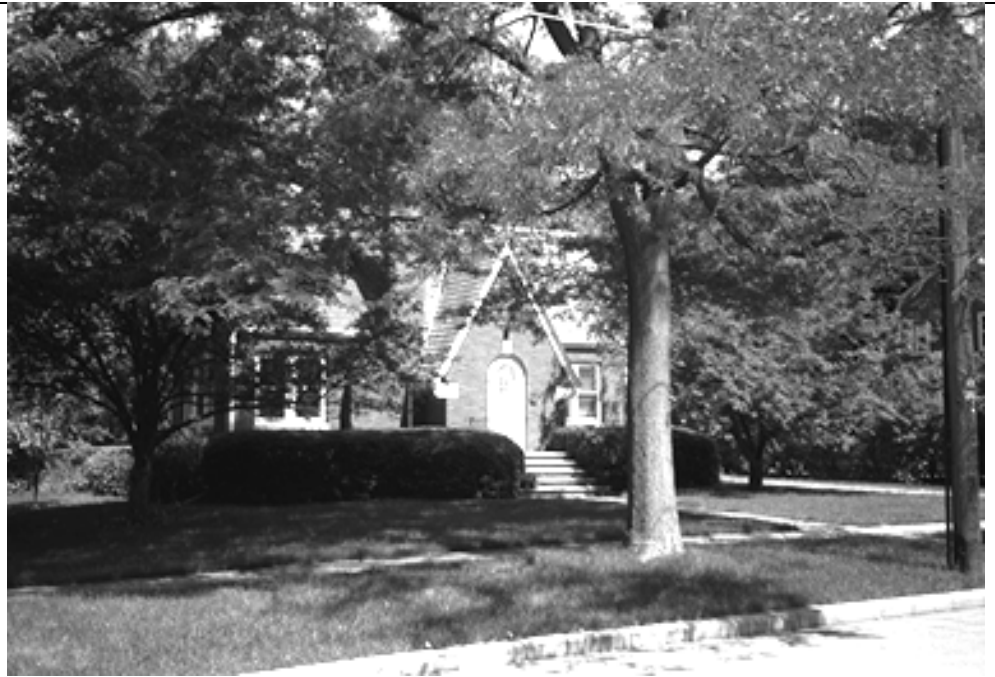
CD-IMAGE # 0601 - 75

- ☐ Significant
- ☒ Contributing
- ☐ Non-Contributing
- ☐ Potential for Individual National Register Designation

Foundation: Concrete

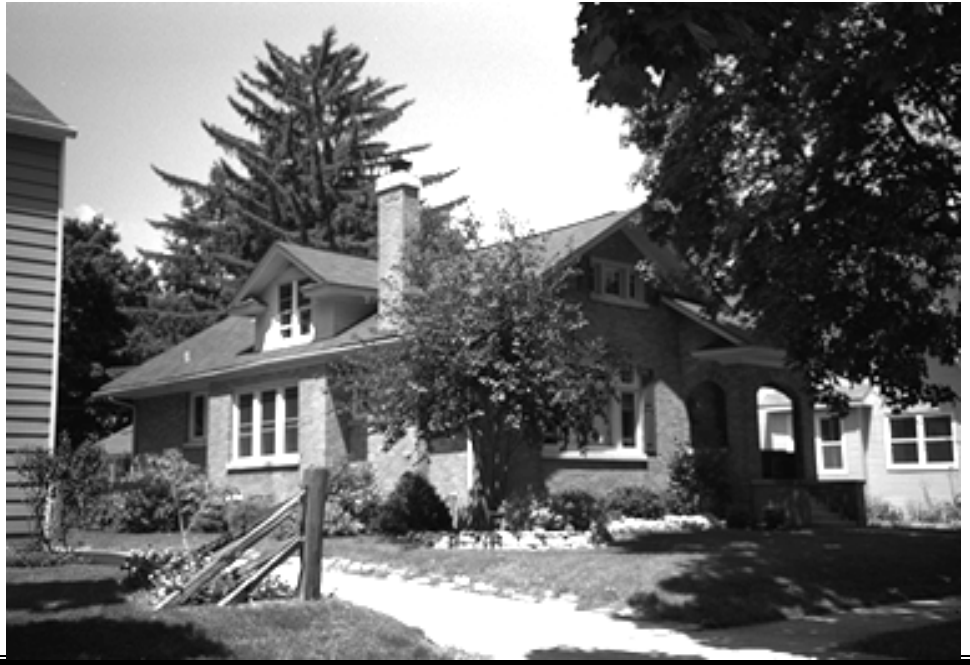
ROLL-IMAGE # 70552 - 26

ARCHITECTURAL FEATURES: The front entry is not centered and features arched brick openings and an unusual roof design. It appears that the roof is a shed design from the view depicted in the photograph. It is in fact a north facing gable intersecting the main roof at an unusual location. All of the gable all feature broken pediments – from the dormers to the main front gable. Many of the windows are grouped together in fours, threes, and twos. The eaves are boxed and are relatively wide.

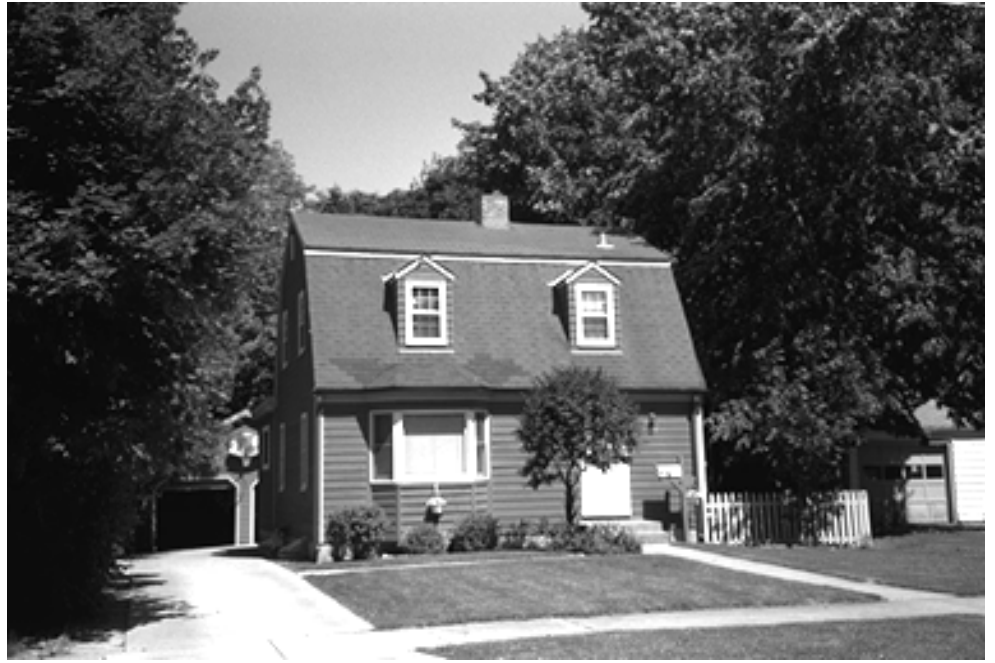
CD-IMAGE # 0601 - 76

- ☐ Significant
- ☐ Contributing
- ☒ Non-Contributing
- ☐ Potential for Individual National Register Designation

Foundation: Concrete
