ARCHITECTURAL SURVEY

NEAR WEST HISTORIC DISTRICT

ST. CHARLES, ILLINOIS

ST. CHARLES HISTORIC PRESERVATION COMMISSION

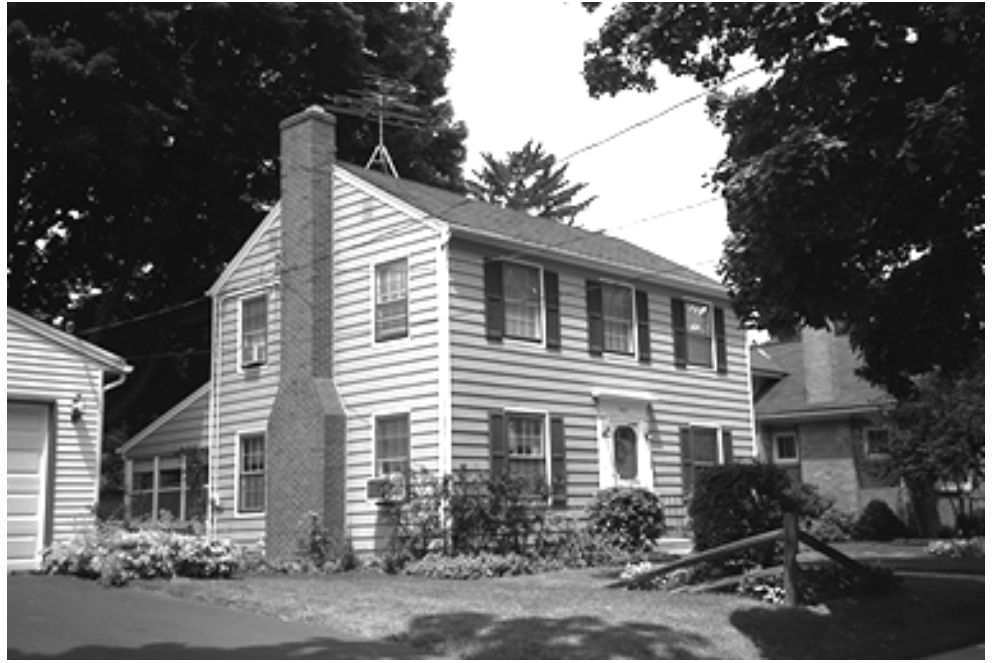
ROLL-IMAGE # 70552 - 25

ALTERATIONS: A shed-roofed porch was added to the rear of the house. The wood original siding was replaced with aluminum.

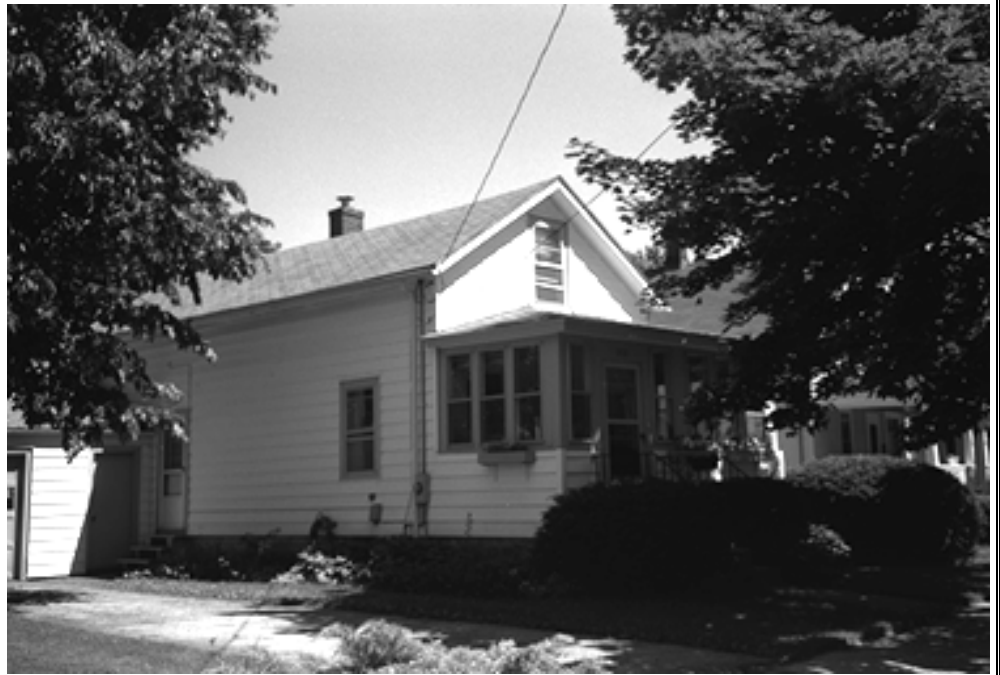
ROLL-IMAGE # 70551 - 5

ALTERATIONS: The front porch has been closed in. Aluminum siding has replaced the original clapboards. A non-sympathetic garage addition was made to the north side of the house.

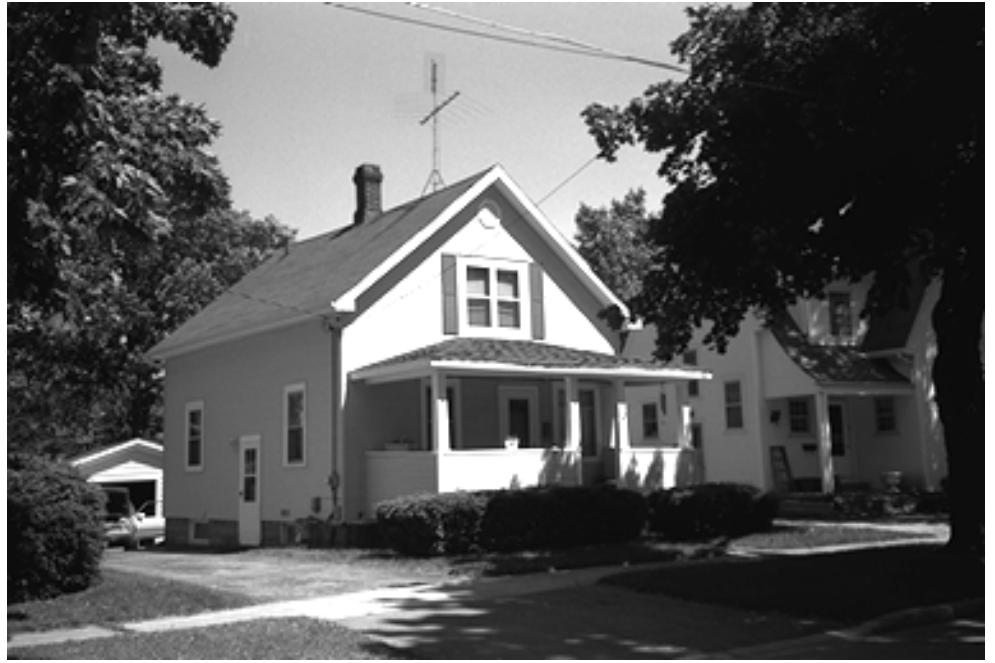
ROLL-IMAGE # 70551 - 6

ARCHITECTURAL FEATURES: A full width front porch covered by a hipped roof creates a pleasant entrance transition to the front door. Tapered wooden columns that begin at the porch deck support the porch roof. There is a stained glass transom at the front living room window. The eaves are narrow and are boxed in with aluminum. This is very plain house with no decorative detailing

ALTERATIONS: Aluminum has replaced the all of the original materials.

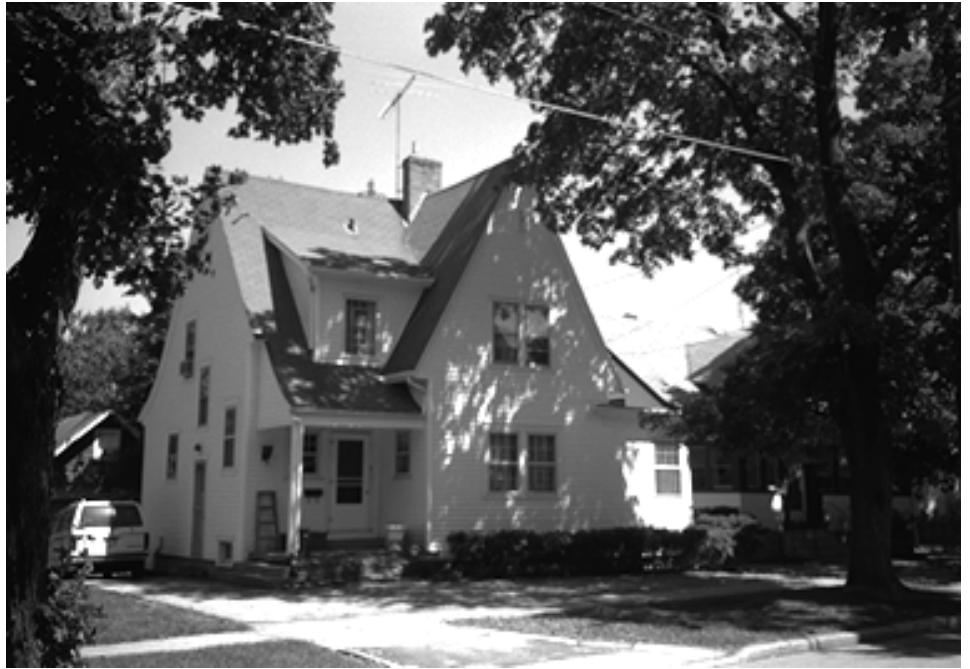
ROLL-IMAGE # 70551 - 7

ALTERATIONS: A one-story flat roof addition was made to the rear of the house. Aluminum siding and windows have replaced the original wood materials. No original details can be seen. Glass block was used in the shed dormer on the front elevation.
