ARCHITECTURAL SURVEY

NEAR WEST HISTORIC DISTRICT
ST. CHARLES, ILLINOIS

ST. CHARLES HISTORIC PRESERVATION COMMISSION

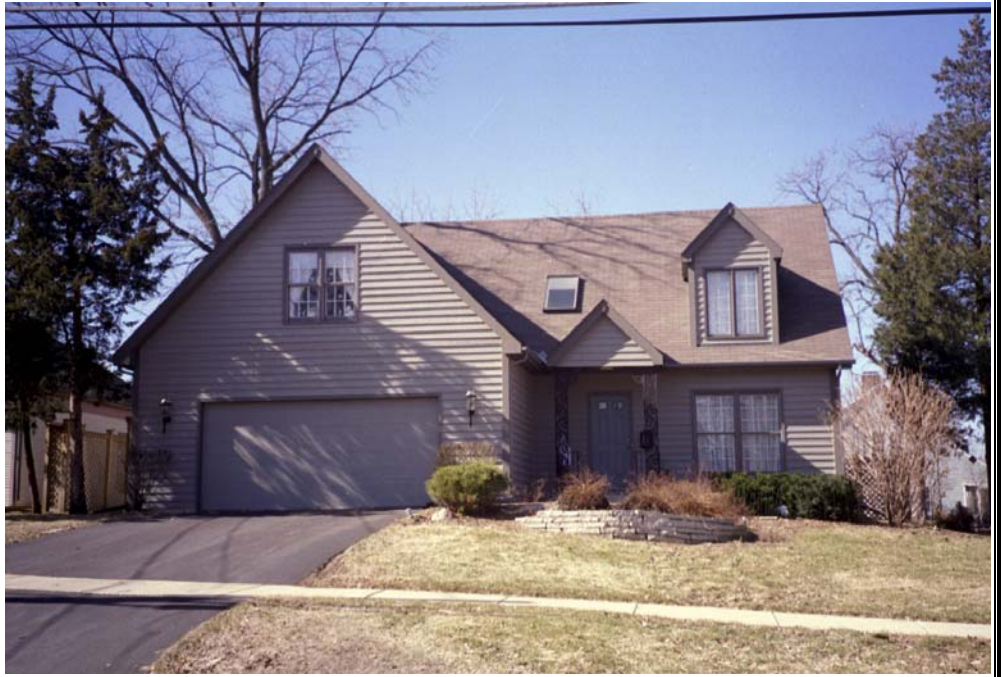
ADDRESS 15 North 6th Street

- ☒ Excellent
- ☐ Good
- ☐ Fair
- ☐ Poor

Architectural Style/Type: Eclectic/Cape Cod

ARCHITECTURAL FEATURES: This is a 1½ story Cape Cod framed home. The garage "L" component of the plan is not part of the original historical style. The skylight and the small gabled entry cover are also inconsistent with the original style.

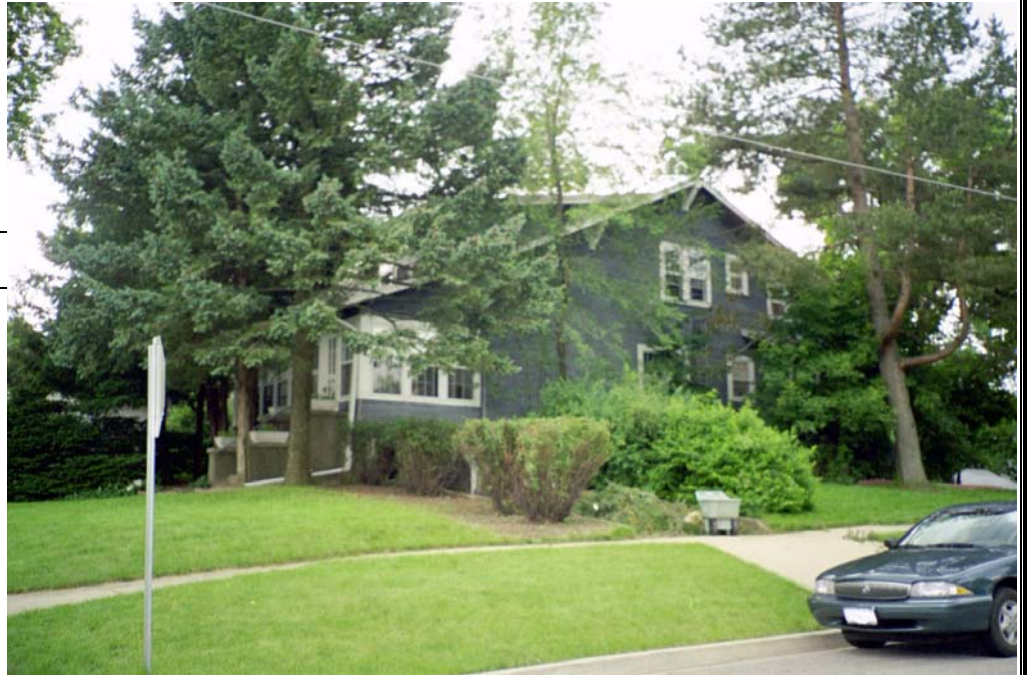
ADDRESS 21 North 6th Street

- ☐ Excellent
- ☒ Good
- ☐ Fair
- ☐ Poor

Architectural Style/Type:	Craftsman Bungalow	Exterior Walls (Current):	Clapboard
Architectural Features:		Exterior Walls (Original):	Clapboard
Date of Construction:	1925	Foundation:	Concrete
Source:	Township Assessor's Office	Roof Type/Material:	Side gable/Asphalt shingle
Overall Plan Configuration:	Simple rectangle	Window Material/Type:	Wd trimmed/Alum inserts/ Double Hung

ARCHITECTURAL FEATURES: This is a very deep house from front to back. The large roof is articulated by the typical details of the style. Wood roof brackets support the wide overhangs, exposed rafter tails are seen at the open eaves, both support soffits sheathed with wooden boards. A small 1-car garage is tucked underneath the front porch. The front entrance is off center and the original wooden front door can be seen from the outside of the porch.

ALTERATIONS: The front porch is closed in a manner sympathetic with the original design. The window openings are trimmed exactly the same as the rest of the windows in the house. There appears to be a small 1-story addition that was added to the north side of the house as a modest room extension. It has a shed roof and blends well with the rest of the house. Another screened porch was added to the rear of the house. It blends well with the rest of the house but has a hipped roof that is tucked under the rear eave of the main roof.

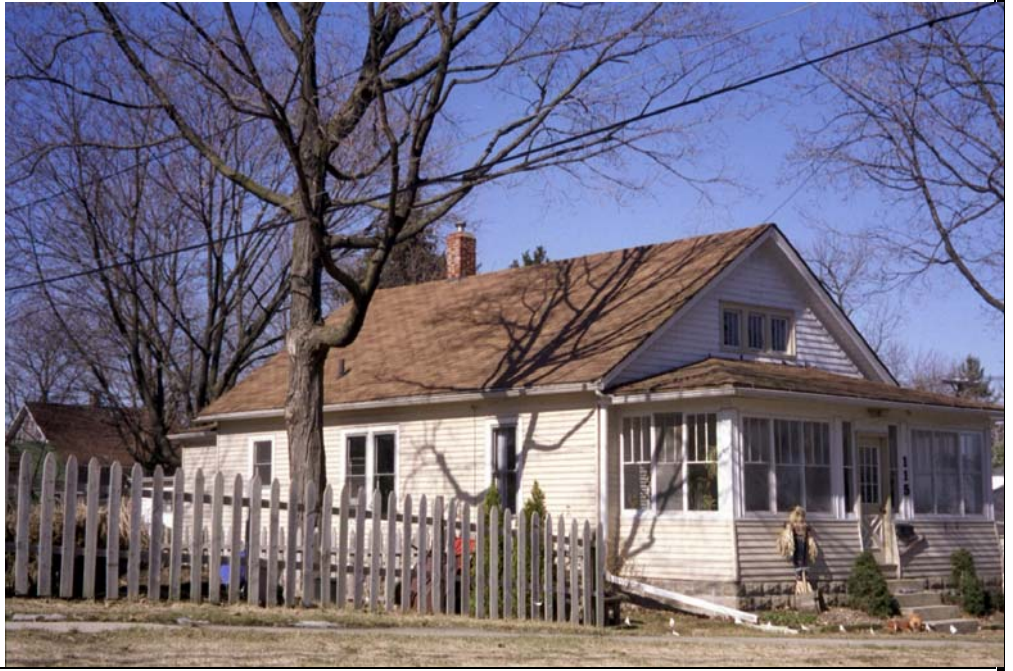
ADDRESS 115 North Sixth Street

- ☐ Excellent
- ☐ Good
- ☒ Fair
- ☐ Poor

Architectural Style/Type: National Bungalow

ARCHITECTURAL FEATURES: A full-width front porch dominates the front façade. The front gable features a group of three windows that are still trimmed in wood. The gable end is covered with wood shingles.

ALTERATIONS: A one-story addition with a gabled roof was made to the rear of the house. The front porch has been closed in.

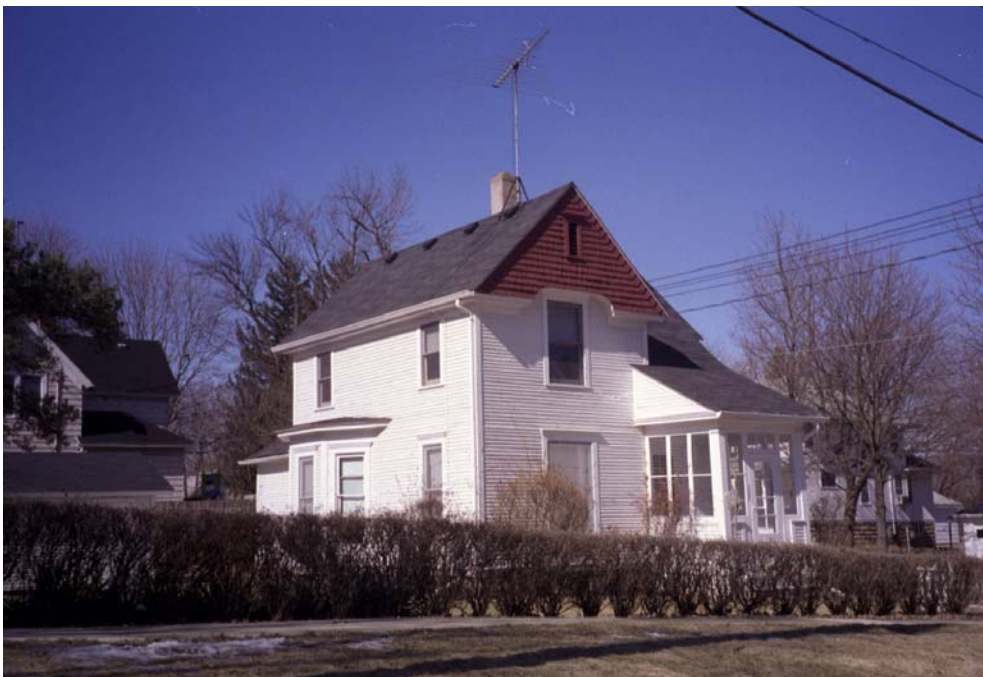
ADDRESS 123 North Sixth Street

- ☐ Excellent
- ☒ Good
- ☐ Fair
- ☐ Poor

Architectural Style/Type:	Victorian/Queen Anne	Exterior Walls (Current):	Clapboard/Wd. shingles
Architectural Features:		Exterior Walls (Original):	Clapboard/Wd. shingles
Date of Construction:	1915	Foundation:	Parged masonry
Source:	Township Assessor's Office	Roof Type/Material:	Cross gable/Asphalt shingle
Overall Plan Configuration:	Simple rectangle w/ addition	Window Material/Type:	Wood trim/Dbl hung/some Aluminum inserts

ARCHITECTURAL FEATURES: The flat arched cut out of the front gable end is a distinctive detail. It is decorated with wood shingles. A small entry porch is covered by a long sweep of the main roof slope. Both of these features are somewhat characteristic of the Shingle or the Queen Anne styles. A relatively deep frieze board trims the wall/eave juncture. Almost all of the windows feature a crown molding at the head. The original front door is still in place inside the porch. There is a small one-story bay window on the south elevation.

ALTERATIONS: The front entry porch has been closed in. A small one-story addition was made to the rear of the house. The side door is aluminum.

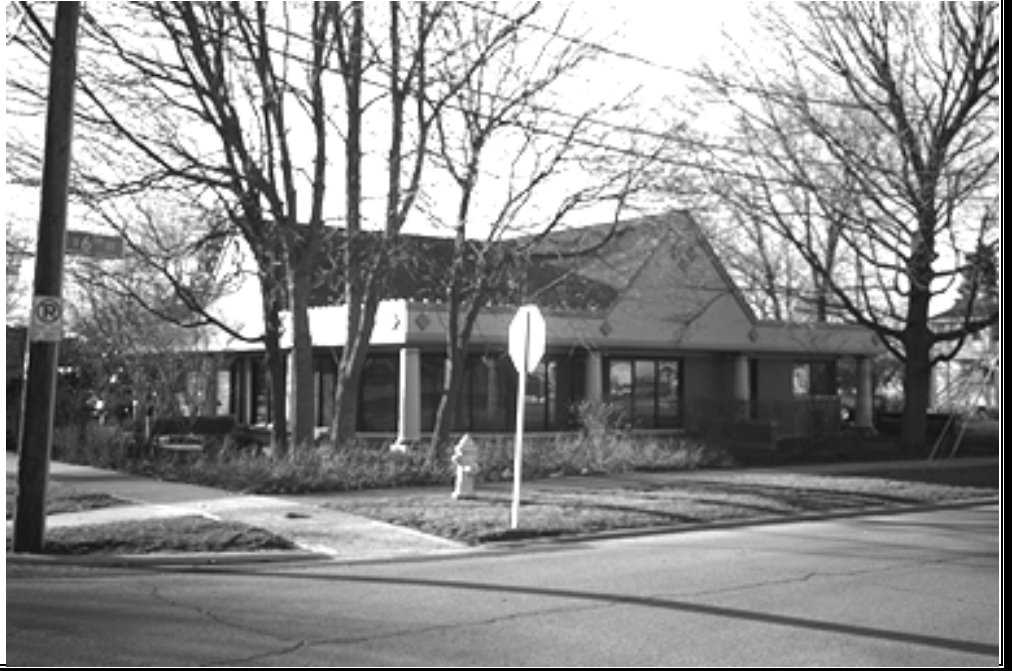
ROLL-IMAGE # 3435 - 1

Architectural Style/Type:	<u>Commercial modern/Post Modern</u>	Exterior Walls (Current):	<u>EIFS/Brick</u>
Architectural Features:	<u></u>	Exterior Walls (Original):	<u>EIFS/Brick</u>
Date of Construction:	<u>1989</u>	Foundation:	<u>Concrete</u>
Source:	<u>Township Assessor's Office</u>	Roof Type/Material:	<u>Cross gable with flat areas</u> <u>Asphalt shingle/BUR</u>
Overall Plan Configuration:	<u>Simple rectangle</u>	Window Material/Type:	<u>Aluminum/Fixed</u>

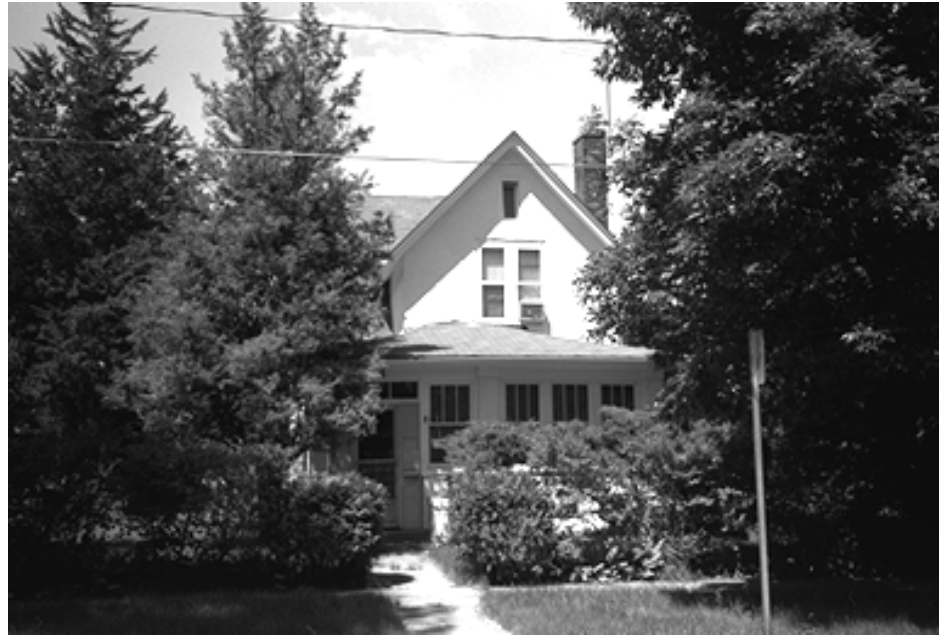
ROLL-IMAGE # 70549 - 21

Architectural Style/Type:	National	Exterior Walls (Current):	Stucco
Architectural Features:		Exterior Walls (Original):	Clapboard?
Date of Construction:	1896	Foundation:	Parged masonry
Source:	Landmark Application	Roof Type/Material:	Cross gable/Asphalt shingle
Overall Plan Configuration:	Simple "T"	Window Material/Type:	Wood/Db. Hung – There are Some alum. inserts

ALTERATIONS: The front porch has been closed in and has an aluminum front door. A 1 story addition to the rear features a balcony on the roof of the ground floor accessed through an aluminum door from the second floor. It is built on a brick foundation. The stucco was applied to the house in 1910.

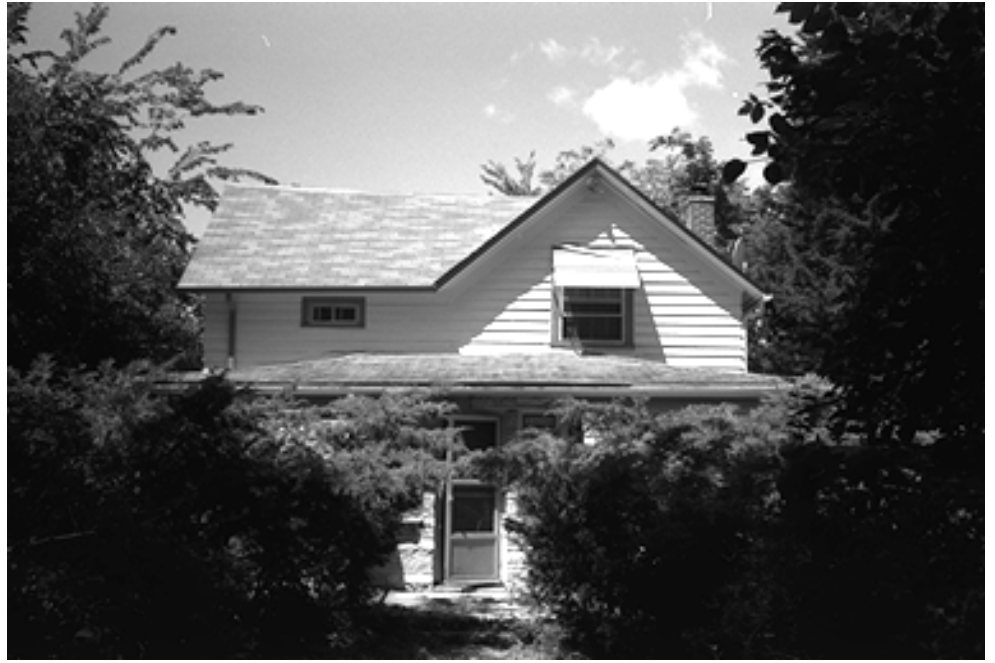
ROLL-IMAGE # 70549 - 22

Architectural Style/Type: <u>National</u>	Exterior Walls (Current): <u>Clapboard</u>
Architectural Features: _____	Exterior Walls (Original): <u>Clapboard</u>
Date of Construction: <u>1872(-)</u>	Foundation: <u>Lannon stone veneer over masonry</u>
Source: <u>Landmark Application</u>	Roof Type/Material: <u>Front gable & Wing</u>
Overall Plan Configuration: <u>Compound w/ Additions</u>	Window Material/Type: <u>Wd. trimmed/Alum/DbI Hung</u>

ALTERATIONS: The front porch was added and subsequently closed in and veneered with Lannon stone. Lannon stone was also used to veneer the face of the original foundations. The porch foundation is concrete. The original is covered, but was most likely not concrete. There are both a large 2 story and small 1 story additions to the rear of the original house. Neither are sympathetic to the original house geometry or scale. The original house is almost completely concealed in the middle of the current configuration. This is actually (3) houses put together, according to documents included in a landmark application.

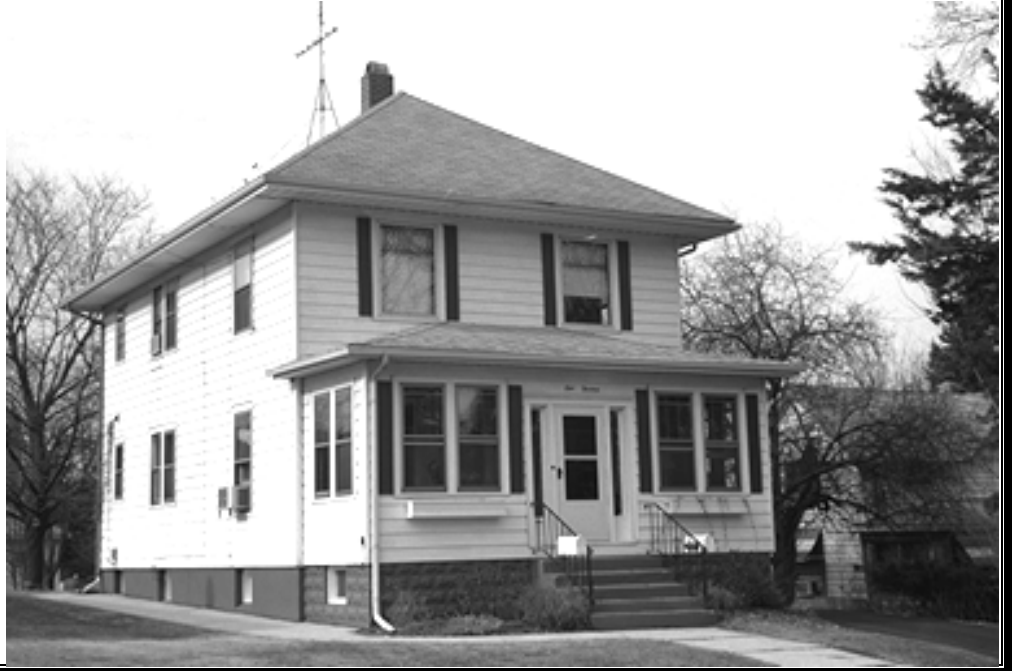
ROLL-IMAGE # 3435 - 26

Foundation: Conc./Orig: Txt CMU/Porch

ALTERATIONS: Aluminum soffits, siding, and windows were changes to the original materials. The front porch was added later. The foundation is textured concrete masonry, unlike the original concrete foundation. The windows of the porch room feature a 3:1 muntin pattern unlike the original windows.

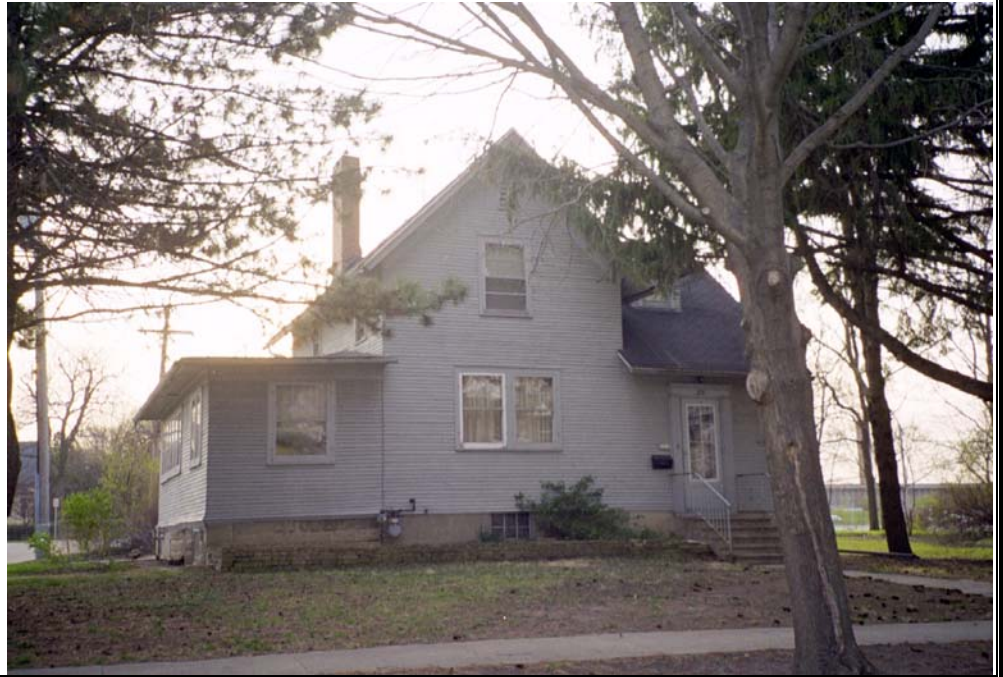
ROLL-IMAGE # 3299 - 10

Architectural Style/Type:	National Folk	Exterior Walls (Current):	Clapboard
Architectural Features:		Exterior Walls (Original):	Clapboard
Date of Construction:	1925	Foundation:	Parged CMU
Source:	Township Assessor's Office	Roof Type/Material:	Cross gable/Asphalt shingle
Overall Plan Configuration:	Compound w/ additions	Window Material/Type:	Wood/Dbf Hung/Removable Storms

ARCHITECTURAL FEATURES: The façade is very plain looking except for the front entry surround which features classical detailing. There are fluted pilasters and a door head that features dentil molding and a crown molding. The other more typical wood trim is very plain. There is a wood molding used at the water table elevation located just above the foundation. The entry is off center. There are no corner boards used on the original house.

ALTERATIONS: A 1-story addition was made to the south side that has a flat roof. The foundation is constructed with 2 different types of CMU – plain and textured. A larger 1½ -story addition was made to the west side of the house featuring a gabled roof. The additions are sympathetic to the original design through the use of similar materials, but do not fit well due to visible discrepancies. The flat roof is one discrepancy and inconsistent window treatments is another. The additions have corner boards and the original does not.

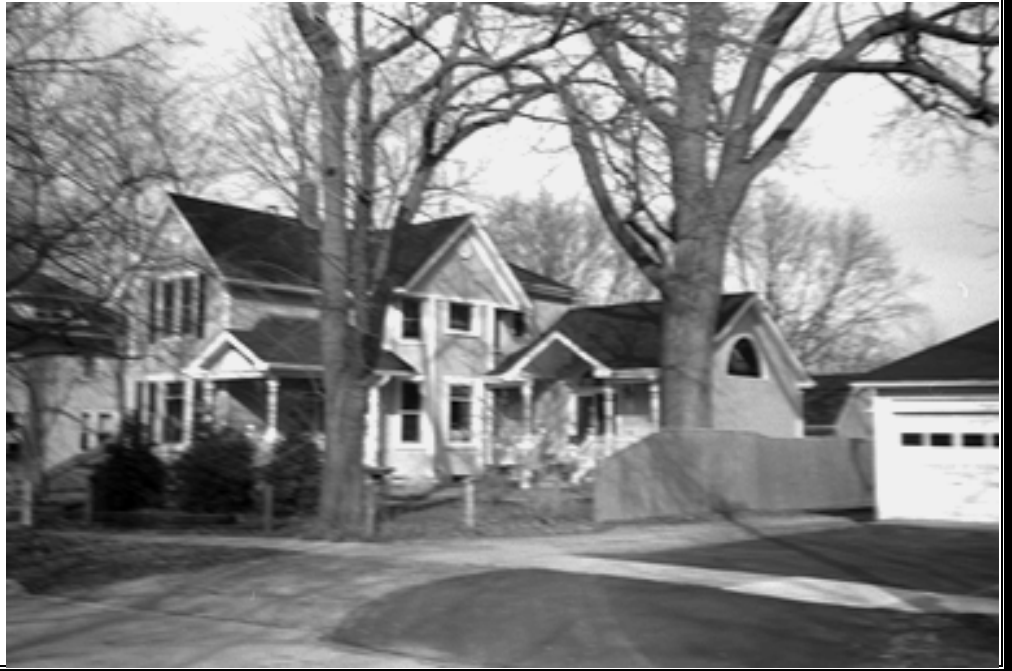
ROLL-IMAGE # 3434 - 16

Foundation: Stone/Orig. – Concrete/Add.

ARCHITECTURAL FEATURES: This is a nice looking remodeled example of the style that used modern materials and systems to replace/conceal the originals. It is unfortunate that so much of the original details were consumed with the remodeling. The massing of the main house follows other examples of the style in the area. The eaves are still open, but are covered with aluminum.

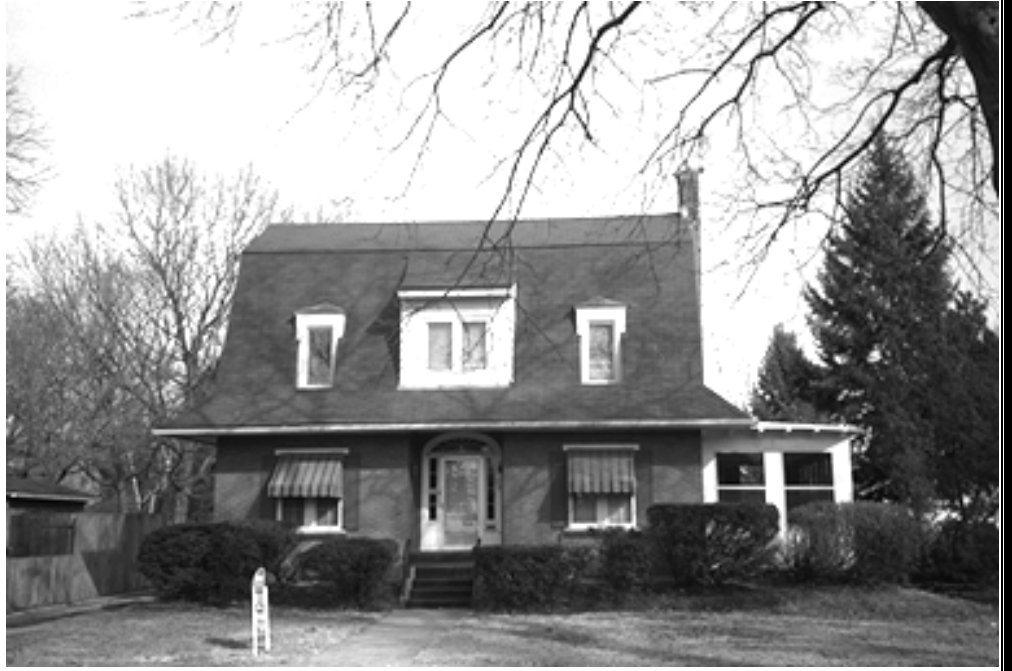
ROLL-IMAGE # 3433 - 33

Architectural Style/Type: <u>Colonial revival/Dutch</u>	Exterior Walls (Current): <u>Brick/front –Alum/sides</u>
Architectural Features: _____	Exterior Walls (Original): <u>Brick/front-Clapbd/sides</u>
Date of Construction: <u>1927</u>	Foundation: <u>Concrete</u>
Source: <u>Township Assessor's Office</u>	Roof Type/Material: <u>Side gambrel/Asphalt shingle</u>
Overall Plan Configuration: <u>Simple rectangle</u>	Window Material/Type: <u>Wood/Dbl Hung w/ Removable storms</u>

ALTERATIONS: Jalousie windows replaced the originals in the dormers and the front door. A flat roofed 1-story screened porch was added to the south side of the house. It is not sympathetic with the original architecture. The front stoop is CIP concrete and has a wrought iron railing.

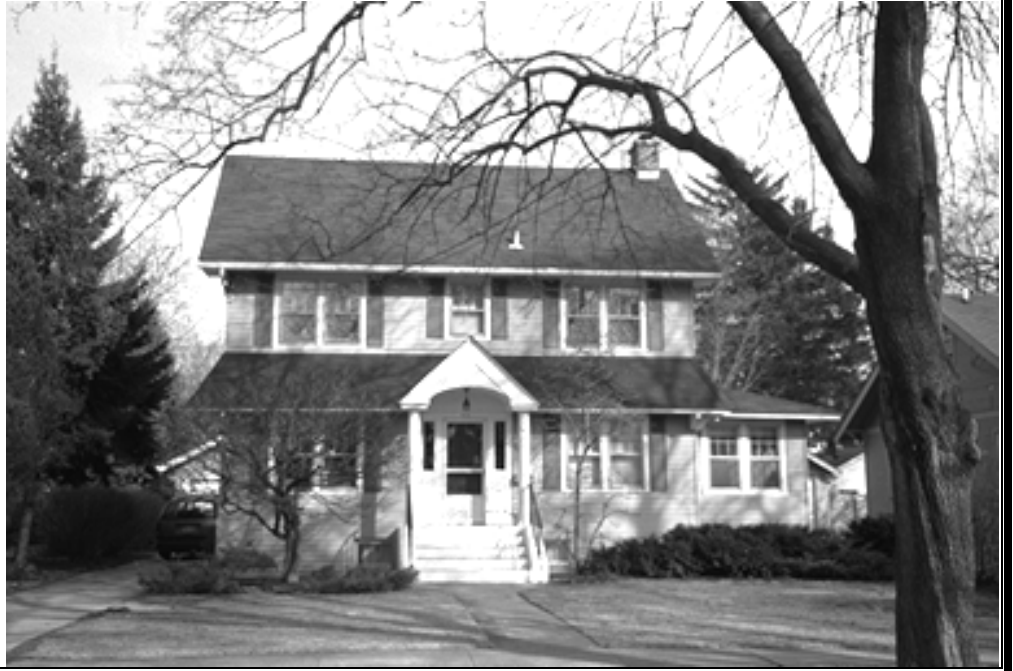
ROLL-IMAGE # 3433 - 34

Foundation: Concrete

ARCHITECTURAL FEATURES: Windows in pairs and the elaborated entrance are frequently found in this style. The façade is symmetrical and the entry is centered. Round Doric columns support the entry canopy. The canopy has an arched soffit. The eaves are boxed with aluminum.
