ARCHITECTURAL SURVEY

NEAR WEST HISTORIC DISTRICT
ST. CHARLES, ILLINOIS

ST. CHARLES HISTORIC PRESERVATION COMMISSION

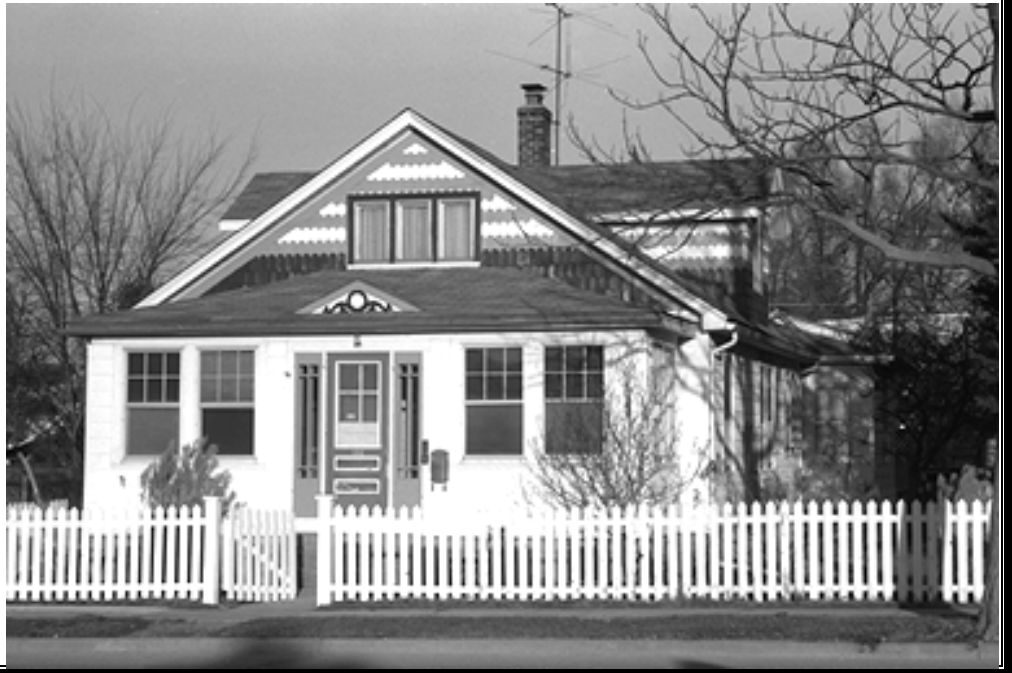
ADDRESS 106 South 7th Street

- ☐ Excellent
- ☒ Good
- ☐ Fair
- ☐ Poor

Architectural Style/Type: Eclectic Bungalow

ARCHITECTURAL FEATURES: The fish scale shingles used on the front gable and the roof dormers are the featured detail of the house. This imbrication may have been added as it is used in an unusual manner. There is a small pediment placed over the front entry that serves a functional role in diverting water as well as a decorative role.

ALTERATIONS: This house has been aluminized. The original siding has been replaced and aluminum windows and trim has replaced the original wood. There is a one story addition featuring a hipped roof to the rear of the house that has a concrete foundation.

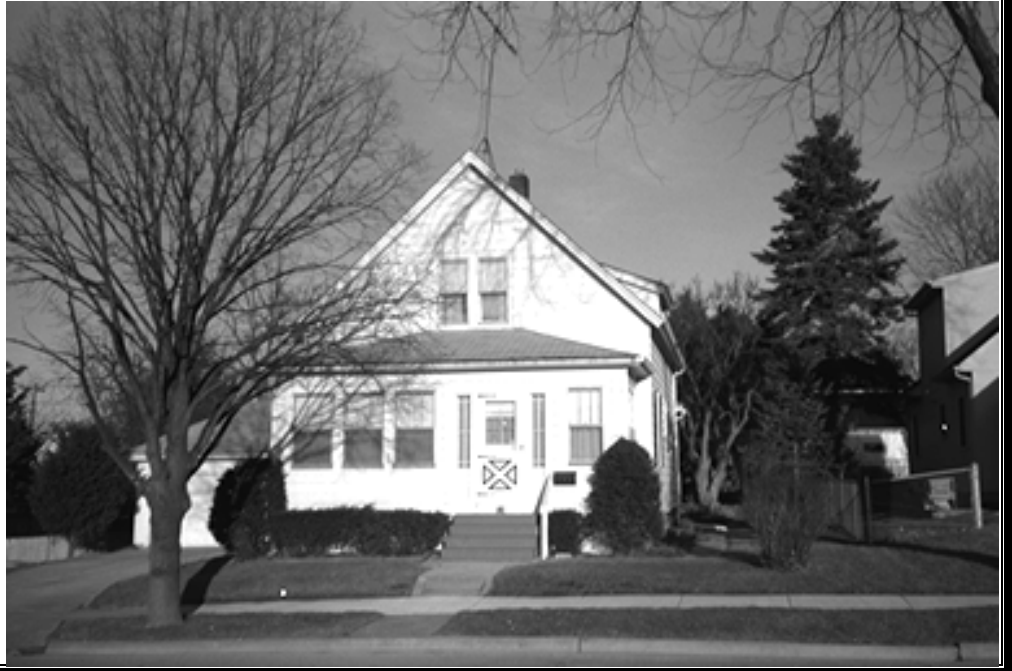
ADDRESS 116 South 7th Street

- ☐ Excellent
- ☒ Good
- ☐ Fair
- ☐ Poor

ARCHITECTURAL FEATURES: This roof is relatively steep – approximately 12:12. The front gable features a pair of windows. The south elevation of the roof has a shed dormer that may have been added later.

ALTERATIONS: The front porch was closed in to make a 3 or 4 season room. This house has been aluminized. The siding, windows, front door and soffits have been changed. There is a small porch that was added to the rear of the house.

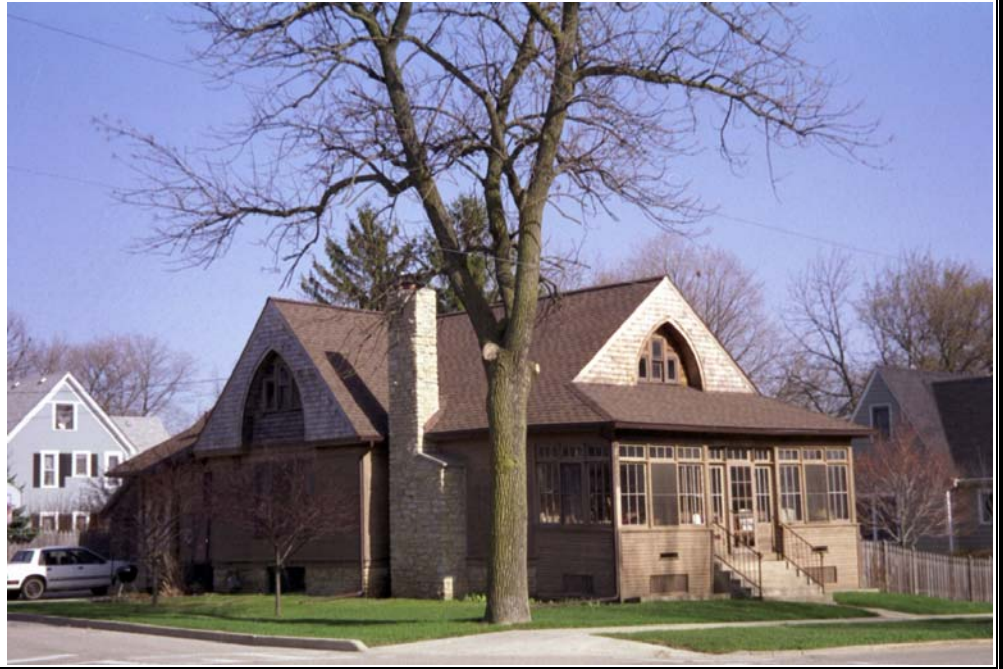
ADDRESS 302 South 7TH Street

- ☐ Excellent
- ☒ Good
- ☐ Fair
- ☐ Poor

ARCHITECTURAL FEATURES: This is a uniquely styled bungalow home that displays quirky but attractive details not commonly seen in the bungalow style.

ALTERATIONS: The front porch was closed in with a window pattern with transoms that does not match the original. Large gables have been added to both the north and south elevations. These exhibit the same pointed arch cut away that is in the front gable. The front gable appears to have been modified from the original. All of the gables have fish scale wood shingles.

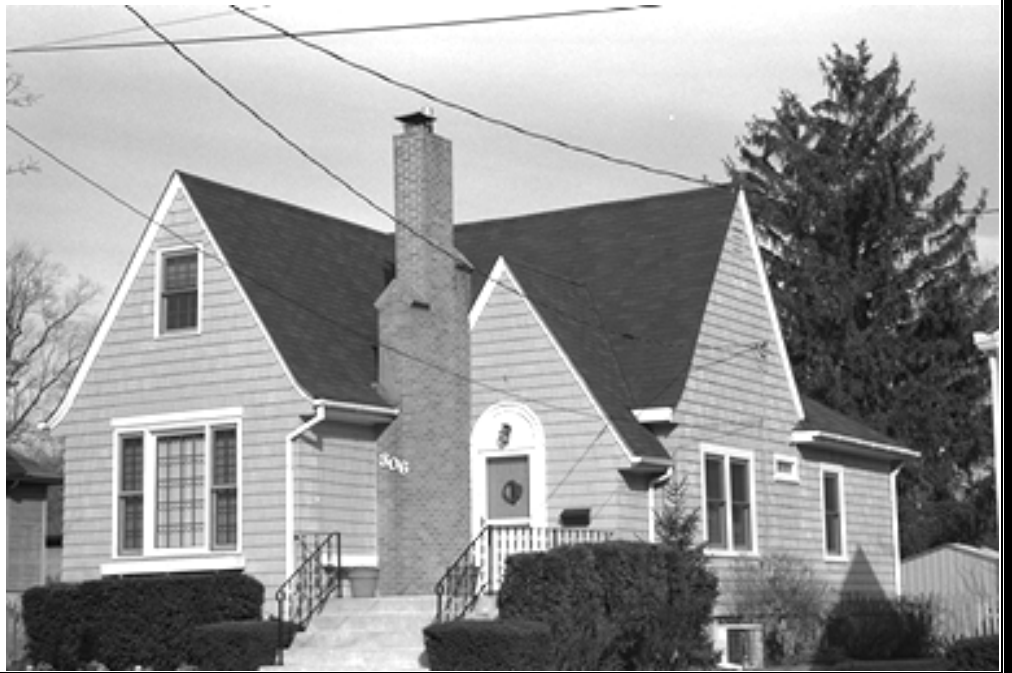
ADDRESS 306 South 7th Street

- ☐ Excellent
- ☒ Good
- ☐ Fair
- ☐ Poor

ARCHITECTURAL FEATURES: This 1 ½ story home has charming cottage scale that is accentuated with very steeply pitched roofs. A brick chimney that soars high next to the front entry features a couple of gabled details that add a little whimsy to the house. The arched top transom above the front door works with the chimney adding to the playfulness of the cottage style.

ALTERATIONS: A single story addition was made to the rear of the house that is somewhat in keeping with the original with the notable exception of a shallower roof pitch.

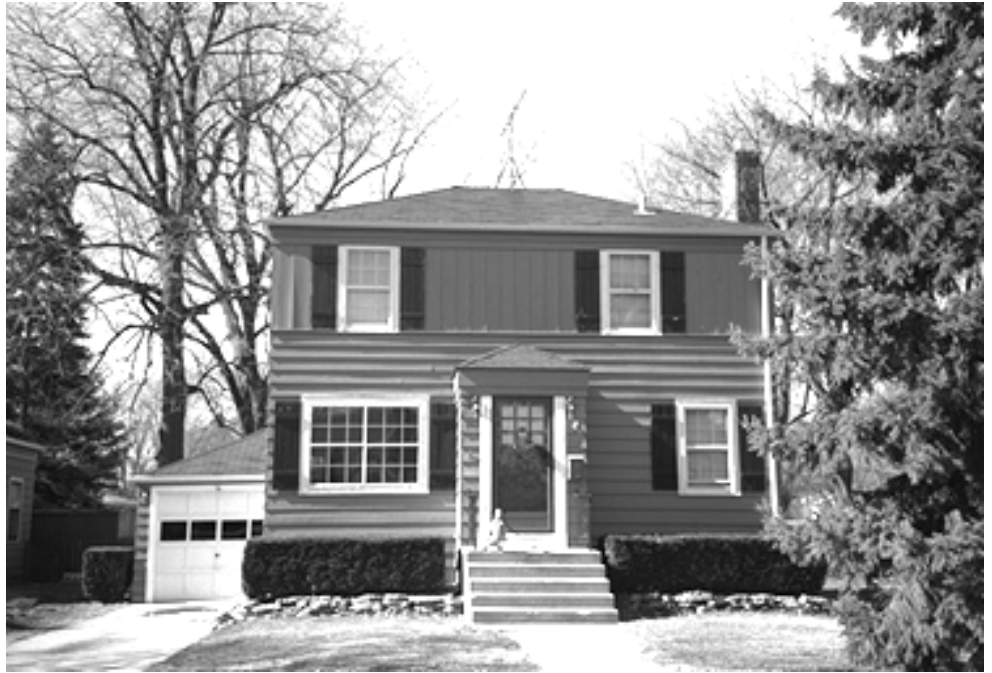
ADDRESS 307 South 7th Street

- ☐ Excellent
- ☐ Good
- ☒ Fair
- ☐ Poor

ARCHITECTURAL FEATURES: The windows do not appear to be organized on the front façade. The small enclosed entry has a hipped roof and is visually supported by two slender fluted pilasters. A stepped frieze detail that encircles the house at the second floor is also used at the eave of the front porch. The large picture window appears out of place on the front façade. This window has removable wooden storms. The first floor is sheathed with wide horizontal boards and the second floor is sheathed in vertical board and batten.

ALTERATIONS: A small garage was added haphazardly to the southwest corner of the house. While it is constructed with the same details as the original house.....it appears out of place and scale.

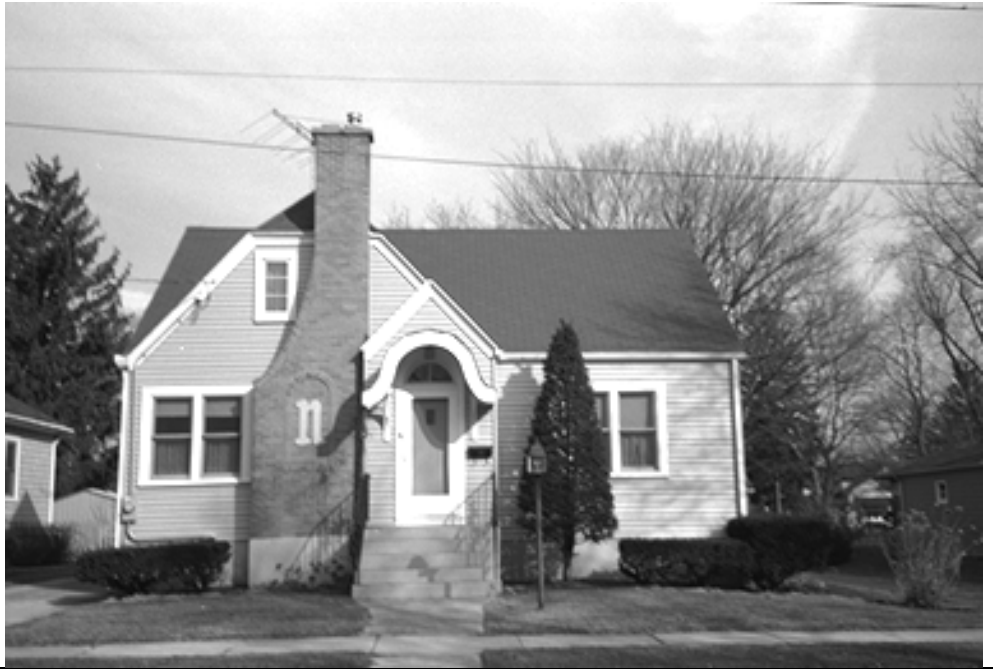
ADDRESS 310 South 7th Street

- ☒ Excellent
- ☐ Good
- ☐ Fair
- ☐ Poor

ARCHITECTURAL FEATURES: This 1 ½ story cottage features a large brick chimney placed alongside the main entry in the front gable. The entry door has an arched top transom that is covered with an arched canopy that is supported by wood brackets. These front door elements reside in their own small gabled peak. The main front gable has a hipped peak. A couple pair of windows seen on the front elevation do not occur elsewhere on the house.

ALTERATIONS: All of the aluminum materials appear to have been added.

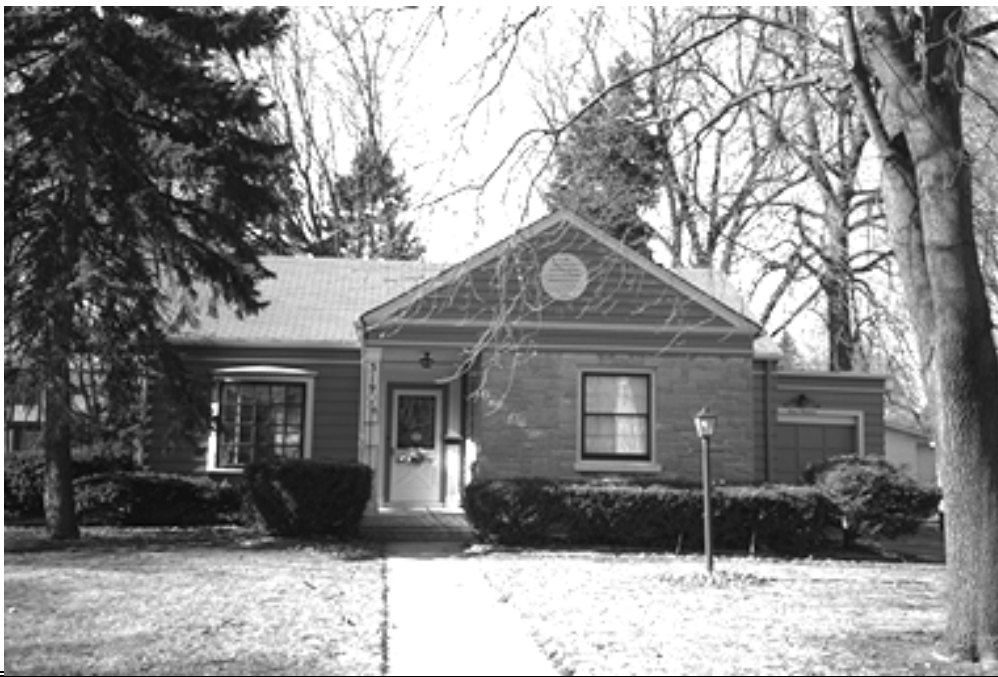
ADDRESS 319 South 7th Street

- ☐ Excellent
- ☒ Good
- ☐ Fair
- ☐ Poor

ARCHITECTURAL FEATURES: The front gable, which features Lannon stone, is the dominant element of the front elevation. A frieze tops the stone wall as the material changes to the wood siding in the upper wall. There is a round attic louver in the gable end that relates to a round spoked window on the north elevation. The front entry is flanked with two fluted pilasters. A subtly curved bow window is located adjacent to the entry.

ALTERATIONS: A flat roofed garage appears to have been added to the north side of the house.

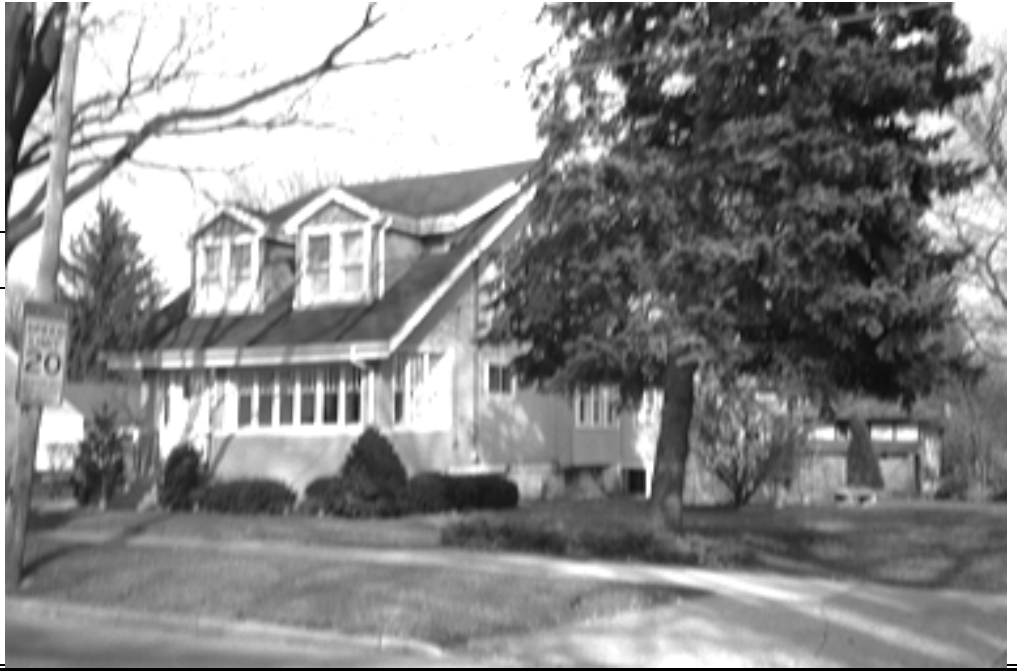
CD-IMAGE # 4368 - 6

- ☐ Significant
- ☐ Contributing
- ☐ Non-Contributing
- ☐ Potential for Individual National Register Designation

- ☐ Excellent
- ☐ Good
- ☐ Fair
- ☐ Poor

Date of Construction: 1923

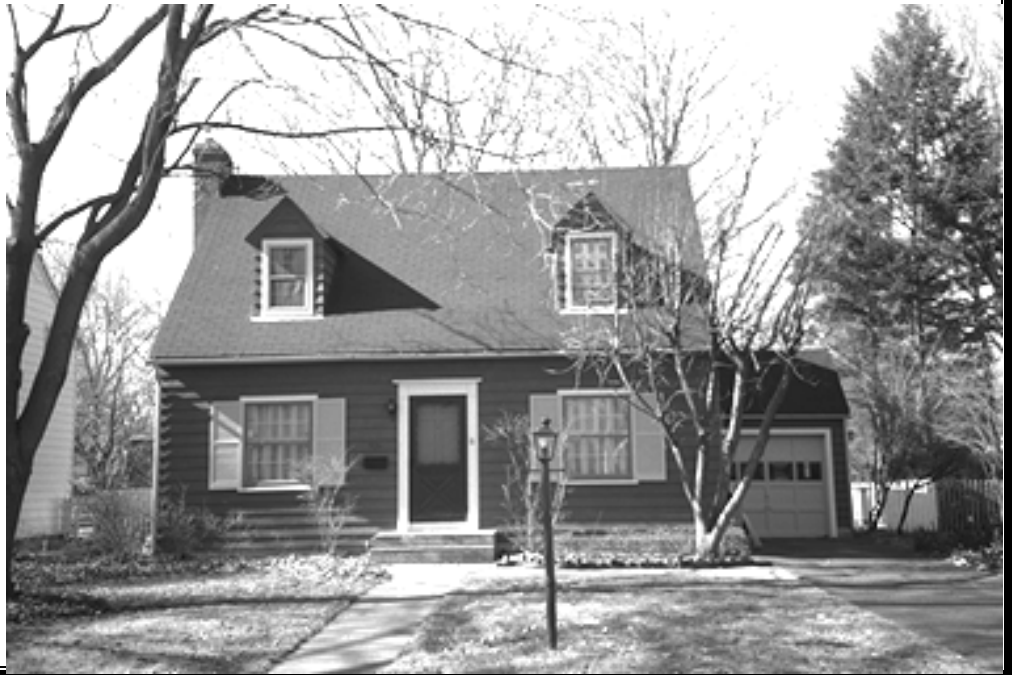
CD-IMAGE # 4370 - 14

- ☐ Significant
- ☒ Contributing
- ☐ Non-Contributing
- ☐ Potential for Individual National Register Designation

Foundation: Concrete

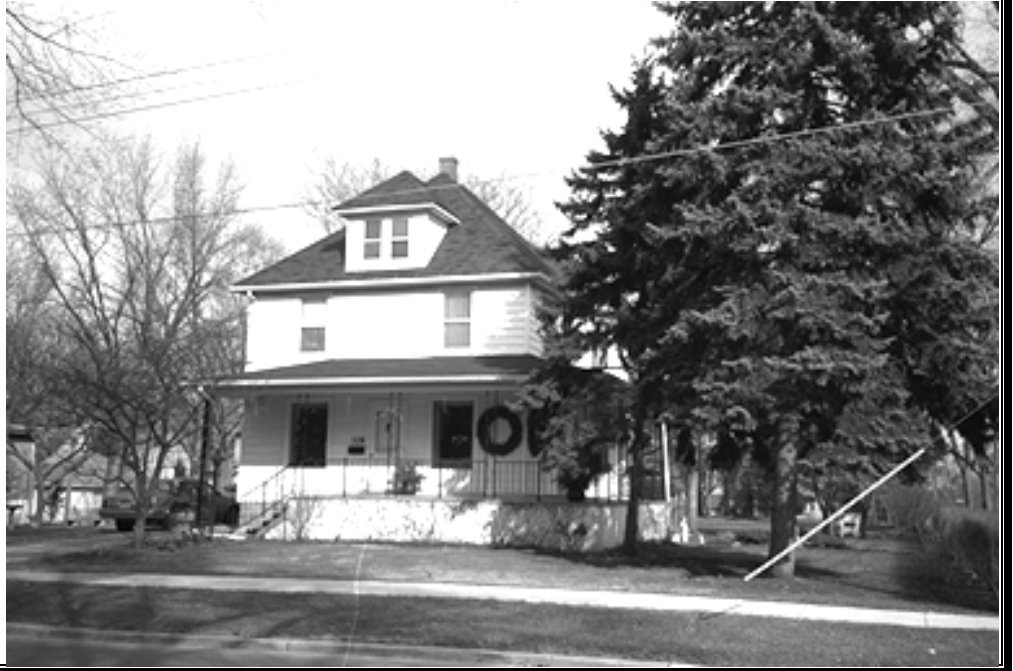
CD-IMAGE # 4368 - 5

- ☐ Significant
- ☐ Contributing
- ☒ Non-Contributing
- ☐ Potential for Individual National Register Designation

Foundation: Textured CMU

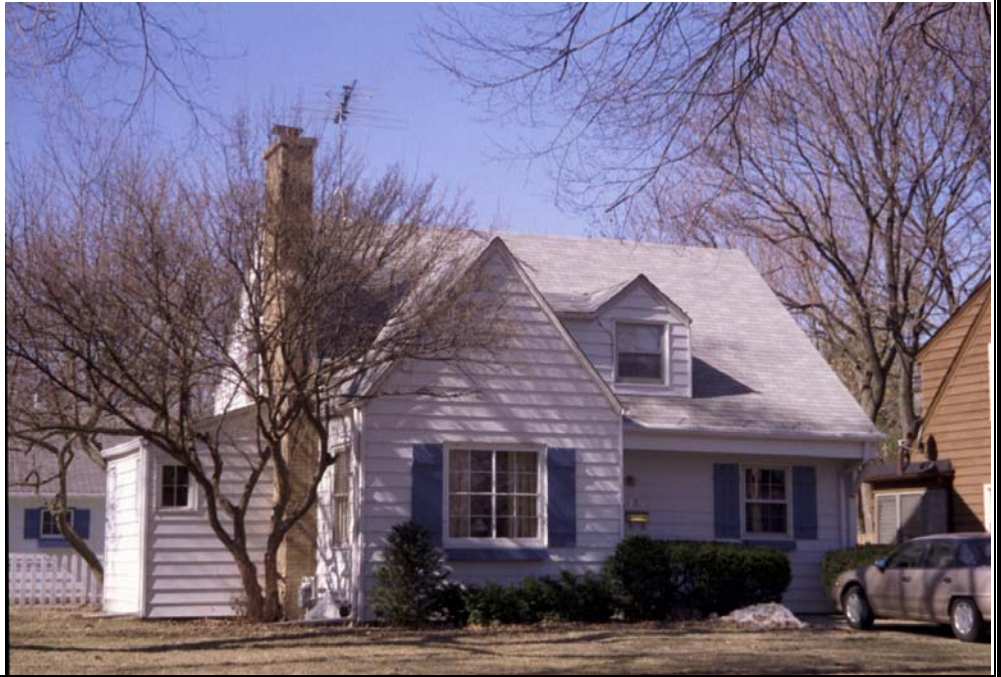
CD-IMAGE # 0298 - 13

- ☐ Significant
- ☐ Contributing
- ☒ Non-Contributing
- ☐ Potential for Individual National Register Designation

| Date of Construction: | <u>1948</u> | Foundation: | <u>Concrete</u> |

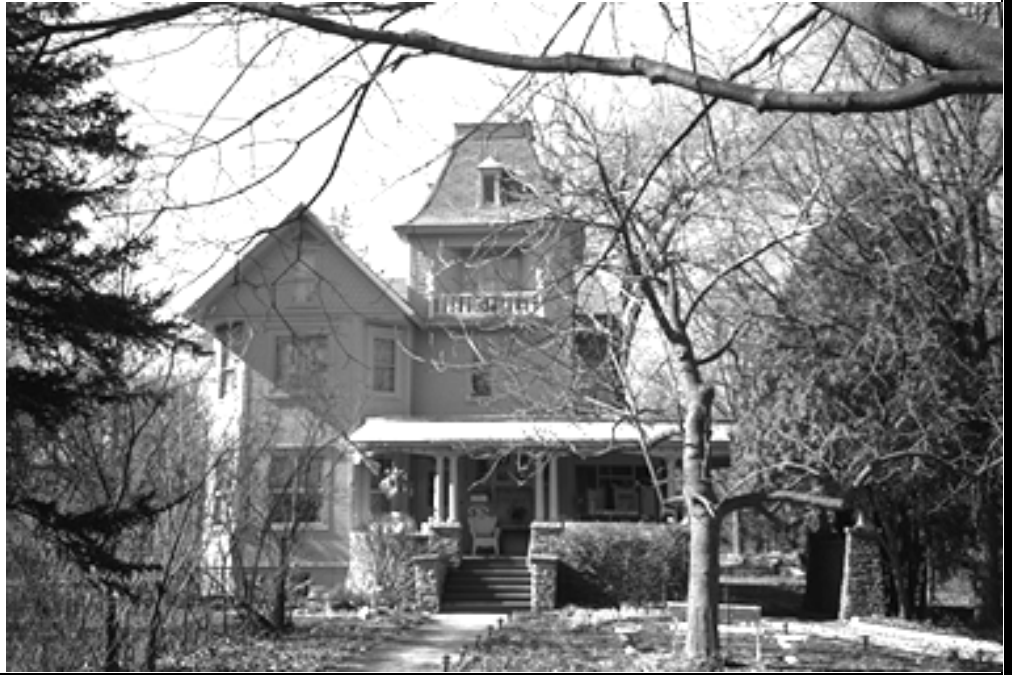
CD-IMAGE # 4370 - 12

- ☒ Significant
- ☐ Contributing
- ☐ Non-Contributing
- ☐ Potential for Individual National Register Designation

| Date of Construction: <u>1885</u> | Foundation: <u>Stone</u> |

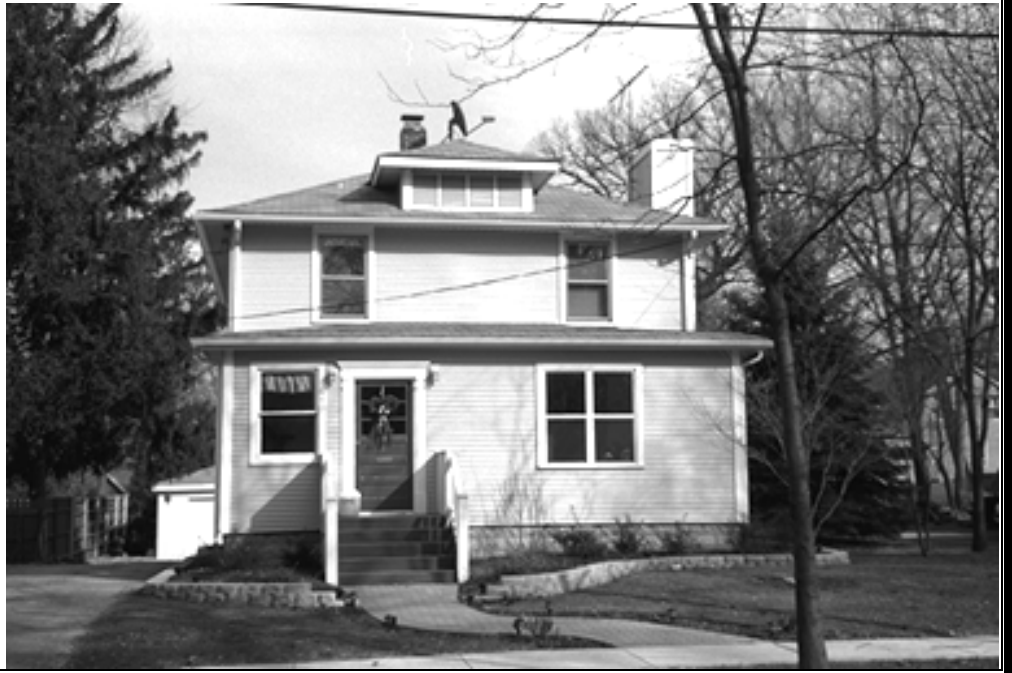
ROLL-IMAGE # 3434 - 4

ALTERATIONS: The front of the house has been significantly altered. The porch has been closed in to create a 4-season room and a large window that has no precedent in the original design has been installed. No evidence of the original columns or details remain visible from the street. There is a chimney that was added to the south side of the house. The entire house has been resided in aluminum and all of the original detailing removed or concealed. Louvers have replaced the original widows in the front roof dormer.

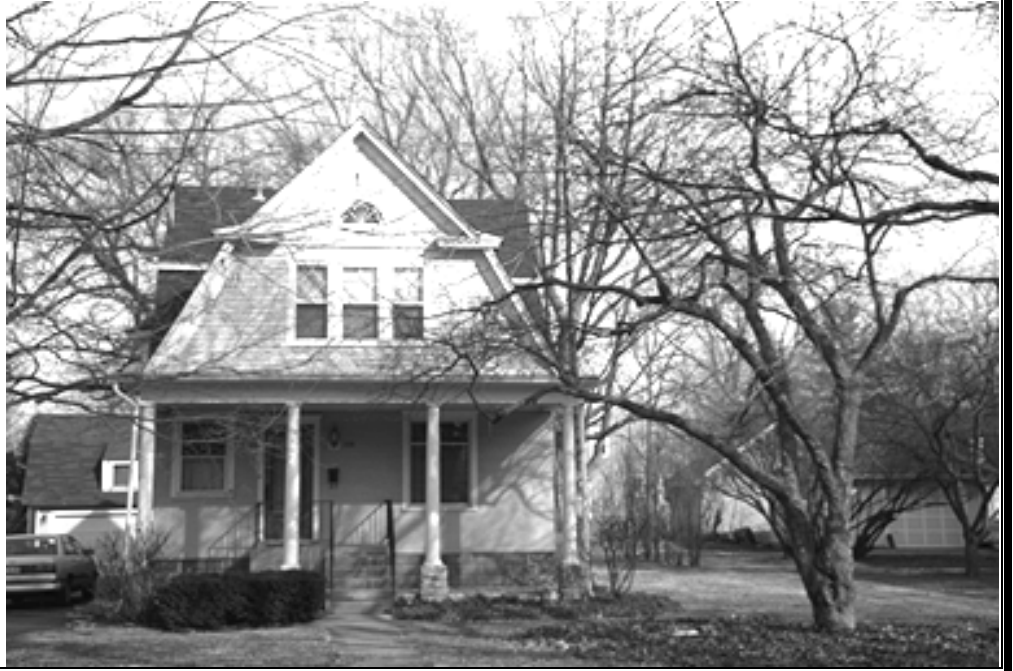
ROLL-IMAGE # 3434 - 3

ALTERATIONS: Some of the original removable storm sashes have been removed and replaced with aluminum inserts and the wrought iron railing and concrete stoop were changes from the original.

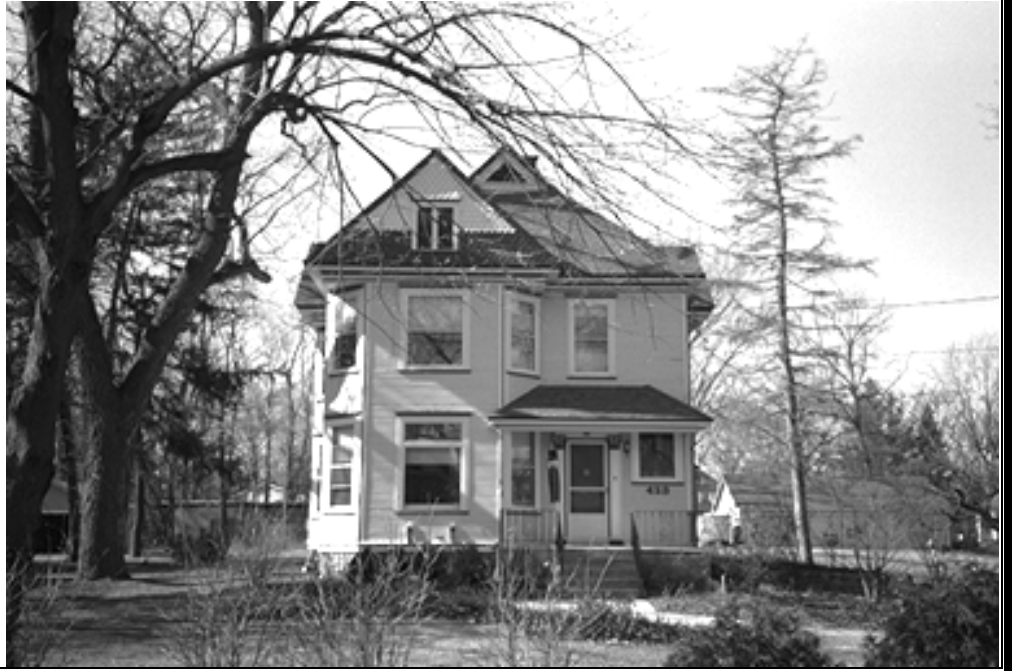
CD-IMAGE # 4370 - 11

- Significant
- ☐ Contributing
- ☐ Non-Contributing
- ☐ Potential for Individual National Register Designation

Foundation: Stone

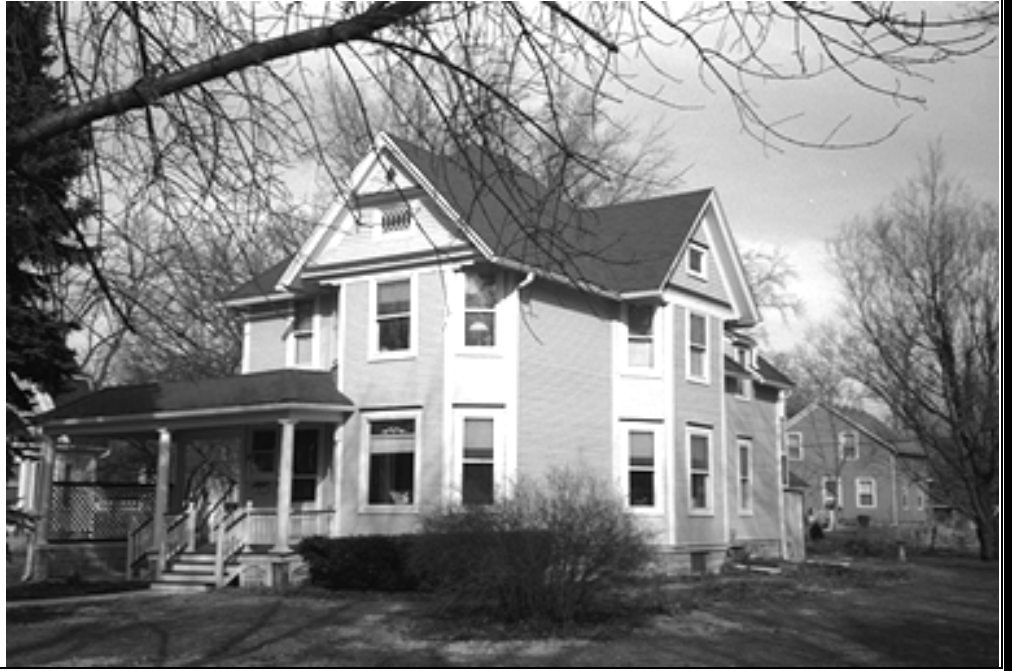
ROLL-IMAGE # 3434 - 2

ARCHITECTURAL FEATURES: The dominant features of the front elevation are the porte cochere and the two story bay projection under the front gable. A saw-tooth wood shingle pattern along with a small window featuring a decorative muntin pattern decorates the pediment of this element. There is a similarly detailed two story bay element located on the south elevation of the house. The porte cochere's roof is supported by round classic Doric columns that rest on concrete foundations. This suggests that the foundations were either replaced or that the porte cochere was not part of the original house.

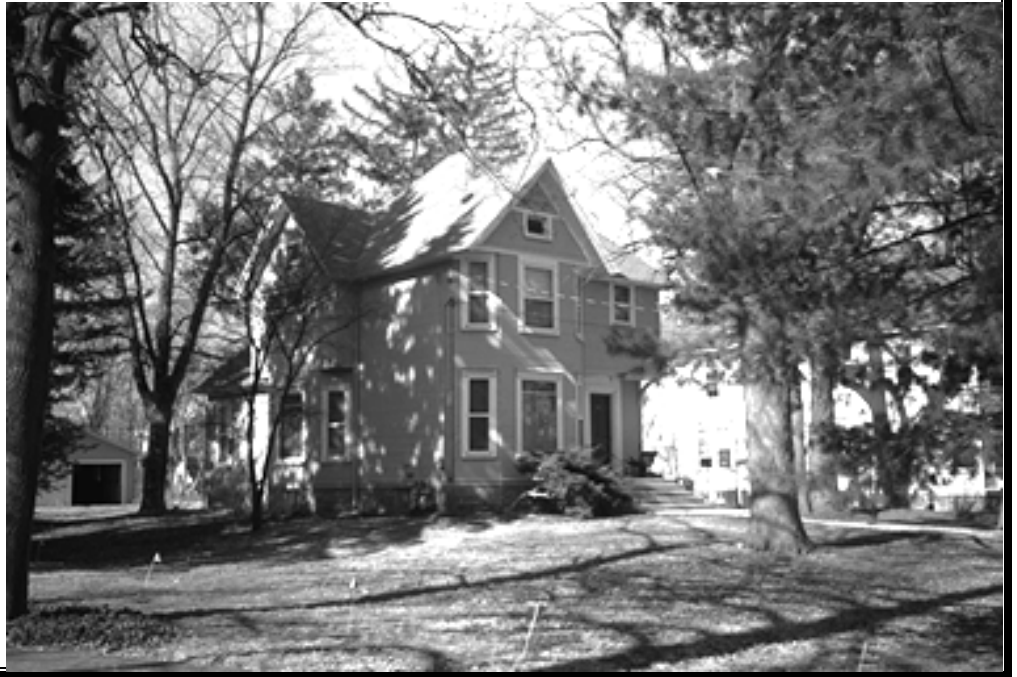
CD-IMAGE # 4370 - 10

- ☒ Significant
☐ Contributing
☐ Non-Contributing
☐ Potential for Individual National Register Designation

Exterior Walls (Current): Clapboard
Exterior Walls (Original): Clapboard
Foundation: Stone
Roof Type/Material: Hipped w/lower cross gables/
Asphalt shingle
Window Material/Type: Wood trim/Aluminum inserts/
Double hung

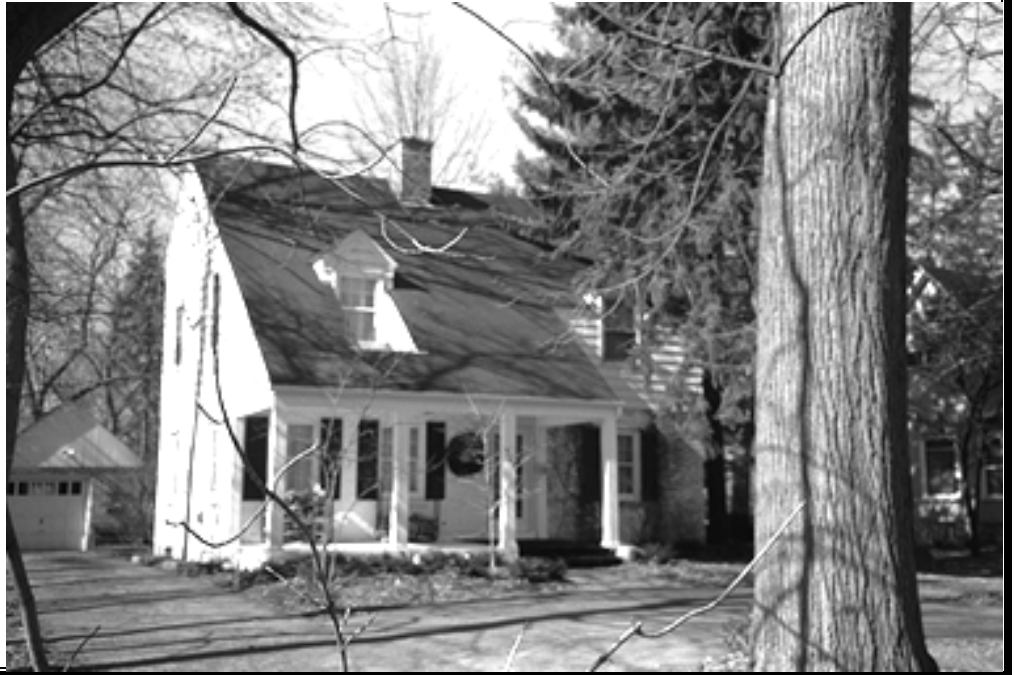
CD-IMAGE # 4370 - 9

- ☐ Significant
- ☒ Contributing
- ☐ Non-Contributing
- ☐ Potential for Individual National Register Designation

Foundation: Concrete

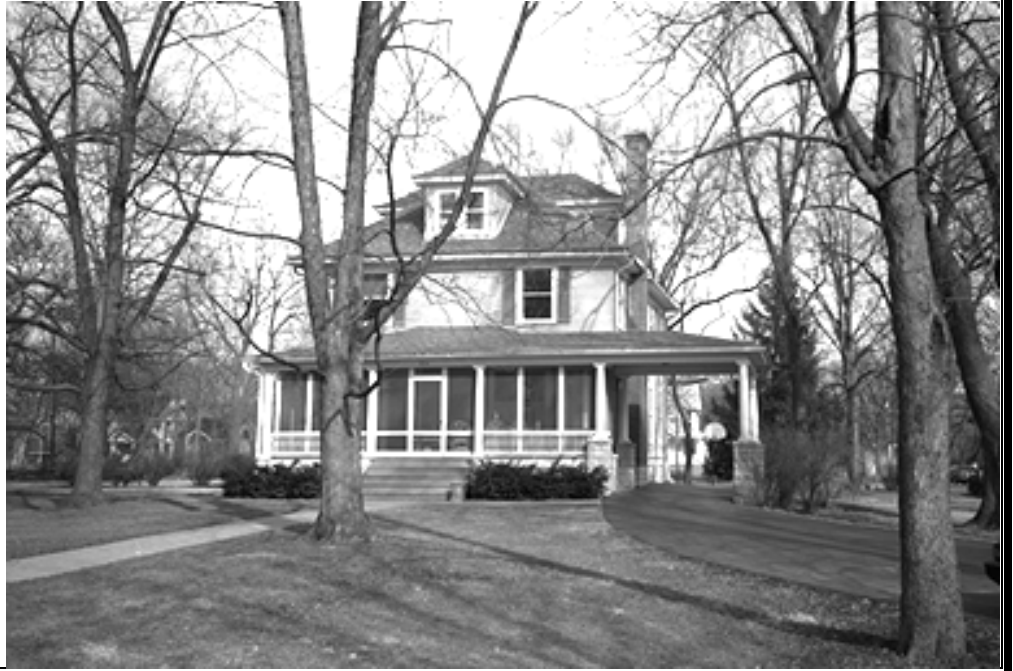
CD-IMAGE # 4368 - 1

- ☒ Significant
- ☐ Contributing
- ☐ Non-Contributing
- ☐ Potential for Individual National Register Designation

Foundation: Stone

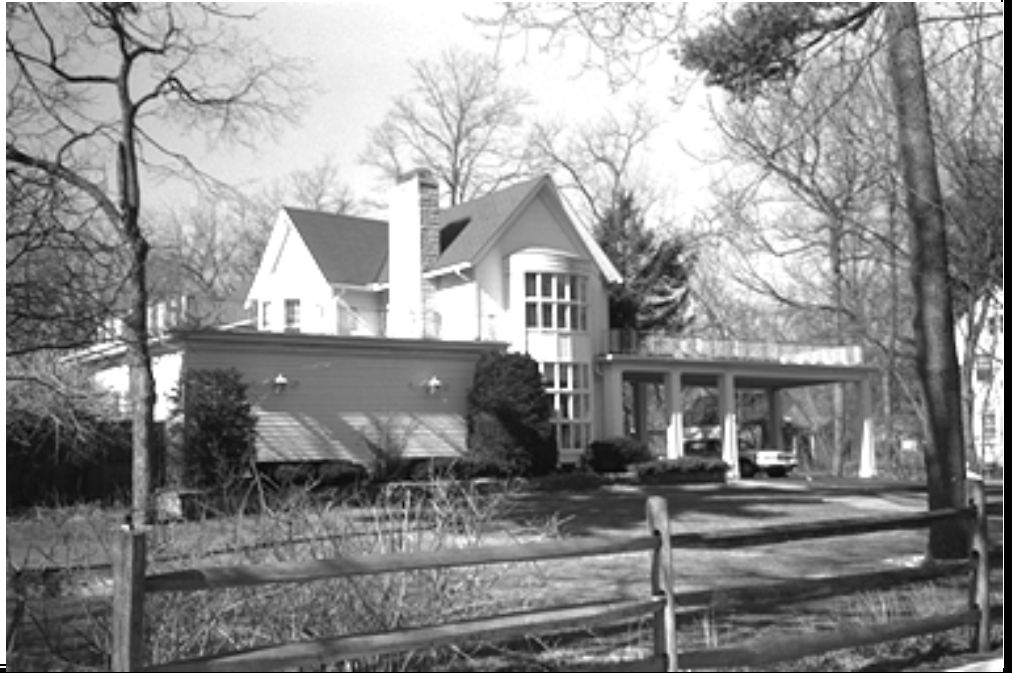
ROLL-IMAGE # 3433 - 8

ALTERATIONS: This house has been totally remodeled to the extent that little of the original house was left intact. The tower formerly occupying the inside corner where the entry is has been removed. The two story bay projections have been engulfed with one story flat roof additions. The large flat roof of the porte cochere relates to the flat roof additions but not to the original house. Aluminum replaced all of the original materials and details that adorned the house. Lannon stone covers the original chimney form.

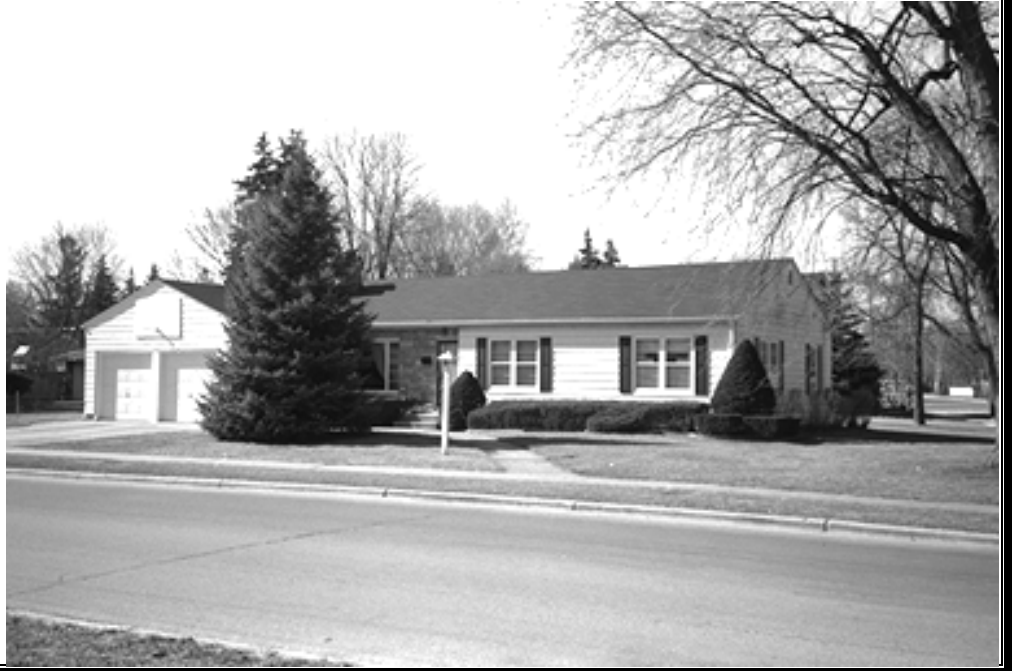
CD-IMAGE # 4370 - 19

- ☐ Significant
- ☒ Contributing
- ☐ Non-Contributing
- ☐ Potential for Individual National Register Designation

Foundation: Concrete

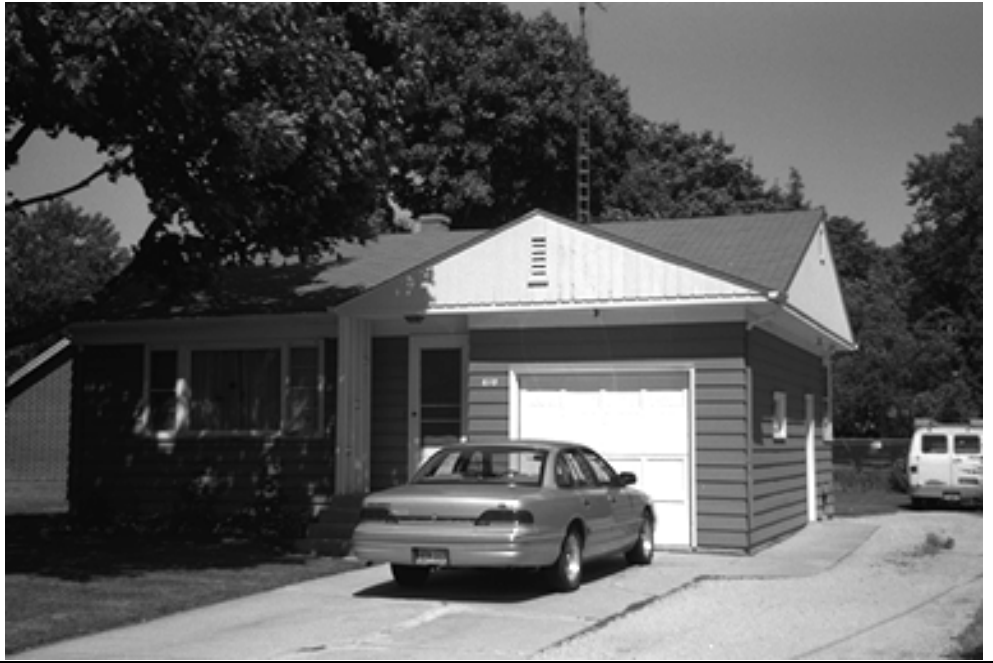
CD-IMAGE # 0601 - 89

- ☐ Significant
- ☐ Contributing
- ☒ Non-Contributing
- ☐ Potential for Individual National Register Designation

| Date of Construction: <u>1956</u> | Foundation: <u>Concrete</u> |

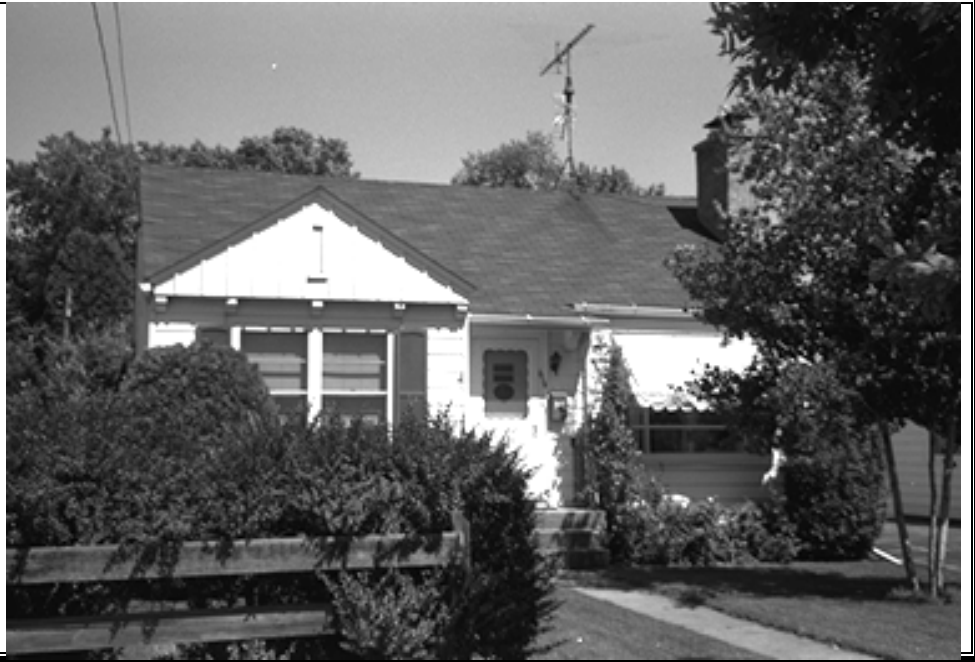
CD-IMAGE # 0601 - 88

- ☐ Significant
- ☒ Contributing
- ☐ Non-Contributing
- ☐ Potential for Individual National Register Designation

| Date of Construction: | <u>1940</u> | Foundation: | <u>Concrete</u> |

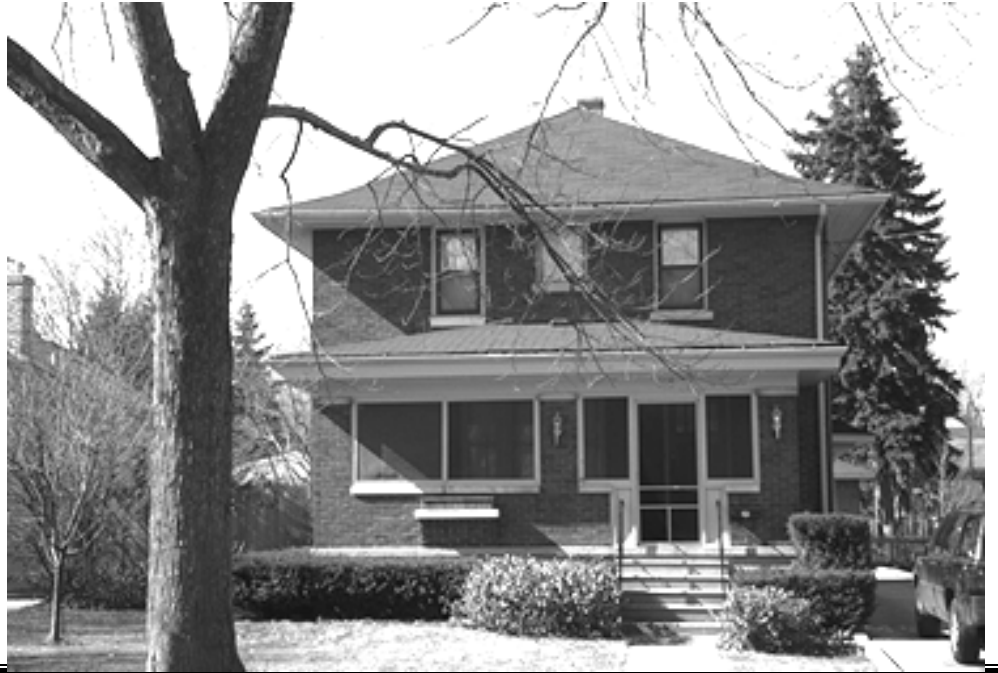
CD-IMAGE # 4370 - 20

- ☐ Significant
- ☒ Contributing
- ☐ Non-Contributing
- ☐ Potential for Individual National Register Designation

Foundation: Concrete
Roof Type/Material: Hipped/Asphalt shingle

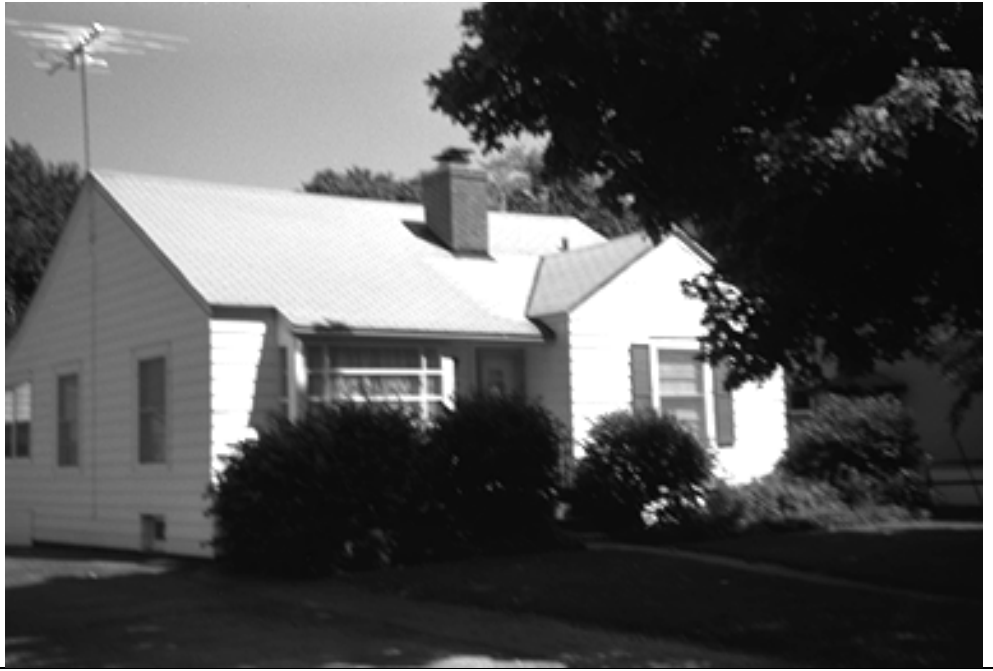
CD-IMAGE # 0601 - 87

- ☐ Significant
- ☒ Contributing
- ☐ Non-Contributing
- ☐ Potential for Individual National Register Designation

Foundation: Concrete

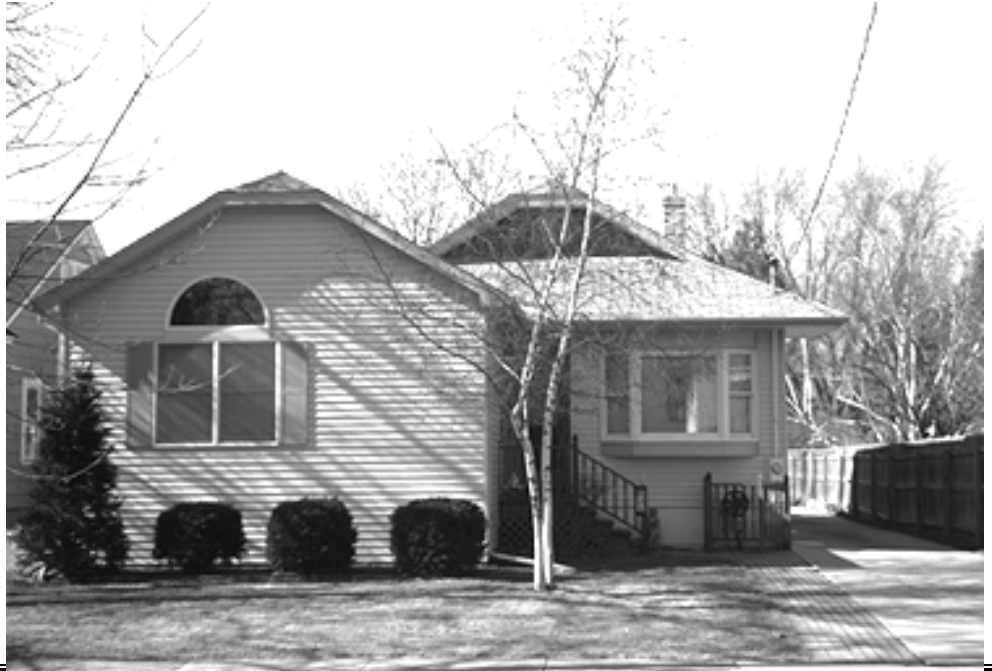
CD-IMAGE # 4370 - 21

- ☐ Significant
- ☐ Contributing
- ☒ Non-Contributing
- ☐ Potential for Individual National Register Designation

Foundation: Parged masonry

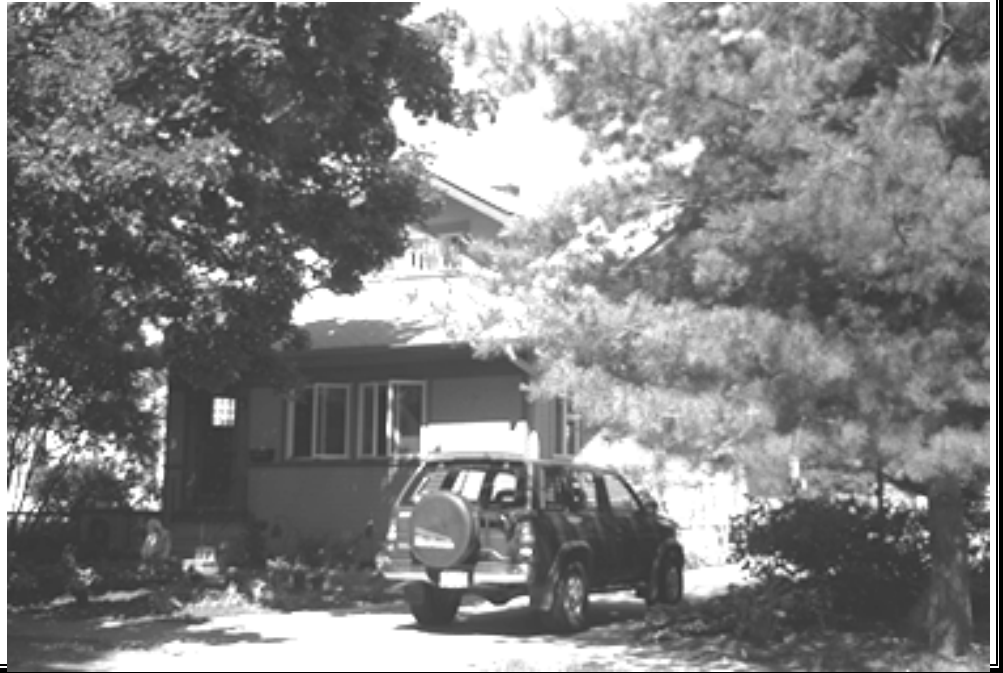
CD-IMAGE # 0601 - 86

- ☐ Significant
- ☐ Contributing
- ☒ Non-Contributing
- ☐ Potential for Individual National Register Designation

Foundation: Parged masonry

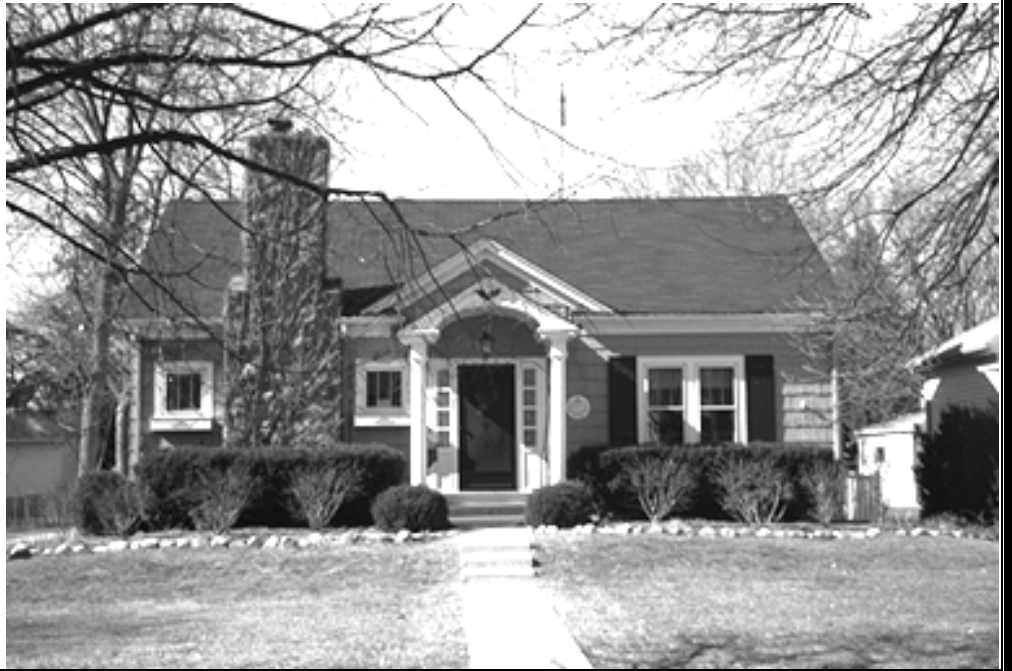
CD-IMAGE # 4370 - 22

- ☐ Significant
- ☒ Contributing
- ☐ Non-Contributing
- ☐ Potential for Individual National Register Designation

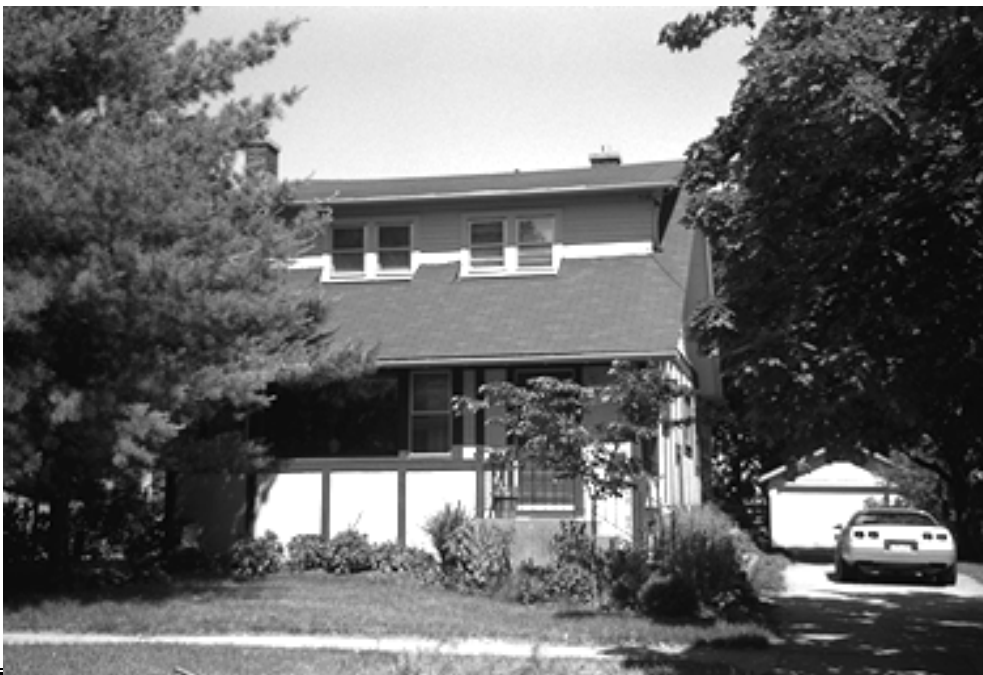
ROLL-IMAGE # 70551 - 13

ALTERATIONS: The current ½ timber siding scheme completely conceals the original materials and details. A poorly constructed shed dormer runs the entire width of the front part of the roof. Aluminum has replaced most of the original wood. Almost none of the original wood details can be seen although some clapboard can be seen in the side gable at the third floor. A shed dormer was also added to the rear of the house.

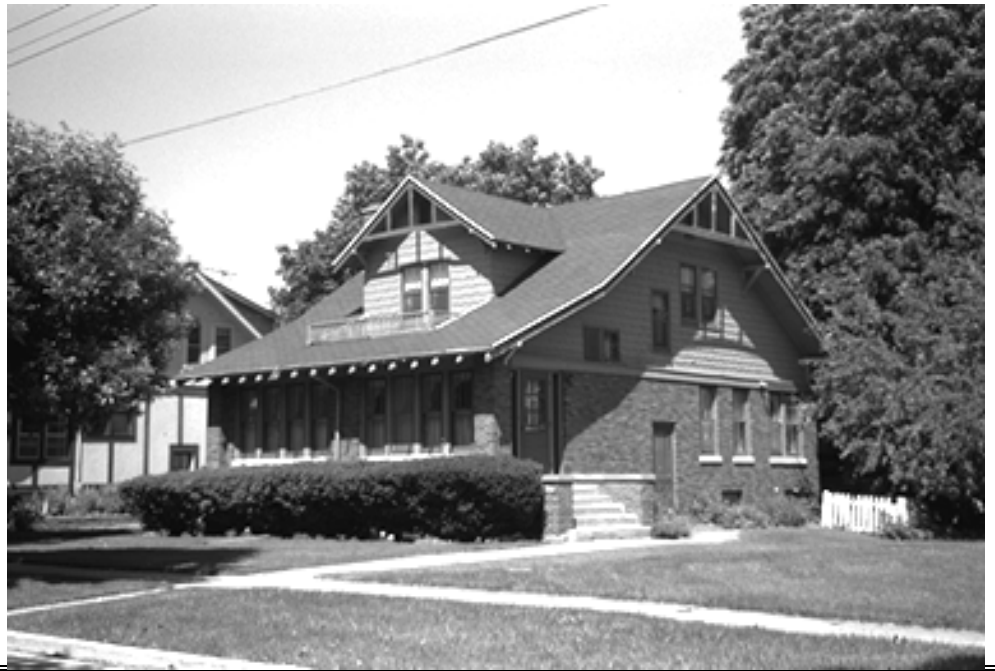
CD-IMAGE # 0601 - 83

- ☒ Significant
- ☐ Contributing
- ☐ Non-Contributing
- ☐ Potential for Individual National Register Designation

| Date of Construction: | 1930 | Foundation: | Concrete? |
