ARCHITECTURAL SURVEY

NEAR WEST HISTORIC DISTRICT
ST. CHARLES, ILLINOIS

ST. CHARLES HISTORIC PRESERVATION COMMISSION

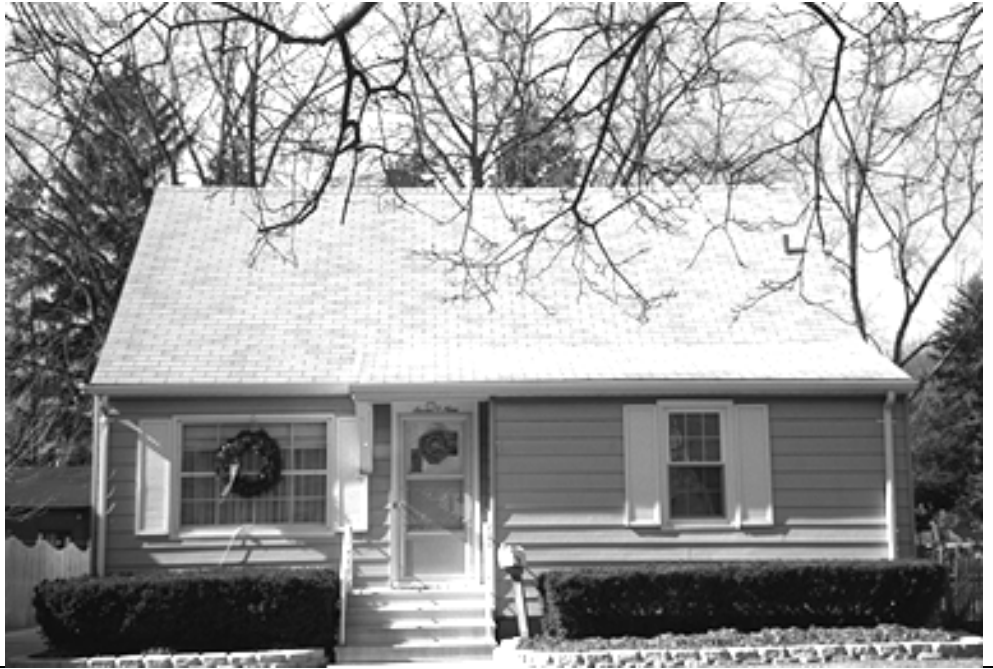
CD-IMAGE # 4370 - 23

- ☐ Significant
- ☐ Contributing
- ☒ Non-Contributing
- ☐ Potential for Individual National Register Designation

Foundation: Concrete

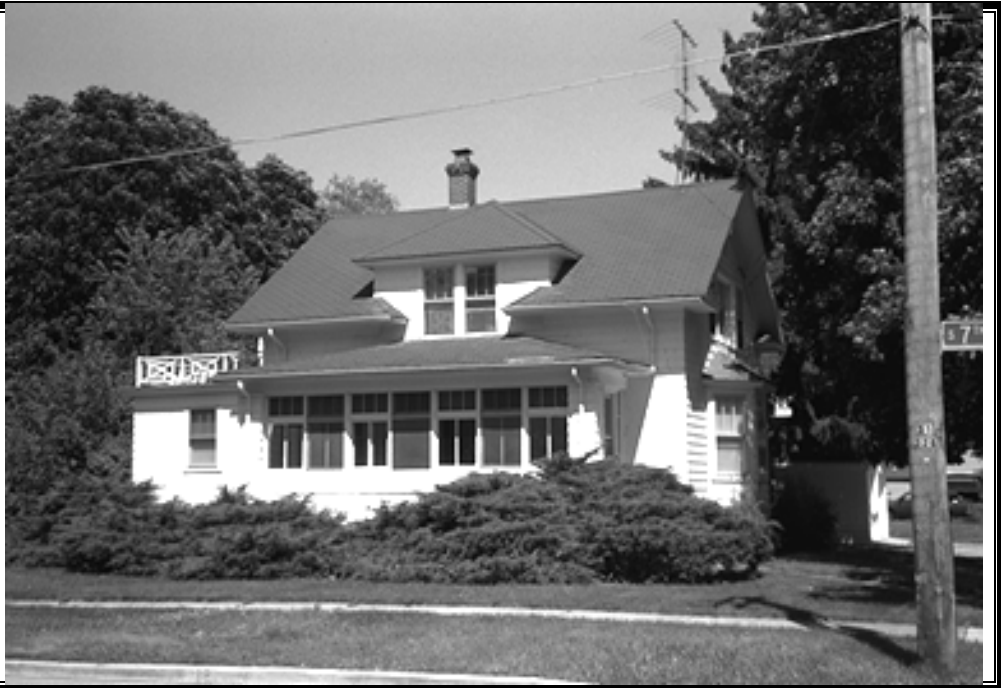
ROLL-IMAGE # 70551 - 10

ARCHITECTURAL FEATURES: This is an unusual house that attempts to relate to its corner site. The hipped roofed wall dormer defines the front access to the main part of the house that appears to be the side of the house. A porch that has been screened in conceals this access. The entrance to the porch is from the south side, which appears to be the front of the house. The south elevation features a two story gabled form with a broken pediment and a discontinuous frieze band. A single story bay window with a sloped roof is also located on this elevation. The eaves are boxed in with wooden strips. The windows have a 3:1 muntin pattern consistently around the house.

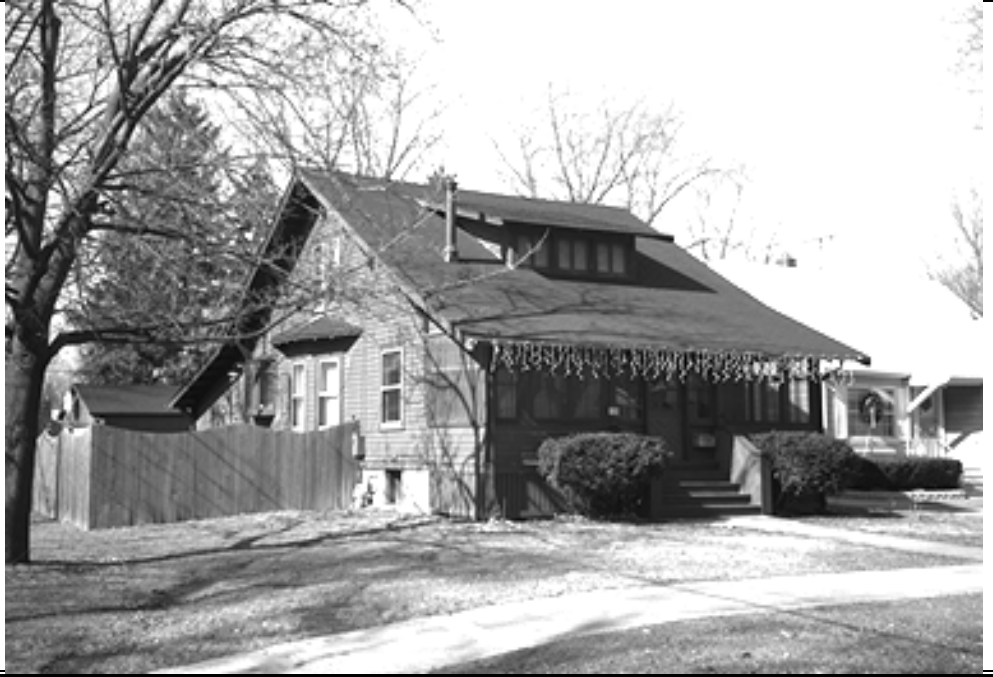
CD-IMAGE # 4370 - 25

- Significant
- ☐ Contributing
- ☐ Non-Contributing
- ☐ Potential for Individual National Register Designation

| Date of Construction: <u>1925</u> | Foundation: <u>Parged masonry</u> |
