ARCHITECTURAL SURVEY

NEAR WEST HISTORIC DISTRICT

ST. CHARLES, ILLINOIS

ST. CHARLES HISTORIC PRESERVATION COMMISSION

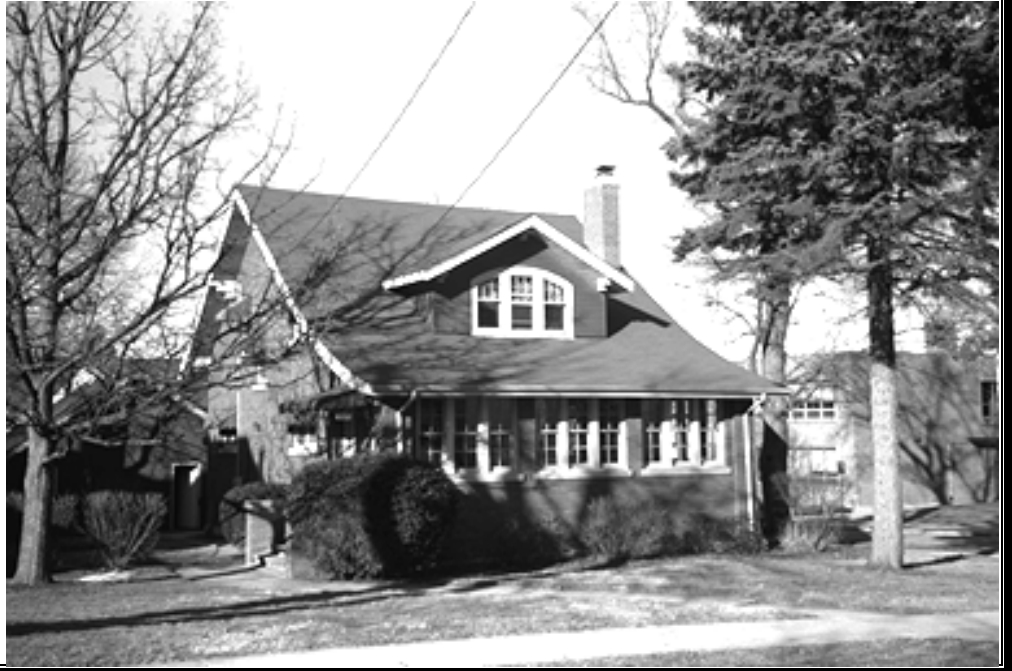
ADDRESS 500 Cedar Street

- ☒ Excellent
- ☐ Good
- ☐ Fair
- ☐ Poor

Architectural Style/Type: Craftsman Bungalow

ARCHITECTURAL FEATURES: The large centered roof dormer and the closed in front porch are prominent features of the front elevation. The windows on the dormer feature a 3:1 pattern and an arched head. Stepped wooden brackets support the wide eaves on the side elevations as well as the dormer. Square brick columns support the roof of the all season porch. As this house is sited on a corner, the entrance is on the protected side (west) of the house.

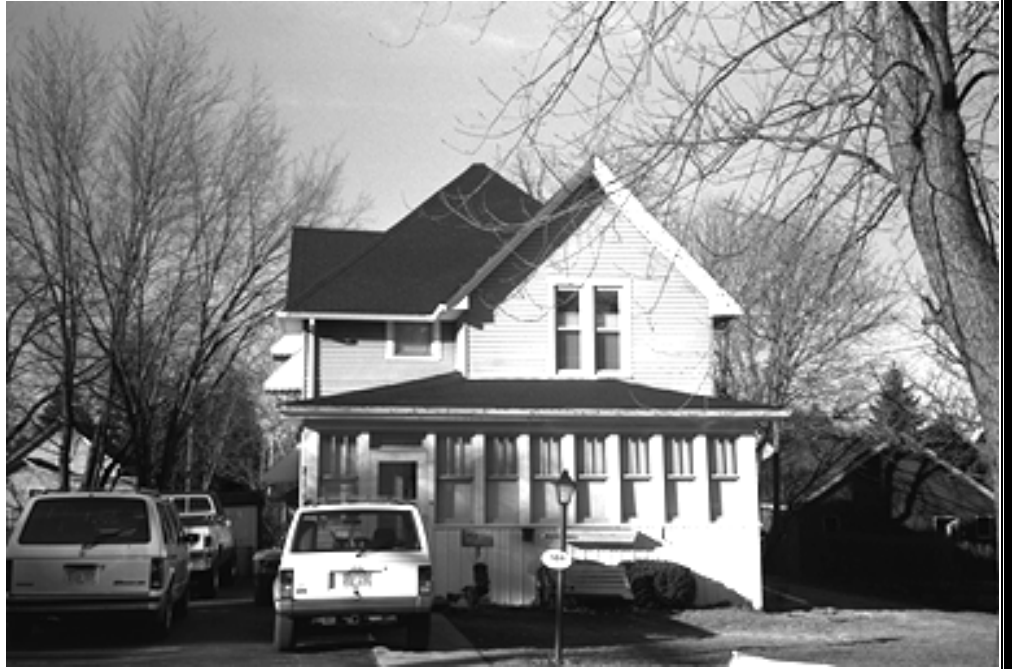
ADDRESS 508 Cedar Street

- ☒ Excellent
- ☐ Good
- ☐ Fair
- ☐ Poor

Architectural Style/Type:	<u>Victorian/Queen Anne</u>	Exterior Walls (Current):	<u>Aluminum on wood frame</u>
Architectural Features:	<u></u>	Exterior Walls (Original):	<u>Clapboard on wood frame</u>
Date of Construction:	<u>1910</u>	Foundation:	<u>Concrete</u>
Source:	<u>Township Assessors Office</u>	Roof Type/Material:	<u>Hipped w/lower cross gables</u>
Overall Plan Configuration:	<u>Simple - massed</u>	Window Material/Type:	<u>Alum/Double hung</u>

ARCHITECTURAL FEATURES: The roofs are steep and the house has typical massing for this style. The full width front porch is the prominent architectural feature of the front elevation. The paired double hung windows located on the 2F of the front gable are narrow and have no muntins.

ALTERATIONS: There is an addition to the rear of the house that has a shallow pitched roof and an elevated wooden deck. These additions are non-sympathetic to the original house. The front porch has been filled in and is sheathed in vertical aluminum siding. The windows feature a 3:1 muntin pattern. All of the aluminum trim, windows, and siding are new.

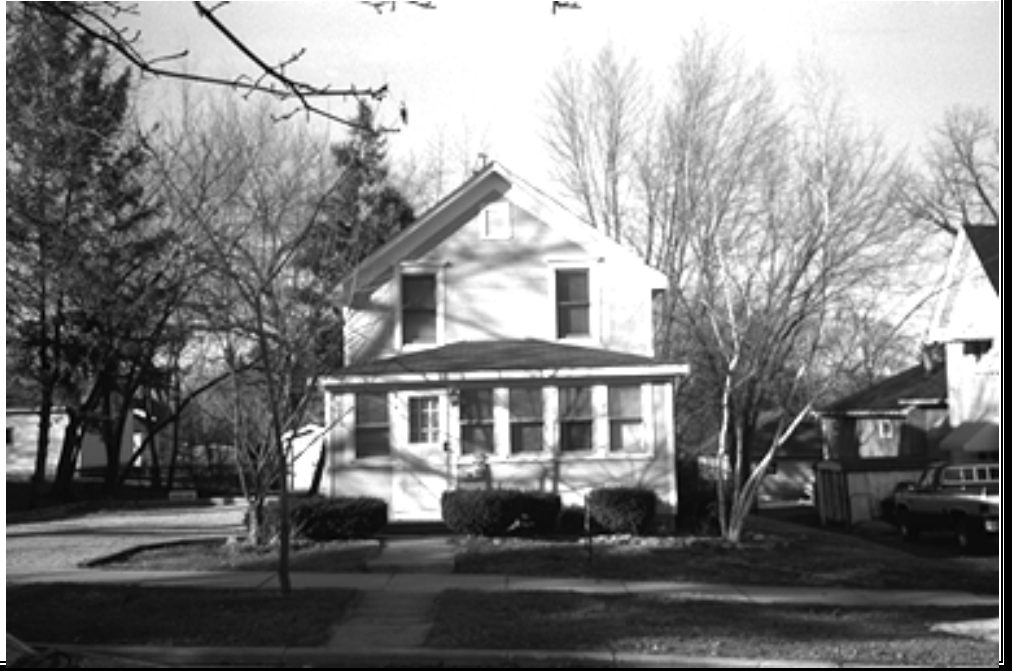
ADDRESS 514 Cedar Street

- ☐ Excellent
- ☒ Good
- ☐ Fair
- ☐ Poor

Architectural Style/Type:	National	Exterior Walls (Current):	Clapboard
Architectural Features:		Exterior Walls (Original):	Clapboard
Date of Construction:	1910	Foundation:	Parged masonry
Source:	Township Assessors Office	Roof Type/Material:	Front gable/Asphalt
Overall Plan Configuration:	Simple - rectangle	Window Material/Type:	Alum/Double hung

ARCHITECTURAL FEATURES: A moderate roof slope and heavy frieze suggest some relation to the Greek revival style. There is also a simple classic wood molding profile at the head of the windows. The full width front porch is closed in for four season use.

ALTERATIONS: An addition to the rear of the house is sympathetic to the original featuring the same siding and a gable roof.

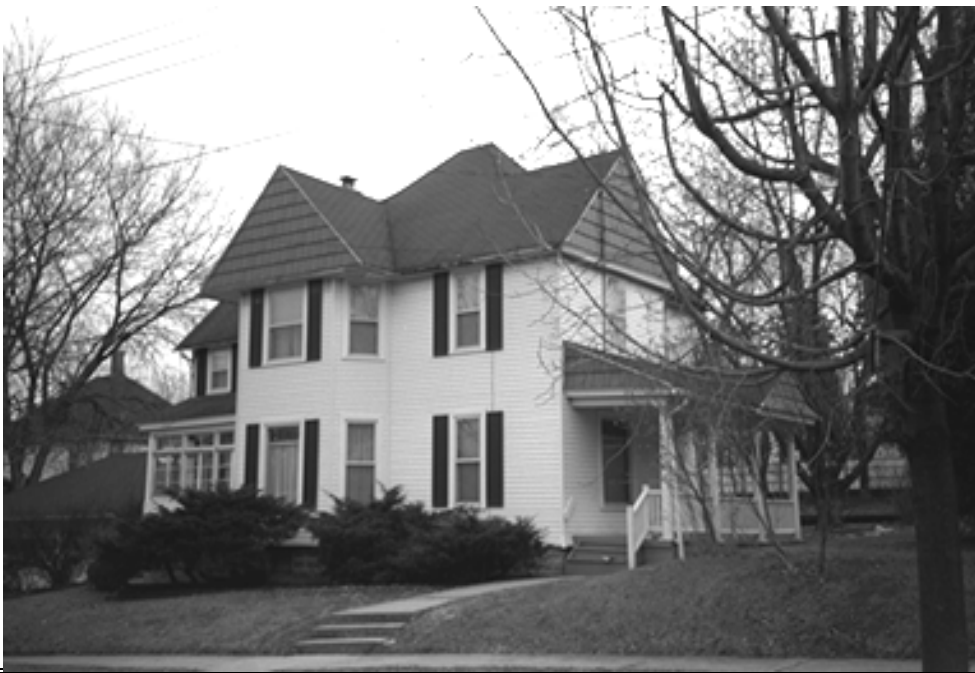
ADDRESS 517 Cedar Street

- ☐ Excellent
- ☐ Good
- ☒ Fair
- ☐ Poor

Architectural Style/Type:	<u>Victorian/Queen Anne</u>	Exterior Walls (Current):	<u>Aluminum/Wd Shingles</u>
Architectural Features:	<u></u>	Exterior Walls (Original):	<u>Clapboard/Wd Shingles</u>
Date of Construction:	<u>1915</u>	Foundation:	<u>Textured CMU</u>
Source:	<u>Township Assessors Office</u>	Roof Type/Material:	<u>Hipped w/ lower cross gables/ Asphalt Shingles</u>
Overall Plan Configuration:	<u>Simple w/Irregularities</u>	Window Material/Type:	<u>Alum/Dbl Hung</u>

ARCHITECTURAL FEATURES: Elements of the original house that remain visible, aside from the overall massing, are the wood shingles in the gable ends and the entry porch. The house is somewhat unusual in that its side is oriented to the street with the entry & porch facing the side yard. Smooth Doric columns support the shed styled roof with a small gable form placed over the entry. The two-story bay element on the north elevation is the most important visual element of the street façade.

ALTERATIONS: The siding and windows have been replaced with aluminum. There is a small sun-porch located on the street elevation that is ironic in that it is the northeast corner of the house.

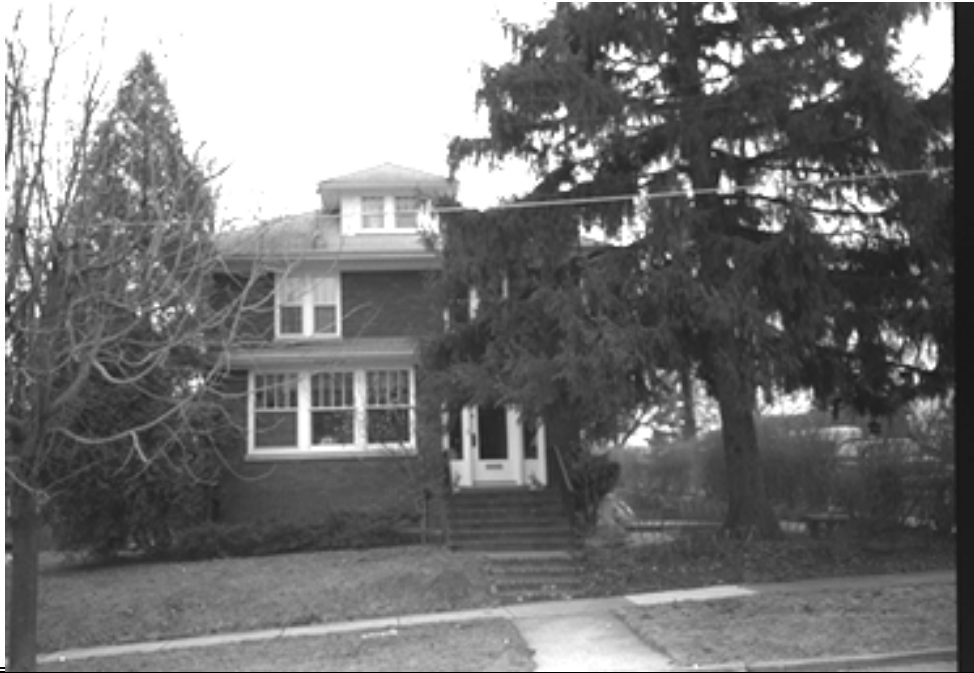
ADDRESS 521 Cedar Street

- ☐ Excellent
- ☒ Good
- ☐ Fair
- ☐ Poor

Architectural Style/Type:	<u>Prairie Four square</u>	Exterior Walls (Current):	<u>Brick</u>
Architectural Features:	<u></u>	Exterior Walls (Original):	<u>Brick</u>
Date of Construction:	<u>1925</u>	Foundation:	<u>Concrete</u>
Source:	<u>Township Assessors Office</u>	Roof Type/Material:	<u>Hipped/Asphalt shingle</u>
Overall Plan Configuration:	<u>Simple square</u>	Window Material/Type:	<u>Alum/Wd/Dbl Hung</u>

ARCHITECTURAL FEATURES: There is a single hipped dormer located on the front side of the house roof. The full width front porch is the dominant architectural feature. Simple square brick columns support the roof of the porch. The double hung windows feature a 4:1 muntin pattern. All of the windows are used in pairs or groups of three.

ALTERATIONS: The soffits are boxed in aluminum. There is a small mudroom vestibule added to the rear of the house that is sheathed with dryvit and has a prefab greenhouse window unit. The porch appears to have been closed in subsequent to the initial construction and the entrance moved to the outer wall. Low brick side-walls were recently added at the front stairs.

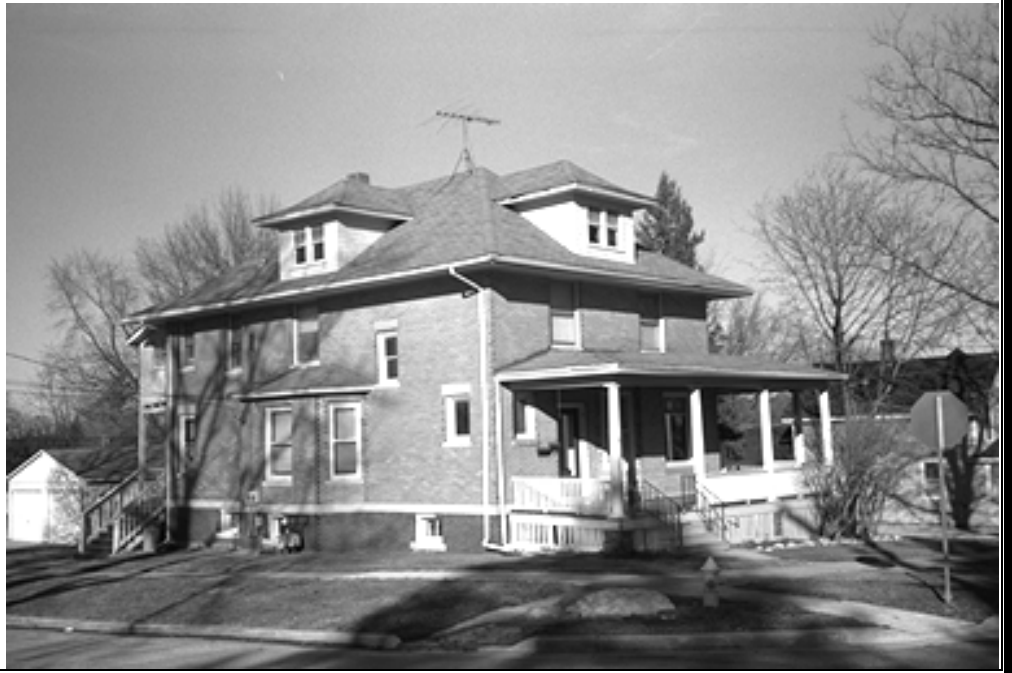
ADDRESS 522 Cedar Street

- ☐ Excellent
- ☒ Good
- ☐ Fair
- ☐ Poor

Architectural Style/Type:	<u>Prairie Foursquare</u>	Exterior Walls (Current):	<u>Brick</u>
Architectural Features:	<u></u>	Exterior Walls (Original):	<u>Brick</u>
Date of Construction:	<u>1890</u>	Foundation:	<u>Brick/Concrete</u>
Source:	<u>Township Assessors Office</u>	Roof Type/Material:	<u>Hipped/Asphalt shingle</u>
Overall Plan Configuration:	<u>Simple square</u>	Window Material/Type:	<u>Wd Trim/Alum/Dbt Hung</u>

ARCHITECTURAL FEATURES: Hipped dormers are placed on the front and side elevations of the roof. The hipped roof flares at the eaves. Wooden Doric columns, with bases on the porch deck, support the roof of the porch. The columns are more of a Colonial Revival reference than a Prairie style detail. A plain wooden railing with square balusters encircles the porch. The stone belt course that marks the first floor line also separates two brick colors emphasizing the horizontal line of the house. These features, along with the wide roof overhangs, are commonly used design elements of the style. The single story bay window on the west side features open brick corners. Most of the windows have stone lintels and sills.

ALTERATIONS: A wooden two-story porch with a shed roof was added to the rear of the house. Its design and detailing are inconsistent with the original design.

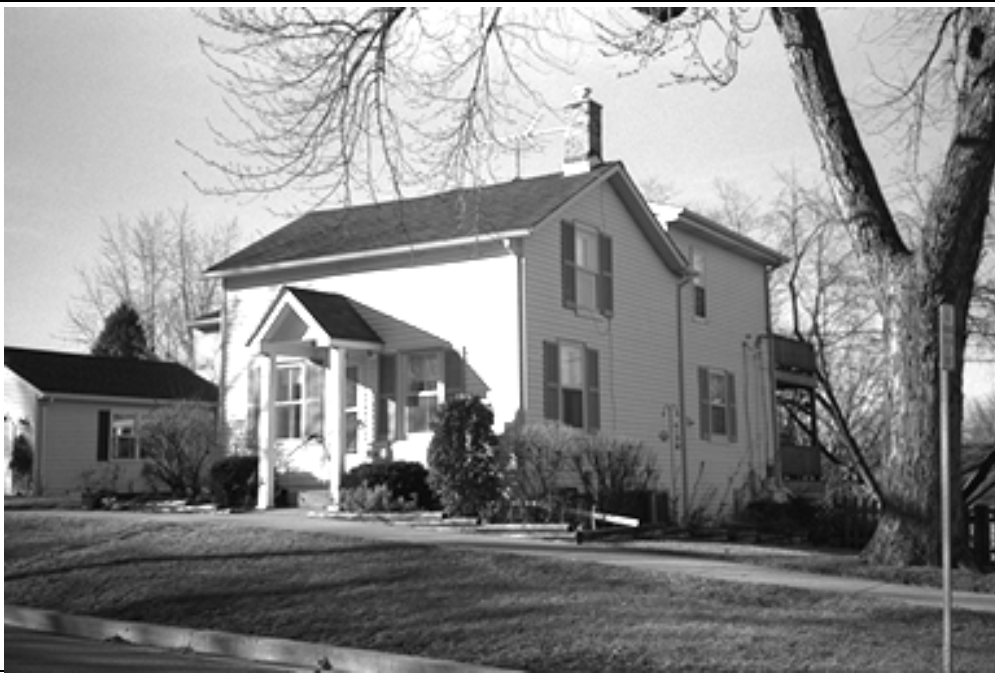
ADDRESS 606 Cedar Street

- ☐ Excellent
- ☒ Good
- ☐ Fair
- ☐ Poor

Architectural Style/Type:	National	Exterior Walls (Current):	Aluminum
Architectural Features:		Exterior Walls (Original):	Clapboard
Date of Construction:	1870 Orig.	Foundation:	Stone / Orig., Conc. / Adds
Source:	Township Assessors Office	Roof Type/Material:	Side gable/Asphalt Shingle
Overall Plan Configuration:	Simple rectangle – Orig.	Window Material/Type:	Alum/DbI Hung

ARCHITECTURAL FEATURES: This house has narrow eaves and shallow roof slope. The lack of windows on the second floor of the front elevation is odd as is the window arrangement on the side elevation. Two square columns support a small gable roofed porch that protects the front door.

ALTERATIONS: Little of the original house is revealed in its current condition. It appears that the aluminum siding and ill-conceived additions have concealed much. The two-story addition to the rear does not relate to the original architecture in any way. A two-story wooden deck that was added to the north of this addition does not relate to the addition or the original house. A small one-story addition featuring an octagonal window was made to the west side of the house.

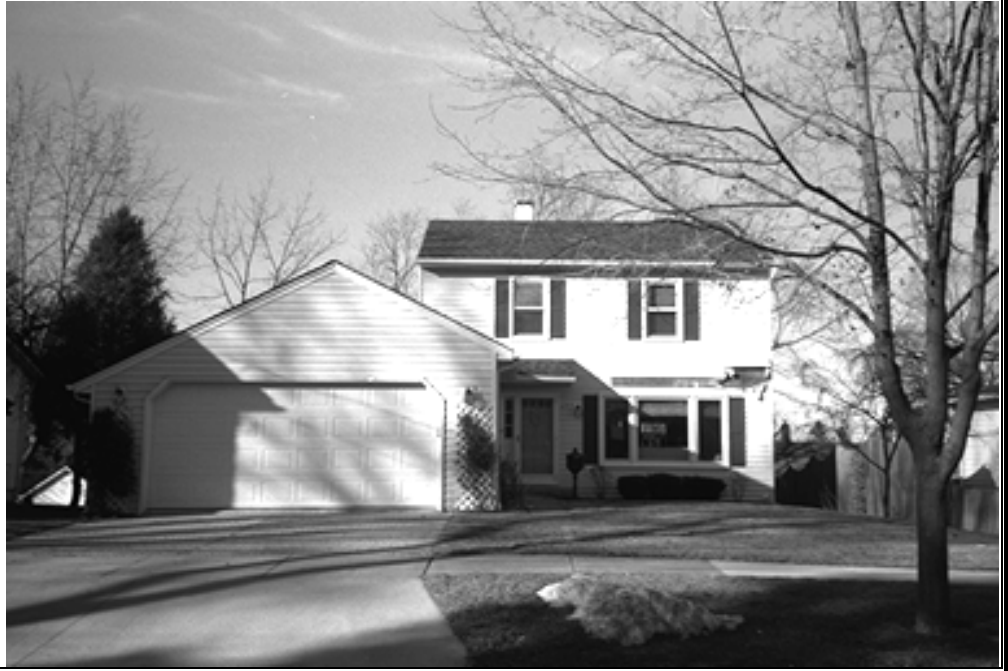
ADDRESS 610 Cedar Street

- ☐ Excellent
- ☒ Good
- ☐ Fair
- ☐ Poor

ARCHITECTURAL FEATURES: The two-car garage dominates the street elevation. It does not relate to the main part of the house. The roof slope is shallow and the overhangs are narrow. A large three-part picture window is an important element of the front façade.

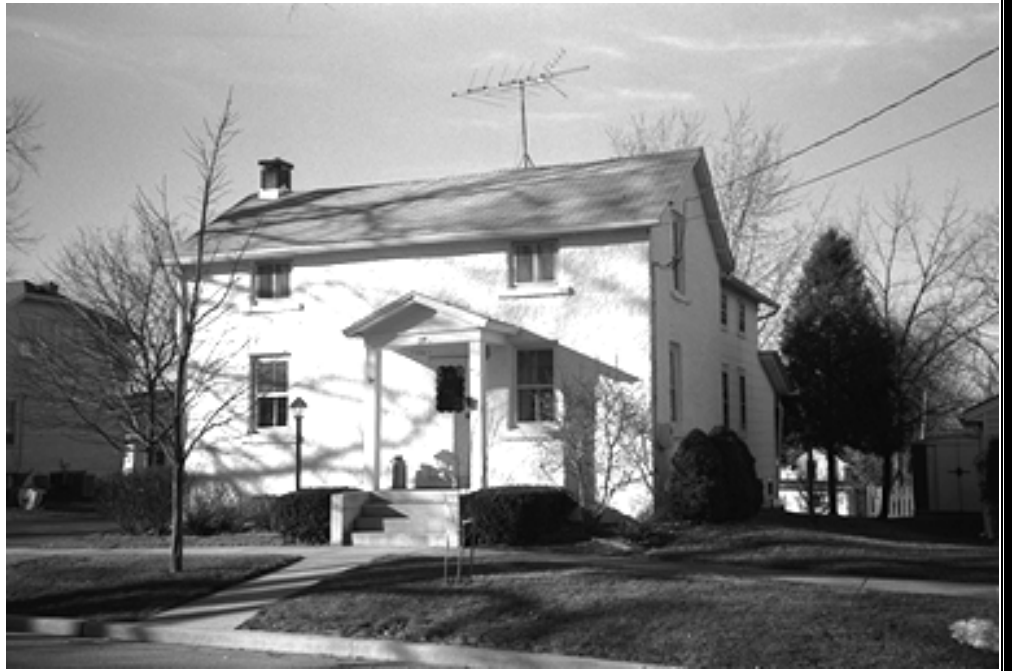
ADDRESS 612 Cedar Street

- ☐ Excellent
- ☐ Good
- ☒ Fair
- ☐ Poor

ARCHITECTURAL FEATURES: This house appears to be related stylistically to the house located up the street at 606 Cedar. The first floor of this house is raised off grade and consequently has steps and a small raised porch at the front door. The roof pitch is shallow and the eaves are narrow. There are exposed rafter tails at the eaves. Two small windows with short head heights are placed on the front elevation at the eave. The windows sills of the original house are articulated. Two square columns support a small gable roofed front porch.

ALTERATIONS: Two additions to the north side of the house have been made. The first is two-stories with a broad gabled roof and is sheathed in a wavy-patterned Masonite siding. The second is a single –story with a shed roof and is also sided with the wavy Masonite. Neither addition relates to the original design.

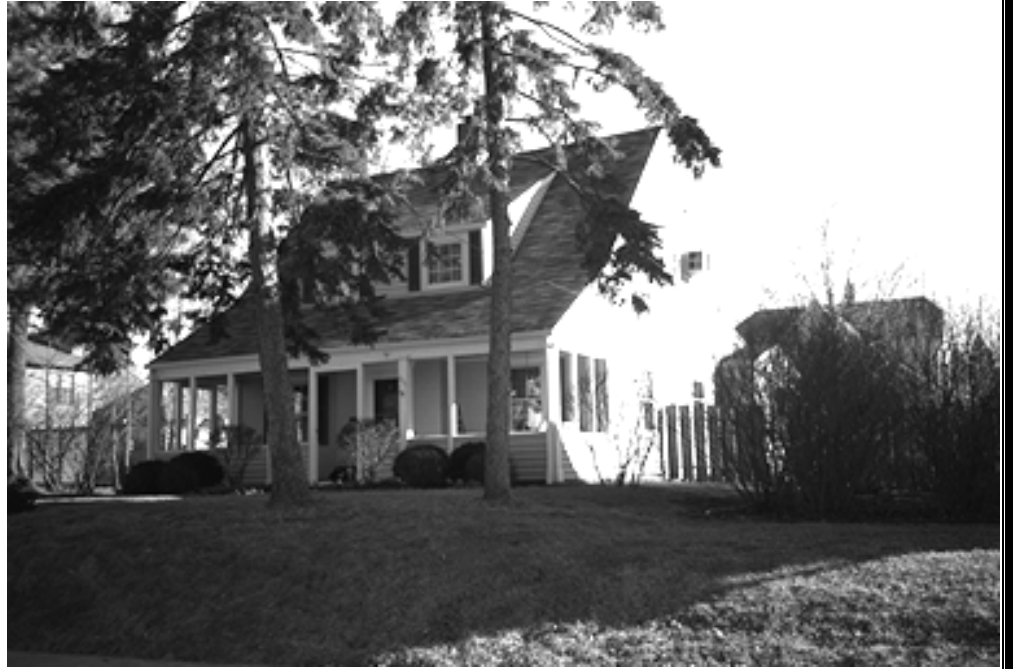
ADDRESS 615 Cedar Street

- ☐ Excellent
- ☒ Good
- ☐ Fair
- ☐ Poor

Architectural Style/Type: <u>Colonial Revival/Cape Cod</u>	Exterior Walls (Current): <u>Clapboard</u>
Architectural Features: _____	Exterior Walls (Original): <u>Clapboard</u>
Date of Construction: <u>1925</u>	Foundation: <u>Concrete</u>
Source: <u>Township Assessors Office</u>	Roof Type/Material: <u>Side Gable/Asphalt shingle</u>
Overall Plan Configuration: <u>Simple Rectangle</u>	Window Material/Type: <u>Wd Trim/Alum/Dbf Hung</u>

ARCHITECTURAL FEATURES: The broad front roof plane flares to cover the porch. 4 square wooden columns originally supported the porch roof. A large shed roofed dormer is placed symmetrically on the front roof. The front door is centered on the front elevation too.

ALTERATIONS: The front porch has been screened in and low clapboard sided walls have been added.
