ARCHITECTURAL SURVEY

NEAR WEST HISTORIC DISTRICT
ST. CHARLES, ILLINOIS

ST. CHARLES HISTORIC PRESERVATION COMMISSION

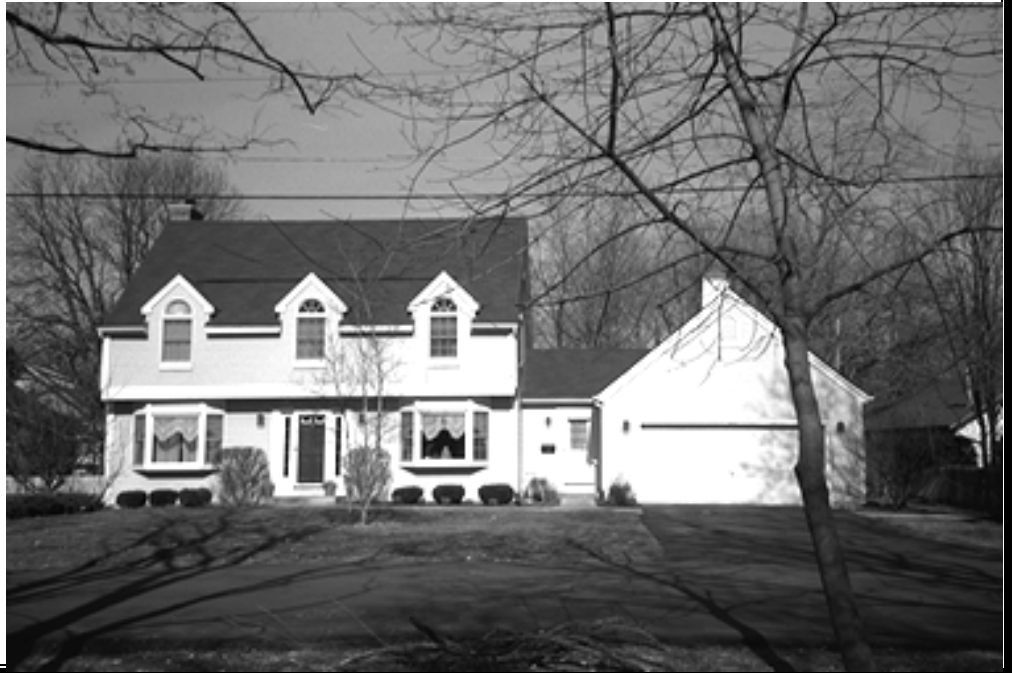
ADDRESS 620 Cutler Street

ARCHITECTURAL FEATURES: This is fundamentally a Garrison Colonial form with the second floor overhang. Fluted pilasters emphasize the entry. The bay windows that flank the entry were popular in the 1950 examples of the style. The three wall dormers on the street elevation feature arch top transoms.

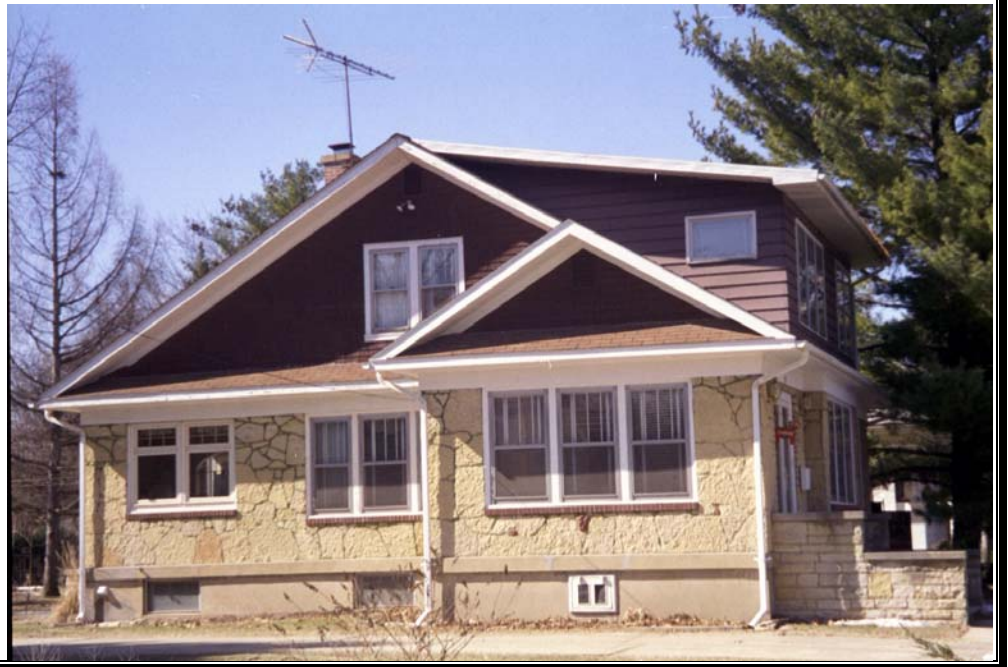
ADDRESS 719 Cutler Street

ARCHITECTURAL FEATURES: The broad random stone pieces are a striking material providing interesting scale relationships with the more traditionally proportioned details of this house. All of the original window openings have brick rowlock sills. The front entry is located off center to the east side of the front elevation. It has its own small side gabled roof integrated into the main roofline. The front steps that lead to the original front double doors are flanked by low stone faced walls. The gable ends are decorated with wood shingles.

ALTERATIONS: The large shed dormer seen on the second floor front elevation is not sympathetic with the original design in material, scale, or detail.

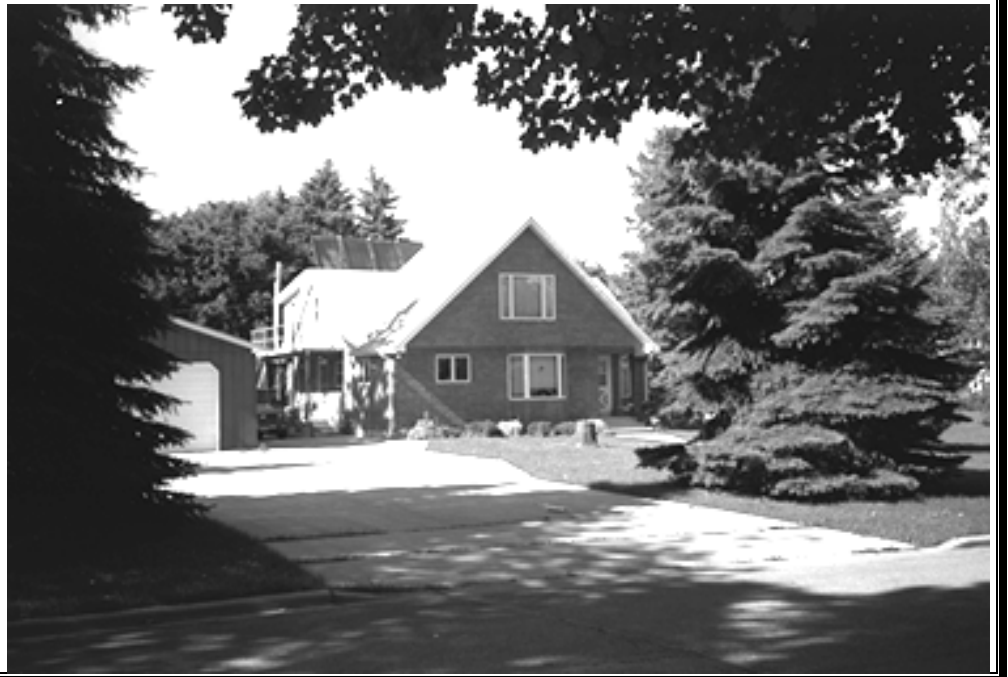
ADDRESS 728 Cutler Street

ARCHITECTURAL FEATURES: The front elevation features a bay window and an off-centered entry. The front entry is covered by the mass of the main roof supported by a large turned wooden column.

ALTERATIONS: The entire front elevation appears to have been changed to the current brick design. The gable ends of the side gables are covered with aluminum siding. There is a wooden stair and platform that was added to the west elevation for access to the 2nd floor. All of the soffits are covered with aluminum.

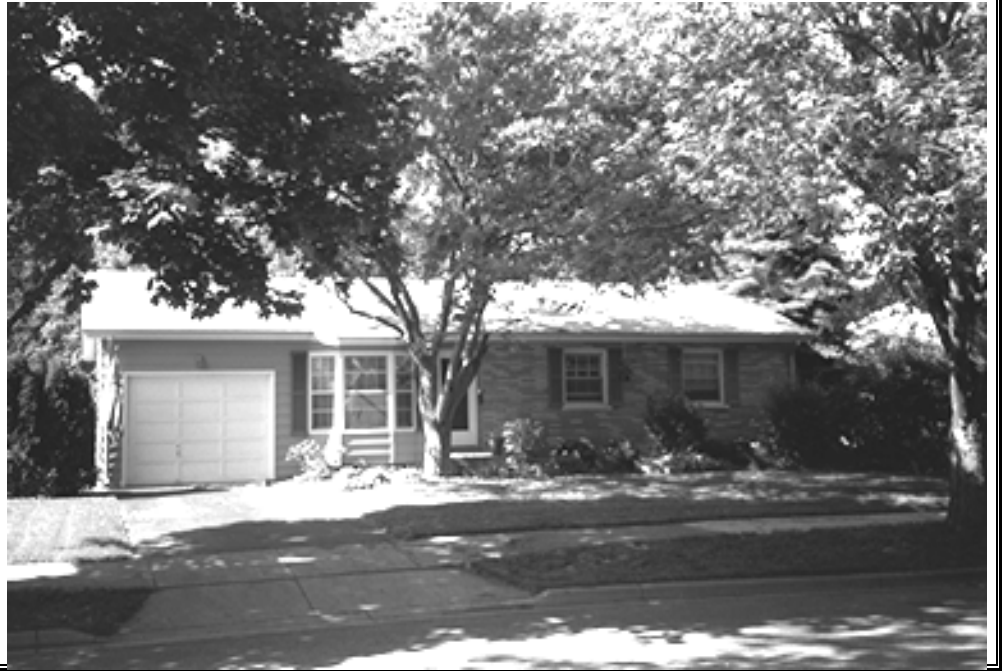
ADDRESS 736 Cutler Street

ARCHITECTURAL FEATURES: This is a small-scaled house with few details. The eaves are narrow and the windows are small. The one-car garage is the most important feature of the original design.

ALTERATIONS: The bay window was added and is covered by an unusual jog in the roof line.

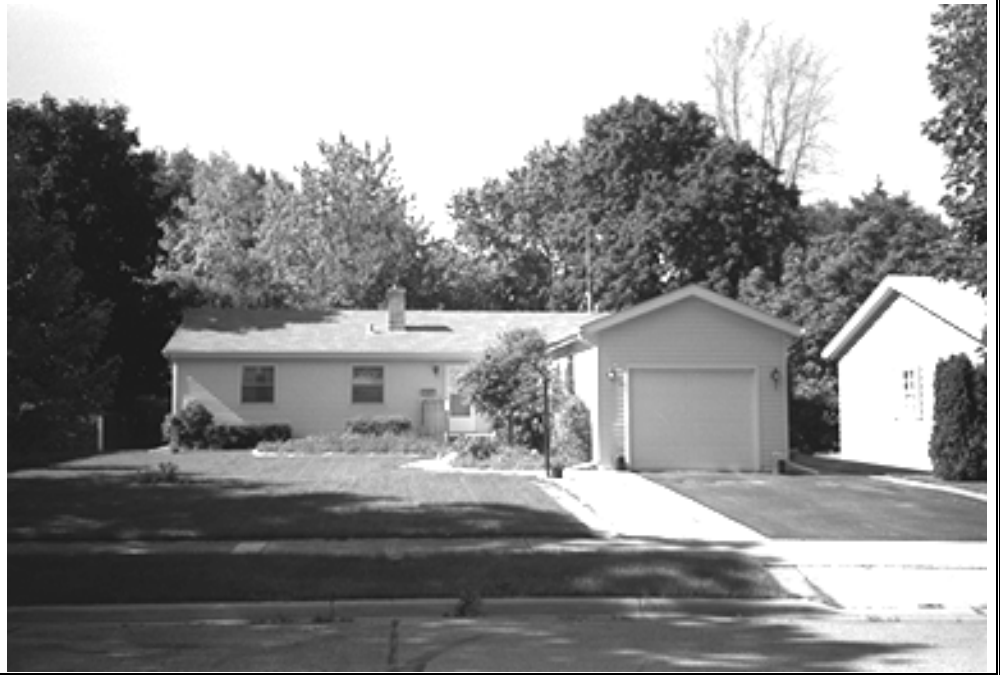
ADDRESS 740 Cutler Street

ARCHITECTURAL FEATURES: This is a modest small-scaled home. The front door is nestled into the corner of the "L". The windows are small and have relatively high sills. The garage is the dominant architectural element of the front façade.

ALTERATIONS: The one-car garage was an addition. The front porch was rebuilt using pressure treated lumber for the deck and the railings. The railings are supported by narrow turned wooden balusters.

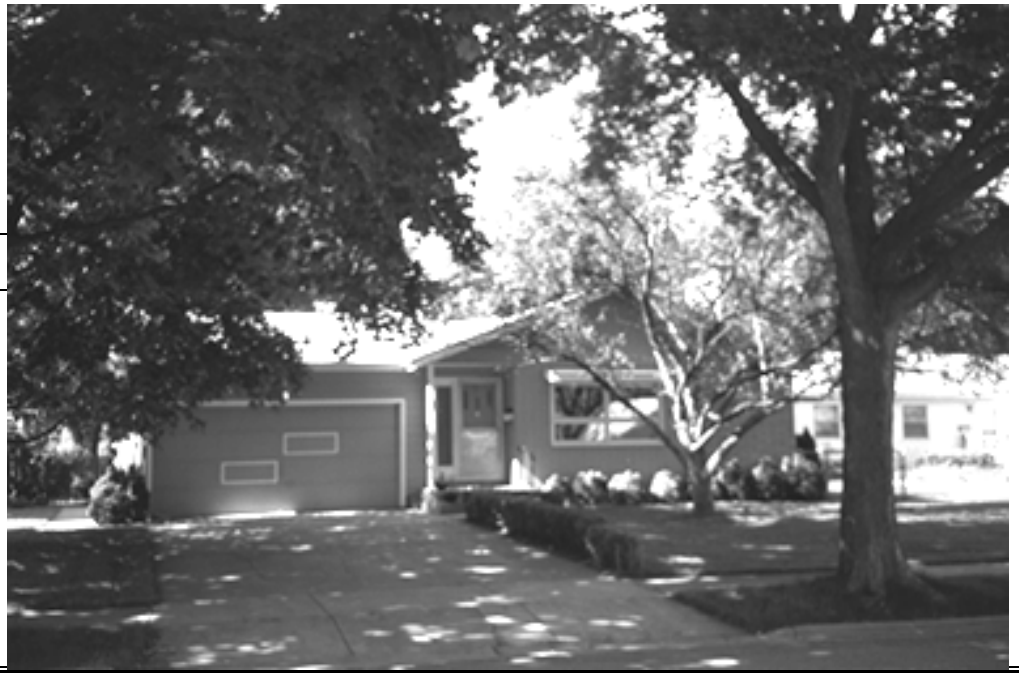
ADDRESS 744 Cutler Street

ARCHITECTURAL FEATURES: There are three different wall treatments on the front façade dominated by the 2 car garage door. Horizontal wood siding is used around the garage door, vertical wood siding around the front door, and brick to the right of the door and on the chimney. The front gable adds interest and scale to the front elevation. The front picture window is divided into 4 lites. The bottom two are operable awning windows.

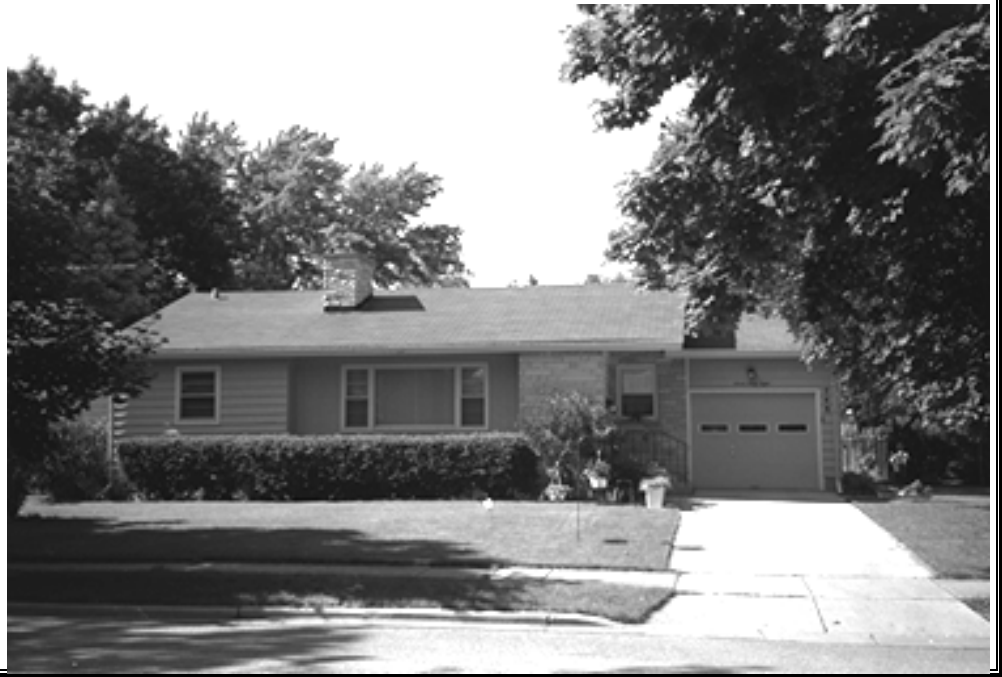
ADDRESS 748 Cutler Street

ARCHITECTURAL FEATURES: The front elevation is sided with both vertical and horizontal wood siding. There is a small area of Lannon stone on the front corner of the house by the garage. The single car garage and the large picture window are the most dominant elements of the front façade. The roof-line is broken at the garage house juncture which serves to de-emphasize the horizontal line of the house.

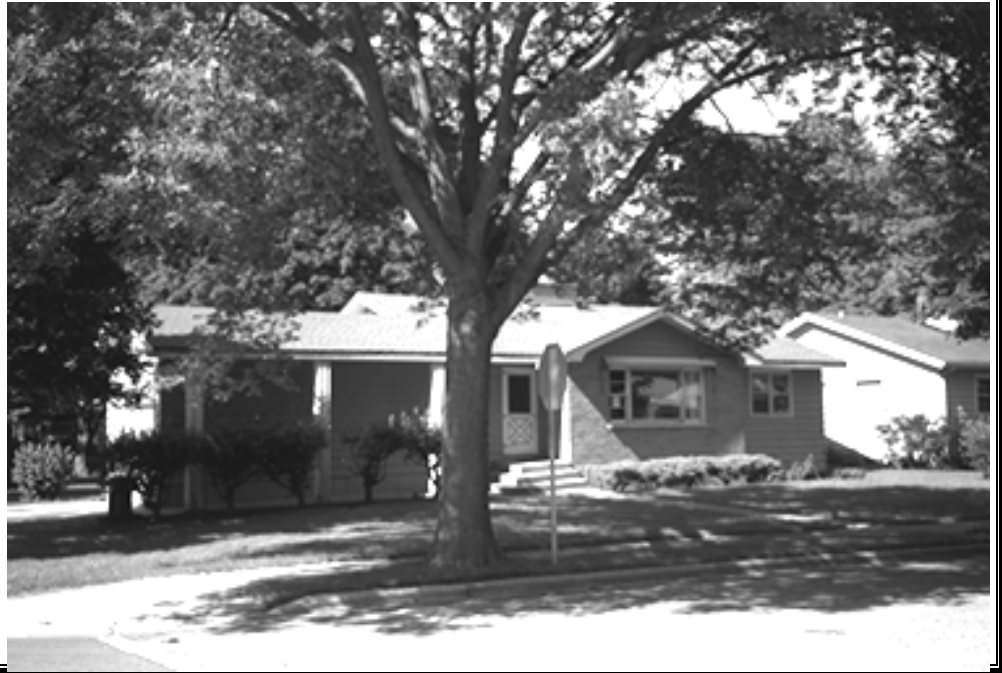
ADDRESS 754 Cutler Street

ARCHITECTURAL FEATURES: A large picture window surrounded with brick is the most important feature of the front elevation. A large retractable awning is located above the picture window. This house has a side-loaded garage. The front entry is not emphasized and the steps leading to it do not have any railings.
