# ARCHITECTURAL SURVEY

NEAR WEST HISTORIC DISTRICT  
ST. CHARLES, ILLINOIS

ST. CHARLES HISTORIC PRESERVATION COMMISSION

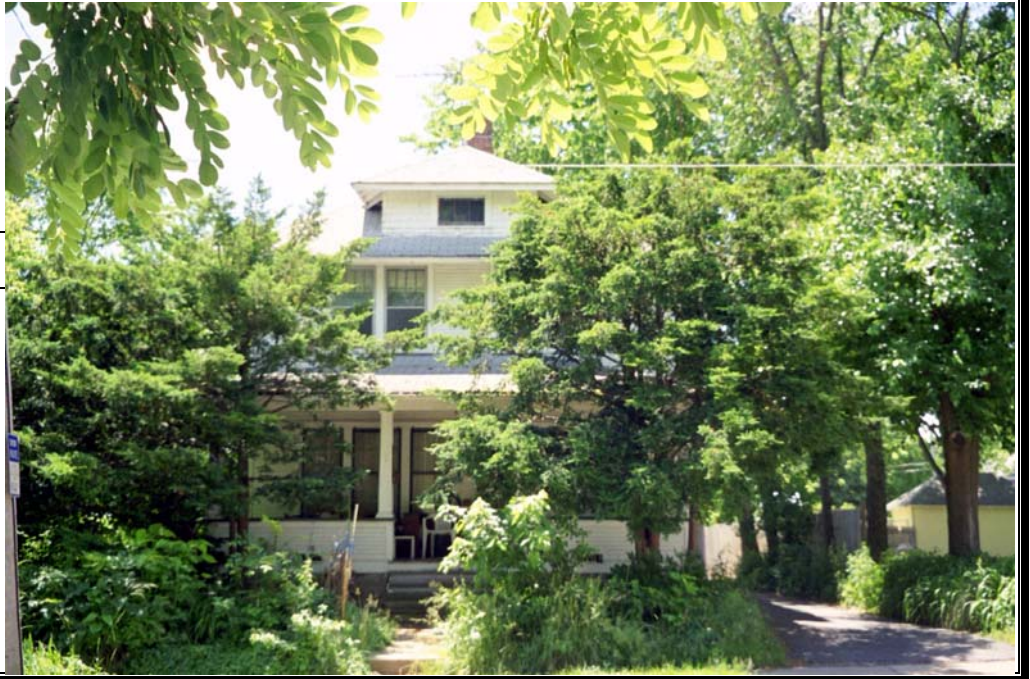
ADDRESS 513 Illinois Street

Architectural Style/Type: Craftsman/ 4 square

Exterior Walls (Current): Clapboard

Date of Construction: 1920

Foundation: Rock faced Concrete block

Roof Type/Material: Hipped/Asphalt

**ARCHITECTURAL FEATURES:** The roof has open eaves with exposed rafter tails. A large roof dormer that has a hipped roof is centered on the front entrance. There is some nice simple detailing around the porch and the window openings. Simply detailed round wood columns bearing on a handrail height wall that encircles the porch support the roof of the full width front porch.

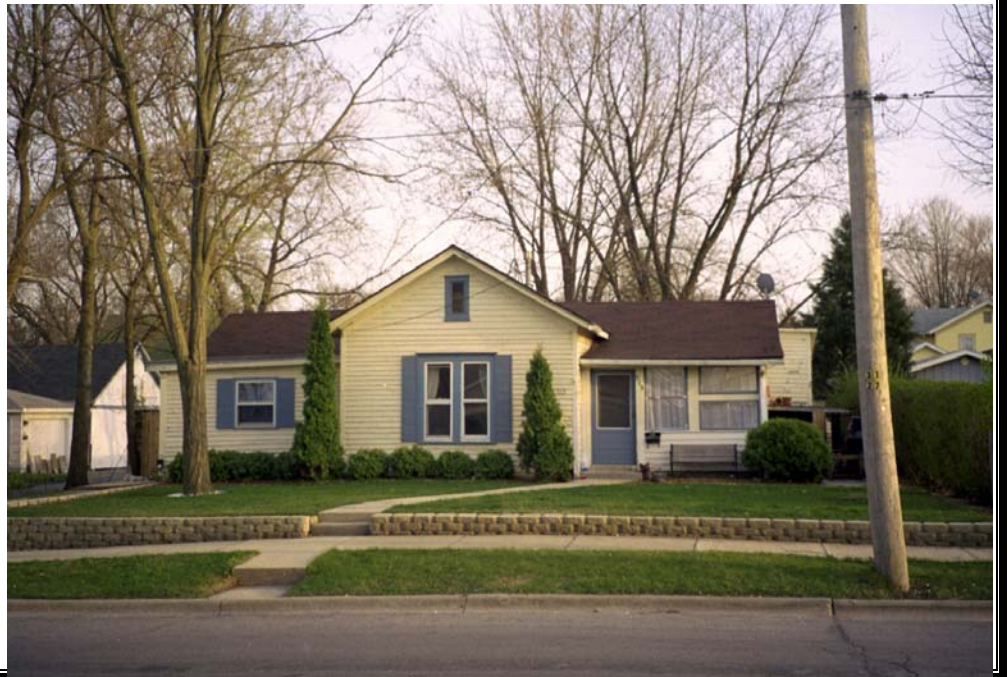
ADDRESS 515 Illinois Street

Architectural Style/Type: National/Cottage

Date of Construction: 1895

Foundation: Parged masonry

Roof Type/Material: Cross gable/Asphalt shingle

**ARCHITECTURAL FEATURES:** The gable form dominates the façade of this small-scaled house. The entry is asymmetrically placed. A frieze board is used at the wall/roof juncture. Corner boards are used to trim the siding at the corners. A break in the roof plane occurs as the main roof approaches the front of the house.

**ALTERATIONS:** The front entry area was remodeled at some point. The windows sizes and configuration is atypical of the rest of the house. The foundation appears to be concrete. An addition appears to have been made to the rear of the house as a small shed roofed area can be seen from the street.

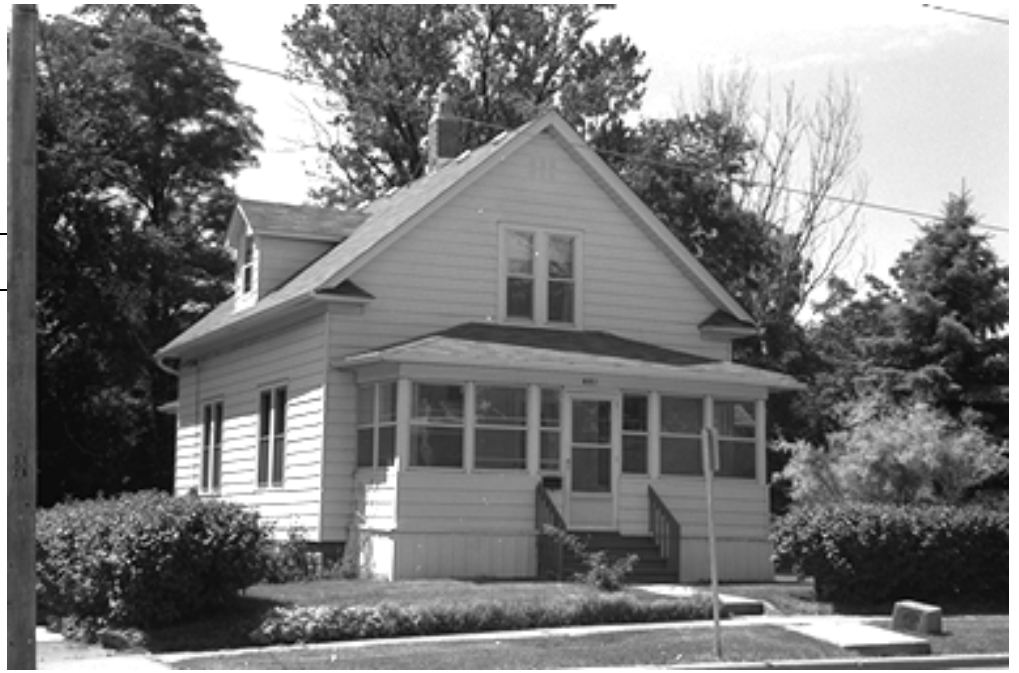
ADDRESS 601 Illinois Street

Architectural Style/Type: <u>National/Front gable</u>	Exterior Walls (Current): <u>Aluminum</u>
Architectural Features: _____	Exterior Walls (Original): <u>Clapboard</u>
Date of Construction: <u>1910</u>	Foundation: <u>Textured Concrete Block</u>
Source: <u>Township Assessor's Office</u>	Roof Type/Material: <u>Front gable/Asphalt</u>
Overall Plan Configuration: <u>Compound L w/ additions</u>	Window Material/Type: <u>Aluminum/Double hung</u>

**ARCHITECTURAL FEATURES:** 1 ½ story with roof dormers on the east and west elevations. This house has a three season front porch and associated front steps that were probably later additions.

**ALTERATIONS:** 1 story additions to the west and south sides have a gabled and flat roof areas. These additions do not relate well to the scale of the original house. The foundation skirt of the front porch has vertical aluminum siding which is not typical of the rest of the house.

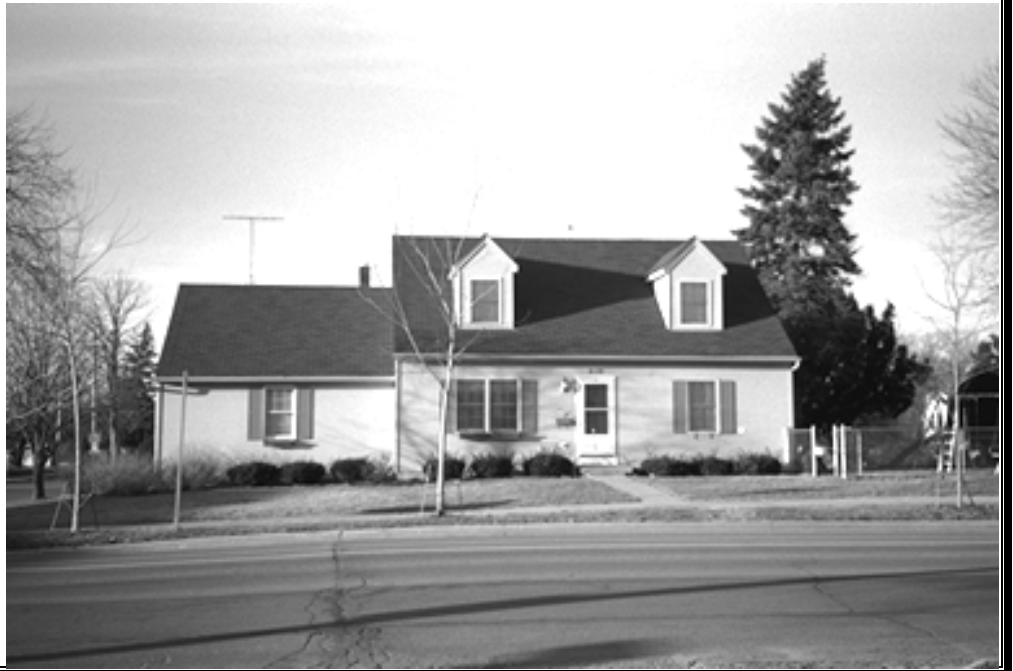
ADDRESS 610 Illinois Street

Architectural Style/Type: Colonial revival/Cape Cod

Exterior Walls (Current): Vinyl on wood frame

Date of Construction: 1988

Roof Type/Material: Side gable/Asphalt

**ARCHITECTURAL FEATURES:** This is new construction. It is a simply detailed interpretation of the original Colonial style. The proportion of the roof to the main body of the house is incorrect, as the slope is not steep enough. The roof dormers are oversized and are out of proportion. This Cape Cod is oversimplified and lacks any of the classic detailing that is commonly part of this style.
