NEAR WEST HISTORIC DISTRICT ST. CHARLES, ILLINOIS

ST. CHARLES HISTORIC PRESERVATION COMMISSION

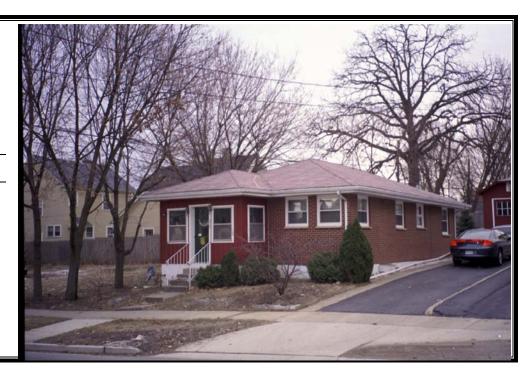
ADDRESS 315 Indiana Street

- ☐ Excellent
- ► Good
- Fair
- □ Poor

ARCHITECTURAL FEATURES: The low horizontal line together with the high windowsills, create an odd sense of proportion. All of the windows are small. The heads of the windows run tight to the boxed soffits.

ALTERATIONS: The porch was added. The window heads do not align with the rest of the window heads. Reverse board and batten siding was used to side the porch.

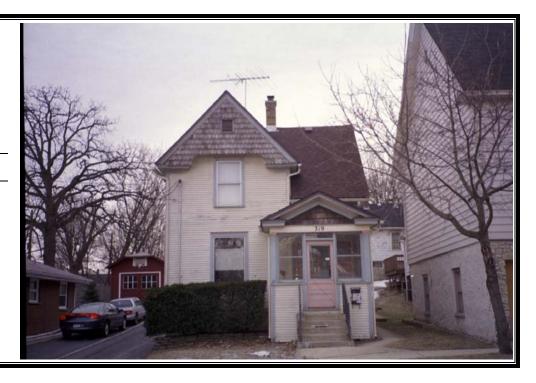
ADDRESS 319 Indiana Street

- Excellent
- □ Good
- ► Fair
- Poor

ARCHITECTURAL FEATURES: A Greek Revival front porch is a curious design element of the front façade. CIP concrete steps with an ornamental wrought iron railing lead the visitor to the entrance. The front gable 1st floor window features a stained glass transom. The eaves are boxed in with wood. A one story bay window is located on the east elevation.

ALTERATIONS: The porch appears to have been added since the rest of the house has a stone foundation. The front gable end has been re-shingled recently.

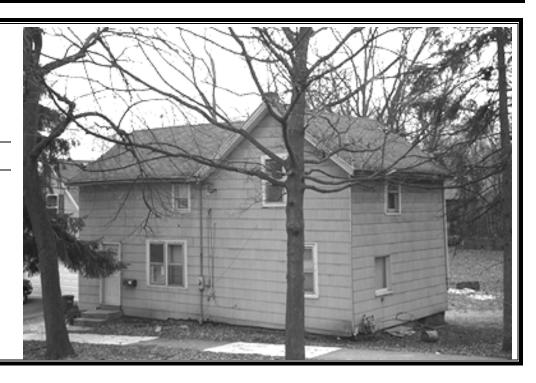
ADDRESS 413 Indiana Street

- Excellent
- Good
- ► Fair
- □ Poor

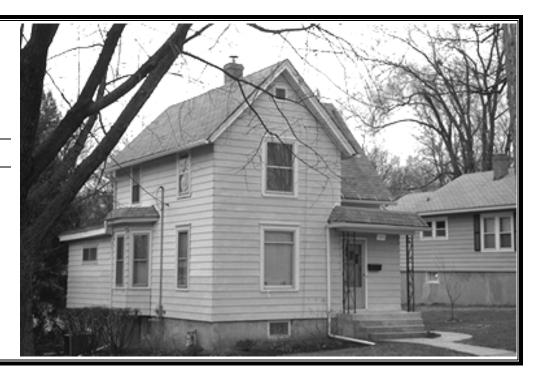
ADDRESS 505 Indiana Street

- Excellent
- **▶** Good
- Fair
- □ Poor

ARCHITECTURAL FEATURES: Simple house with little trim. What trim there is plain. None of the windows have muntin bars.

ALTERATIONS: The additions to the rear and the front entry have flat roofs that are non-conforming with the original roofs. The closed in front porch design with the cast iron columns, front doors, and "mansard" roof edge is unsympathetic with the original house. All of the original trim has been covered with aluminum. The bay window on the east elevation was added at a later date.

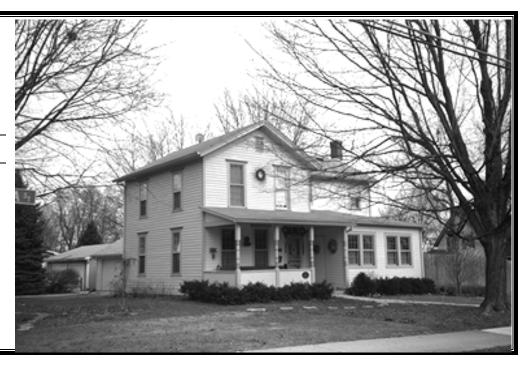
ADDRESS 520 Indiana Street

ARCHITECTURAL FEATURES: The roof of the small front porch at the front gable is supported by three full height turned wood columns. The front gabled mass appears to be the original house, everything else appears to have been added at a later date. The windows have relatively broad flat wooden trim with a shaped piece at the head. There is a continuous frieze molding at the eave and the eaves are relatively narrow. The one story additions have shed type roofs while the two story east wing is a cross gable relative to the original roof.

ALTERATIONS: It appears that the porch, the east 2 story & 1-story wing, and the small rear entry were added at a later date. All of the additions were sensitively designed and, for the most part, are sympathetic to the original house.

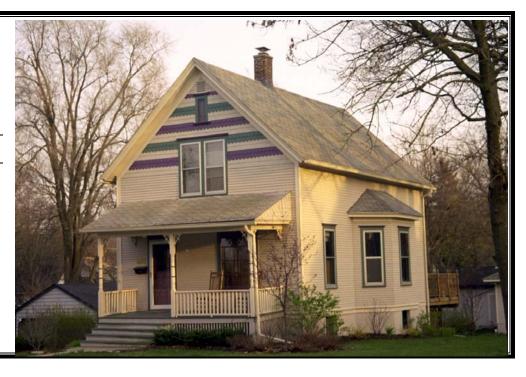
ADDRESS 521 Indiana Street

ARCHITECTURAL FEATURES: The front porch, which features turned columns and ornamental wooden brackets, runs the full width of the house. The balusters are square, indicating that they were probably replaced. This is a simple, unassuming house with the charming character of the Victorian style. Fish scale shingles articulate the front gable under the narrow overhang. A one story bay adds interest to the side elevation.

ALTERATIONS: The porch balusters were replaced.

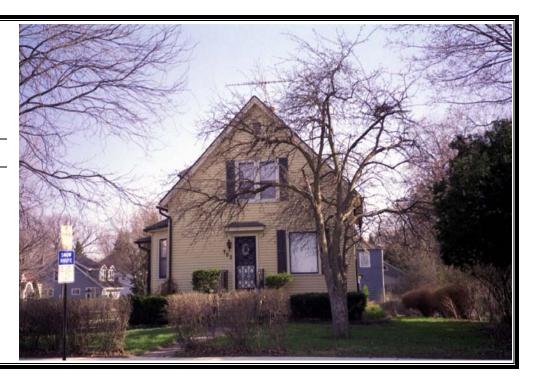
ADDRESS 703 Indiana Street

- Excellent
- □ Good
- ▶ Fair
- □ Poor

ARCHITECTURAL FEATURES: The basic form of the original Cape Cod is in tact. Any original details have been concealed through remodeling.

ALTERATIONS: An addition was made to the east side of the house that has jalousie windows and a shallow pitched hipped roof. Another addition was made to the south side of the house that features a flat roof encircled with a wrought iron railing. The additions have concrete foundations. Wooden steps with wrought iron railings reach the front door. A wrought iron storm door was installed during remodeling.

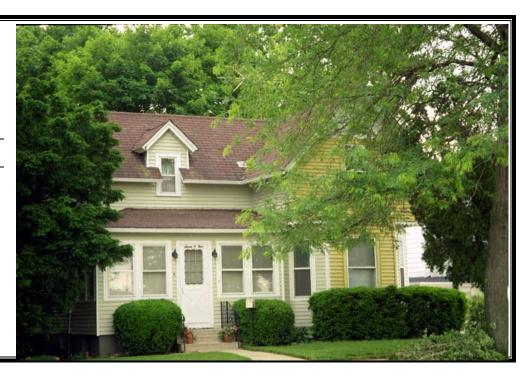
ADDRESS 709 Indiana Street

- ► Excellent
- □ Good
- Fair
- □ Poor

ARCHITECTURAL FEATURES: The dominant front gable has cutaway corners w/ some scalloped trim. There is fish-scale siding above the second floor window located in the front gable. A gabled roofed wall dormer is centered over the front entry. A four season front porch serves as the entry. This house is relatively simply detailed than is typical for the style.

ALTERATIONS: The front porch was added after the original house was built. The detailing is not sympathetic to the original. The window trim, the front storm door, and the light fixtures do not fit with the rest of the house. The soffits are aluminum. A typical Victorian porch would have been open with the roof being supported with freestanding columns.

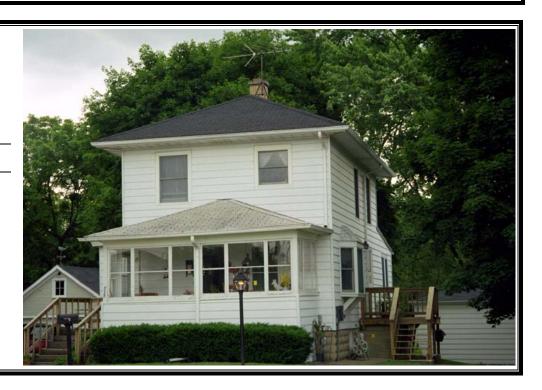
ADDRESS 715 Indiana Street

- ► Excellent
- □ Good
- □ Fair
- Poor

ARCHITECTURAL FEATURES: The pyramidal roof is the most distinguishable remaining architectural feature of the original house. The wide eaves may have originally been open but it is not possible to tell as they are currently boxed in with aluminum. The windows surrounds are very plainly detailed.

ALTERATIONS: The closed in four season porch is an obvious later addition as is the rear 1 story area with the shed roof. The aluminum siding, soffits, and windows were also later modifications. Little remains of the original wood detailing. Two entry stairs that were constructed with pressure treated wood have been added to the east and west sides of the house. A bay window has been added to the west side of the house.
