# ARCHITECTURAL SURVEY

## NEAR WEST HISTORIC DISTRICT

### ST. CHARLES, ILLINOIS

ST. CHARLES HISTORIC PRESERVATION COMMISSION

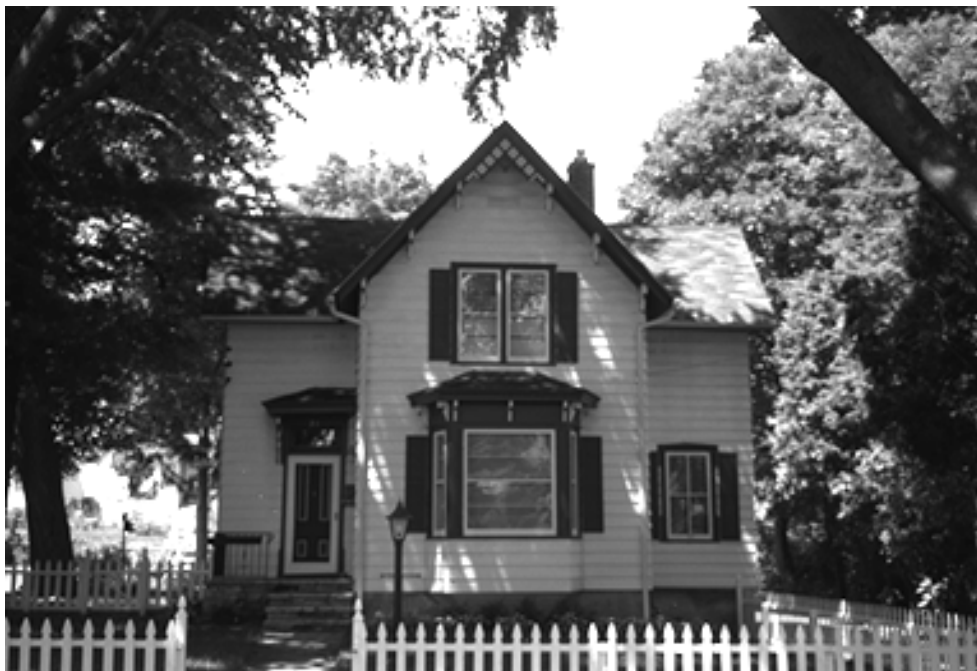
ADDRESS 315 South 5<sup>th</sup> Street

- ☐ Excellent
- ☐ Good
- ☒ Fair
- ☐ Poor

Architectural Style/Type:	<u>Victorian-Folk Victorian</u>	Exterior Walls (Current):	<u>Aluminum</u>
Architectural Features:	<u></u>	Exterior Walls (Original):	<u>Clapboard</u>
Date of Construction:	<u>1860</u>	Foundation:	<u>Parged masonry</u>
Source:	<u>Township Assessor's Office</u>	Roof Type/Material:	<u>Cross gable/Asphalt Shingle</u>
Overall Plan Configuration:	<u>Compound-Cross</u>	Window Material/Type:	<u>Wood/DbI Hung/ Removable storms</u>

**ARCHITECTURAL FEATURES:** The front gable is the dominant architectural element of the façade. A small-hipped roof supported by ornate wooden brackets tops a one-story bay window on the ground floor of the front gable. Wooden brackets support the overhang and patterned vergeboards decorate the peak of the front gable. Carved wooden brackets support a small-hipped roof over the entrance located off center to the left of the front gable. Modest pediment forms are typically used over the window heads. The front stoop is constructed with native stone and appears to be original construction.

**ALTERATIONS:** A small-screened porch was added to the rear of the house. The front storm door is aluminum.

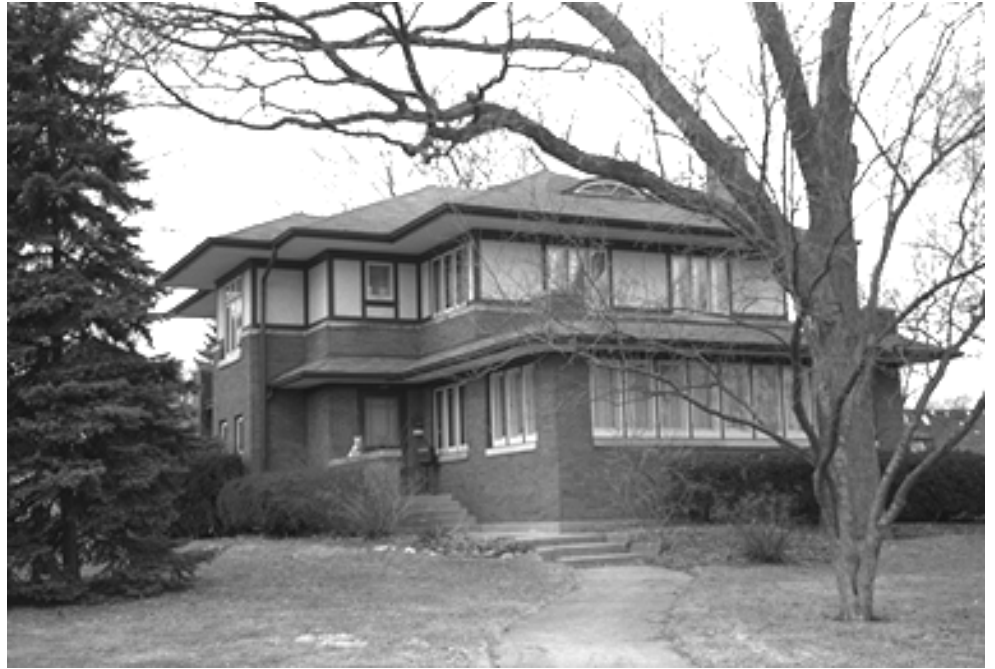
ADDRESS 325 South 6<sup>th</sup> Street

- ☒ Excellent
- ☐ Good
- ☐ Fair
- ☐ Poor

Architectural Style/Type: Prairie Style

**ARCHITECTURAL FEATURES:** The first floor is articulated with banded wood casement windows situated in brick with similar windows in stucco used on the second floor. The proportions of the window module typify this style. The hierarchy of the materials used is indicative of this style of architecture. The hipped roof has the broad overhangs that are also typical of the Prairie style.

ALTERATIONS: None

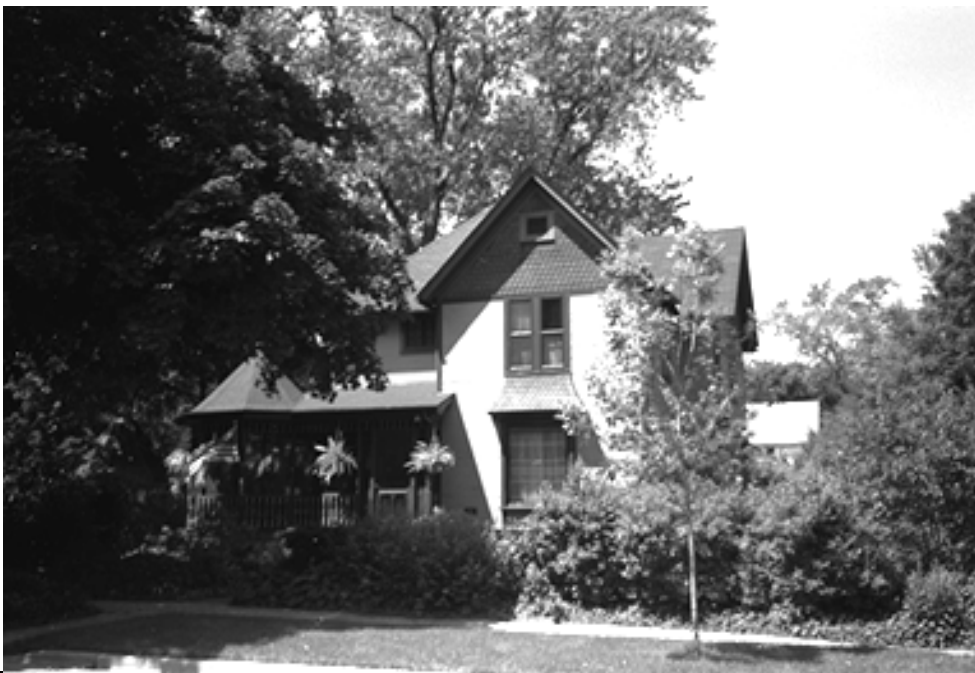
ADDRESS 403 South 6<sup>th</sup> Street

- Excellent
- ☐ Good
- ☐ Fair
- ☐ Poor

Architectural Style/Type:	<u>Victorian/Queen Anne</u>	Exterior Walls (Current):	<u>Clapboard</u>
Architectural Features:	<u></u>	Exterior Walls (Original):	<u>Clapboard</u>
Date of Construction:	<u>1898</u>	Foundation:	<u>Stone/Brick</u>
Source:	<u>Landmark Application</u>	Roof Type/Material:	<u>Hipped w/lower cross gables/ Asphalt shingle</u>
Overall Plan Configuration:	<u>Compound</u>	Window Material/Type:	<u>Wood/Dbl Hung/Removable Storms</u>

**ARCHITECTURAL FEATURES:** An abundance of spindle-work details articulate the front porch. The roof over the porch is supported by turned columns and prominently features a faceted turret at the corner. The gable ends have the characteristic fish-scale shingles (imbrication). A small curving roof that covers the front picture window in the gable end is also imbricated. The corners of the north gable end are cut away. The eaves are open and are covered with plywood.

**ALTERATIONS:** The front porch has been screened in and a nicely detailed reproduction Victorian screened door installed.

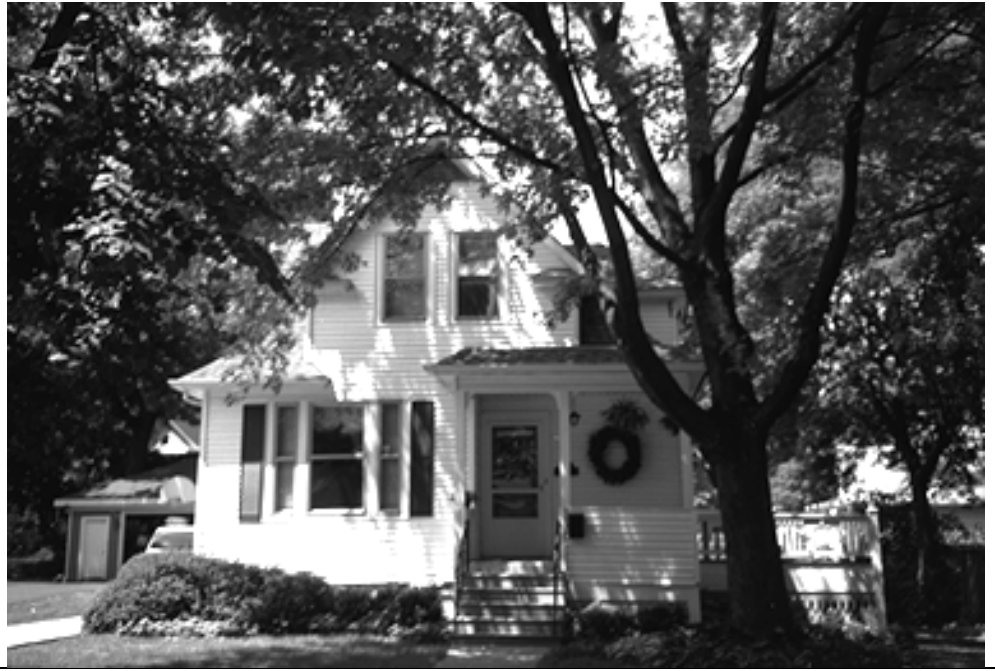
ADDRESS 411 South 6<sup>TH</sup> Street

- ☒ Excellent
- ☐ Good
- ☐ Fair
- ☐ Poor

Architectural Style/Type: Victorian - Folk

**ARCHITECTURAL FEATURES:** The front gable and the small front porch are the dominant elements of this façade. The street elevation is small scaled, almost cottage like. Two leaded glass windows flank a larger window on the ground floor. Simple square columns and small simple brackets support the roof over the porch that overlaps the front gable. A hipped roof dormer and a shed dormer are placed on the north side of the roof.

**ALTERATIONS:** It appears that a 1½-story addition was made to the rear of the house that is compatible with the original design. The wooden deck to the rear incorporates Victorian detailing in the skirting, newels, finials, and the center panels of the balustrade. It is sensitively integrated into the architecture of the house. A new aluminum storm door protects the original ½ light wooden door.

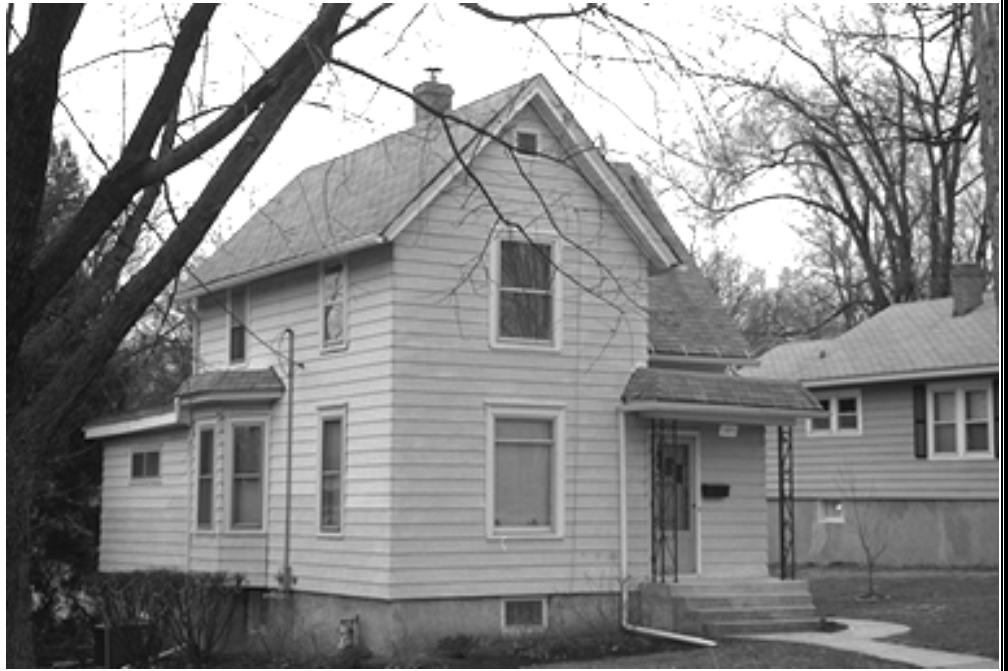
ROLL-IMAGE # 3436 - 5

Architectural Style/Type:	<u>National/Front Gable &amp; wing</u>	Exterior Walls (Current):	<u>Aluminum on wood frame</u>
Architectural Features:	<u></u>	Exterior Walls (Original):	<u>Clapboard on wood frame</u>
Date of Construction:	<u>1925</u>	Foundation:	<u>Parged stone</u>
Source:	<u>Township Assessor's Office</u>	Roof Type/Material:	<u>Cross gable/Asphalt single</u>
Overall Plan Configuration:	<u>Compound w/ additions</u>	Window Material/Type:	<u>Alum/Double Hung</u>

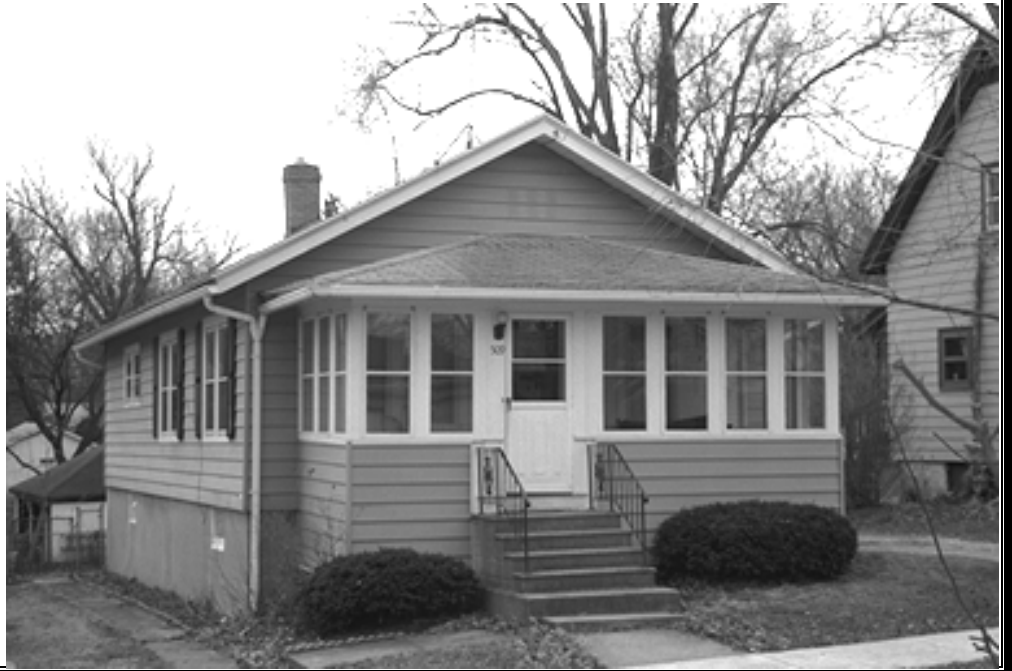
ROLL-IMAGE # 3436 - 6

- ☐ Significant
- ☐ Contributing
- ☒ Non-Contributing
- ☐ Potential for Individual National Register Designation

Foundation: Concrete

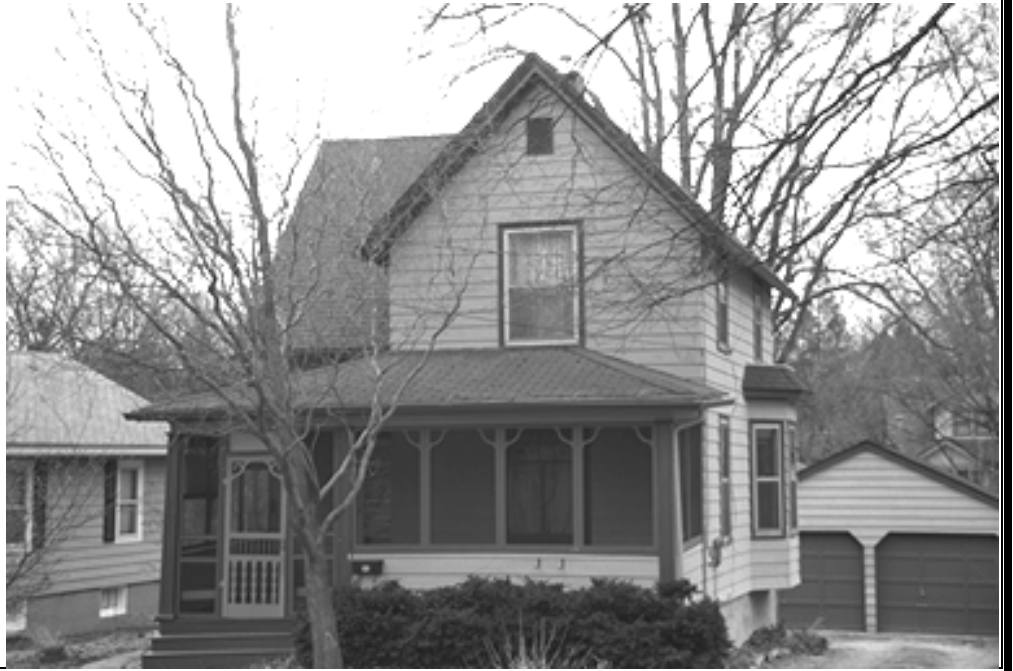
ROLL-IMAGE # 3436 - 7

- ☐ Significant
- ☒ Contributing
- ☐ Non-Contributing
- ☐ Potential for Individual National Register Designation

Foundation: Parged stone

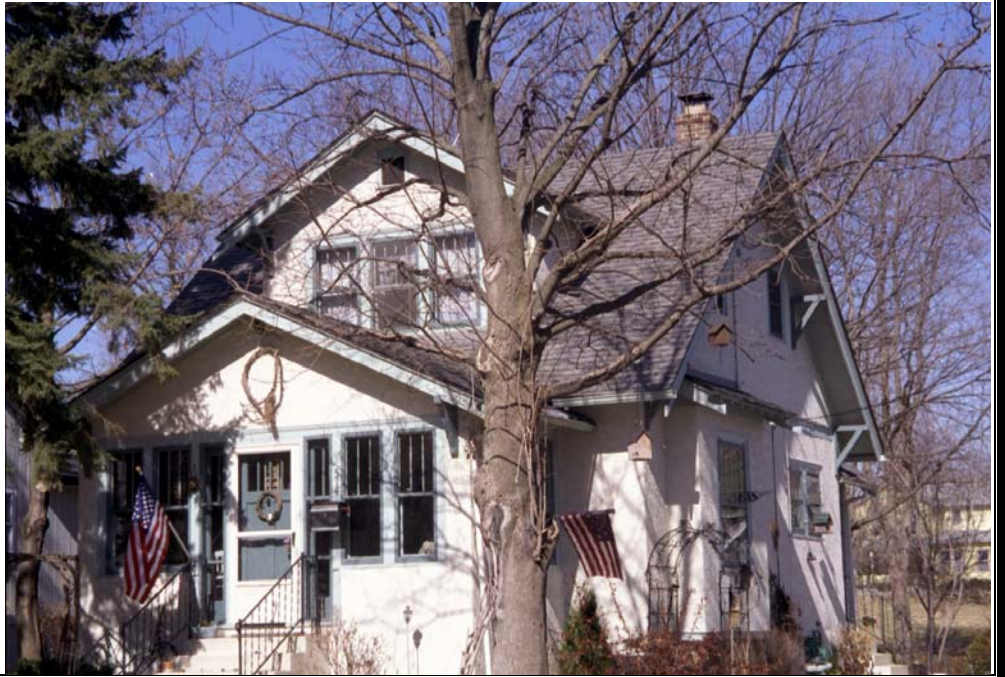
ROLL-IMAGE # 2727 - 12

Architectural Style/Type: <u>Craftsman</u>	Exterior Walls (Current): <u>Stucco</u>
Architectural Features: _____	Exterior Walls (Original): <u>Stucco</u>
Date of Construction: <u>1923</u>	Foundation: <u>Stucco finish over masonry</u>
Source: <u>Township Assessor's Office</u>	Roof Type/Material: <u>Side gable/Asphalt shingle</u>
Overall Plan Configuration: <u>Simple rectangle</u>	Window Material/Type: <u>Wd/DbI hung/Rem. storms</u>

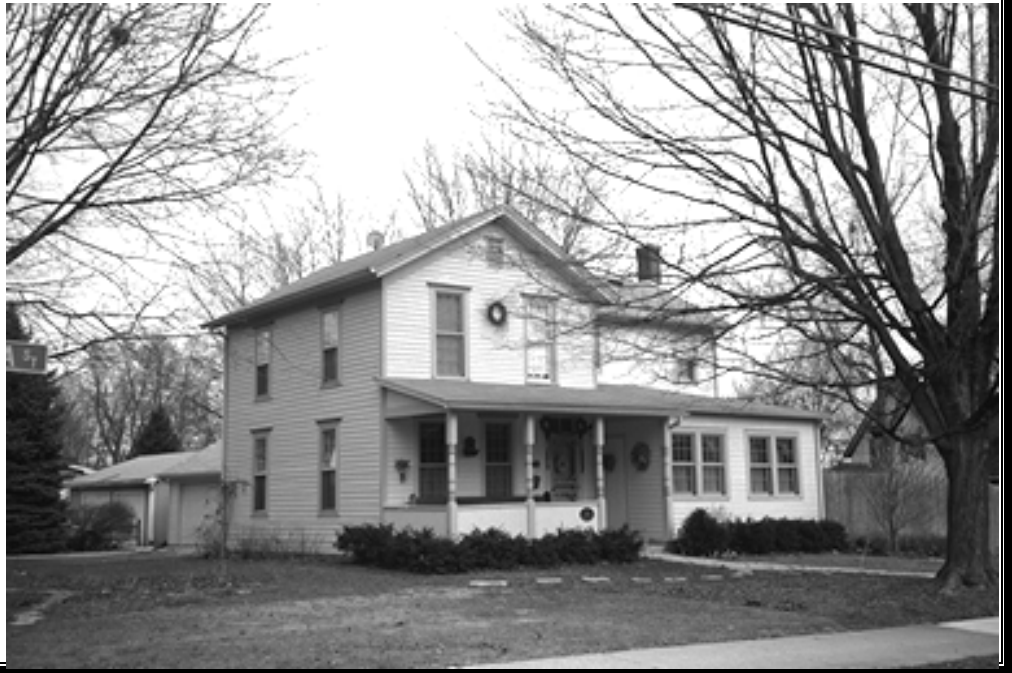
ROLL-IMAGE # 3435 - 24

Architectural Style/Type:	<u>Greek Revival</u>	Exterior Walls (Current):	<u>Clapboard on wood frame</u>
Architectural Features:	<u></u>	Exterior Walls (Original):	<u>Clapboard on wood frame</u>
Date of Construction:	<u>1870</u>	Foundation:	<u>Stone</u>
Source:	<u>Township Assessor's Office</u>	Roof Type/Material:	<u>Gable front &amp; wing/Asphalt</u>
Overall Plan Configuration:	<u>Compound mass w/ additions</u>	Window Material/Type:	<u>Aluminum/Double hung 6:6</u>

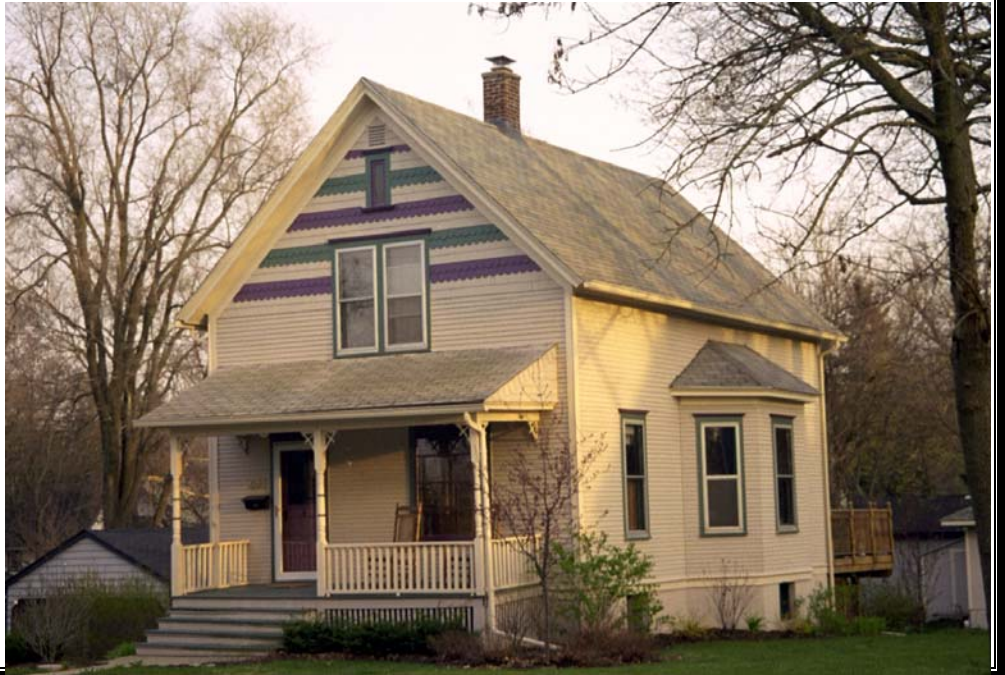
ROLL-IMAGE # 3299 - 9

**ARCHITECTURAL FEATURES:** The front porch, which features turned columns and ornamental wooden brackets, runs the full width of the house. The balusters are square, indicating that they were probably replaced. This is a simple, unassuming house with the charming character of the Victorian style. Fish scale shingles articulate the front gable under the narrow overhang. A one story bay adds interest to the side elevation.

**ALTERATIONS:** The porch balusters were replaced.

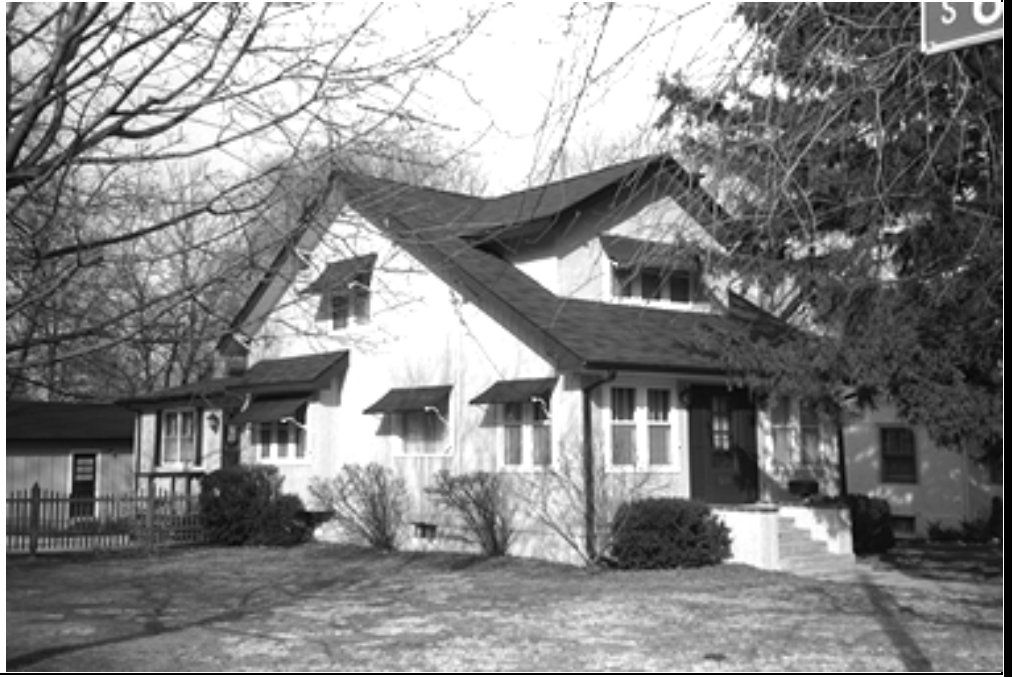
ROLL-IMAGE # 3434 - 11

Architectural Style/Type:	<u>Craftsman</u>	Exterior Walls (Current):	<u>Reverse Bd. &amp; Batten Wood Siding</u>
Architectural Features:	<u></u>	Exterior Walls (Original):	<u>Stucco</u>
Date of Construction:	<u>1926</u>	Foundation:	<u>Concrete</u>
Source:	<u>Township Assessor's Office</u>	Roof Type/Material:	<u>Side gable/Asphalt shingle</u>
Overall Plan Configuration:	<u>Simple rectangle w/addition</u>	Window Material/Type:	<u>Wd trim/Alum/Dbh hung</u>

**ALTERATIONS:** The house been resided in wood. The windows have been replaced with aluminum. The eaves have been covered with aluminum. There was a small one-story addition made to the north side of the house that features a gable roof and a brick veneered foundation
