NEAR WEST HISTORIC DISTRICT ST. CHARLES, ILLINOIS

ST. CHARLES HISTORIC PRESERVATION COMMISSION

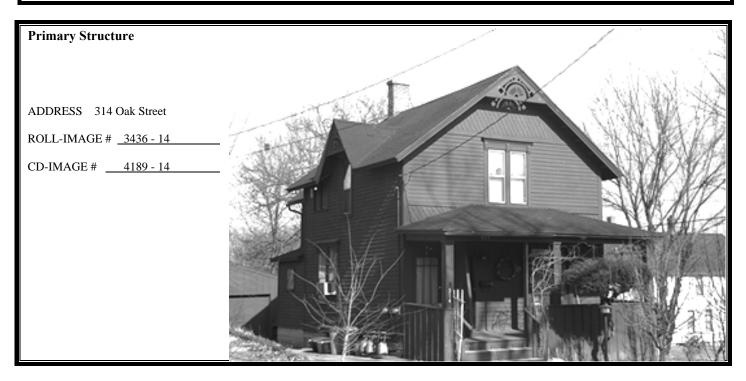
- Excellent
- ► Good
- 🗆 Fair
- Poor

Architectural Style/Type:	Victorian	Exterior Walls (Current):	Clapboard
Architectural Features:		Exterior Walls (Original):	Clapboard
Date of Construction:	1015	Foundation:	*
	1915 Township Assessor's Office		Cross-gable/Asphalt
Overall Plan Configuration:	Compound-mass	Window Material/Type:	Alum & wood/dbl. hung
U	4	7 1

ARCHITECTURAL FEATURES: Fish-scale siding is typical at all of the gables of the original house. An intricately detailed bargeboard crowns the peak of the main front gable, as well as the cross gables. The window detailing is elaborate. A wooden pilaster topped with brackets flank the openings on the original windows, which are topped with nicely detailed header trim. A full width porch is a dominant element of the front façade. It appears to have been added as the detailing does not match the rest of the original house.

ALTERATIONS: There is an addition toe the rear of the house that features a hipped roof. The detailing of this addition does not match the original house. The windows are wooden with removable fixed sashes and have simple trim. The siding is board and batten that matches the front porch that also appears to have been added at a later date. There is another 2-story addition to the north that appears to have preceded the others. It follows the original house more closely than the later additions.

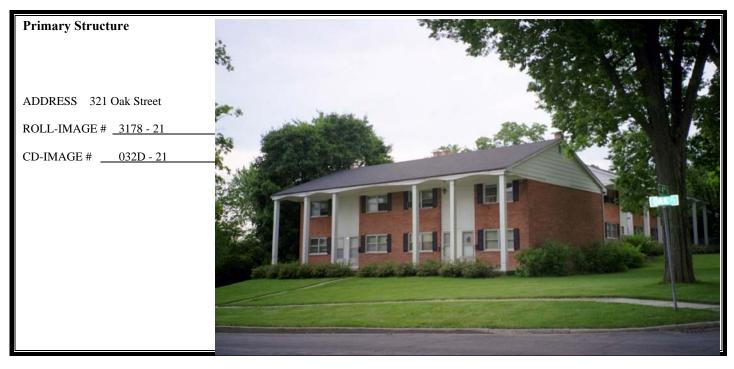
- Excellent
- ► Good
- □ Fair
- Poor

Architectural Style/Type:	Colonial Revival/Apt.	Exterior Walls (Current):	Brick veneer on wood frame/
			Wd. siding
Architectural Features:		Exterior Walls (Original):	Brick veneer on wood frame/
			Wd siding
Date of Construction:	1964	Foundation:	Concrete
Source:	Township Assessors Office	Roof Type/Material:	Side gable/Asphalt shingle
Overall Plan Configuration:	Rectangular	Window Material/Type:	Alum/Double Hung

ARCHITECTURAL FEATURES: 2 story white square columns support the full width front porch. The paired windows are typical for the style.

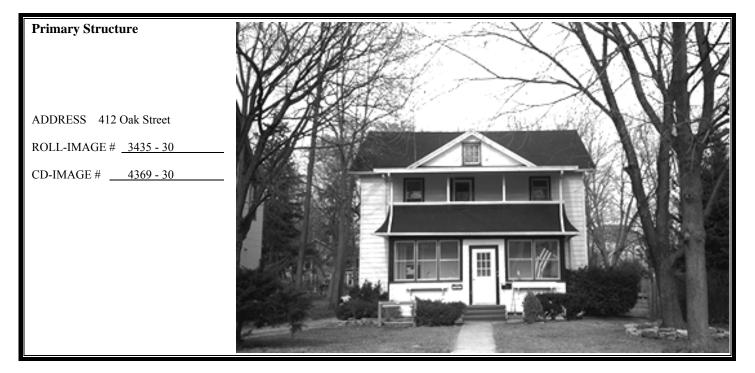
- Excellent
- □ Good
- ► Fair
- Poor

Architectural Style/Type:	Eclectic/Colonial revival	Exterior Walls (Current):	Aluminum
Architectural Features:		Exterior Walls (Original):	Clapboard
Date of Construction: Source:	1910 Township Assessor's Office		Parged masonry Cross gable/Asphalt shingle
Overall Plan Configuration:	Simple rectangle	Window Material/Type:	Alum/Dbl hung

ARCHITECTURAL FEATURES: The centered gable on the front indicates that this was a more formal and symmetrical elevation prior to the remodeling.

ALTERATIONS: The front elevation has been compromised by the haphazard porch and balcony addition. This addition had nothing to do with the original style. The original detailing was further obscured when the aluminum siding was installed. The integrity of the formal front entry was also compromised by the porch addition. A 1 story addition was made to the rear of the house.

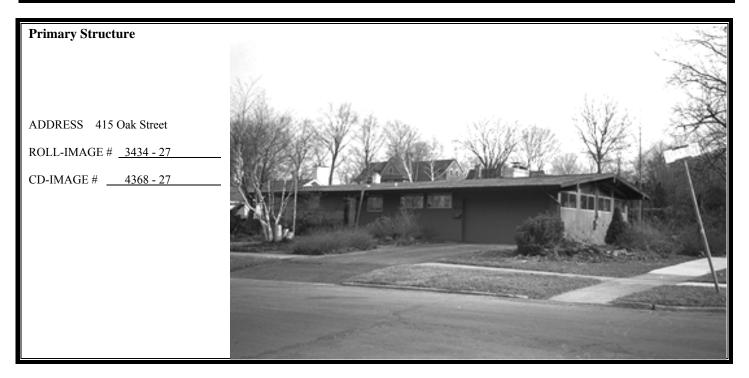
- Excellent
- ► Good
- 🗆 Fair
- Poor

Architectural Style/Type:	Modern/California ranch	Exterior Walls (Current):	Vertical wood siding/Stone
Architectural Features:		Exterior Walls (Original):	Vertical wood siding/Stone
Date of Construction: Source:	1956 Township Assessor's Office	Foundation: Roof Type/Material:	Concrete Side gable/Asphalt shingle
Overall Plan Configuration:	Simple rectangle	Window Material/Type:	Alum/Sliders

ARCHITECTURAL FEATURES: This house has a low horizontal character. The narrow horizontal band of high windows accentuates the horizontal line. The roof seems to float over the walls of the house as a result of the use of wide overhangs, narrow fascia, and the high band of windows. A large expanse of glass placed high on the west elevation covered by a wide overhang supported by cantilevered wooden beams contributes to the floating character of the roof. Lannon stone was used to accentuate the front entry area. The garage door opening is integrated into the front elevation – it does not dominate.

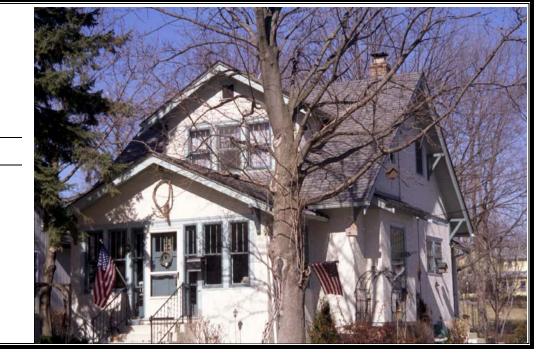
- ADDRESS 514 Oak Street
- ROLL-IMAGE # <u>2727 12</u>
- CD-IMAGE # 0298 12

- □ Excellent
- ► Good
- 🗆 Fair
- Poor

Architectural Style/Type:	Craftsman	Exterior Walls (Current):	Stucco
Architectural Features:		Exterior Walls (Original):	Stucco
Date of Construction: Source:	1923 Township Assessor's Office		Stucco finish over masonry Side gable/Asphalt shingle
Overall Plan Configuration:	Simple rectangle	Window Material/Type:	Wd/Dbl hung/Rem. storms

ARCHITECTURAL FEATURES: A consistent vocabulary of wood detailing around the window and door openings as well as the wood brackets and exposed rafter tails makes this a good example of the style. The wide overhangs and eaves are also typical for the style. The fascia boards have a curved cutout detail at the eave line. A narrow band of wood trim separates the first and second floors. Many of the windows are grouped in twos and threes. The windows have a 3:1 muntin pattern.

ALTERATIONS: The aluminum front door and wrought iron railings are inconsistent.

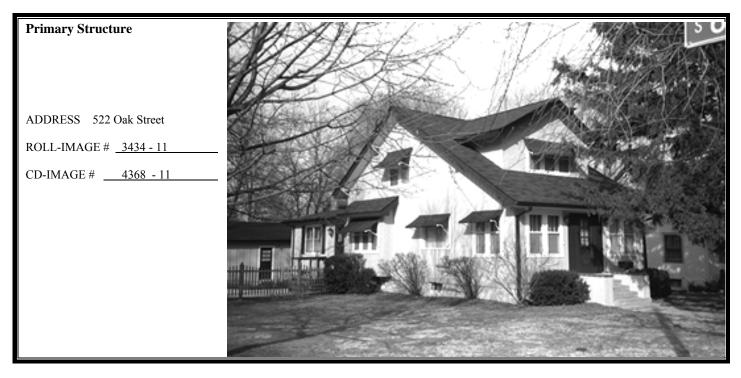
- □ Excellent
- ► Good
- 🗆 Fair
- Poor

Architectural Style/Type:	Craftsman	Exterior Walls (Current):	Reverse Bd. & Batten Wood
			Siding
Architectural Features:		Exterior Walls (Original):	Stucco
Date of Construction:	1926	Foundation:	Concrete
Source:	Township Assessor's Office	Roof Type/Material:	Side gable/Asphalt shingle
Overall Plan Configuration:	Simple rectangle w/addition	Window Material/Type:	Wd trim/Alum/Dbl hung

ARCHITECTURAL FEATURES: The overall character of this house is very similar to 514 Oak – next door. Wood brackets that support the wide roof overhangs and the wood trim around the window and door openings are some remaining details of the original design. The roof dormer on the front elevation is still sided with the original stucco finish.

ALTERATIONS: The house been resided in wood. The windows have been replaced with aluminum. The eaves have been covered with aluminum. There was a small one-story addition made to the north side of the house that features a gable roof and a brick veneered foundation

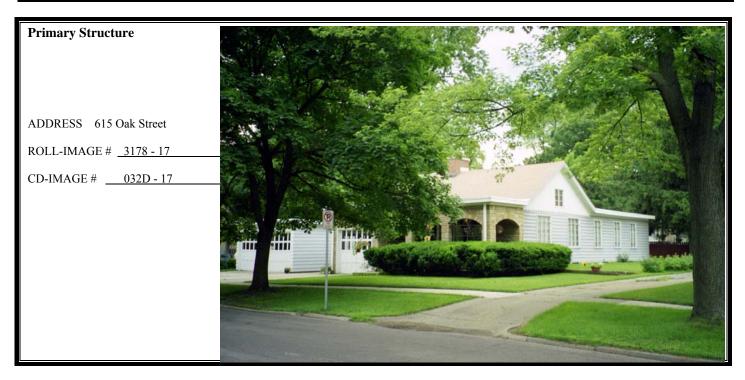
- Excellent
- ► Good
- Fair
- Poor

Architectural Style/Type:	Modern ranch	Exterior Walls (Current):	Aluminum/Stone
Architectural Features:		Exterior Walls (Original):	Aluminum
	1951 Township Assessor's Office	Foundation: Roof Type/Material:	Concrete Side gable/Asphalt shingle
Overall Plan Configuration:	Simple w/ additions	Window Material/Type:	Steel/Casements/Transoms

ALTERATIONS: Most of the original house has been concealed with additions. A Lannon stone porch with segmented arch openings was added to the front to conceal the bulk of a one-car garage. A large one-story flat roofed addition was made to the rear.

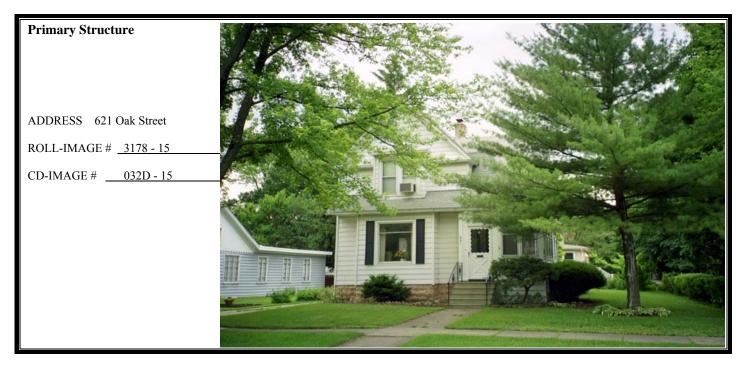
- Excellent
- ► Good
- Fair
- Poor

Architectural Style/Type:	Eclectic/Victorian	Exterior Walls (Current):	Aluminum
Architectural Features:		Exterior Walls (Original):	Clapboard
Date of Construction: Source:	1890 Township Assessor's Office	Foundation: Roof Type/Material:	Stone Cross gable/Asphalt shingle
Overall Plan Configuration:	Simple rectangle	Window Material/Type:

ARCHITECTURAL FEATURES: The stone foundation walls and the leaded glass transom over the front picture window are pleasant reminders as to what this house might have been.

ALTERATIONS: The house has been resided with aluminum everywhere – concealing all of the original detailing in the process. The precast front steps with the wrought iron railings are a later addition. There is a small covered porch located on the southeast corner that is supported by square posts. The soffit is covered with aluminum.

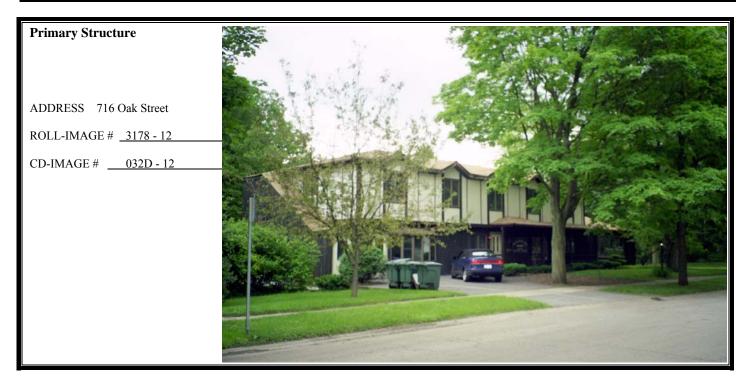
- Excellent
- ► Good
- 🗆 Fair
- Poor

Architectural Style/Type:	Educational	Exterior Walls (Current):	Synthetic stucco panel w/
			Wood trim/Wd siding
Architectural Features:		Exterior Walls (Original):	Synthetic stucco panel w/
			Wood trim/Wd siding
Date of Construction:	1954	Foundation:	Concrete
Source:	Township Assessor's Office	Roof Type/Material:	Hipped/Asphalt shingle
Overall Plan Configuration:	Compound	Window Material/Type:	Aluminum/Casements

ARCHITECTURAL FEATURES: Several design devices have been successfully used to create a more residential feel to fit into the neighborhood context. The west elevation is articulated with five wall dormers, a bow window, and a small covered entry porch. The ground floor is sided with reverse board & batten wood siding.

ALTERATIONS: A large 1-story addition was made to the south side of the building to create a new entry/drop-off for the students. It features casement windows, double doors, and a flat-roofed canopy.

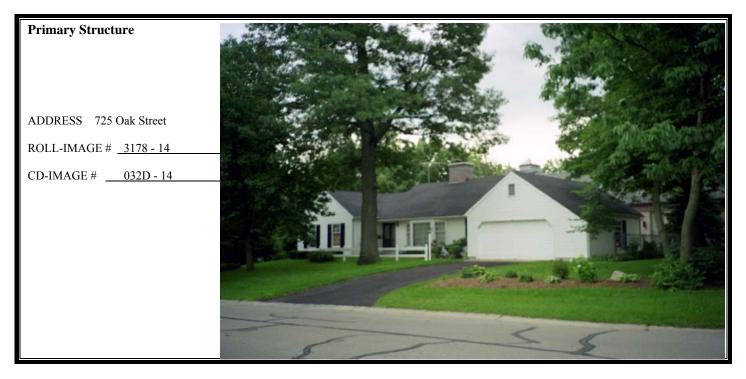
- Excellent
- Good
- 🗆 Fair
- Poor

Architectural Style/Type:	Eclectic/Modern ranch	Exterior Walls (Current):	Aluminum
Architectural Features:		Exterior Walls (Original):	Aluminum
	1974 Township Assessor's Office	Foundation: Roof Type/Material:	Concrete Cross gable/Asphalt shingle
Overall Plan Configuration:	Compound "U"	Window Material/Type:	Alum/Dbl hung

ARCHITECTURAL FEATURES: The front elevation features two front-facing gable ends. The west gable end covers the two-car garage that is a dominant element of the front elevation. Double doors are used in the front entry and a wide bay window is covered with a narrow overhang next to the front door.
