NEAR WEST HISTORIC DISTRICT ST. CHARLES, ILLINOIS

ST. CHARLES HISTORIC PRESERVATION COMMISSION

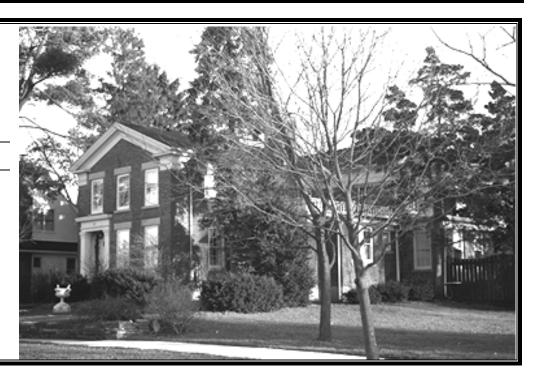
ADDRESS 511 Walnut Street

- Excellent
- ► Good
- Fair
- □ Poor

Architectural Style/Type:	Greek Revival	Exterior Walls (Current):	Brick
Architectural Features:		Exterior Walls (Original):	Brick
Date of Construction: Source:	1875 Township Assessor's Office	Foundation: Roof Type/Material:	Stone Cross gable/Asphalt
Overall Plan Configuration:	1	Window Material/Type:

ARCHITECTURAL FEATURES: A large front gable dominates the front of the house. A heavy frieze band located at the roof line is broken at the front elevation. There is a prominent entrance detailed in the classical tradition in wood. Stone lintels and sills are typical around the house. The window pattern is 6:6.

ALTERATIONS: The original roof was undoubtedly wood shakes or shingles. There have been several additions constructed with both brick and clapboard exteriors. Some of the additions are 1 story adding to the rambling character of the house. Some of the 1 story elements have flat roofs.

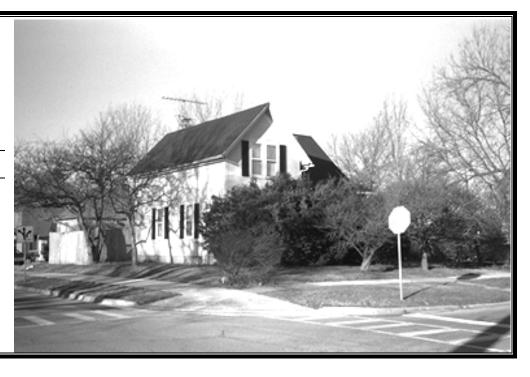
ADDRESS 622 Walnut Street

- Excellent
- Good
- ▶ Fair
- □ Poor

Architectural Style/Type:	Gothic revival/Gable front &	Exterior Walls (Current):	Clapboard
Architectural Features:	wing	Exterior Walls (Original):	Clapboard
	1000	,	•
Date of Construction:			Parged Masonry
Source:	Township Assessor's Office	Roof Type/Material:	Cross gable/Asphalt
Overall Plan Configuration:	Compound L	Window Material/Type:	Aluminum/Double hung

ARCHITECTURAL FEATURES: The front gable has distinct vertical proportions & steep roof slope. There is a partial width front porch that has a shed type roof that is supported by turned columns. All of the windows have simple wood trim. The siding has relatively wide trim @ the eaves and corners. There is a small rear entry that retains the detail character of the front porch. The eaves are open by are soffited in line w/ the roof slope.

ALTERATIONS: This roof probably had wood shakes or shingles originally.
