ST. CHARLES HISTORIC PRESERVATION COMMISSION

ARCHITECTURAL SURVEY

ST. CHARLES CENTRAL DISTRICT

DIXON ASSOCIATES / ARCHITECTS

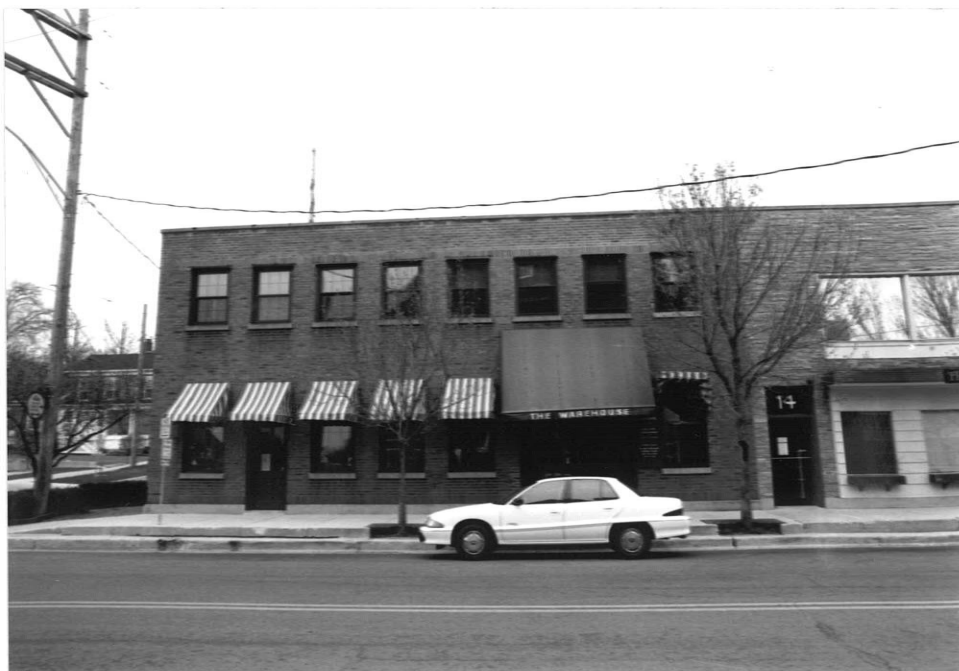
111 East Cedar Avenue

Former factory building, two stories of brick with clay tile coping at parapet. Adaptive use as retail shops.

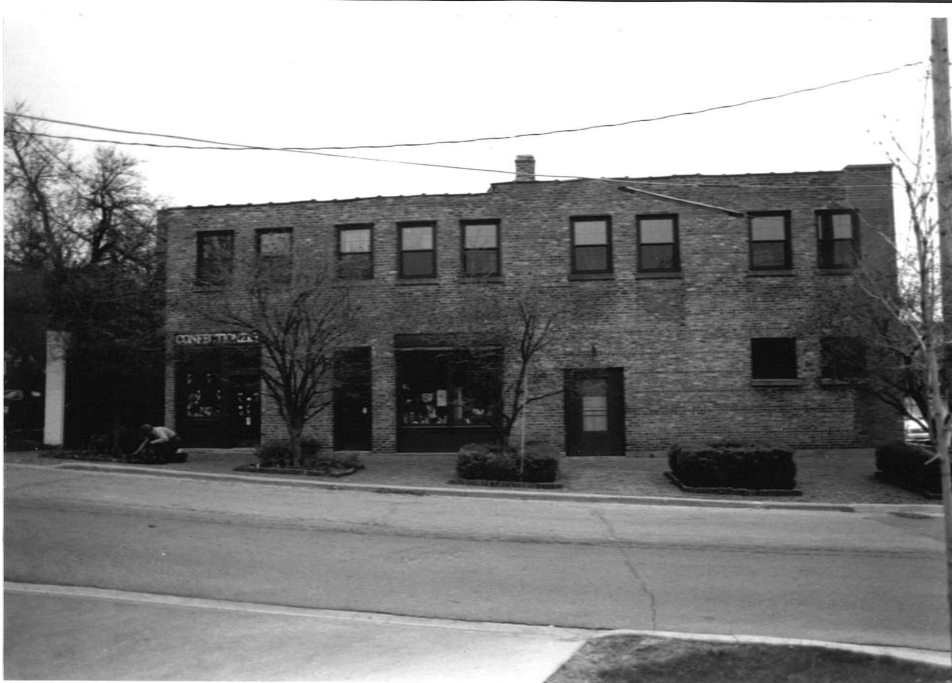
111 East Cedar Avenue

North Elevation.

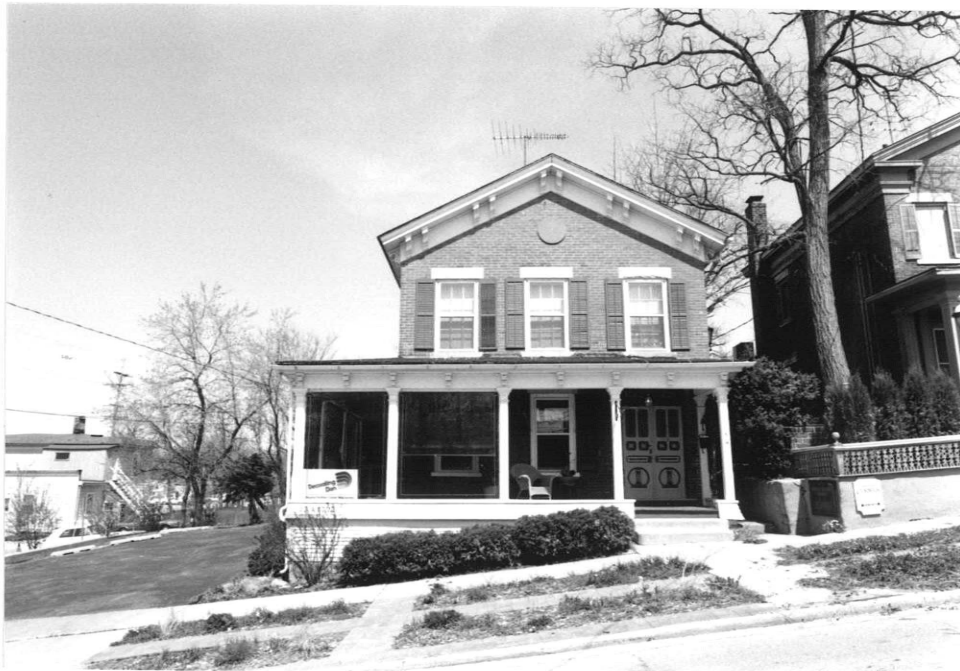
116 East Cedar Avenue

Double bracketed eave at front gable roof. Wrap around porch. Stone lintels at windows on brick structure.

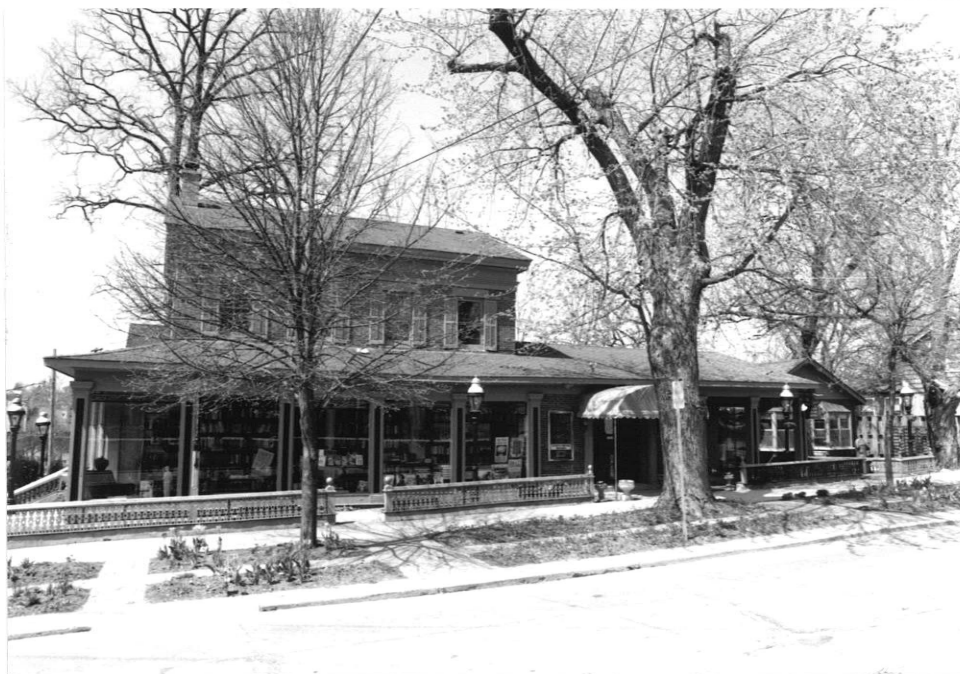
116 East Cedar Avenue

East Elevation.

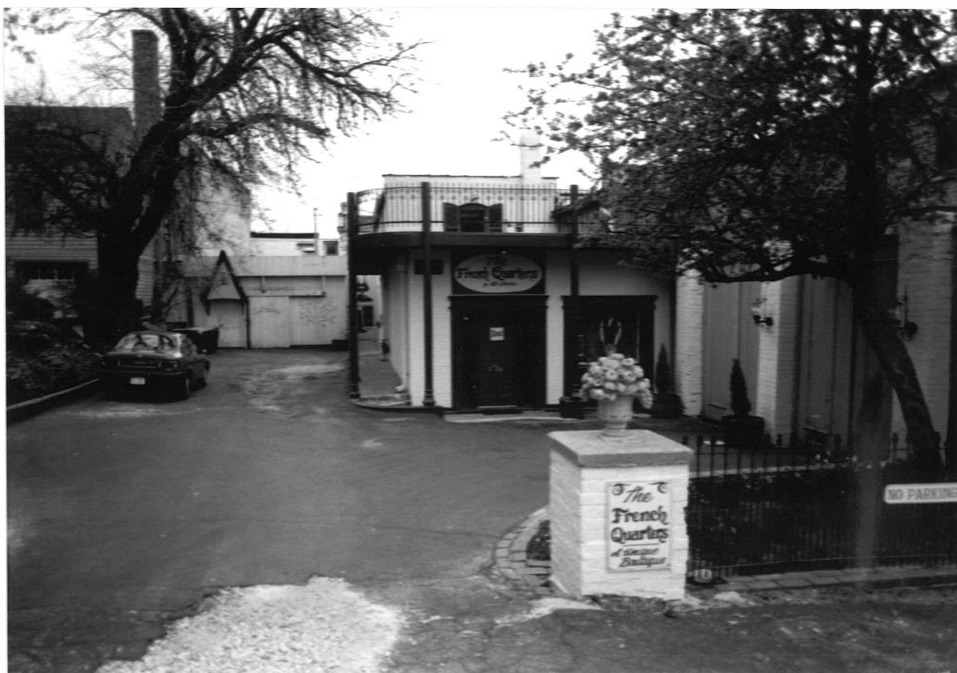
117 East Cedar Avenue

Wrought iron railing on roof of one story brick structure with wrap around overhang.

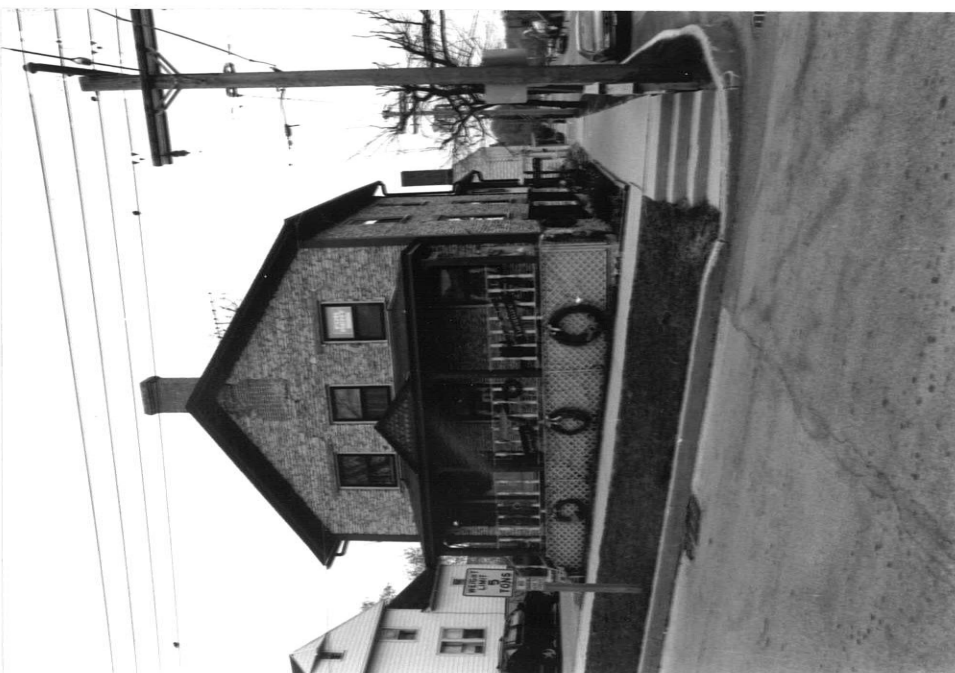
201 East Cedar Avenue

Two story limestone structure with front gable. Appears to have had stucco finish originally. Stucco removed in the 1980's. Originally the home of Thomas and Elizabeth Collins.

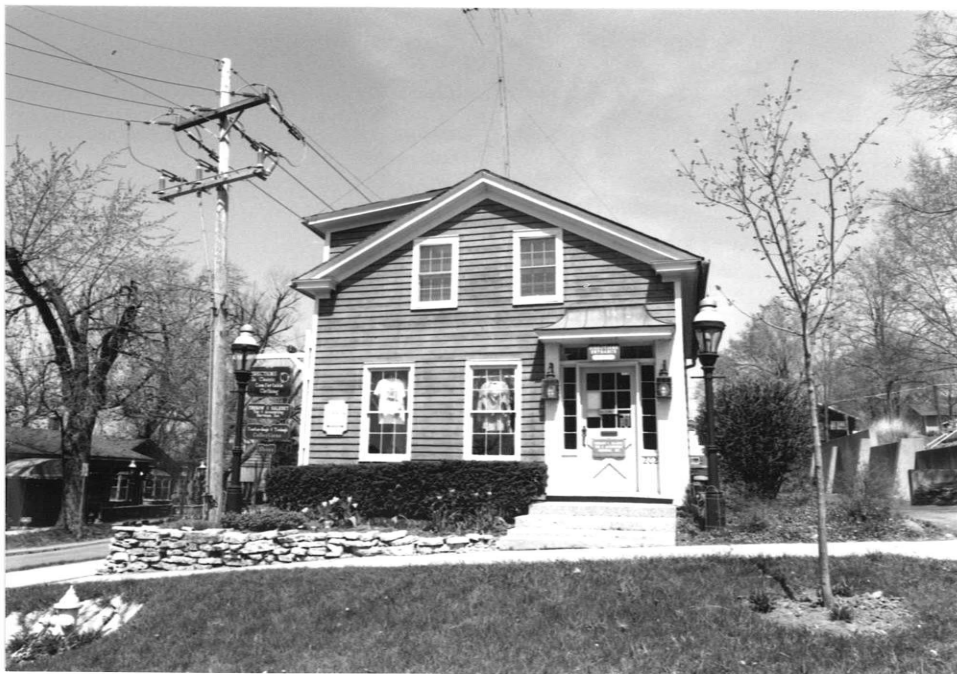
202 East Cedar Avenue

Front gabled one and one-half story wood frame structure with broken pediment. Six over six double hung windows at front. Box bay added at west elevation. Full width dormer added at west side of roof.

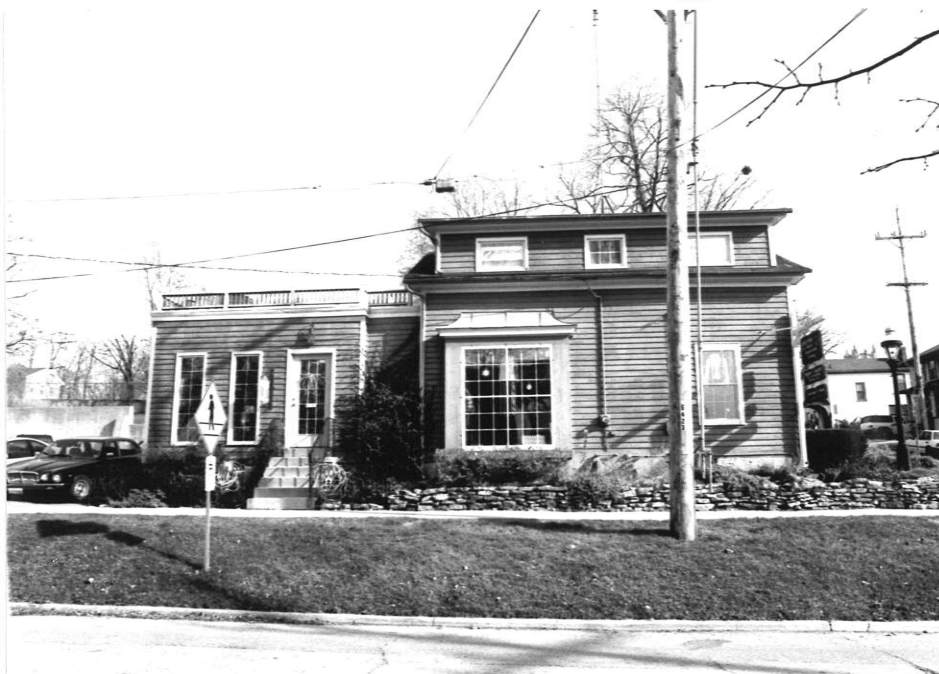
202 East Cedar Avenue

West Elevation.

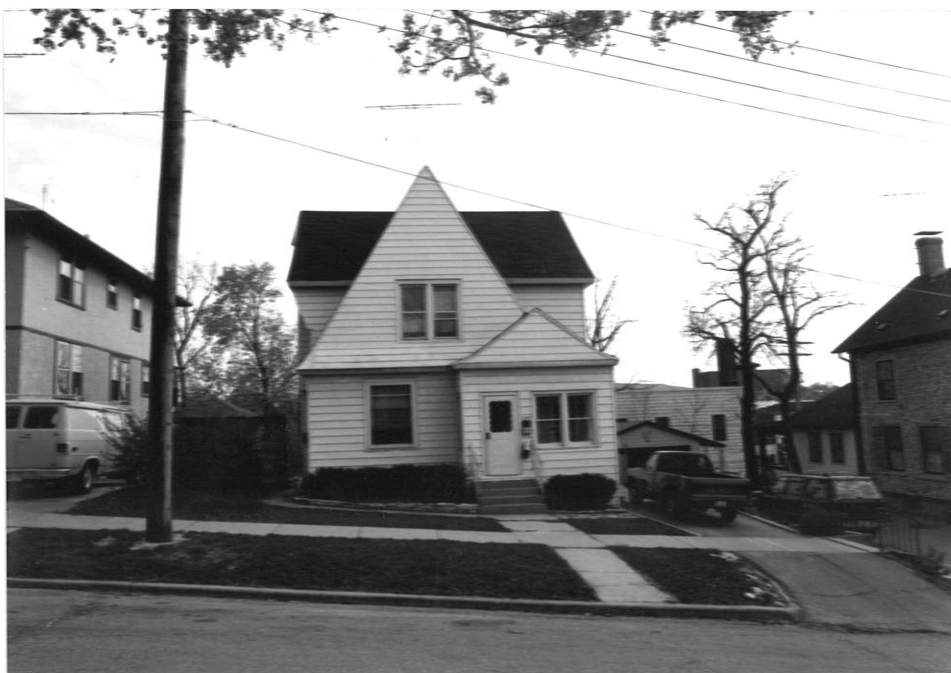
207 East Cedar Avenue

Steep front gable two story section with shallow gable at one story entrance. Clad over with synthetic siding.

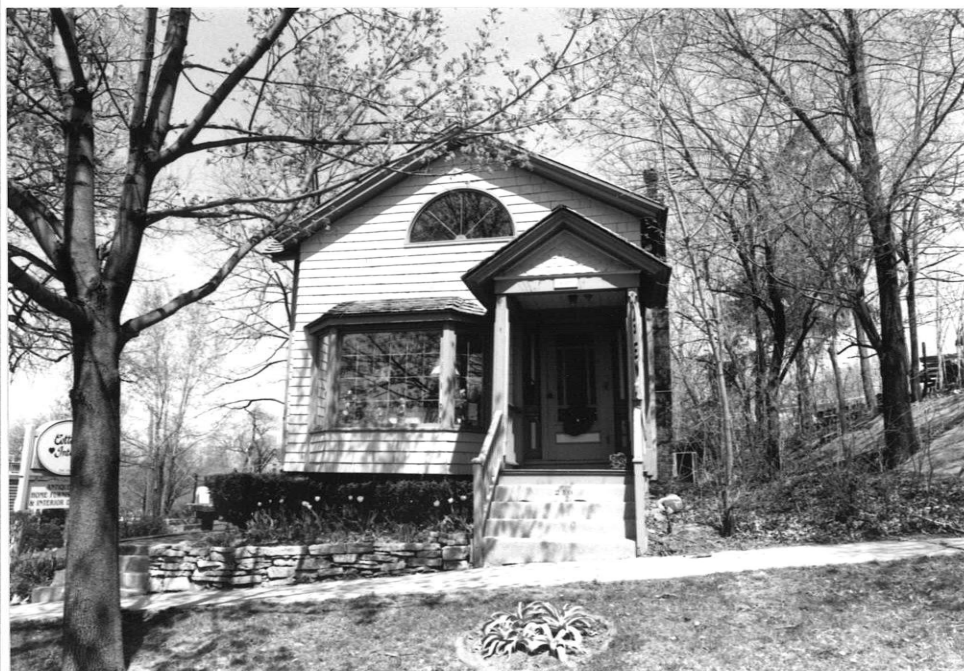
210 East Cedar Avenue

Front gabled roof. Bay window and porch appear to be added recently. Round top window at second level added recently.

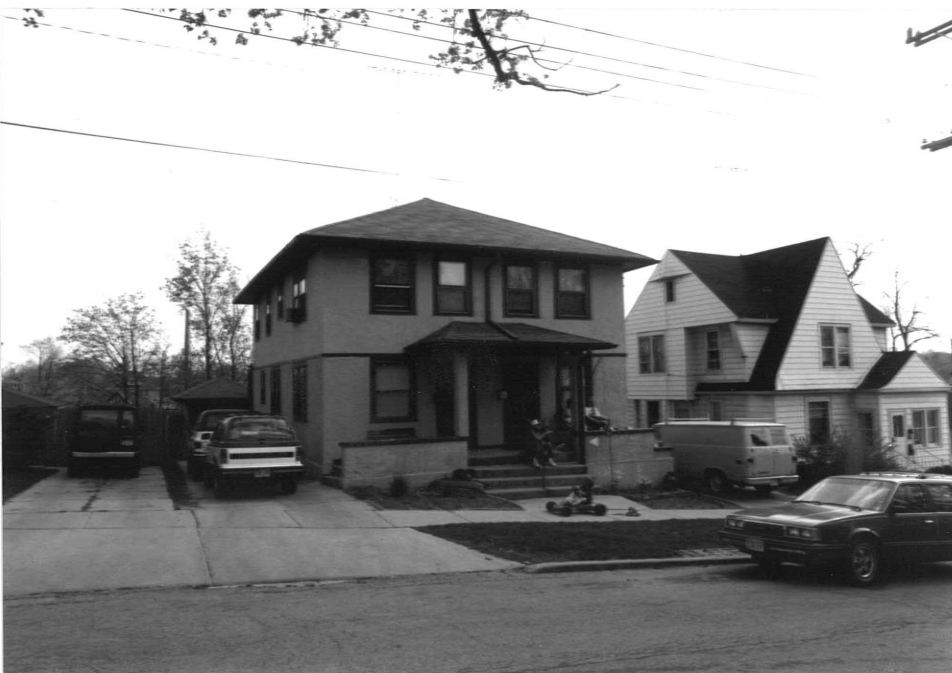
211-215 East Cedar Avenue

Hipped roof, two story symmetrical front entry house.
Porch greatly modified. Stucco finish.

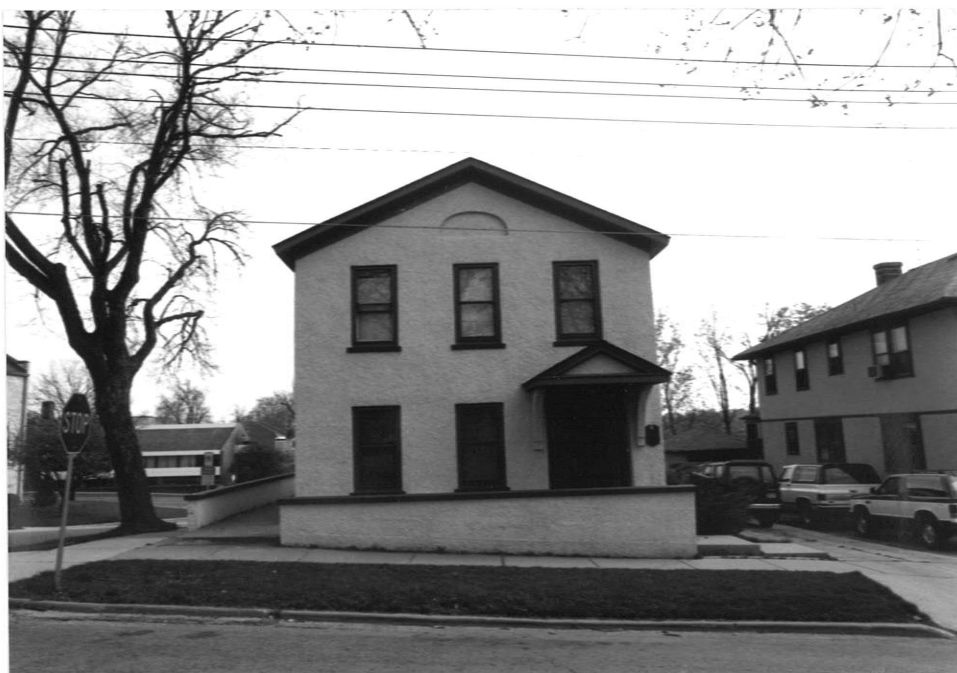
217 East Cedar Avenue

Two story structure with one story addition at south. Front gabled roof. Stucco exterior filled in fan light and greatly affected the appearance.

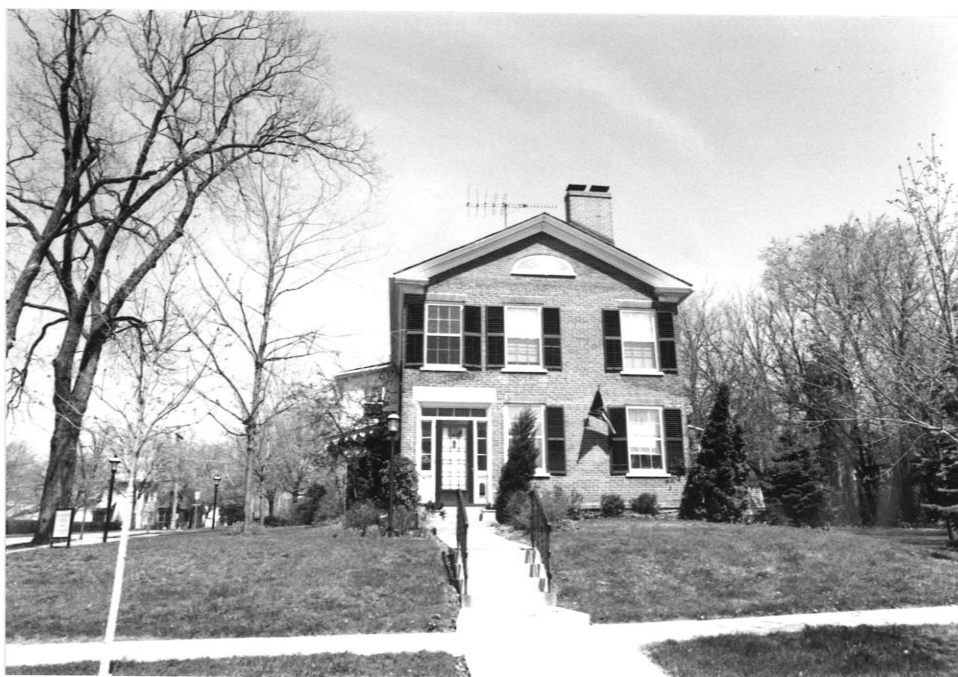
304 Cedar Avenue

Credited as being the oldest brick dwelling in St. Charles. Original plan was simple rectangle with gable roof. Entrance on south is a single door with sidelights and transom with stone lintel. Additions were existing in 1855, including bargeboard detailing on one story section suggesting Gothic Revival style.

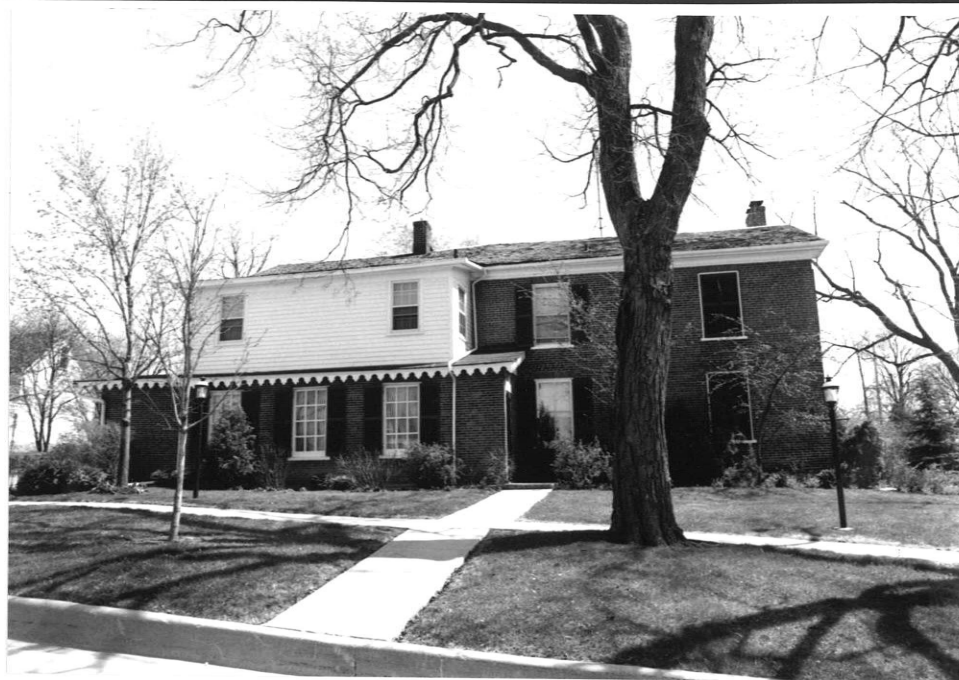
304 Cedar Avenue

West Elevation, showing
early additions to north of
original building.

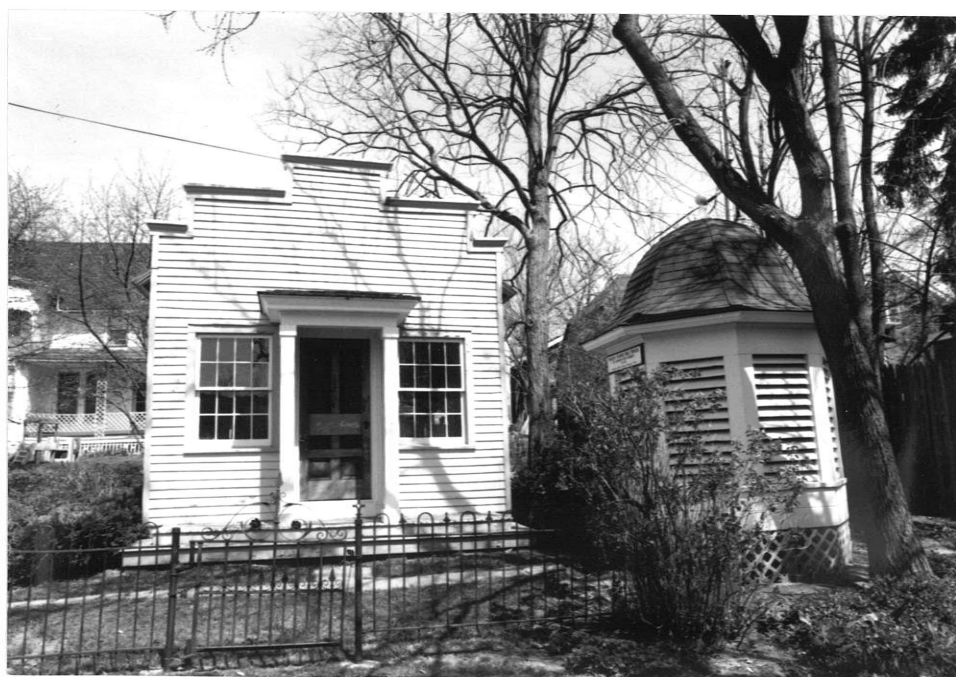
304 Cedar Avenue

Outbuildings, including the
Judge Steven S. Jones law
office and bell tower from
Shelby School.

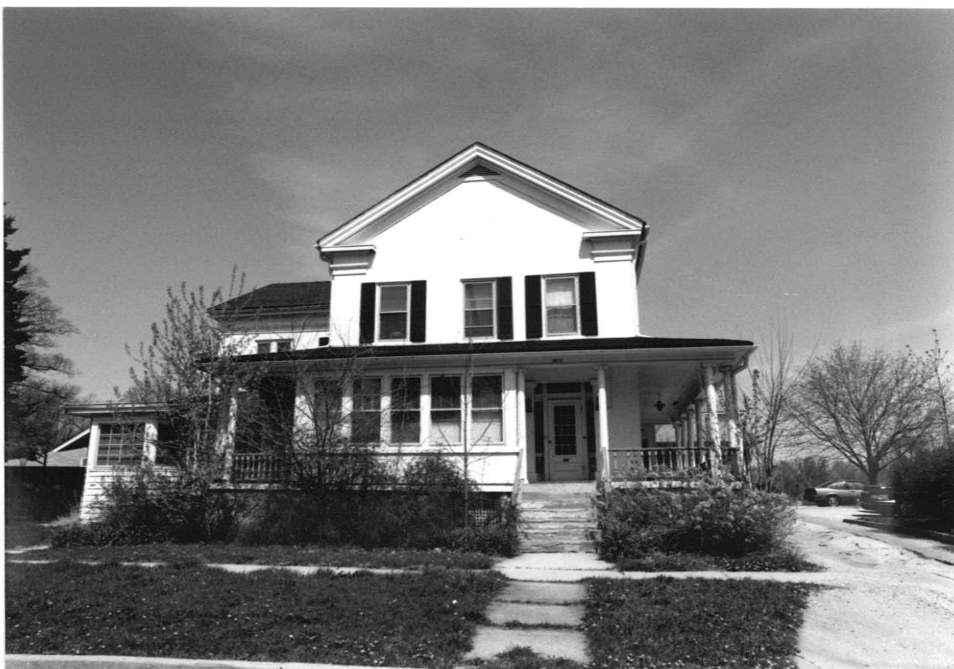
414-416 East Cedar Avenue

Front gabled roof with broken pediment. Later wrap around porch. Two story painted masonry except for rear section in wood clapboard siding.

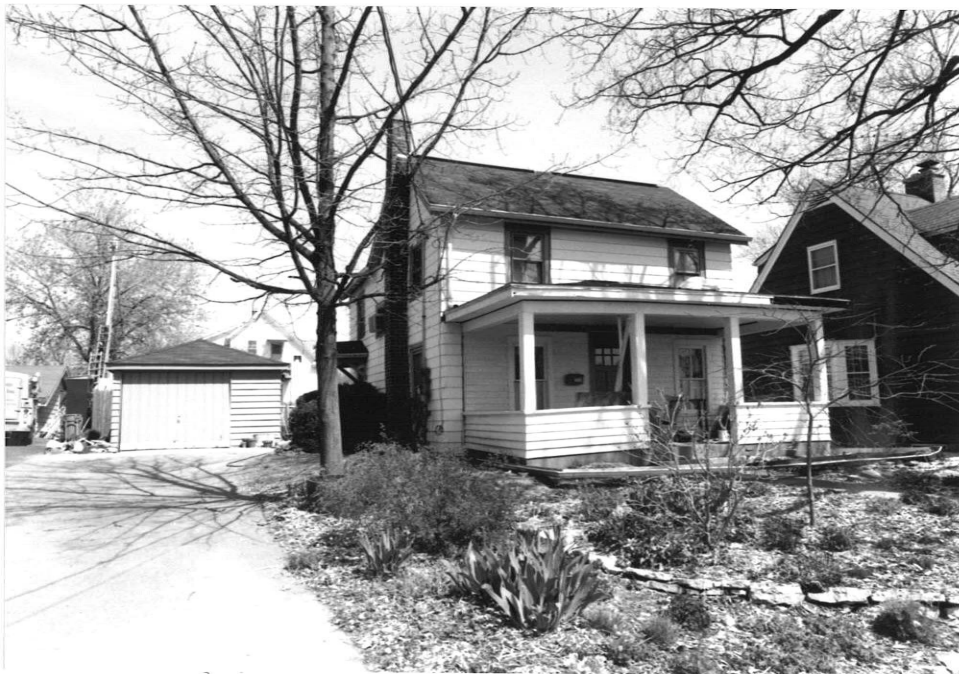
510 East Cedar Avenue

Two story wood frame structure with full width front porch, symmetrical facade. One over one windows at second floor, two over two windows on first floor.

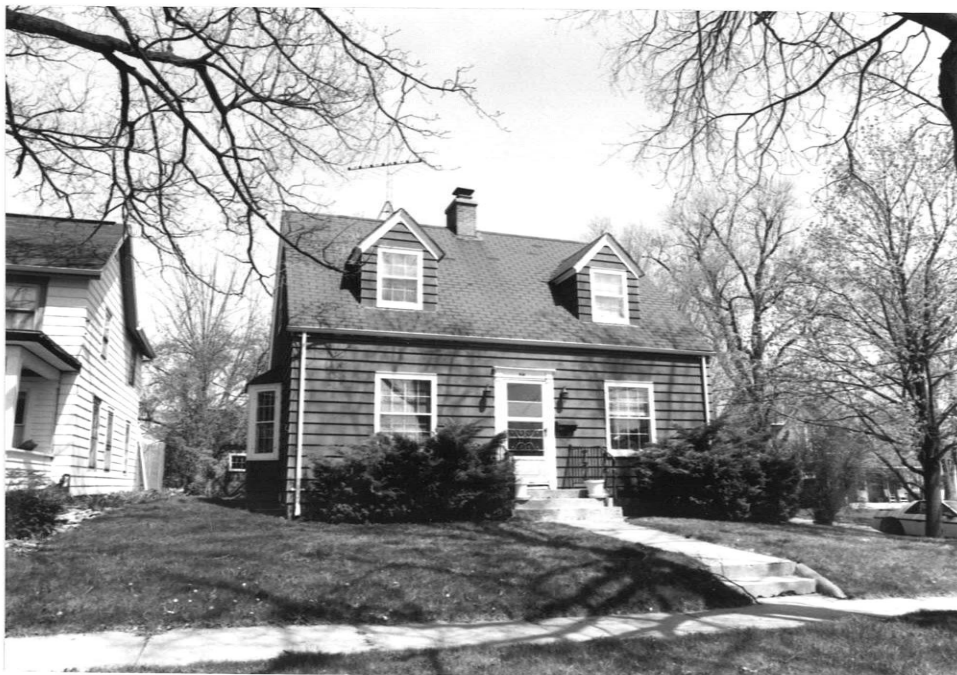
518 East Cedar Avenue

One and one-half story wood frame house with two dormers. Symmetrical with center door. "Cape Cod" appearance.
