ST. CHARLES HISTORIC PRESERVATION COMMISSION

**ARCHITECTURAL SURVEY**  
**ST. CHARLES CENTRAL DISTRICT**  
**ST. CHARLES, ILLINOIS**

DIXON ASSOCIATES / ARCHITECTS

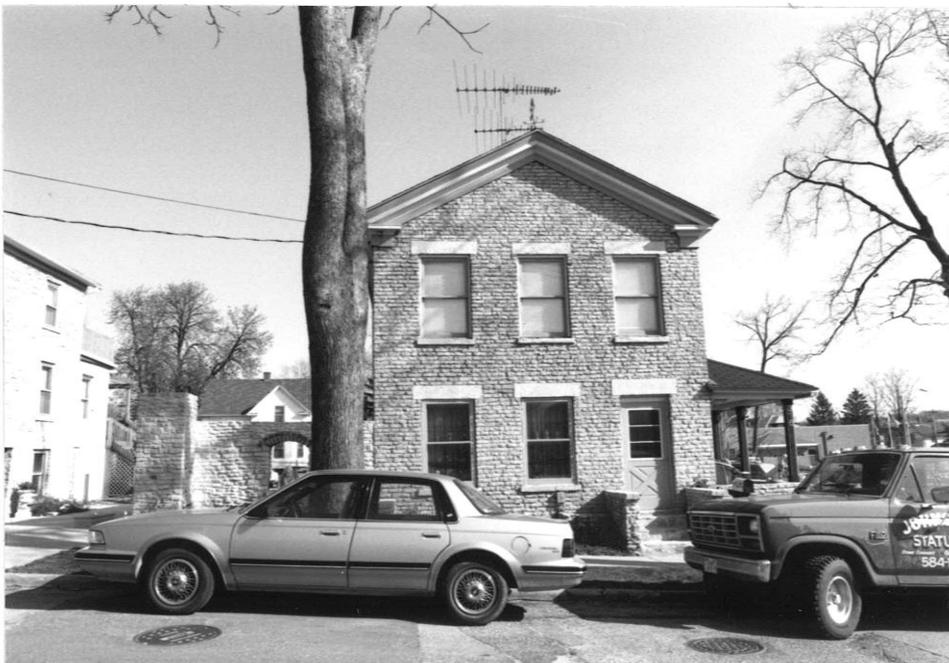
**NEGATIVE NO. 28**

1	2	3
<input type="checkbox"/> Unaltered	<input type="checkbox"/>	<input type="checkbox"/>	<input type="checkbox"/>
<input checked="" type="checkbox"/> Minor Alteration	<input checked="" type="checkbox"/>	<input type="checkbox"/>	<input type="checkbox"/>
<input type="checkbox"/> Major Alteration	<input type="checkbox"/>	<input type="checkbox"/>	<input type="checkbox"/>
<input checked="" type="checkbox"/> Additions	<input checked="" type="checkbox"/>	<input type="checkbox"/>	<input type="checkbox"/>
Sensitive to original	<input checked="" type="checkbox"/>	<input type="checkbox"/>	<input type="checkbox"/>
Insensitive to original	<input type="checkbox"/>	<input type="checkbox"/>	<input type="checkbox"/>

Rough limestone exterior with cut limestone window beads and sills. East porch and north section added. Board and batten sided garage added.

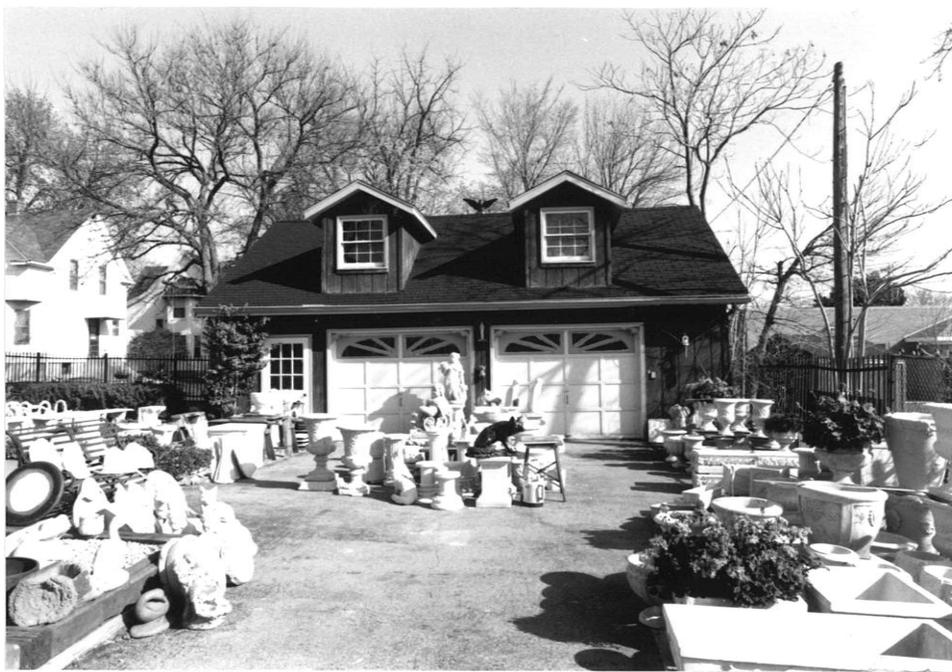
NEGATIVE NO. 29

Garage

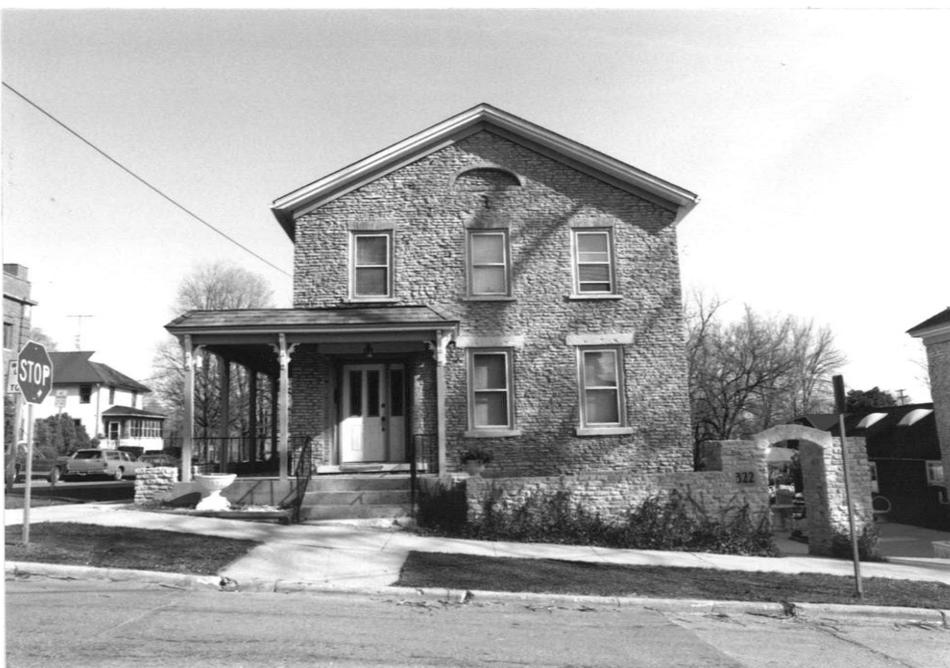
**NEGATIVE NO. 27**

1	2	3
<input type="checkbox"/> Unaltered	<input type="checkbox"/>	<input type="checkbox"/>	<input type="checkbox"/>
<input checked="" type="checkbox"/> Minor Alteration	<input checked="" type="checkbox"/>	<input type="checkbox"/>	<input type="checkbox"/>
<input type="checkbox"/> Major Alteration	<input type="checkbox"/>	<input type="checkbox"/>	<input type="checkbox"/>
<input type="checkbox"/> Additions	<input type="checkbox"/>	<input type="checkbox"/>	<input type="checkbox"/>
Sensitive to original	<input type="checkbox"/>	<input type="checkbox"/>	<input type="checkbox"/>
Insensitive to original	<input type="checkbox"/>	<input type="checkbox"/>	<input type="checkbox"/>

Rough limestone exterior with cut limestone window heads and sills at first floor, brick window heads at south elevation, second floor. Porch and perimeter low stone wall added in 1990's. Fan lite at south gable end filled with stone.

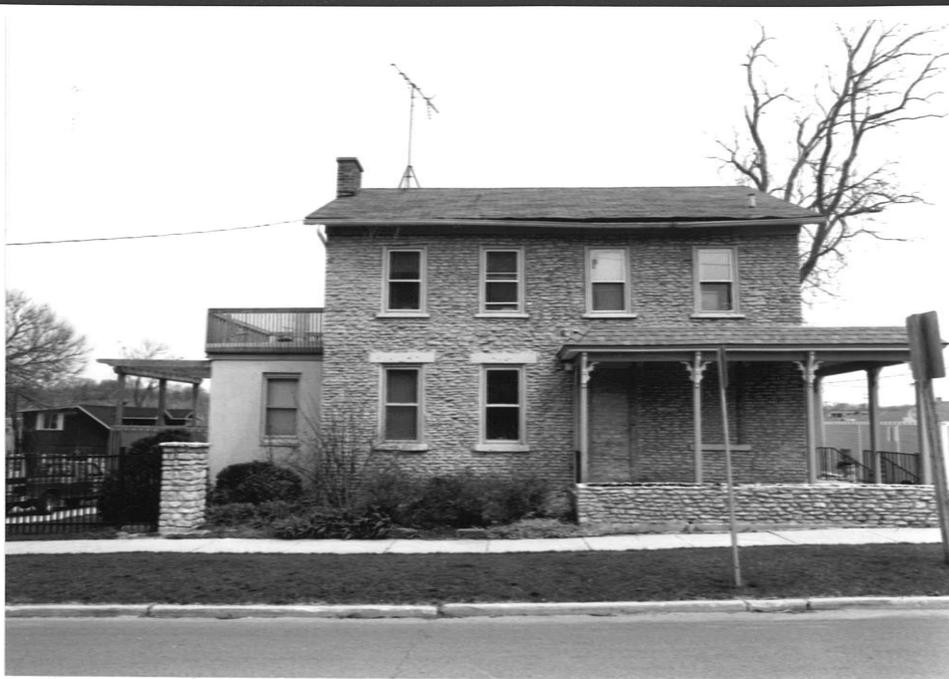
**NEGATIVE NO. 27**

West side, wrap around porch added in 1990's.

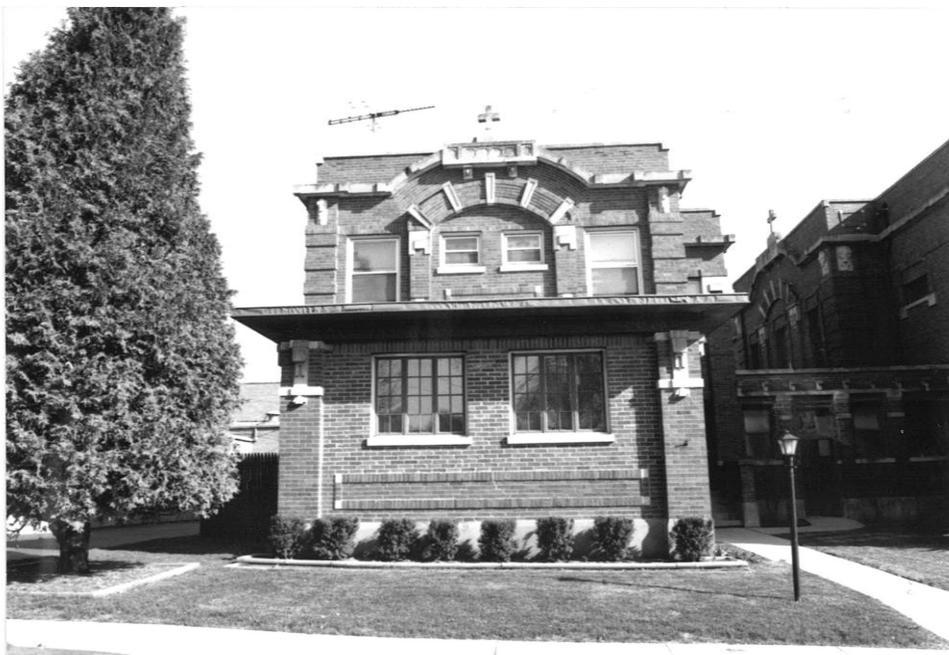
**NEGATIVE NO. 24**

**Features:** St. Patrick Rectory

Brick structure with significant stone accents. Elaborate stone caps to masonry pilasters on south facade. Stone at upper facade matches church to east.

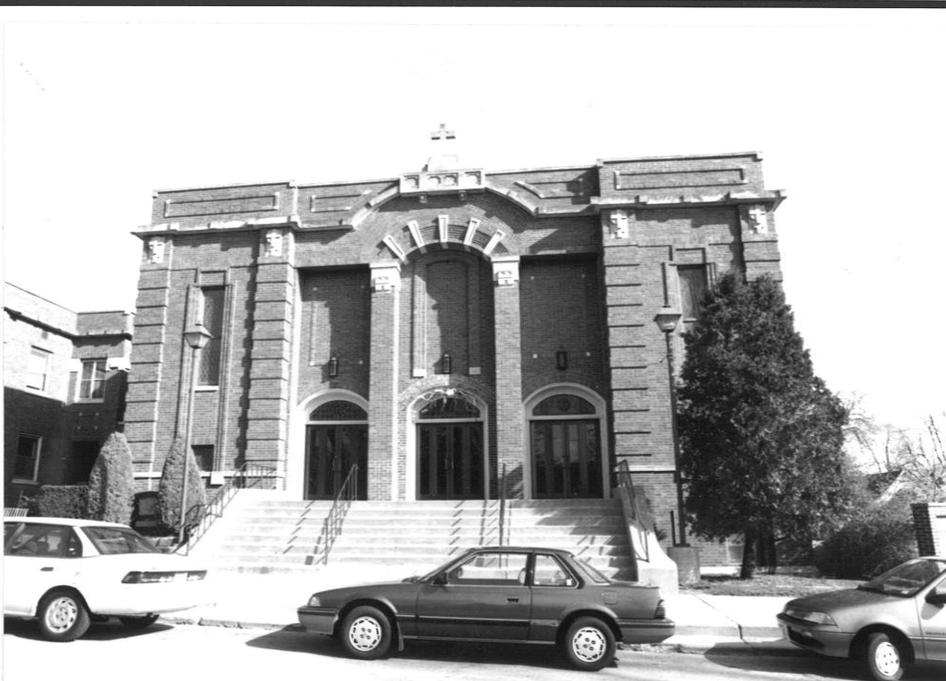
**NEGATIVE NO. 25**

**Features:** St. Patrick Church

Triple arch entry doors divided by masonry pilasters. Stone accents trim parapet and over central entry door at south. Similar stone detail at east elevation.

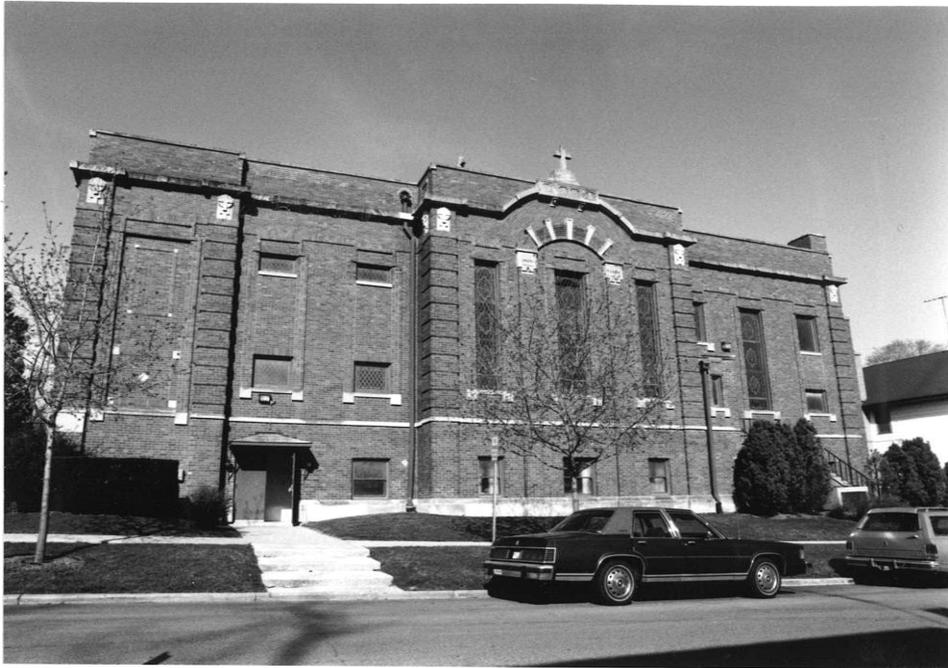
**NEGATIVE NO. 26**

East side
