ST. CHARLES HISTORIC PRESERVATION COMMISSION

**ARCHITECTURAL SURVEY**  
MILLINGTON HISTORIC DISTRICT  
ST. CHARLES, ILLINOIS  
Date of Survey: 2003  
Survey Updated: Dec. 2016

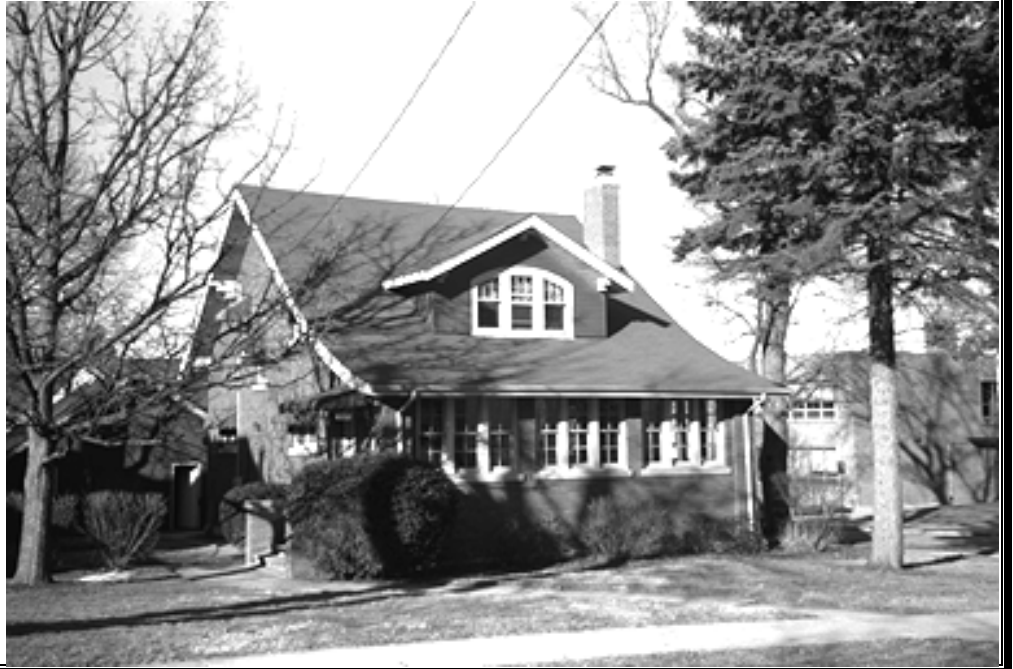
ADDRESS 500 Cedar Street

**ARCHITECTURAL FEATURES:** The large centered roof dormer and the closed in front porch are prominent features of the front elevation. The windows on the dormer feature a 3:1 pattern and an arched head. Stepped wooden brackets support the wide eaves on the side elevations as well as the dormer. Square brick columns support the roof of the all season porch. As this house is sited on a corner, the entrance is on the protected side (west) of the house.

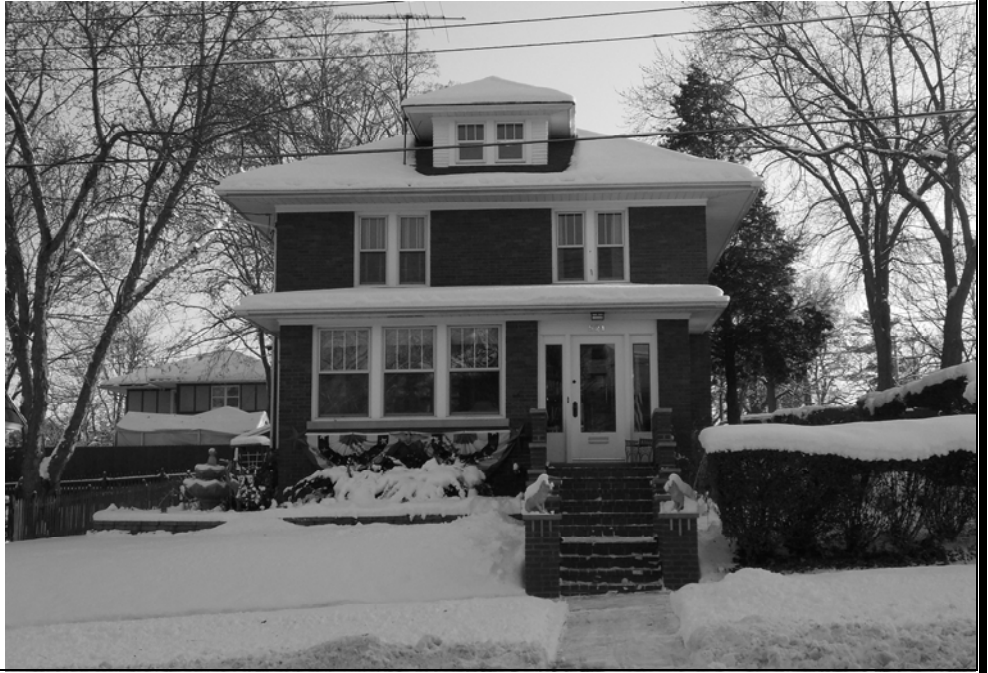
ADDRESS 521 Cedar Street

**ARCHITECTURAL FEATURES:** There is a single hipped dormer located on the front side of the house roof. The full width front porch is the dominant architectural feature. Simple square brick columns support the roof of the porch. The double hung windows feature a 4:1 muntin pattern. All of the windows are used in pairs or groups of three.

**ALTERATIONS:** The soffits are boxed in aluminum. There is a small mudroom vestibule added to the rear of the house that is sheathed with dryvit and has a prefab greenhouse window unit. The porch appears to have been closed in subsequent to the initial construction and the entrance moved to the outer wall. Low brick side-walls were recently added at the front stairs.

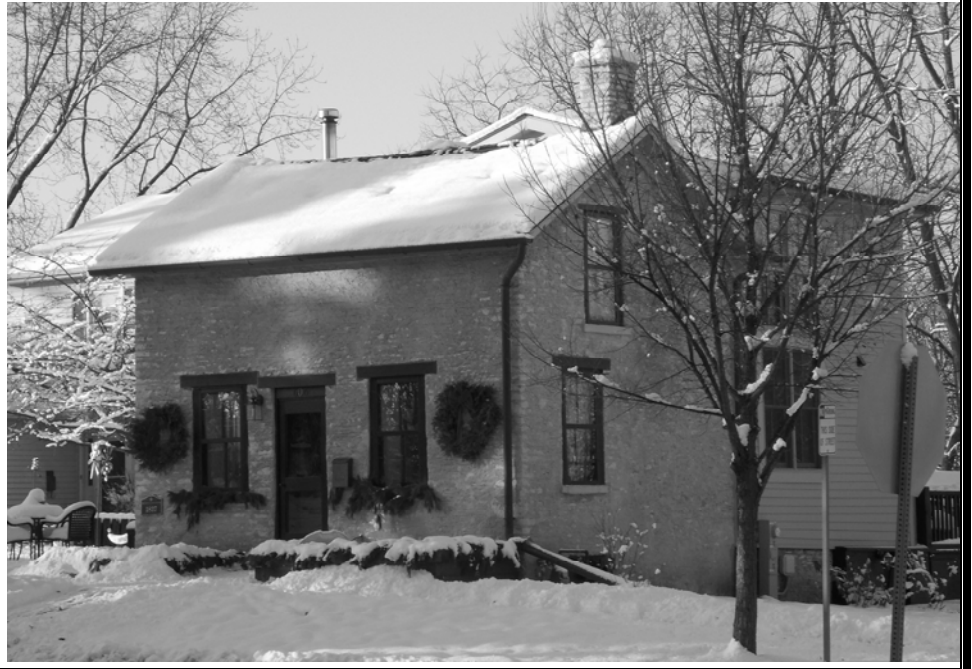
ADDRESS 606 Cedar Street

**ARCHITECTURAL FEATURES:** The original portion of the house is constructed of limestone. This house has narrow eaves and shallow roof slope. The lack of windows on the second floor of the front elevation is odd as is the window arrangement on the side elevation.

**ALTERATIONS:** The two-story addition to the rear does not relate to the original architecture in any way. A small one-story addition featuring an octagonal window was made to the west side of the house.

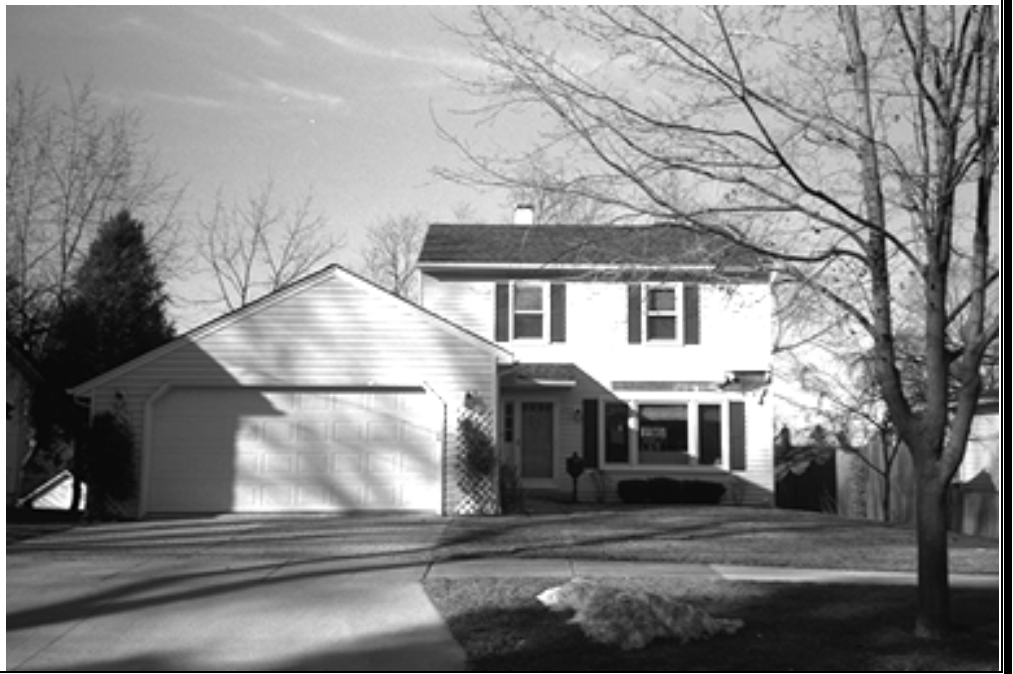
ADDRESS 610 Cedar Street

**ARCHITECTURAL FEATURES:** The two-car garage dominates the street elevation. It does not relate to the main part of the house. The roof slope is shallow and the overhangs are narrow. A large three-part picture window is an important element of the front façade.
