ST. CHARLES HISTORIC PRESERVATION COMMISSION

ARCHITECTURAL SURVEY
ST. CHARLES CENTRAL DISTRICT
ST. CHARLES, ILLINOIS

DIXON ASSOCIATES / ARCHITECTS

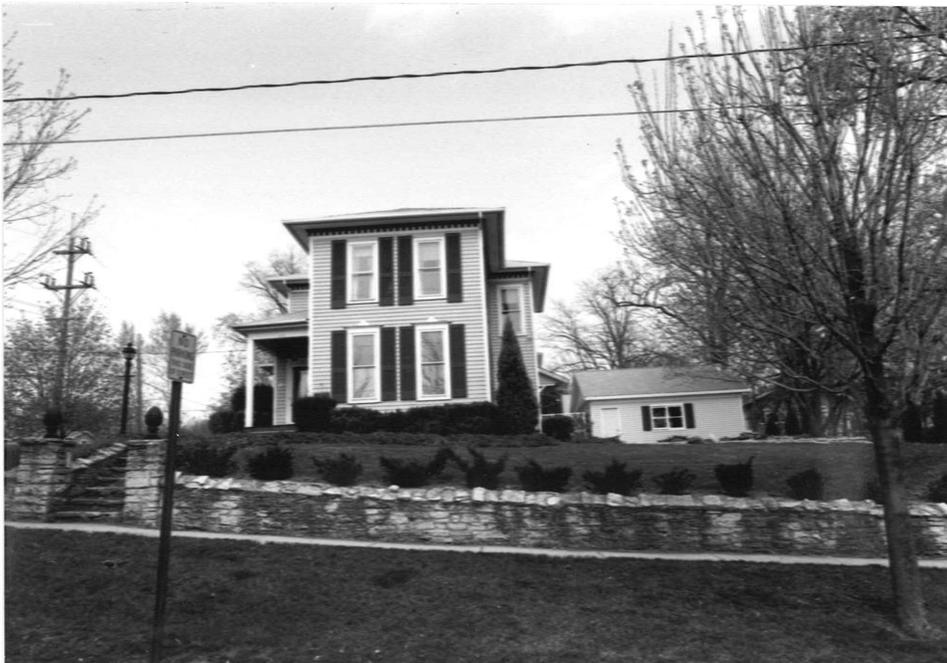
201 East Chestnut Avenue

Style: Italianate

Date of Construction: 1879

Two story clapboard sided structure with wide overhangs on hip roof. Addition to east has gable roof. Tall narrow windows.

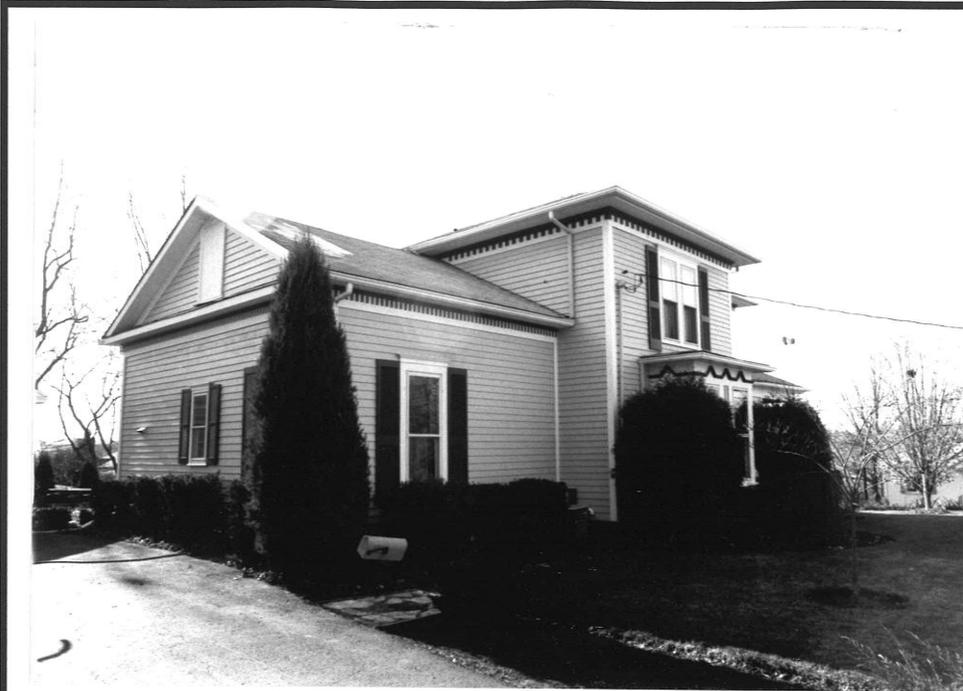
201 East Chestnut Avenue

North Elevation.

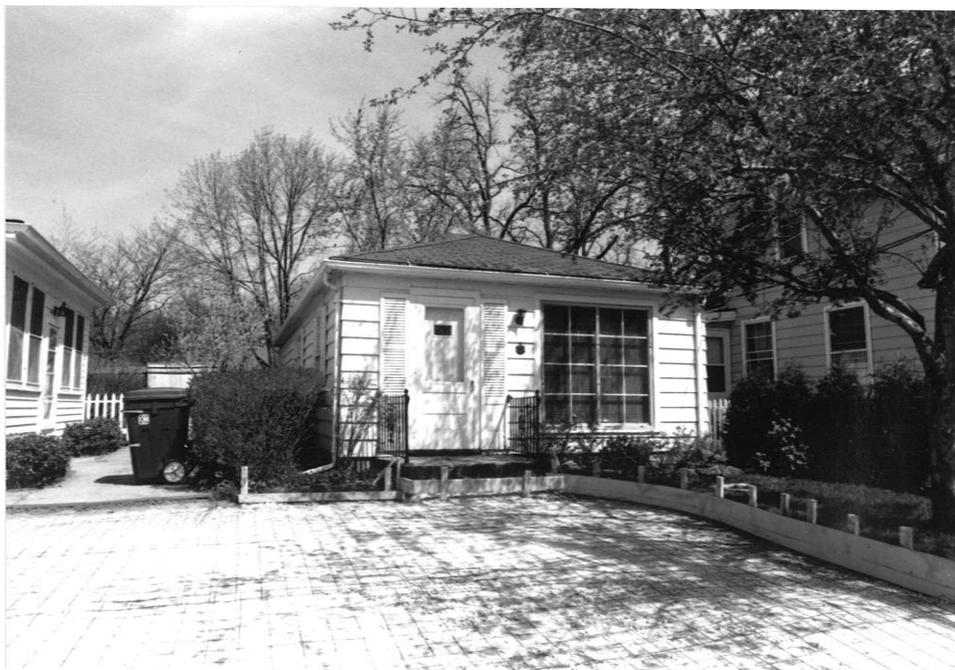
208 East Chestnut Avenue

Style: Modern - Ranch

Date of Construction: Post 1944

Low pitch hip roof. Wide exposure horizontal siding.
Picture window.

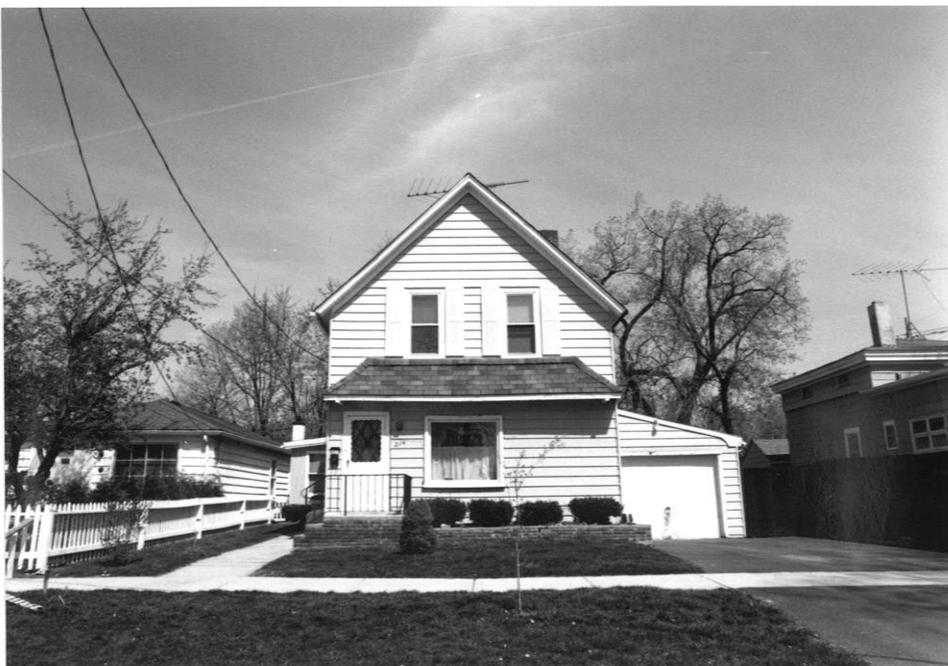
214 East Chestnut Avenue

Style: Substantially Altered

Two story gable end structure with hip roof over first floor.

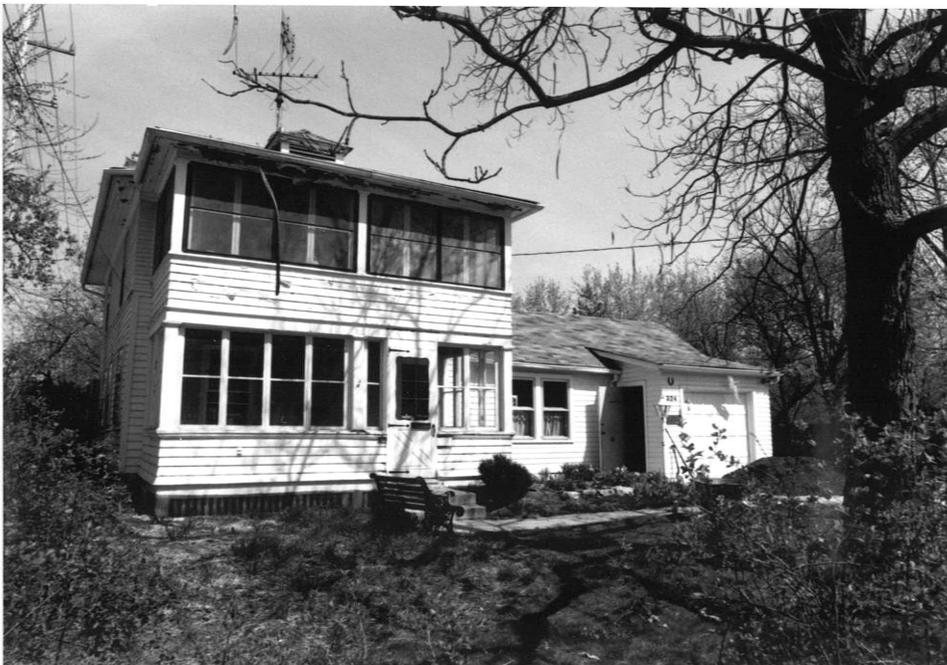
304 East Chestnut Avenue

Style: Substantially Altered

Two story hip roof structure with two story enclosed porch at front. Attached one car garage.

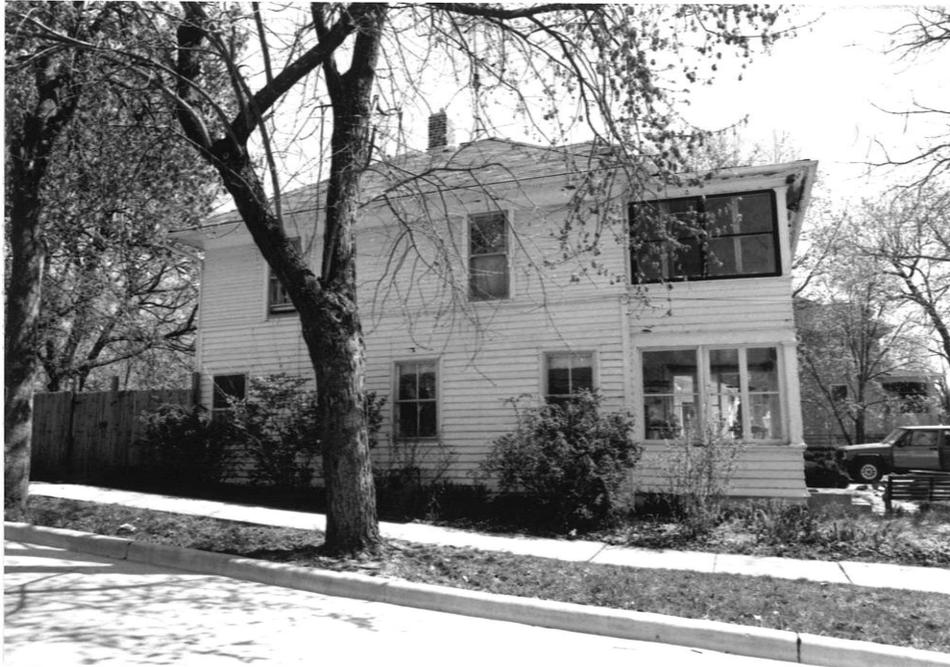
304 East Chestnut Avenue

West Elevation.

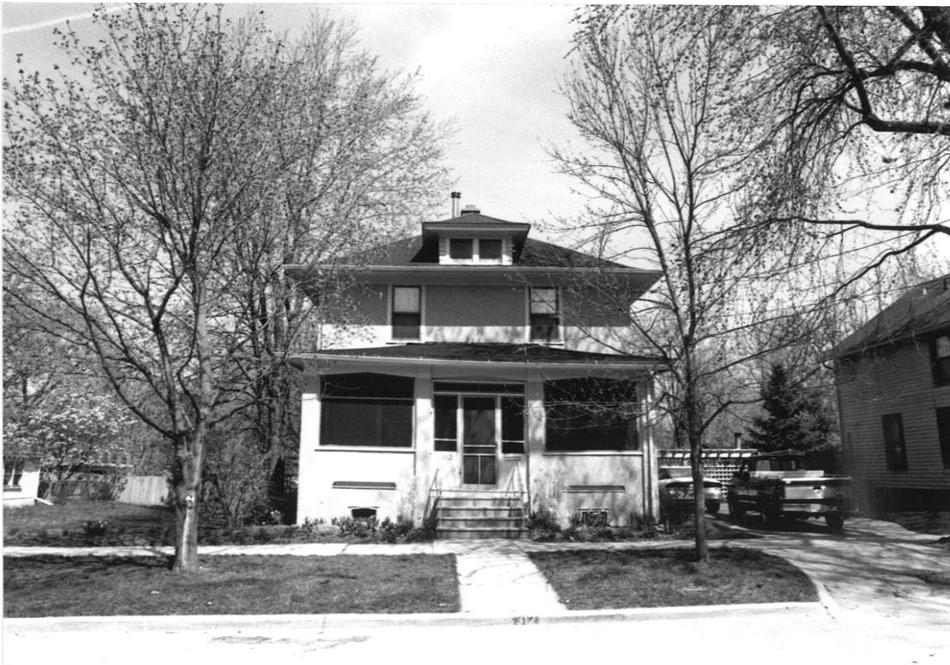
312 East Chestnut Avenue

Style: Foursquare

Date of Construction: 1910-1920

Two story structure with hip roof and hip roof dormer. Hip roof over full width. Enclosed porch. Wide soffits. Stucco exterior.

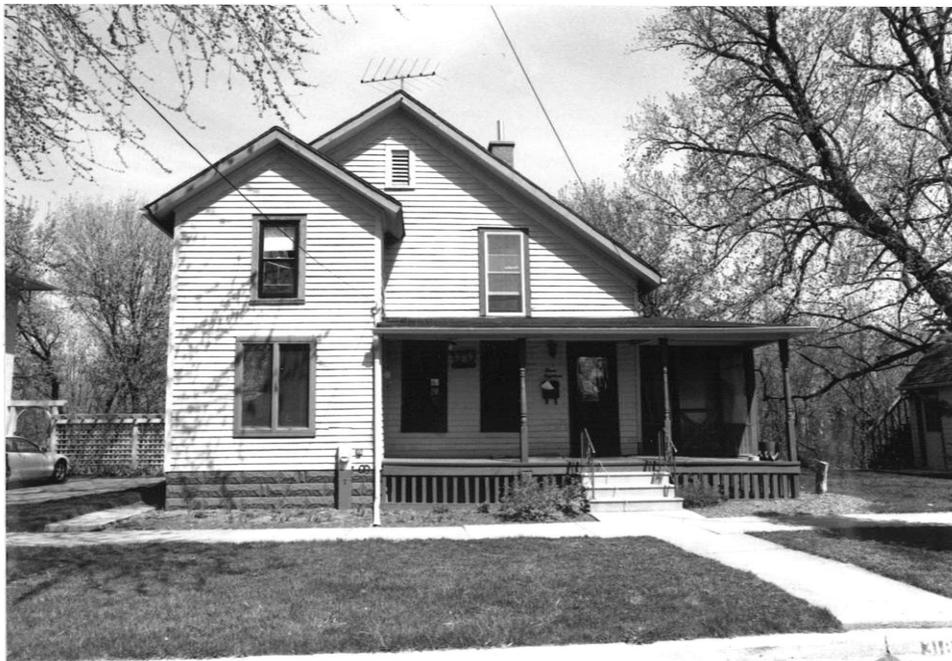
318 East Chestnut Avenue

Style: National

Date of Construction: 1860-1870

Gable end structure with gable roof over front wing. Partial enclosed wrap around porch. Some details may have been altered.

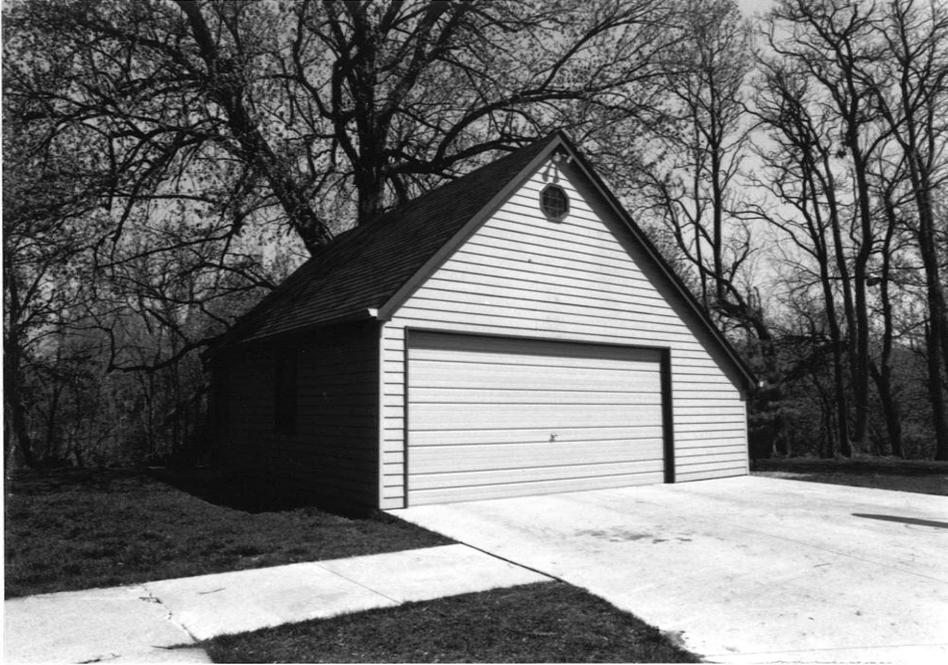
318 East Chestnut Avenue

Garage.
