ARCHITECTURAL SURVEY
MILLINGTON HISTORIC DISTRICT
ST. CHARLES, ILLINOIS
Date of Survey: 2003

ST. CHARLES HISTORIC PRESERVATION COMMISSION

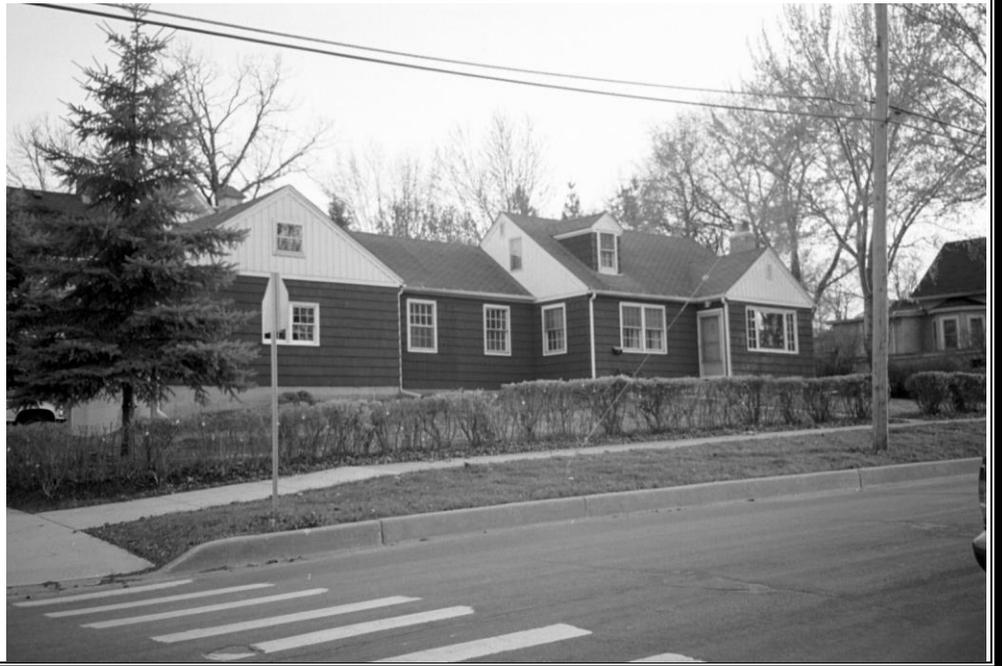
ADDRESS 501 State Street

Architectural Style/Type: <u>Colonial Revival/Cape Cod</u>	Exterior Walls (Current): <u>Cedar shingle</u>
Architectural Features: _____	Exterior Walls (Original): <u>Cedar single</u>
Date of Construction: <u>1930</u>	Foundation: <u>Concrete block/Concrete @ garage</u>
Source: <u>Township Assessor's Office</u>	Roof Type/Material: <u>Side gable/Asphalt shingle</u>
Overall Plan Configuration: <u>Simple rectangle</u>	Window Material/Type: <u>Alum/Wd/double hung</u>

ARCHITECTURAL FEATURES: There is a small dormer on the front of the house near the entrance. A small cupola was installed over the garage.

ALTERATIONS: This house was moved to this site in 1966 from the site of the Coca Cola plant. The foundation was built onsite using standard CMU and then the house was moved. The garage was built onsite on a concrete foundation.

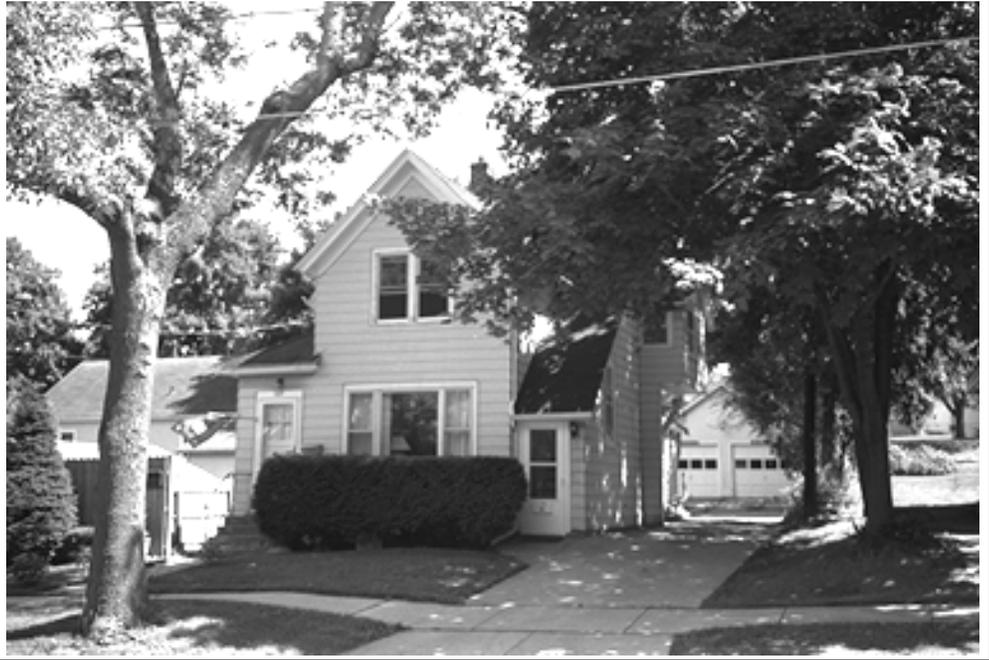
ADDRESS 609 State Street

Architectural Style/Type: <u>National</u>	Exterior Walls (Current): <u>Aluminum</u>
Architectural Features: _____	Exterior Walls (Original): <u>Clapboard</u>
Date of Construction: <u>1915</u>	Foundation: <u>Parged masonry/concrete</u>
Source: <u>Township Assessor's Office</u>	Roof Type/Material: <u>Cross gable/Asphalt shingle</u>
Overall Plan Configuration: <u>Compound/mass</u>	Window Material/Type: <u>Aluminum/Double hung</u>

ALTERATIONS: A 2 story addition to the west side sits on a concrete foundation. A 1 story addition to the south side is somewhat sympathetic with the massing of the original house. A large picture window was installed at the ground floor front elevation replacing the original windows/door.

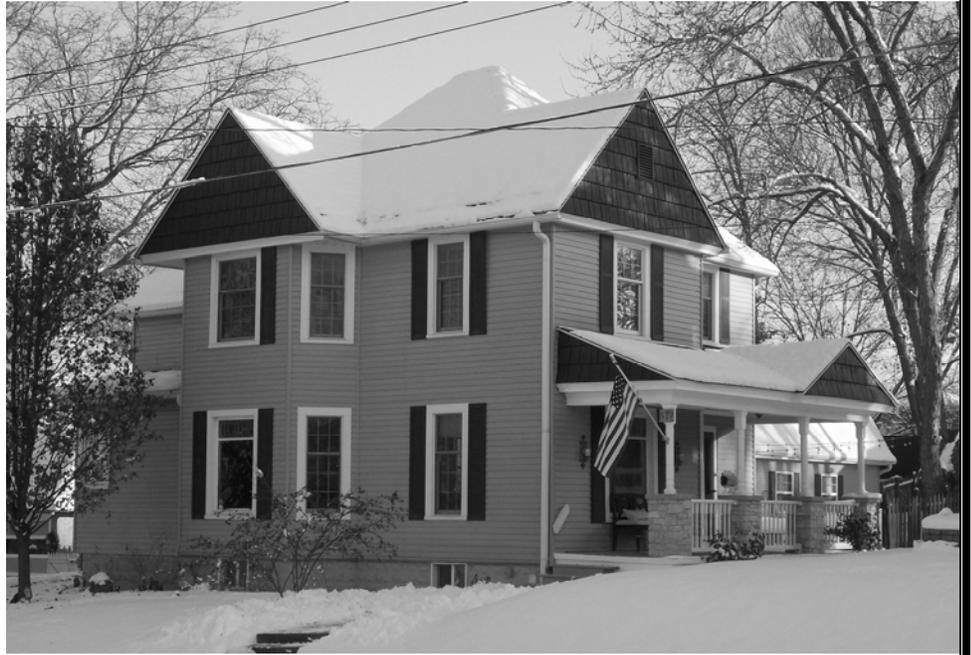
ADDRESS 517 Cedar Street

Foundation: Textured CMU

ALTERATIONS: The siding has been replaced with aluminum and the windows have been replaced with vinyl. A small sun-porch located on the street elevation at the northeast corner of the house has been enclosed. The porch columns rest on stone

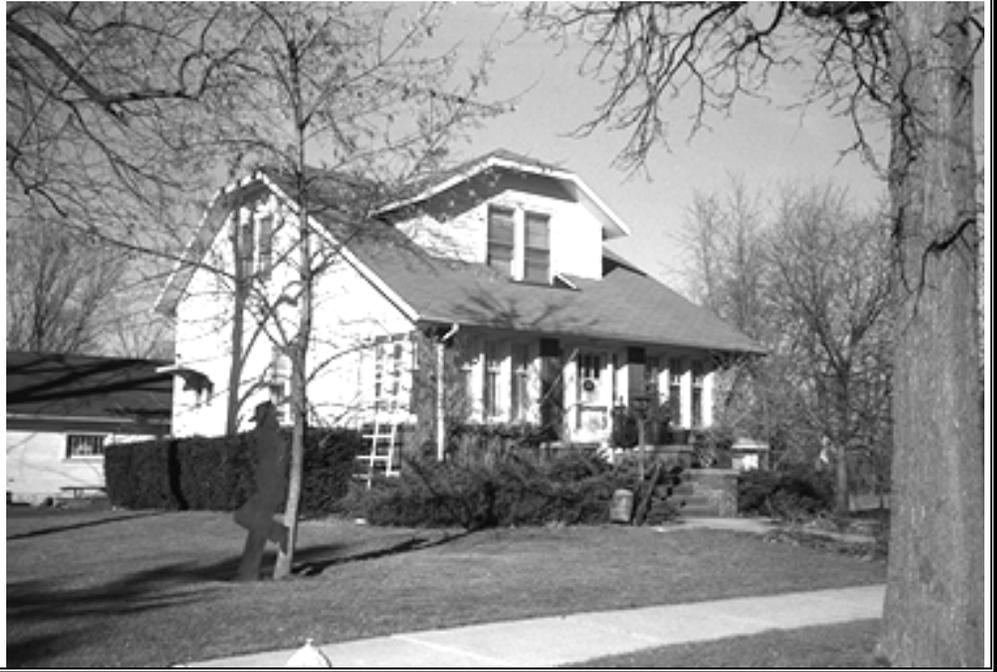
ADDRESS 622 Cedar Street

Architectural Style/Type: <u>Craftsman Bungalow</u>	Exterior Walls (Current): <u>Clapboard w/brick front porch</u>
Architectural Features: _____	Exterior Walls (Original): <u>Clapboard</u>
Date of Construction: <u>1925</u>	Foundation: <u>Parged masonry – Orig.</u>
Source: <u>Township Assessors Office</u>	Roof Type/Material: <u>Hipped Side gable/ Asphalt Shingle</u>
Overall Plan Configuration: <u>Simple rectangle</u>	Window Material/Type: <u>Alum/Dbf Hung</u>

ALTERATIONS: The brick appears to have been added when the front porch was closed in. There is a large 2-story addition to the rear that has a gable roof and detailing similar to the original house. The addition has a concrete foundation.

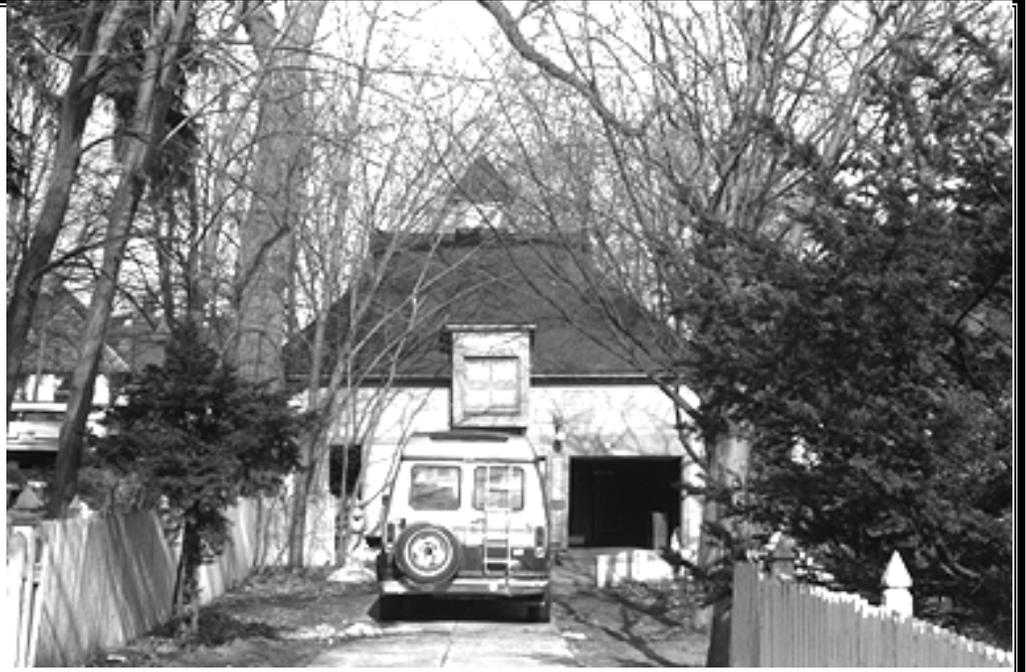
ADDRESS 502 West Main Street

ALTERATIONS: A non-contributing brick wall has been constructed in front of the carriage house.

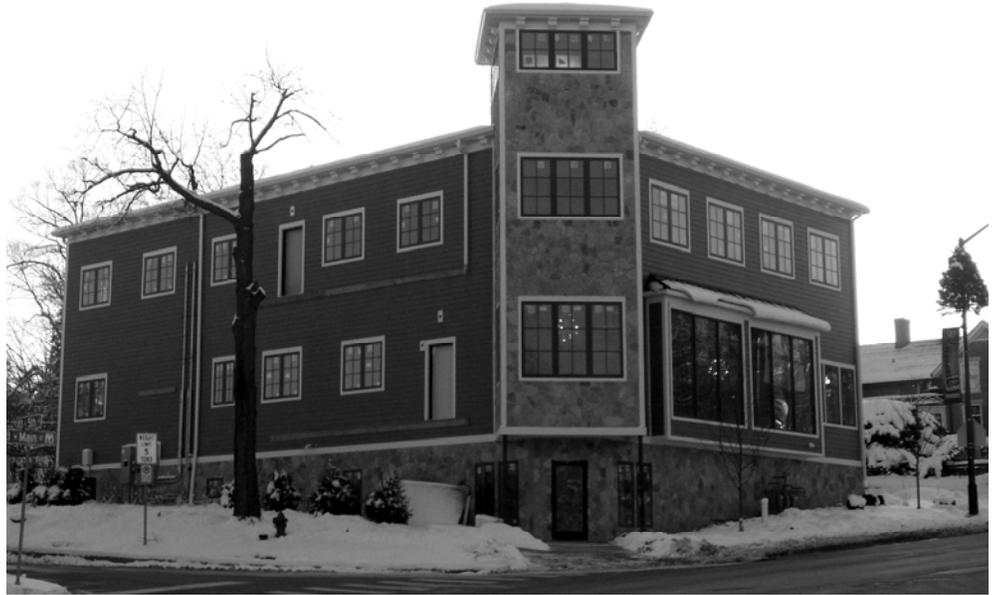
ADDRESS 505 West Main Street

Date of Construction: 2016
1950 (orig. foundation)

ARCHITECTURAL FEATURES: New construction on top of 1950 foundation. The structure reflects a mixture of elements from various architectural styles. The corner entrance is covered by a three-story protruding stone veneer tower. Large cantilevered windows are prominent on the north elevation. The roofline features a bracketed cornice.

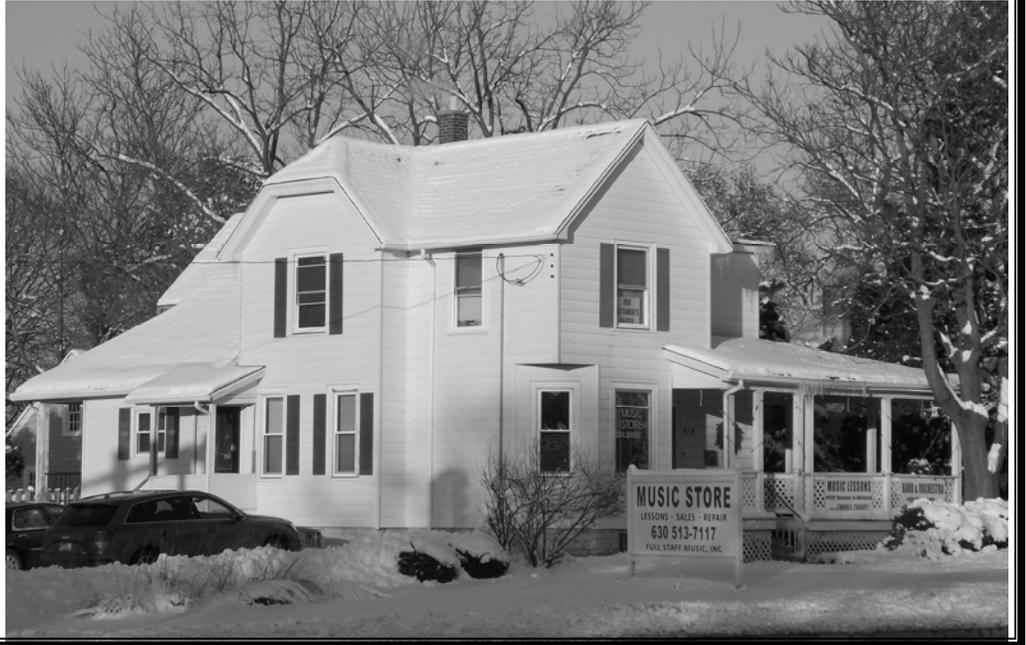
ADDRESS 614 West Main Street

Architectural Style/Type: <u>Queen Anne</u>	Exterior Walls (Current): <u>Aluminum</u>
Architectural Features: _____	Exterior Walls (Original): <u>Clapboard</u>
Date of Construction: <u>1900</u>	Foundation: <u>Stone(orig), Conc.@ additions</u>
Source: <u>Township Assessor's Office</u>	Roof Type/Material: <u>Cross gable/asphalt shingle</u>
Overall Plan Configuration: <u>Compound - mass</u>	Window Material/Type: <u>Alum/DbI. hung</u>

ALTERATIONS: The wrap around front porch has been recently redone using wolmanized lumber and does not relate well to the rest of the house. All of the detailing that this house once might have had is completely concealed by all of the aluminum. There is an addition at the rear that has a slightly lower gable roof than the main roof. A rear porch was added at some point using plain CMU as a foundation. This is currently a commercial occupancy.

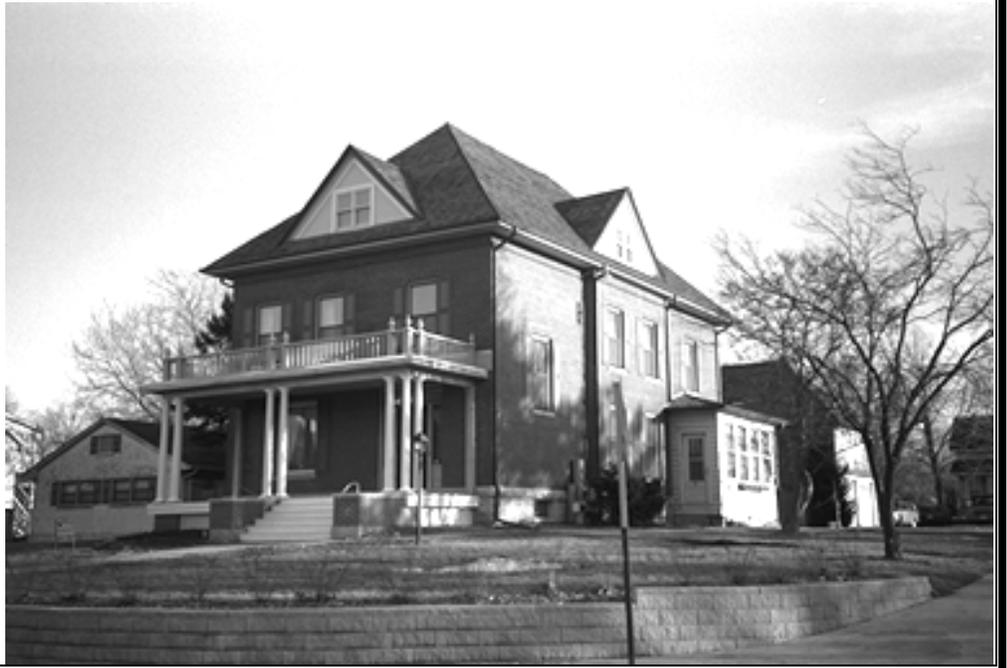
ADDRESS 619 West Main Street

Foundation: Stone(orig.),Conc.(Additions)

ARCHITECTURAL FEATURES: This is a large imposing façade accentuated by being elevated above the street level and by being located on a very prominent site. The roof is a simple hip with a long ridgeline and is articulated with large triangular roof dormers on the north, east, and west elevations. The east and west dormers crown a two story brick projection serving to break up what could have been an uneventful façade. The top of the stone foundation stops vertically at the first floor line and adds visual interest and character to the massive looking house.

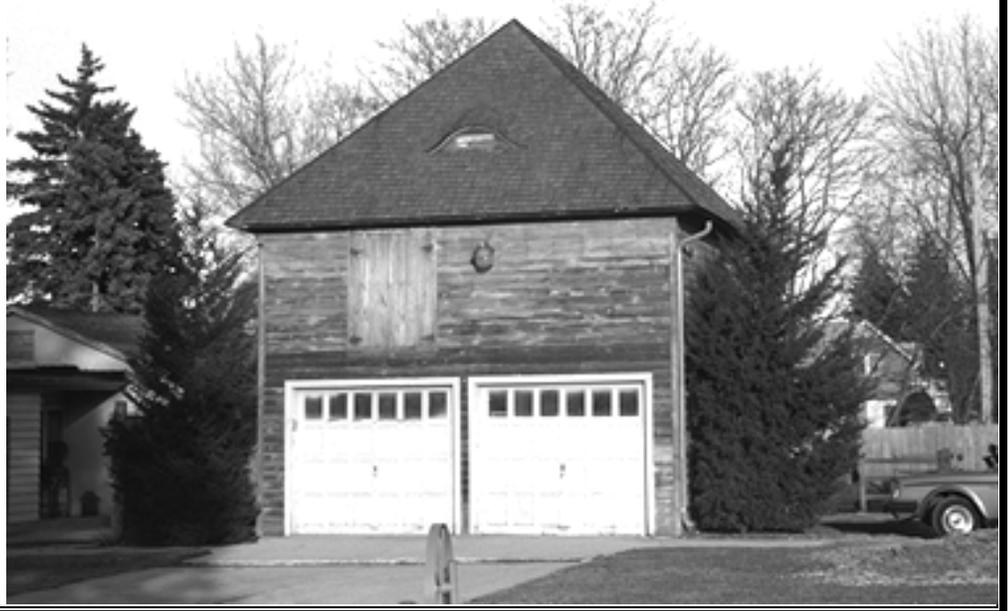
ADDRESS 619 West Main Street

Architectural Style/Type:	<u>Colonial revival</u>	Exterior Walls (Current):	<u>Clapboard</u>
Architectural Features:	<u></u>	Exterior Walls (Original):	<u>Clapboard</u>
Date of Construction:	<u>1890 est.</u>	Foundation:	<u>Stone?</u>
Source:	<u>Owner</u>	Roof Type/Material:	<u>Hipped/Wood shingle</u>
Overall Plan Configuration:	<u>Simple square</u>	Window Material/Type:	<u>Wood</u>

ALTERATIONS: This appears to have been a barn that was adaptively reused as a garage. Overhead garage doors have replaced the original doors and are not sympathetic with the original barn design.

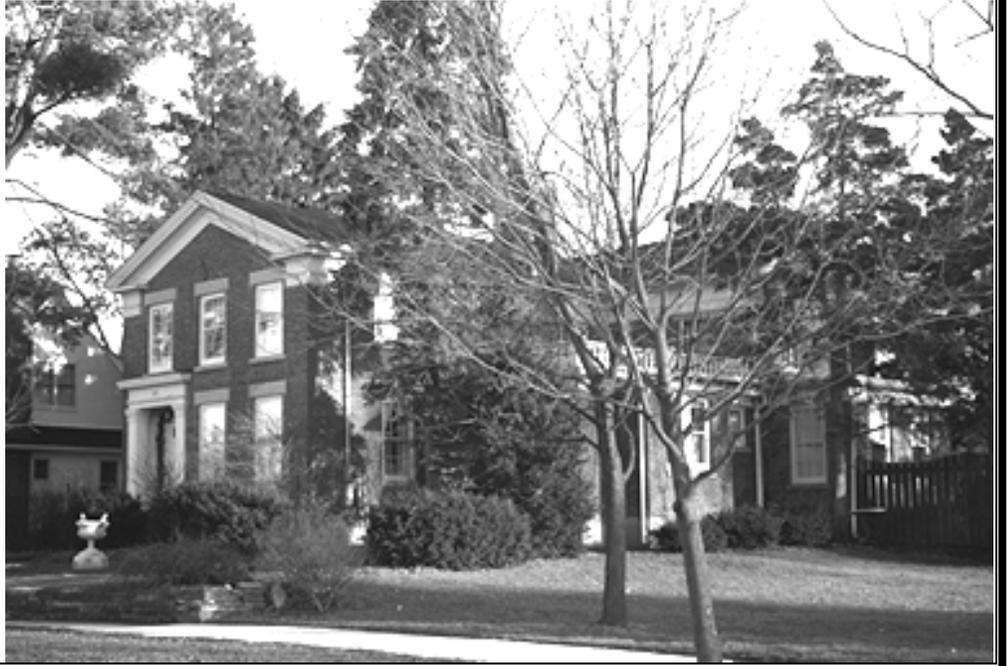
ADDRESS 515 Walnut Street

Foundation: Stone

ARCHITECTURAL FEATURES: A large front gable dominates the front of the house. A heavy frieze band located at the roof line is broken at the front elevation. There is a prominent entrance detailed in the classical tradition in wood. Stone lintels and sills are typical around the house. The window pattern is 6:6.

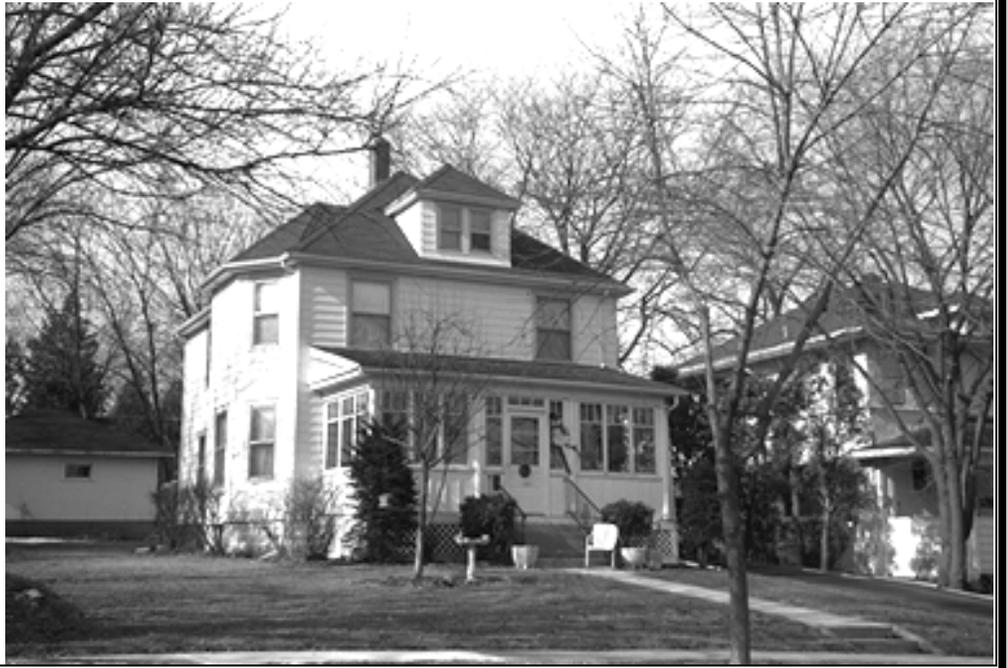
ADDRESS 17 North 5th Street

Foundation: Textured CMU

ALTERATIONS: The front porch has been closed in. The windows of the porch do not currently match the rest of the house as the proportions of the openings do not match nor do the muntin patterns. The porch foundation is skirted with a wooden lattice while the deck is accessed by a CIP concrete stoop and a wrought iron railing.
