ST. CHARLES HISTORIC PRESERVATION COMMISSION

ARCHITECTURAL SURVEY
MILLINGTON HISTORIC DISTRICT
ST. CHARLES, ILLINOIS
Date of Survey: 2003

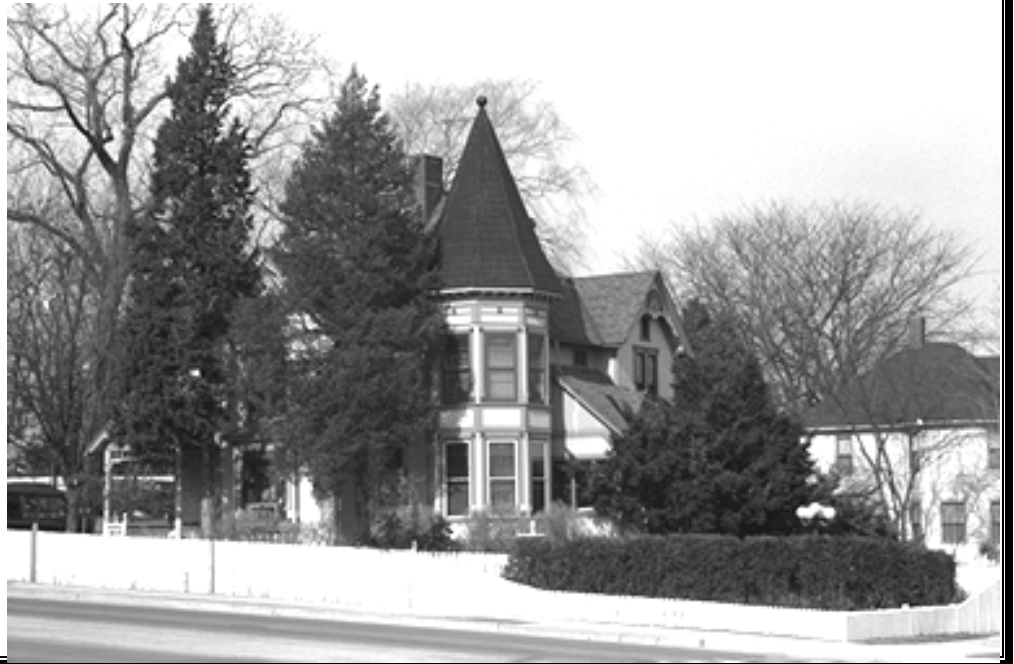
ADDRESS 502 West Main Street

Architectural Style/Type: Victorian – Queen Anne

Exterior Walls (Current): Wood clapboard on a wood frame

Foundation: Stone

Roof Type/Material: Hipped with cross gables

ARCHITECTURAL FEATURES: This is an elaborately detailed example of the style. A system of ornamental wood trim is used throughout the house. All of the window and door openings are trimmed in a similar manner. A two-story corner tower is the most visible architectural detail. It relates well to the corner site and the adjacent city park. Elaborate spindle-work decorates the gable ends. Spindle-work detailing is used on the porches located on the east and west sides of the house.

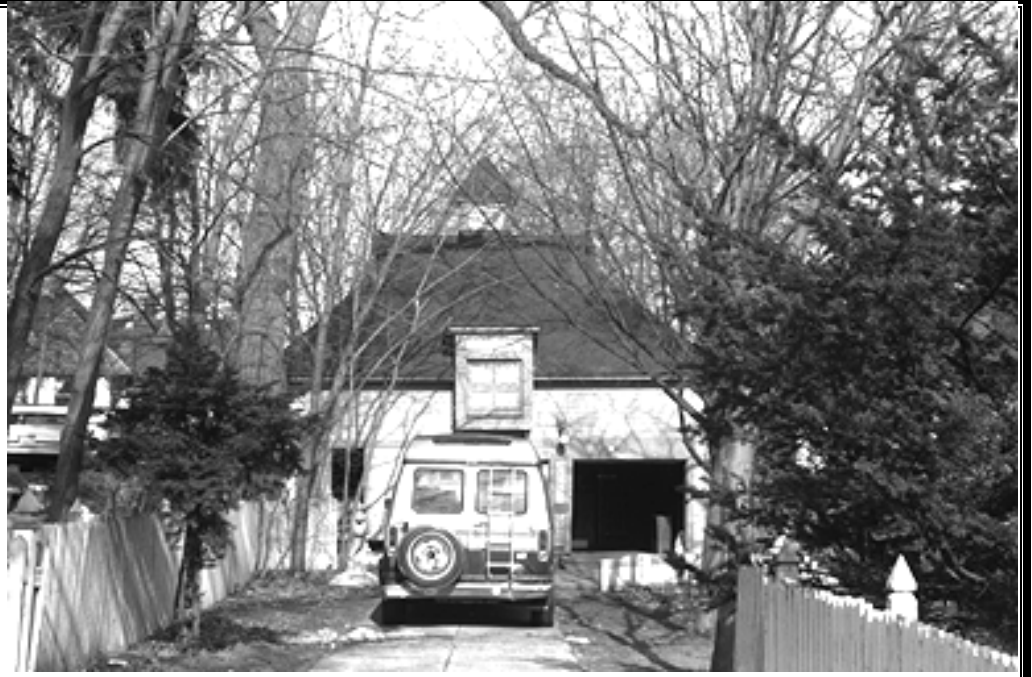
ADDRESS 502 West Main Street

ALTERATIONS: A non-contributing brick wall has been constructed in front of the carriage house.

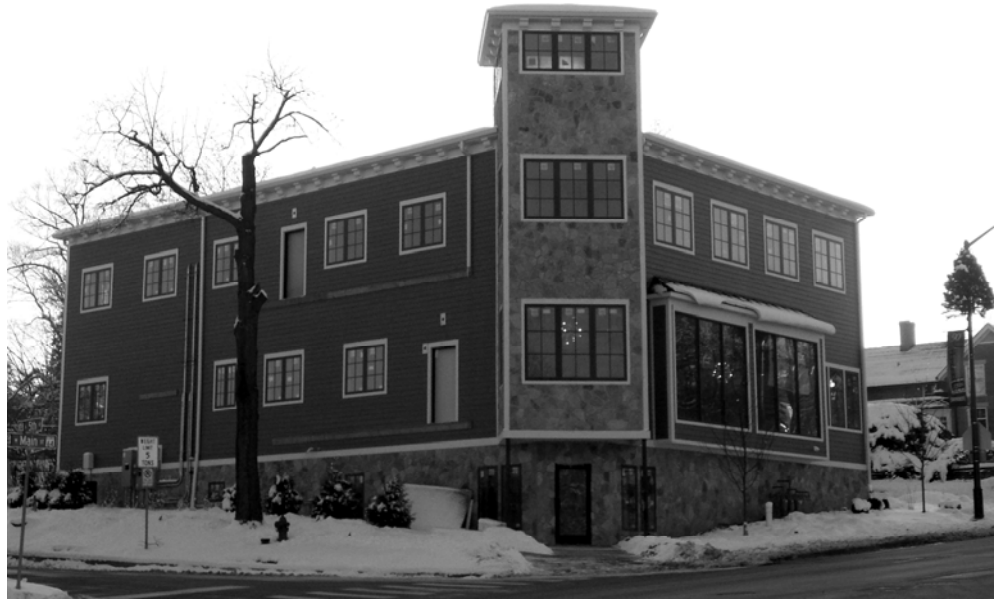
ADDRESS 505 West Main Street

Architectural Style/Type: Commercial

Exterior Walls (Current): Cement board, stone veneer

ARCHITECTURAL FEATURES: New construction on top of 1950 foundation. The structure reflects a mixture of elements from various architectural styles. The corner entrance is covered by a three-story protruding stone veneer tower. Large cantilevered windows are prominent on the north elevation. The roofline features a bracketed cornice.

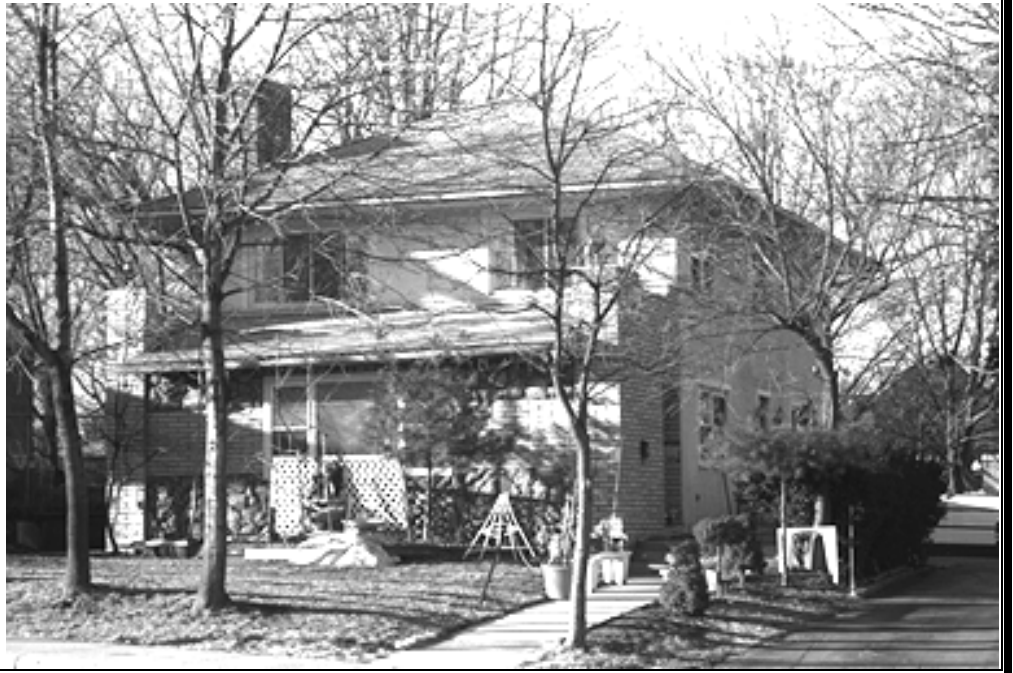
ADDRESS 514 West Main Street

Architectural Style/Type: Prairie Style 4 square

Exterior Walls (Current): Stucco on masonry

ARCHITECTURAL FEATURES: This house exhibits some of the typical features of the style in the roof form and its' broad eaves. The windows on the 2F are banded together in the Prairie Style fashion.

ALTERATIONS: A screened in front porch runs the full width of the house. Its' walls are brick and the detailing does not match the rest of the house.

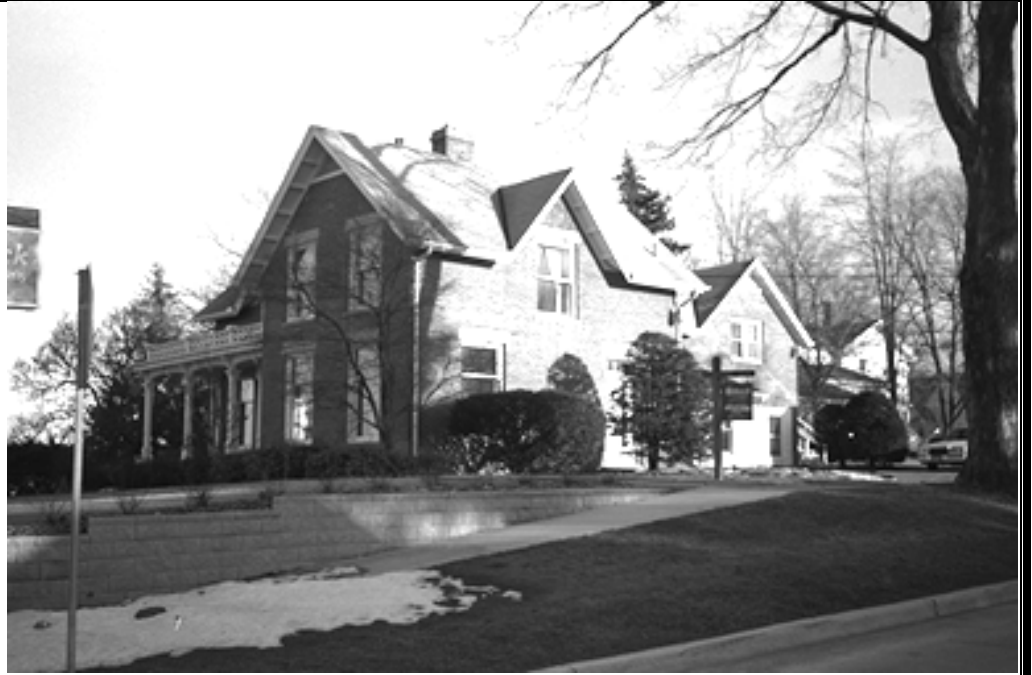
ADDRESS 521 West Main Street

Architectural Style/Type: Gothic Revival
 Architectural Features: _____
 Date of Construction: 1890
 Source: Township Assessor's Office
 Overall Plan Configuration: Compound asymmetrical

Exterior Walls (Current): Brick
 Exterior Walls (Original): Brick
 Foundation: Stone
 Roof Type/Material: Cross gabled/Asphalt shingles
 Window Material/Type: Alum/Wood/Double hung

ARCHITECTURAL FEATURES: This house is sited high up the hill west and overlooking the downtown. It has an impressive façade as a result. The detailing of the brick walls is relatively plain, but it has large stone lintels. The walls extend into the gables without a break meeting the open eaves and exposed rafter ends. This gives the house the lofty feeling associated with the gothic style. The porch at the entry has flat arches supported by square posts and includes a delicately detailed railing.

ALTERATIONS: A large 2 story addition was put onto the rear of the house that was relatively sympathetic to the original. The addition used the same materials, roof pitch, and detailing as the original house. There is also a non-sympathetic 1 story addition to the west side sheathed in clapboard. The windows are 6:1 pattern and the roofing is black asphalt shingles. Another 1 story addition to the rear has a flat roof deck & an exit from the 2F and is also sheathed in clapboard.

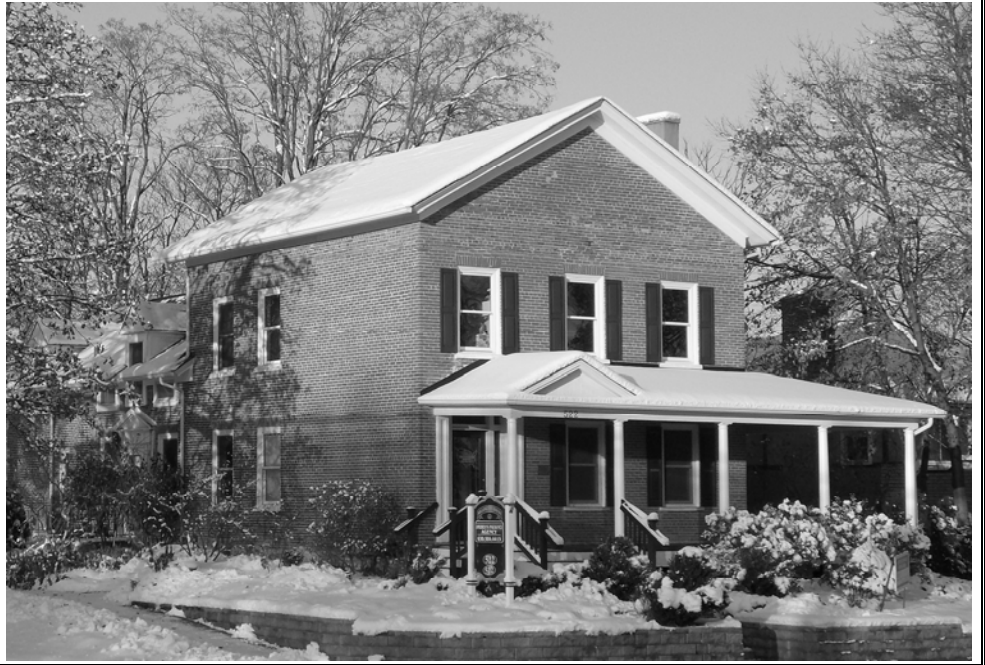
ADDRESS 522 West Main Street

Architectural Style/Type: Greek Revival

ARCHITECTURAL FEATURES: There are brick jack arches over the windows, which have stone sills. Full height classic columns support the wrap - around front porch and a small pediment emphasizes the entrance. The eaves are accented with a wide band of trim.

ALTERATIONS: A large addition to the rear of the house features frieze band windows and a simple gable roof like the original

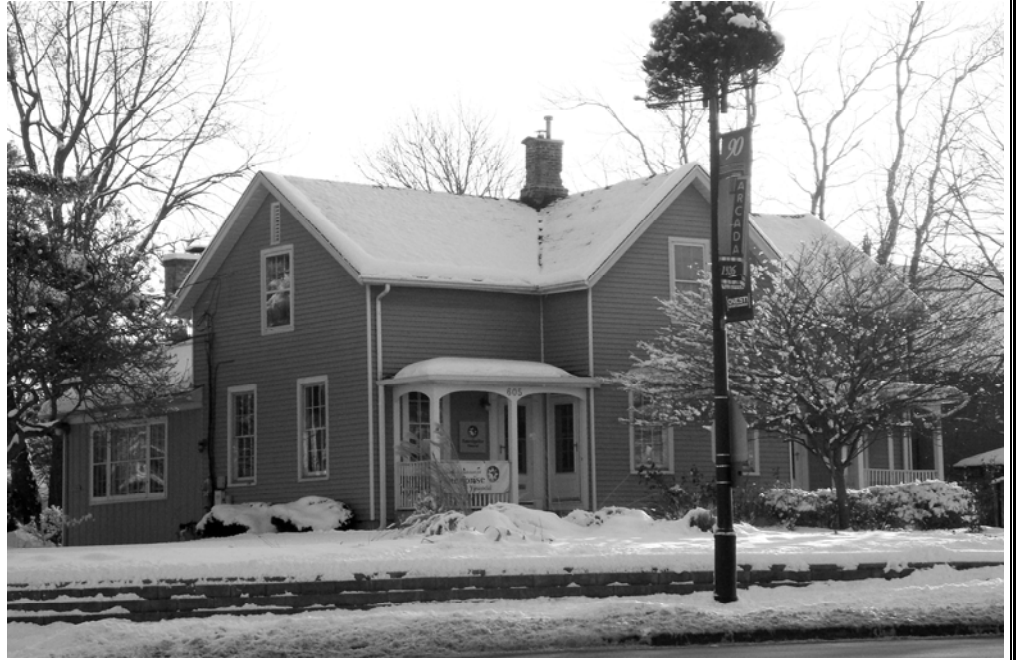
ADDRESS 605 West Main Street

Architectural Style/Type: National

ARCHITECTURAL FEATURES: This is an unusual front elevation featuring two front porches that are supported by shallow arches springing from simple full height square column. Classically detailed fluted pilasters flank both of the front entrances.

ALTERATIONS: The addition to the rear is one story and has a roof that has a shallower pitch that the main house. The aluminum siding is typically horizontal, but is vertical at the addition. There is another addition that has a shed roof that is accessed by an exterior site built wooden stair. This addition has horizontal aluminum siding. There is currently a commercial tenant occupying the building.

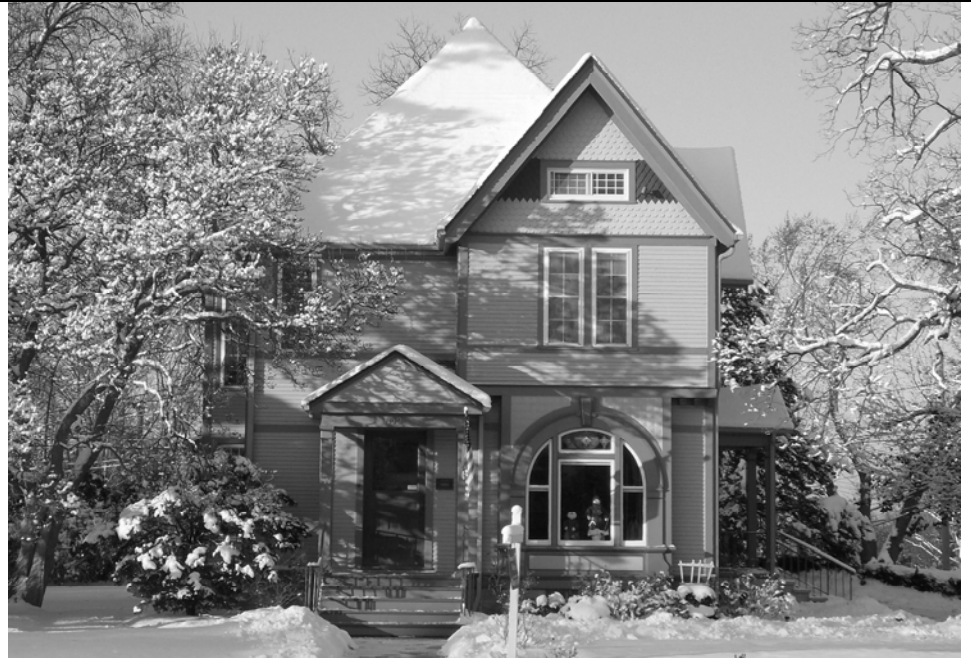
ADDRESS 612 West Main Street

Architectural Style/Type: Queen Anne

ARCHITECTURAL FEATURES: This house features a hipped roof with lower cross gables. The entry has a small gabled porch with square columns. The front gable is a dominant feature of the asymmetrical front elevation. This feature also has a large arched tripartite window and cut away corners and imbricated shingles under the gable.

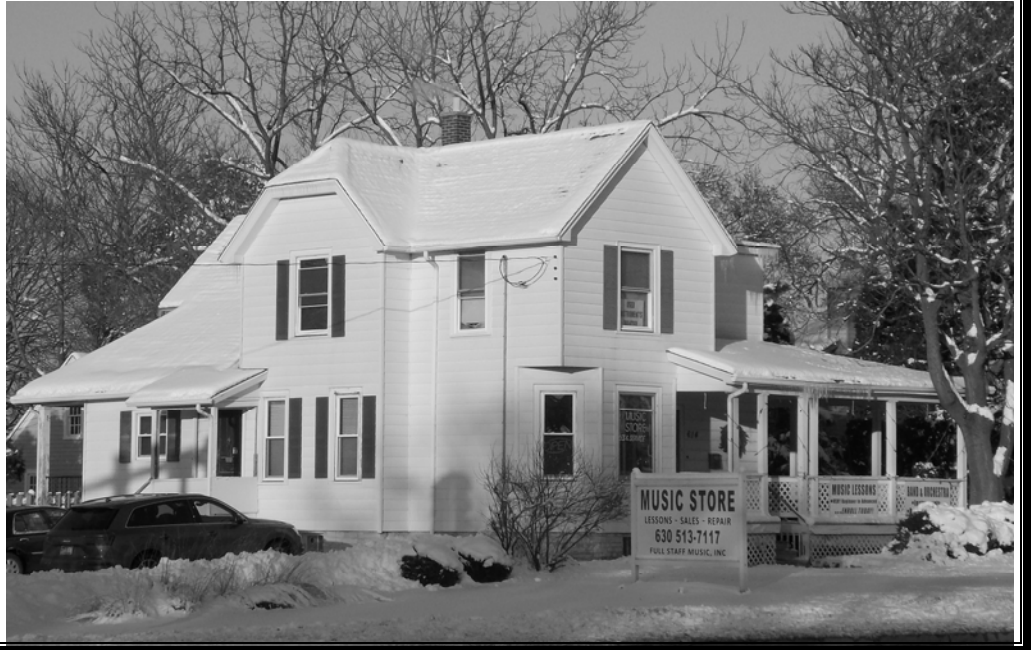
ADDRESS 614 West Main Street

Architectural Style/Type: <u>Queen Anne</u>	Exterior Walls (Current): <u>Aluminum</u>
Architectural Features: _____	Exterior Walls (Original): <u>Clapboard</u>
Date of Construction: <u>1900</u>	Foundation: <u>Stone(orig), Conc.@ additions</u>
Source: <u>Township Assessor's Office</u>	Roof Type/Material: <u>Cross gable/asphalt shingle</u>
Overall Plan Configuration: <u>Compound - mass</u>	Window Material/Type: <u>Alum/DbI. hung</u>

ARCHITECTURAL FEATURES: The front gable has cut away corners as if it once had some Victorian detailing. The west side gable has a curious hipped gable that is out of place with the rest of the house.

ALTERATIONS: The wrap around front porch has been recently redone using wolmanized lumber and does not relate well to the rest of the house. All of the detailing that this house once might have had is completely concealed by all of the aluminum. There is an addition at the rear that has a slightly lower gable roof than the main roof. A rear porch was added at some point using plain CMU as a foundation. This is currently a commercial occupancy.

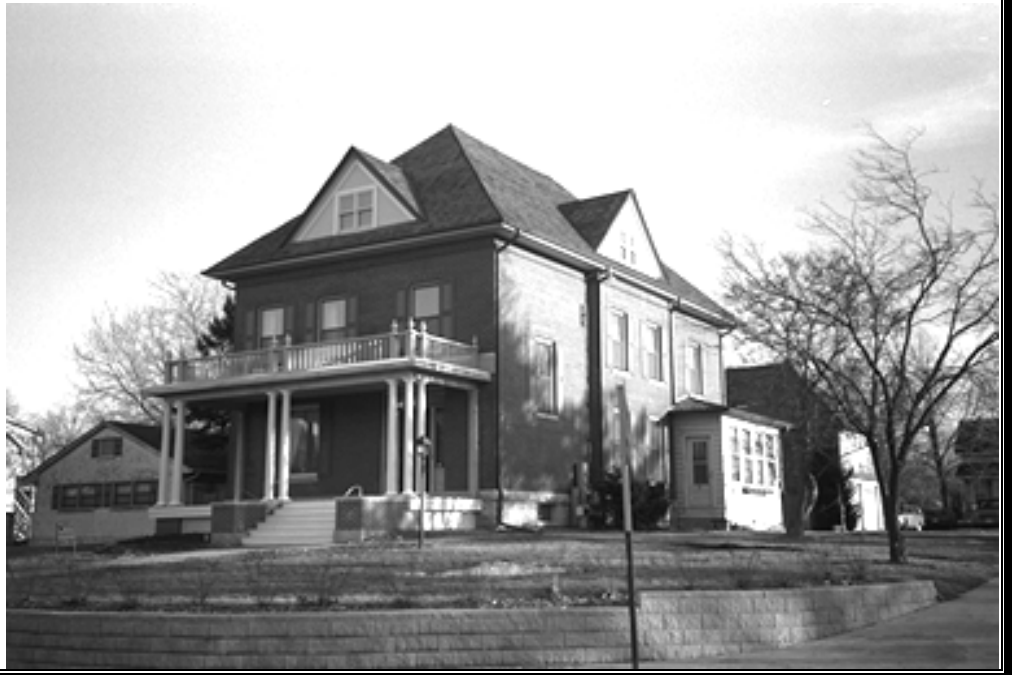
ADDRESS 619 West Main Street

Architectural Style/Type: <u>Colonial Revival</u>	Exterior Walls (Current): <u>Brick</u>
Architectural Features: _____	Exterior Walls (Original): <u>Brick</u>
Date of Construction: <u>1900</u>	Foundation: <u>Stone(orig.),Conc.(Additions)</u>
Source: <u>Township Assessor's Office</u>	Roof Type/Material: <u>Hipped/Wood shingle (orig.)</u>
Overall Plan Configuration: <u>Simple w/ additions</u>	Window Material/Type: <u>Alum/Wd./Dbl. hung</u>

ARCHITECTURAL FEATURES: This is a large imposing façade accentuated by being elevated above the street level and by being located on a very prominent site. The roof is a simple hip with a long ridgeline and is articulated with large triangular roof dormers on the north, east, and west elevations. The east and west dormers crown a two story brick projection serving to break up what could have been an uneventful façade. The top of the stone foundation stops vertically at the first floor line and adds visual interest and character to the massive looking house.

ALTERATIONS: The front porch is an important element of the front façade and has recently been rebuilt using modern materials. The detailing is good and the design appears to be compatible with the main house. Several additions have been made to the west, south, and east sides of the original house. None of these are sympathetic with the original design in any way. There is no sense of scale, material, or detail references in any of these additions. An adjacent one - story house is connected to the main house at the rear.

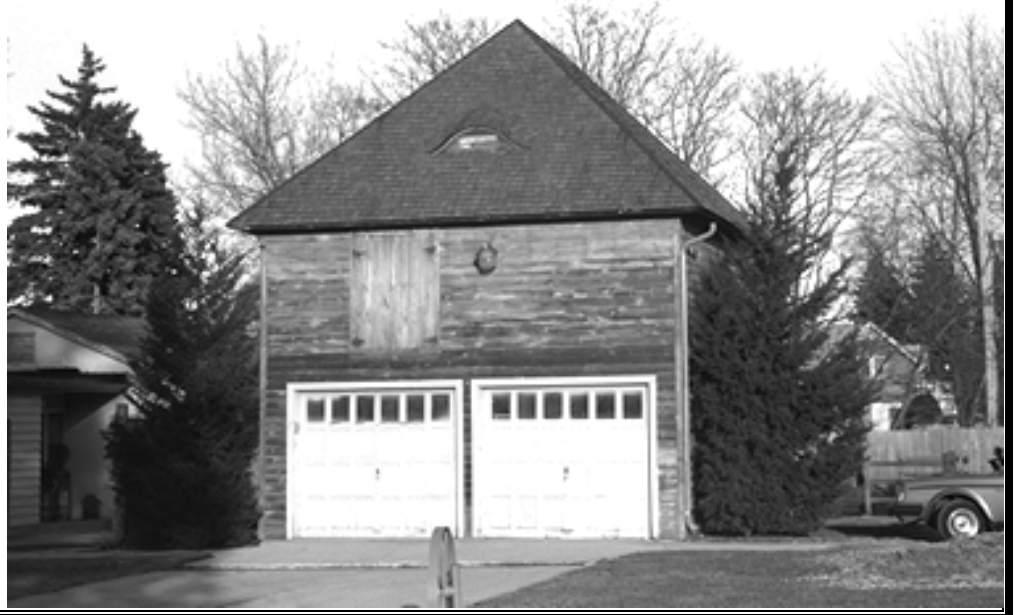
ADDRESS 619 West Main Street

Architectural Style/Type: <u>Colonial revival</u>	Exterior Walls (Current): <u>Clapboard</u>
Architectural Features: _____	Exterior Walls (Original): <u>Clapboard</u>
Date of Construction: <u>1890 est.</u>	Foundation: <u>Stone?</u>
Source: <u>Owner</u>	Roof Type/Material: <u>Hipped/Wood shingle</u>
Overall Plan Configuration: <u>Simple square</u>	Window Material/Type: <u>Wood</u>

ARCHITECTURAL FEATURES: The hipped pyramidal roof together with the lone eyebrow dormer and hayloft doors has an eccentrically interesting overall appearance.

ALTERATIONS: This appears to have been a barn that was adaptively reused as a garage. Overhead garage doors have replaced the original doors and are not sympathetic with the original barn design.
