ST. CHARLES HISTORIC PRESERVATION COMMISSION

# ARCHITECTURAL SURVEY ST. CHARLES CENTRAL DISTRICT ST. CHARLES, ILLINOIS

DIXON ASSOCIATES / ARCHITECTS

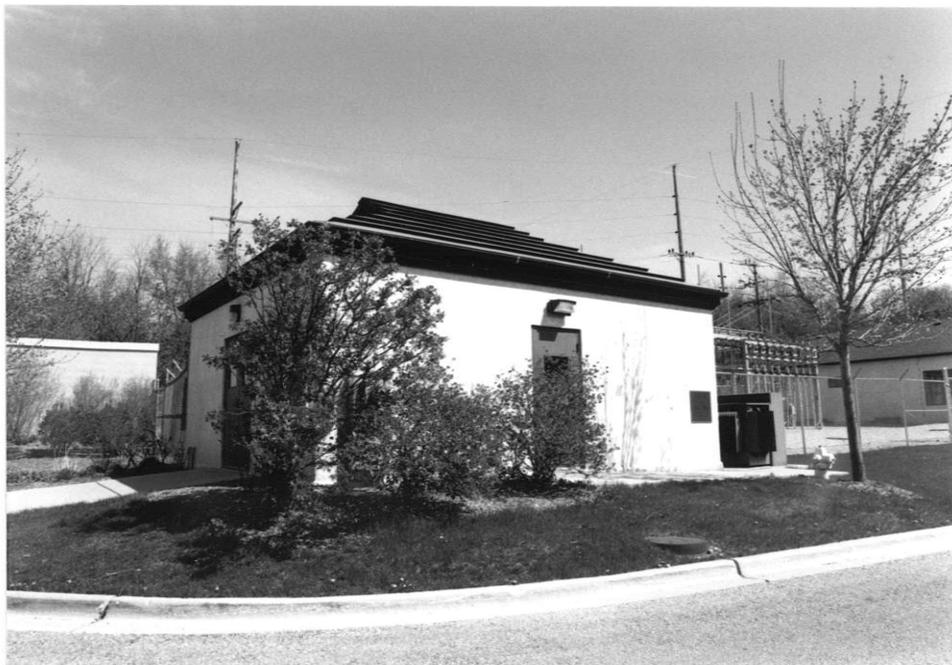
**NEGATIVE NO. 13**

Square, aggregate finish cement plaster building with metal hip roof.

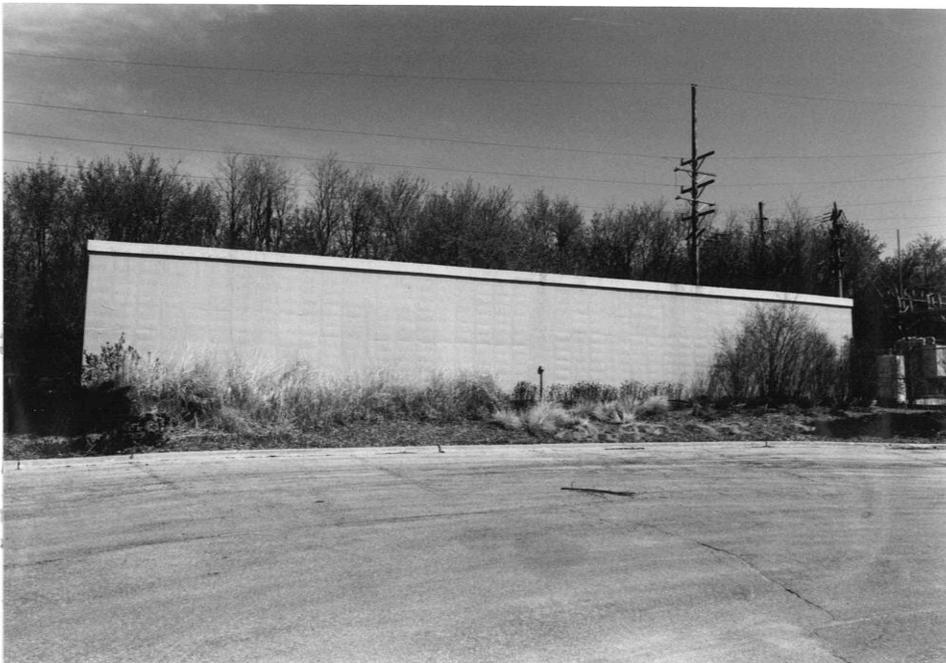
**NEGATIVE NO. 11**

Electric equipment enclosure wall.

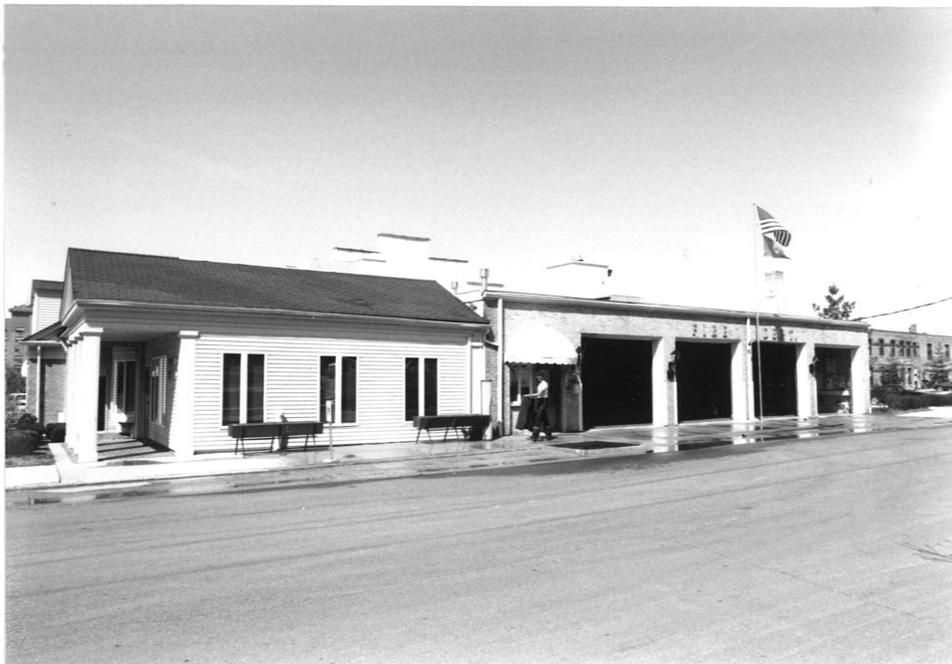
**NEGATIVE NO. 7**

**Style:** Neo-colonial  
**Date of Construction:** Post 1944  
**Source:** A Field Guide to American Architecture  
**Features:**  
 Utilitarian masonry structure at fire barn. Neo-colonial facade at south section of building housing fire department and Chamber of Commerce offices.

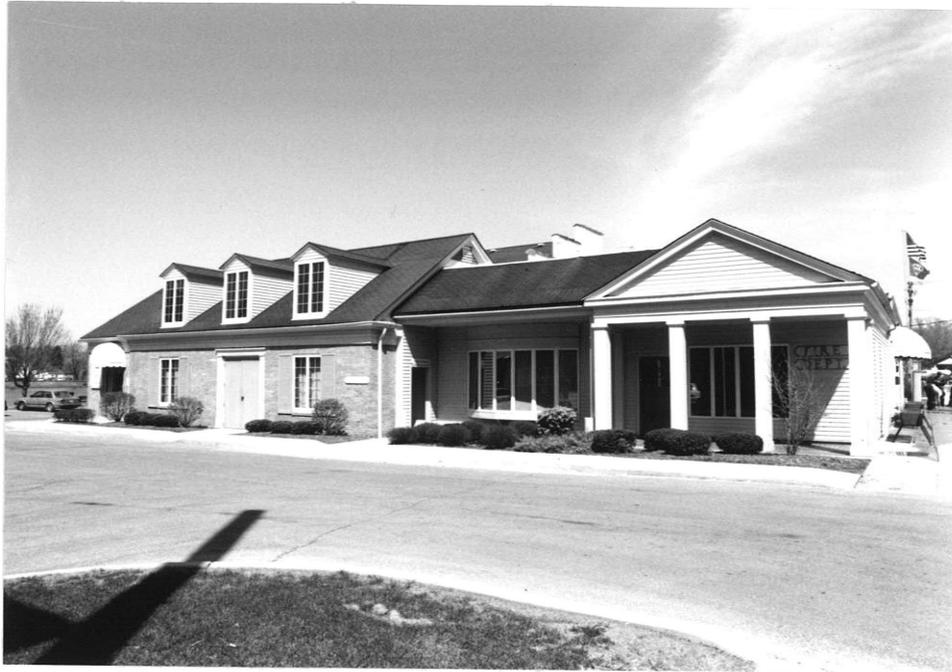
**NEGATIVE NO. 6**

South facade

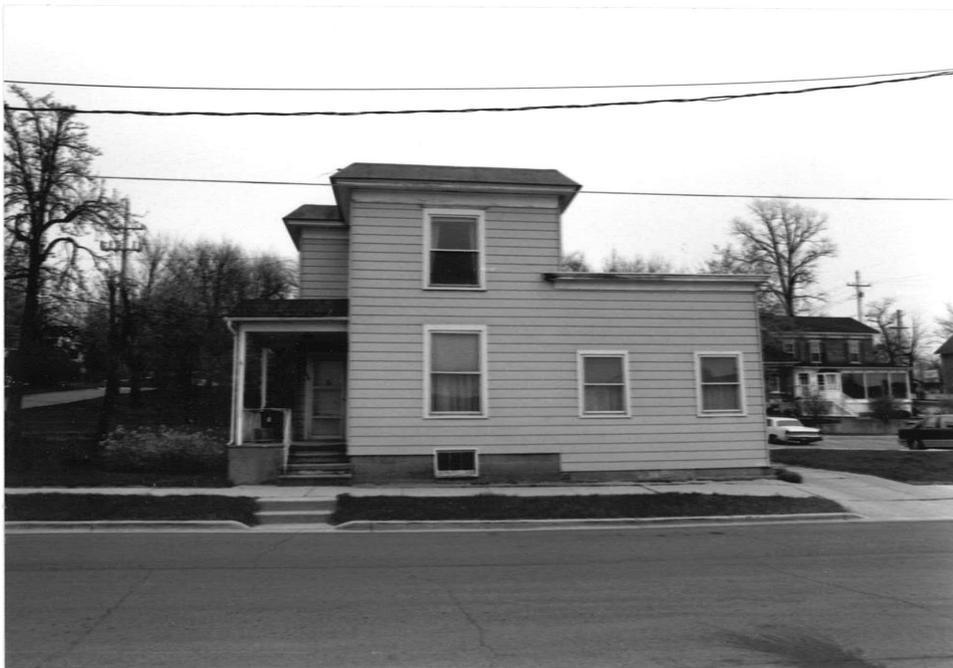
**NEGATIVE NO. 29**

**Style:** Second Empire  
**Date of Construction:** 1855-1885  
**Source:** A Field Guide to American Houses  
**Features:**  
 Synthetic sided, two story structure with mansard roof.  
 Greatly modified with additions and porch changes.

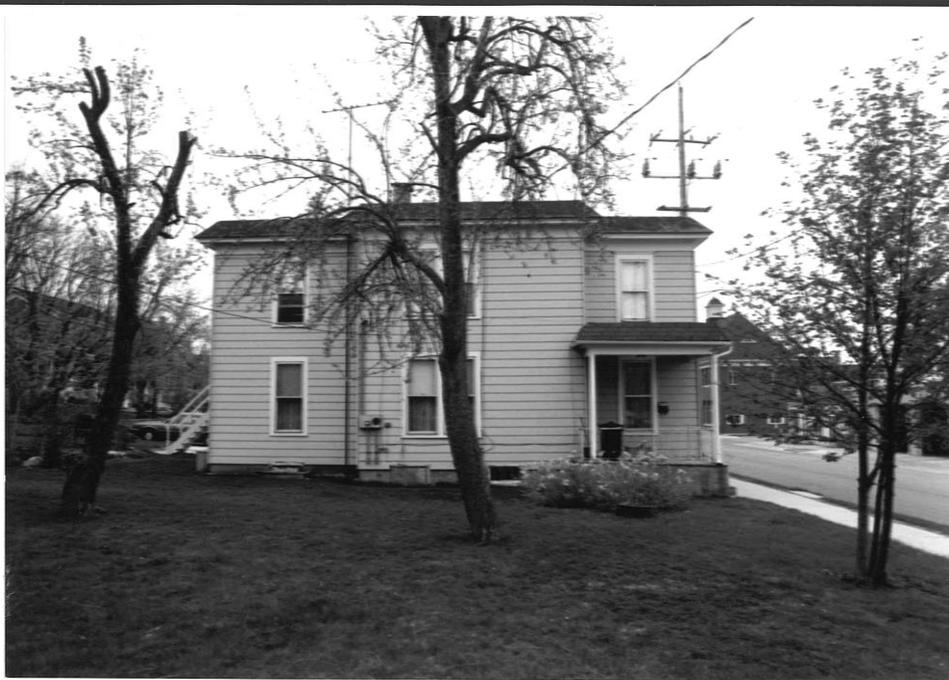
**NEGATIVE NO. 30**

North Elevation.

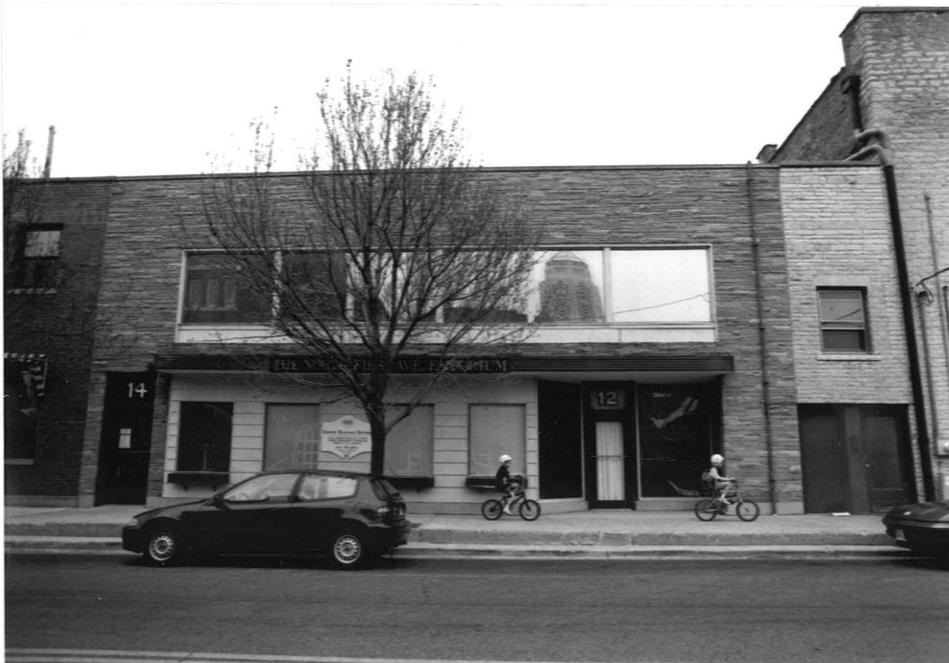
**NEGATIVE NO. 25**

Two story, greatly modified structure. Synthetic siding at first floor, lannon stone cladding at second floor. Large picture windows at second floor.

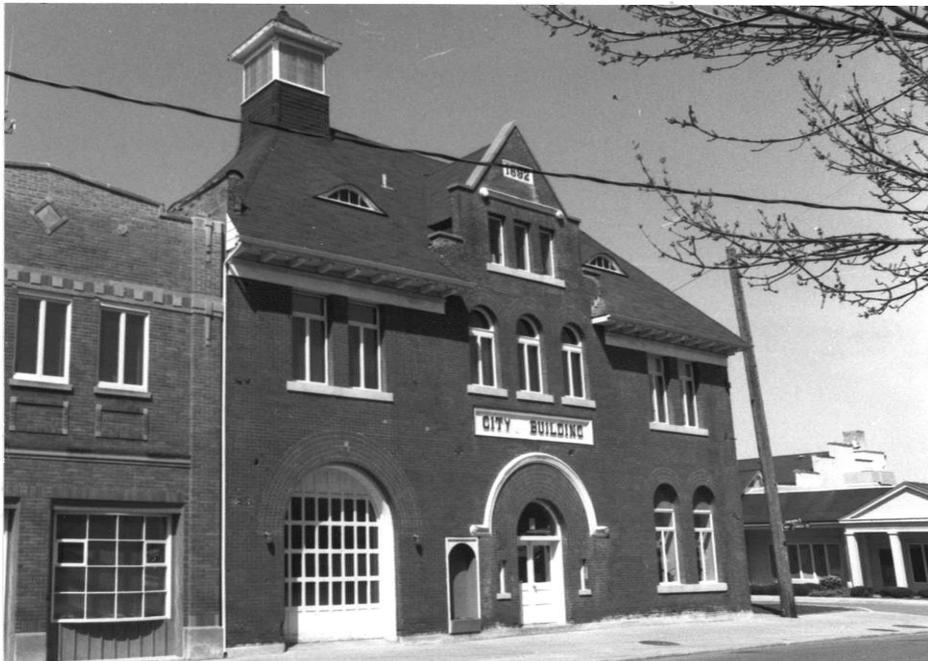
**NEGATIVE NO. 5**

Hipped roof red brick building with bell tower, "eye lid" windows characteristic of H.H. Richardson's Romanesque style. The roof soffit is articulated with wood brackets. The middle of the front (east) facade has a full arch with a vertical continuation of the brickface through the soffit to a gable end "dormer" with three windows and datestone.

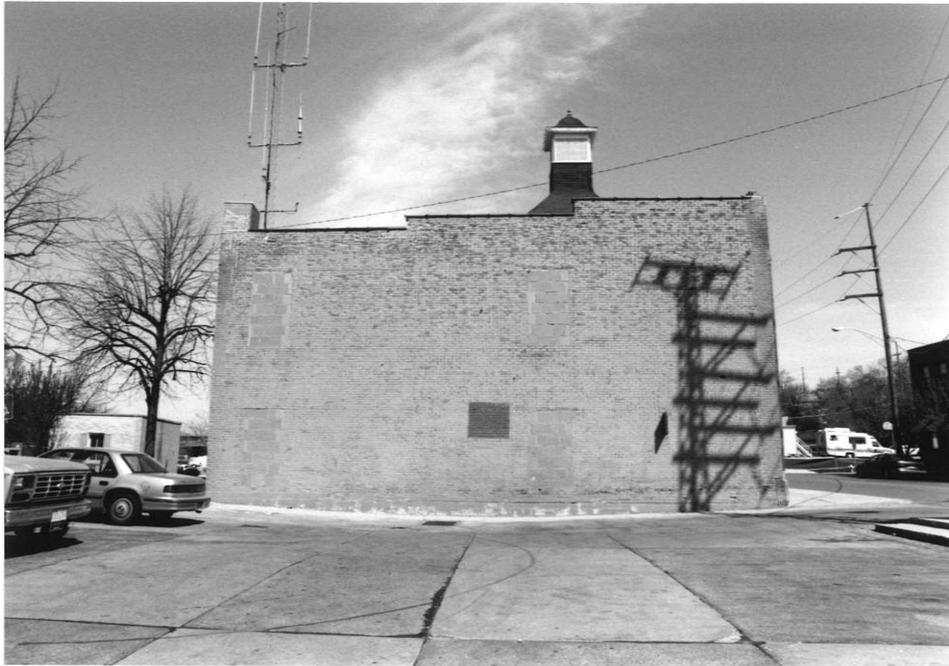
**NEGATIVE NO. 2**

South Elevation with four  
blocked in windows.

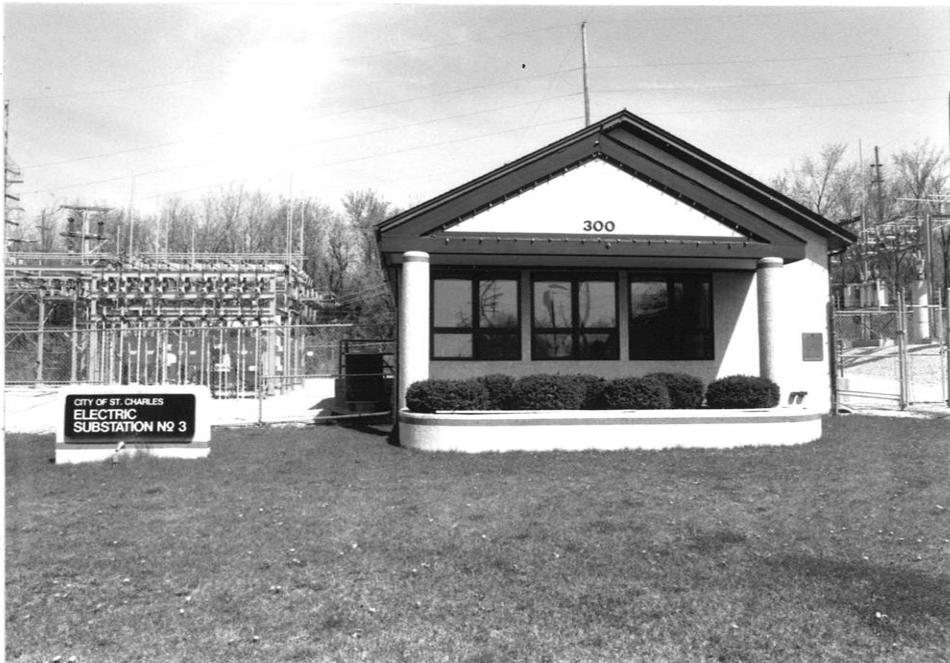
**NEGATIVE NO. 14**

Gable roof to front. Projected gable acts as sun shade for large south facing windows in this adaptive use from a lumber storage building to an electric substation building. Cement plaster finish over concrete block added in 1986 remodeling.
