ST. CHARLES HISTORIC PRESERVATION COMMISSION

ARCHITECTURAL SURVEY
ST. CHARLES CENTRAL DISTRICT
ST. CHARLES, ILLINOIS

DIXON ASSOCIATES / ARCHITECTS

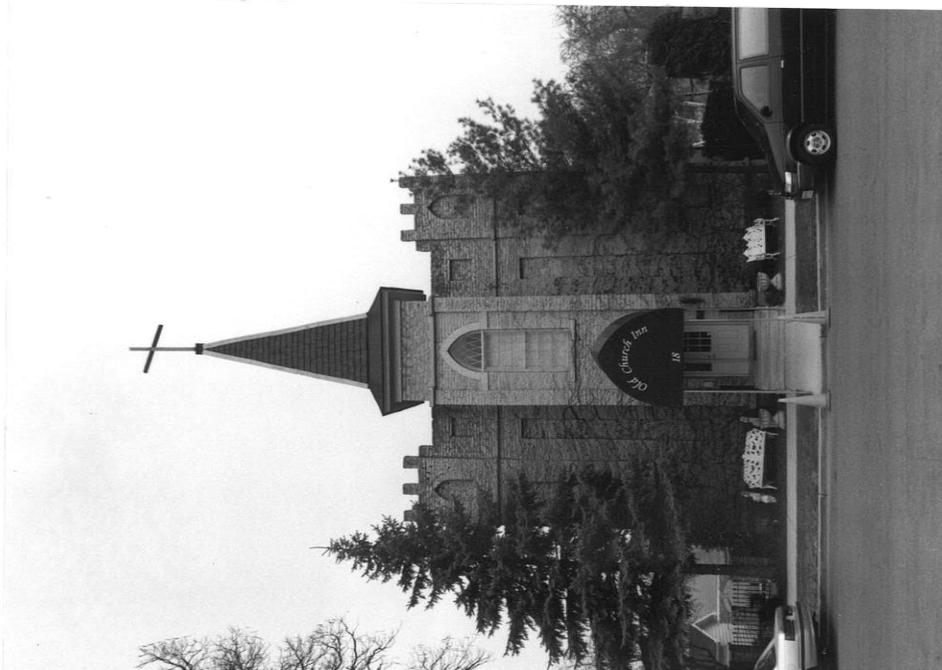
NEGATIVE NO. 23

Style: Gothic Revival

Date of Construction: 1851

Steeply pitched roof steeple with wooden cross towers over layered limestone building. Castellated parapet. Pointed, Gothic shape windows. Stone addition to north built in 1992, Dixon Associates, architects.

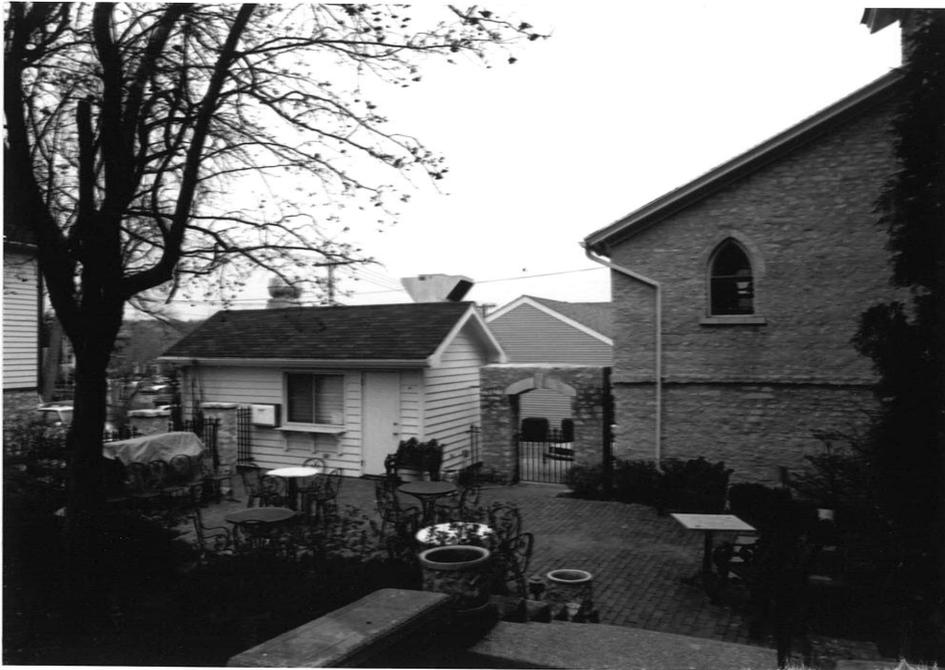
NEGATIVE NO. 24

West side of north addition,
showing wood frame garage
structure now used for
serving courtyard.

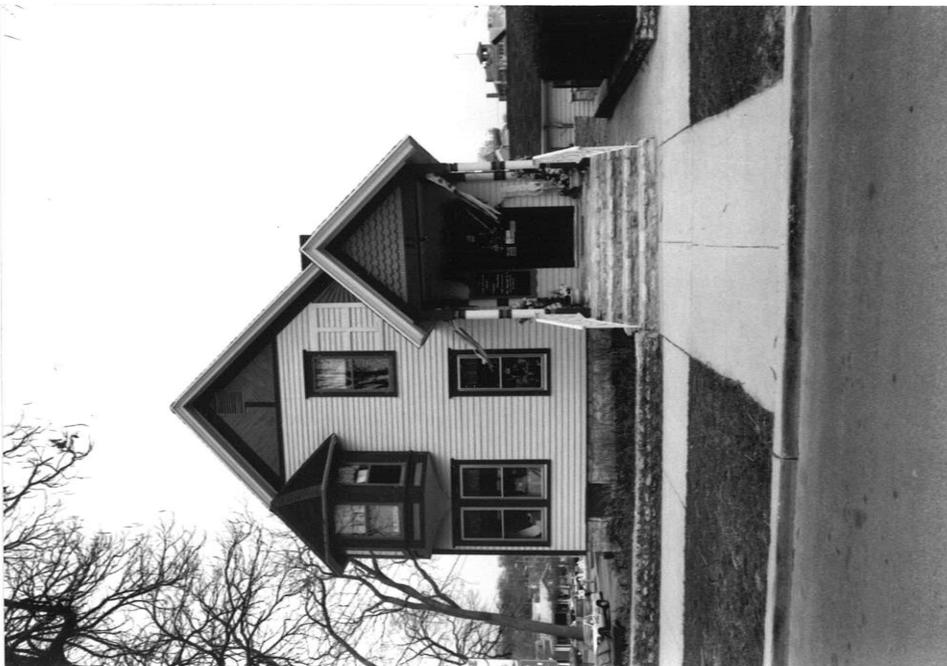
NEGATIVE NO. 25

Style: Queen Anne

Date of Construction: 1880's

Stone foundation, two story wood clapboard sided with gable ornament. Turret type projecting bay window at second floor. Former parsonage for St. Patrick Church.

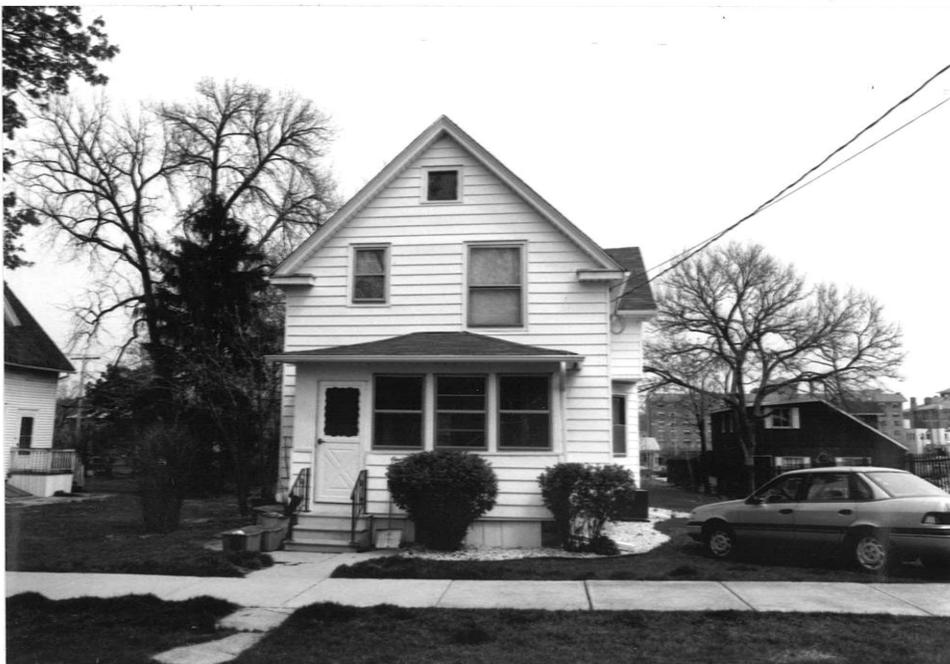
NEGATIVE NO. 28

Style: National Folk

Date of Construction: 1870-1910

Front gabled roof two story structure with later synthetic siding, aluminum soffits. Porch enclosed. Broken pediment at front gable end.

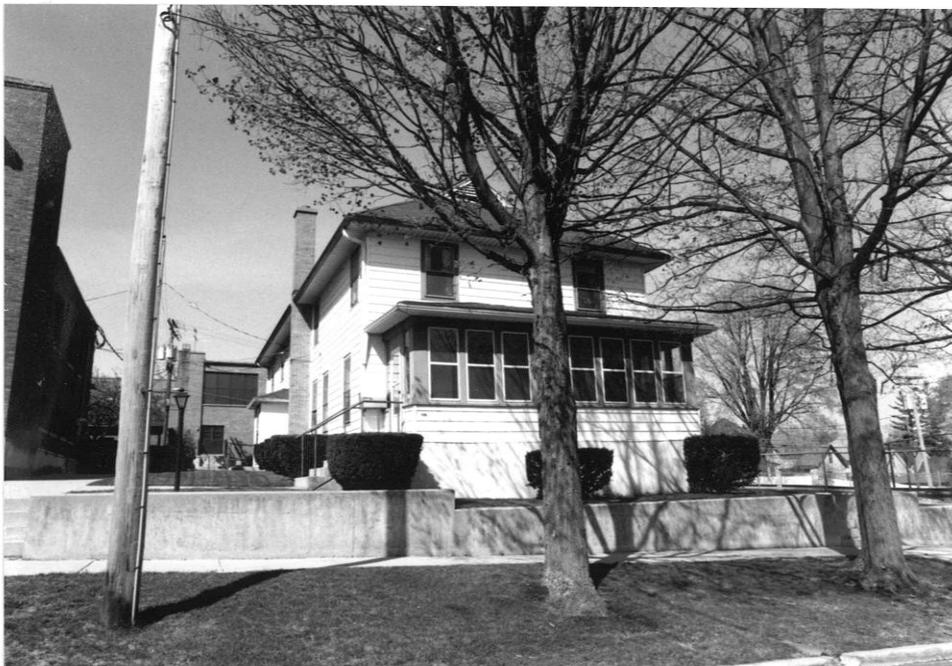
NEGATIVE NO. 36

Style: American Foursquare

Date of Construction: ca. 1920's

Hipped roof, symmetrical with front entry porch across entire east side. Enclosed porch, double hung windows.

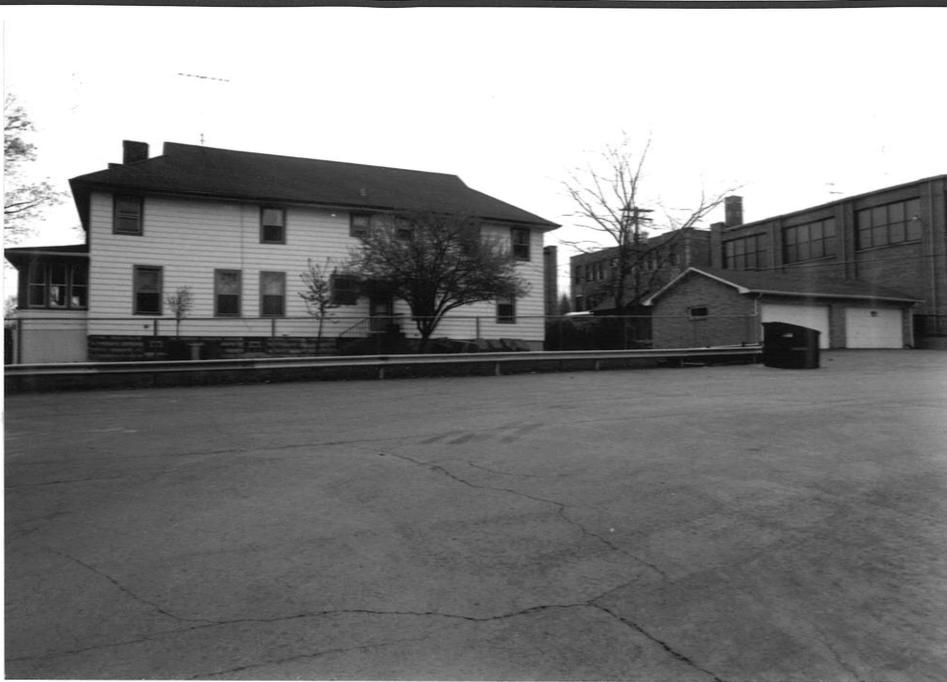
NEGATIVE NO. 31

View from north, showing masonry garage to west.

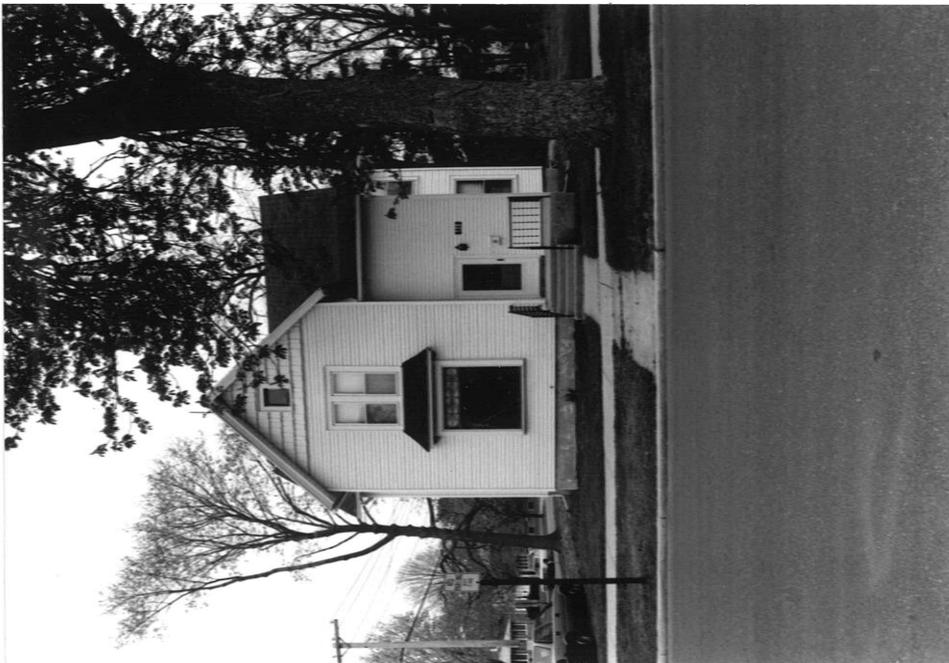
NEGATIVE NO. 29

Style: National Folk

Date of Construction: 1870-1910

Front gable and wing. Shingles at gable, clapboard sided below. Mansard type roof over first floor picture window with art glass transom.

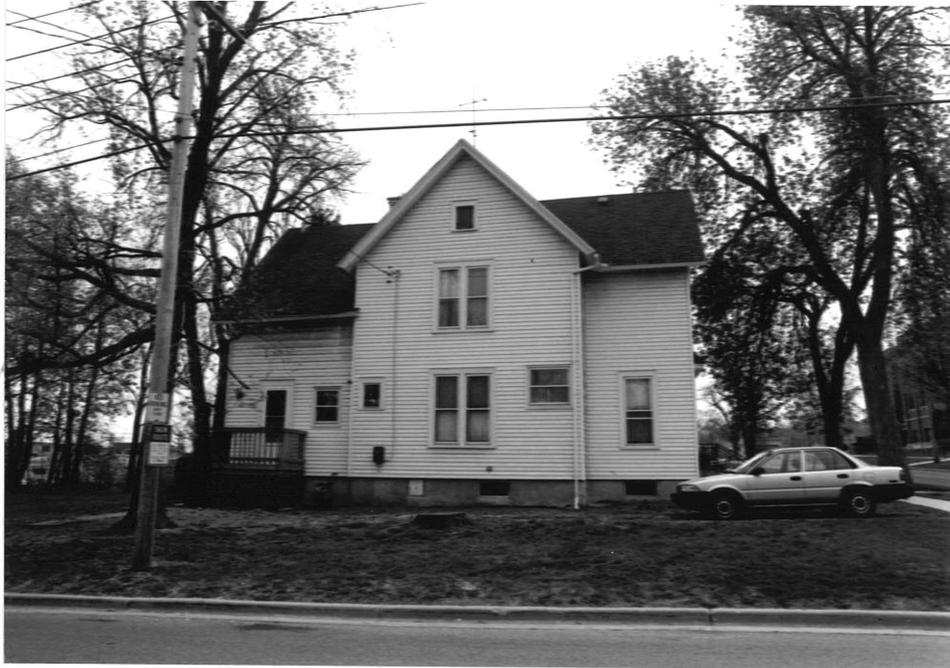
NEGATIVE NO. 30

North Elevation
