ST. CHARLES HISTORIC PRESERVATION COMMISSION

ARCHITECTURAL SURVEY
ST. CHARLES CENTRAL DISTRICT
ST. CHARLES, ILLINOIS

DIXON ASSOCIATES / ARCHITECTS

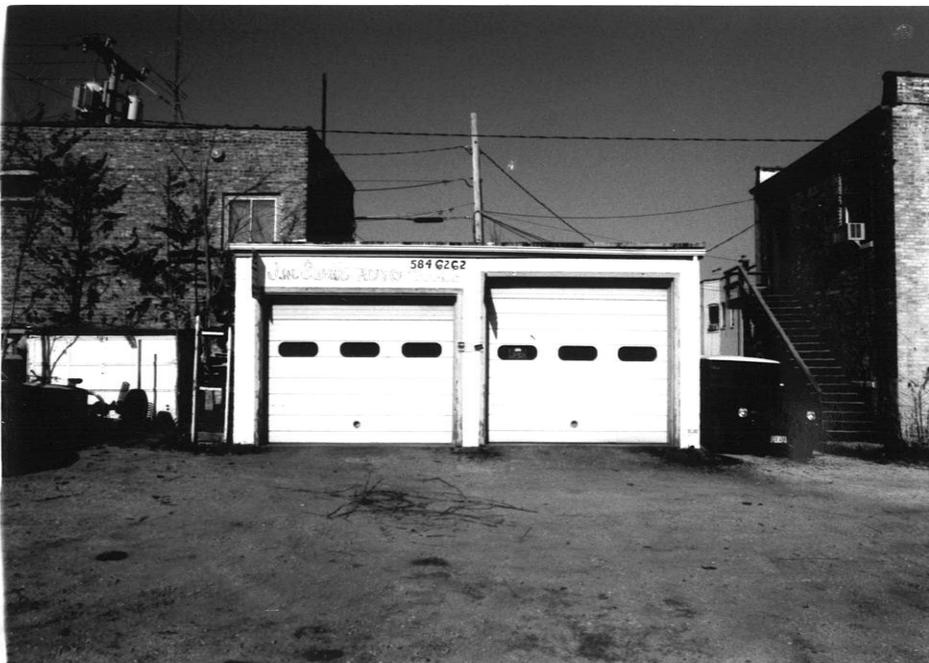
13 1/2 South 2nd Street

Style: Utilitarian

Date of Construction: 1940-1960

Concrete block two door garage.

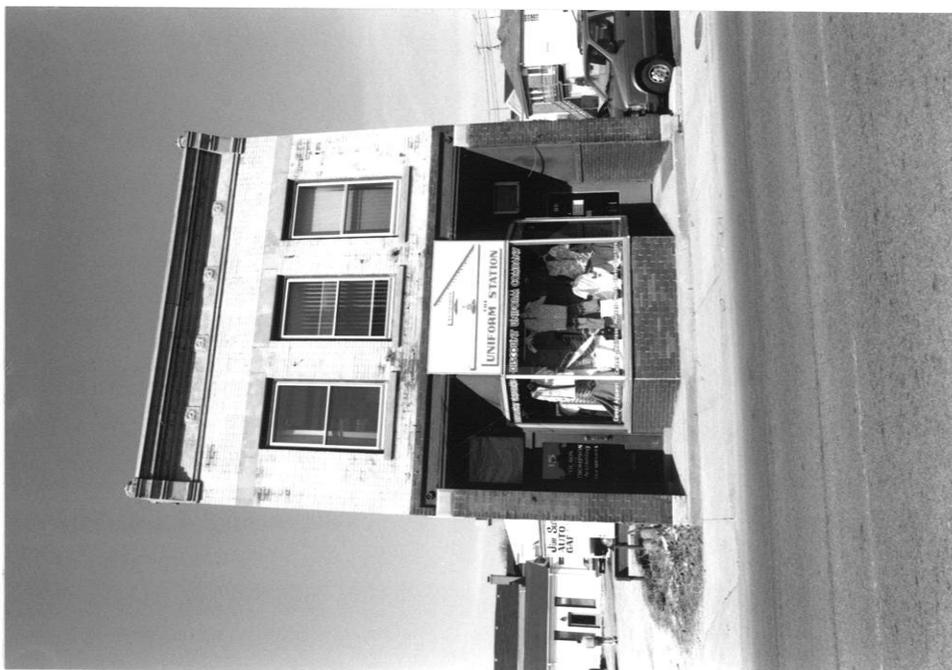
13/15 South 2nd Street

Style: Italianate

Date of Construction: 1880's

Two story brick structure with distinctive metal cornice at parapet. Recessed entries at first floor.

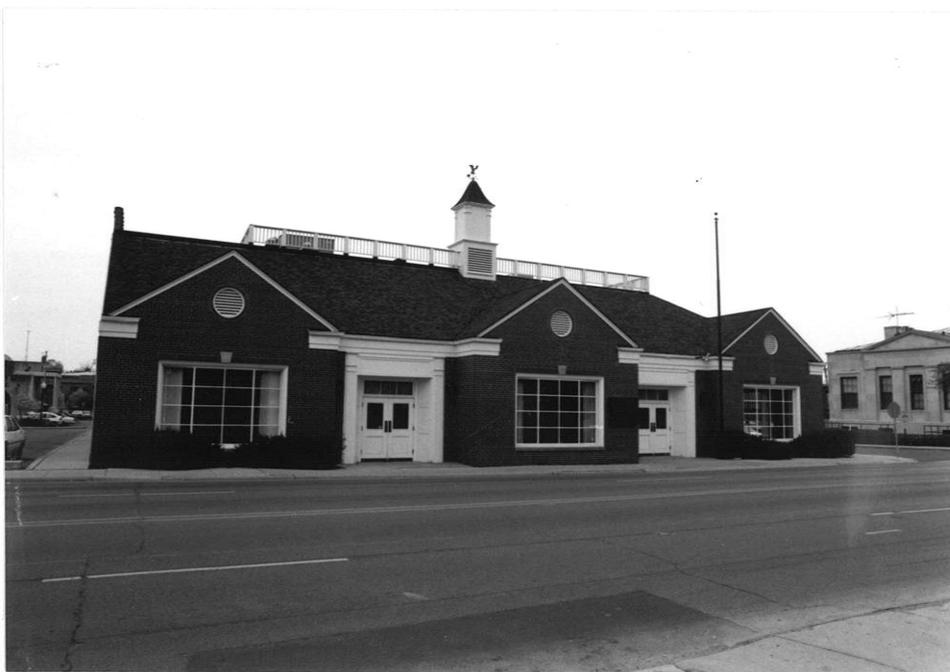
24 South 2nd Street

Style: Neocolonial
Date of Construction: ca. 1950 to present
Source: A Field Guide to American Houses
Features:
 Former savings and loan building. Little concern for copying colonial prototypes carefully. Large picture windows in weak gable end sections.

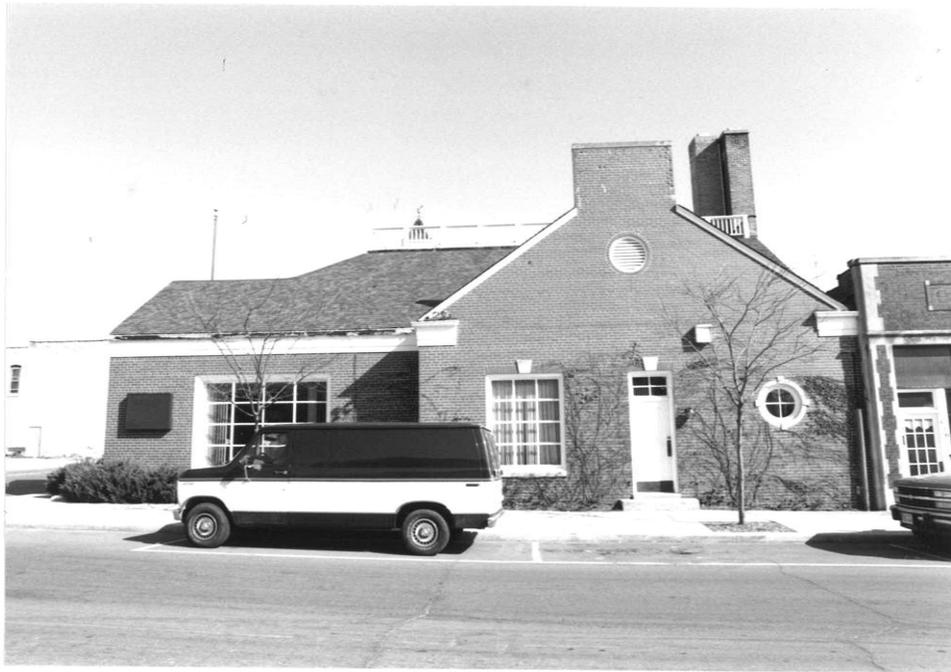
24 South 2nd Street

South Elevation

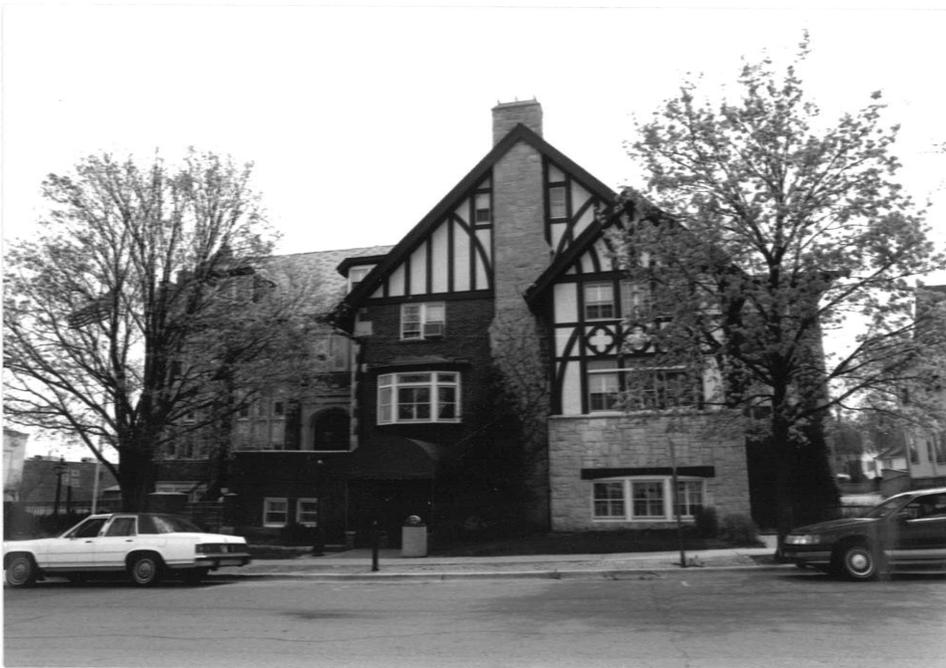
101 South 2nd Street

Style: Tudor

Date of Construction: 1926

Steeply pitched roof, half-timbering on upper levels with brick on lower level. Tall, narrow windows in multiple groups. Massive chimney at north elevation. Stone accents.

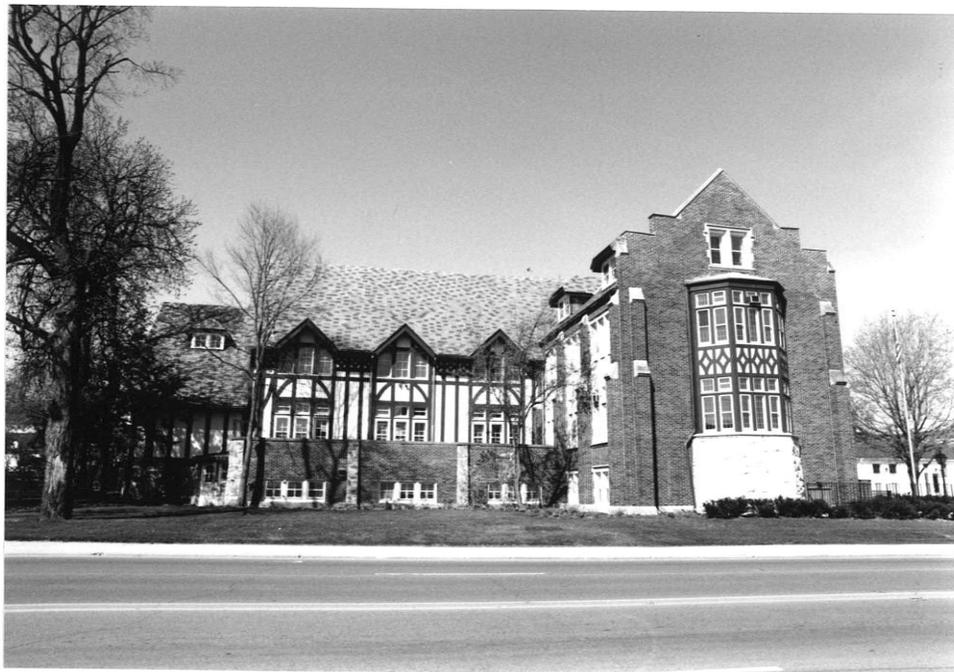
101 South 2nd Street

East Elevation

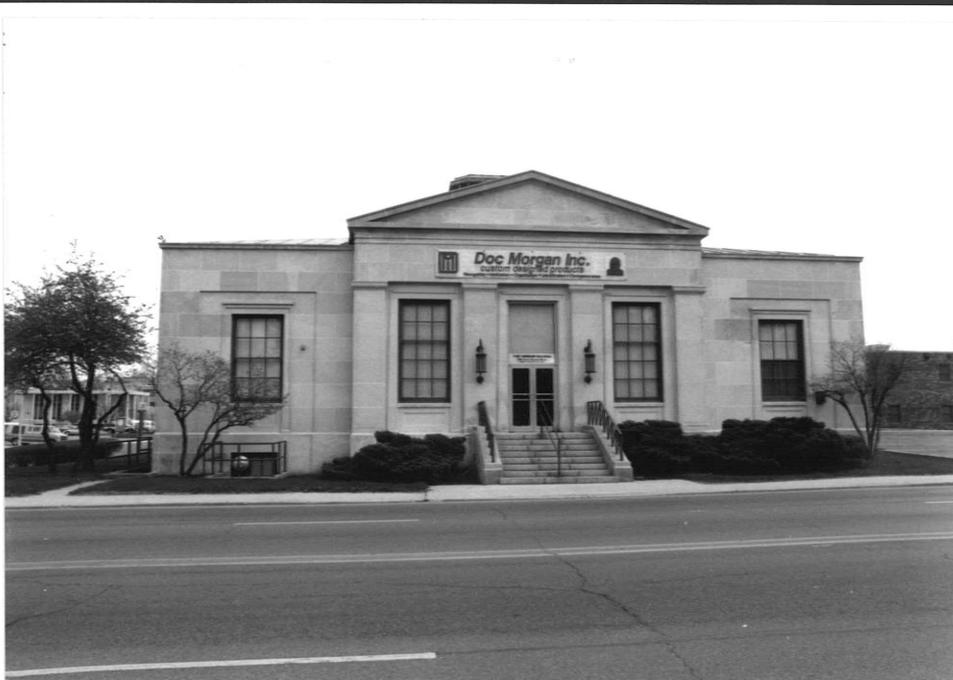
108 South 2nd Street

Style: Classical Revival

Date of Construction: 1936

Monumental recessed entry with large divided lite windows on major facades. Essentially square in plan, a gable pediment is featured on all sides. Originally the St. Charles Post Office.

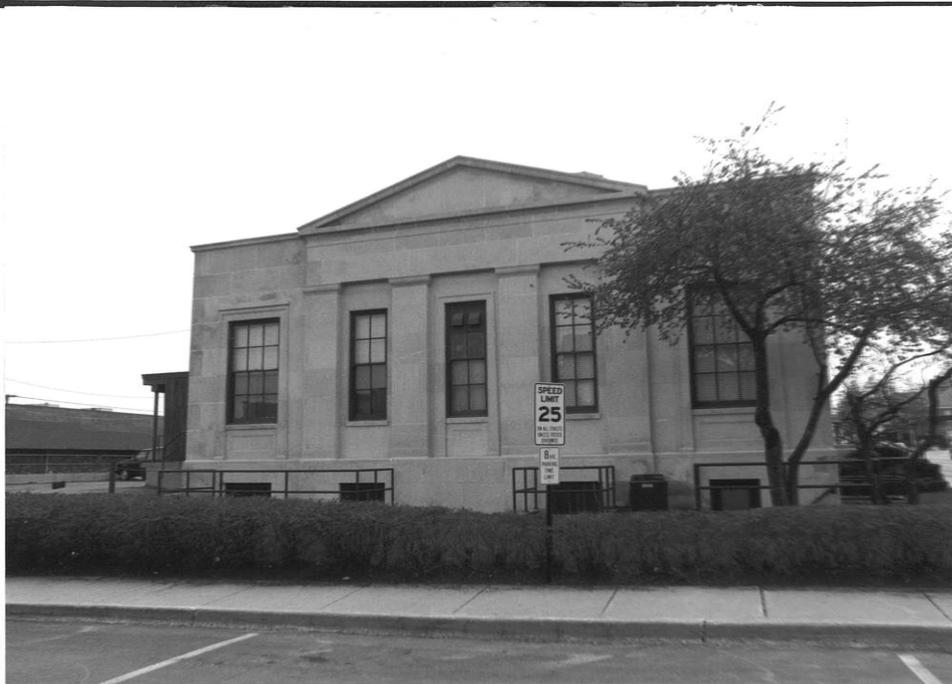
108 South 2nd Street

North Elevation

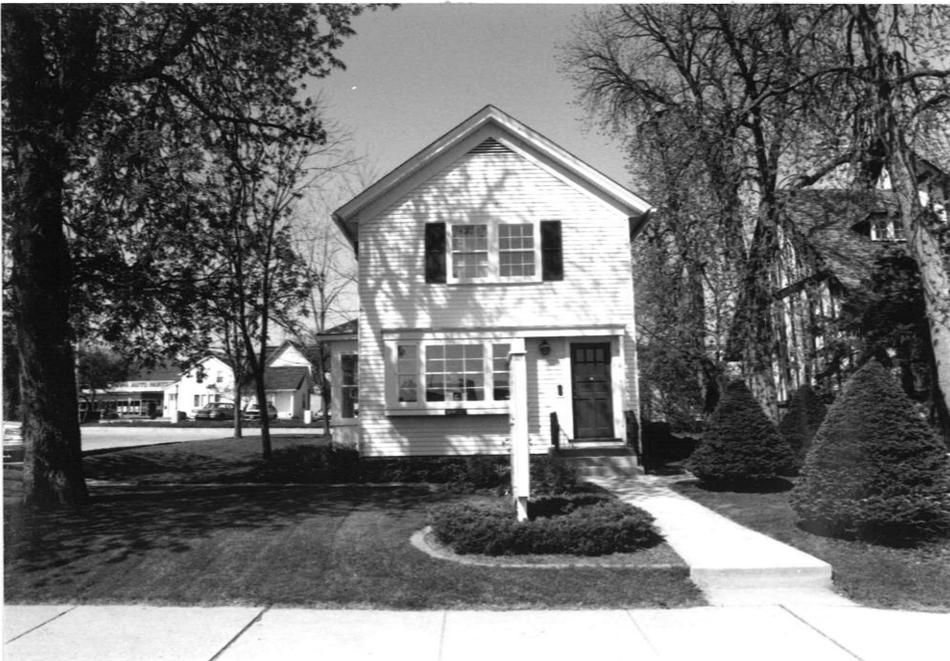
115 South 2nd Street

Style: Greek Revival

Date of Construction: 1825-1860

Two story clapboard siding, front gable roof. Double windows at second floor, box bay window at first floor.

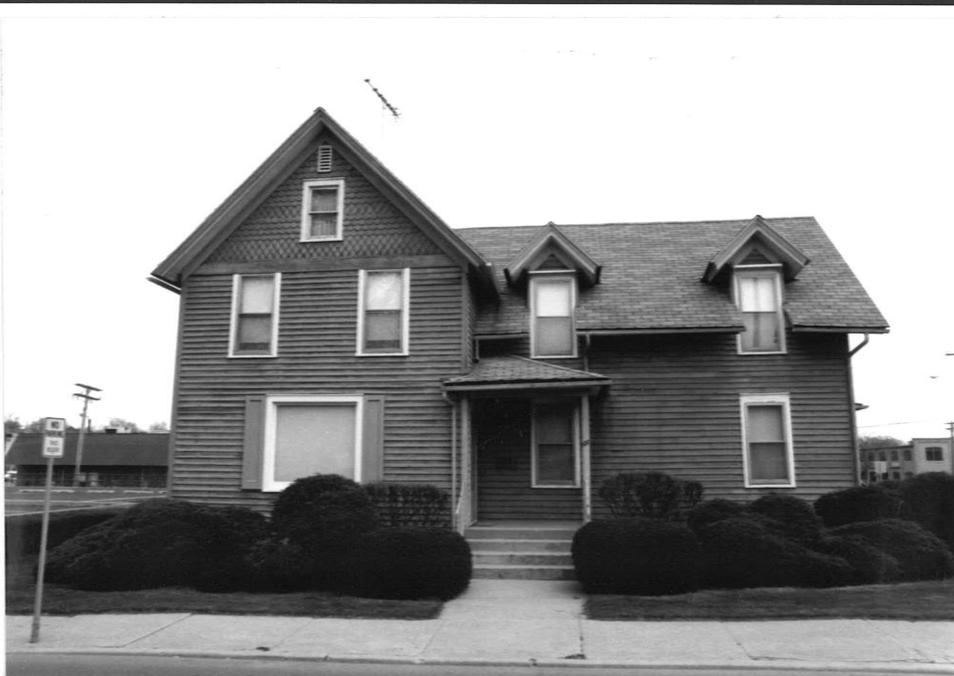
122 South Second Street

Style: Folk Victorian

Date of Construction: 1870-1910

Patterned shingles in front gable. Cross gable to south with two dormers cutting eave line. Clapboard siding on two stories. Wrap around porch at south.

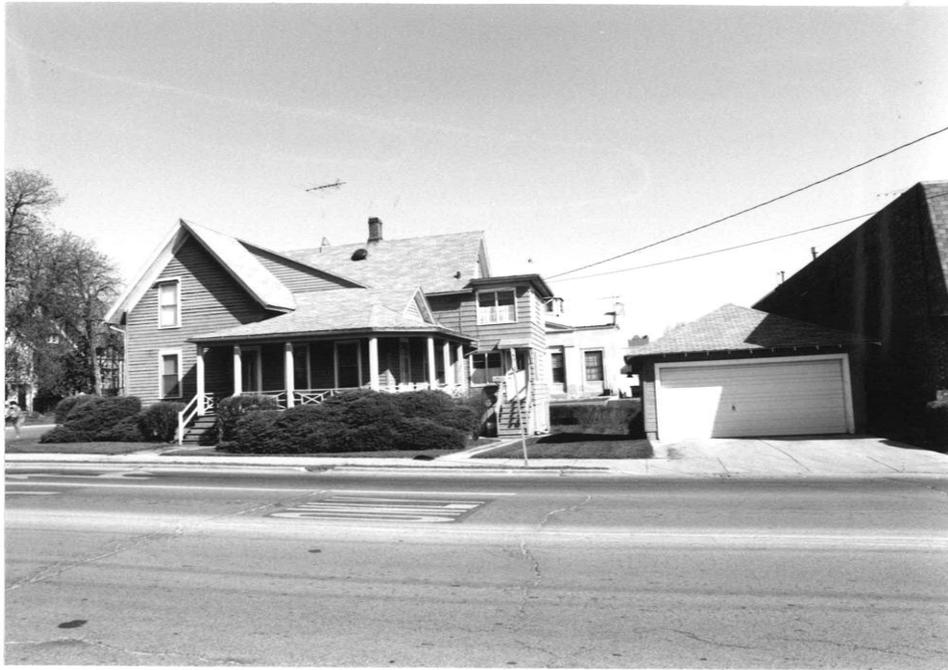
122 South Second Street

South Elevation, showing later garage.

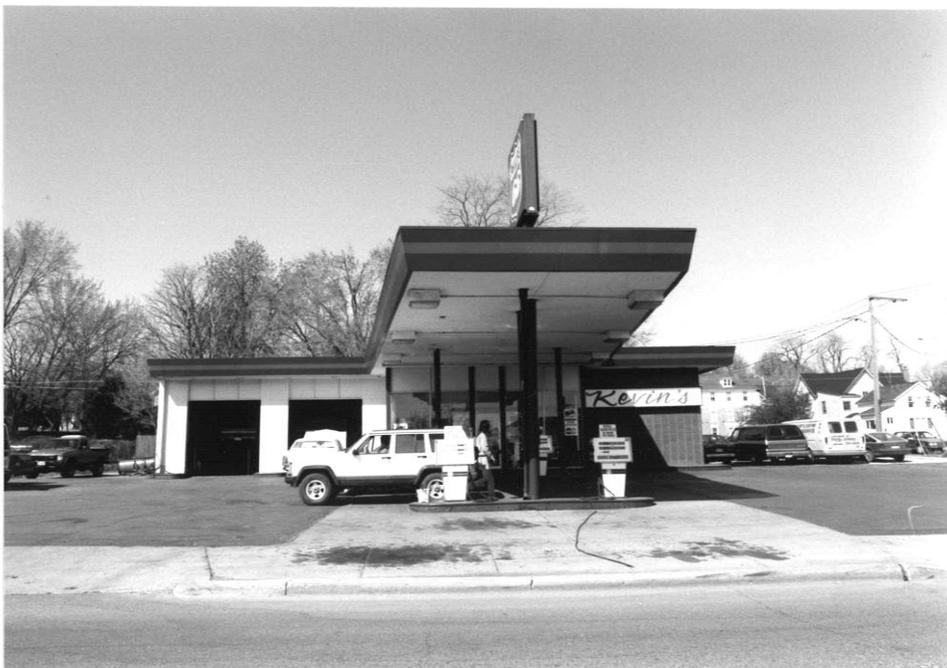
201 South 2nd Street

Style: NA
 Date of Construction: Post 1944
 Source: NA
 Features:
 Gas station

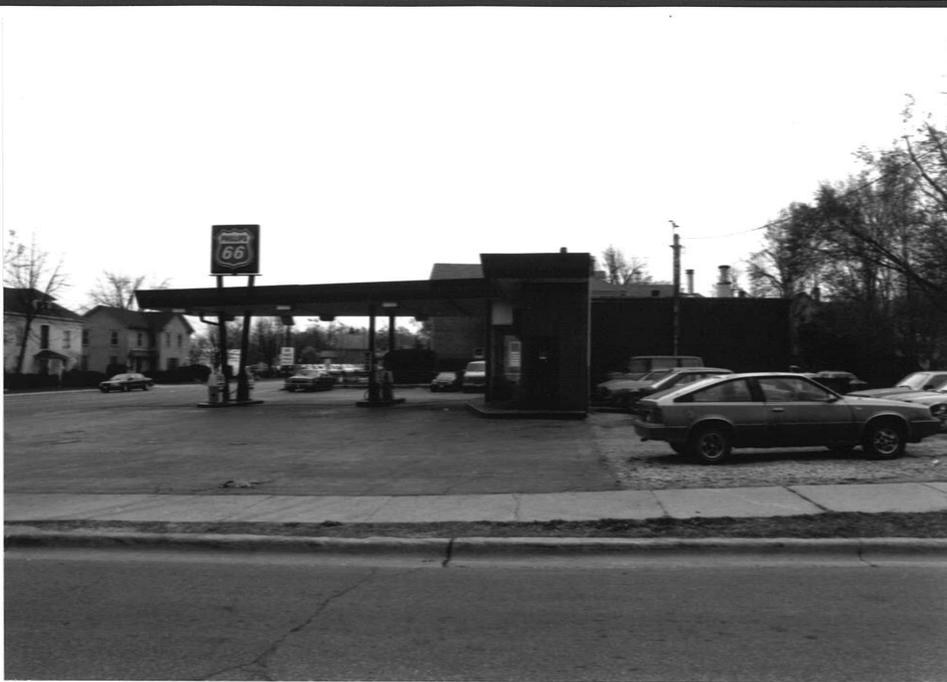
201 South 2nd Street

North Elevation

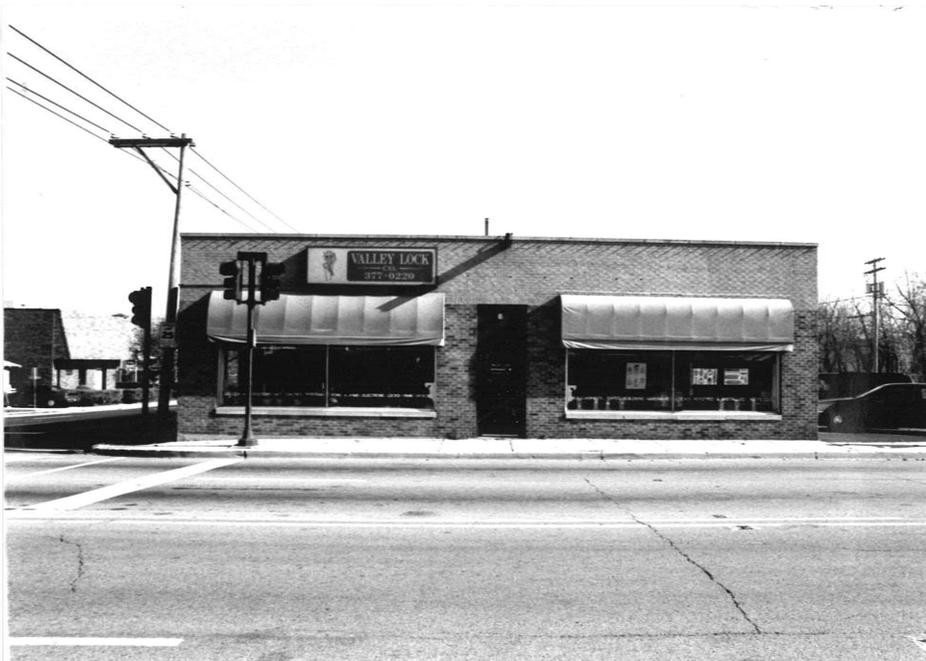
202 South 2nd Street

Style: Utilitarian

Date of Construction: 1940-1960

Brick one story building. Large picture windows at west and north facades.

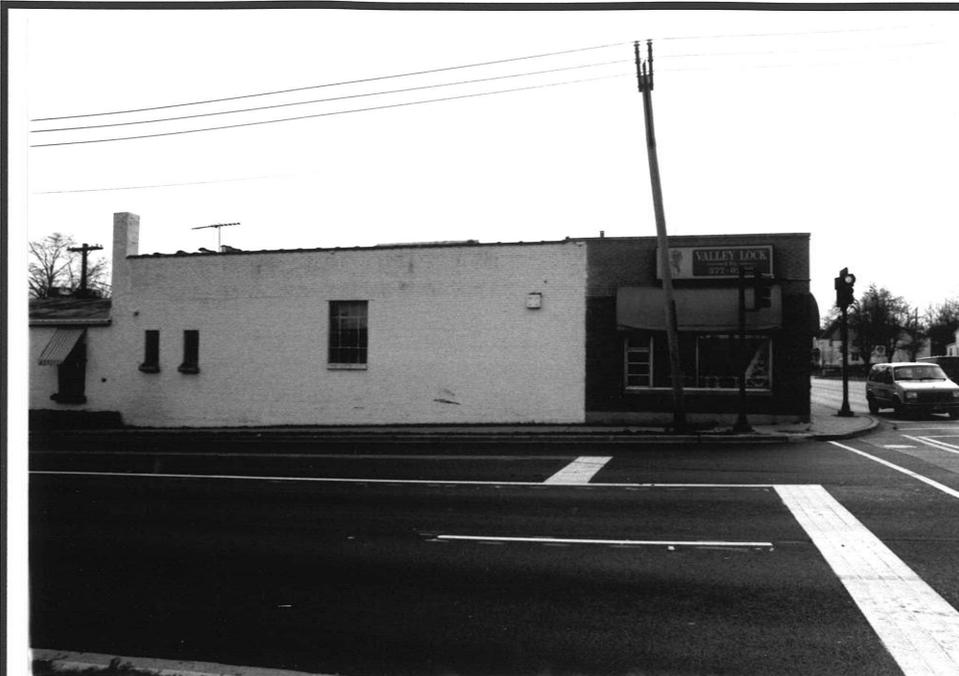
202 South 2nd Street

North Elevation.

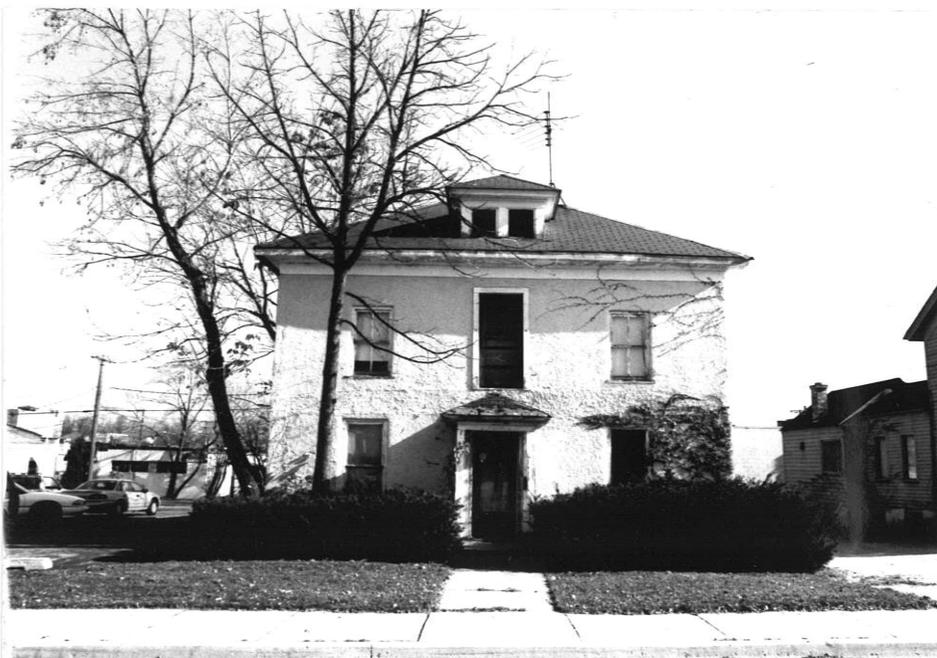
Address:
 210 South 2nd Street

Style: Prairie
Date of Construction: 1900-1920
Source: A Field Guide to American Houses
Features:
 Two story stucco finish house with hip roof and single dormer. Appears that full width front porch has been removed. Symmetrical facade to front.

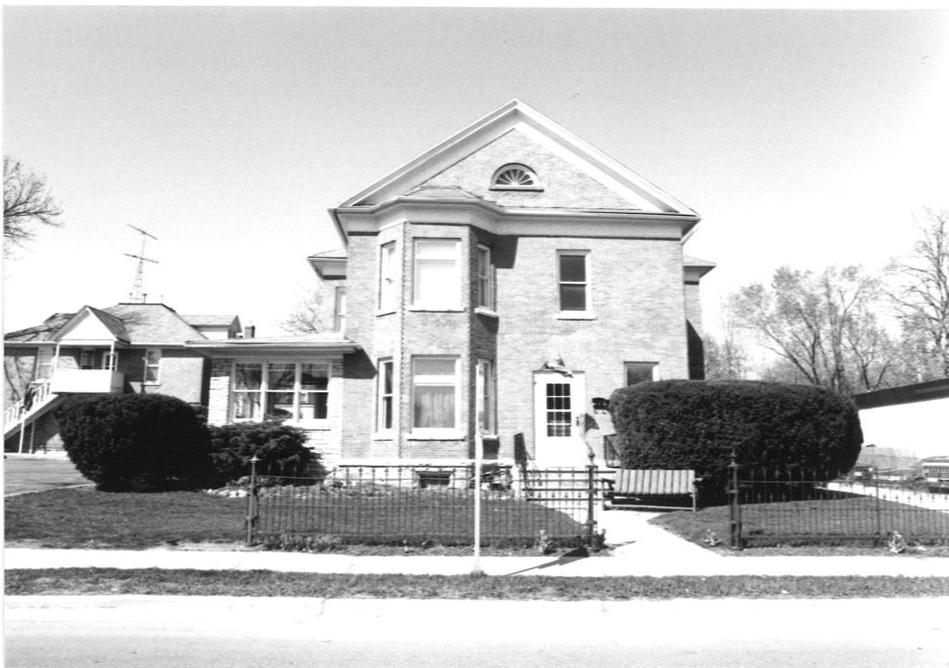
217 South 2nd Street

Style: Neoclassical

Date of Construction: 1895-1950

Brick structure with full pediment gable roof. Two story bay window. Fan light at gable. Unadorned.

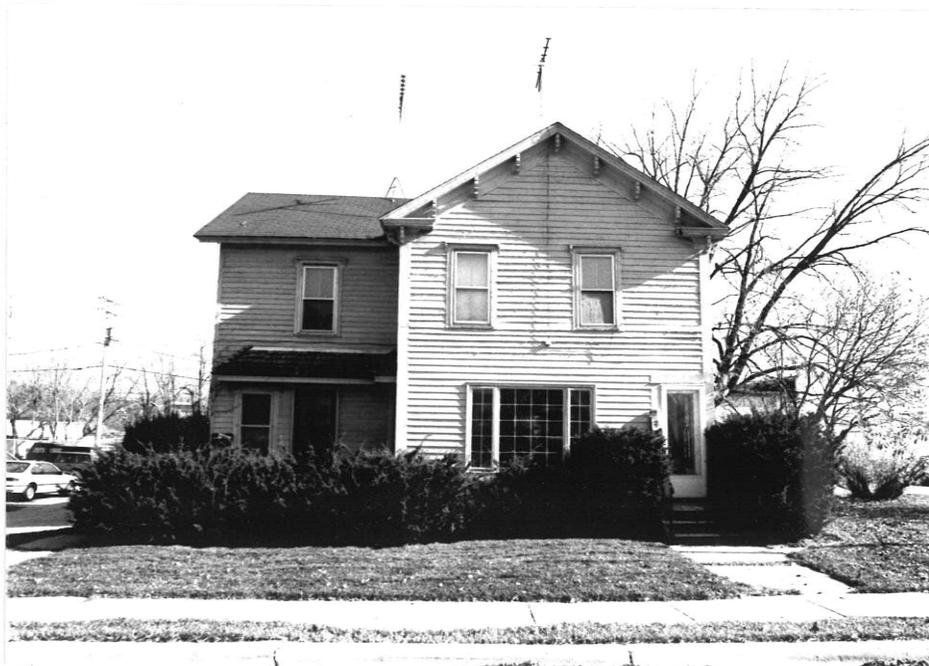
218-218 1/2 S. 2nd Street

Style: Italianate

Date of Construction: 1840-1885

L-shaped two story wood clapboard sided house. Front gable, assymetrical. Broken pediment with overhanging eave supported by decorative brackets. Simple hoods at second floor windows.

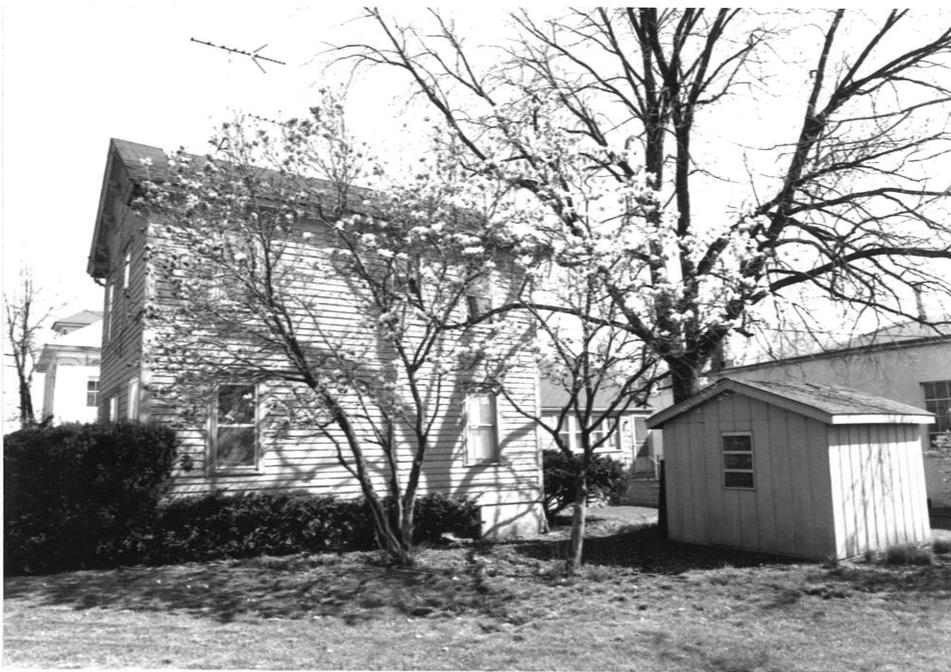
218-218 1/2 S. 2nd Street

South Elevation.

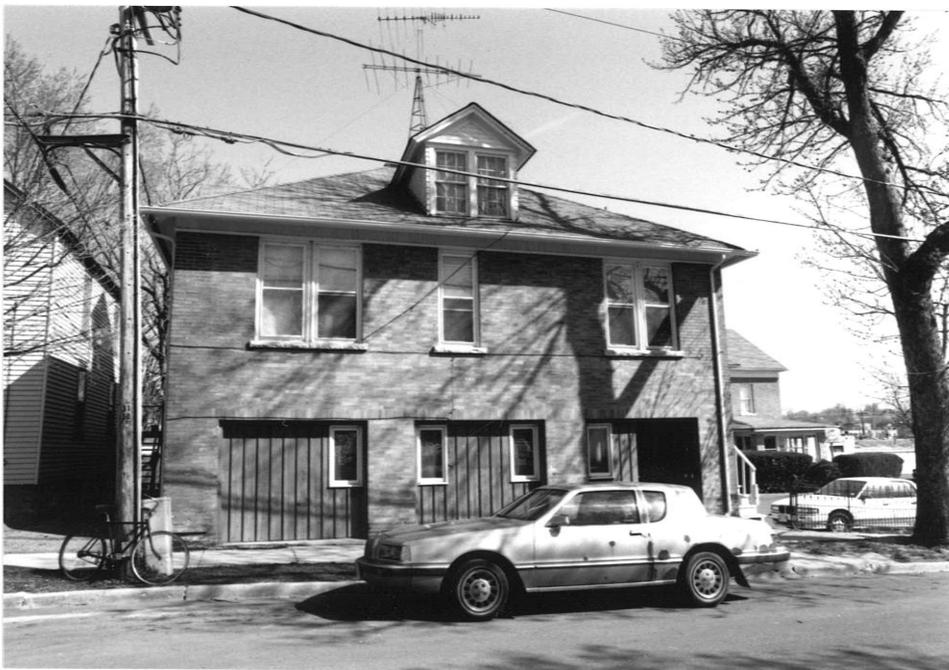
220 South 2nd Street
 221

Hipped roof, two story structure, brick with stone window sills at second story. Gable dormer with double window at south elevation.

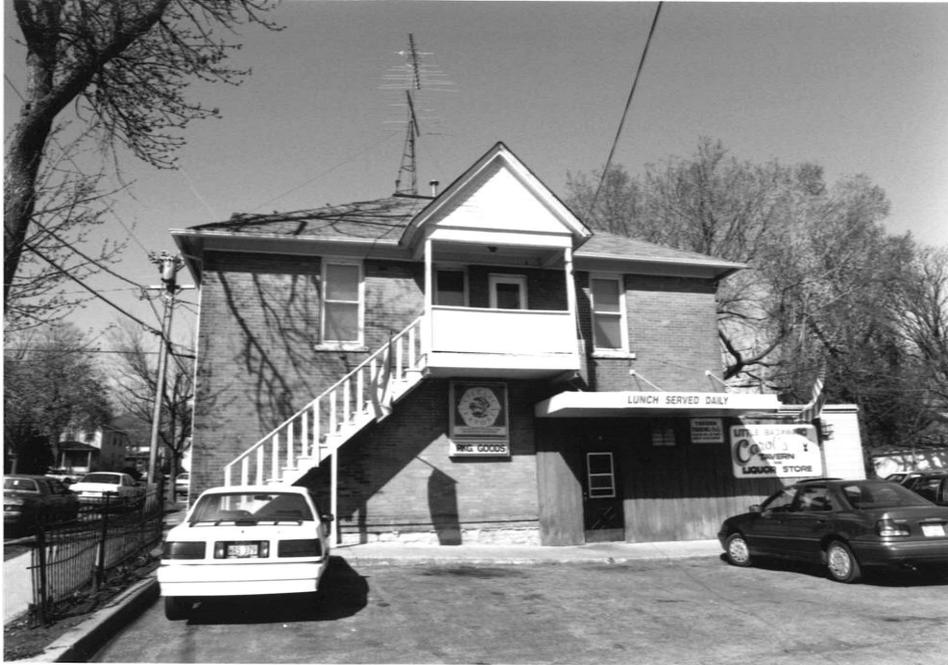
220 South 2nd Street

East Elevation
