ST. CHARLES HISTORIC PRESERVATION COMMISSION

ARCHITECTURAL SURVEY
ST. CHARLES CENTRAL DISTRICT
ST. CHARLES, ILLINOIS

DIXON ASSOCIATES / ARCHITECTS

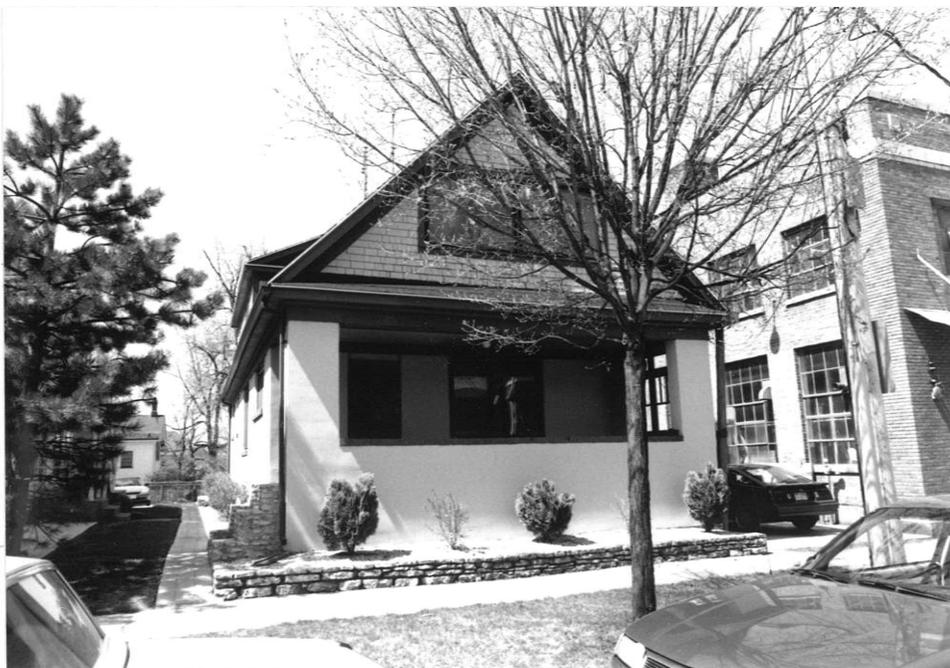
13 South 4th Avenue

Style: Shingle

Date of Construction: 1880-1900

Cement plaster first floor with front gable shingled.
 Deeply recessed front porch. Dormers at second floor.

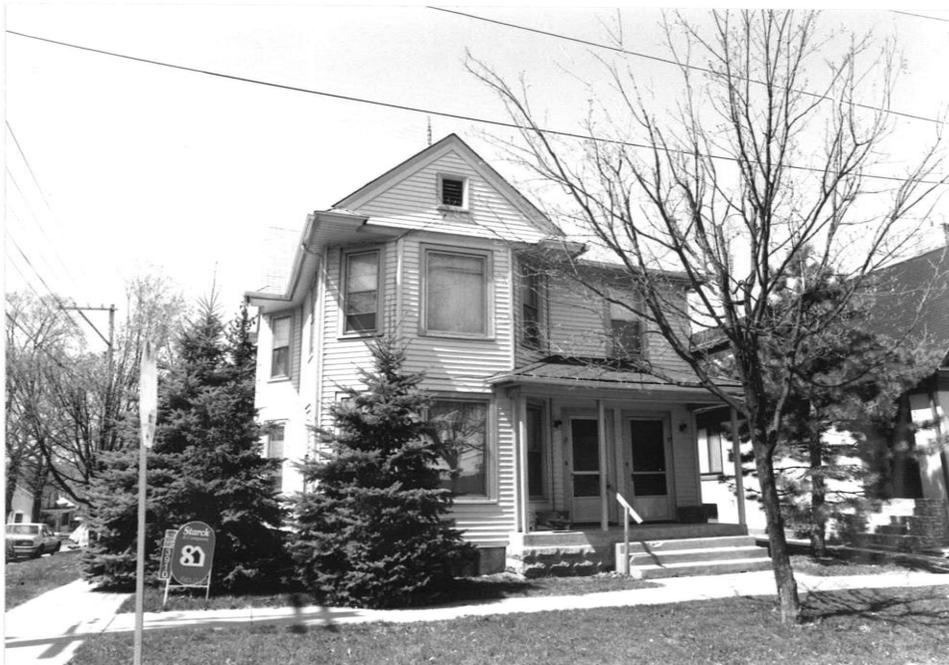
15-17 South 4th Avenue

Style: Queen Anne

Date of Construction: 1880-1910

Two story wood frame structure. Two story bay sections at east and south elevations with gable roofs on hip main roof.

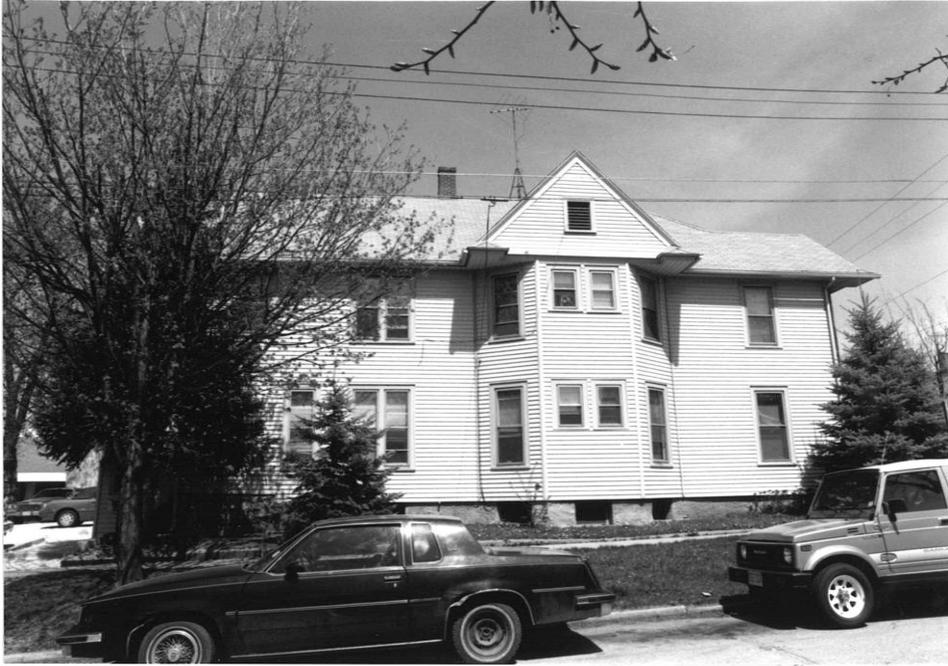
15-17 South 4th Avenue

South Elevation.

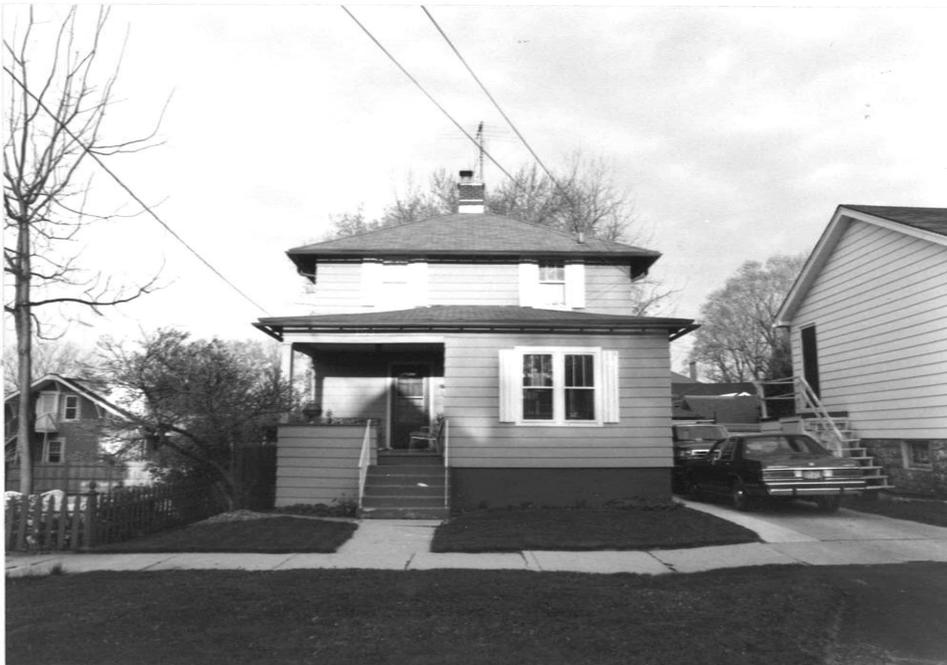
105 South 4th Avenue

Style: Foursquare

Date of Construction: 1900-1920

Two-story hip roof structure. Hip roof over one story. Partially enclosed porch.

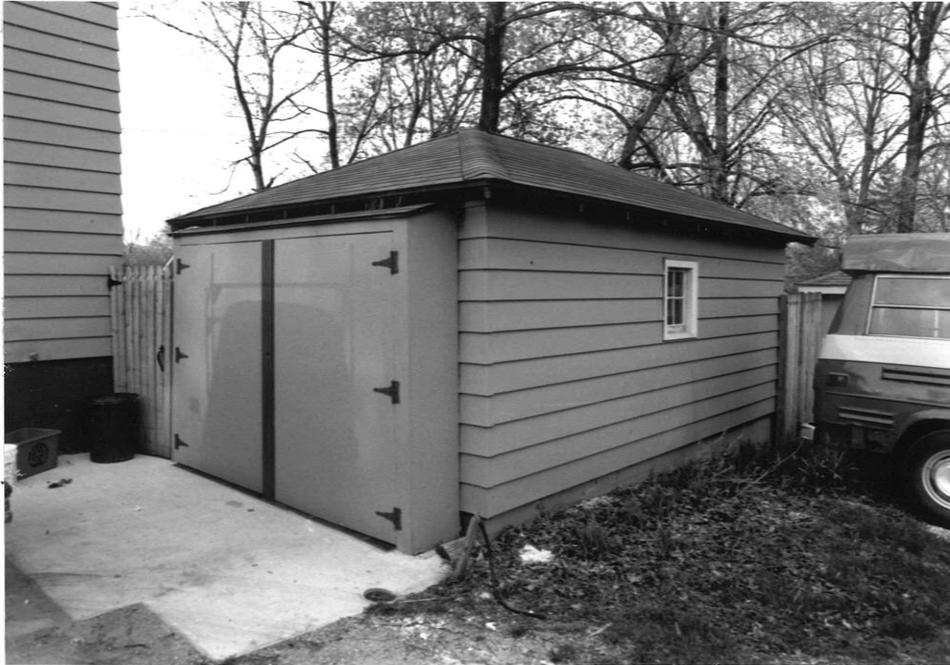
105 South 4th Avenue

Garage.

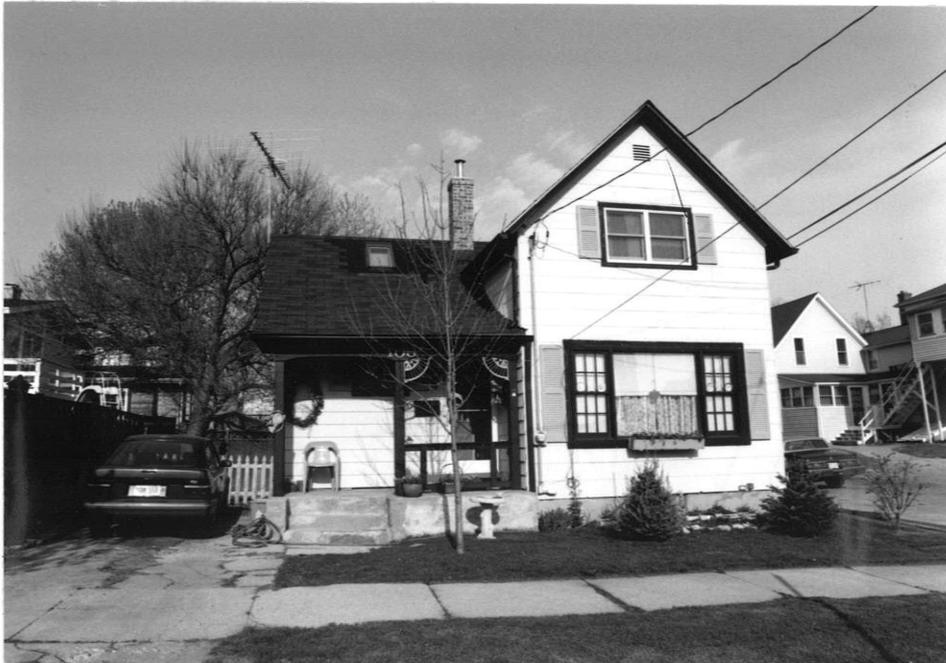
108 South 4th Avenue

Style: Folk Victorian

Date of Construction: 1870-1910

Front gable and wing form. Shed roof over entry porch. Spindle work details at porch. Some features have been altered or removed.

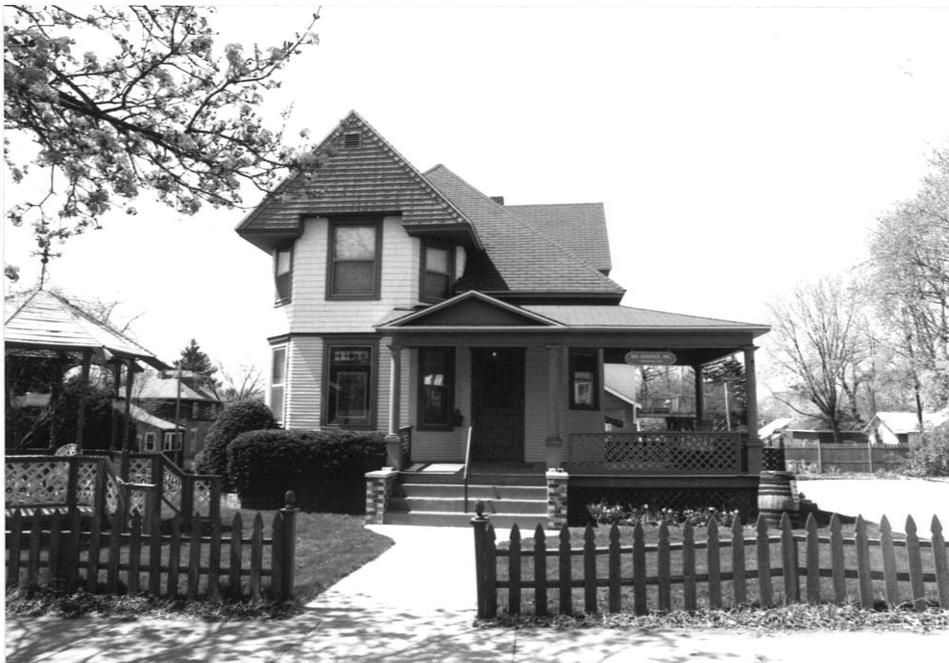
115 South 4th Avenue

Style: Queen Anne

Date of Construction: 1890-1910

Hip roof with two-story gable roof bay and lower cross gables. Wrap around porch gable peak over stair. Classical columns at porch. Wood shingles at projected gable end.

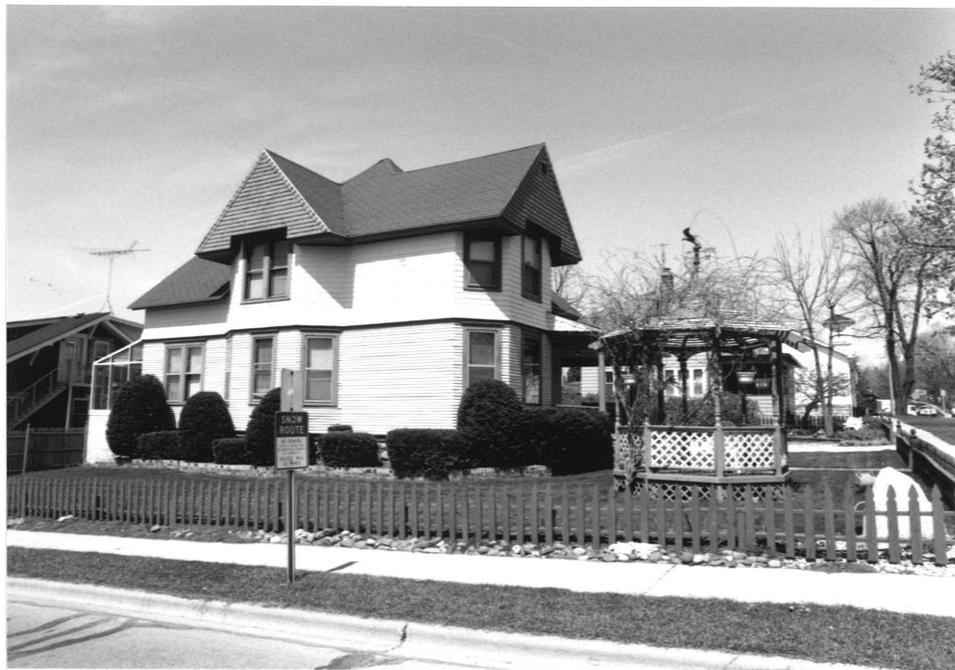
115 South 4th Avenue

South Elevation

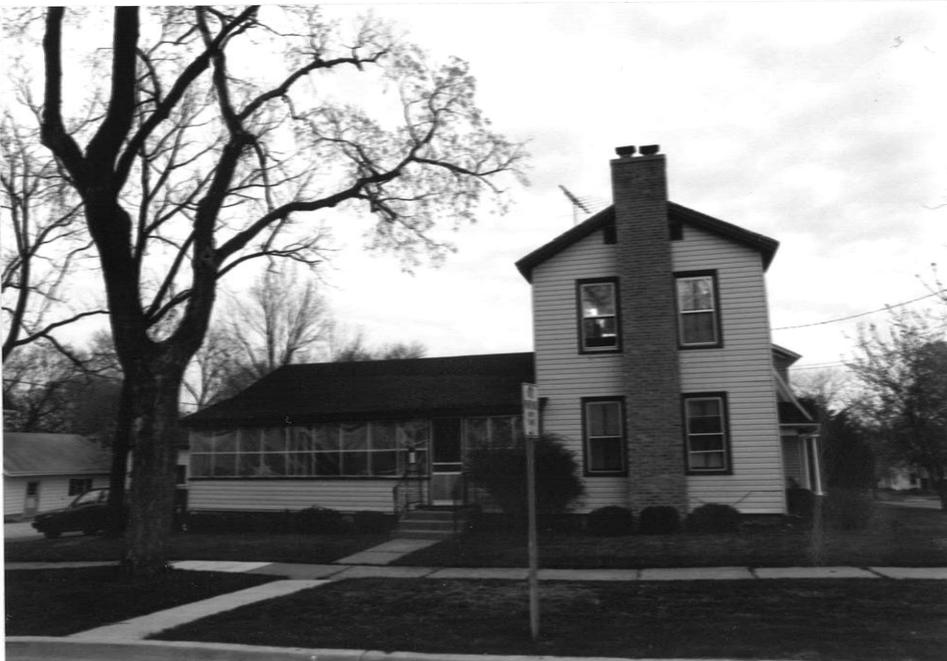
205 South 4th Avenue

Style: National

Date of Construction: 1850-1890

Gable roof two story frame house with brick chimney added to the front and one story addition on the side.

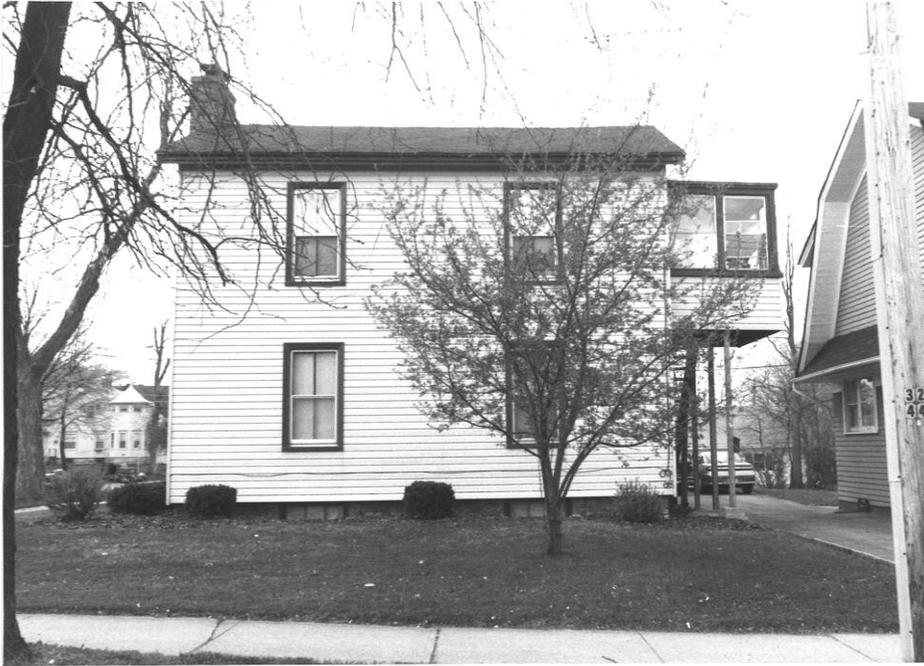
205 South 4th Avenue

North Elevation

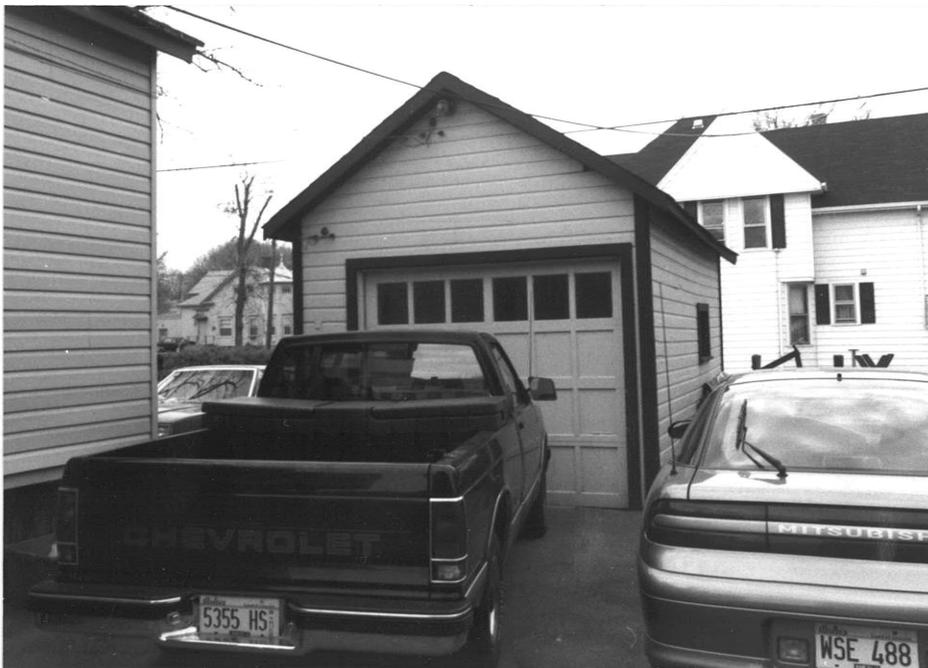
205 South 4th Avenue

Garage

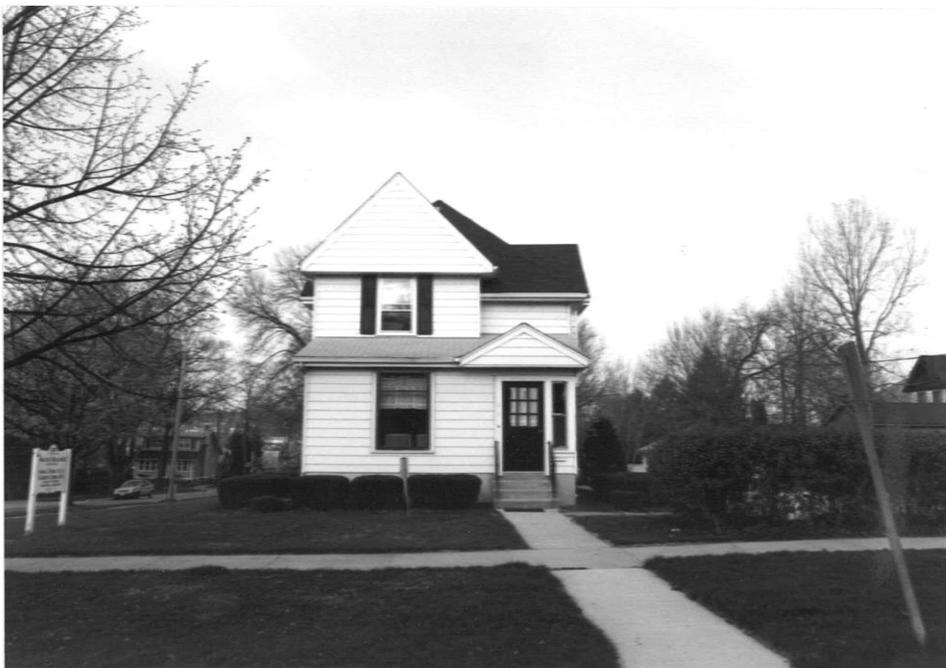
215 South 4th Avenue

Style: Queen Anne - Altered

Date of Construction: 1890-1910

Multiple gable roof with two-story side wing, first floor bay. Shed roof over enclosed porch. Details have been removed or altered.

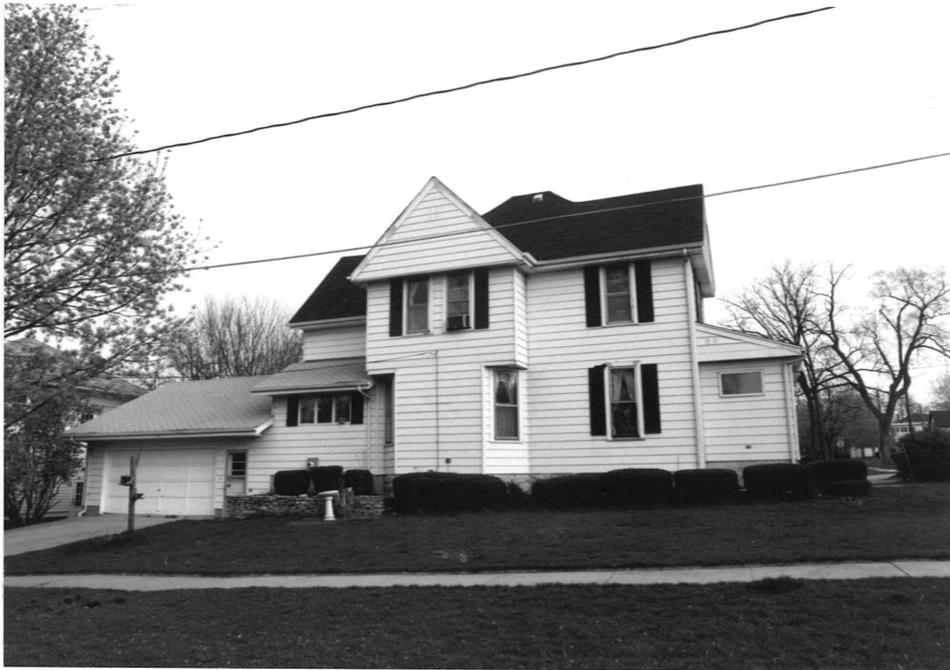
215 South 4th Avenue

South Elevation.

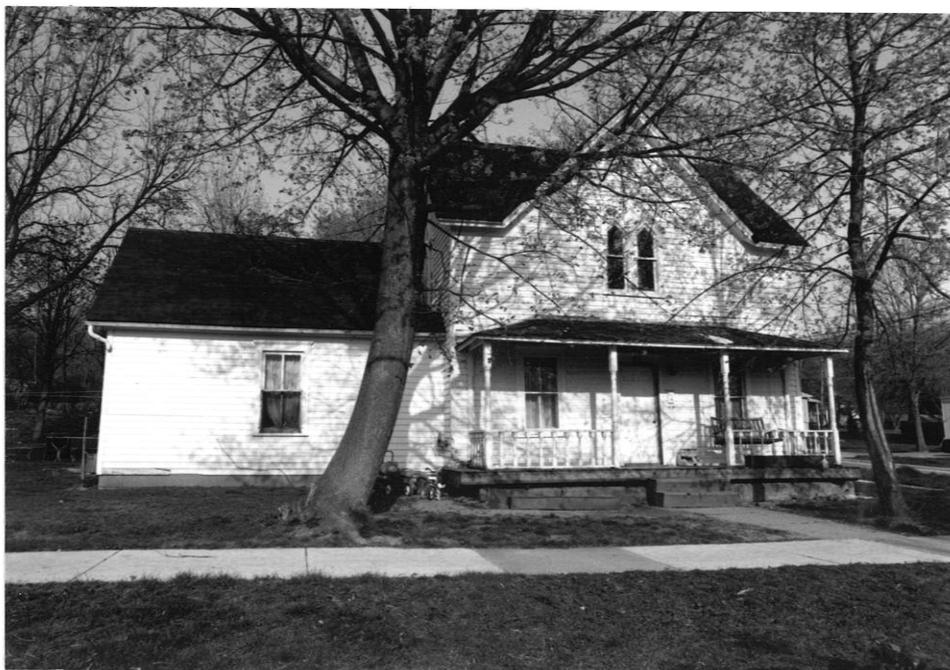
216 South 4th Avenue

Style: Gothic Revival

Date of Construction: 1840-1860

Two-story structure with centered gable roof. Hip roof over one story porch. Decorative porch posts and spindles. Triangular arched windows at second floor.

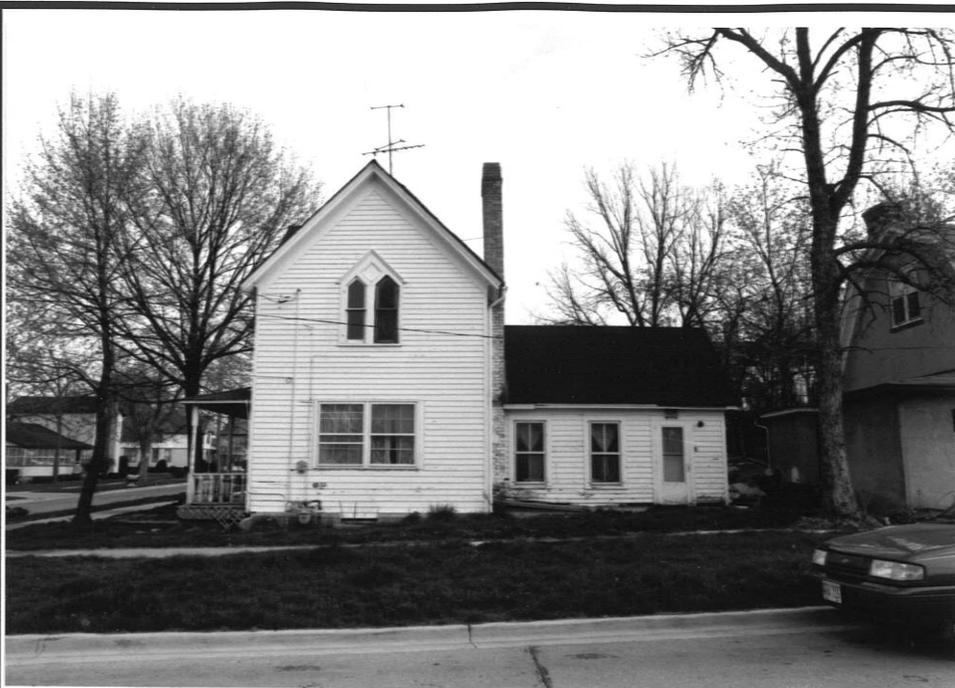
216 South 4th Avenue

South Elevation.
