ST. CHARLES HISTORIC PRESERVATION COMMISSION

ARCHITECTURAL SURVEY
ST. CHARLES CENTRAL DISTRICT
ST. CHARLES, ILLINOIS

DIXON ASSOCIATES / ARCHITECTS

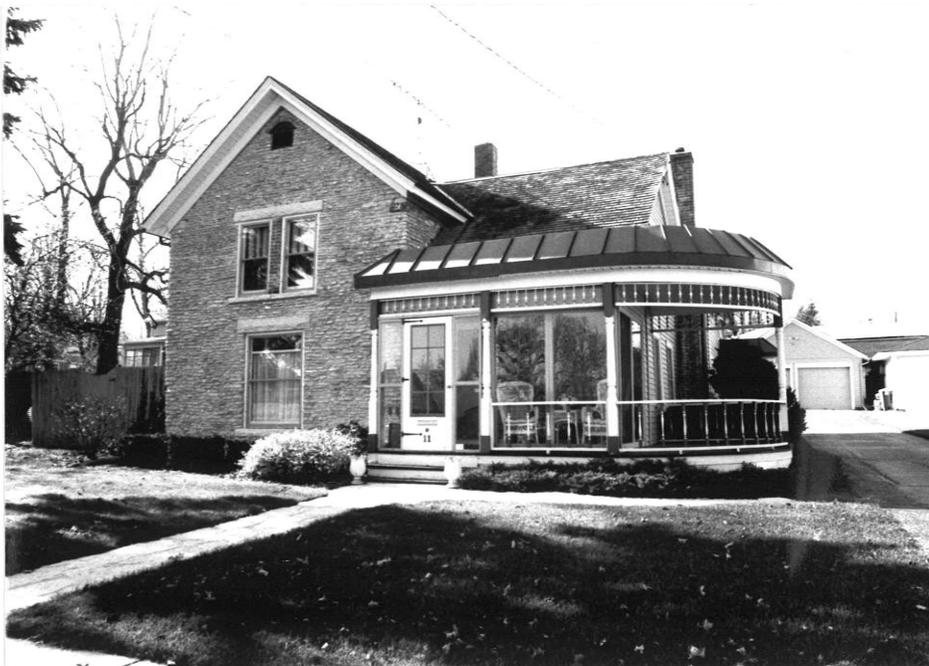
11 South 4th Street

Style: Greek Revival and Queen Anne

Stone two story structure. Cut stone lintels with rough stone wall. Cross gable. Standing seam metal roof at one story wrap around, curved end entry porch. Spindlework at porch.

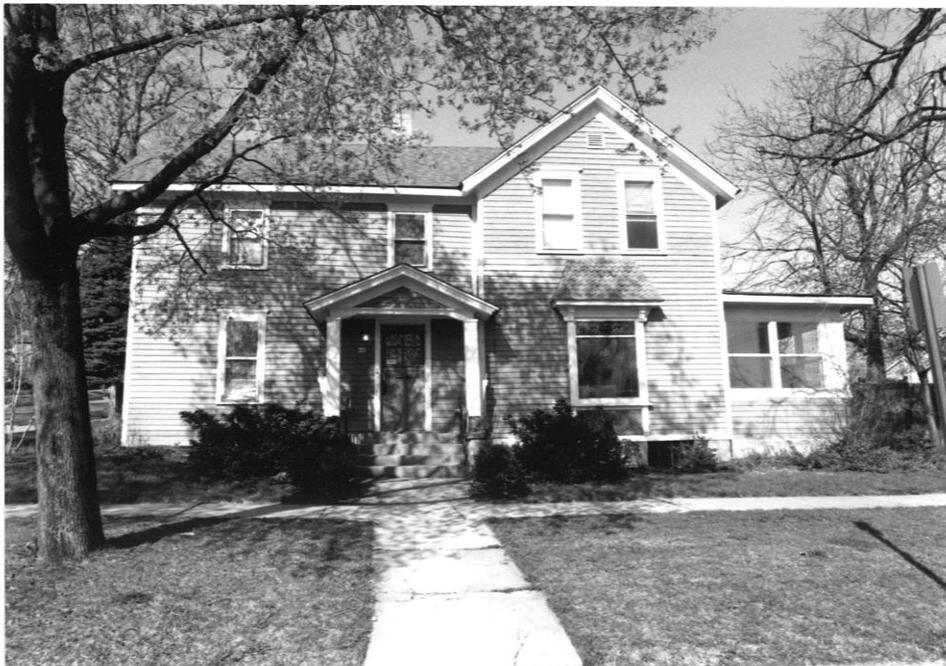
21 South 4th Street

Style: Queen Anne

Cross gabled roofs. Entry at east side has lower pitched gable roof. Single story porch added to north side. Picture windows with transoms on east and south sides.

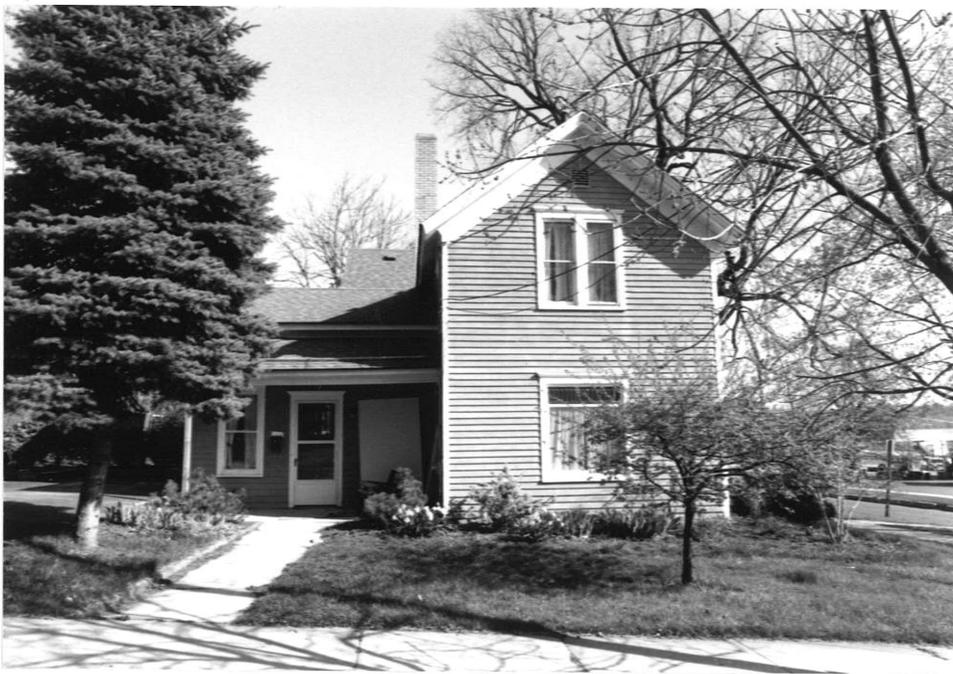
21 South 4th Street

South Elevation

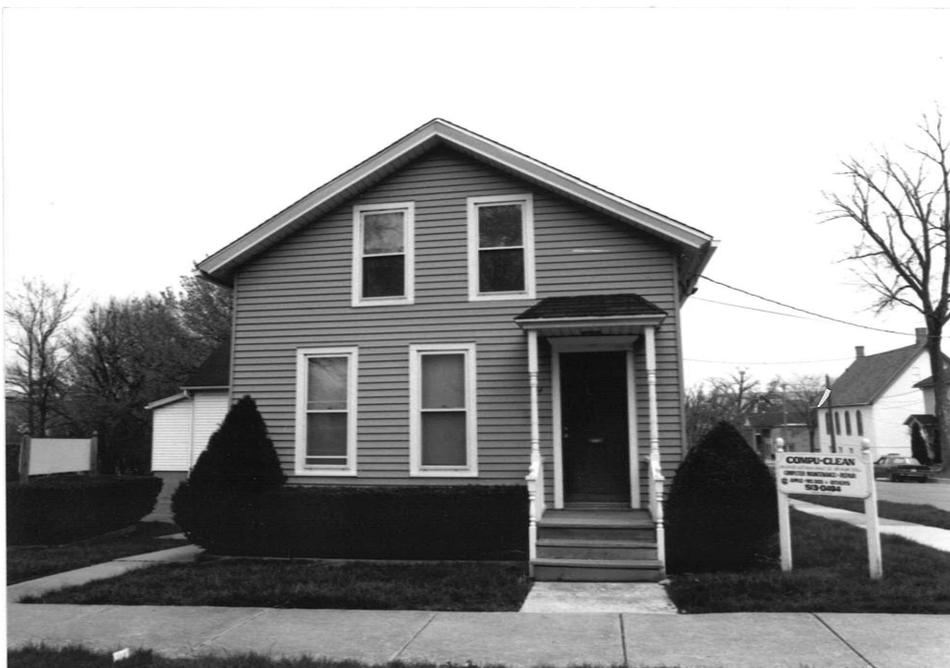
24 South 4th Street

Style: Greek Revival

Simple gable roof. Synthetic siding over original clapboard. Entrance porch roof and columns not original.

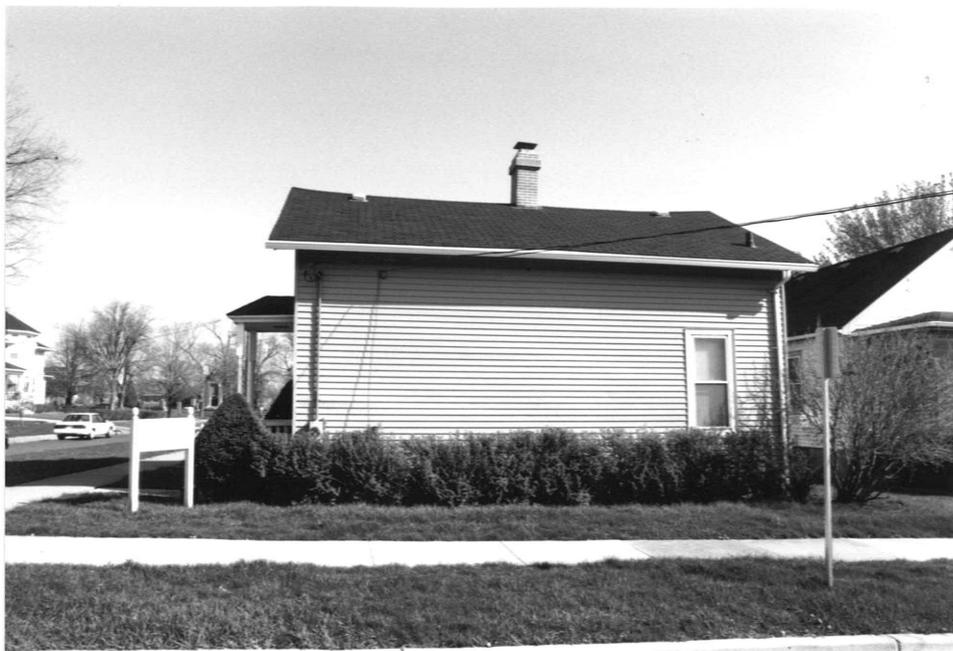
24 South 4th Street

South Elevation

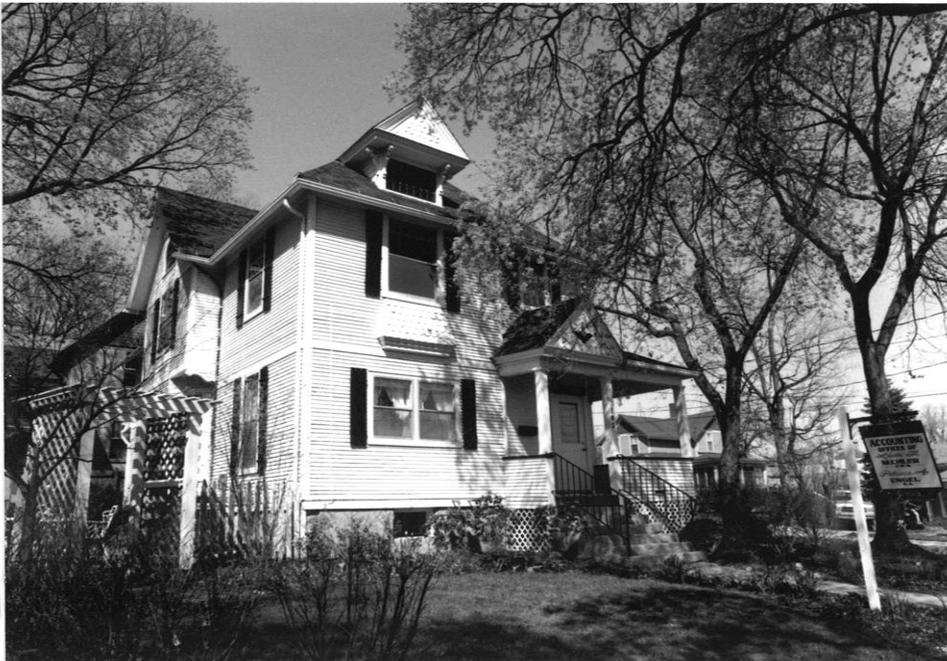
103 South 4th Street/
 403 West Walnut Street

Style: Queen Anne

Front hip roof to cross gable transverse roof. Two story wood frame with shingle texture in gabled and bracketed dormer and gabled front entry porch. Pair of windows at front appear altered due to shingled cap width not relating.

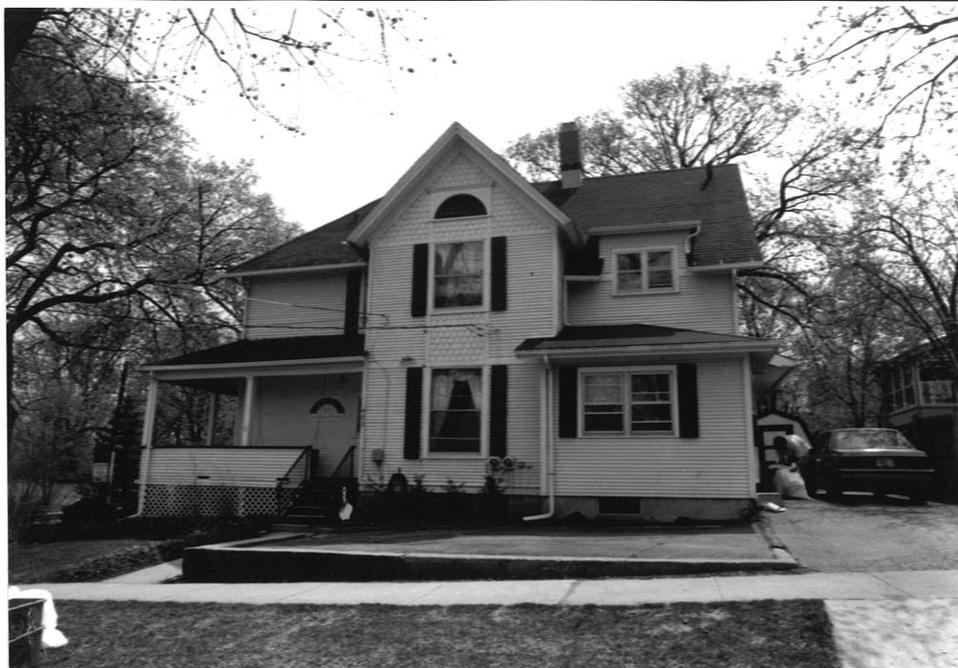
103 South 4th Street/
403 West Walnut Street

North Elevation.

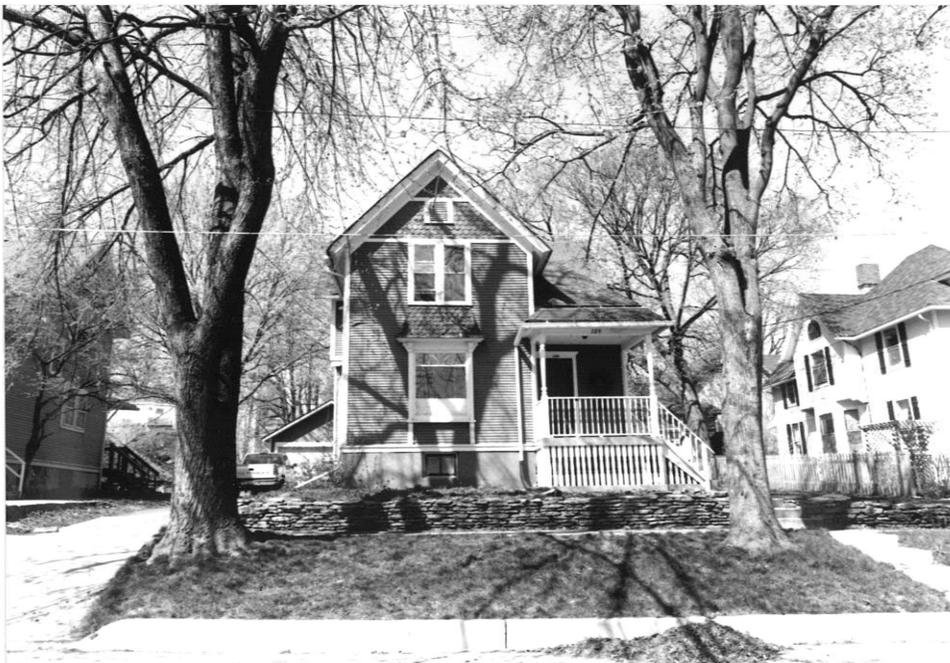
109 South 4th Street

Style: Stick

Steeply pitched front gabled roof with double window on second floor and picture window with shingled hood on first floor.

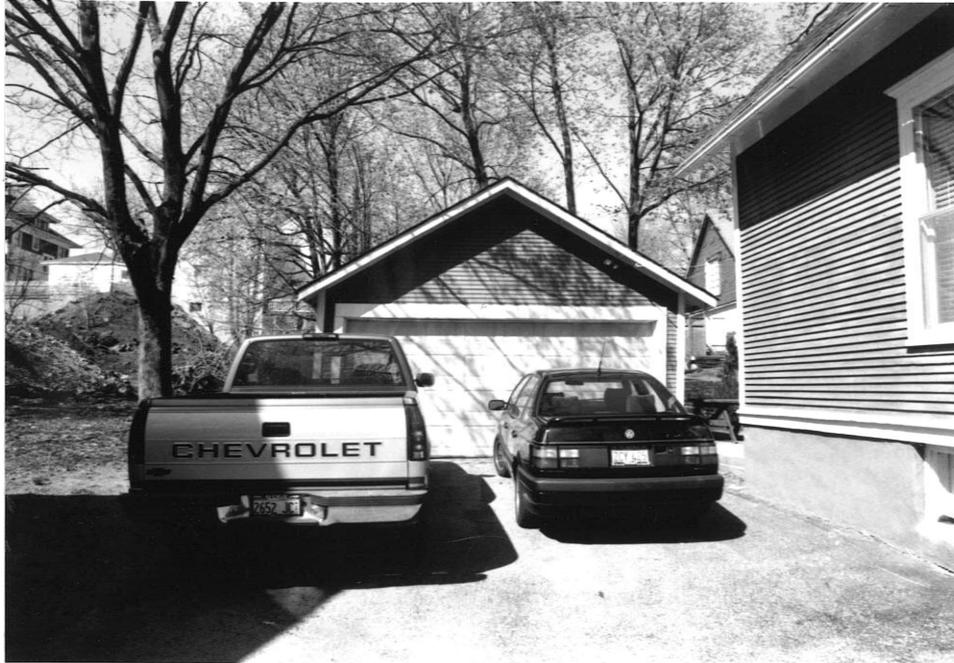
Address:
109 South 4th Street

Remarks:
Garage.

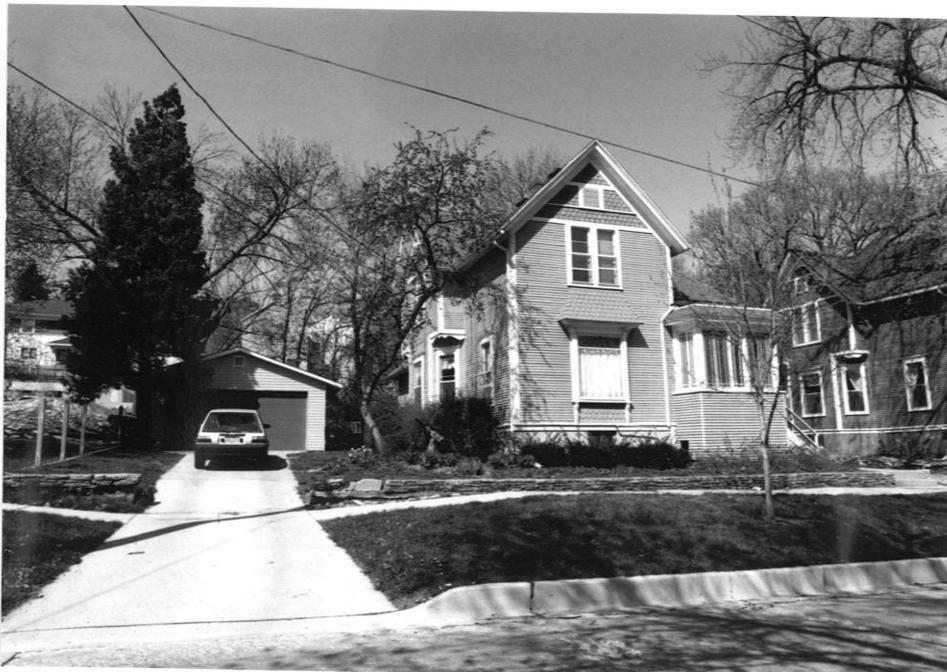
113 South 4th Street

Style: Stick

Steeply pitched front gabled roof with double window at second floor and picture window with shingled hood on first floor.

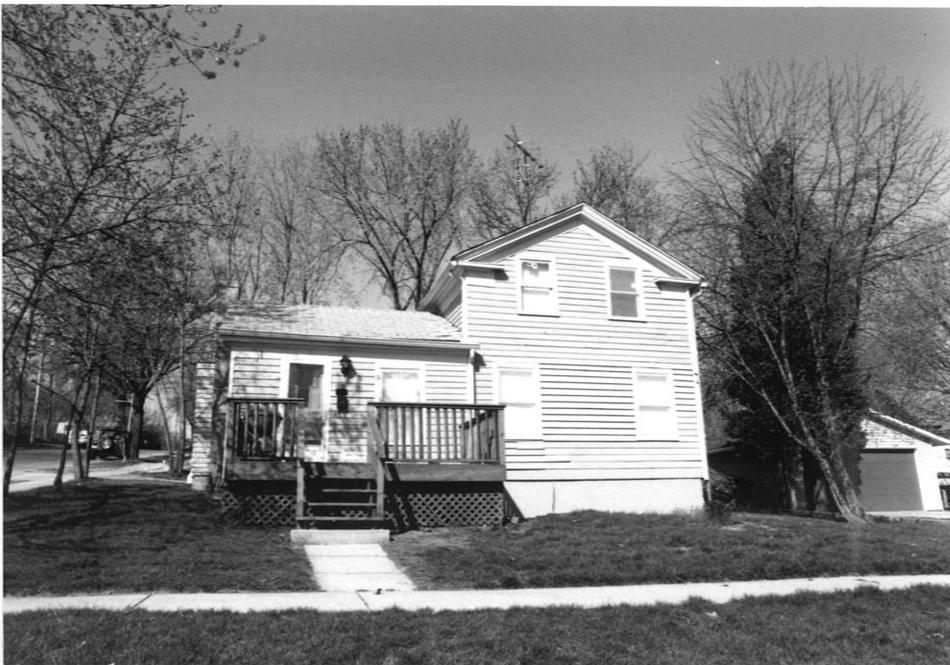
121 South 4th Street

Style: Greek Revival

Wood frame two story building with one story addition.
 Simple one over one windows.

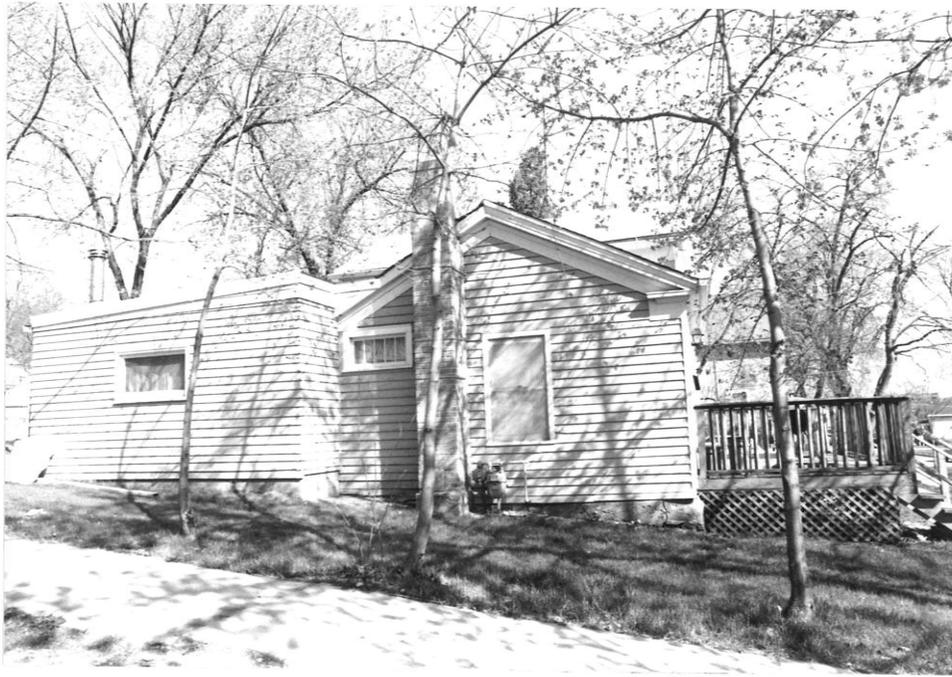
121 South 4th Street

South Elevation.

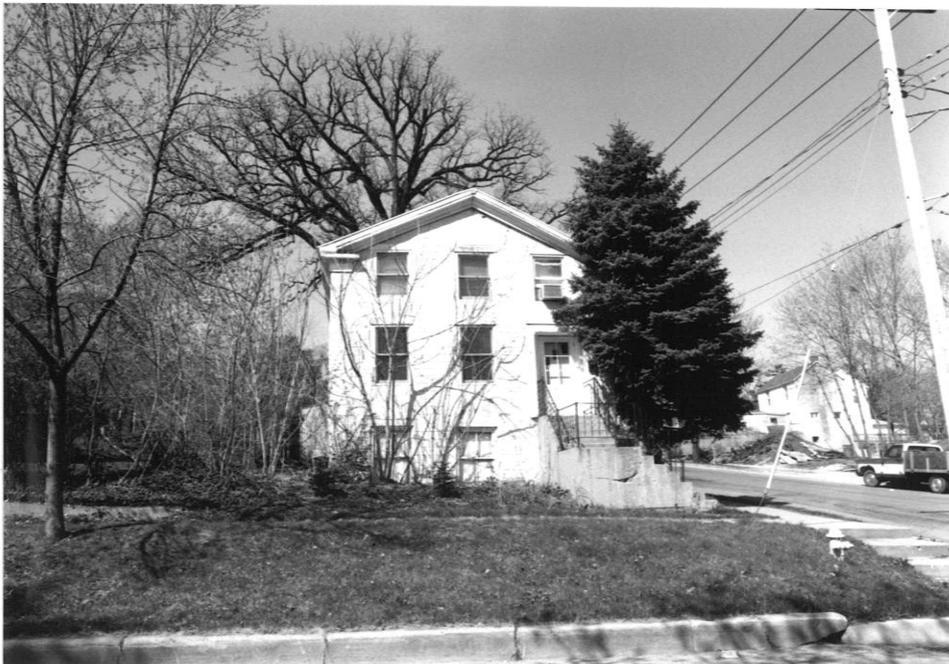
201 South Fourth Street

Style: Greek Revival

Gable front with broken pediment. Beaded horizontal joints on painted stone walls. One over one double hung windows are not original.

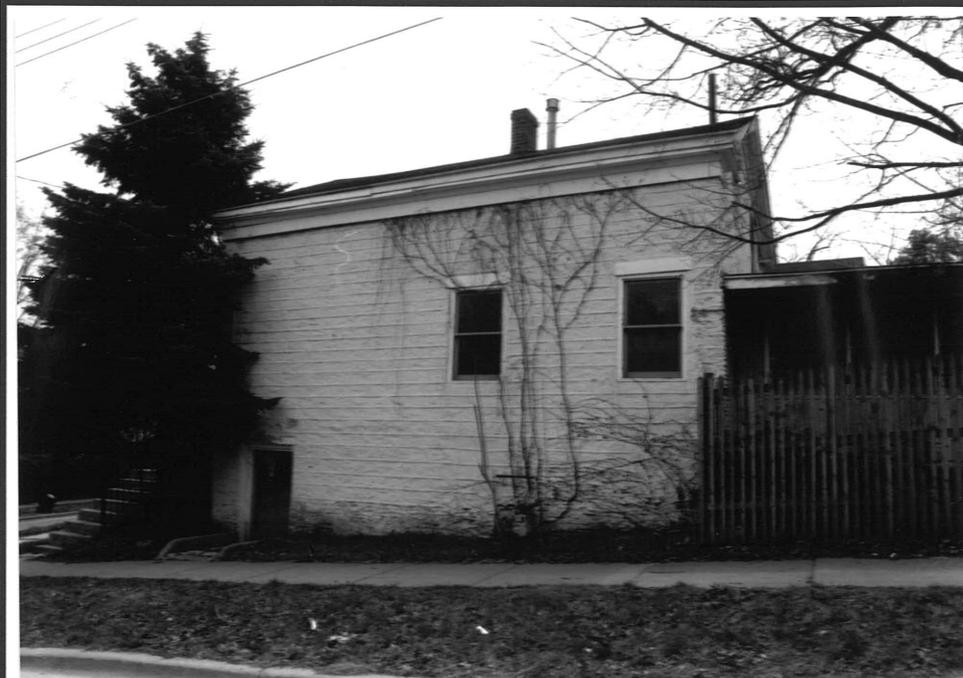
201 South Fourth Street

North Elevation

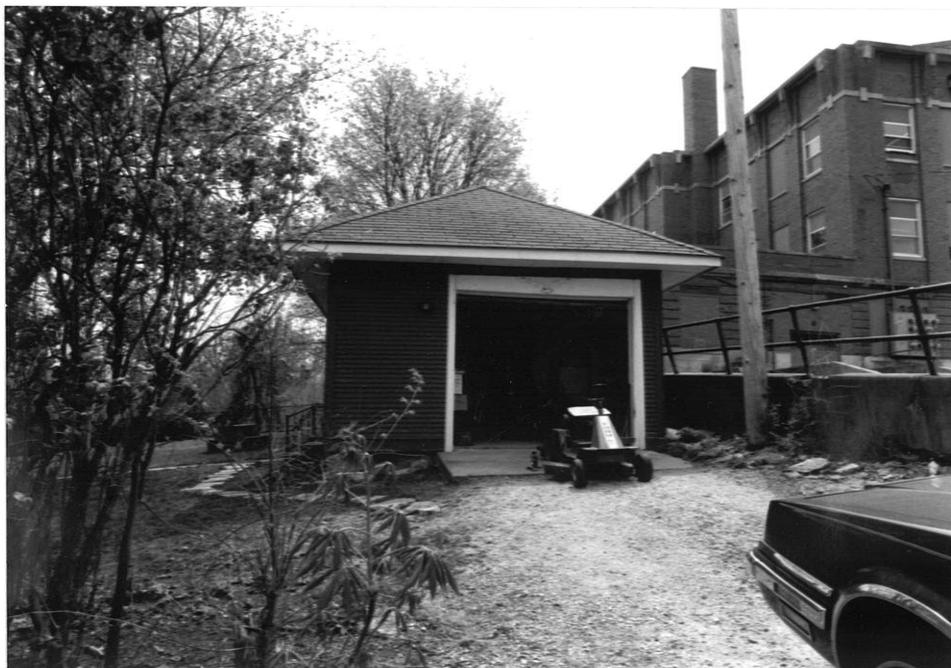
201 South Fourth Street

North view of garage

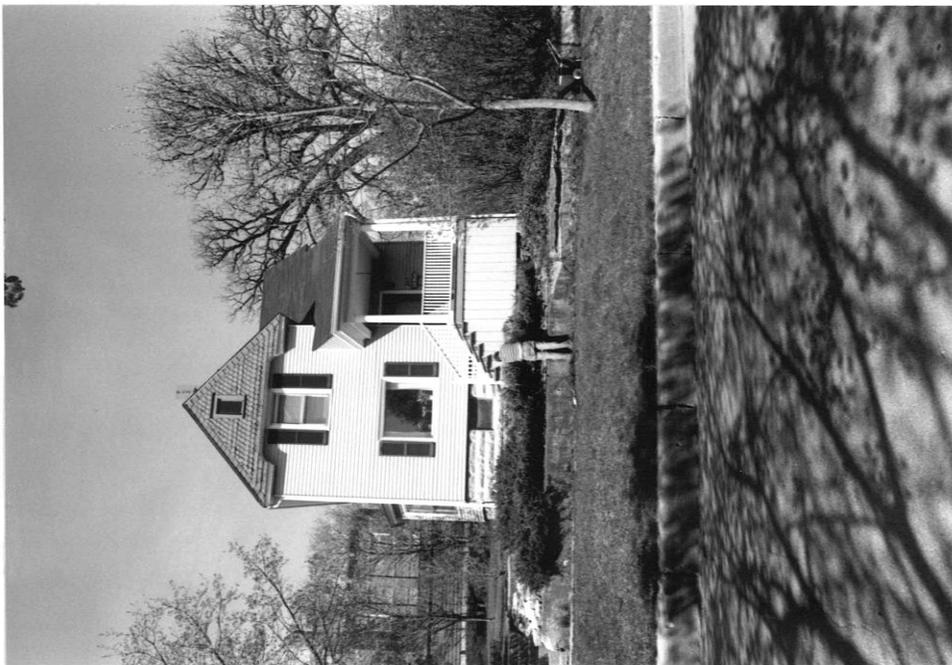
207 South Fourth Street

Style: Queen Anne

Front gabled roof with diamond and fishscale shingles. Classical (Doric) columns at entrance porch hinting at a Colonial Revival influence. Large, rock-face, regularly coursed stone foundation.

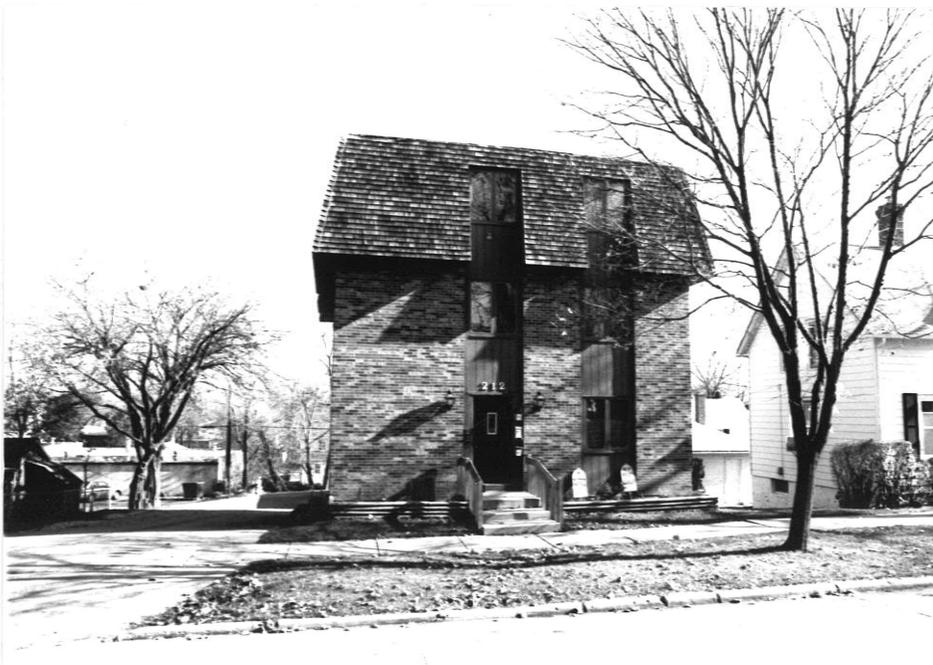
212 South 4th Street

Style: Neoelectic

Mansard roof third floor, widely used by home builders in the 1960's. Brick lower two floors.

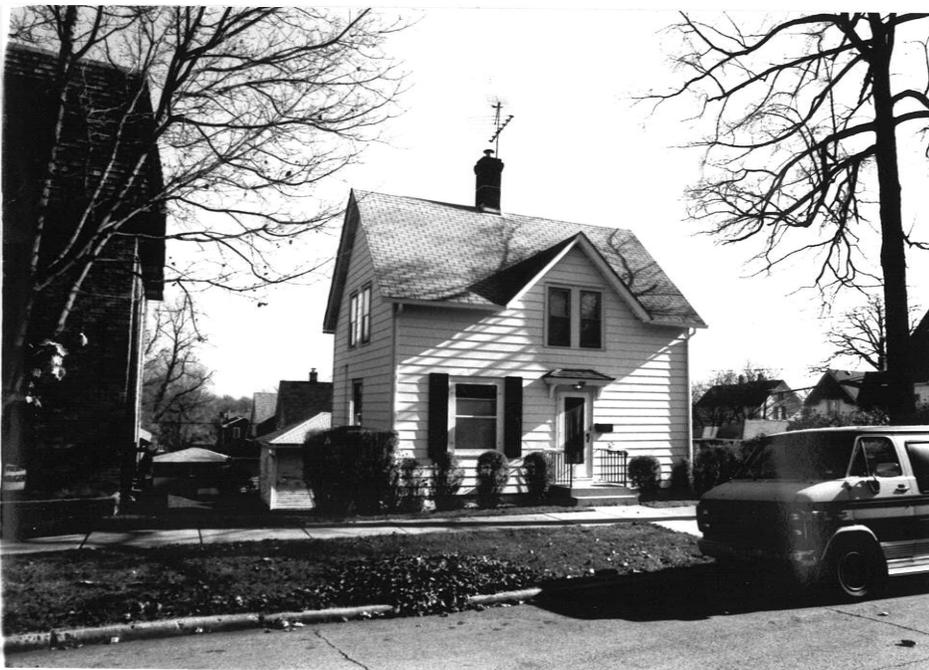
220 South 4th Street

Style: Queen Anne

Cross gabled wood frame house with synthetic siding. Assymetrical front facade with double window in front gable.

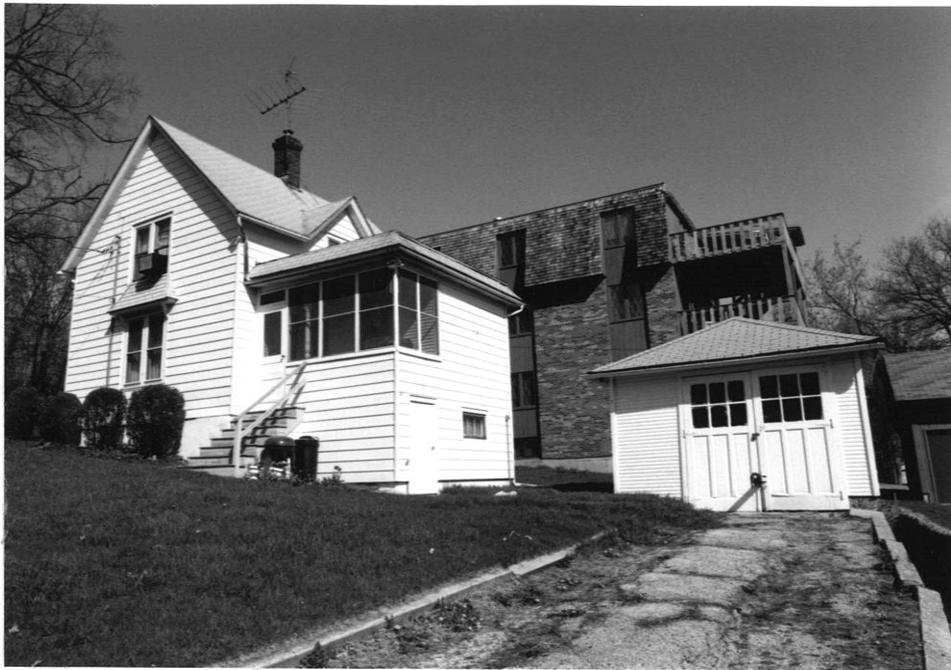
220 South 4th Street

South Elevation, showing
wood clapboard sided garage
with swinging panel doors
with six lights each.
