ST. CHARLES HISTORIC PRESERVATION COMMISSION

ARCHITECTURAL SURVEY
ST. CHARLES CENTRAL DISTRICT
ST. CHARLES, ILLINOIS

DIXON ASSOCIATES / ARCHITECTS

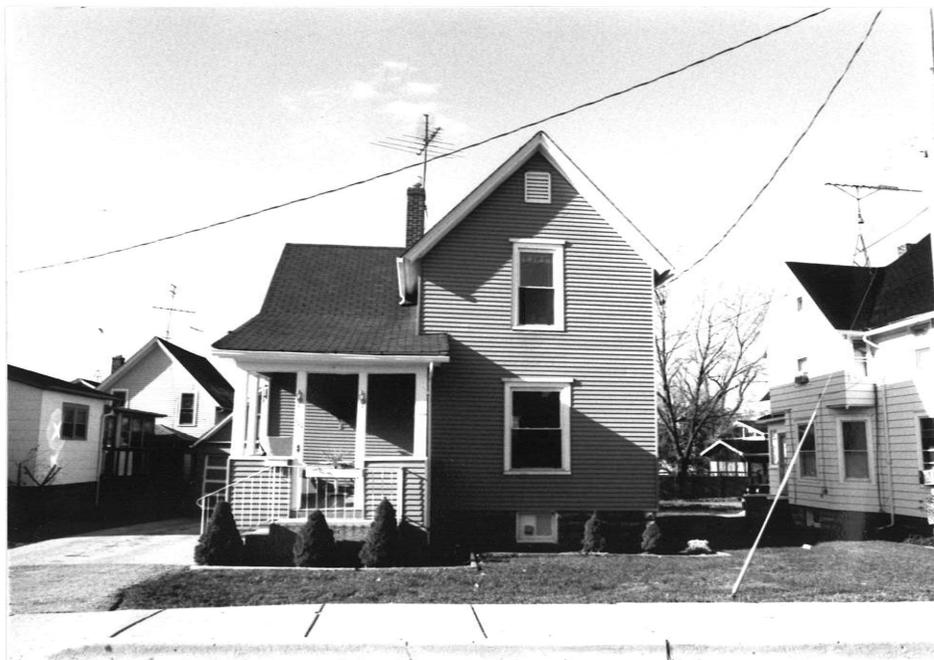
111 South 5th Avenue

Style: National

Date of Construction: 1880-1890

Gable front and wing form. Shed roof over entry porch.
 Some details have been removed or altered.

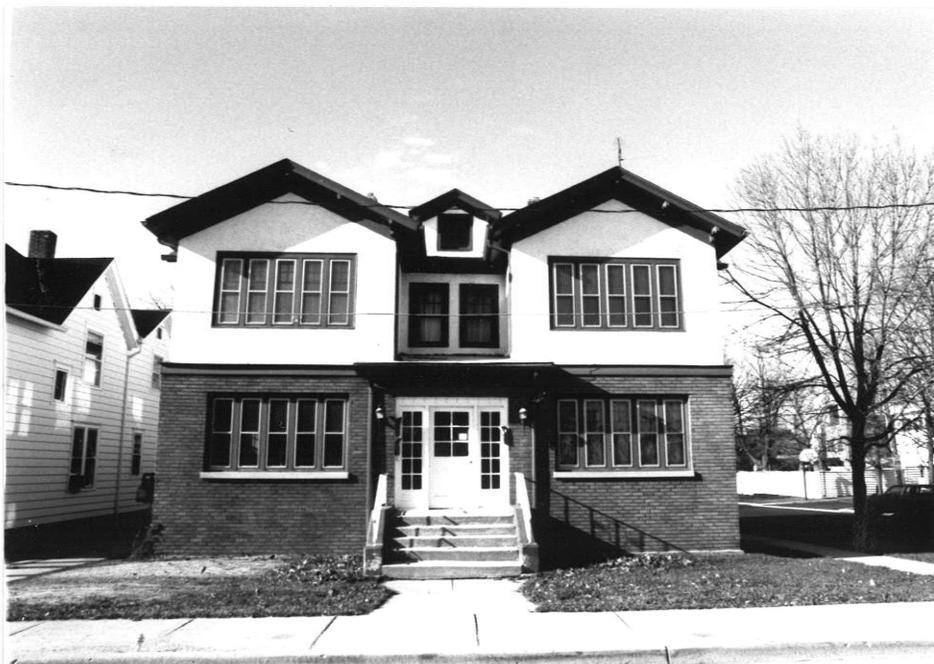
103 South 5th Avenue

Style: Prairie

Date of Construction: 1900-1920

Duplex form. Paired front gable roof. Brackets at gable. Brick exterior at first floor with stucco at second floor. Horizontal band. Enclosed entry has been altered.

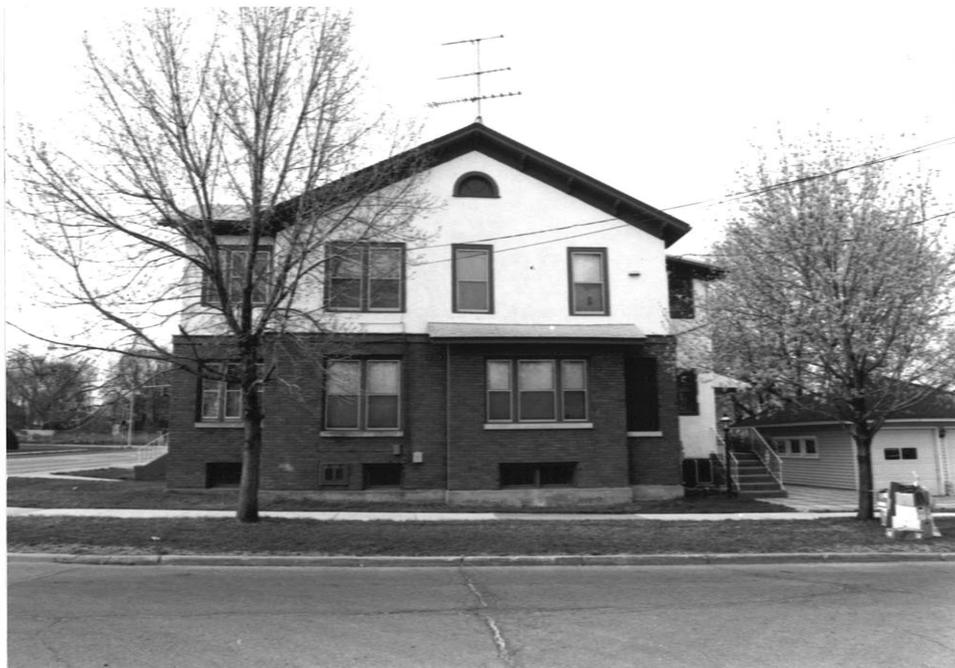
103 South 5th Avenue

North Elevation.

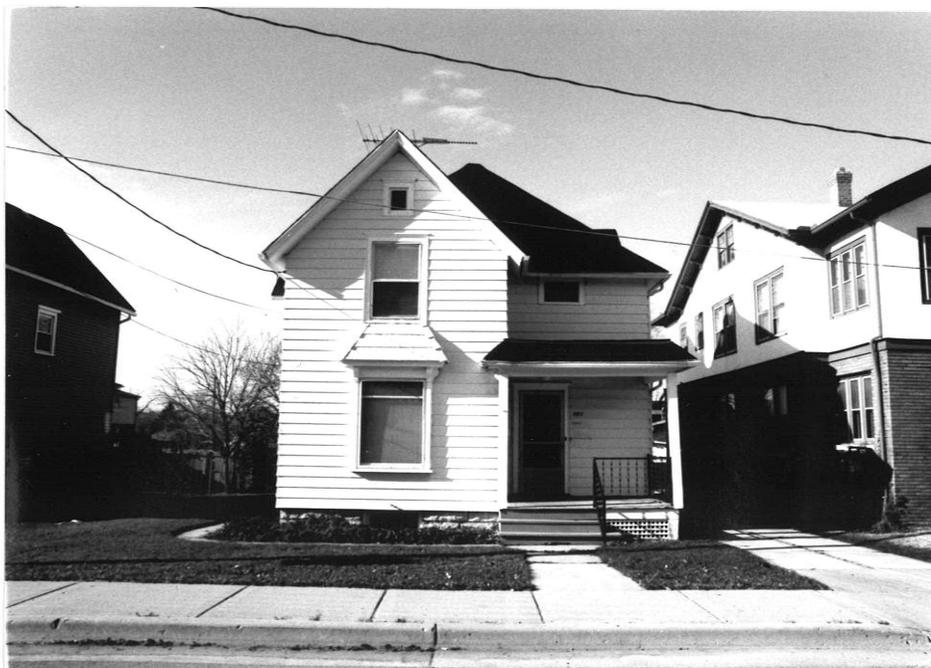
107 South 5th Avenue

Style: National

Date of Construction: 1880-1890

Two-story structure with hip roof with lower cross gables. Shed roof over entry porch. Brackets at first floor bay window. Stone foundation.
