# State Street Creek & 7<sup>th</sup> Avenue Creek Watershed Plan

## Addendum to Ferson-Otter Creek Plan

APPLIED ECOLOGICAL SERVICES, INC.

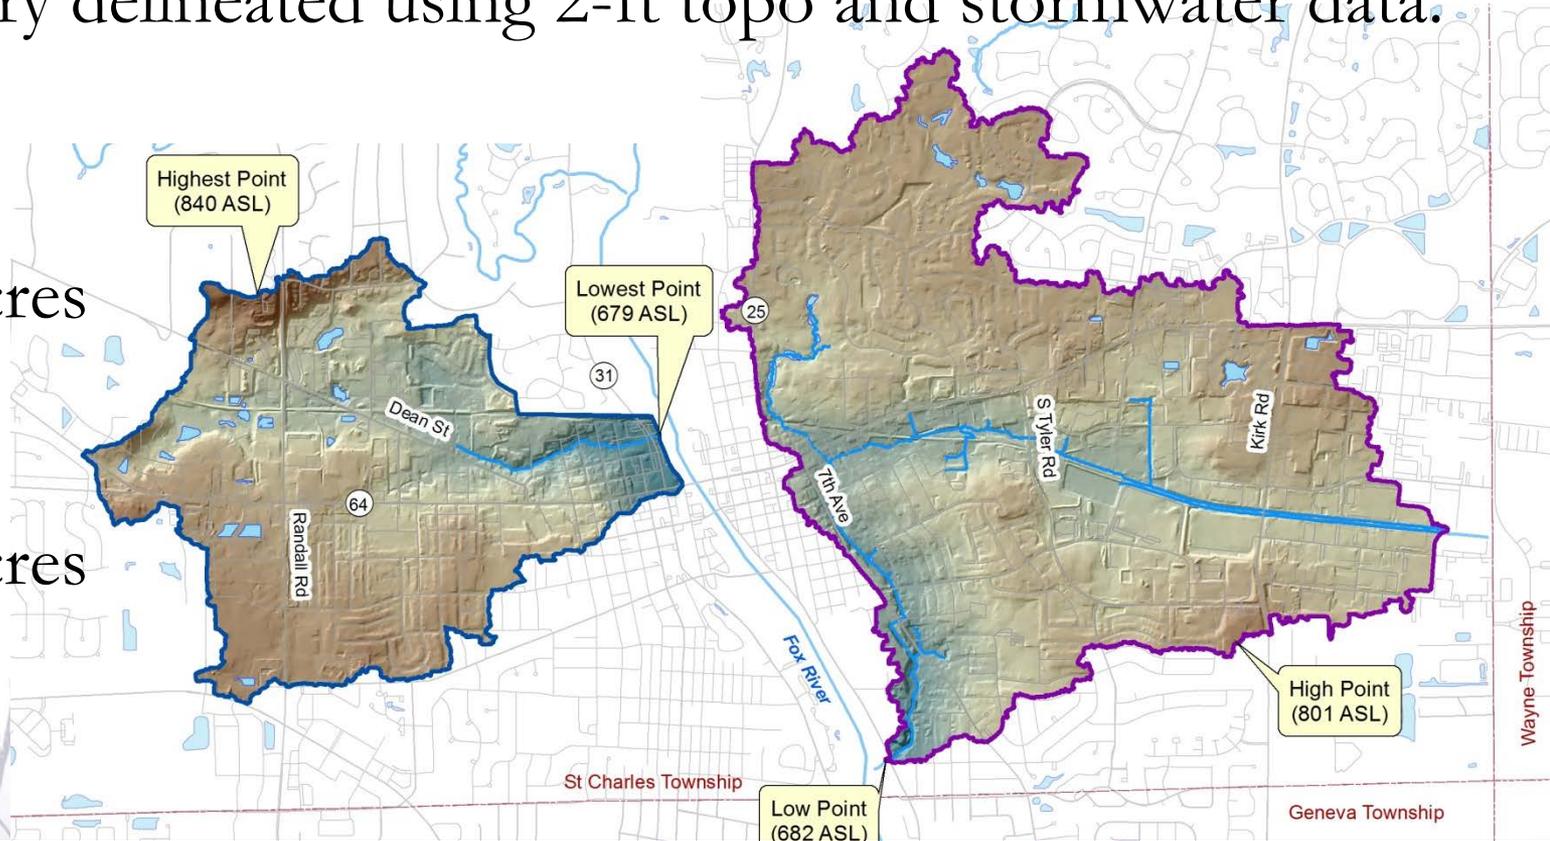
- Wisconsin Episode glacier 14,000 years ago
- Highest point = 840 ft ASL; lowest point = 679 ft ASL
- Boundary delineated using 2-ft topo and stormwater data.
- State St Creek is 1,030 acres
- 7<sup>th</sup> Ave Creek is 1,885 acres

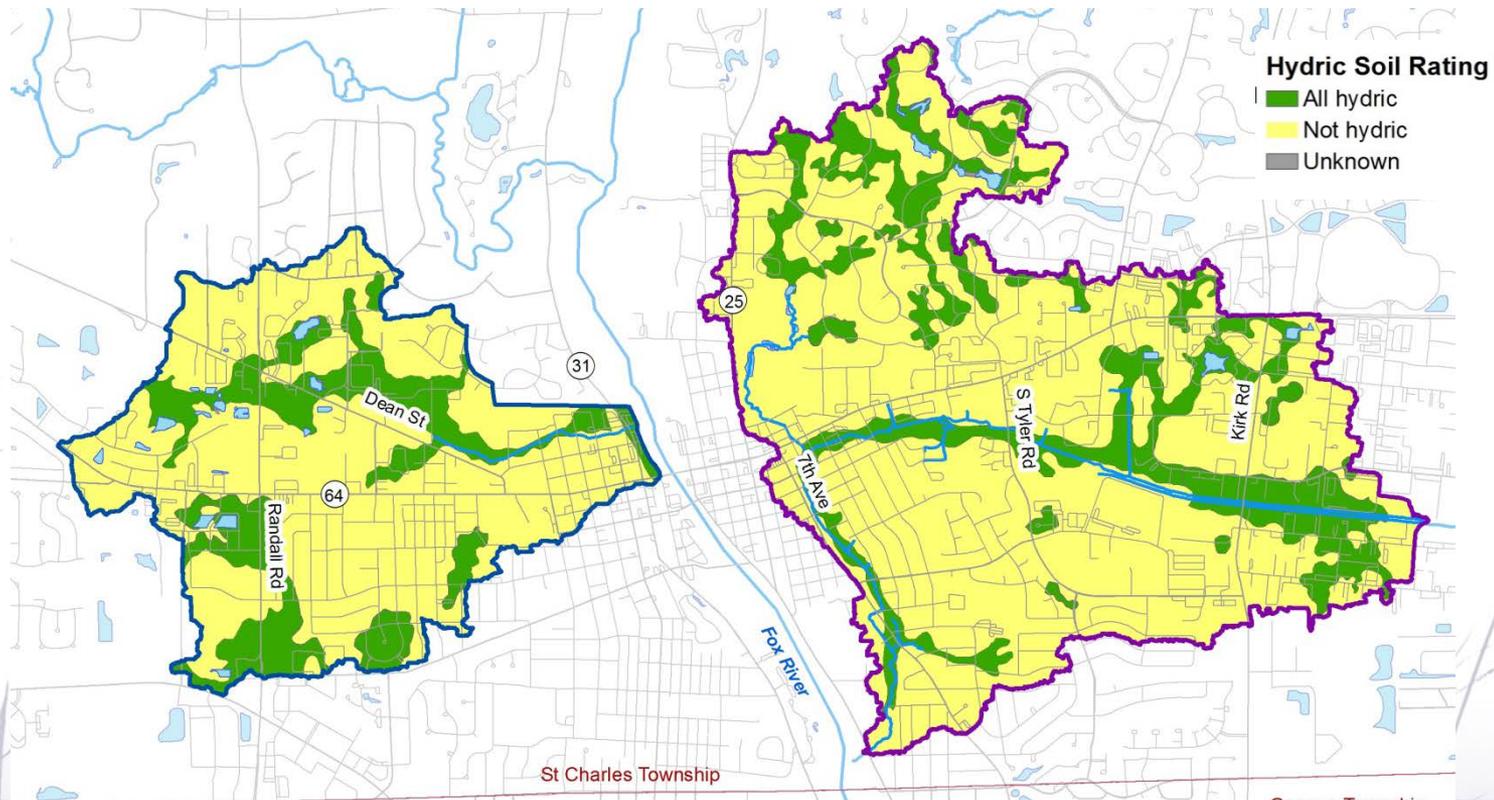
- Indication of where wetlands once were located
- 254.5 acres of hydric soils in State Street Creek
- 413.8 acres of hydric soils in the 7th Avenue Creek

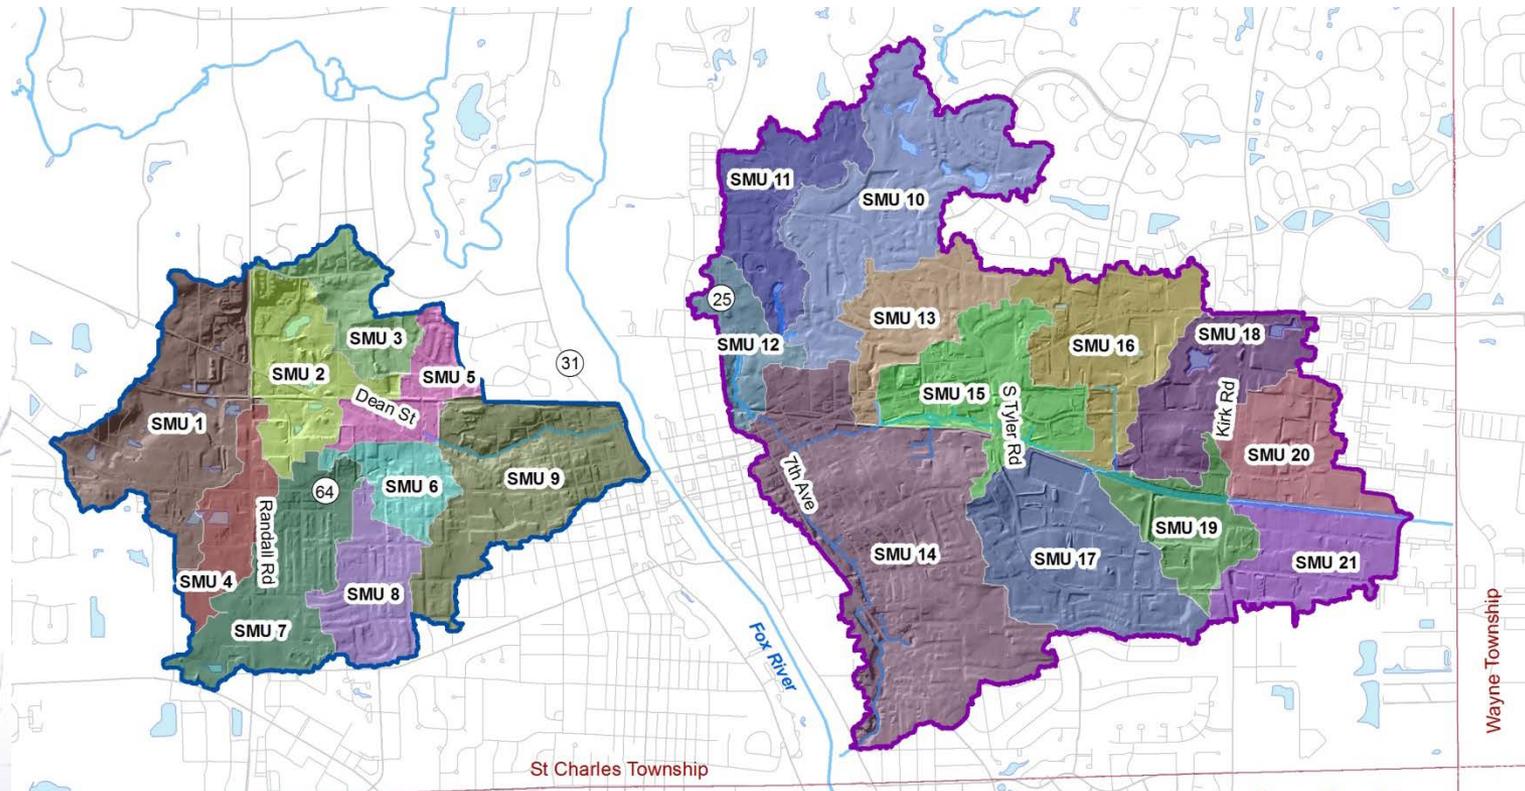
- 21 SMUs: range from 53 to 423 acres in size
- 9 in State Street Creek Watershed
- 12 in 7<sup>th</sup> Avenue Creek Watershed

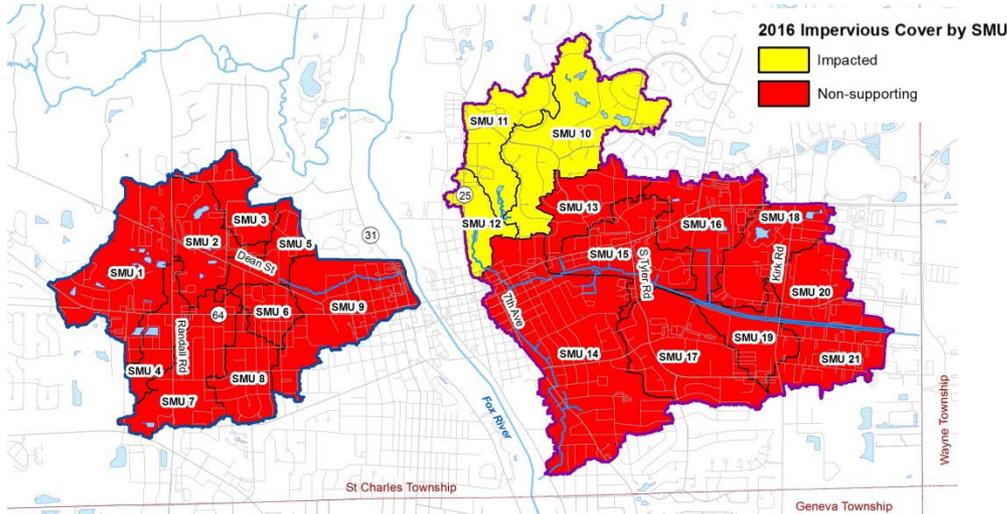
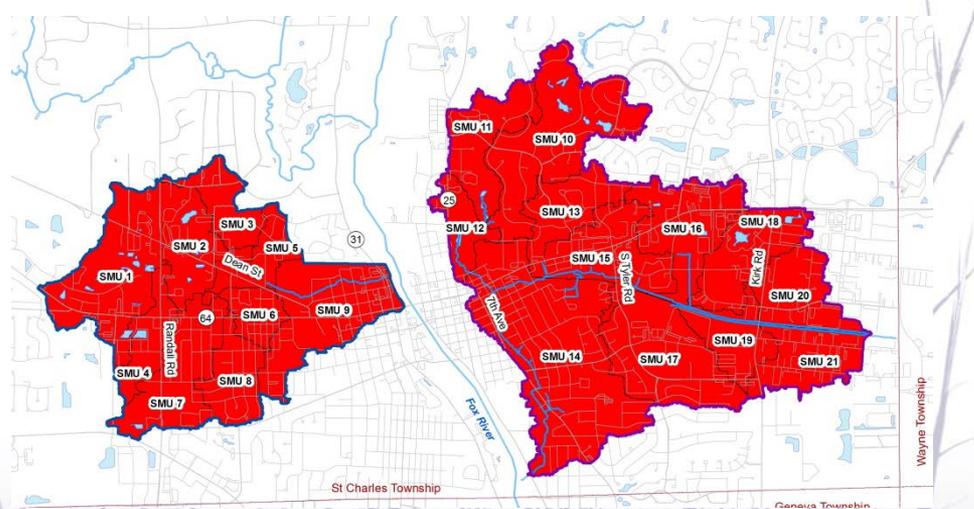
SMU	Step 1:	Existing (2012) Impervious Classification	Step 2:	Predicted Impervious Classification
	Existing Impervious %		Predicted Impervious %	
1	61.0%	Non-Supporting	53.5%	Non-Supporting
2	59.1%	Non-Supporting	59.2%	Non-Supporting
3	29.7%	Non-Supporting	33.8%	Non-Supporting
4	67.9%	Non-Supporting	73.1%	Non-Supporting
5	40.6%	Non-Supporting	44.1%	Non-Supporting
6	33.9%	Non-Supporting	48.5%	Non-Supporting
7	45.2%	Non-Supporting	57.2%	Non-Supporting
8	29.7%	Non-Supporting	38.9%	Non-Supporting
9	39.9%	Non-Supporting	46.0%	Non-Supporting
10	16.6%	Impacted	28.3%	Non-Supporting
11	18.5%	Impacted	27.1%	Non-Supporting
12	21.0%	Impacted	28.2%	Non-Supporting
13	25.8%	Non-Supporting	36.9%	Non-Supporting
14	30.5%	Non-Supporting	42.1%	Non-Supporting
15	62.6%	Non-Supporting	63.2%	Non-Supporting
16	70.9%	Non-Supporting	71.3%	Non-Supporting
17	44.2%	Non-Supporting	59.7%	Non-Supporting
18	62.6%	Non-Supporting	67.6%	Non-Supporting

19	74.3%	Non-Supporting	73.5%	Non-Supporting
20	74.3%	Non-Supporting	74.1%	Non-Supporting
21	73.8%	Non-Supporting	71.7%	Non-Supporting

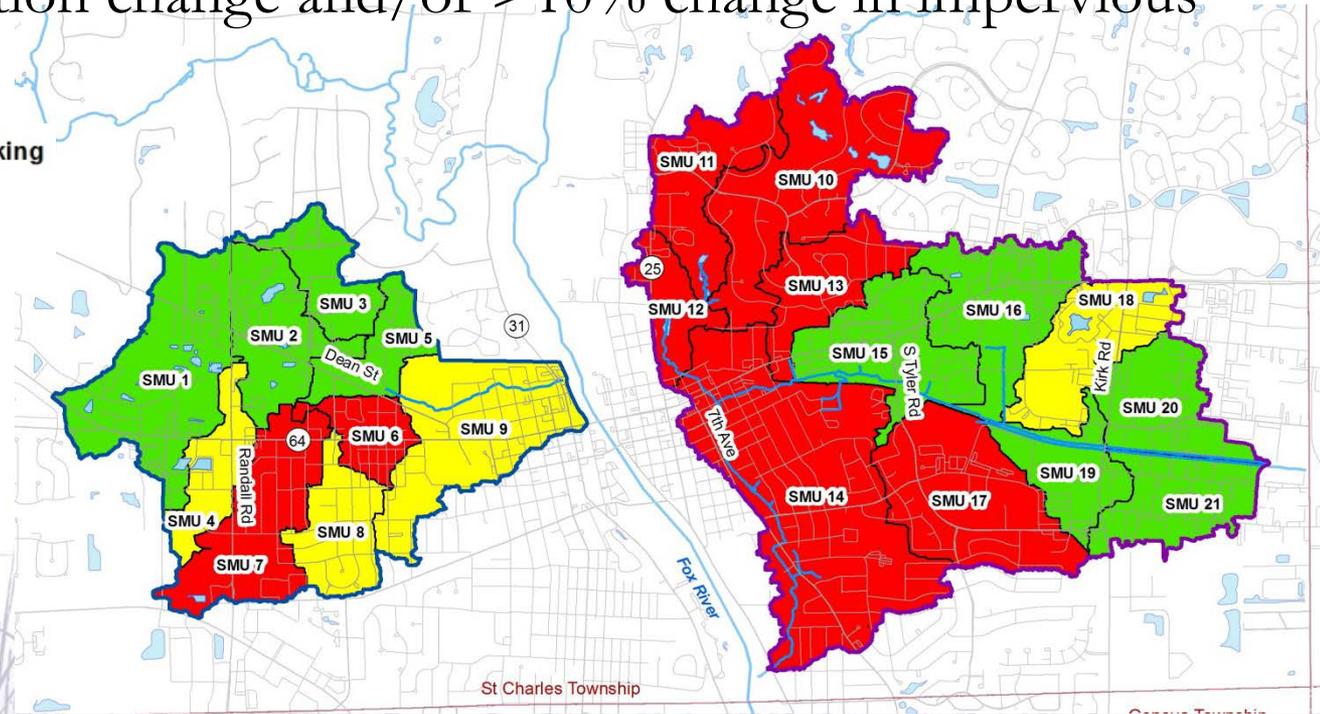
## Vulnerability Ranking

Vulnerability to future development for each SMU was categorized as Low, Medium, or High:

- **Low** = no change in classification; <5% change in impervious cover
- **Medium** = 5-10% change in impervious cover
- **High** = classification change and/or >10% change in impervious cover

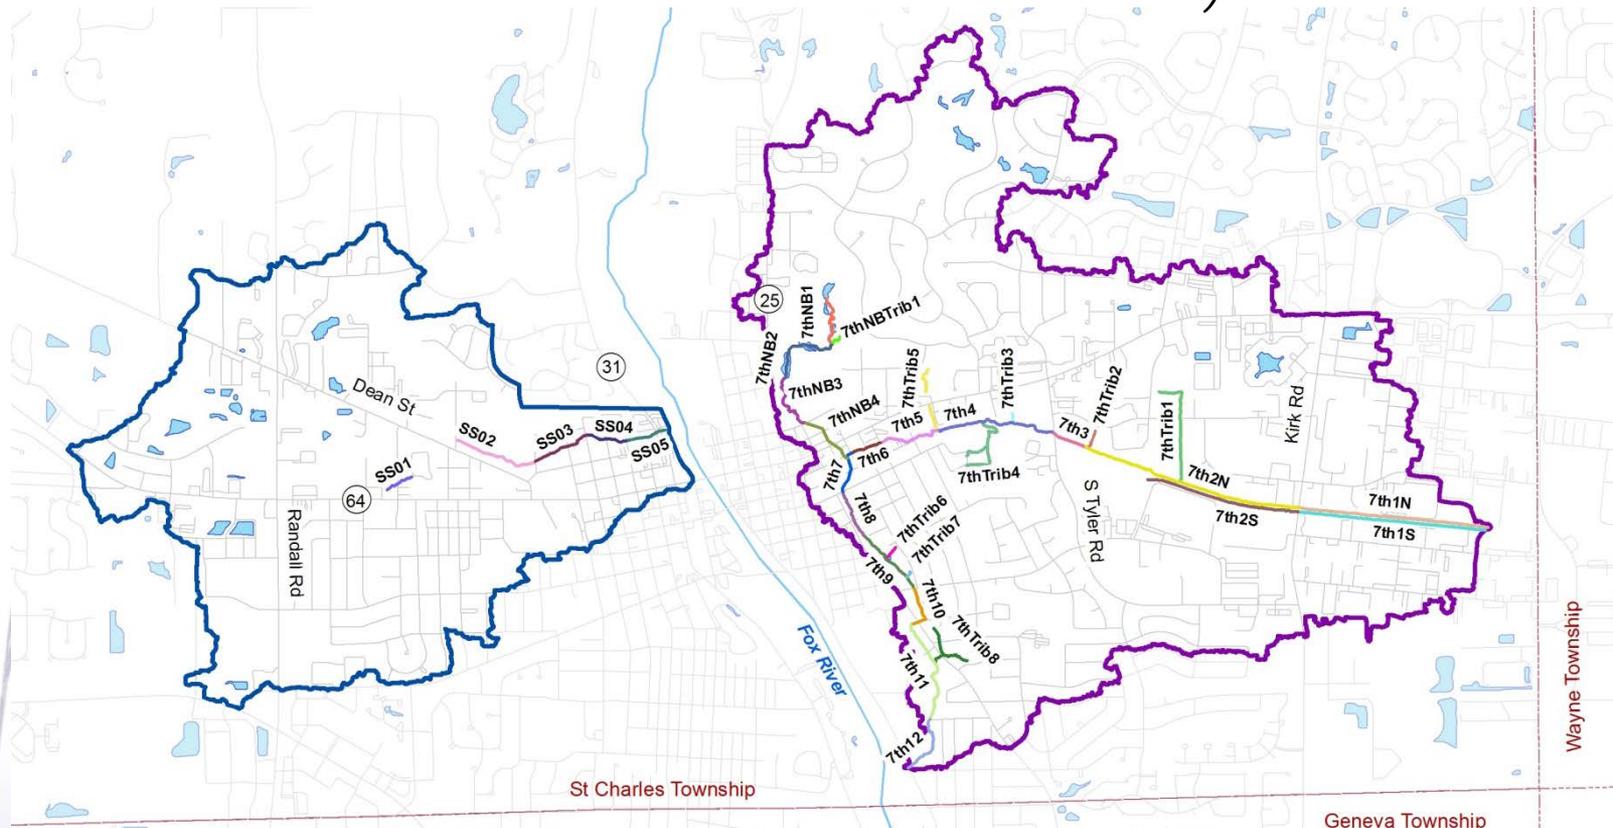
- 0.8 miles - State Street Creek
- 6.7 miles - 7<sup>th</sup> Ave Creek and tributaries (inventoried 5.4 miles of main channel and branches)

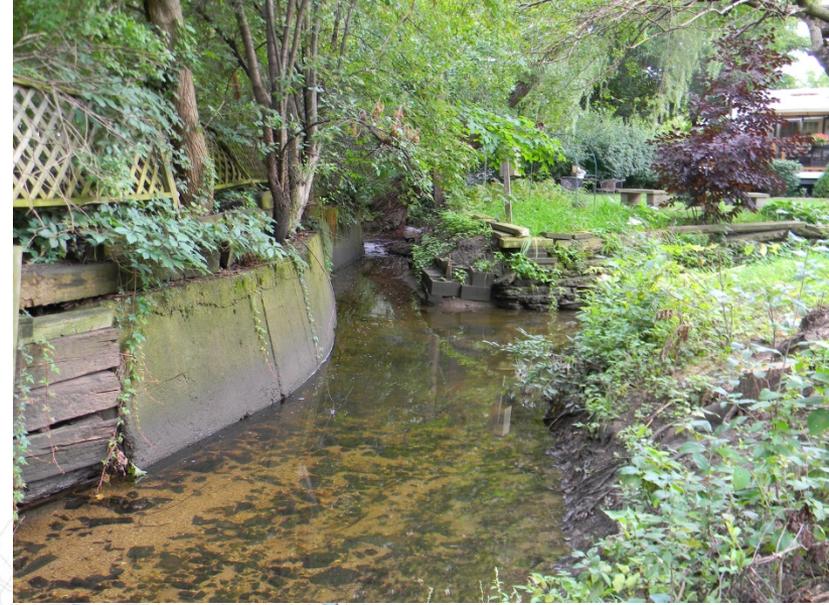
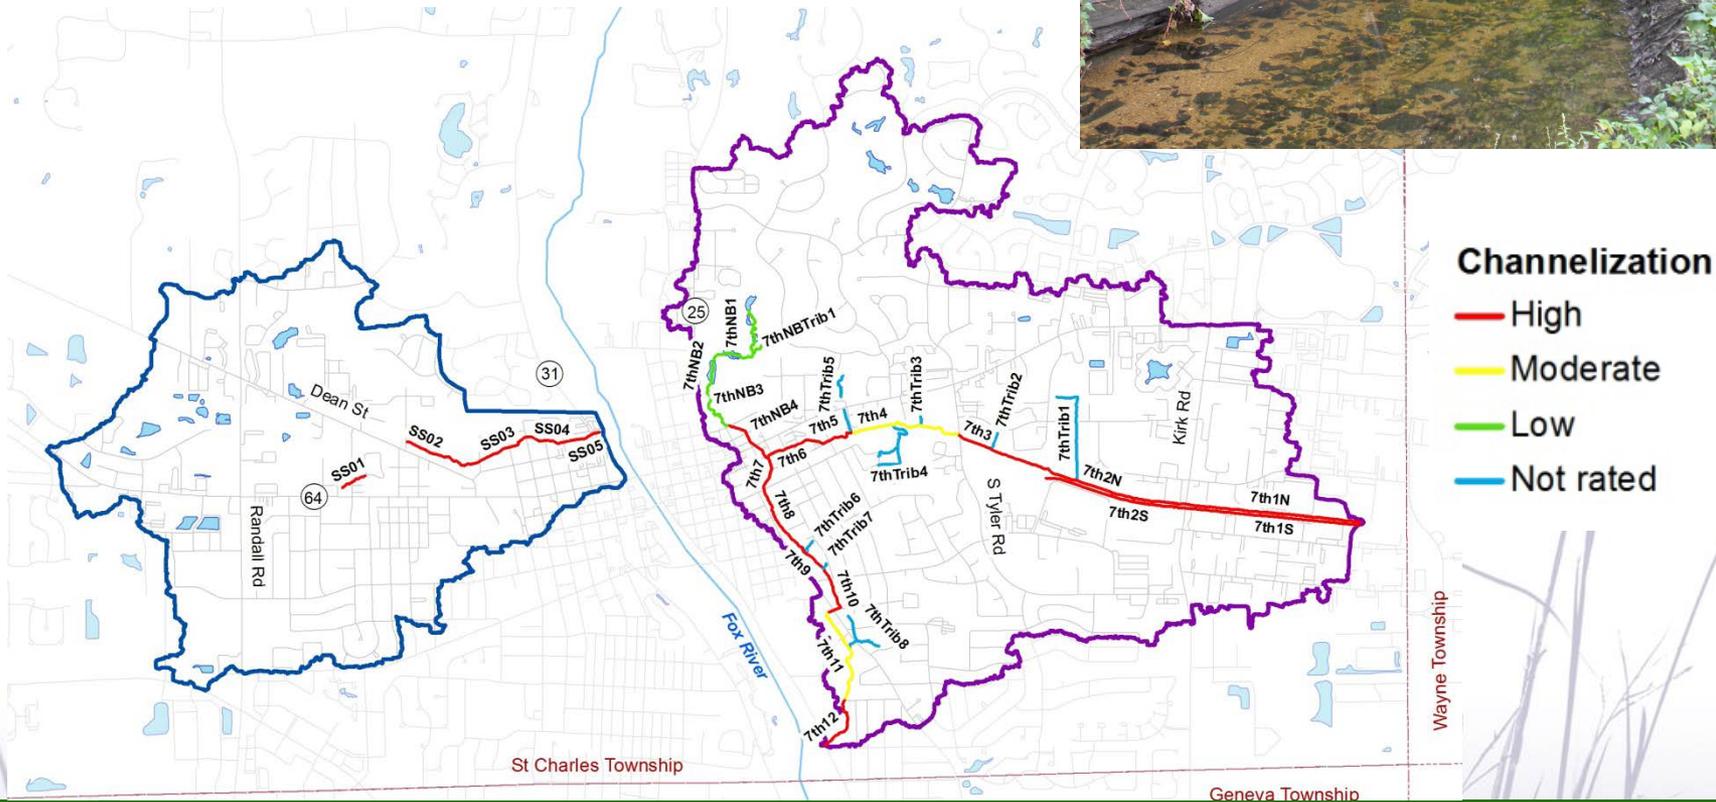
- State St entirely channelized
- 7<sup>th</sup> Ave Creek – 3.9 miles highly channelized

- Channelized means ditched; berms common along channelized streams
- Channelized streams typically disconnected from floodplain
- Natural streams meander and provide pools and riffles that improve water quality

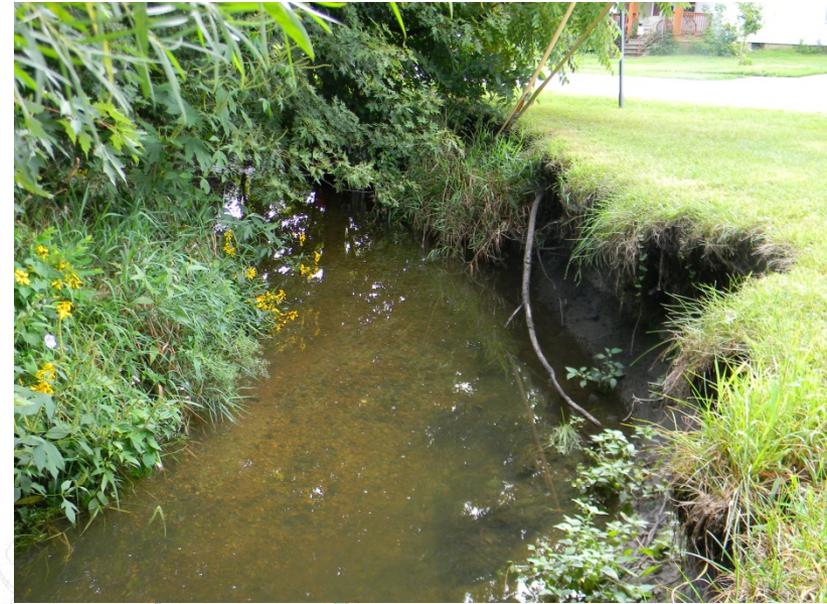
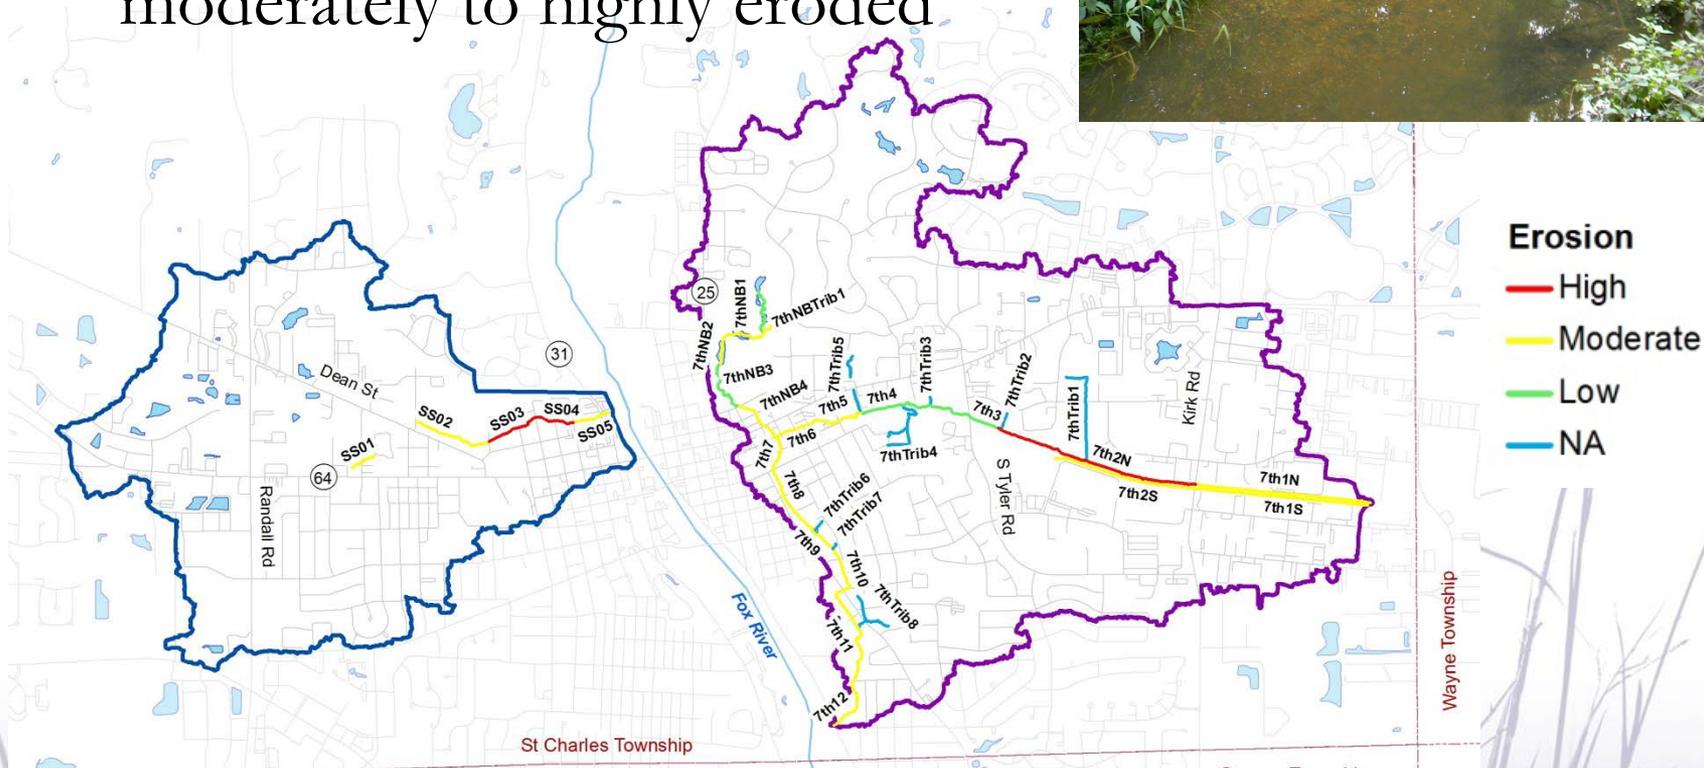
- State St - 100% moderately to highly eroded
- 7<sup>th</sup> Ave Creek – 83% moderately to highly eroded

- Result of instability in flow rate or volume, human alteration, or change in streambank vegetation
- Resulting sediment accumulation and transportation downstream can cause significant water quality problems

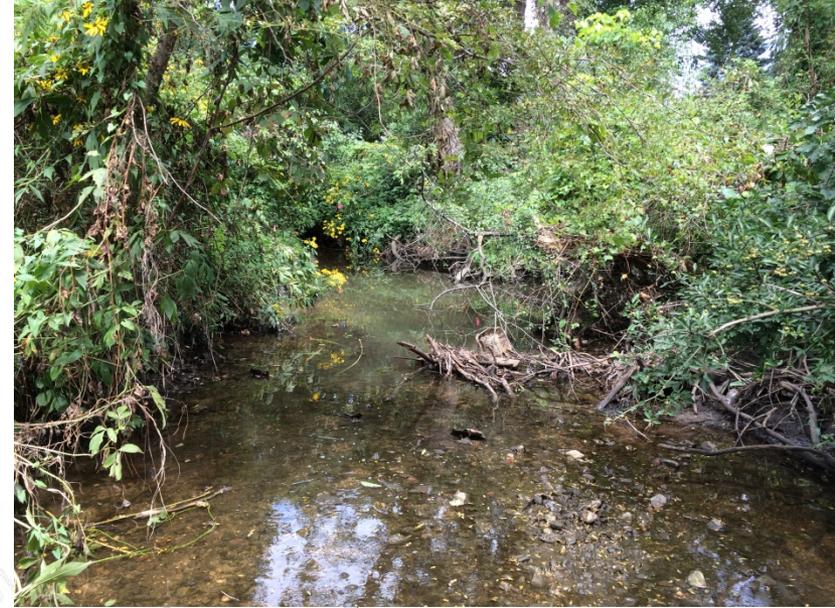
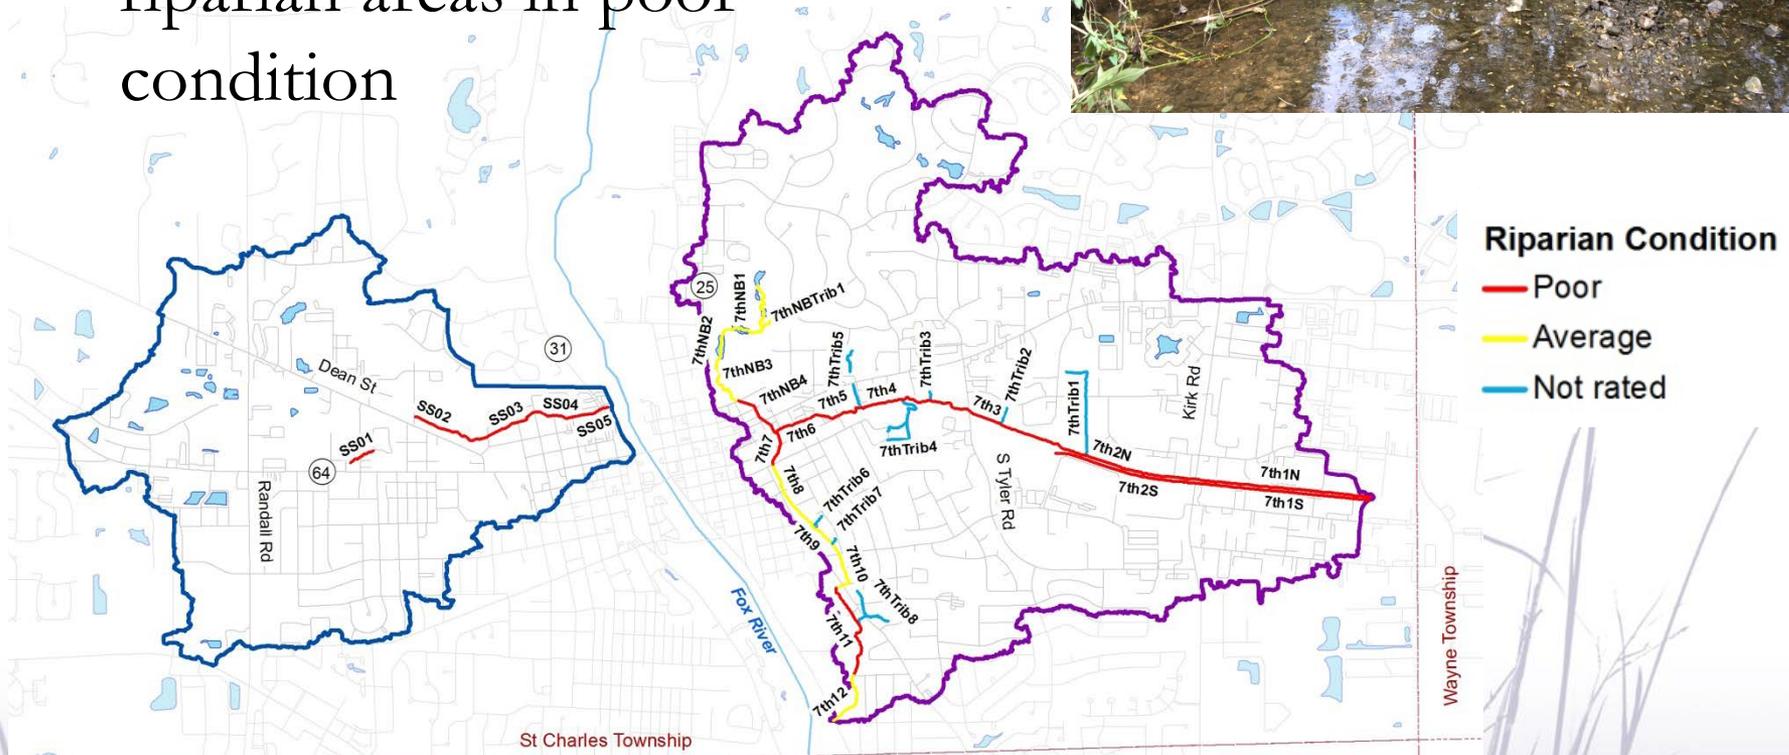
- State St – 100% of riparian areas in poor condition
- 7<sup>th</sup> Ave Creek – 72% of riparian areas in poor condition

- Buffers or corridors on either side of stream
- Filter pollutants, provide beneficial wildlife habitat, and connect green infrastructure

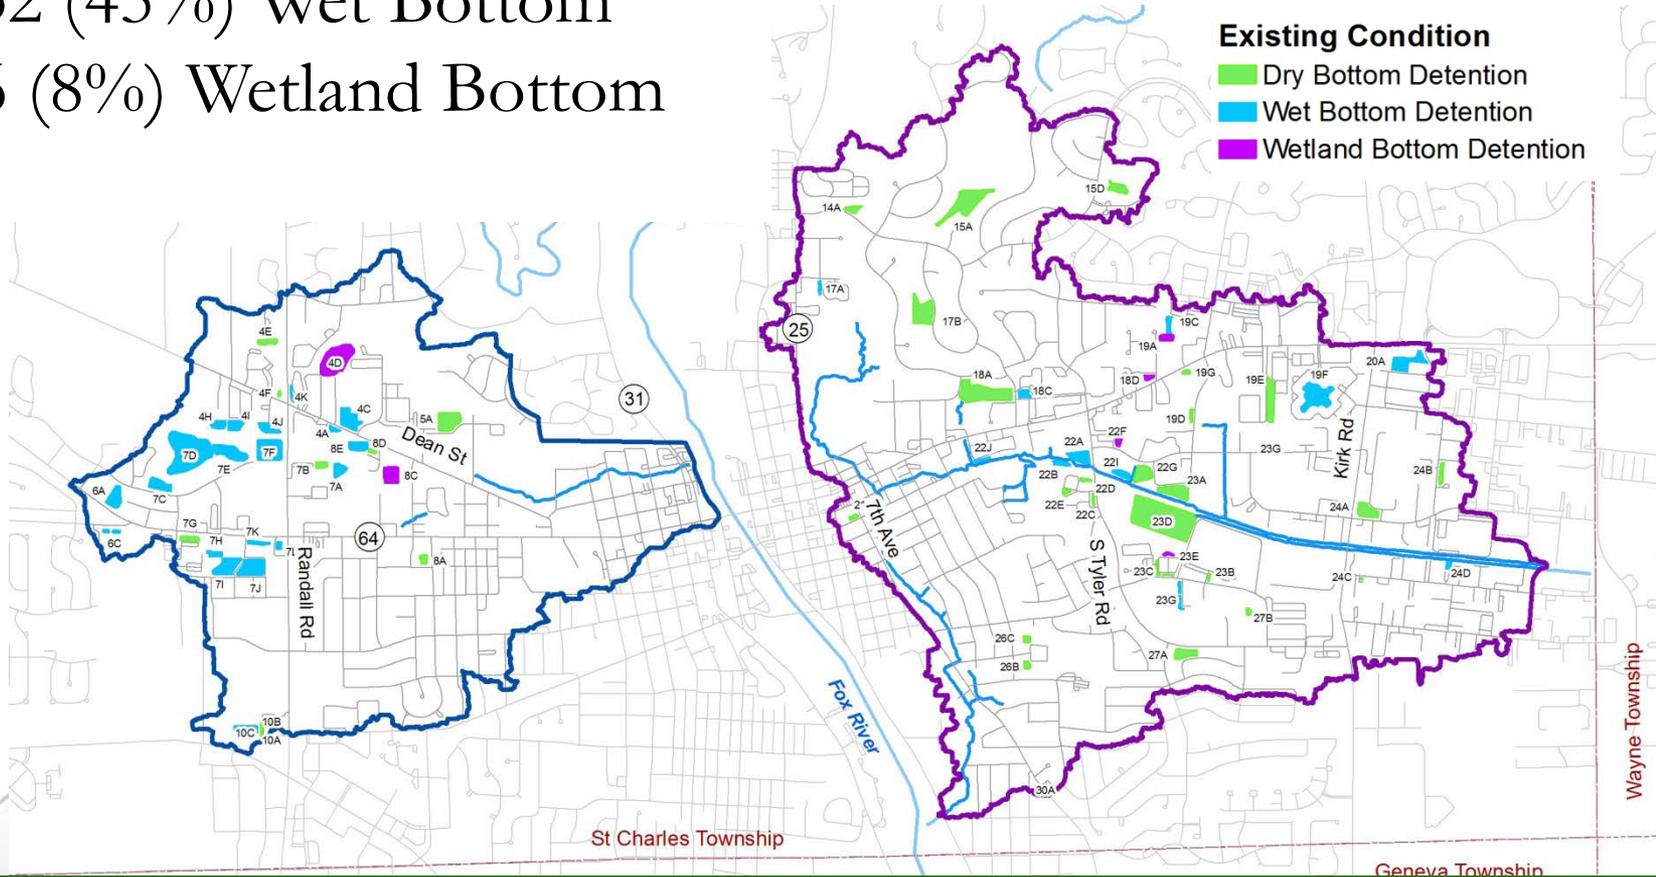
72 inventoried (86 acres)

- 34 (47%) Dry bottom
- 32 (45%) Wet Bottom
- 6 (8%) Wetland Bottom

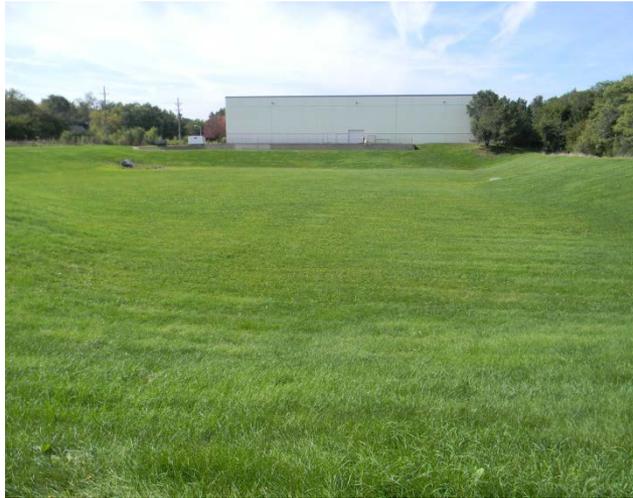
**Dry Bottom**

Many existing basins would benefit from naturalizing side slopes and installation of native buffers

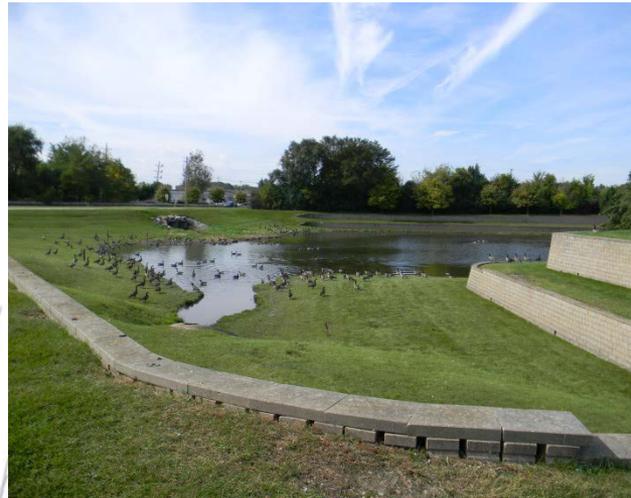
**Wet Bottom**

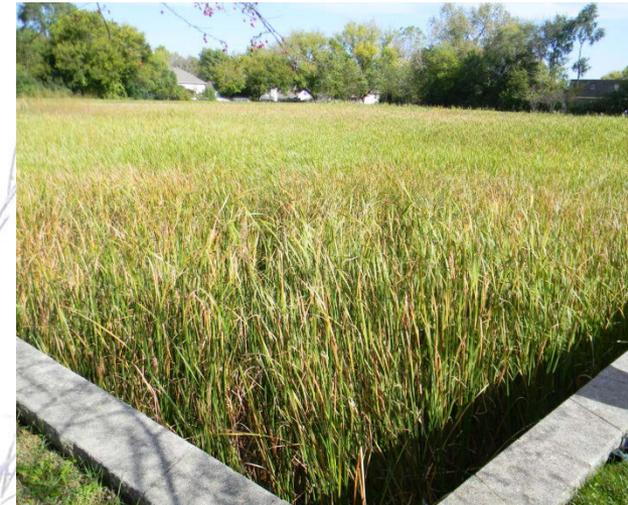
**Wetland Bottom**

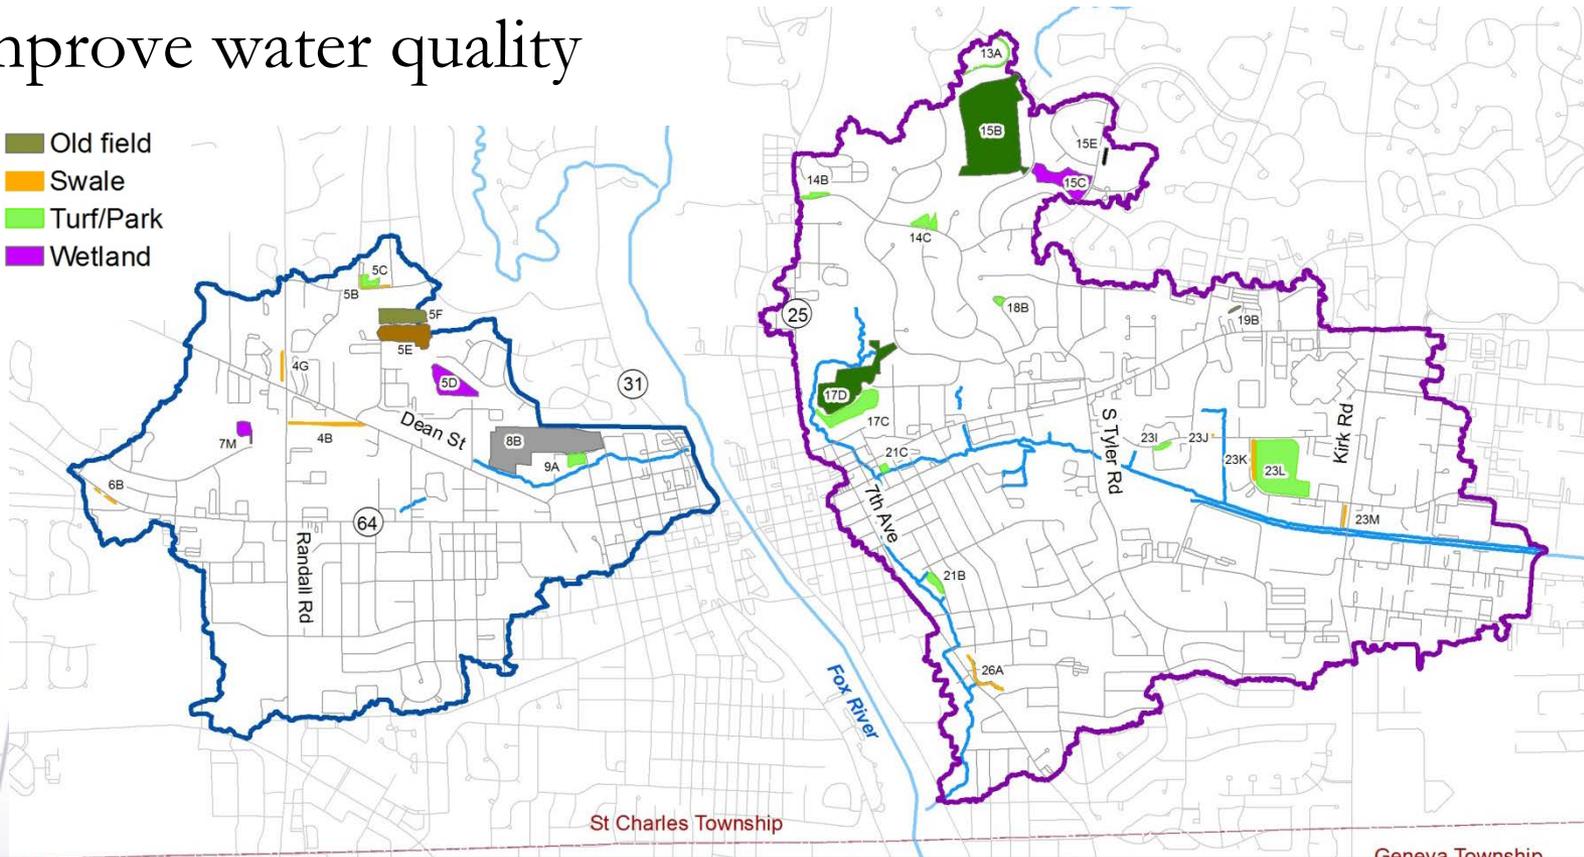
29 inventoried (114 acres)

Many natural or turf areas that could be managed to improve water quality

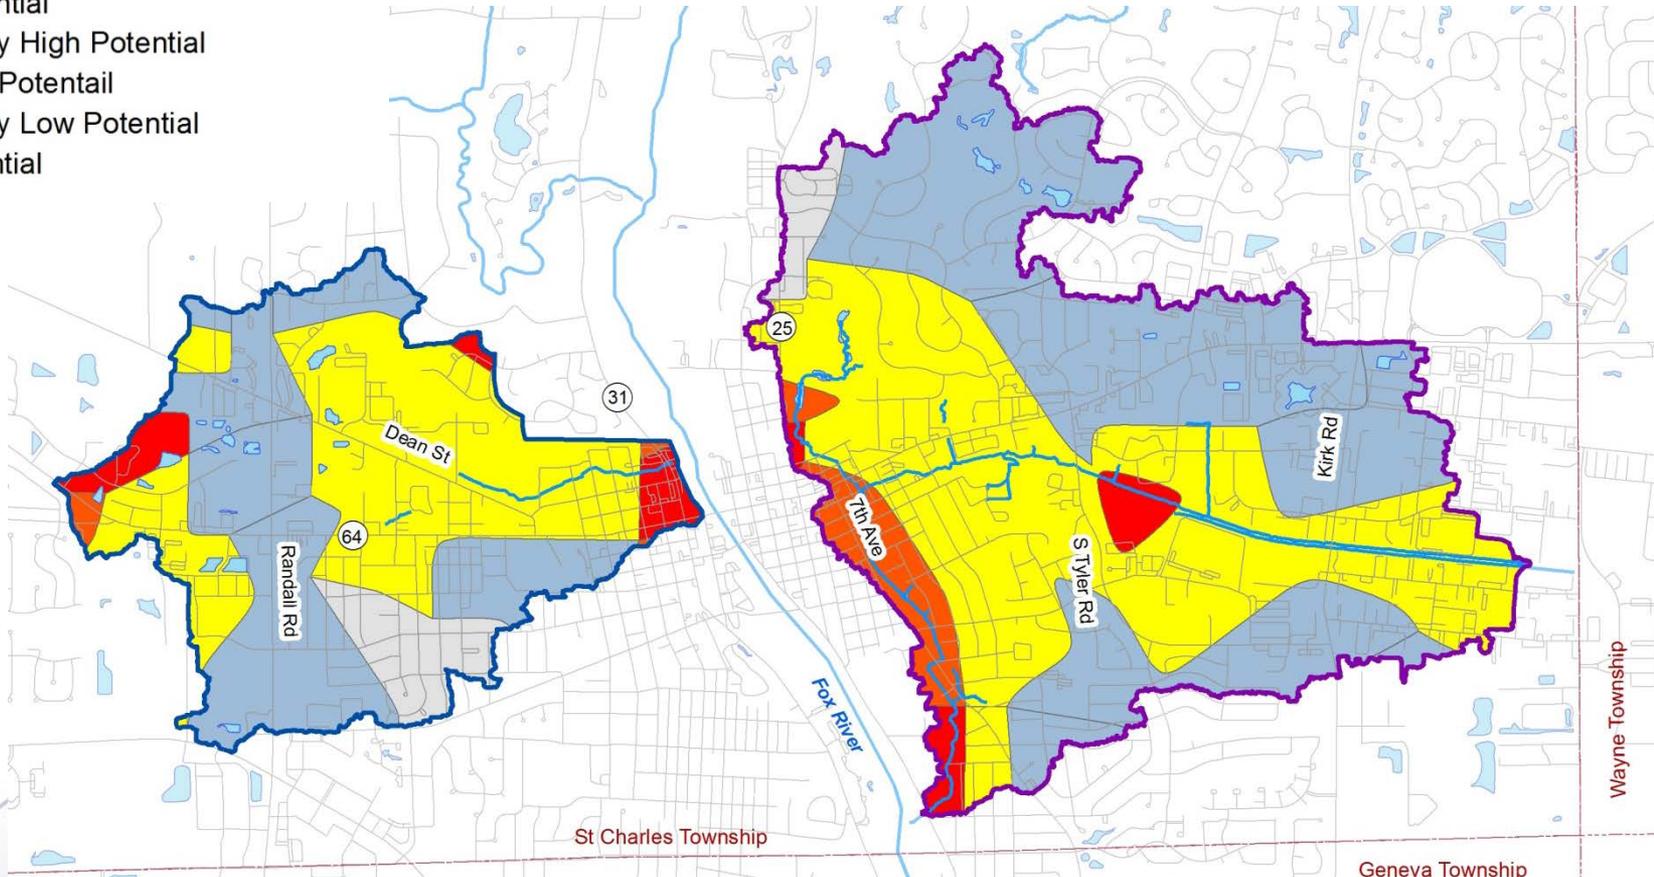
## Aquifer Sensitivity Classification (Kane County)

- High Potential
- Moderately High Potential
- Moderate Potential
- Moderately Low Potential
- Low Potential

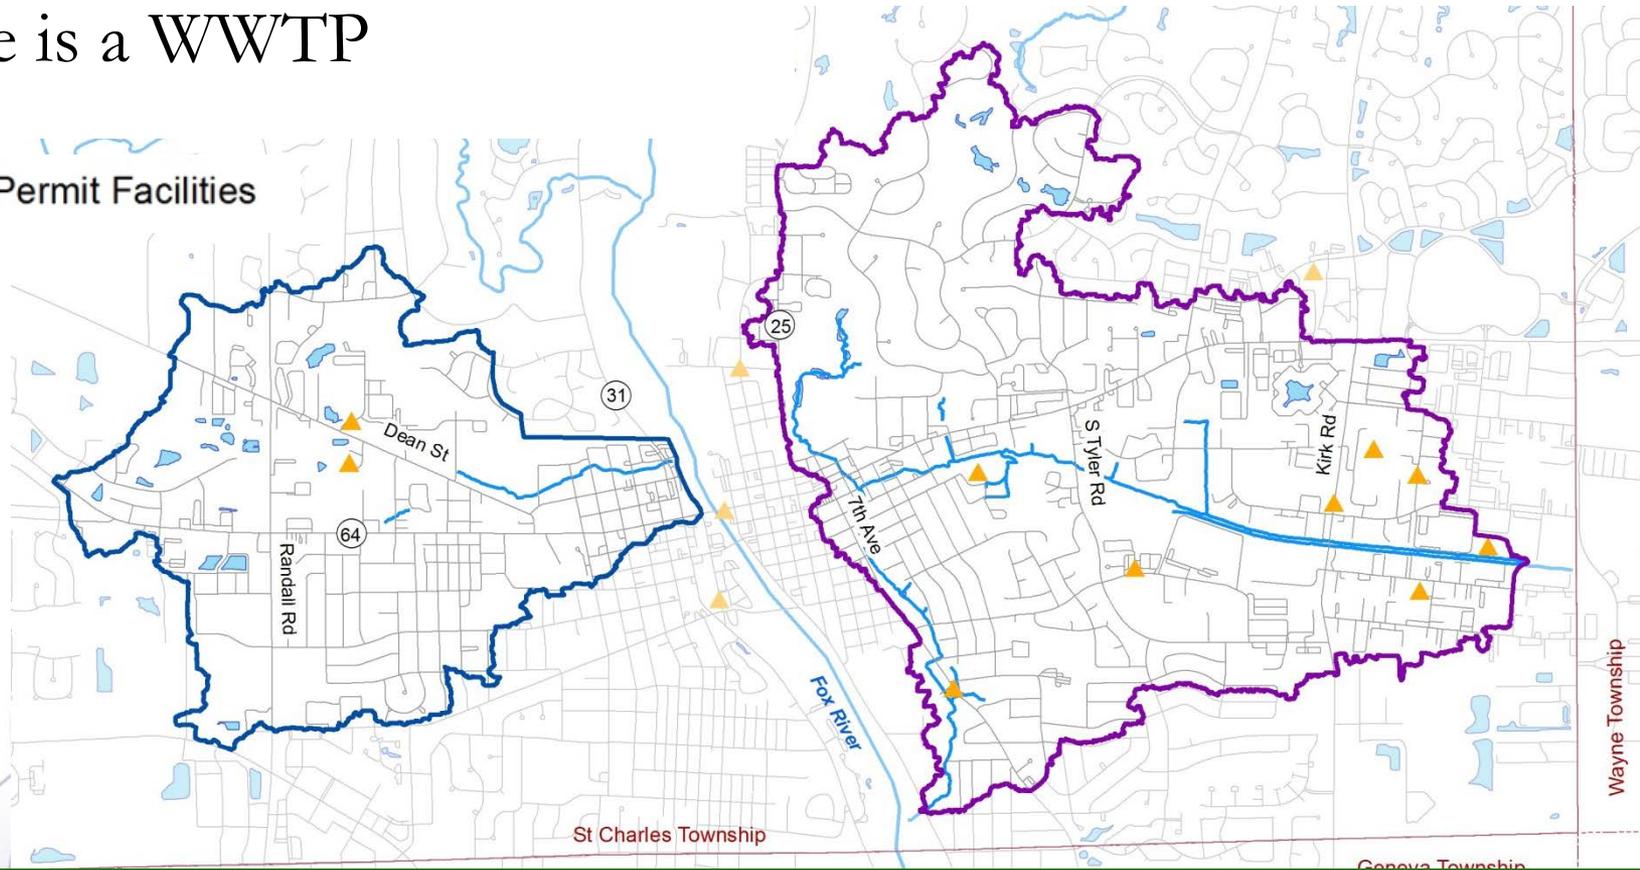
- 2 NPDES permit sites in State Street Creek
- 8 NPDES permit sites in 7<sup>th</sup> Avenue Creek
- One is a WWTP
