ARCHITECTURAL SURVEY
MILLINGTON HISTORIC DISTRICT
ST. CHARLES, ILLINOIS
Date of Survey: 2003

ST. CHARLES HISTORIC PRESERVATION COMMISSION

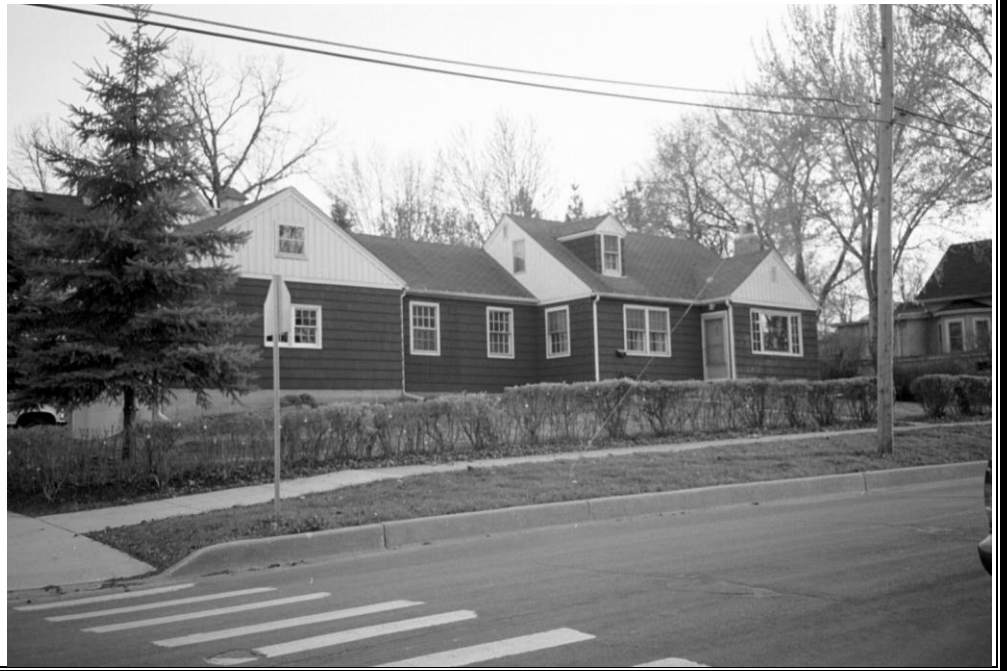
ADDRESS 501 State Street

Architectural Style/Type:	<u>Colonial Revival/Cape Cod</u>	Exterior Walls (Current):	<u>Cedar shingle</u>
Architectural Features:	<u></u>	Exterior Walls (Original):	<u>Cedar single</u>
Date of Construction:	<u>1930</u>	Foundation:	<u>Concrete block/Concrete @ garage</u>
Source:	<u>Township Assessor's Office</u>	Roof Type/Material:	<u>Side gable/Asphalt shingle</u>
Overall Plan Configuration:	<u>Simple rectangle</u>	Window Material/Type:	<u>Alum/Wd/double hung</u>

ARCHITECTURAL FEATURES: There is a small dormer on the front of the house near the entrance. A small cupola was installed over the garage.

ALTERATIONS: This house was moved to this site in 1966 from the site of the Coca Cola plant. The foundation was built onsite using standard CMU and then the house was moved. The garage was built onsite on a concrete foundation.

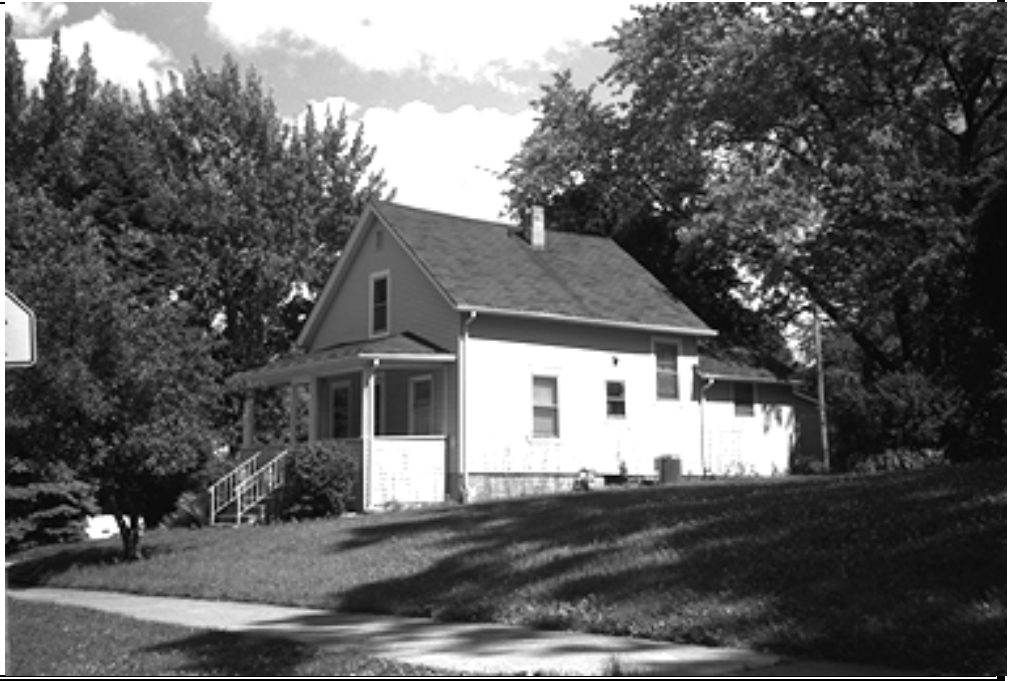
ADDRESS 515 State Street

Architectural Style/Type: <u>National</u>	Exterior Walls (Current): <u>Clapboard</u>
Architectural Features: _____	Exterior Walls (Original): <u>Clapboard</u>
Date of Construction: <u>1925</u>	Foundation: <u>Concrete</u>
Source: <u>Township Assessor's Office</u>	Roof Type/Material: <u>Front gable/Asphalt shingle</u>
Overall Plan Configuration: <u>Simple/Rectangle</u>	Window Material/Type: <u>Alum/double hung</u>

ARCHITECTURAL FEATURES: Round classical columns support the full width front porch.

ALTERATIONS: A one story addition was made to the rear of the house that is somewhat sympathetic with the original house. A 2 story addition was also put on the rear of the house and is not sympathetic with the original style. A flat roofed garage addition is also not sympathetic to the original. The soffits have been boxed in with aluminum.

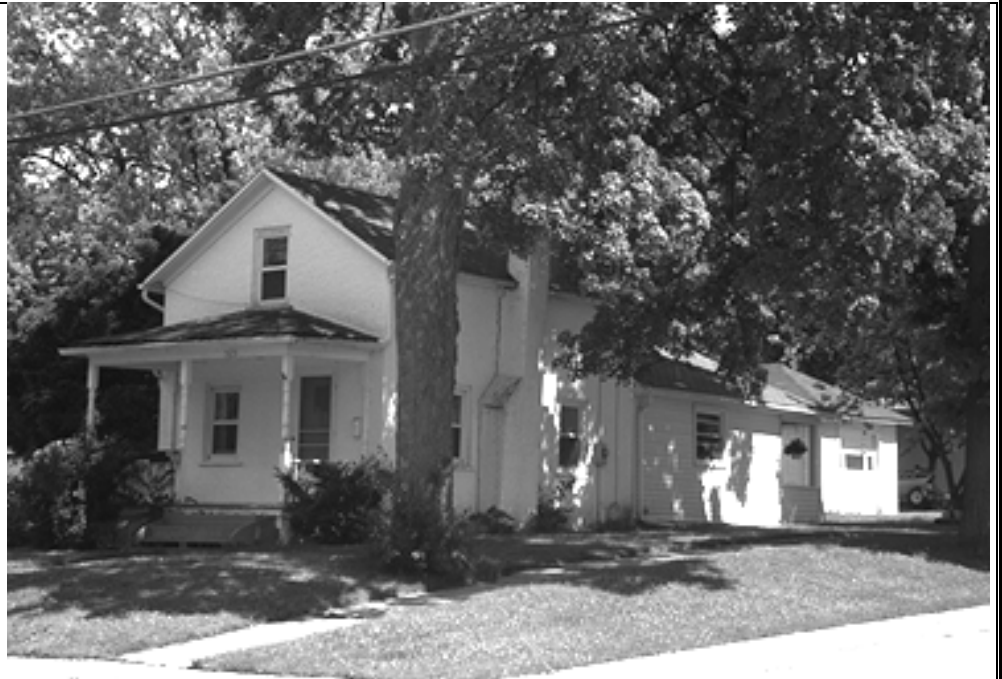
ADDRESS 523 State Street

Architectural Style/Type: <u>Folk Victorian</u>	Exterior Walls (Current): <u>Brick/Aluminum</u>
Architectural Features: _____	Exterior Walls (Original): <u>Brick</u>
Date of Construction: <u>1910</u>	Foundation: <u>Parged masonry</u>
Source: <u>Township Assessor's Office</u>	Roof Type/Material: <u>Front gable/Asphalt shingle</u>
Overall Plan Configuration: <u>Simple/rectangle</u>	Window Material/Type: <u>Alum/Double hung</u>

ARCHITECTURAL FEATURES: The front porch runs the full width and its roof is supported by turned columns. It is simply detailed overall lacking the fine detailing commonly associated with the style.

ALTERATIONS: The additions to the rear are sided with aluminum. It appears that there have been 2 additions.

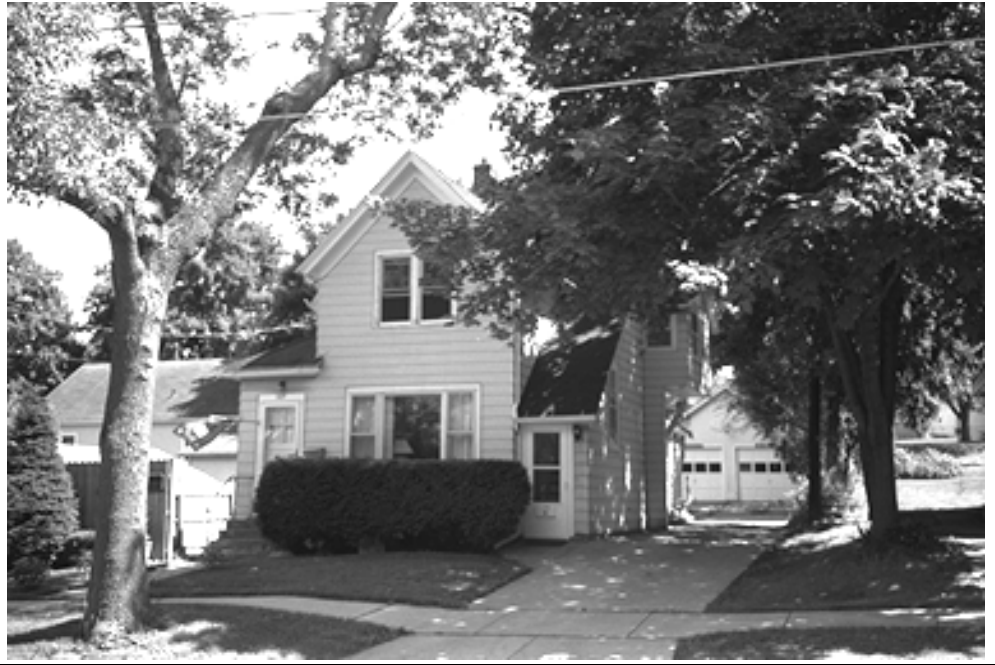
ADDRESS 609 State Street

Architectural Style/Type: <u>National</u>	Exterior Walls (Current): <u>Aluminum</u>
Architectural Features: _____	Exterior Walls (Original): <u>Clapboard</u>
Date of Construction: <u>1915</u>	Foundation: <u>Parged masonry/concrete</u>
Source: <u>Township Assessor's Office</u>	Roof Type/Material: <u>Cross gable/Asphalt shingle</u>
Overall Plan Configuration: <u>Compound/mass</u>	Window Material/Type: <u>Aluminum/Double hung</u>

ARCHITECTURAL FEATURES: The original house has been transformed through additions and modifications that make it difficult to see what the original style really was. The front gable end dominates the street elevation. A pair of double hung windows is all that remains of the original design elements apparent from the street.

ALTERATIONS: A 2 story addition to the west side sits on a concrete foundation. A 1 story addition to the south side is somewhat sympathetic with the massing of the original house. A large picture window was installed at the ground floor front elevation replacing the original windows/door.

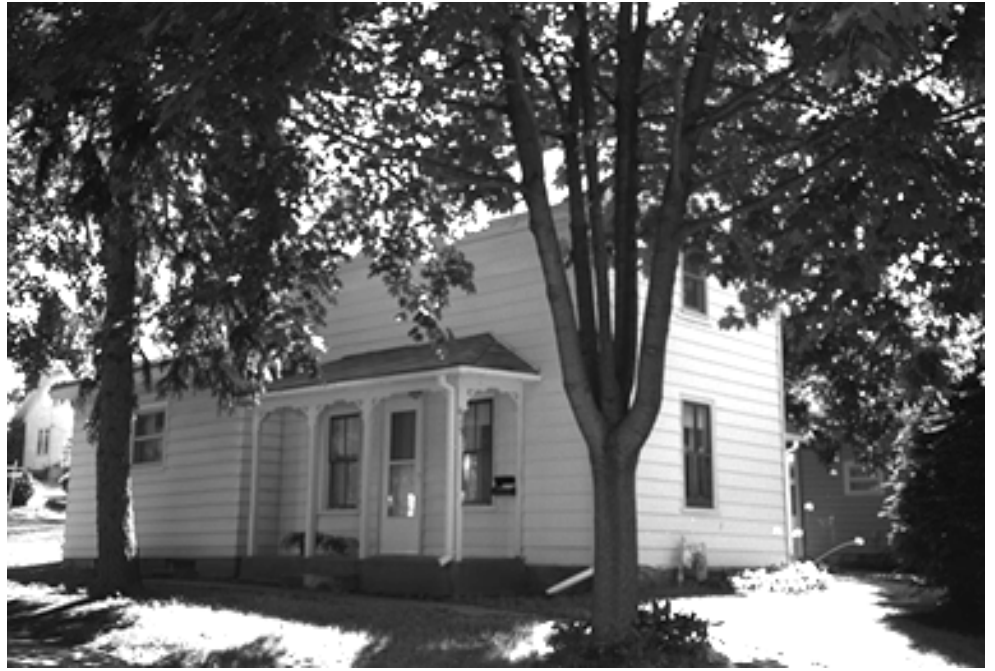
ADDRESS 615 State Street

Architectural Style/Type: <u>Folk Victorian</u>	Exterior Walls (Current): <u>Aluminum</u>
Architectural Features: _____	Exterior Walls (Original): <u>Clapboard</u>
Date of Construction: <u>1910</u>	Foundation: <u>Parged masonry</u>
Source: <u>Township Assessor's Office</u>	Roof Type/Material: <u>Front gable/Asphalt shingle</u>
Overall Plan Configuration: <u>Simple rectangle</u>	Window Material/Type: <u>Wood/Alum/double hung</u>

ARCHITECTURAL FEATURES: The side porch and entrance features some ornate wood detailing and brackets. Relates well in scale and proportion to the neighborhood buildings of the same era.

ALTERATIONS: Aluminum siding on the main part of the house was installed at the same time that a 1 story addition was made to the south side. The addition has a flat roof and window sizes that are not in keeping with the original. A one story addition to the west side that has a gabled roof is more in style with the original. All of the house is covered with aluminum – soffits, fascia, and siding.

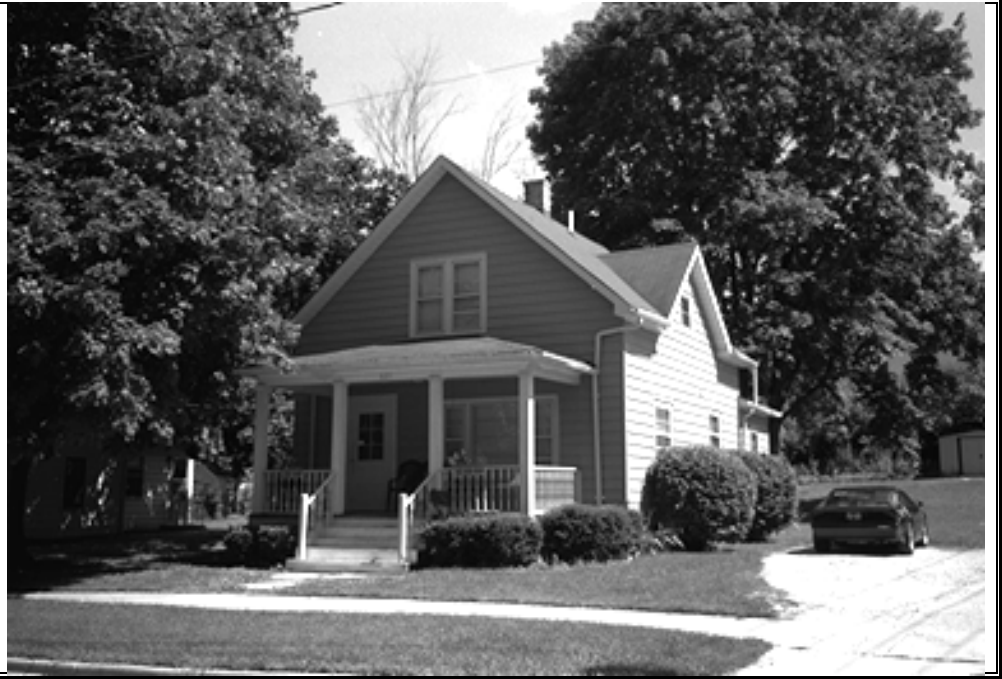
ADDRESS 621 State Street

Architectural Style/Type: <u>National</u>	Exterior Walls (Current): <u>Aluminum</u>
Architectural Features: _____	Exterior Walls (Original): <u>Clapboard</u>
Date of Construction: <u>1910</u>	Foundation: <u>Parged masonry</u>
Source: <u>Township Assessor's Office</u>	Roof Type/Material: <u>Cross gable/Asphalt shingle</u>
Overall Plan Configuration: <u>Simple – orig.</u>	Window Material/Type: <u>Aluminum/Double hung</u>

ARCHITECTURAL FEATURES: Square columns support the front porch's hipped roof while the porch rail is supported by turned balusters. The ceiling of the porch is bead board.

ALTERATIONS: This house has been aluminized. The front porch has been recently remodeled in keeping with the style of the house. A one story addition to the south side has a hipped roof and therefore is not in keeping with the original style.
