ST. CHARLES HISTORIC PRESERVATION COMMISSION

ARCHITECTURAL SURVEY
ST. CHARLES CENTRAL DISTRICT
ST. CHARLES, ILLINOIS

DIXON ASSOCIATES / ARCHITECTS

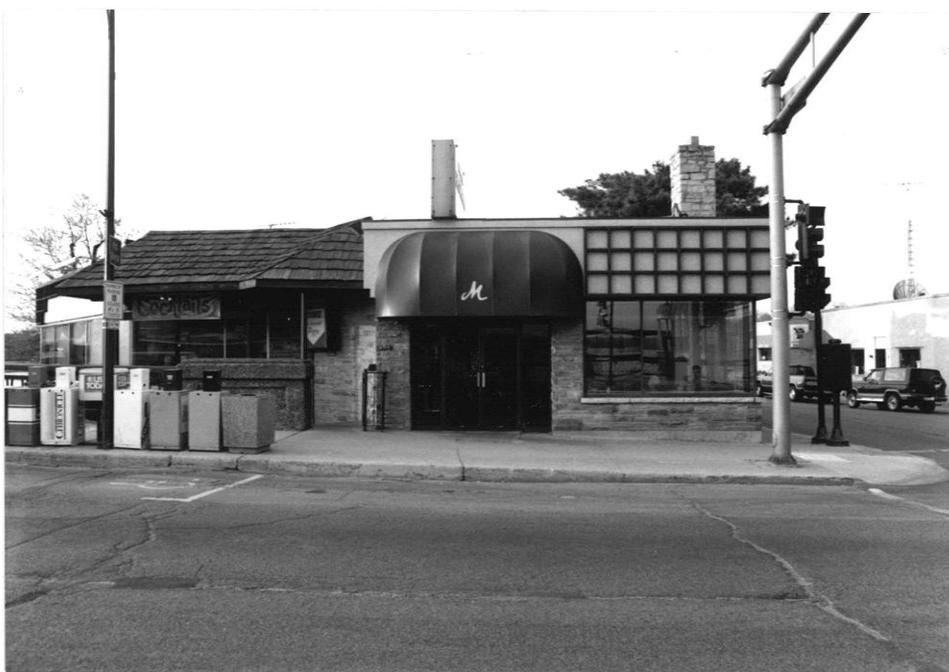
1 West Main Street

Style: Vernacular Commercial

Date of Construction: 1830 (original)

Original log structure totally hidden by later additions. Mix of stone veneer with various upper facade modifications including cement plaster with wood lattice and wood shakes.

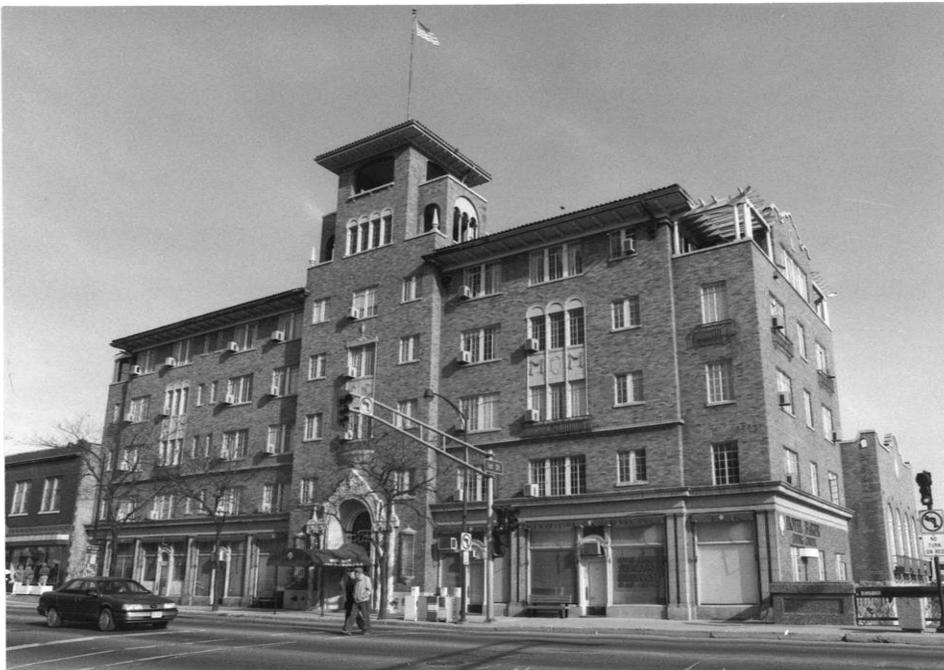
100 West Main Street

Style: Romantic Revival

Date of Construction: 1926-8

Moorish/Spanish Romantic Revival building in brick with beige terra cotta ornamentation. Five stories high plus a square tower projected at the elaborately detailed center entrance. Paired, engaged terra cotta columns flank entrance door. Colored glass "peacock" above the door. Red clay tile roof projects beyond the facade.

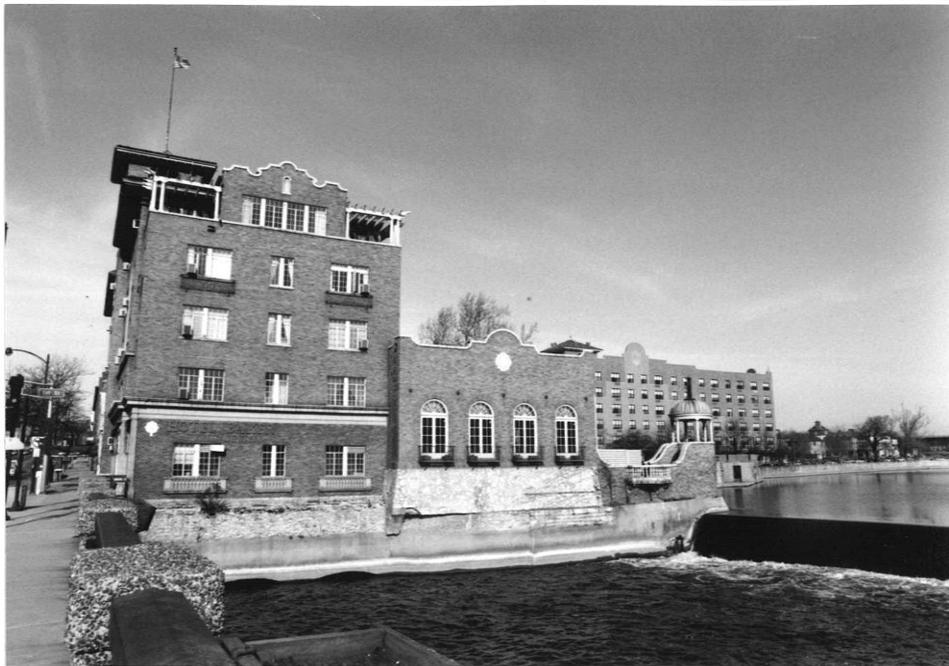
100 West Main Street

East, riverside view showing five story building, Trophy Room exterior and gazebo.

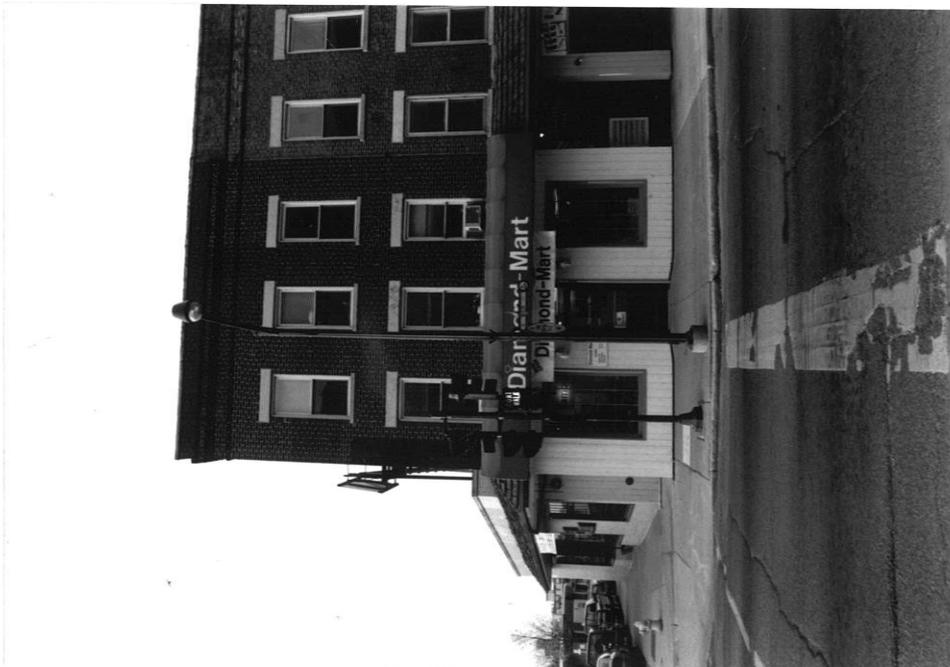
103 West Main Street

Style: Commercial Vernacular

Date of Construction: 1880's

Three story brick building with stone lintels at one over one double hung windows at second and third floors. Simple, unadorned parapet. Plywood cladding and plastic awning at first floor.

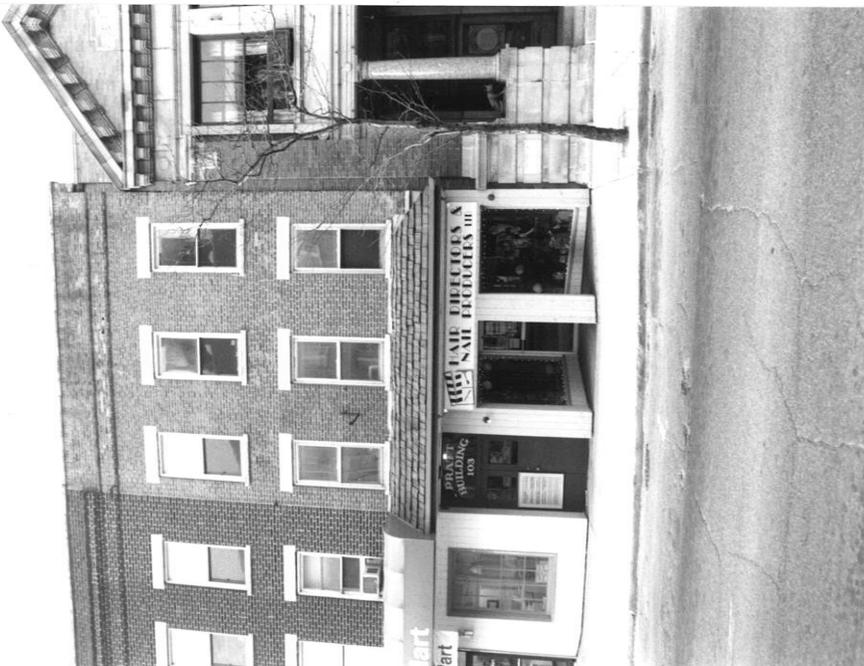
105 West Main Street

Style: Commercial Vernacular

Date of Construction: 1880's

Three story brick building with stone lintels at one over one double hung windows at second and third floors. Simple, unadorned parapet. Added wood shingle mansard roof and plywood cladding at first floor.

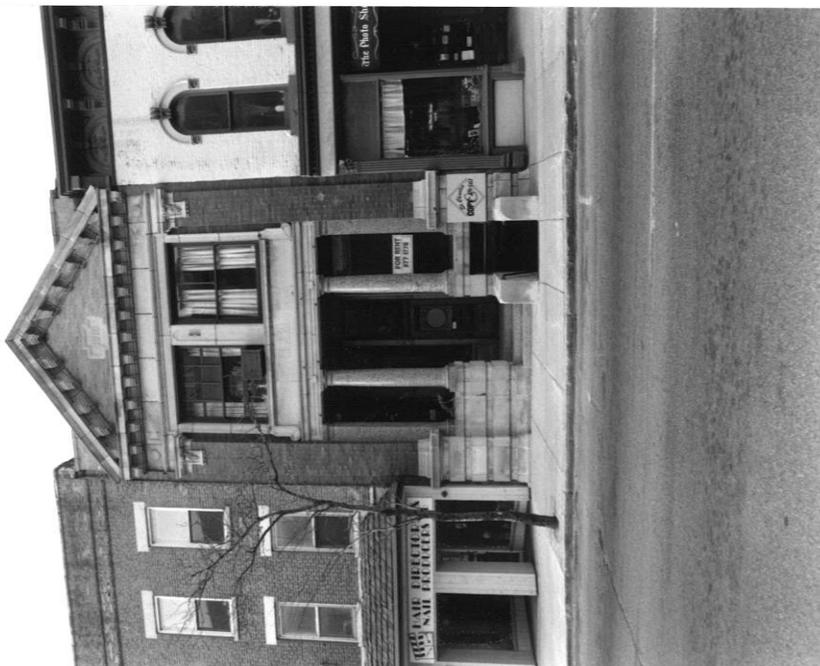
107 West Main Street

Style: Classical Revival

Date of Construction: 1916

Original bank building (St. Charles National Bank) with glazed brick and stone facade. Gable end to front with two round columns flanking deeply recessed central entrance. Two large four over one double hung windows at second floor. Classical ornaments in stone. Deep joints in rusticated stone at base.

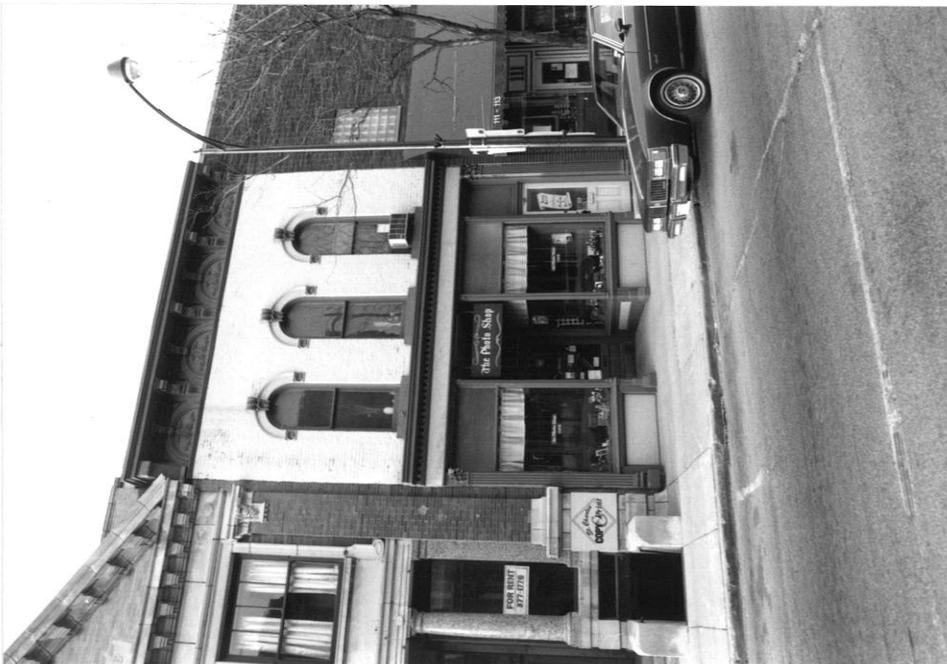
109 West Main Street

Style: Italianate

Date of Construction: 1880's

Two story masonry structure with cast iron storefront
 Metal cornice at first floor level and elaborate, bracketted
 cornice at roof. Arch top second floor windows have
 elaborate stone lintels.

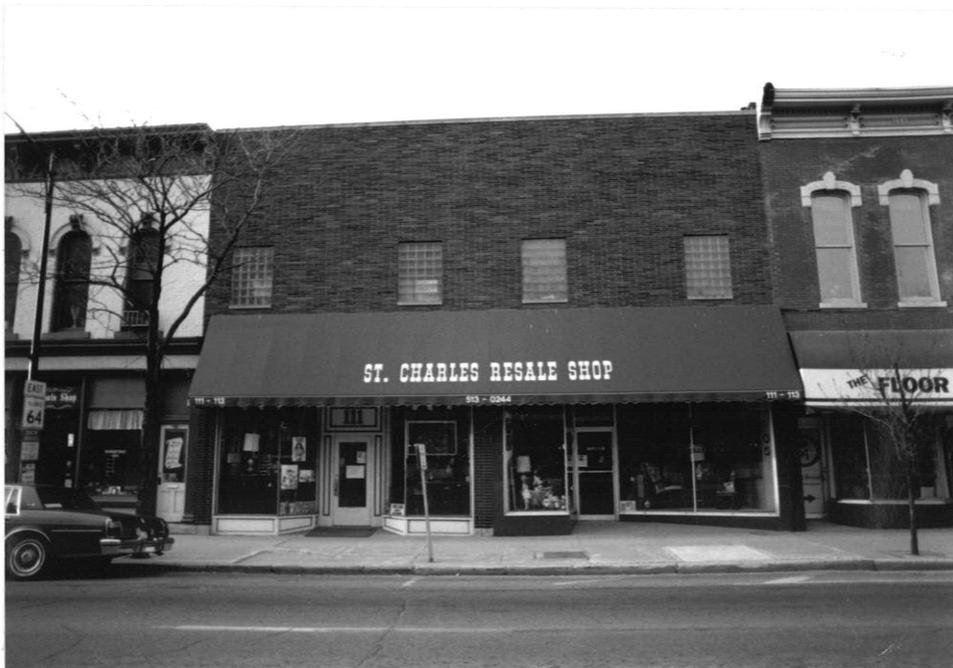
111/113 West Main Street

Style: Substantially Altered

Extensively remodelled second story with brick and glass block windows.

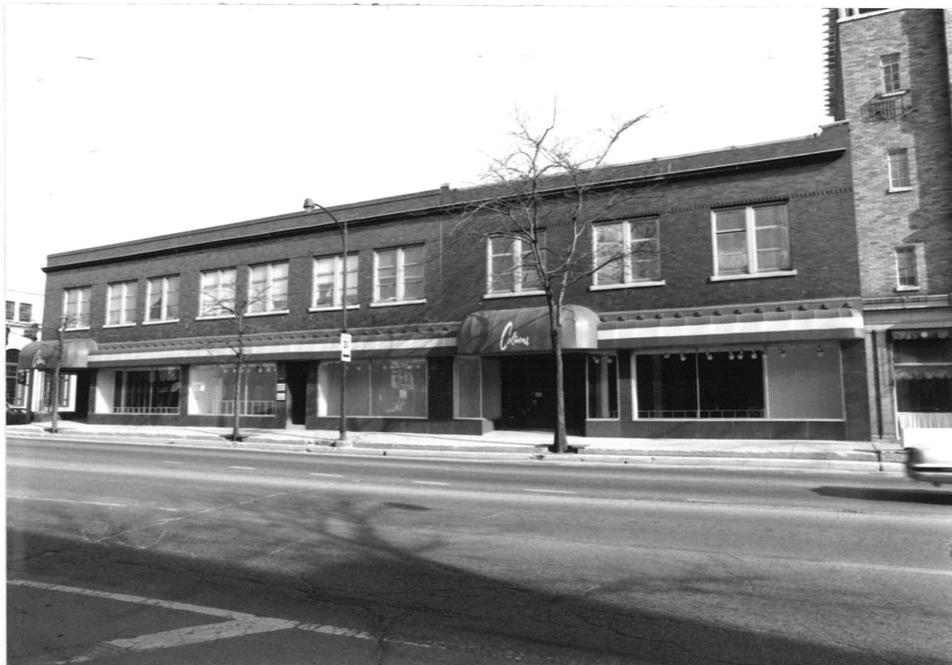
116 West Main Street

Style: Commercial Vernacular

Original Colson store established at this site in 1880. A major fire occurred in 1975, followed by a major reconstruction.

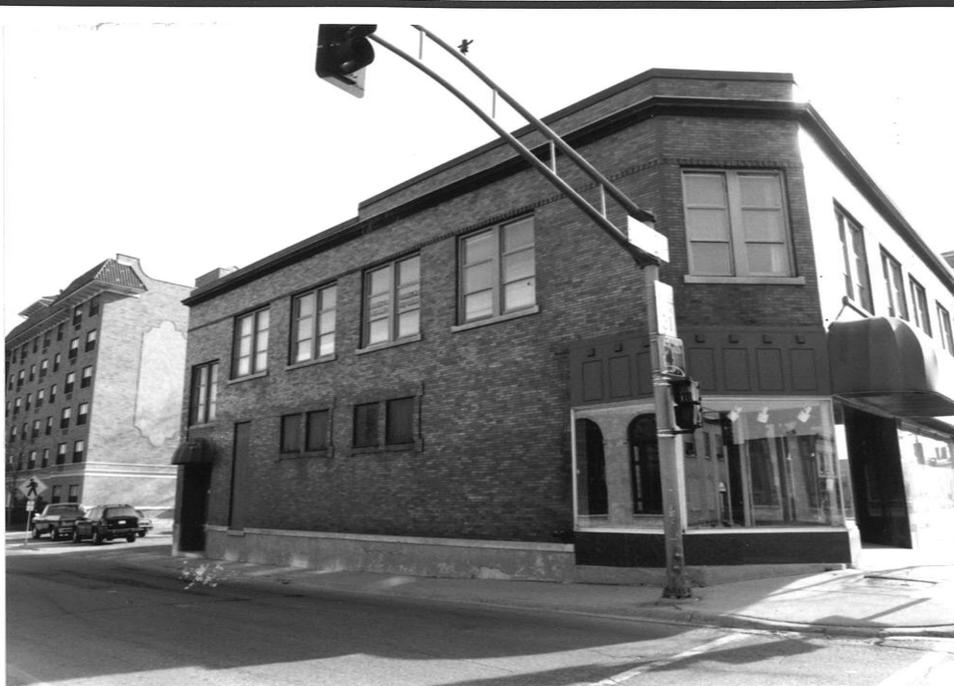
CONTINUATION SHEET NO: 1

Two story brick front structure with tall second floor windows on Main Street elevation. Four over four windows. Center stone window lintel replaced with synthetic material to match stone. Elaborate metal cornice.

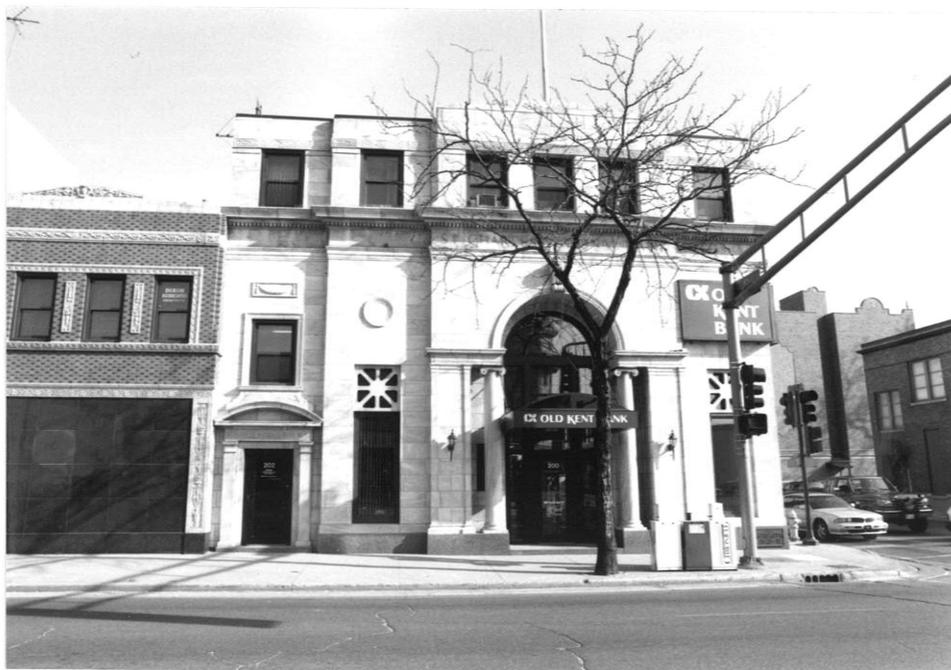
200 West Main Street

Erected by Col. Edward Baker as the St. Charles National Bank. Windows changed to aluminum from steel in late 1980's. Major interior remodeling added a second floor which was later removed in the late 1980's. Marble exterior with Ionic columns flanking arched entry on south facade.

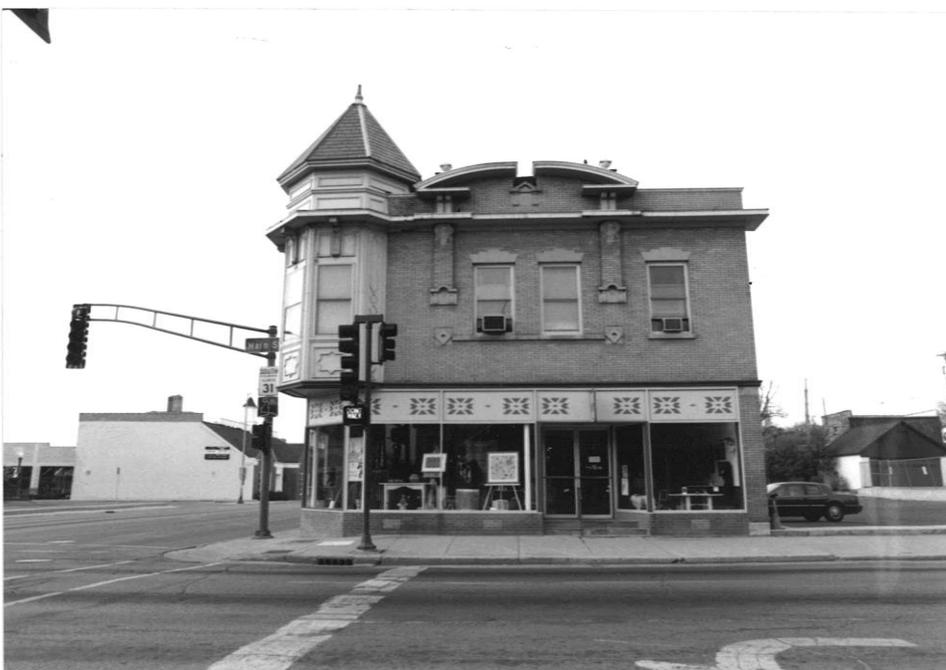
203 West Main Street

Two story brick structure with stone accents.
 Predominant turret with conical roof at northeast corner.

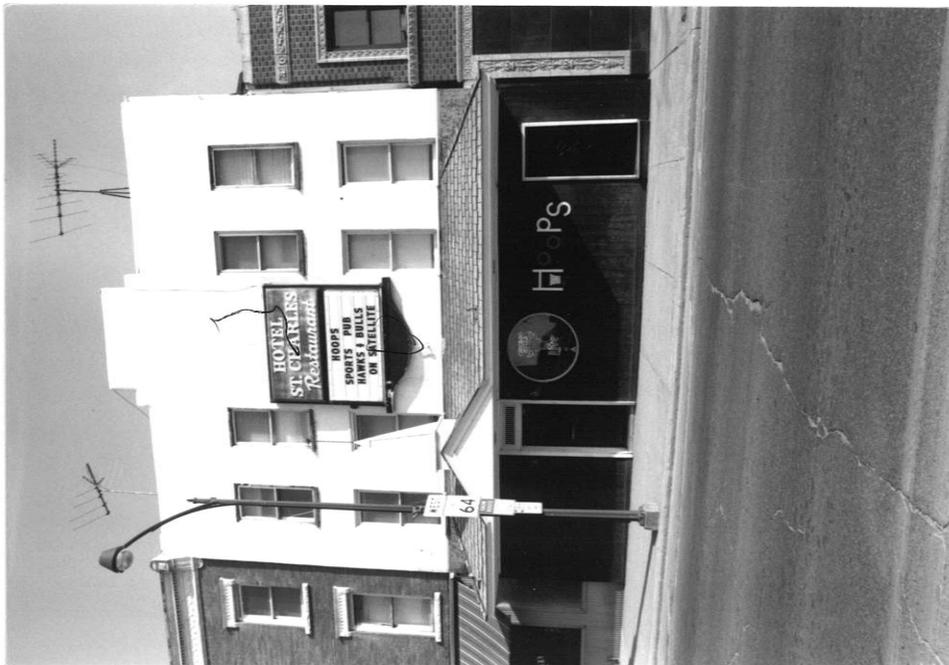
204/206 West Main Street

Greatly modified exterior with cement plaster at two upper stories, plywood at first floor. Part of White Front Hotel to the west, now called the Hotel St. Charles. Two level balcony with front facing gable removed.

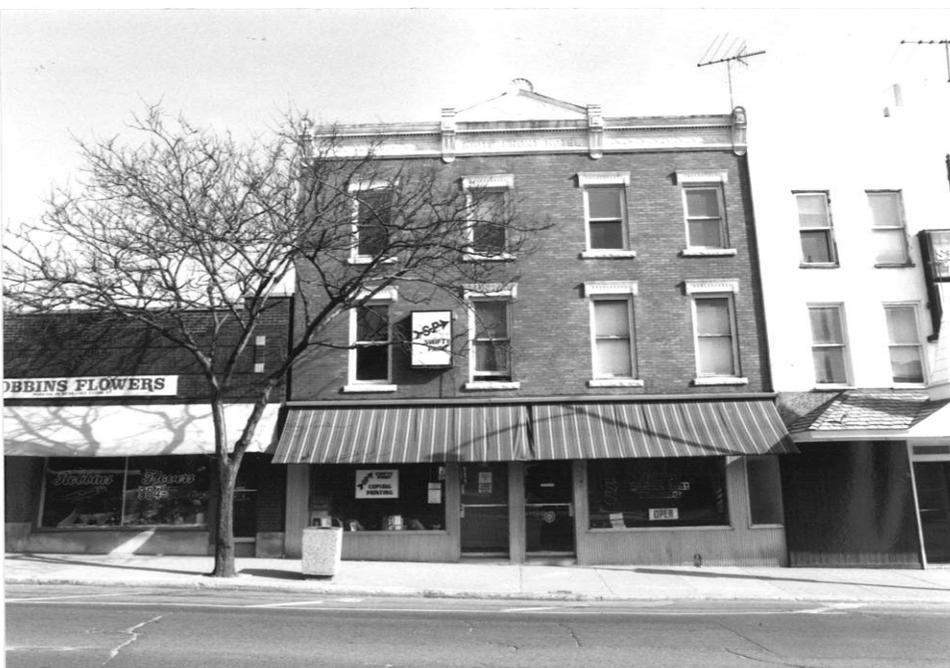
208/210 West Main Street

Elaborate metal cornice and window heads on three story building. First floor clad with aluminum. Extension of the White Front Hotel to the east. Cornice is crowned with a projecting gable and adorned with brackets and inscription.

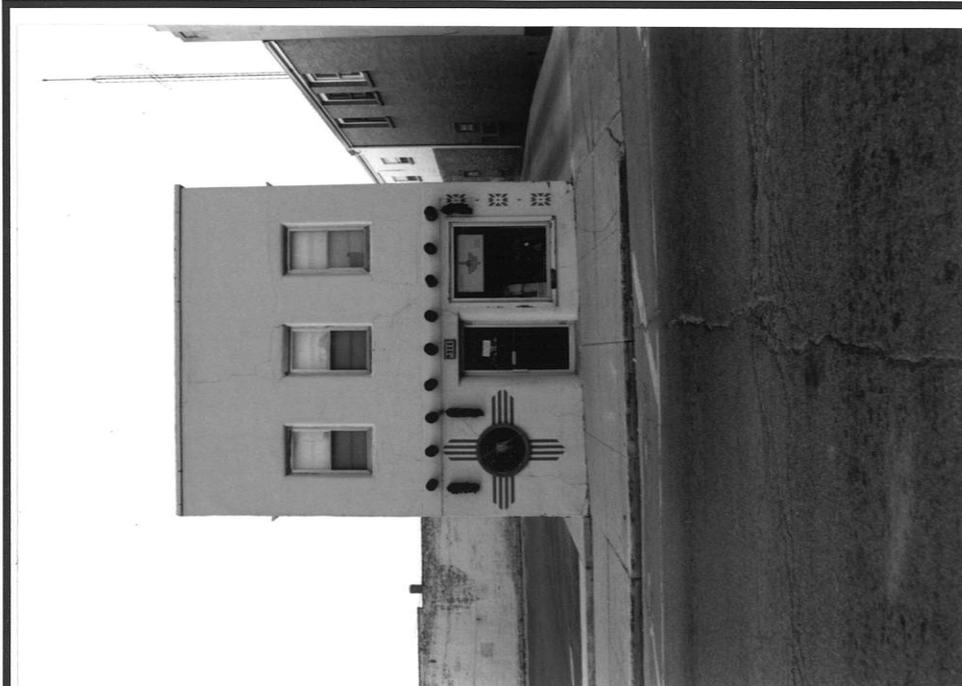
211 West Main Street

Greatly modified two story structure. Cement plaster finish with false log beam projections for appearance as "Southwest" store. Curved walls at entry door and round window at first floor.

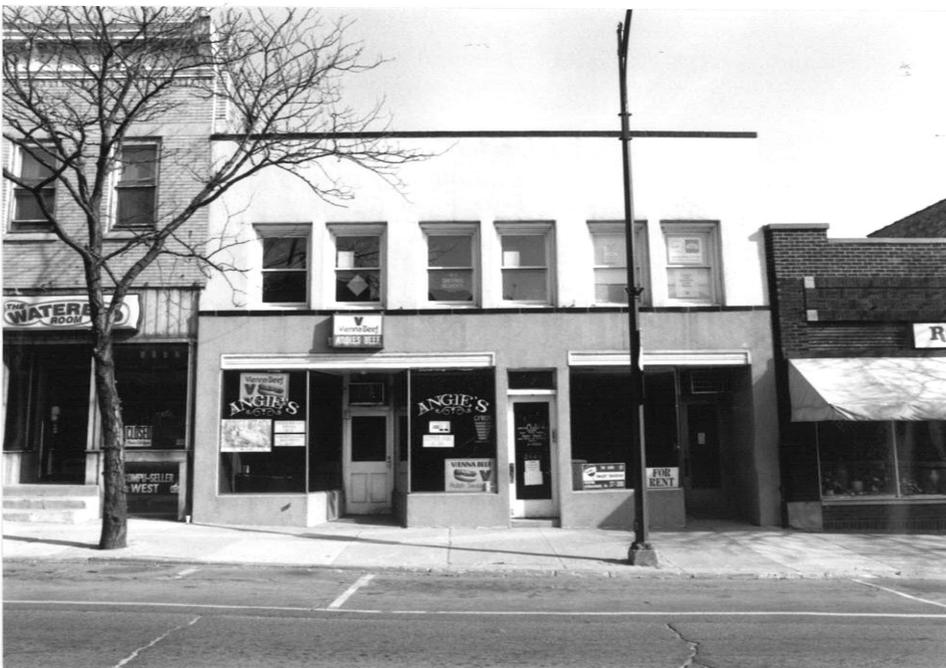
214/216 West Main Street

Two story structure with cement plaster finish added in 1980's.

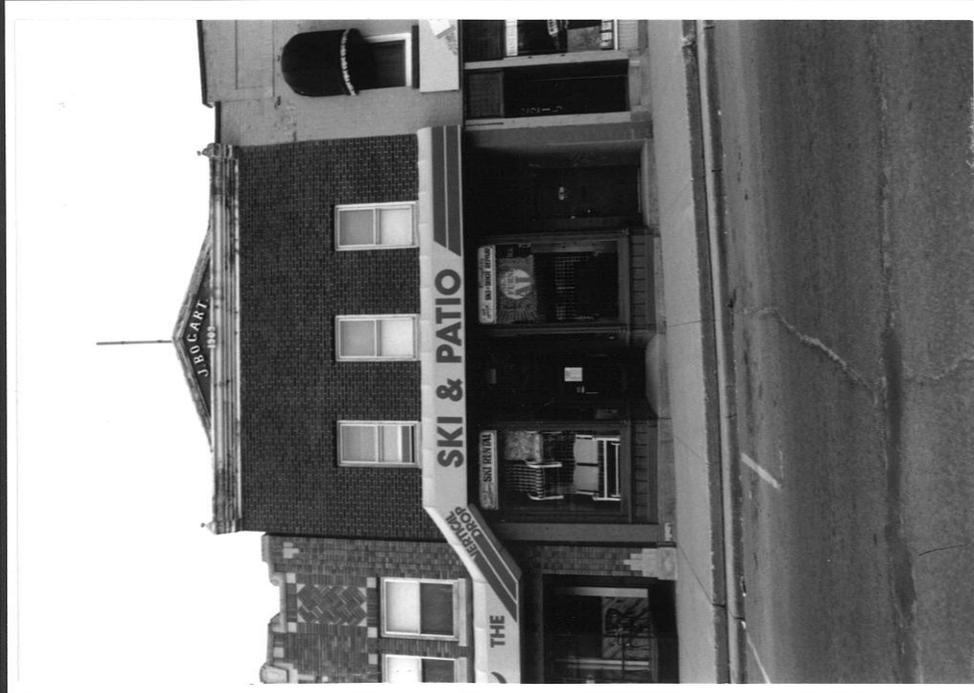
219-219 1/2 W. Main Street

Cast iron storefront extant. Upper level of this two story structure has simple brick facade, unadorned windows. Cornice is metal with small gable. Lettering indicates "J. BOGART" and "1909".

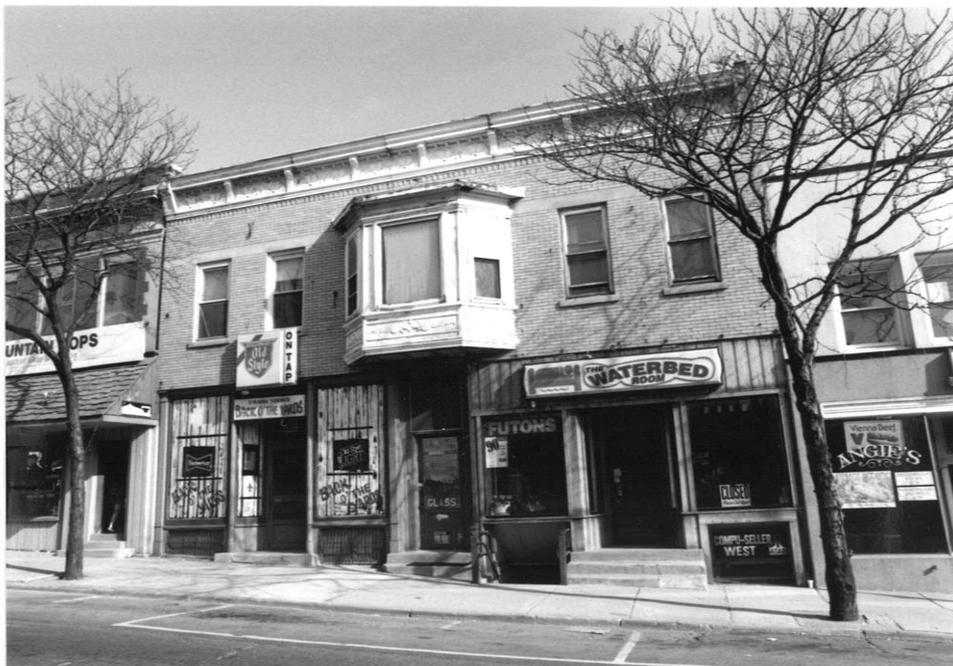
220/222 West Main Street

Two story brick structure with metal cornice and projecting bay window at second floor. Stoneband above second floor windows. Cast iron storefront remains at west store, covered over at east store.

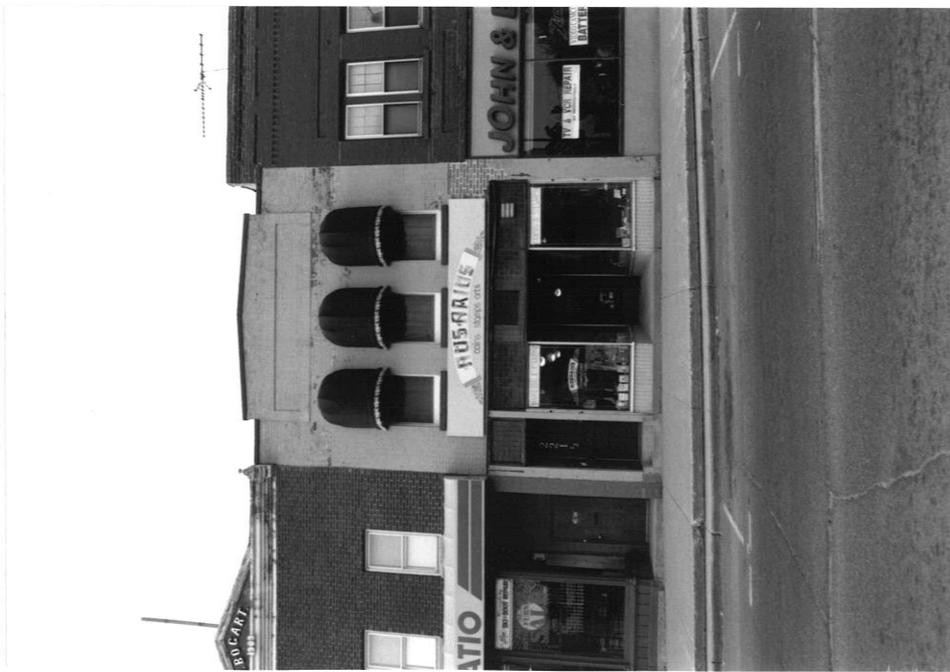
221-221 1/2 W. Main Street

Two story masonry structure with painted brick front.
 Recessed brick panel at parapet. Recessed entry doors.

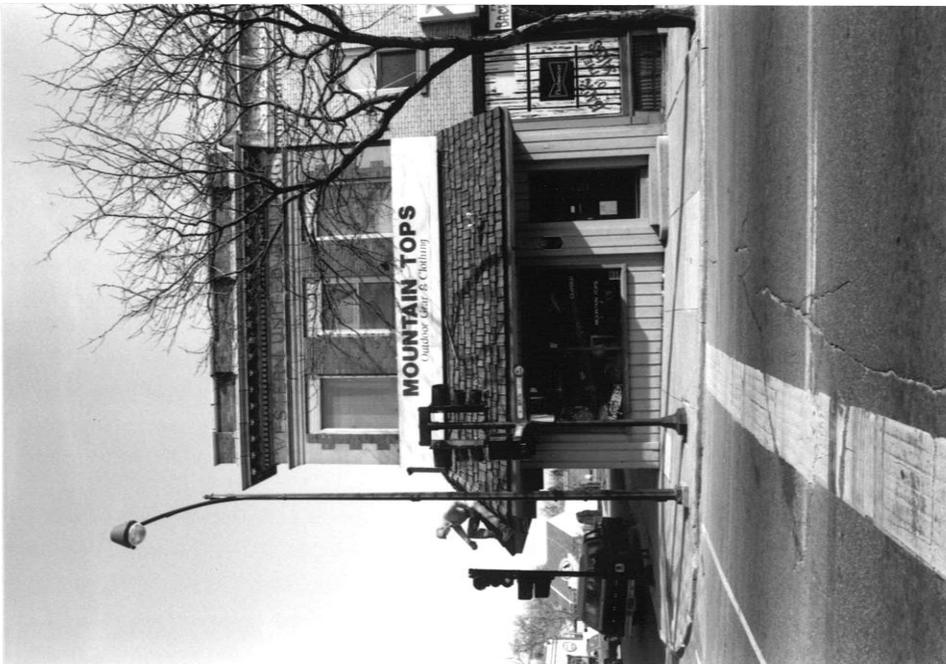
228 West Main Street

Finely detailed stone cornice with brick parapet. Stone quoins at corners of south upper facade with "Western United Building" inscription. Storefront facade greatly modified with wood shake projecting roof and board and batten siding.

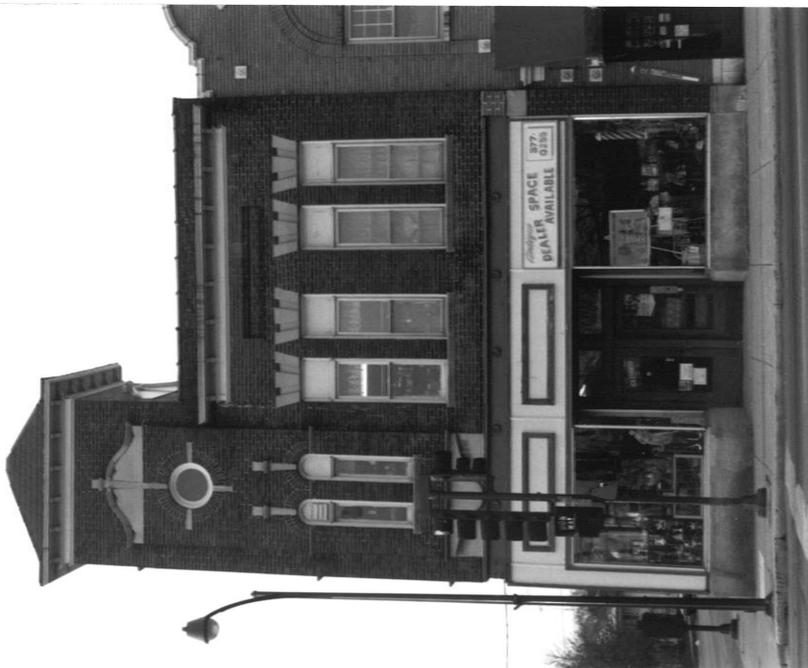
301 West Main Street

Style: Italian Renaissance
Date of Construction: ca. 1900
Source: A Field Guide to American Houses
Features:
Masonry building, brick with significant stone accents above windows. Circle windows, two sides of corner square tower. Tall, narrow windows at second floor. First floor windows at east side with full semi-circle arches.

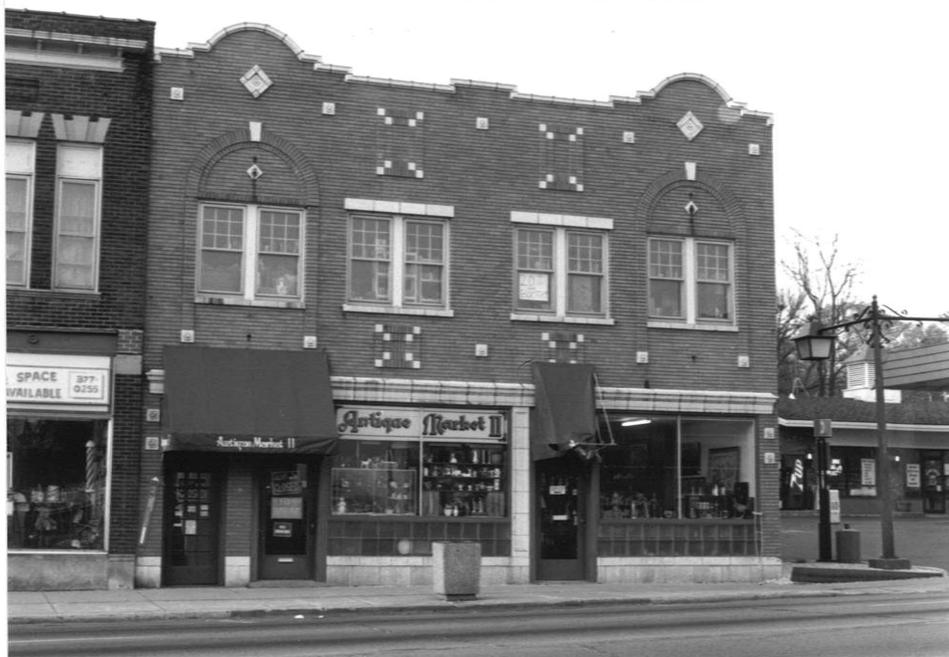
303 West Main Street

Beige terra cotta accents in tan brick facade. Paired double hung windows in upper level with 9 over 1 lites. Decorative terra cotta capped parapet with two curved top sections. Lower facade storefronts trimmed in terra cotta.

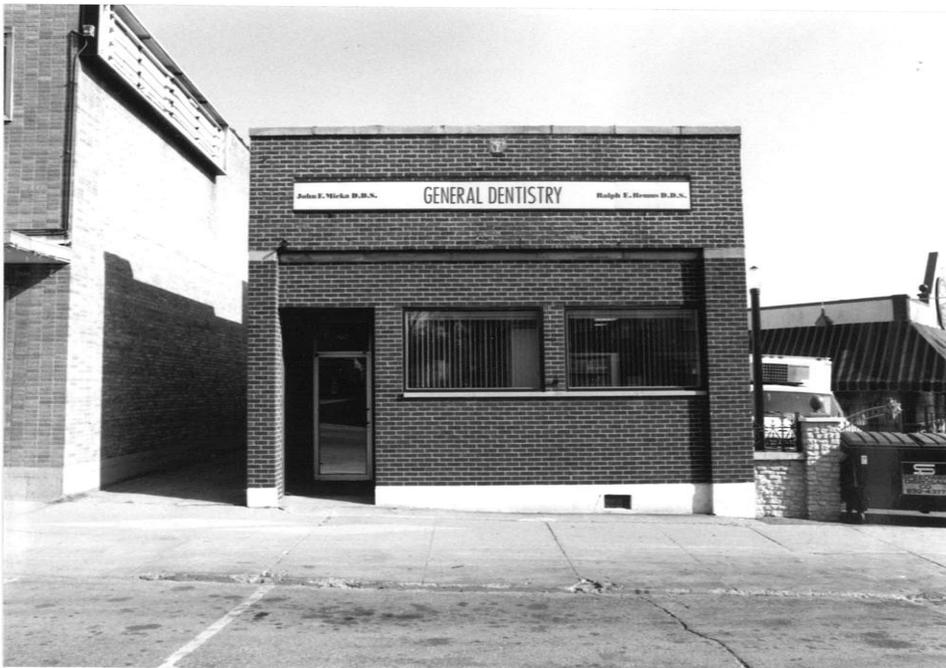
306 West Main Street

Brick facade on one story structure with stone parapet cap. Recessed entry with two high front picture windows. Recessed panel in brick at upper facade.

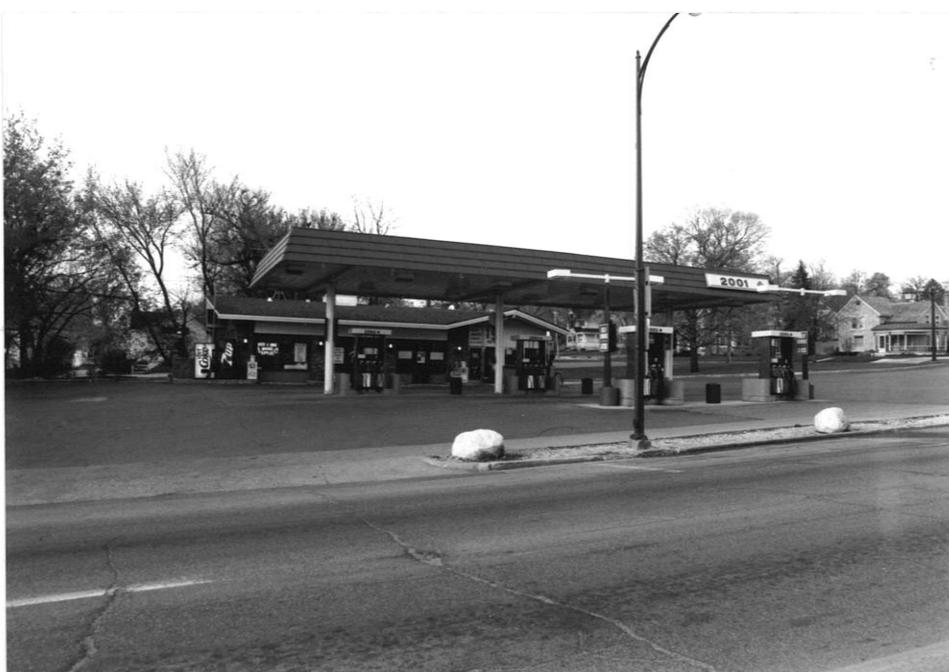
307 West Main Street

Low gabled ranch style building. Mansard canopy over gas pumps added in late 1980's.

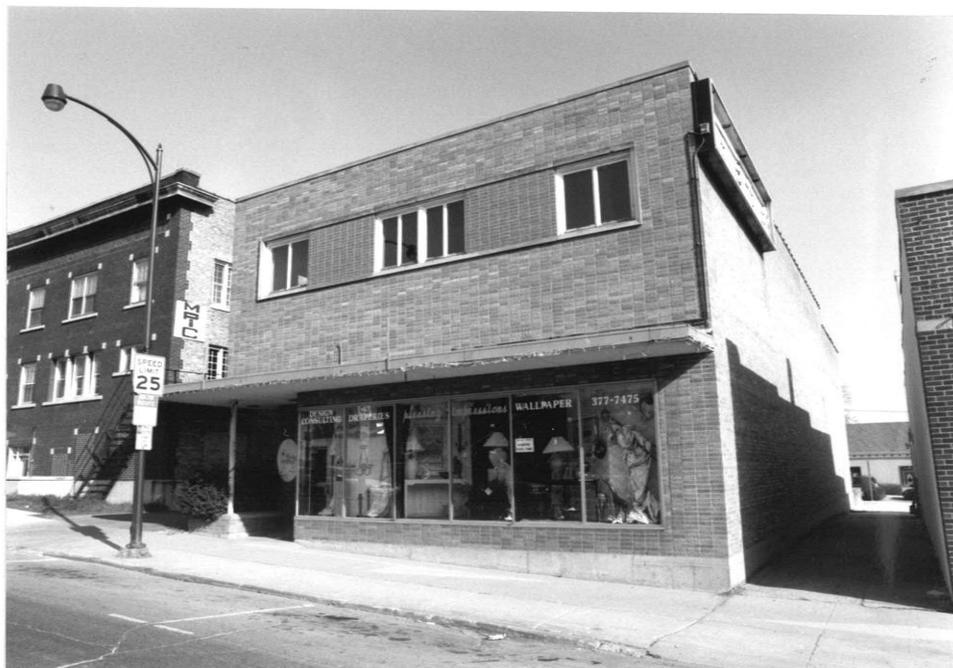
312 West Main Street

Stacked bond brick front, projecting canopy over large plate glass windows, entire width at first level. Second level windows are casement type set in stone surround.

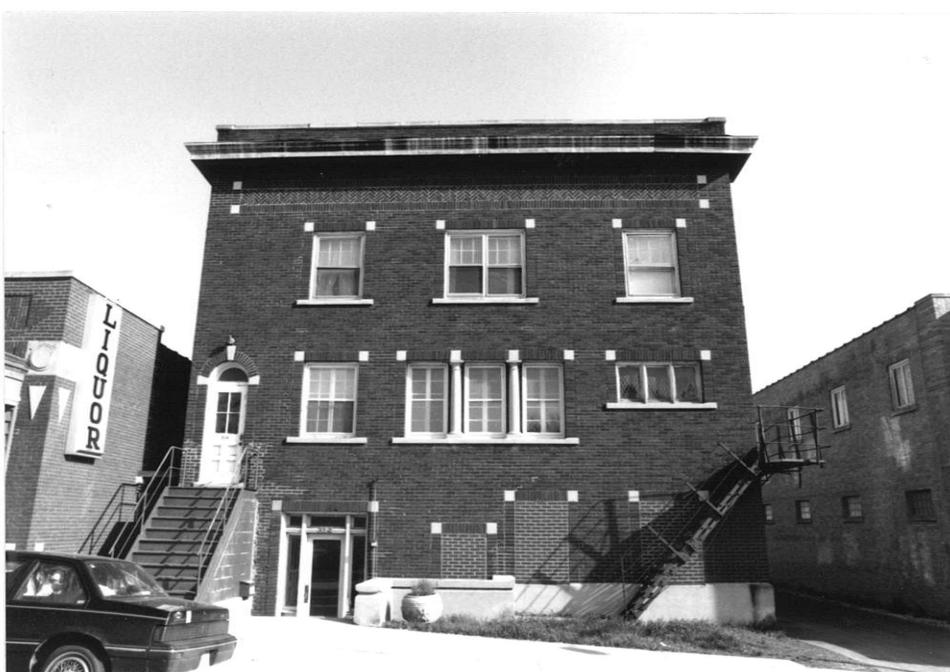
314/316 West Main Street

Built as the Lambert Convalescing Home, became a hospital in 1930. Brick masonry with square limestone accents. Herringbone brick pattern at upper facade panel. Parapet capped with stone. Projecting soffit at roof line. Lower level entry with transom and sidelights. Second level entry with circle top transom.

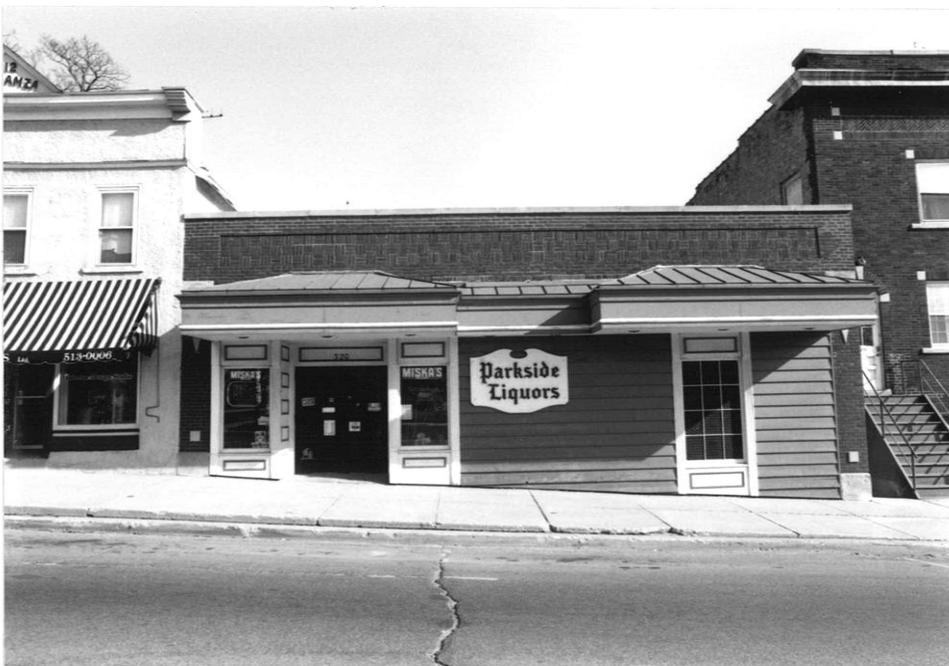
320 West Main Street

Masonry one story structure with stone parapet cap. Recessed panel in upper facade has herringbone brick pattern. Standing seam metal roof canopy over lower facade. Wood sided lower storefront added later. Decorative stone accents at corners.

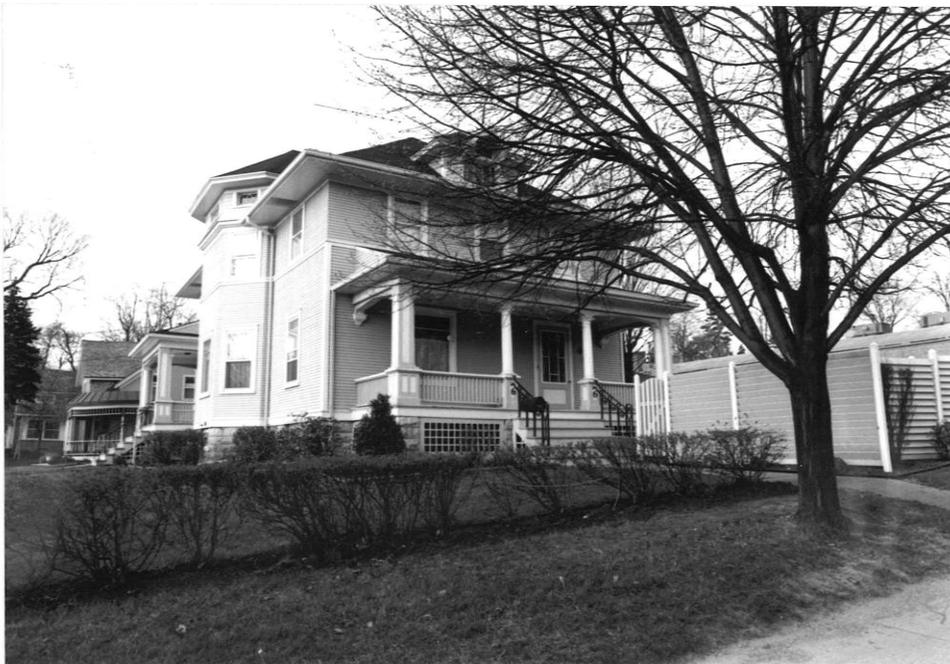
405 West Main Street

Full width front porch. Hip roof with Palladian dormer to north, bay to east. Clapboard siding. Stone or rock face block foundation.

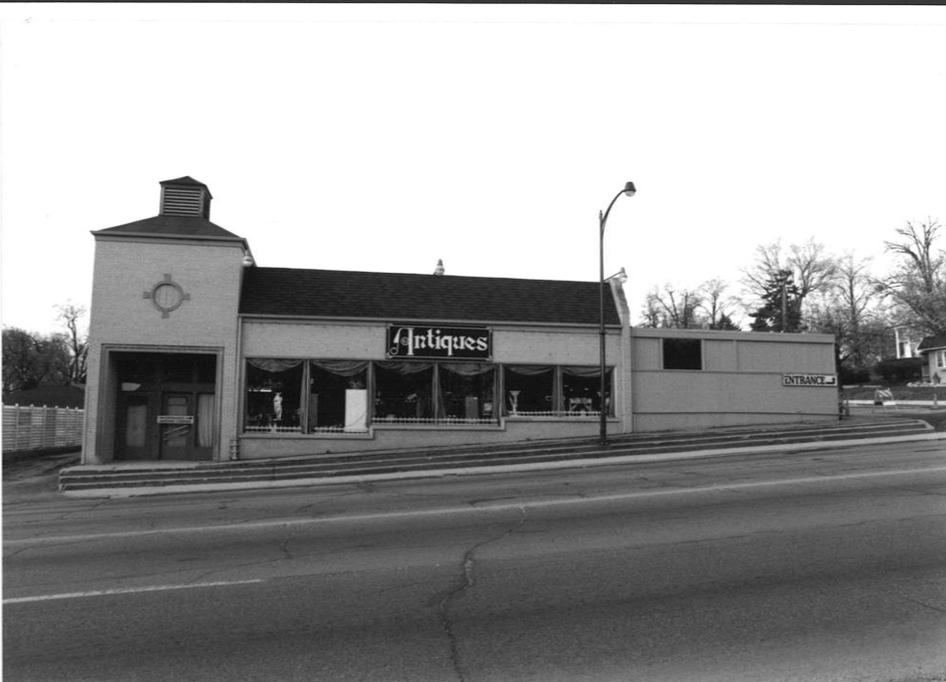
413 West Main Street

Former Atlantic and Pacific Tea Company store, now an antique store. Full round louver with four keystones in square tower at northeast corner. Tower has louvered cupola at top. Stone surround in recessed entry in tower. Tan brick building.

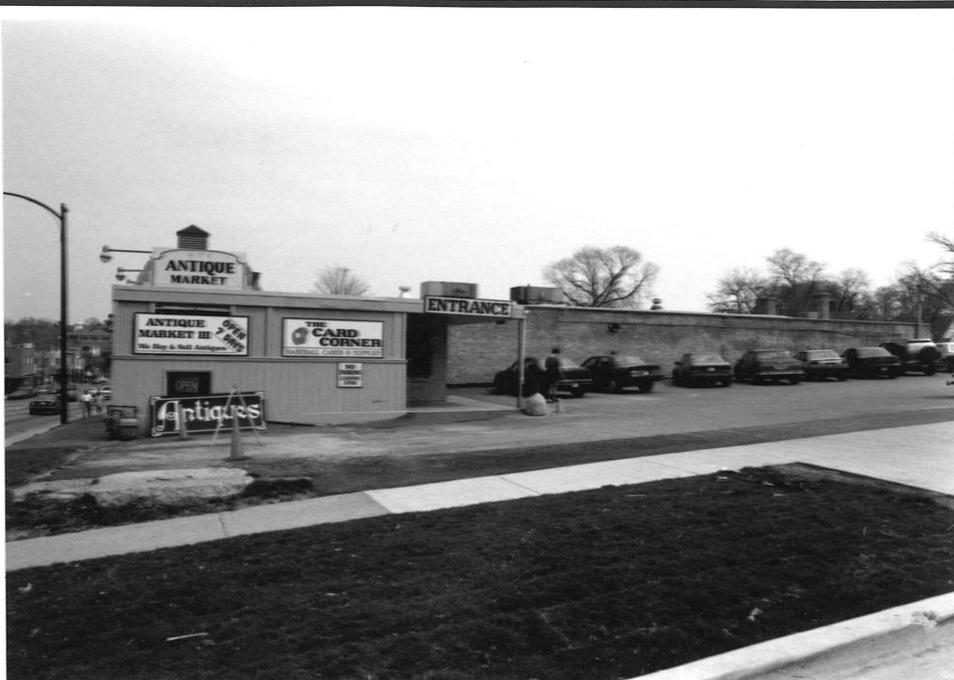
Address:
413 West Main Street

Remarks:
West Elevation
