ST. CHARLES HISTORIC PRESERVATION COMMISSION

ARCHITECTURAL SURVEY
 MILLINGTON HISTORIC DISTRICT
 ST. CHARLES, ILLINOIS
 Date of Survey: 2003

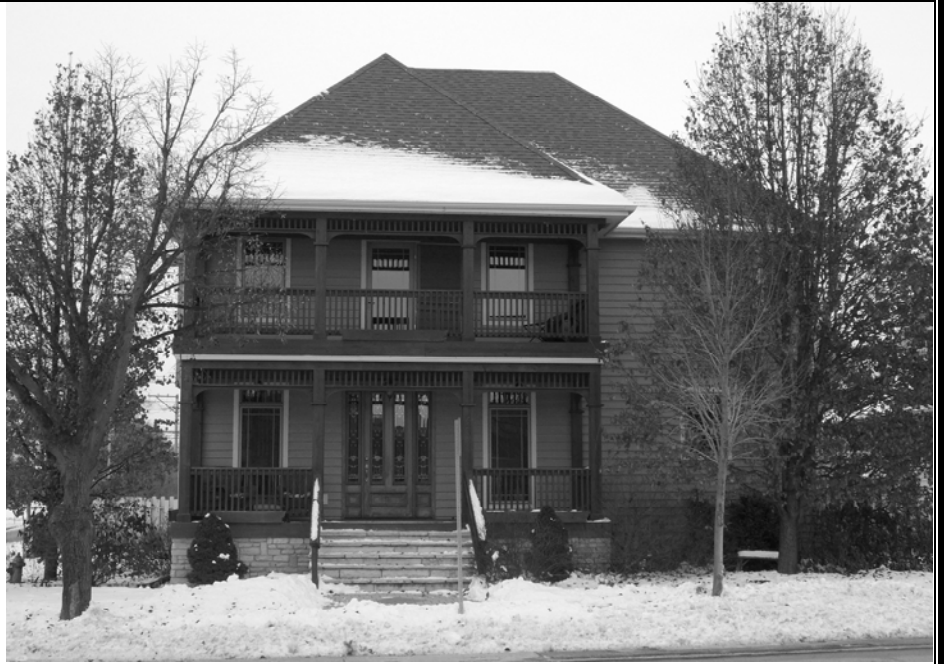
ADDRESS 623 Walnut Street

Architectural Style/Type: <u>Neoclectic</u>	Exterior Walls (Current): _____
Architectural Features: _____	Exterior Walls (Original): <u>Clapboard</u>
Date of Construction: <u>2007</u>	Foundation: <u>Concrete</u>
Source: <u>Township Assessor</u>	Roof Type/Material: <u>Hipped/Asphalt</u>
Overall Plan Configuration: <u>Compound</u>	Window Material/Type: <u>Material unknown/Casement</u>

ARCHITECTURAL FEATURES: Large two-story structure with a steeply pitched, cross-hipped roof and attached, side-loaded garage. The offset two-story front entry porch is the dominant architectural feature.
