ST. CHARLES HISTORIC PRESERVATION COMMISSION

ARCHITECTURAL SURVEY
ST. CHARLES CENTRAL DISTRICT
ST. CHARLES, ILLINOIS

DIXON ASSOCIATES / ARCHITECTS

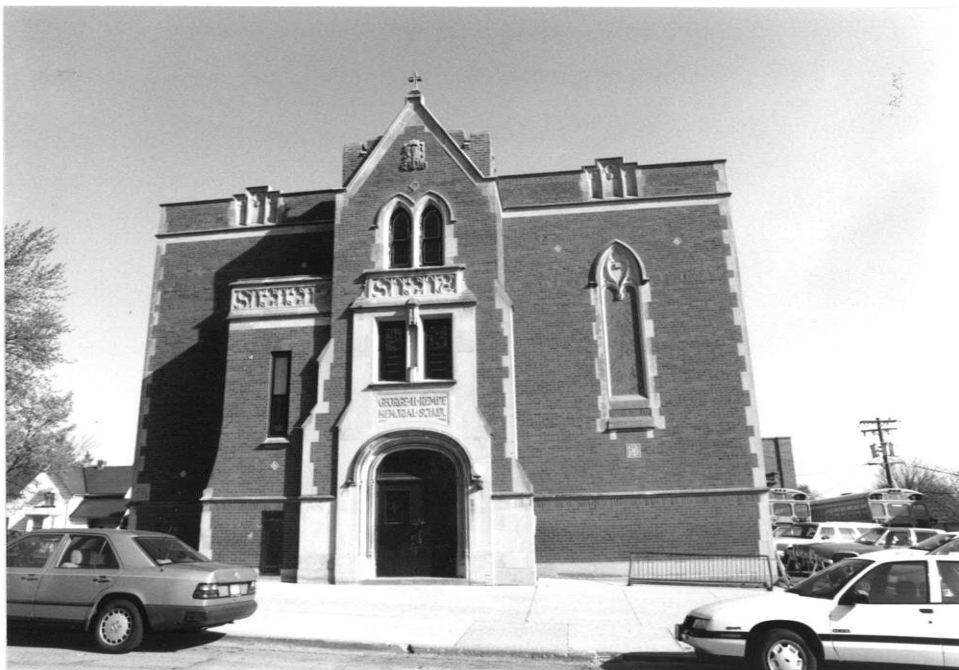
NEGATIVE NO. 23

Style: Gothic Revival

Date of Construction: 1929-30

Main facade at the south features stone trim in brick with Gothic arched windows. Arched entrance in stone projected out from face of building, capped with gable at parapet line. School building dedicated as George H. Rempe Memorial.

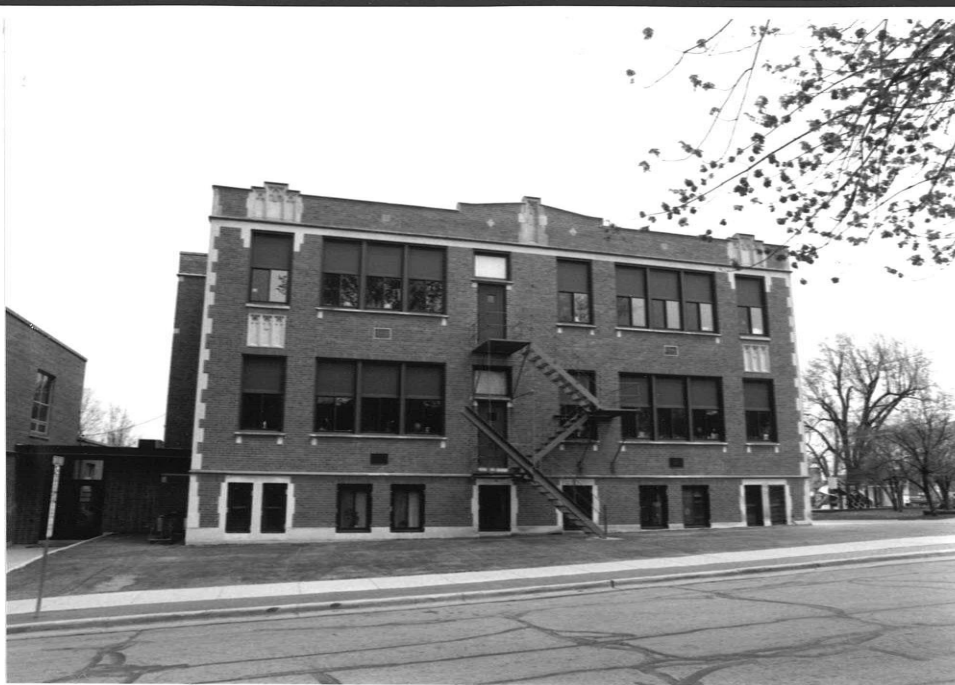
NEGATIVE NO. 34

West Elevation. Stone quoins on brick building. 2 1/2 stories plus decorative parapet with stone accents in brick.

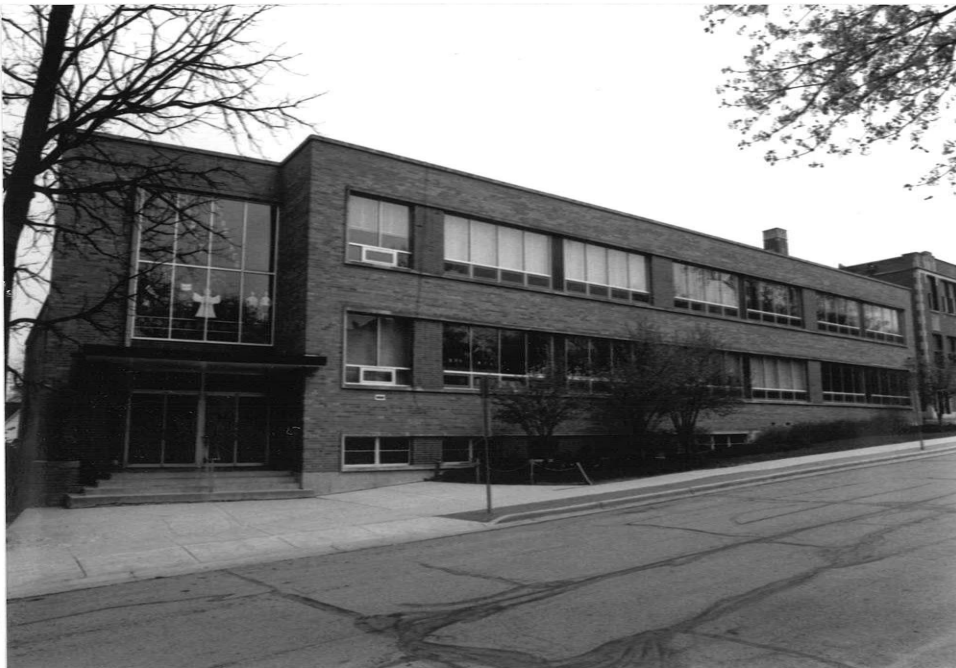
NEGATIVE NO. 33

Style: Modern

Date of Construction: 1958-59

Simple bands of windows on each floor with cut stone frame. Flat roof and simple box forms contribute to typical 1950's school building appearance.

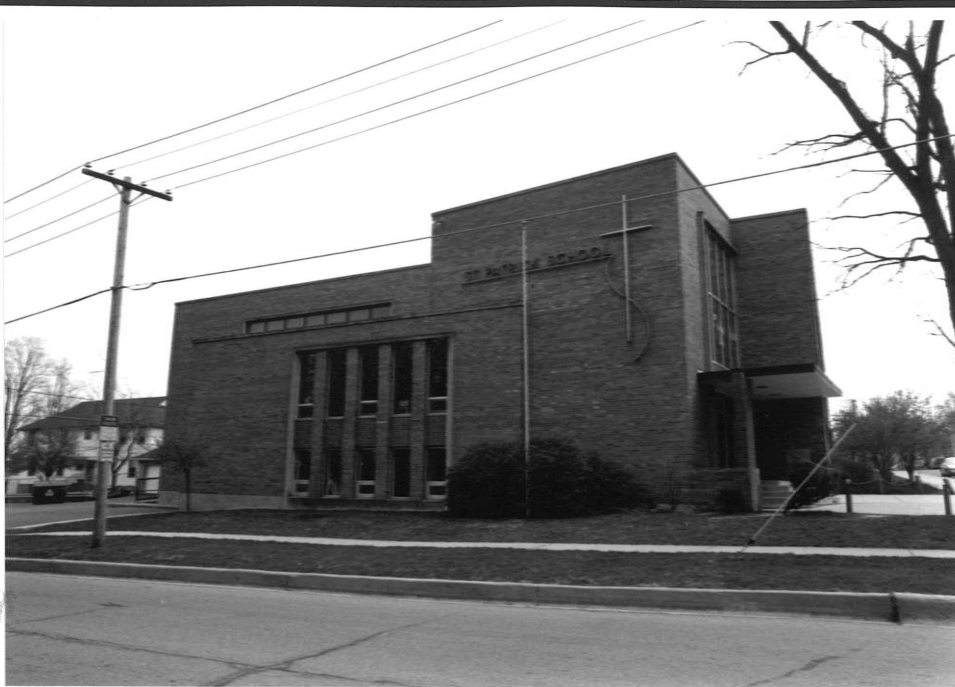
NEGATIVE NO. 32

North side facing State Street

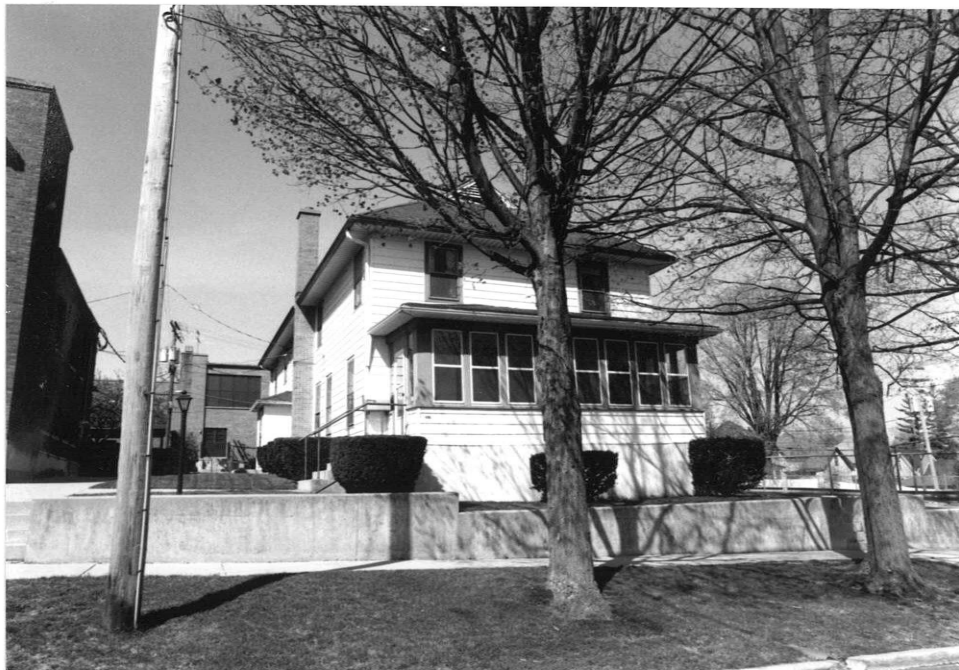
NEGATIVE NO. 36

Style: American Foursquare

Hipped roof, symmetrical with front entry porch across entire east side. Enclosed porch, double hung windows.

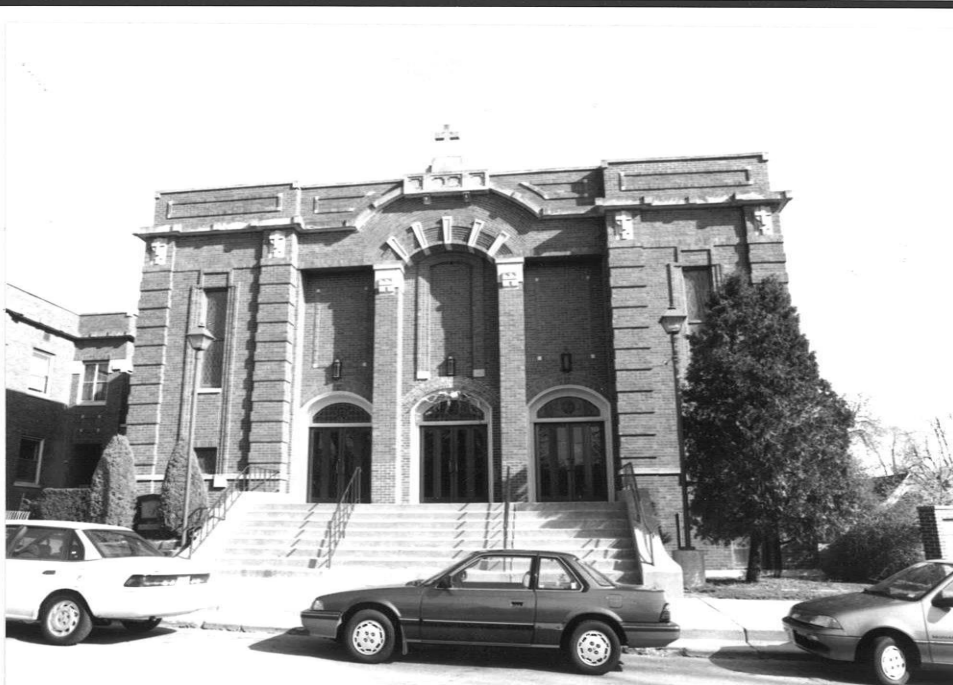
NEGATIVE NO. 25

Style: Eclectic/Italian Renaissance

Triple arch entry doors divided by masonry pilasters. Stone accents trim parapet and over central entry door at south. Similar stone detail at east elevation.

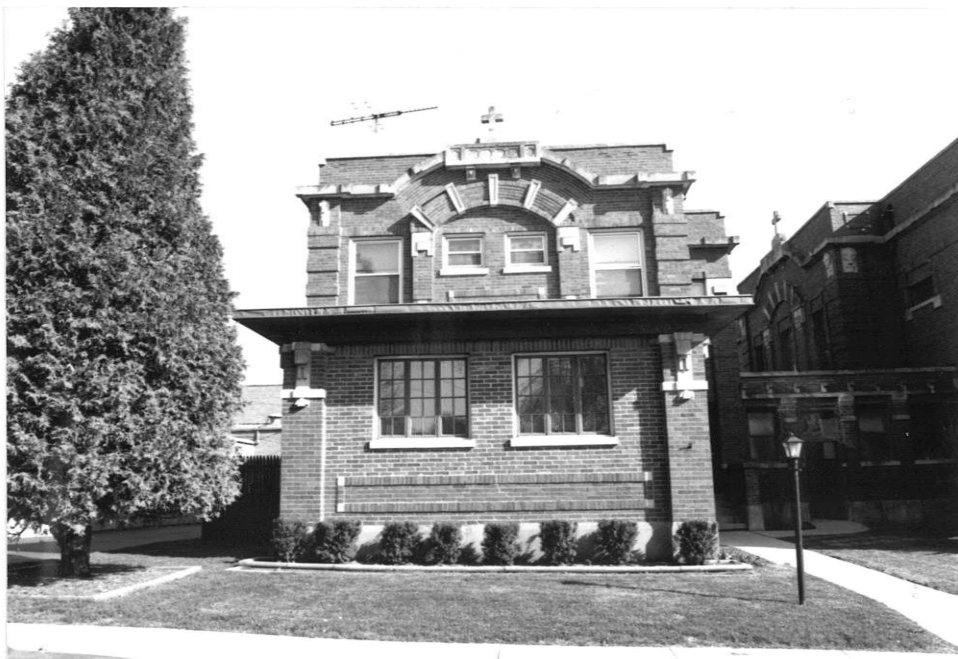
NEGATIVE NO. 24

Style: Eclectic/Italian Renaissance

Brick structure with significant stone accents. Elaborate stone caps to masonry pilasters on south facade. Stone at upper facade matches church to east.

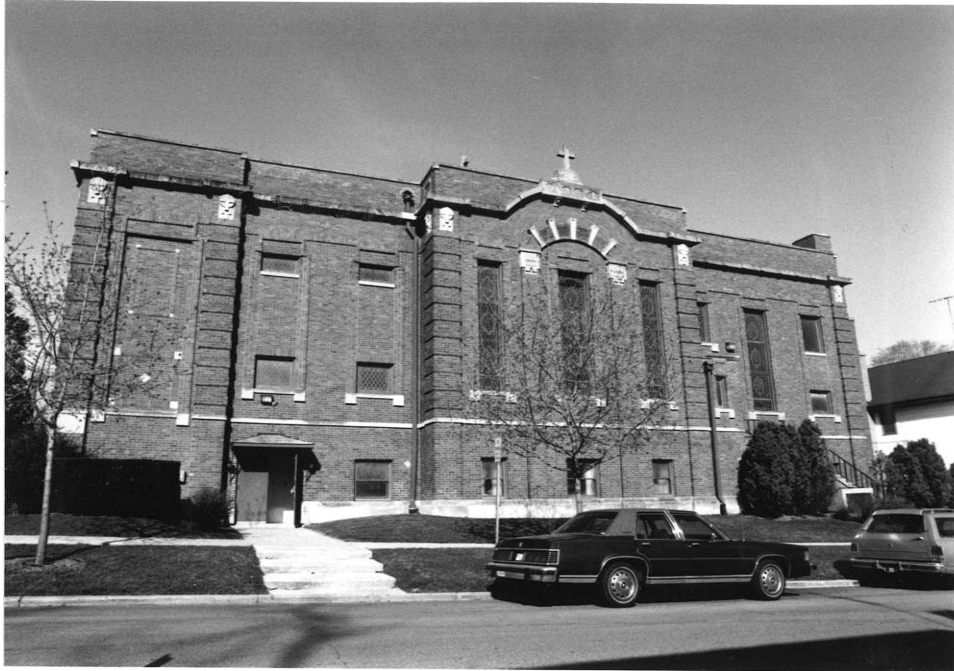
NEGATIVE NO. 26

East side

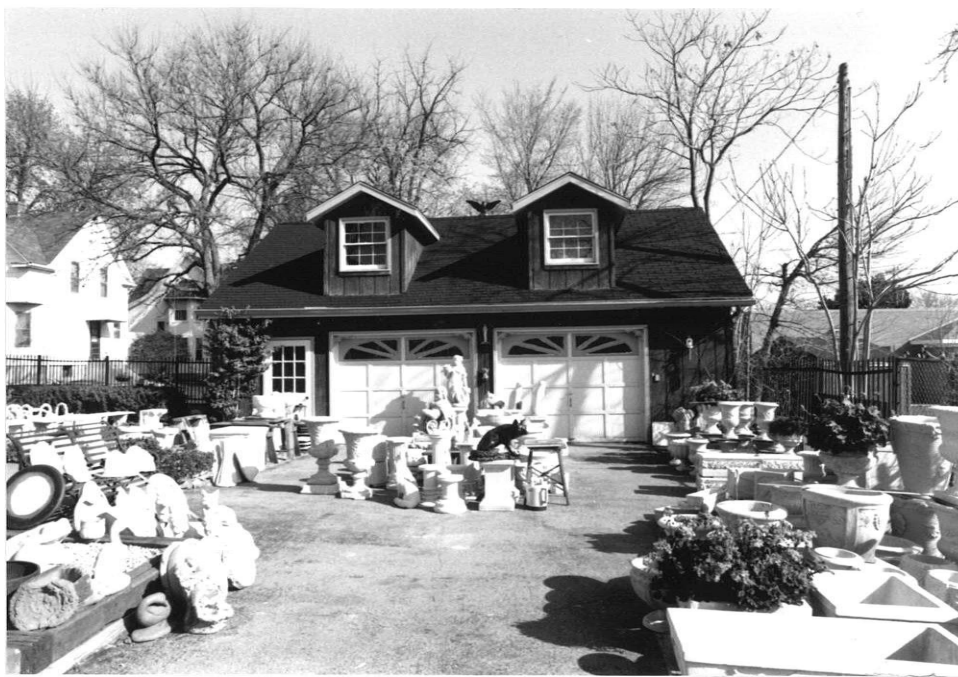
NEGATIVE NO. 29

Garage

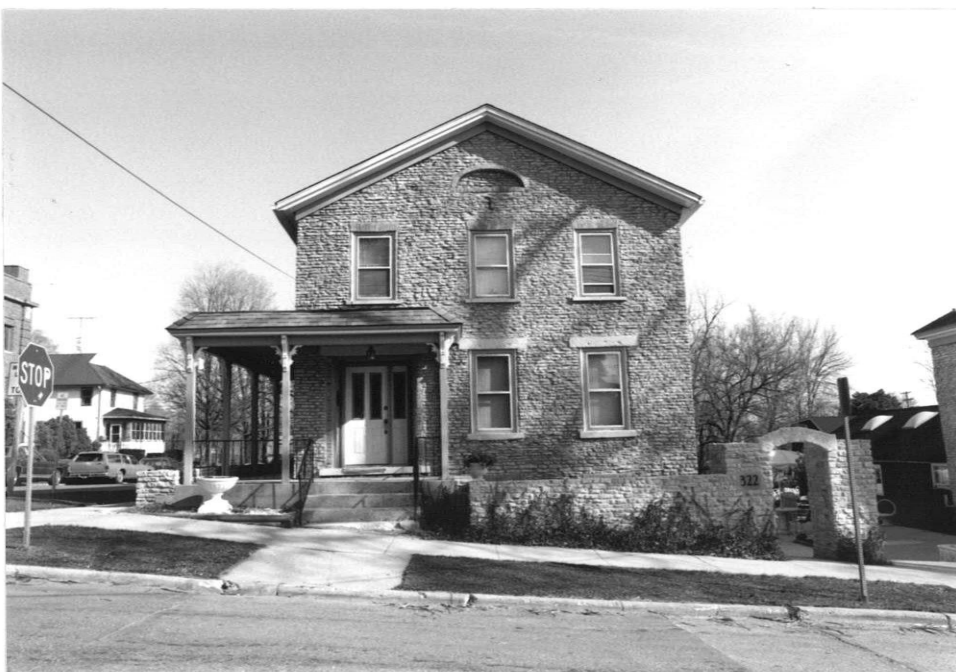
NEGATIVE NO. 27

Style: Greek Revival

Rough limestone exterior with cut limestone window heads and sills at first floor, brick window heads at south elevation, second floor. Porch and perimeter low stone wall added in 1990's. Fan lite at south gable end filled with stone.

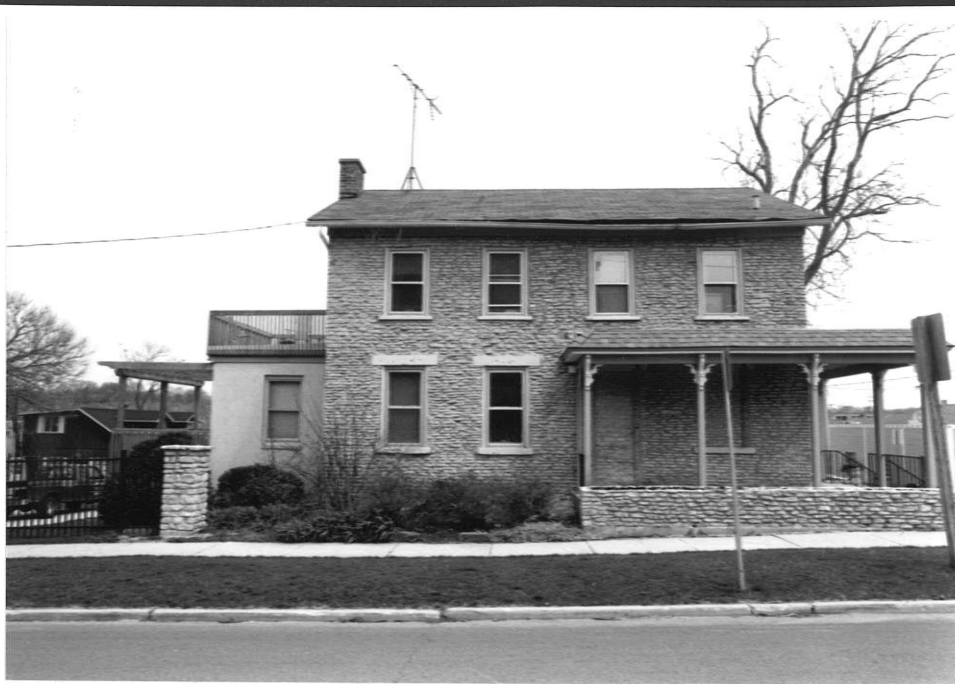
NEGATIVE NO. 27

West side, wrap around porch
added in 1990's.
