<b>HISTORIC PRESERVATION COMMISSION AGENDA ITEM EXECUTIVE SUMMARY</b>			
	<b>Agenda Item Title/Address:</b>	411 Prairie St.		
	<b>Proposal:</b>	General feedback		
	<b>Petitioner:</b>	Susan Olson		
<b>Please check appropriate box (x)</b>				
	<b>PUBLIC HEARING</b>		<b>MEETING 9/20/17</b>	<b>X</b>
<b>AGENDA ITEM CATEGORY:</b>				
	Certificate of Appropriateness (COA)		Façade Improvement Plan	
	Preliminary Review		Landmark/District Designation	
X	Discussion Item		Commission Business	
<b>ATTACHMENTS:</b>				
Ordinance Criteria for Landmarking Photos of building Architectural Survey page				
<b>EXECUTIVE SUMMARY:</b>				
Susan Olson is seeking feedback from the Commission regarding whether there would be support for a potential landmark designation of her home, 411 Prairie St.				
<b>RECOMMENDATION / SUGGESTED ACTION:</b>				
Provide feedback to the petitioner.

# ARCHITECTURAL SURVEY

NEAR WEST HISTORIC DISTRICT  
ST. CHARLES, ILLINOIS

ADDRESS 411 Prairie Street

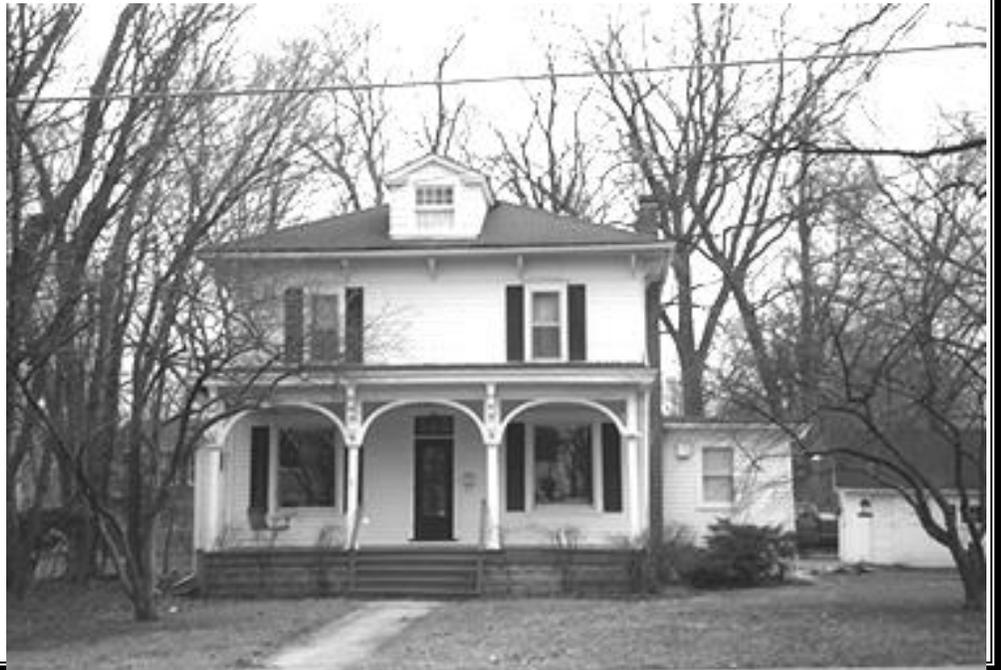
ROLL-IMAGE # 101 - 6

Architectural Style/Type: Eclectic/Four square

**ARCHITECTURAL FEATURES:** There are several layers of stylistic detailing superimposed over a relatively simple foursquare plan. An exaggerated dormer with a broad frieze band, discontinuous at the gable end, and a broad frieze band with narrow windows placed over the 2F windows are typical of the Greek Revival style. This is not a typical form for that style. The imbrication at the 2F and the scrolled wooden brackets supporting the main roof and the porch roof are typical Victorian elements. This is not a typical form for that style either. The serpentine columns supporting the porch roof are rare and originate from the Baroque style. Some of the more exotic revival styles use this type of expression on occasion. The vestigial arch forms

**ARCHITECTURAL FEATURES (cont'd):** that spring from the serpentine columns is another curious and rare detail sometimes seen in the Victorian style. There is a rope molding used on the inside edge of the arches. There is a small - scaled dentil course used at the edge of the porch roof. A transom window is located over the front door relates to the tall head trim at the front first floor windows and emphasizes the height of the entrance. Some of the original removable storm windows are still in place.

**ALTERATIONS:** There have been modest single story additions made to both the east and west sides of the house. These are sparsely detailed hipped roof structures placed towards the rear of the house in an attempt to de-emphasize them. Another shed-roofed addition was made to the rear. It too is relatively modestly detailed. This house is said to have been moved to this site from another location.
