ARCHITECTURAL SURVEY

CENTRAL HISTORIC DISTRICT

ST. CHARLES, ILLINOIS

ST. CHARLES HISTORIC PRESERVATION COMMISSION

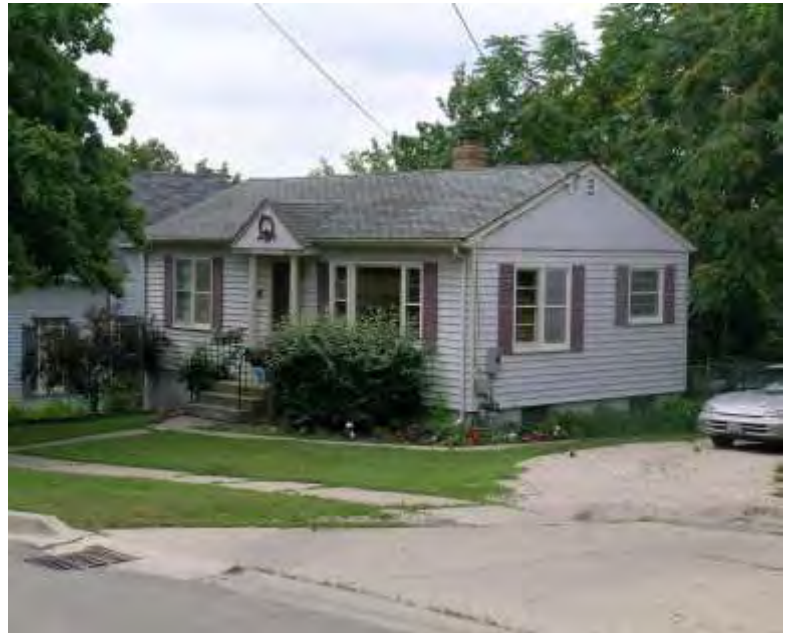
ADDRESS 215 N 2nd Ave

- ☐ Significant
- ☐ Contributing
- ☒ Non-Contributing
- ☐ Potential for Individual National Register Designation

- ☒ Excellent
- ☐ Good
- ☐ Fair
- ☐ Poor

Architectural Style/Type:	<u>Ranch</u>	Exterior Walls (Current):	<u></u>
Architectural Features:	<u></u>	Exterior Walls (Original):	<u></u>
Date of Construction:	<u>1940-1960</u>	Foundation:	<u></u>
Source:	<u></u>	Roof Type/Material:	<u></u>
Overall Plan Configuration:	<u></u>	Window Material/Type:	<u></u>

ARCHITECTURAL FEATURES: Aluminum sided one story house with side-gabled roof. Symmetrical appearance to the street with central small gable entrance. Decorative iron handrails.

ALTERATIONS: None

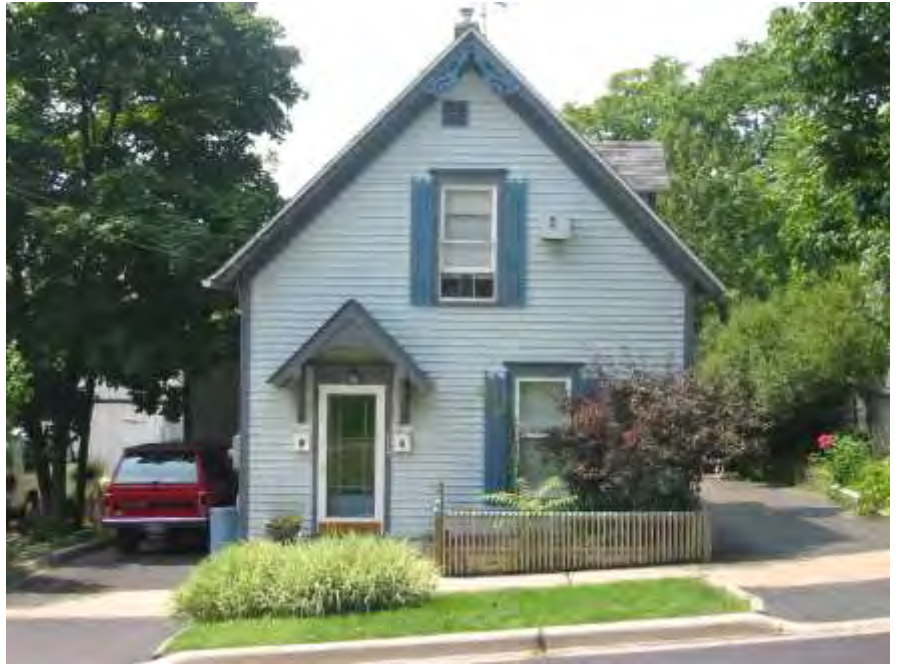
ADDRESS 211 N 2nd Ave

- ☐ Significant
- ☒ Contributing
- ☐ Non-Contributing
- ☐ Potential for Individual National Register Designation

- ☒ Excellent
- ☐ Good
- ☐ Fair
- ☐ Poor

Architectural Style/Type: Greek Revival

Date of Construction: 1870-1910

ARCHITECTURAL FEATURES: Front gabled roof with wing addition at rear, south side. Elaborate brackets at gable roof entrance.

ALTERATIONS: Addition to first floor.

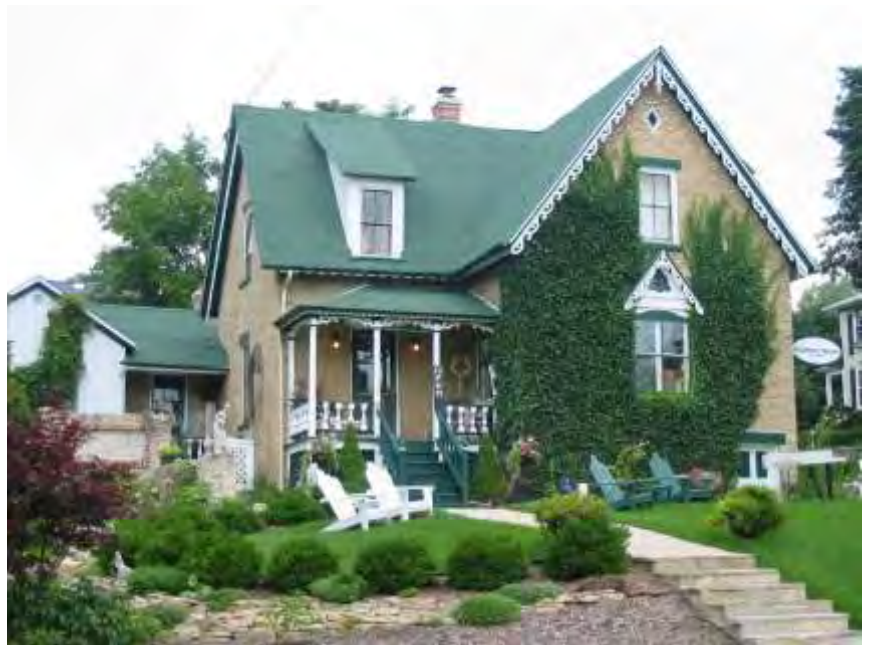
ADDRESS 116 State Ave

- ☐ Significant
- ☒ Contributing
- ☐ Non-Contributing
- ☐ Potential for Individual National Register Designation

- ☐ Excellent
- ☒ Good
- ☐ Fair
- ☐ Poor

Architectural Style/Type: Gothic Revival

Date of Construction: 1840

ARCHITECTURAL FEATURES: Random limestone exterior with steeply sloping roof, cross-gabled. Decorative verge boards at gables. Small gable over first floor entry window, south side. Enclosed porch at entry. Stone lintels at windows. Two different dormer shapes at east elevation.

ALTERATIONS: Minor alterations to first floor, second floor, and roof/cornice.

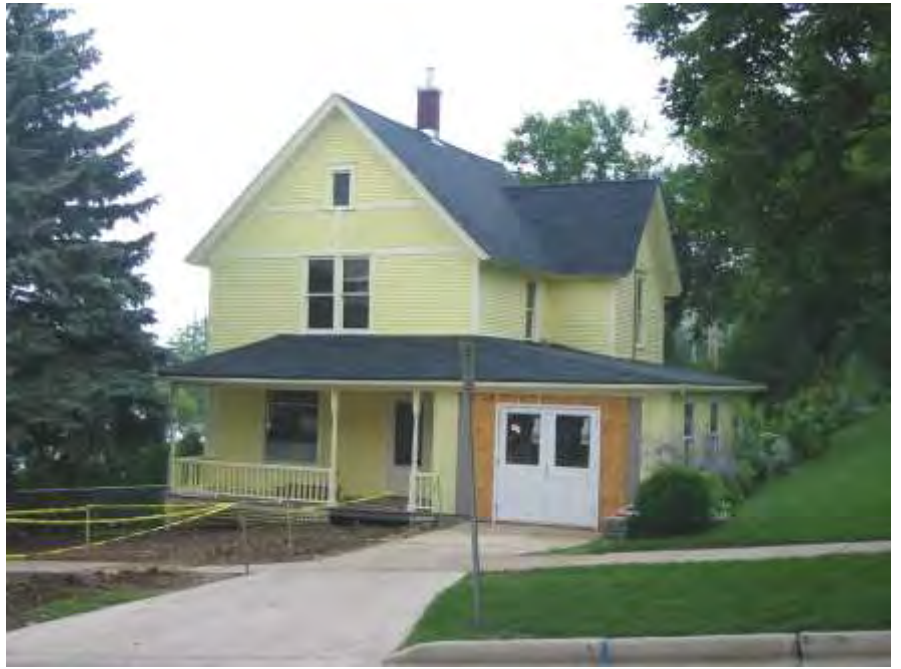
ADDRESS 108 State Ave

- ☐ Significant
- ☒ Contributing
- ☐ Non-Contributing
- ☐ Potential for Individual National Register Designation

- ☒ Excellent
- ☐ Good
- ☐ Fair
- ☐ Poor

Architectural Style/Type: <u>Stick</u>	Exterior Walls (Current): _____
Architectural Features: _____	Exterior Walls (Original): _____
Date of Construction: <u>1860-1890</u>	Foundation: _____
Source: _____	Roof Type/Material: _____
Overall Plan Configuration: _____	Window Material/Type: _____

ARCHITECTURAL FEATURES: Steeply pitched gable roof. Horizontal and vertical bands in contrasting color to base wall for emphasis. Wood clapboards, horizontal except for diagonal in lower half of gable. Full width front porch.

ALTERATIONS: Minor alteration to first floor. Addition to first floor.

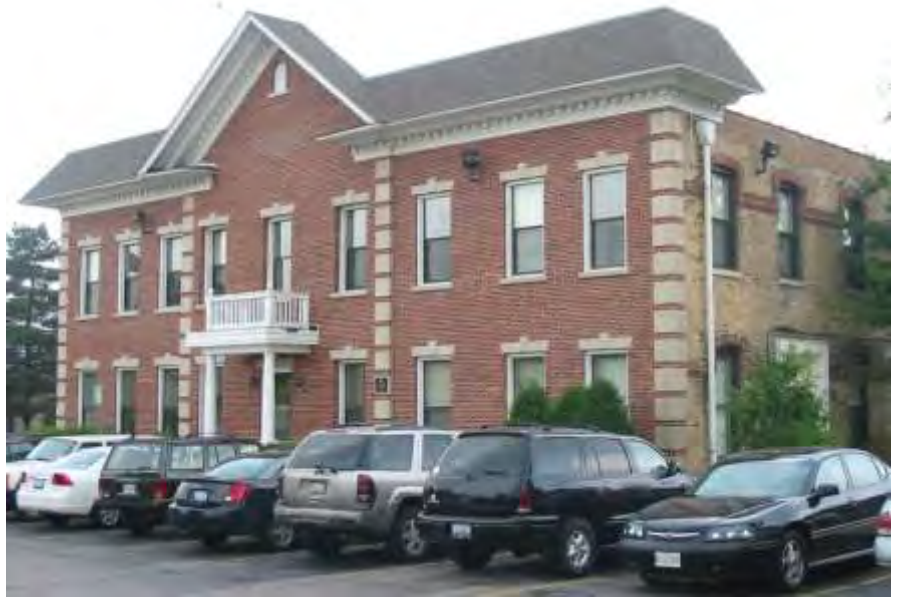
ADDRESS 10 State Ave

- ☐ Significant
- ☐ Contributing
- ☒ Non-Contributing
- ☐ Potential for Individual National Register Designation

- ☐ Excellent
- ☒ Good
- ☐ Fair
- ☐ Poor

Architectural Style/Type: <u>Substantially altered</u>	Exterior Walls (Current): _____
Architectural Features: _____	Exterior Walls (Original): _____
Date of Construction: <u>pre 1900</u>	Foundation: _____
Source: _____	Roof Type/Material: _____
Overall Plan Configuration: _____	Window Material/Type: _____

ARCHITECTURAL FEATURES: Original factory building at east side, addition to west. South face clad with limestone slabs in 1930s. East façade shows band of face brick as decorative element in common brick wall.

ALTERATIONS: Major alterations to first floor and second floor. Additions to first floor and second floor.

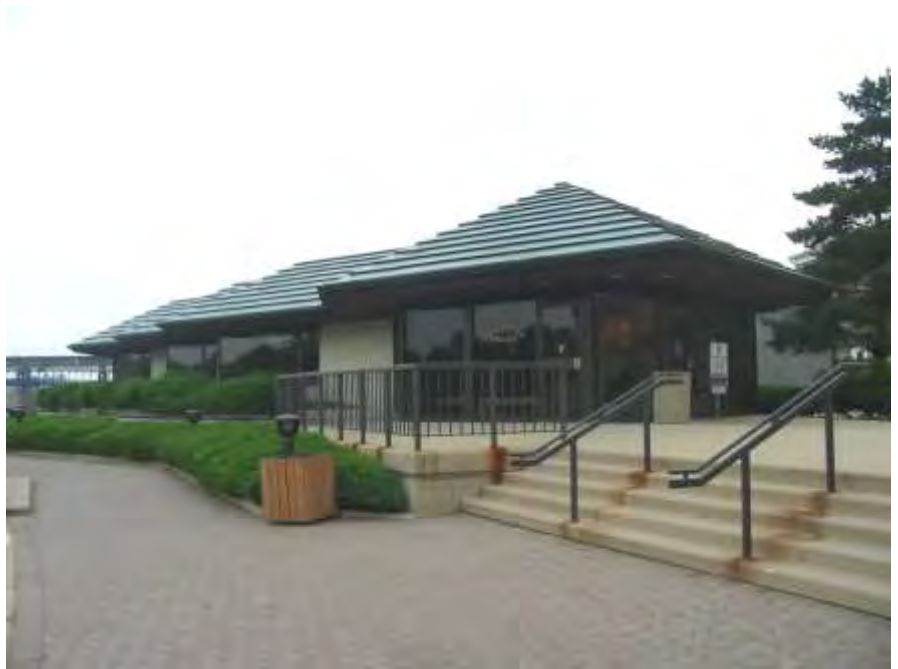
ADDRESS 2 State Ave

- ☐ Significant
☐ Contributing
☒ Non-Contributing
☐ Potential for Individual National Register Designation

- ☒ Excellent
☐ Good
☐ Fair
☐ Poor

Architectural Style/Type: Modern

Date of Construction: 1985

ARCHITECTURAL FEATURES: One story aggregate finish exterior with metal hip roof. Large overhanging eaves with horizontal emphasis in roof lines.

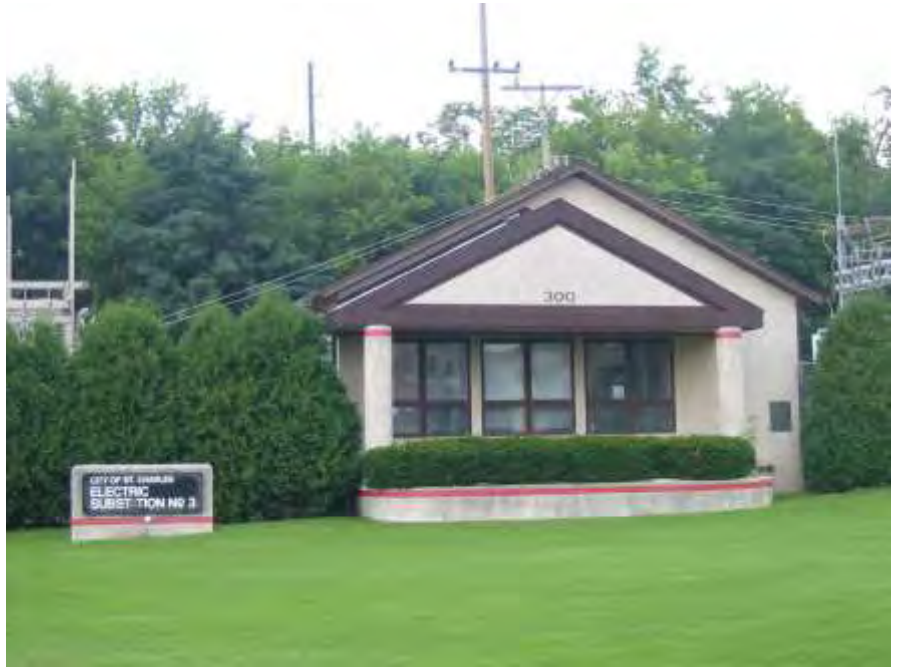
ADDRESS 300 N 1st Ave

- ☐ Significant
- ☐ Contributing
- ☒ Non-Contributing
- ☐ Potential for Individual National Register Designation

- ☒ Excellent
- ☐ Good
- ☐ Fair
- ☐ Poor

Architectural Style/Type: Commercial Vernacular

Date of Construction: 1910-1930, 1986 remodel

ARCHITECTURAL FEATURES: Gable roof to front. Projected gable acts as sun shade for large south facing windows in this adaptive use from a lumber storage building to an electrical substation building. Cement plaster finish over concrete block added in 1986 remodeling. Square, aggregate finish cement plaster building with metal hip roof west of main structure built in 1985.

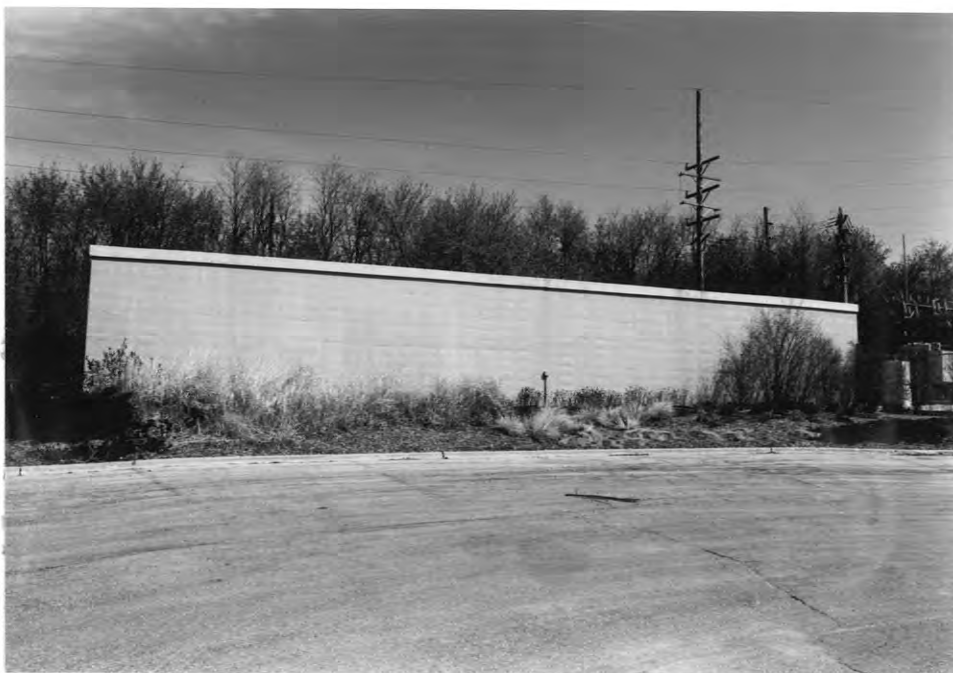
- ☐ Significant
- ☐ Contributing
- ☒ Non-Contributing

- ☒ Excellent: Well-maintained
- ☐ Good: Minor maintenance needed
- ☐ Fair: Major repairs needed
- ☐ Poor: Deteriorated

Electric equipment enclosure wall.

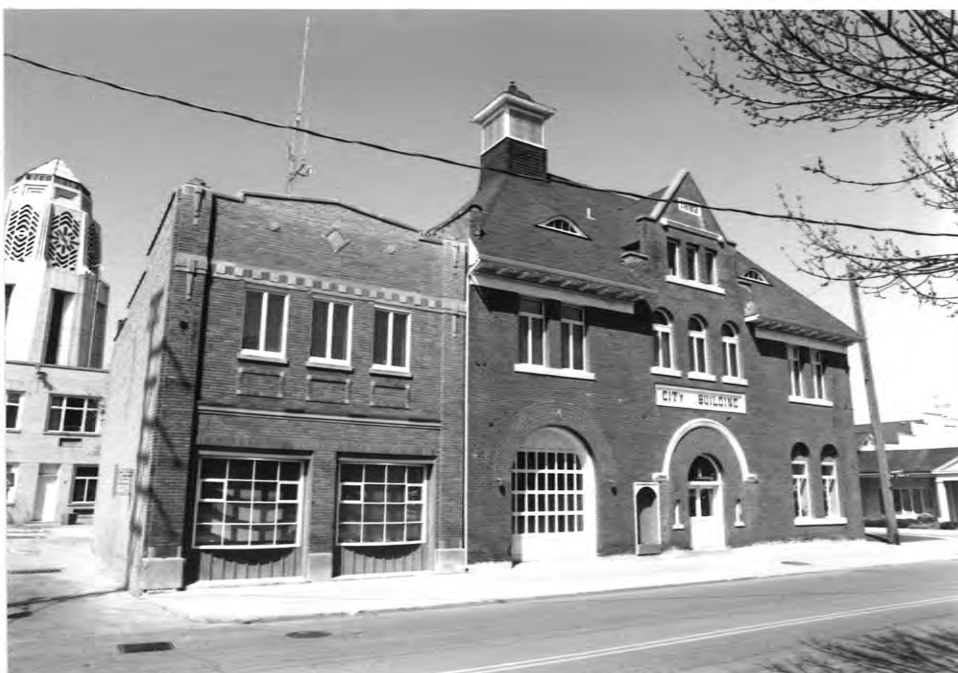
15 North First Avenue

A local commercial building perpetuating late Victorian design, but simpler and sparer. Originally two garage doors on the first level, now windows. Three windows at second floor each over masonry panels. A band of stone provides a header over these windows. Stone accents adorn the parapet area.

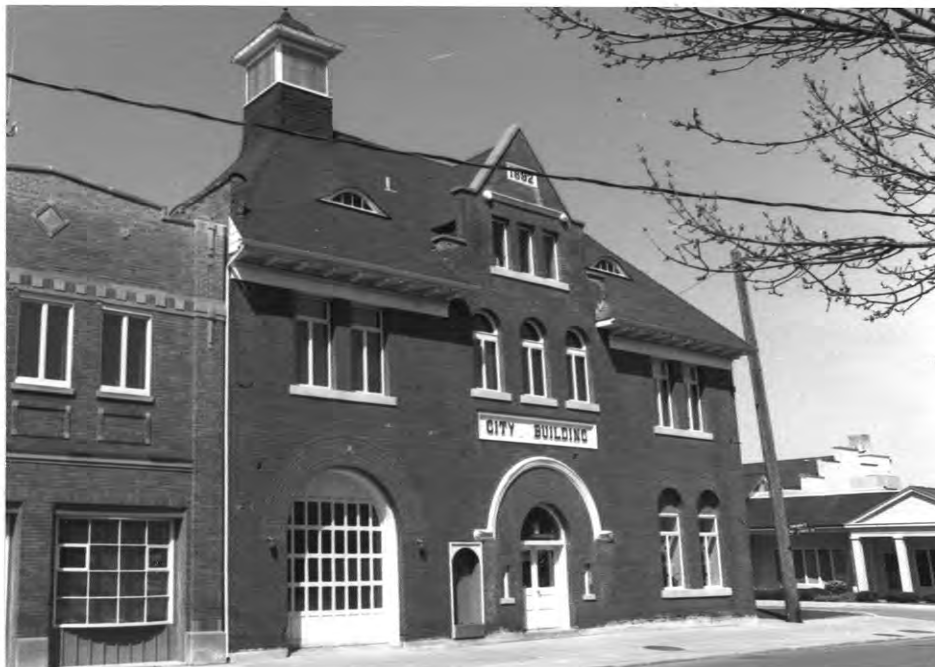
- ☒ Excellent: Well-maintained
- ☐ Good: Minor maintenance needed
- ☐ Fair: Major repairs needed
- ☐ Poor: Deteriorated

Hipped roof red brick building with bell tower, "eye lid" windows characteristic of H.H. Richardson's Romanesque style. The roof soffit is articulated with wood brackets. The middle of the front (east) facade has a full arch with a vertical continuation of the brickface through the soffit to a gable end "dormer" with three windows and datestone.

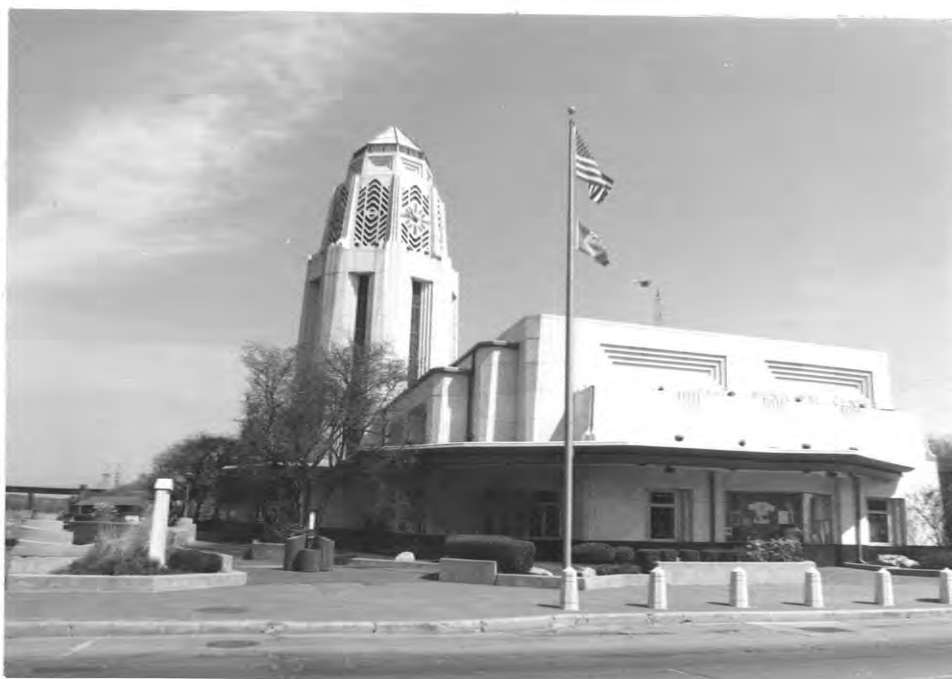
2 East Main Street

- ☒ **Excellent: Well-maintained**
☐ **Good: Minor maintenance needed**
☐ **Fair: Major repairs needed**
☐ **Poor: Deteriorated**

Sits on prominent site overlooking the Fox River. White Georgian marble exterior. Deeply recessed windows with colored glass windows in tower. Section of tower with pierced grillwork, clocks on four sides of the octagonal form. Tower is capped by a diamond shaped form illuminated at night. Geometric patterns appear throughout in the floors, walls and ceilings. Architects were R. Harold Zook and D. Coder Taylor.

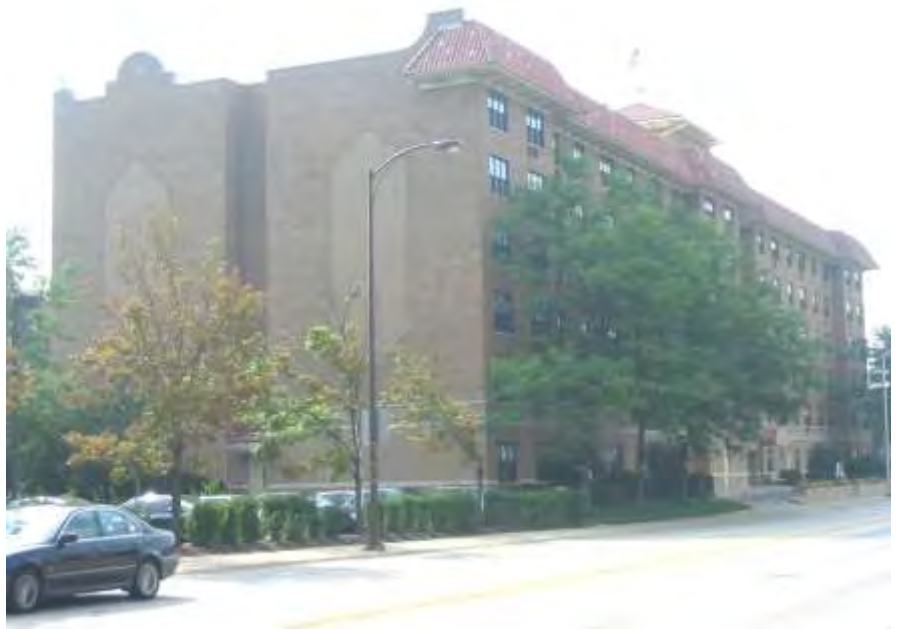
- ☐ Significant
- ☐ Contributing
- ☒ Non-Contributing
- ☐ Potential for Individual National Register Designation

Architectural Style/Type: <u>Romantic Revival</u>	Exterior Walls (Current): <u>Concrete block & brick</u>
Architectural Features: _____	Exterior Walls (Original): <u>Concrete block & brick</u>
Date of Construction: <u>1986</u>	Foundation: _____
Source: _____	Roof Type/Material: <u>Clay tile</u>
Overall Plan Configuration: _____	Window Material/Type: <u>Aluminum</u>

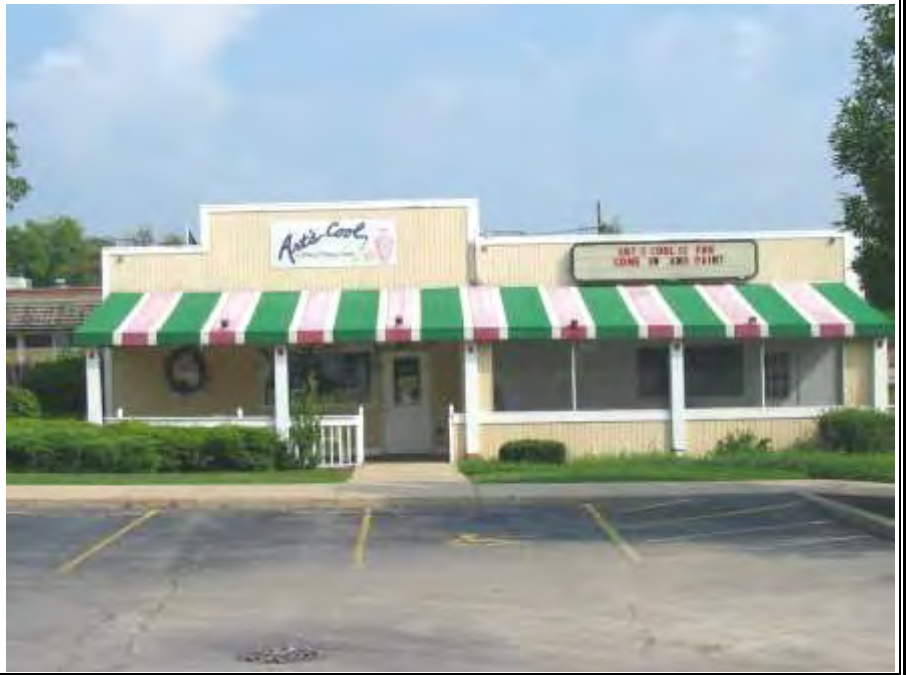
- ☐ Significant
- ☐ Contributing
- ☒ Non-Contributing
- ☐ Potential for Individual National Register Designation

Architectural Style/Type: <u>Vernacular Commercial</u>	Exterior Walls (Current): <u>Plywood Siding</u>
Architectural Features: _____	Exterior Walls (Original): _____
Date of Construction: <u>Post 1944</u>	Foundation: _____
Source: _____	Roof Type/Material: _____
Overall Plan Configuration: _____	Window Material/Type: _____

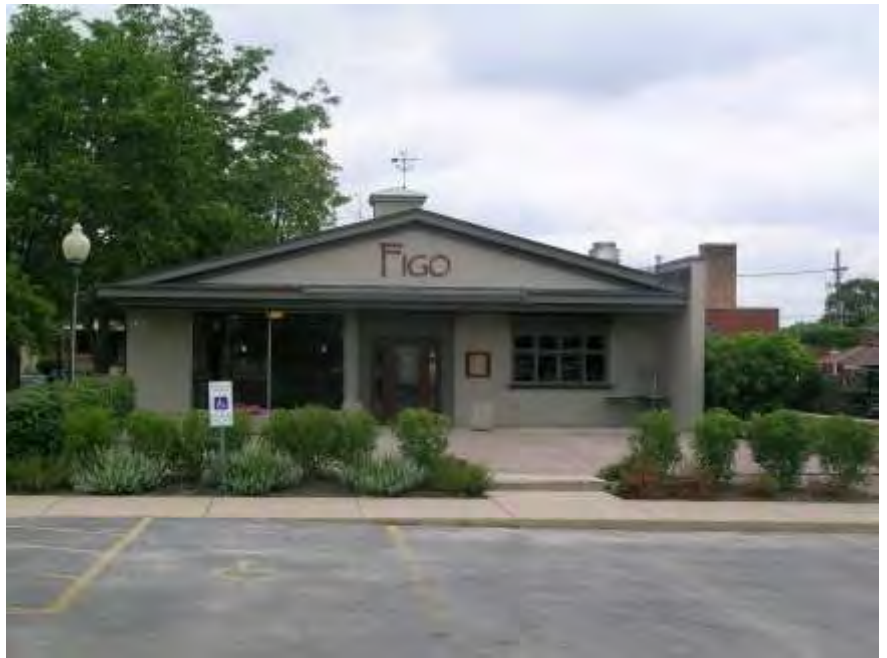
ADDRESS 100-110 N 3rd St

- ☐ Significant
- ☐ Contributing
- ☒ Non-Contributing
- ☐ Potential for Individual National Register Designation

Architectural Style/Type: <u>Vernacular Commercial</u>	Exterior Walls (Current): <u>Plywood siding</u>
Architectural Features: _____	Exterior Walls (Original): _____
Date of Construction: <u>Post 1944</u>	Foundation: _____
Source: _____	Roof Type/Material: _____
Overall Plan Configuration: _____	Window Material/Type: _____

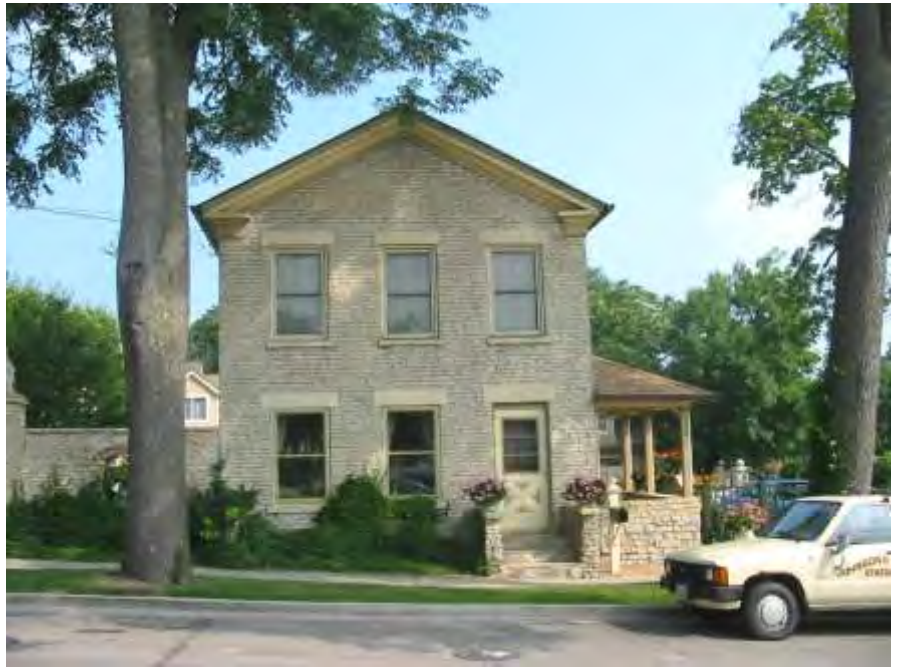
- ☐ Significant
- ☒ Contributing
- ☐ Non-Contributing
- ☐ Potential for Individual National Register Designation

ALTERATIONS: Minor to first floor, Addition to first floor.

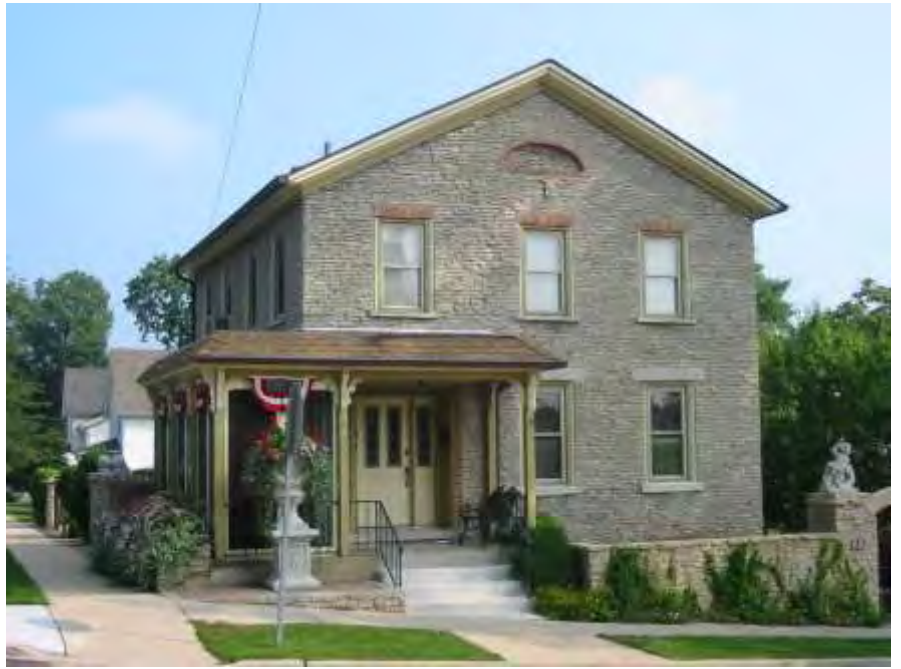
- ☐ Significant
- ☒ Contributing
- ☐ Non-Contributing
- ☐ Potential for Individual National Register Designation

Architectural Style/Type: <u>Greek Revival</u>	Exterior Walls (Current): <u>Rough limestone</u>
Architectural Features: _____	Exterior Walls (Original): <u>Rough limestone</u>
Date of Construction: <u>1840's</u>	Foundation: _____
Source: _____	Roof Type/Material: <u>Gable/Asphalt Shingle</u>
Overall Plan Configuration: _____	Window Material/Type: <u>Aluminum</u>

ALTERATIONS: Minor to first floor

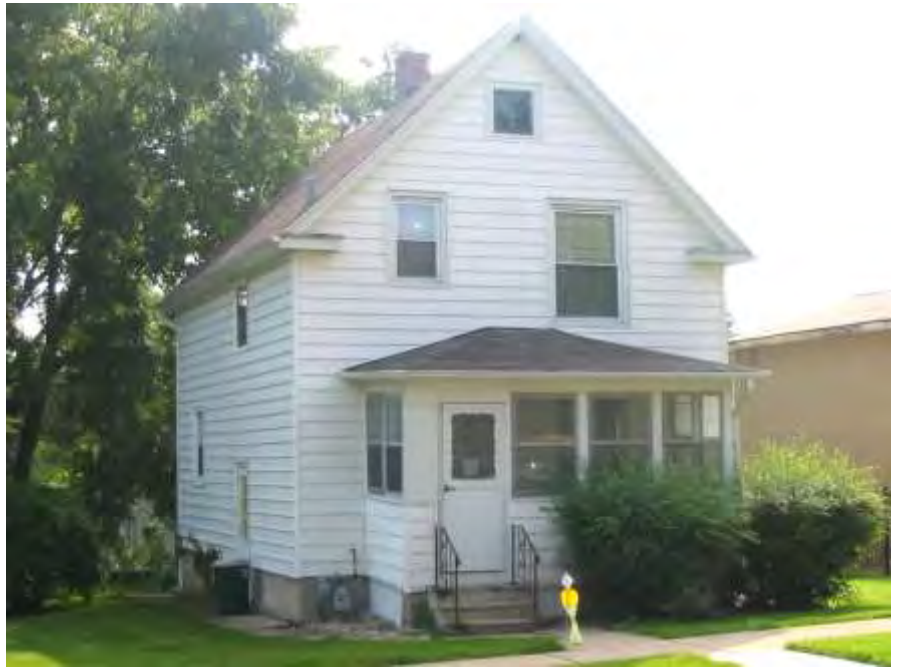
- ☐ Significant
- ☐ Contributing
- ☒ Non-Contributing
- ☐ Potential for Individual National Register Designation

ARCHITECTURAL FEATURES: Front gabled roof two story with later synthetic siding, aluminum soffits. Porch enclosed. Broken pediment at front gable end.

ALTERATIONS: Major alterations to first floor and second floor.

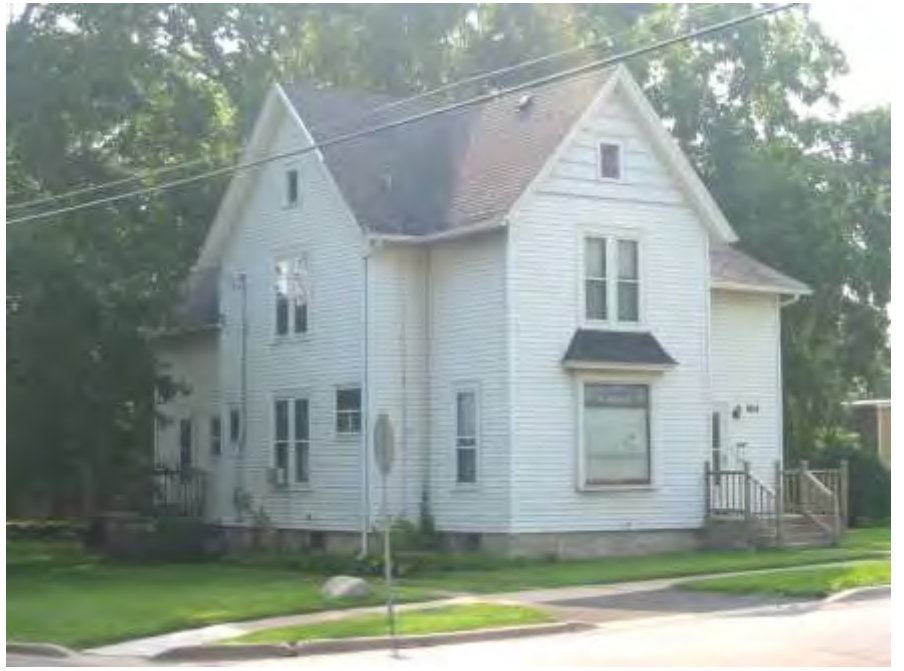
- ☐ Significant
- ☒ Contributing
- ☐ Non-Contributing
- ☐ Potential for Individual National Register Designation

Architectural Style/Type: <u>National Folk</u>	Exterior Walls (Current): <u>Clapboard</u>
Architectural Features: _____	Exterior Walls (Original): <u>Clapboard</u>
Date of Construction: <u>1910</u>	Foundation: _____
Source: <u>Assessor</u>	Roof Type/Material: <u>Asphalt shingle</u>
Overall Plan Configuration: _____	Window Material/Type: _____

ALTERATIONS: Minor alteration to first floor.

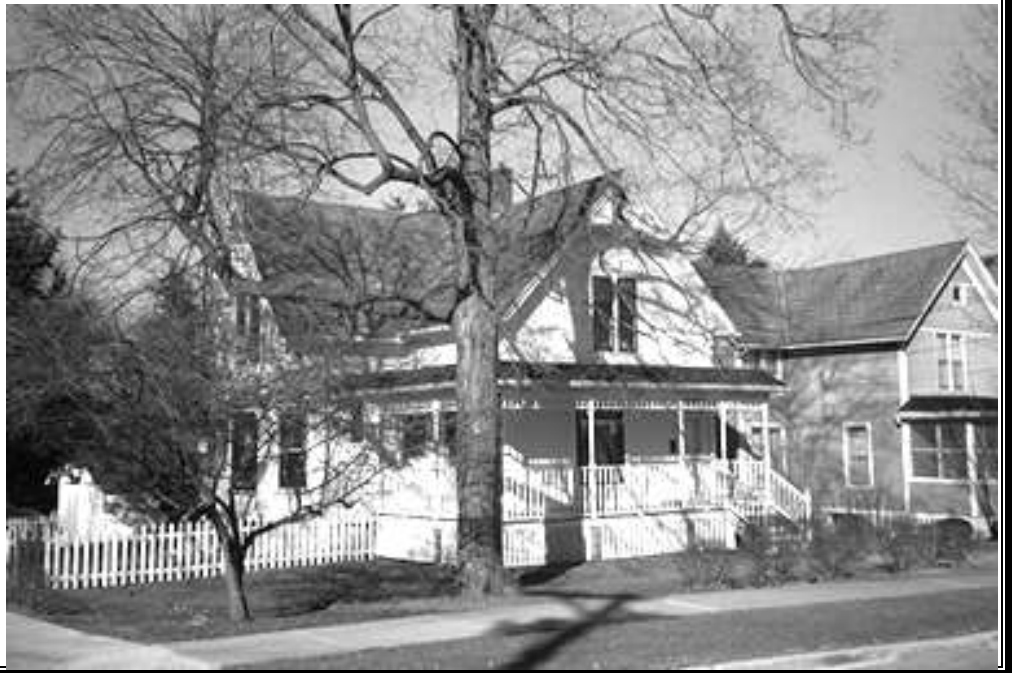
- ☒ Significant
- ☐ Contributing
- ☐ Non-Contributing
- ☐ Potential for Individual National Register Designation

Architectural Style/Type:	<u>Victorian/Folk</u>	Exterior Walls (Current):	<u>Clapboard</u>
Architectural Features:	<u></u>	Exterior Walls (Original):	<u>Clapboard</u>
Date of Construction:	<u>1893</u>	Foundation:	<u>Textured CMU/Stone</u>
Source:	<u>Township Assessor's Office</u>	Roof Type/Material:	<u>Cross gable/Asbestos shingle</u>
Overall Plan Configuration:	<u>Simple w/ irregularities</u>	Window Material/Type:	<u>Alum/Wd/double hung</u>

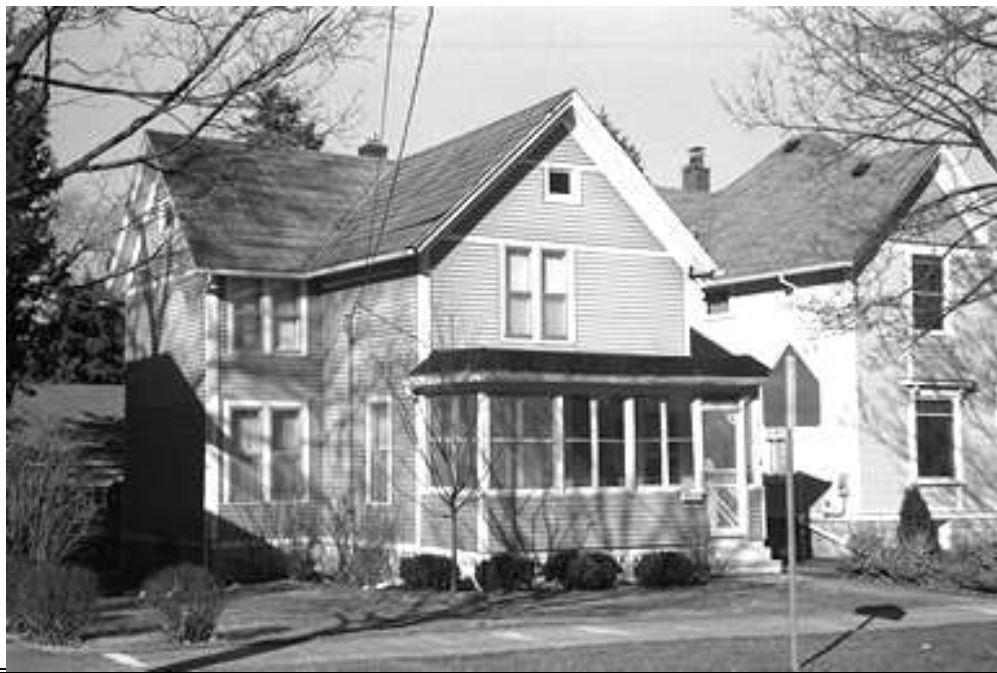
- ☐ Significant
- ☒ Contributing
- ☐ Non-Contributing
- ☐ Potential for Individual National Register Designation

Foundation: Parged stone

ALTERATIONS: The front porch does not appear to be part of the original house. There is an addition to the rear of the house that has a gable roof. It is compatible with the remodeled house. The wooden deck is not sympathetic to the original style.

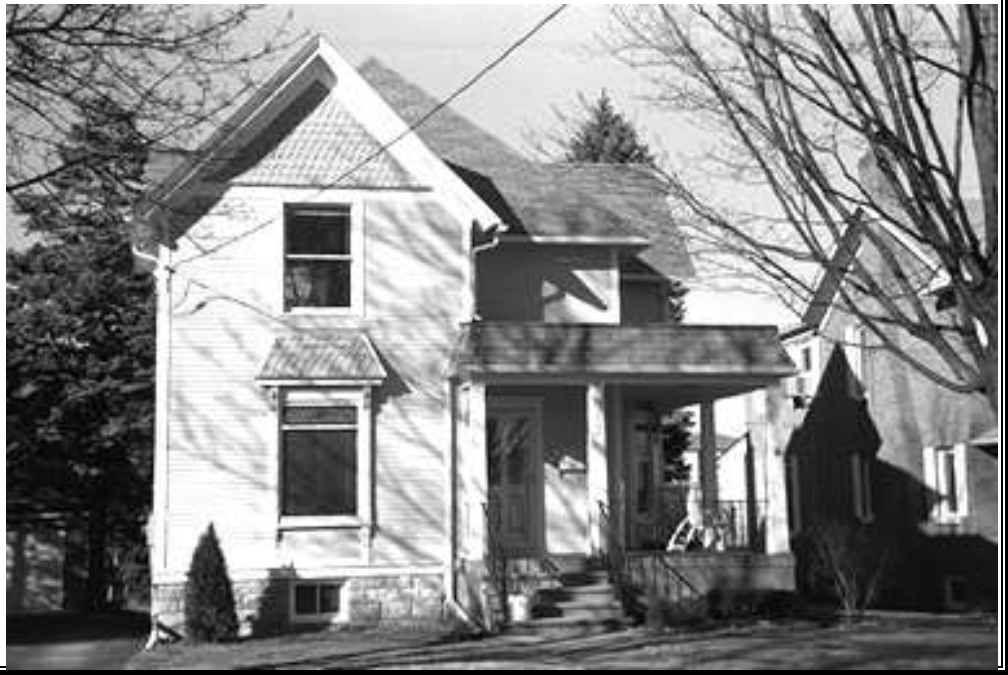
- ☐ Significant
- ☒ Contributing
- ☐ Non-Contributing
- ☐ Potential for Individual National Register Designation

Architectural Style/Type:	<u>Victorian/Queen Anne</u>	Exterior Walls (Current):	<u>Clapboard</u>
Architectural Features:	<u></u>	Exterior Walls (Original):	<u>Clapboard</u>
Date of Construction:	<u>1900</u>	Foundation:	<u>Stone</u>
Source:	<u>Township Assessor's Office</u>	Roof Type/Material:	<u>Hipped w/ lower gables/ Asphalt shingle</u>
Overall Plan Configuration:	<u>Compound</u>	Window Material/Type:	<u>Wd/Alum/Double hung</u>

ALTERATIONS: A deck has been added to the rear of the house that is not in character with the original style.

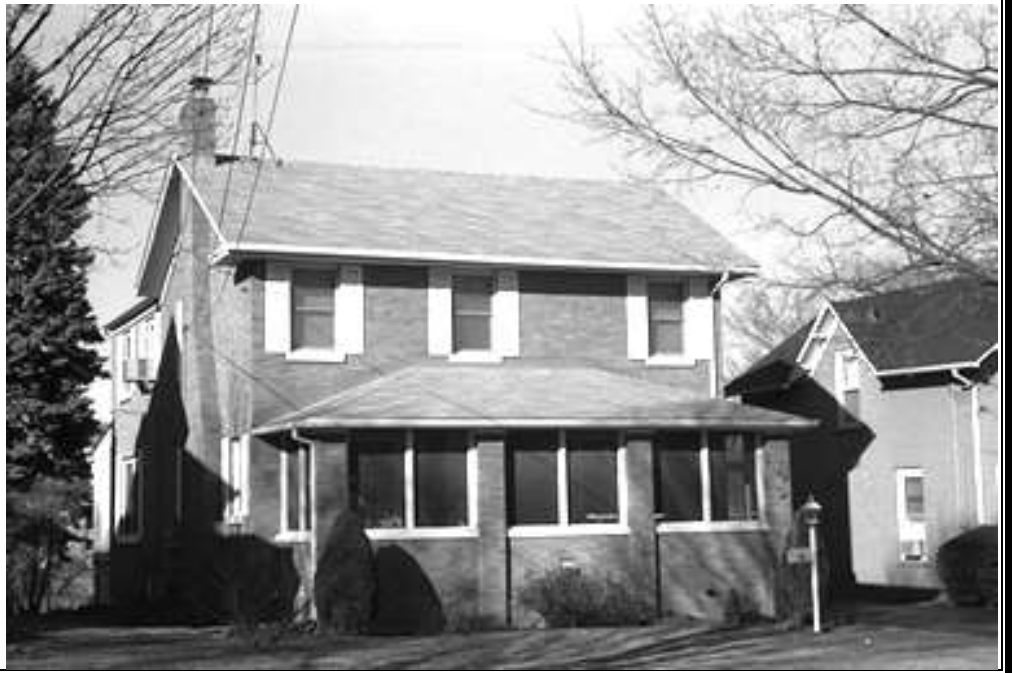
- ☐ Significant
- ☒ Contributing
- ☐ Non-Contributing
- ☐ Potential for Individual National Register Designation

Foundation: Concrete

ALTERATIONS: The front porch has been screened in and there are two substantial additions to the rear that do not follow the Colonial precedent.

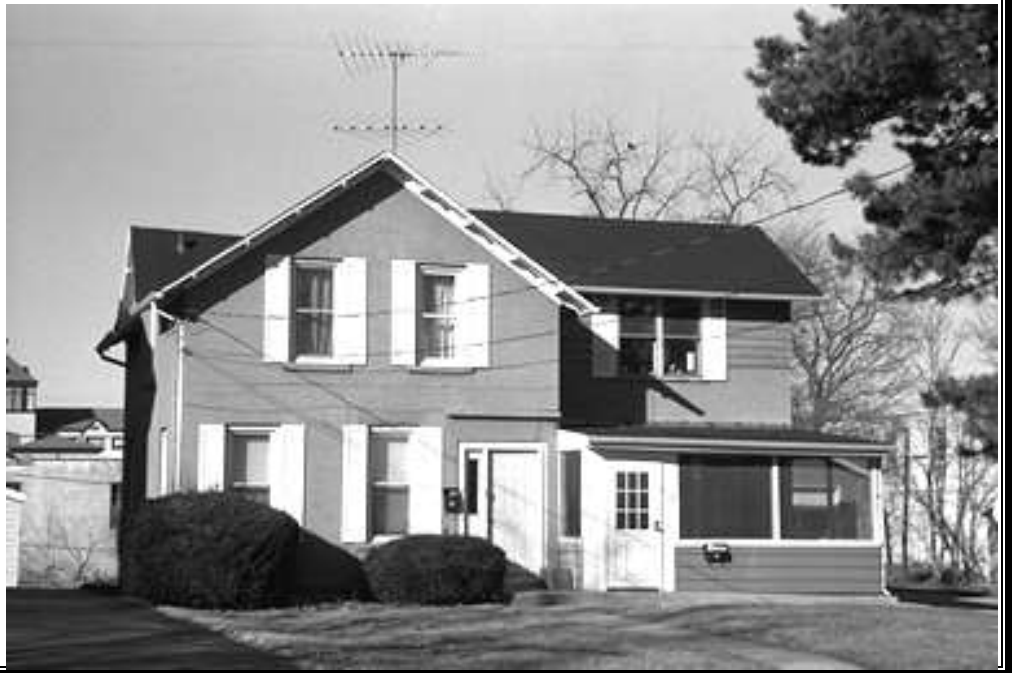
- ☐ Significant
- ☒ Contributing
- ☐ Non-Contributing
- ☐ Potential for Individual National Register Designation

Foundation: Stone

ALTERATIONS: head of the door. The front door is an aluminum panel door that is a recent addition. There is a 1 story mudroom addition located at the rear of the house that is sheathed in aluminum siding that matches the front screened in porch.

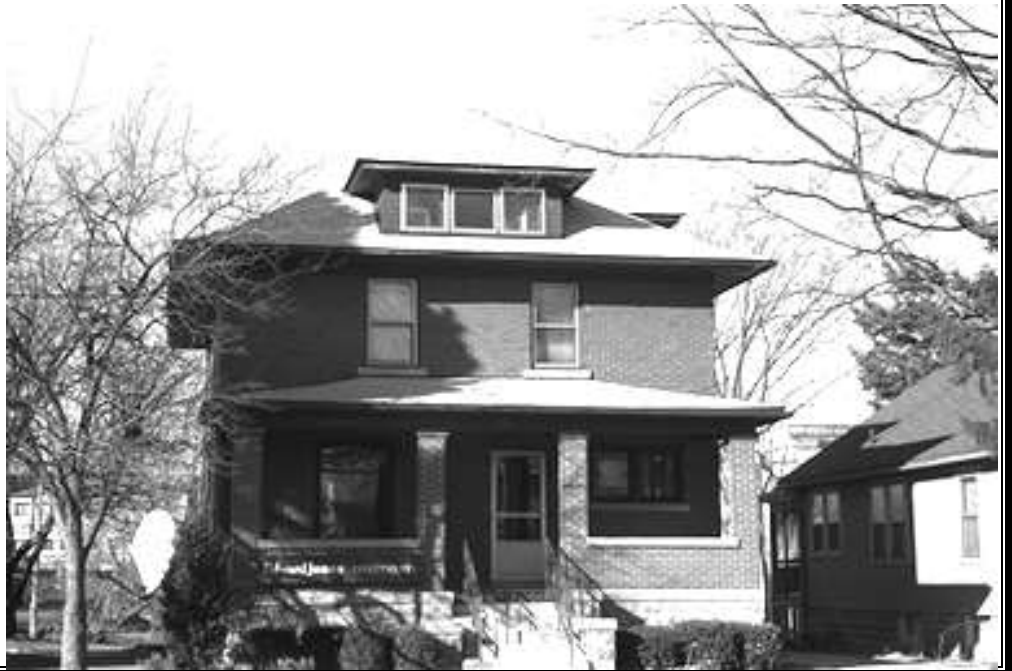
- ☐ Significant
- ☒ Contributing
- ☐ Non-Contributing
- ☐ Potential for Individual National Register Designation

Architectural Style/Type:	<u>Prairie foursquare</u>	Exterior Walls (Current):	<u>Brick</u>
Architectural Features:	<u></u>	Exterior Walls (Original):	<u>Brick</u>
Date of Construction:	<u>1923</u>	Foundation:	<u>Textured CMU</u>
Source:	<u>Township Assessor's Office</u>	Roof Type/Material:	<u>Hipped/Asphalt shingle</u>
Overall Plan Configuration:	<u>Simple/Foursquare</u>	Window Material/Type:	<u>Alum/Double hung</u>

ARCHITECTURAL FEATURES: A symmetrical hipped roof has wide eave overhangs that are boxed in giving the house a Prairie Style appearance. The hipped roof dormers still have the narrow wood strip soffit material. The main roofs eaves have been boxed in with aluminum. The broad eaves of the main roof and the porch combined with the masonry string - course at the top of the foundation wall contribute to an emphasis on the horizontal. A front porch that has a hipped roof supported by square brick columns runs the full width of the street elevation. The columns are simply detailed and flow from the lower porch wall with no articulation. There is some stained glass in the windows located on the porch that adds character and charm. This house lacks the typical exposed rafter tails and brackets commonly associated with the Craftsman style.

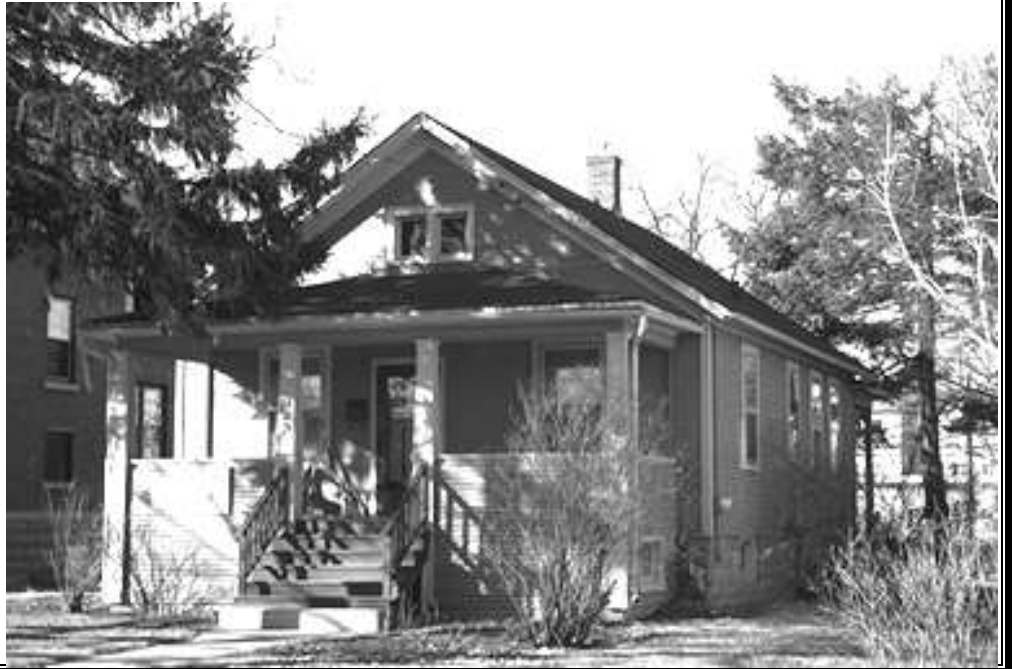
- ☐ Significant
- ☒ Contributing
- ☐ Non-Contributing
- ☐ Potential for Individual National Register Designation

Foundation: Textured CMU

ARCHITECTURAL FEATURES: Simply detailed front gabled bungalow that features a full width front porch topped with a hipped roof. The porch roof is supported by square columns that start at the foundation at the corners and at the porch deck near the entry stairs. These columns feature some craftsman applied wood details. The porch rail is solid and is sheathed in the same siding as the main body of the house. A frieze board is located at the wall roof intersection and the eaves are open.

ALTERATIONS: There is a screened in porch to the rear of the house that is not original.

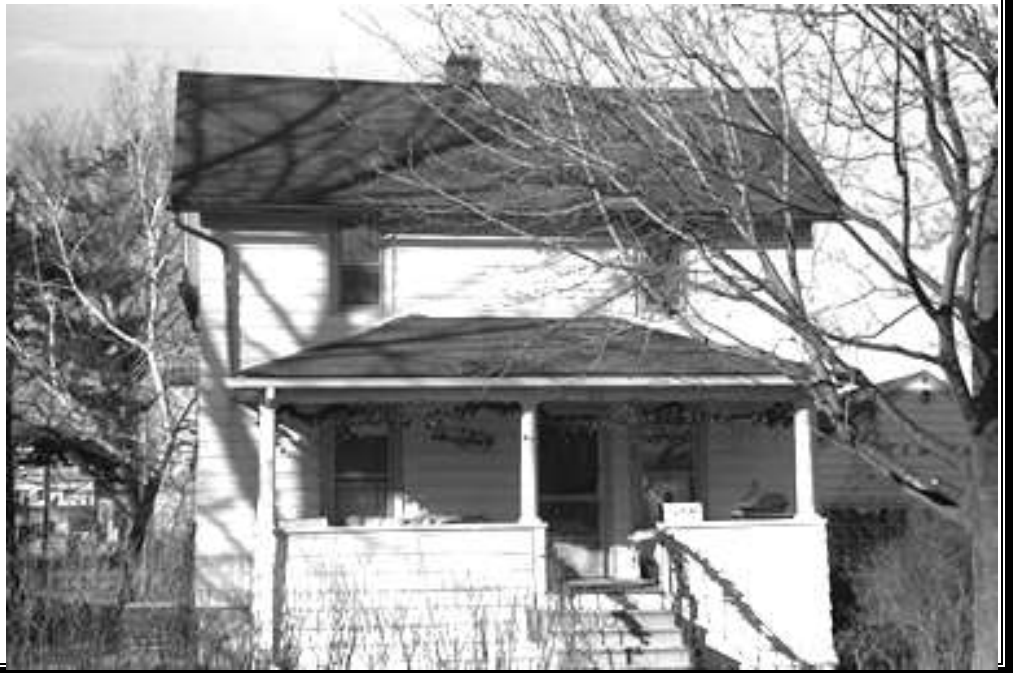
- ☐ Significant
- ☐ Contributing
- ☒ Non-Contributing
- ☐ Potential for Individual National Register Designation

Architectural Style/Type:	National Style/I-House	Exterior Walls (Current):	Alum
Architectural Features:		Exterior Walls (Original):	Clapboard
Date of Construction:	1900	Foundation:	Textured CMU
Source:	Township Assessor's Office	Roof Type/Material:	Side gable/Asphalt shingle
Overall Plan Configuration:	Simple/I plan	Window Material/Type:	Double hung/Alum

ALTERATIONS: This currently houses a mixed occupancy of residential and a bait shop. A poorly done addition to the rear of the house is attached to a garage/bait shop.

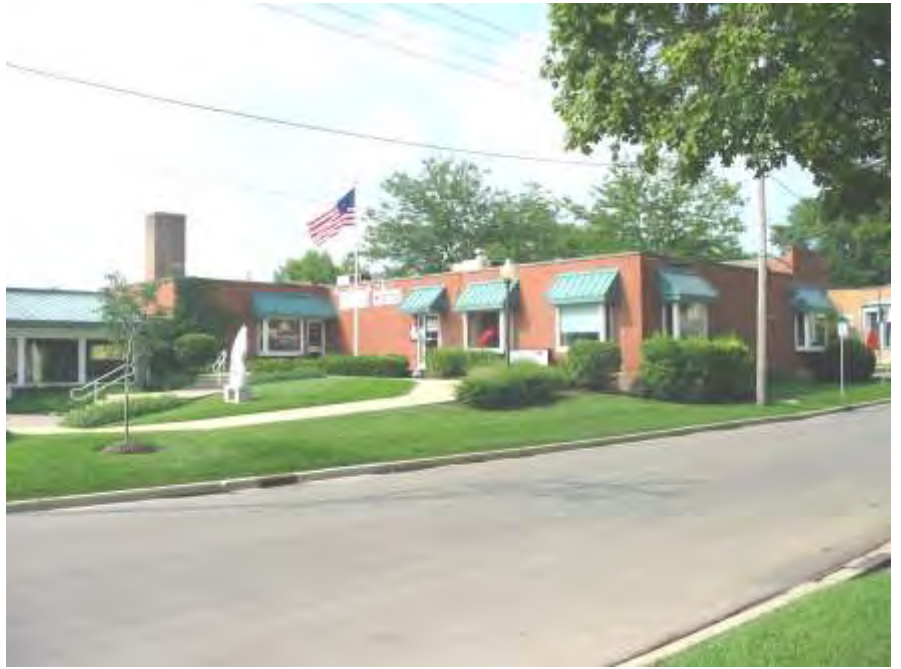
- ☐ Significant
- ☐ Contributing
- ☒ Non-Contributing
- ☐ Potential for Individual National Register Designation

Architectural Style/Type: <u>Utilitarian</u>	Exterior Walls (Current): <u>Brick</u>
Architectural Features: _____	Exterior Walls (Original): <u>Brick</u>
Date of Construction: <u>1920-1950</u>	Foundation: _____
Source: _____	Roof Type/Material: _____
Overall Plan Configuration: _____	Window Material/Type: _____
