ARCHITECTURAL SURVEY

NEAR WEST HISTORIC DISTRICT

ST. CHARLES, ILLINOIS

ST. CHARLES HISTORIC PRESERVATION COMMISSION

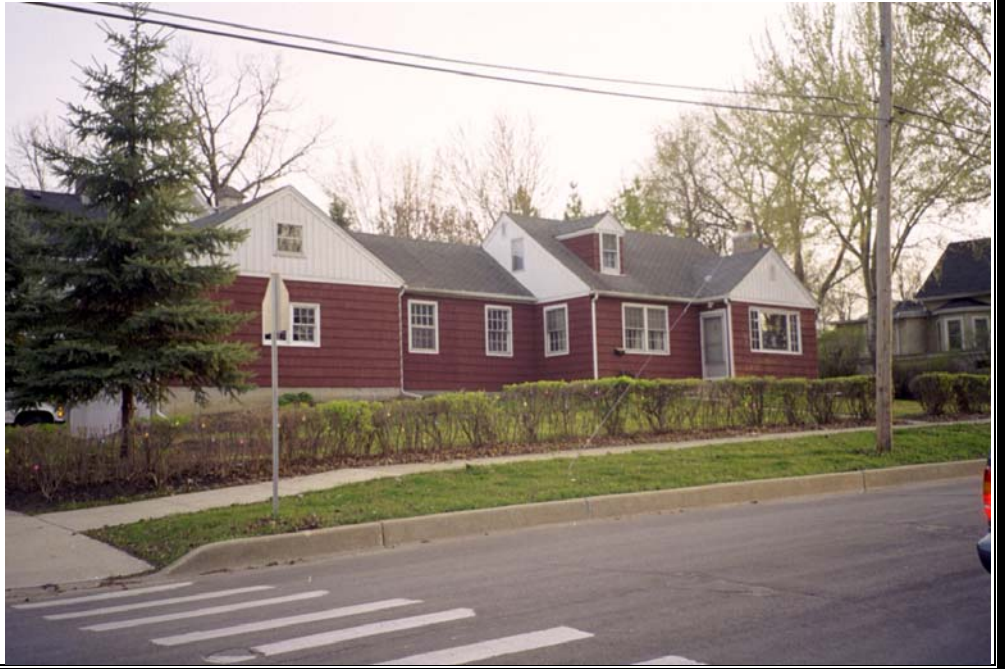
ADDRESS 501 State Street

- ☐ Excellent
- ☒ Good
- ☐ Fair
- ☐ Poor

Architectural Style/Type:	<u>Colonial Revival/Cape Cod</u>	Exterior Walls (Current):	<u>Cedar shingle</u>
Architectural Features:	<u></u>	Exterior Walls (Original):	<u>Cedar single</u>
Date of Construction:	<u>1930</u>	Foundation:	<u>Concrete block/Concrete @ garage</u>
Source:	<u>Township Assessor's Office</u>	Roof Type/Material:	<u>Side gable/Asphalt shingle</u>
Overall Plan Configuration:	<u>Simple rectangle</u>	Window Material/Type:	<u>Alum/Wd/double hung</u>

ARCHITECTURAL FEATURES: There is a small dormer on the front of the house near the entrance. A small cupola was installed over the garage.

ALTERATIONS: This house was moved to this site in 1966 from the site of the Coca Cola plant. The foundation was built onsite using standard CMU and then the house was moved. The garage was built onsite on a concrete foundation.

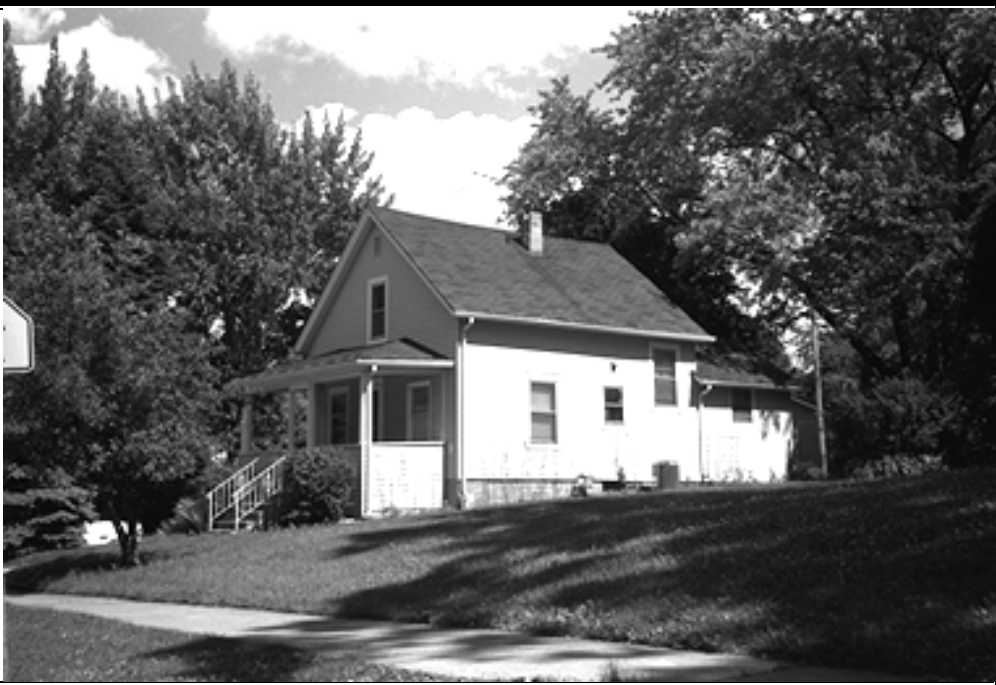
ADDRESS 515 State Street

- ☐ Excellent
- ☒ Good
- ☐ Fair
- ☐ Poor

ARCHITECTURAL FEATURES: Round classical columns support the full width front porch.

ALTERATIONS: A one story addition was made to the rear of the house that is somewhat sympathetic with the original house. A 2 story addition was also put on the rear of the house and is not sympathetic with the original style. A flat roofed garage addition is also not sympathetic to the original. The soffits have been boxed in with aluminum.

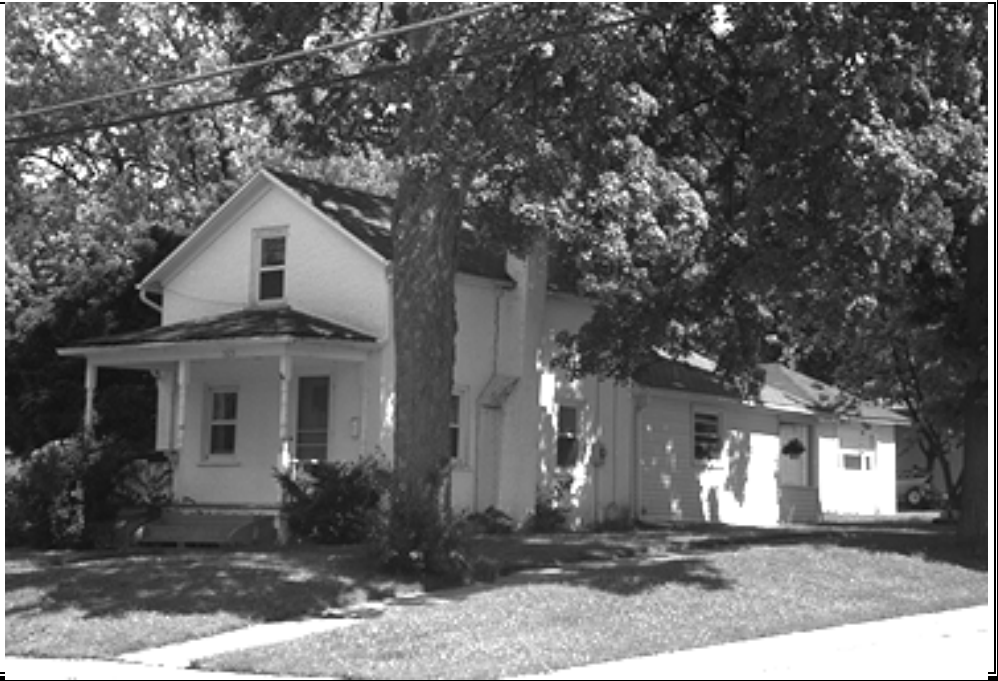
ADDRESS 523 State Street

- ☐ Excellent
- ☒ Good
- ☐ Fair
- ☐ Poor

Architectural Style/Type:	<u>Folk Victorian</u>	Exterior Walls (Current):	<u>Brick/Aluminum</u>
Architectural Features:	<u></u>	Exterior Walls (Original):	<u>Brick</u>
Date of Construction:	<u>1910</u>	Foundation:	<u>Parged masonry</u>
Source:	<u>Township Assessor's Office</u>	Roof Type/Material:	<u>Front gable/Asphalt shingle</u>
Overall Plan Configuration:	<u>Simple/rectangle</u>	Window Material/Type:	<u>Alum/Double hung</u>

ARCHITECTURAL FEATURES: The front porch runs the full width and its roof is supported by turned columns. It is simply detailed overall lacking the fine detailing commonly associated with the style.

ALTERATIONS: The additions to the rear are sided with aluminum. It appears that there have been 2 additions.

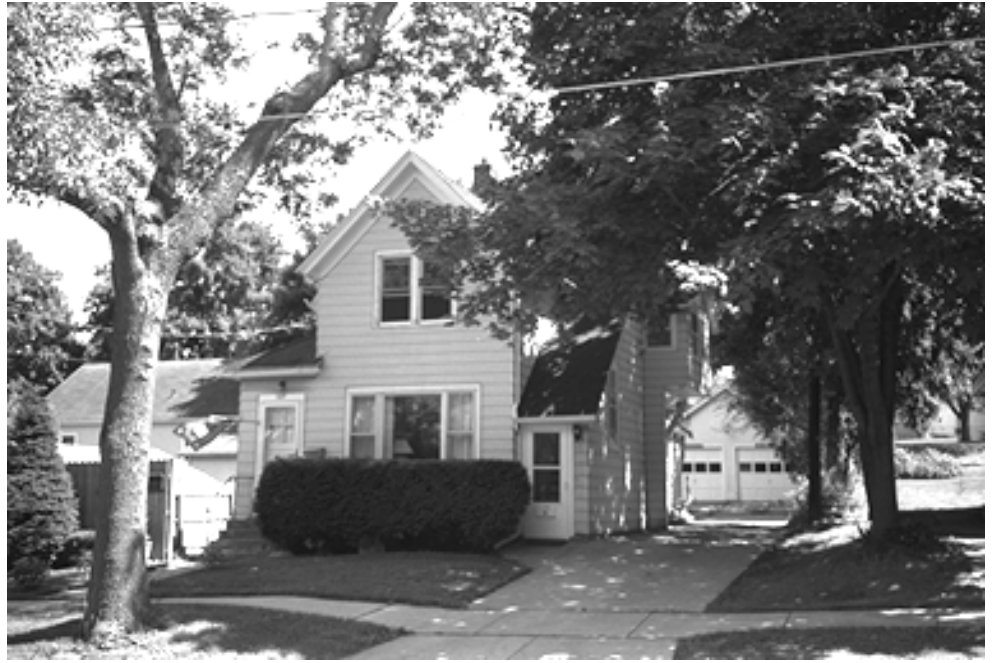
ADDRESS 609 State Street

- ☐ Excellent
- ☐ Good
- ☒ Fair
- ☐ Poor

Architectural Style/Type:	<u>National?</u>	Exterior Walls (Current):	<u>Aluminum</u>
Architectural Features:	<u></u>	Exterior Walls (Original):	<u>Clapboard</u>
Date of Construction:	<u>1915</u>	Foundation:	<u>Parged masonry/concrete</u>
Source:	<u>Township Assessor's Office</u>	Roof Type/Material:	<u>Cross gable/Asphalt shingle</u>
Overall Plan Configuration:	<u>Compound/mass</u>	Window Material/Type:	<u>Aluminum/Double hung</u>

ARCHITECTURAL FEATURES: The original house has been transformed through additions and modifications that make it difficult to see what the original style really was. The front gable end dominates the street elevation. A pair of double hung windows is all that remains of the original design elements apparent from the street.

ALTERATIONS: A 2 story addition to the west side sits on a concrete foundation. A 1 story addition to the south side is somewhat sympathetic with the massing of the original house. A large picture window was installed at the ground floor front elevation replacing the original windows/door.

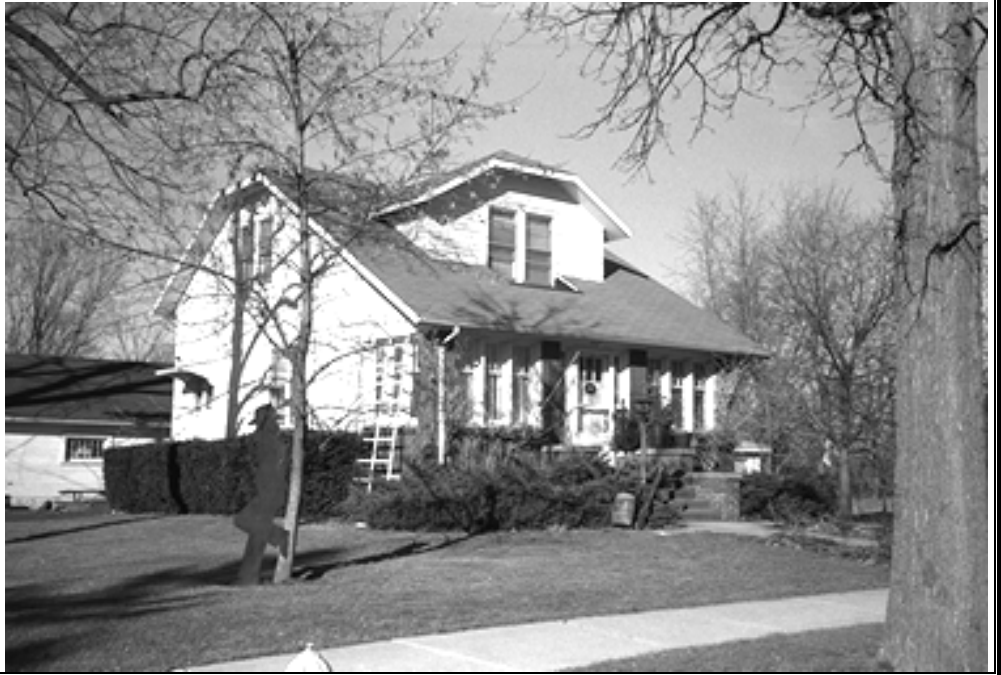
ROLL-IMAGE # 3432 - 19

Architectural Style/Type:	Craftsman Bungalow	Exterior Walls (Current):	Clapboard w/brick front porch
Architectural Features:		Exterior Walls (Original):	Clapboard
Date of Construction:	1925	Foundation:	Parged masonry – Orig.
Source:	Township Assessors Office	Roof Type/Material:	Hipped Side gable/ Asphalt Shingle
Overall Plan Configuration:	Simple rectangle	Window Material/Type:	Alum/Dbf Hung

ALTERATIONS: The brick appears to have been added when the front porch was closed in. There is a large 2-story addition to the rear that has a gable roof and detailing similar to the original house. The addition has a concrete foundation.

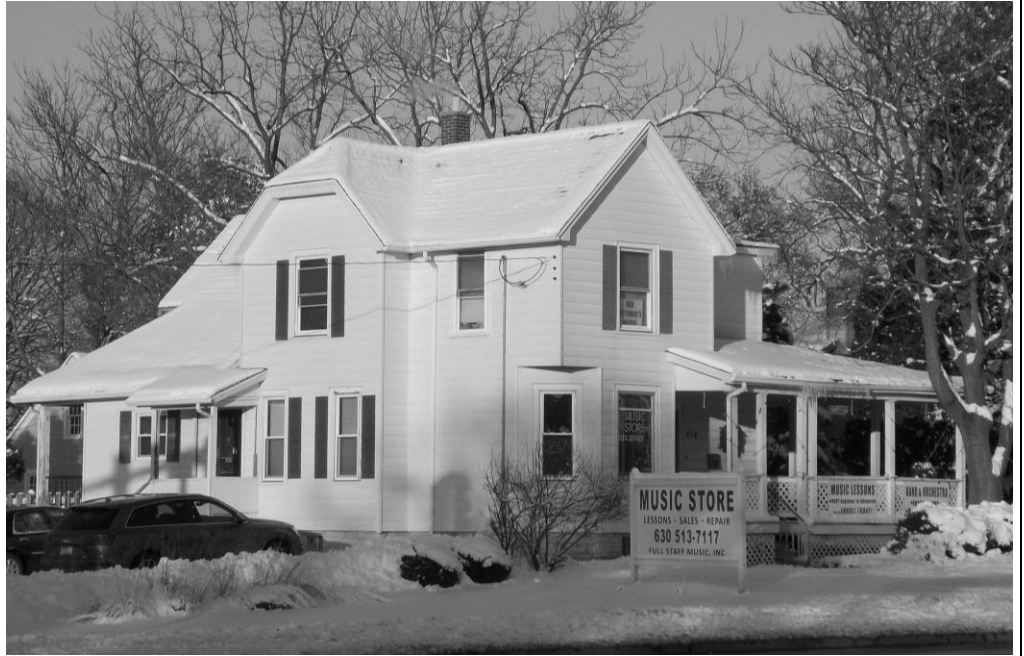
Architectural Style/Type:	<u>Eclectic folk</u>	Exterior Walls (Current):	<u>Aluminum</u>
Architectural Features:	<u></u>	Exterior Walls (Original):	<u>Clapboard</u>
Date of Construction:	<u>1900</u>	Foundation:	<u>Stone(orig), Conc. @ additions</u>
Source:	<u>Township Assessor's Office</u>	Roof Type/Material:	<u>Cross gable/asphalt shingle</u>
Overall Plan Configuration:	<u>Compound - mass</u>	Window Material/Type:	<u>Alum/Dbf. hung</u>

ALTERATIONS: The wrap around front porch has been recently redone using wolmanized lumber and does not relate well to the rest of the house. All of the detailing that this house once might have had is completely concealed by all of the aluminum. There is an addition at the rear that has a slightly lower gable roof than the main roof. A rear porch was added at some point using plain CMU as a foundation. This is currently a commercial occupancy.

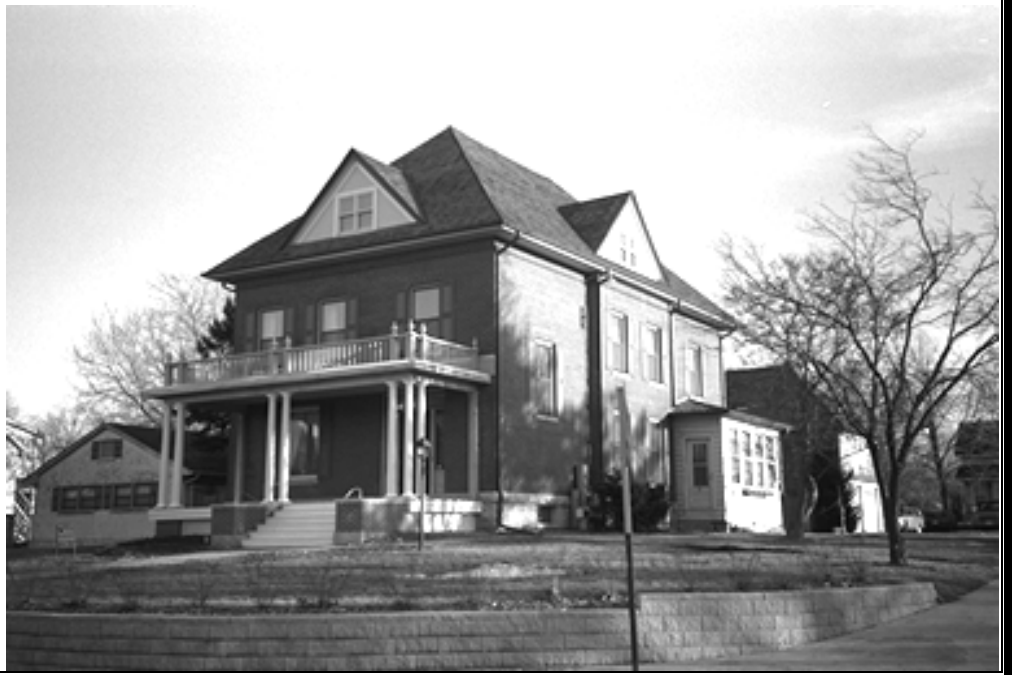
ROLL-IMAGE # 3435 - 5

Foundation: Stone(orig.), Conc.(Additions)

ARCHITECTURAL FEATURES: This is a large imposing façade accentuated by being elevated above the street level and by being located on a very prominent site. The roof is a simple hip with a long ridgeline and is articulated with large triangular roof dormers on the north, east, and west elevations. The east and west dormers crown a two story brick projection serving to break up what could have been an uneventful façade. The top of the stone foundation stops vertically at the first floor line and adds visual interest and character to the massive looking house.

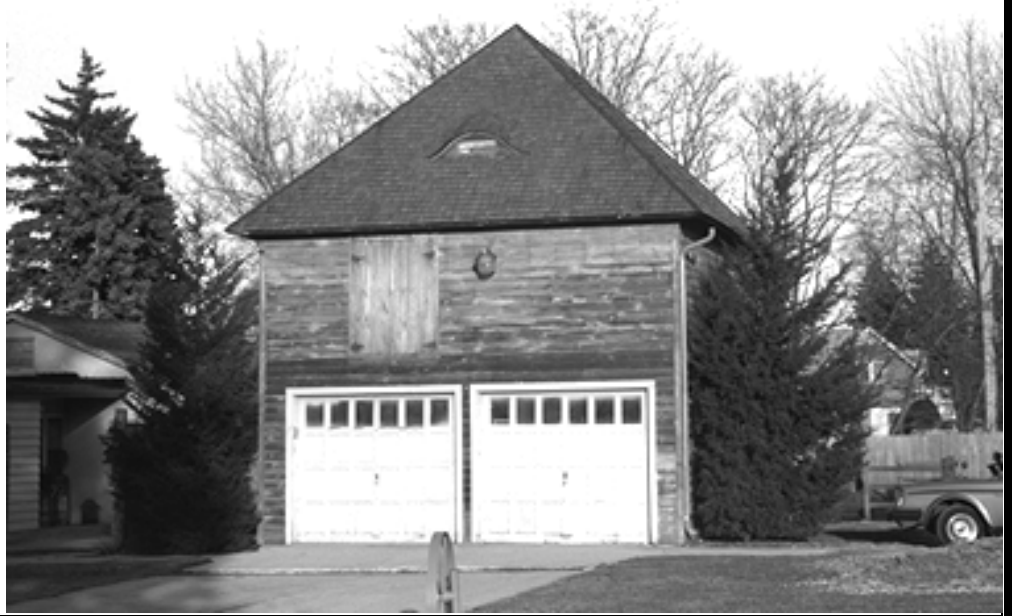
ROLL-IMAGE # 3435 - 3

Architectural Style/Type:	<u>Colonial revival</u>	Exterior Walls (Current):	<u>Clapboard</u>
Architectural Features:	<u></u>	Exterior Walls (Original):	<u>Clapboard</u>
Date of Construction:	<u>1890 est.</u>	Foundation:	<u>Stone?</u>
Source:	<u>Owner</u>	Roof Type/Material:	<u>Hipped/Wood shingle</u>
Overall Plan Configuration:	<u>Simple square</u>	Window Material/Type:	<u>Wood</u>

ALTERATIONS: This appears to have been a barn that was adaptively reused as a garage. Overhead garage doors have replaced the original doors and are not sympathetic with the original barn design.

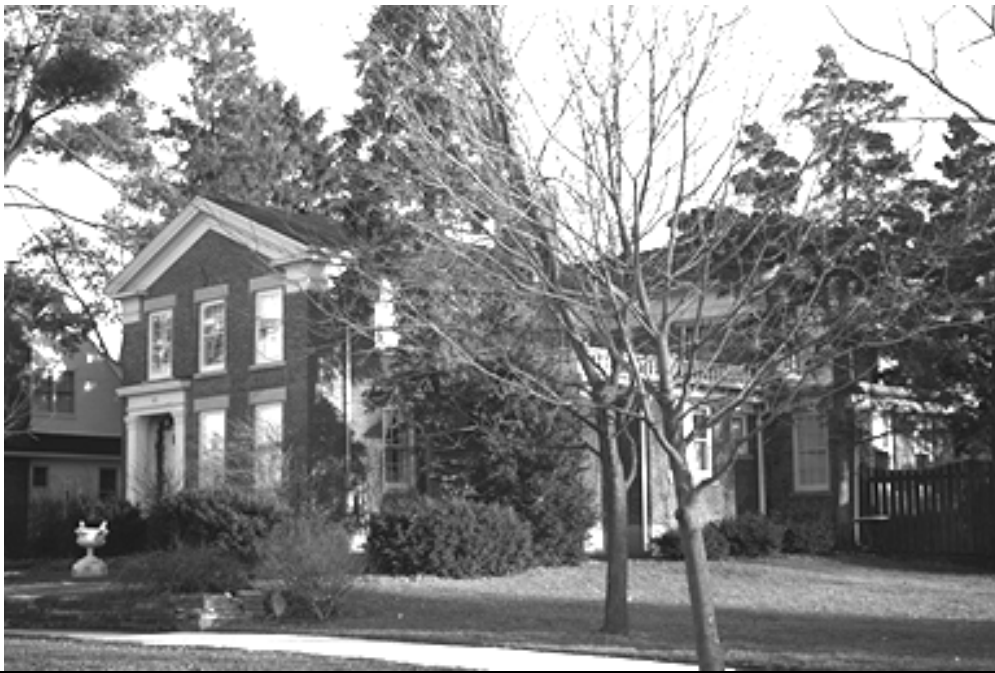
ROLL-IMAGE # 3435 - 8

Foundation: Stone

ARCHITECTURAL FEATURES: A large front gable dominates the front of the house. A heavy frieze band located at the roof line is broken at the front elevation. There is a prominent entrance detailed in the classical tradition in wood. Stone lintels and sills are typical around the house. The window pattern is 6:6.

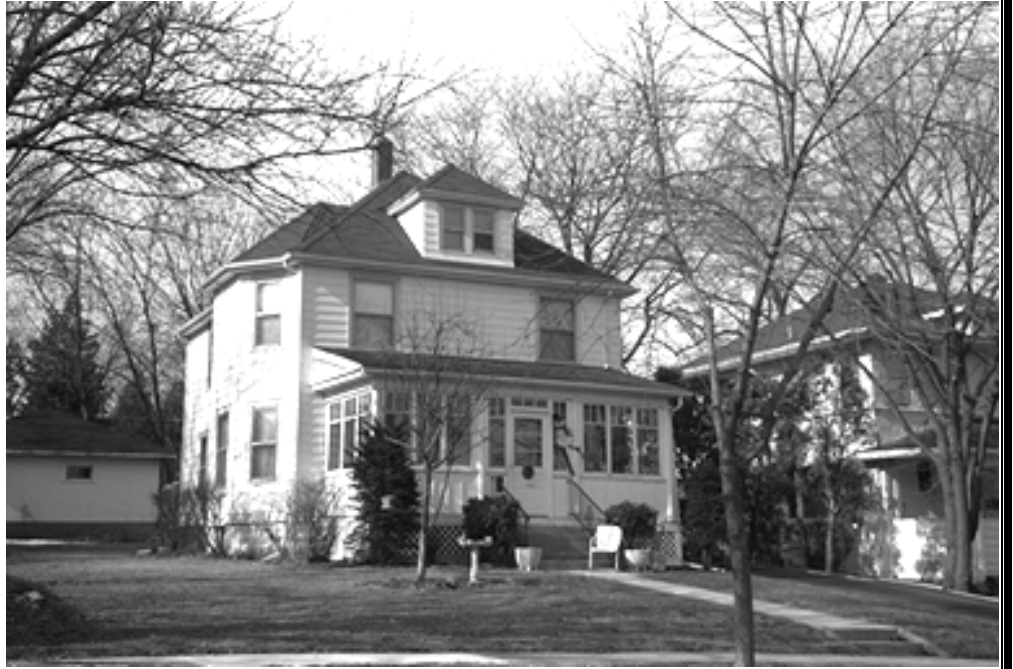
ROLL-IMAGE # 3435 - 19

Architectural Style/Type:	<u>Prairie 4 square</u>	Exterior Walls (Current):	<u>Aluminum</u>
Architectural Features:	<u></u>	Exterior Walls (Original):	<u>Clapboard</u>
Date of Construction:	<u>1920</u>	Foundation:	<u>Textured CMU</u>
Source:	<u>Township Assessor's Office</u>	Roof Type/Material:	<u>Hipped/Asphalt Shingle</u>
Overall Plan Configuration:	<u>4 square</u>	Window Material/Type:	<u>Aluminum/Dbl Hung</u>

ALTERATIONS: The front porch has been closed in. The windows of the porch do not currently match the rest of the house as the proportions of the openings do not match nor do the muntin patterns. The porch foundation is skirted with a wooden lattice while the deck is accessed by a CIP concrete stoop and a wrought iron railing.

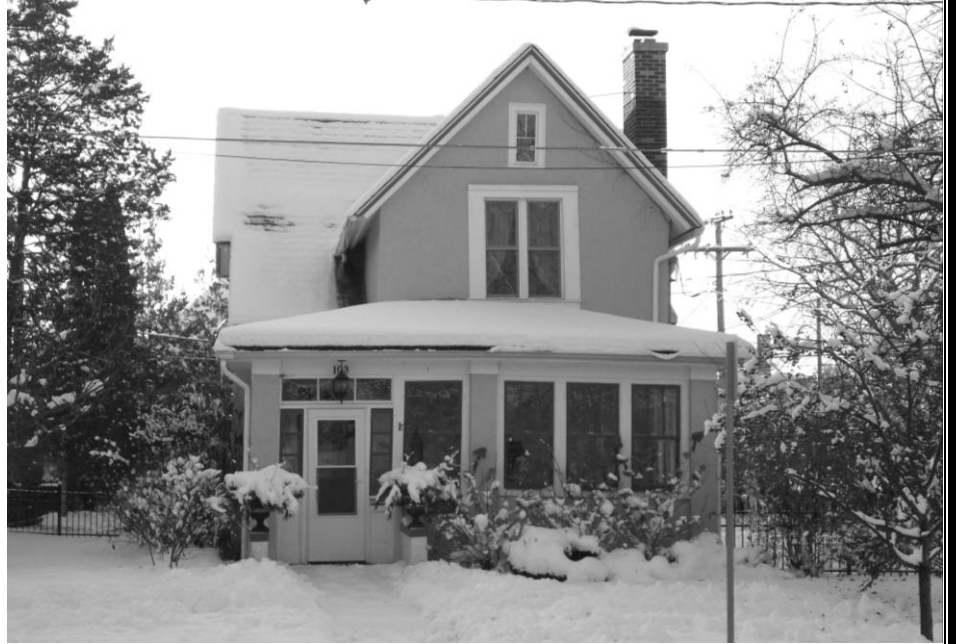
Architectural Style/Type:	National	Exterior Walls (Current):	Stucco
Architectural Features:		Exterior Walls (Original):	Clapboard?
Date of Construction:	1896	Foundation:	Parged masonry
Source:	Landmark Application	Roof Type/Material:	Cross gable/Asphalt shingle
Overall Plan Configuration:	Simple "T"	Window Material/Type:	Wood/Db. Hung – There are Some alum. inserts

ALTERATIONS: The front porch has been closed in and has an aluminum front door. A 1 story addition to the rear features a balcony on the roof of the ground floor accessed through an aluminum door from the second floor. It is built on a brick foundation. The stucco was applied to the house in 1910.

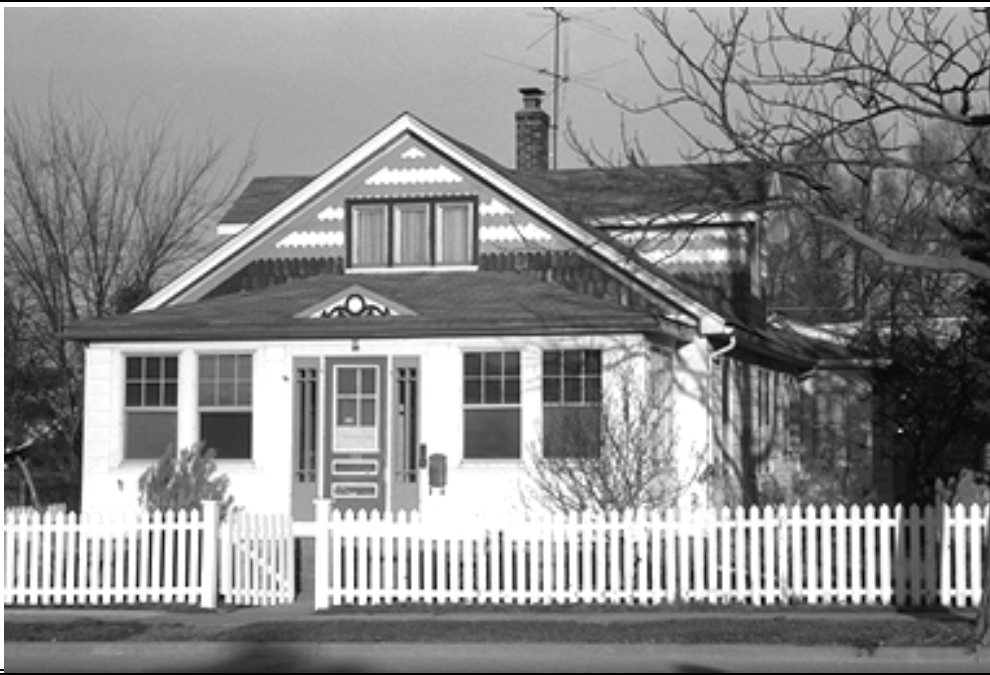
ROLL-IMAGE # 3435 - 15

Foundation: Textured CMU

ALTERATIONS: This house has been aluminized. The original siding has been replaced and aluminum windows and trim has replaced the original wood. There is a one story addition featuring a hipped roof to the rear of the house that has a concrete foundation.
