ARCHITECTURAL SURVEY

NEAR WEST HISTORIC DISTRICT

ST. CHARLES, ILLINOIS

ST. CHARLES HISTORIC PRESERVATION COMMISSION

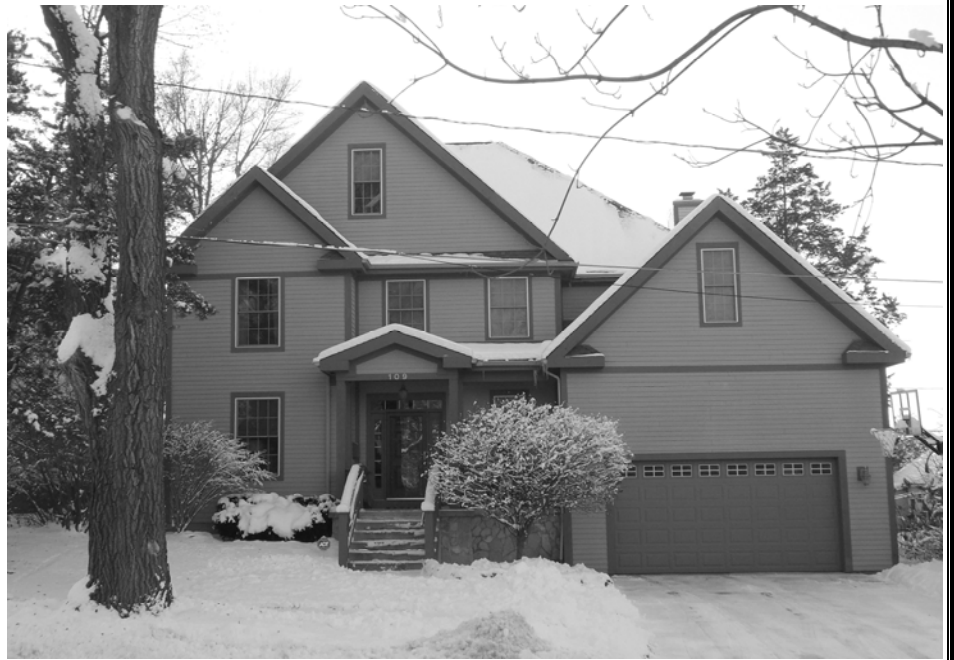
ADDRESS 109 South 6th Street

- ☒ **Excellent**
- ☐ Good
- ☐ Fair
- ☐ Poor

The multiple front gables, two of which have cornice returns, are the most prominent features of the front elevation, along with the protruding garage “L”. A small front entrance porch is supported by a shed roof overhang and gable form over the front door.

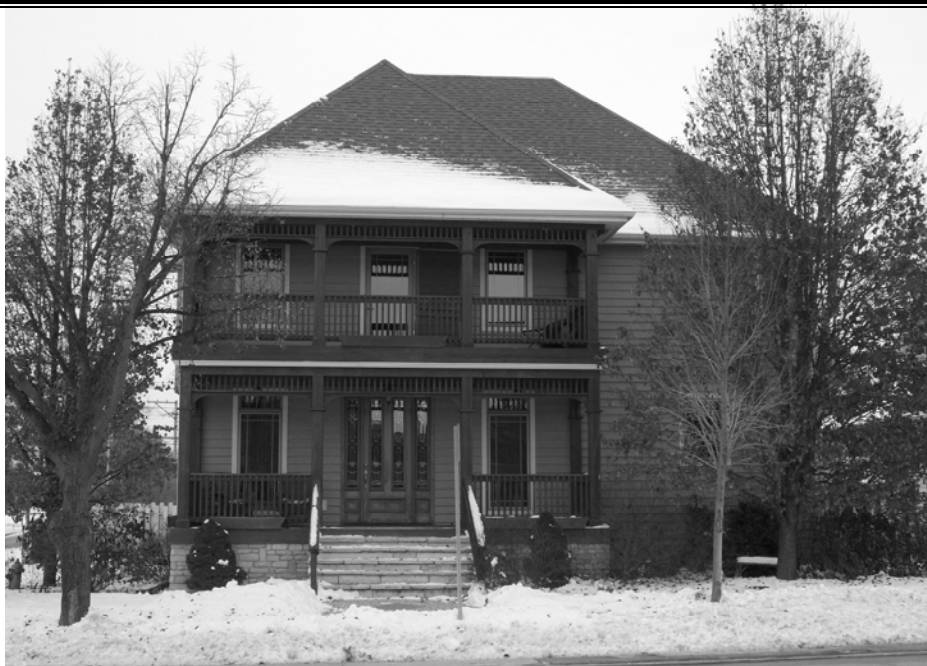
ADDRESS 623 Walnut Street

- ☒ Excellent
☐ Good
☐ Fair
☐ Poor

ARCHITECTURAL FEATURES: Large two-story structure with a steeply pitched, cross-hipped roof and attached, side-loaded garage. The offset two-story front entry porch is the dominant architectural feature.

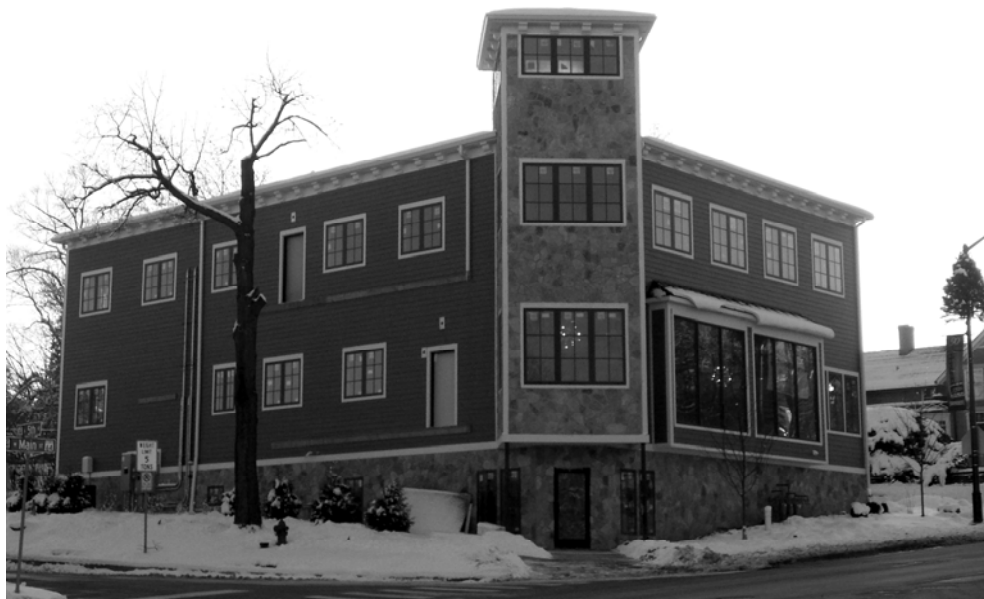
ADDRESS 505 West Main Street

- ☒ **Excellent**
- ☐ Good
- ☐ Fair
- ☐ Poor

ARCHITECTURAL FEATURES: New construction on top of 1950 foundation. The structure reflects a mixture of elements from various architectural styles. The corner entrance is covered by a three-story protruding stone veneer tower. Large cantilevered windows are prominent on the north elevation. The roofline features a bracketed cornice.

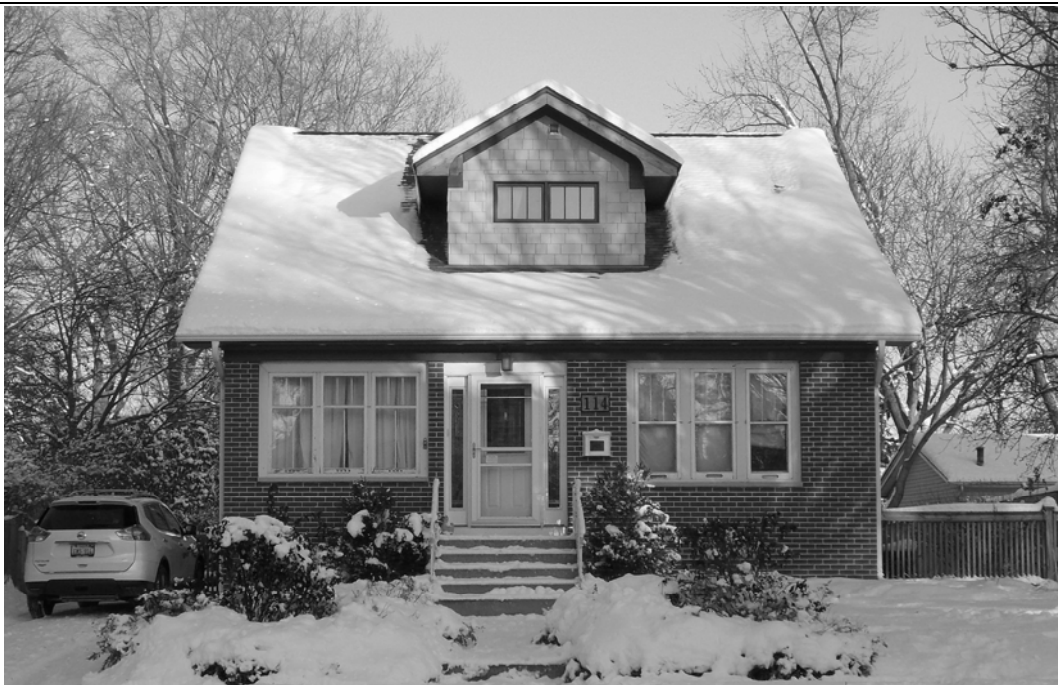
ADDRESS 114 South 6th Street

- ☐ Excellent
- ☒ Good
- ☐ Fair
- ☐ Poor

ARCHITECTURAL FEATURES: This house appears to be symmetrical at first glance, but is not. The entry is off center and the windows to the right and left of the entry are different. It appears that this could have been a Craftsman bungalow at one time judging from the overhangs and massing. The roof dormer on the front elevation is also somewhat typical of the style.

ALTERATIONS: Any original wood details that might have been are gone. A brick veneer was added to the front and wrapped around to what was probably the back of the front porch. The soffits are open and covered with plywood. **The front**

dormer has been pushed forward and the window opening has been modified.

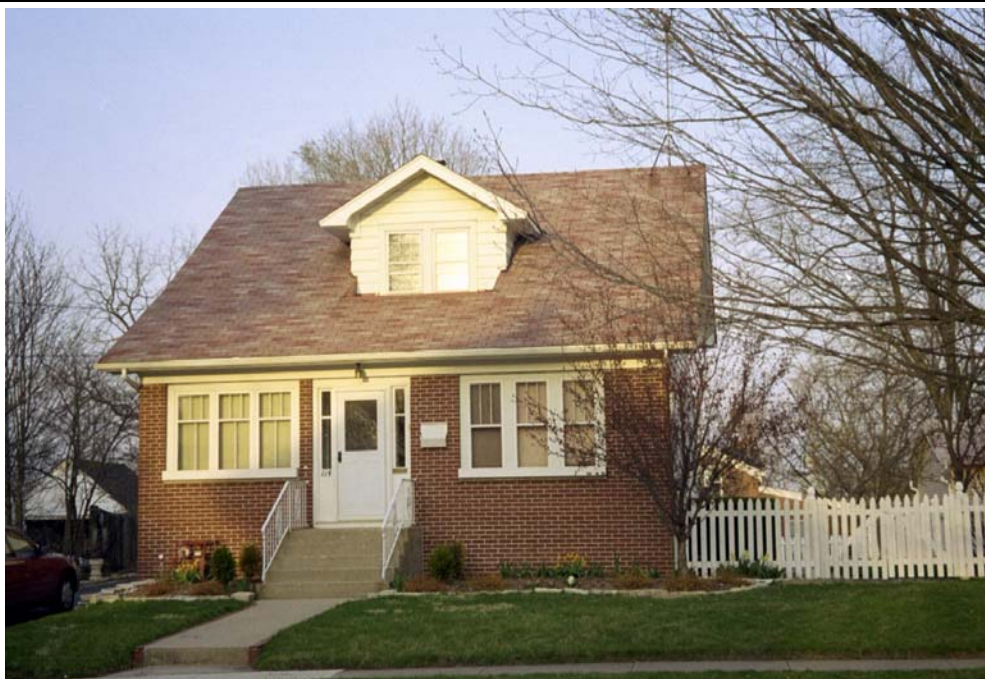
ROLL-IMAGE # 3299 - 8

- ☐ Excellent
- ☒ Good
- ☐ Fair
- ☐ Poor

ARCHITECTURAL FEATURES: This house appears to be symmetrical at first glance, but is not. The entry is off center and the windows to the right and left of the entry are different. It appears that this could have been a Craftsman bungalow at one time judging from the overhangs and massing. The roof dormer on the front elevation is also somewhat typical of the style.

ALTERATIONS: Any original wood details that might have been are gone. A brick veneer was added to the front and wrapped around to what was probably the back of the front porch. The soffits are open and covered with plywood.

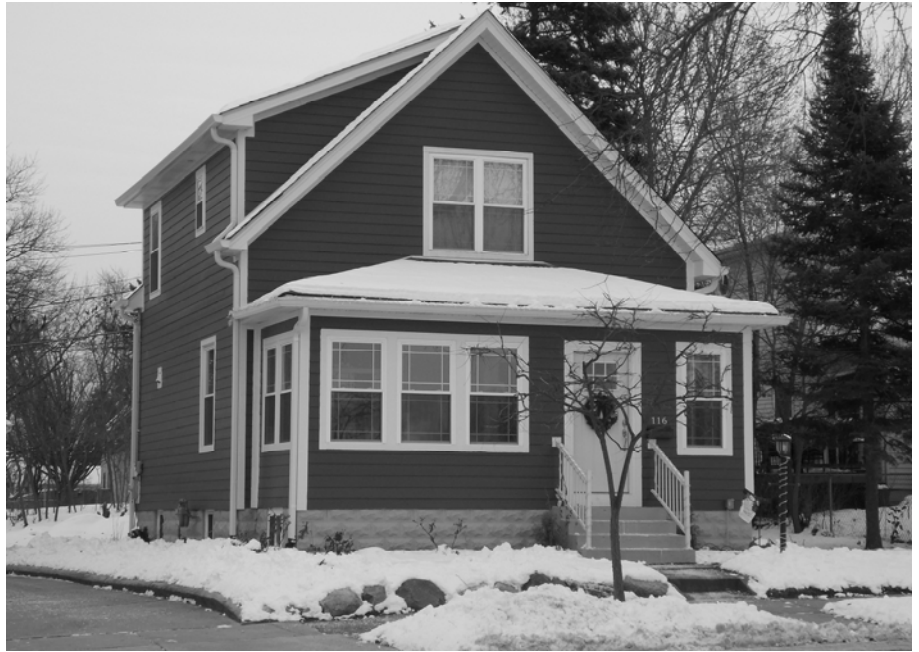
ADDRESS 116 South 7th Street

- ☐ Excellent
- ☒ Good
- ☐ Fair
- ☐ Poor

ARCHITECTURAL FEATURES: This roof is relatively steep – approximately 12:12. The front gable features a pair of windows. The south elevation of the roof has a shed dormer that may have been added later.

ALTERATIONS: The front porch was closed in to make a 3 or 4 season room. ~~This house has been aluminized.~~ The siding, windows, front door and soffits have been changed. There is a small porch that was added to the rear of the house. ~~A shed dormer has been added on the north elevation.~~

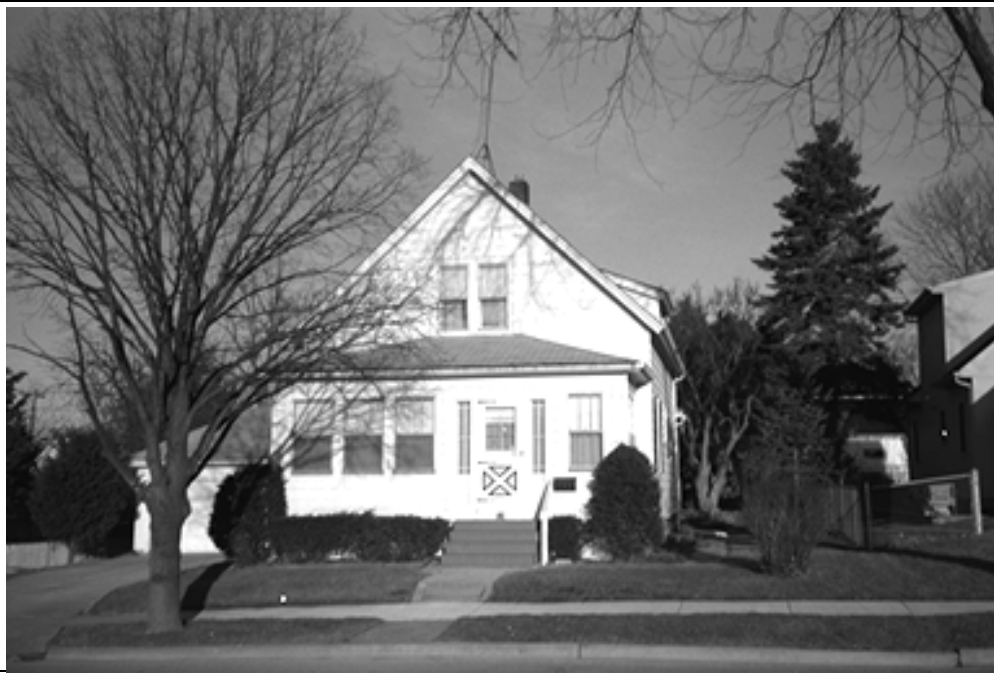
ROLL-IMAGE # 3435 - 14

- ☐ Excellent
- ☒ Good
- ☐ Fair
- ☐ Poor

ARCHITECTURAL FEATURES: This roof is relatively steep – approximately 12:12. The front gable features a pair of windows. The south elevation of the roof has a shed dormer that may have been added later.

ALTERATIONS: The front porch was closed in to make a 3 or 4 season room. This house has been aluminized. The siding, windows, front door and soffits have been changed. There is a small porch that was added to the rear of the house.

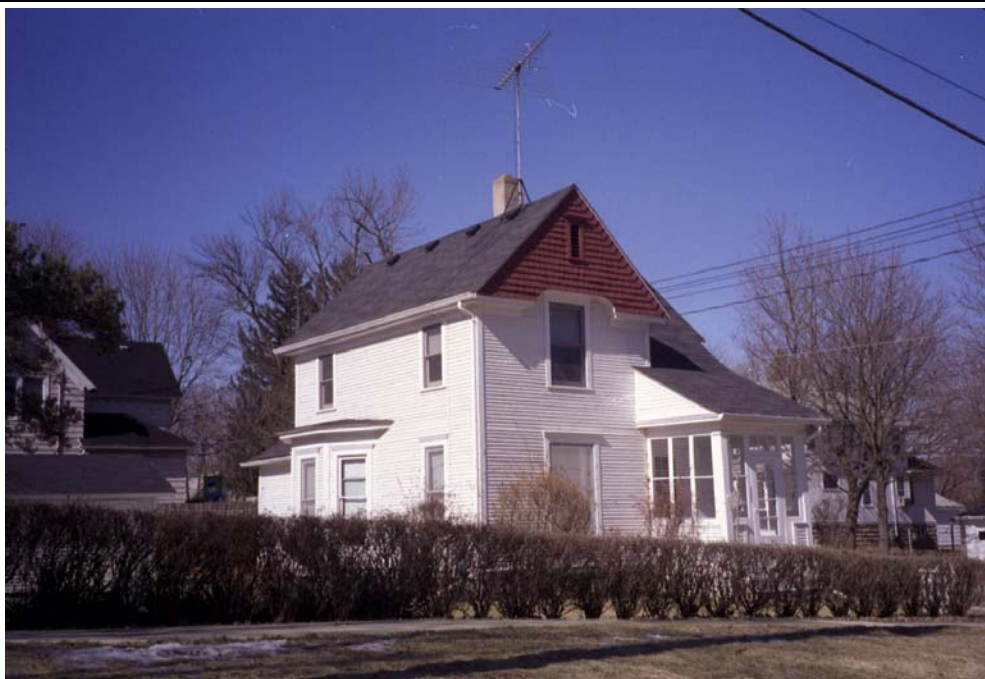
ROLL-IMAGE # 2727 - 8CD-IMAGE # 0298 - 8

- ☐ Excellent
☒ Good
☐ Fair
☐ Poor

ARCHITECTURAL FEATURES: The flat arched cut out of the front gable end is a distinctive detail. It is decorated with wood shingles. A small entry porch is covered by a long sweep of the main roof slope. Both of these features are somewhat characteristic of the Shingle or the Queen Anne styles. A relatively deep frieze board trims the wall/eave juncture. Almost all of the windows feature a crown molding at the head. The original front door is still in place inside the porch. There is a small one-story bay window on the south elevation.

ALTERATIONS: The front entry porch has been closed in. A small one-story addition was made to the rear of the house. The side door is aluminum.

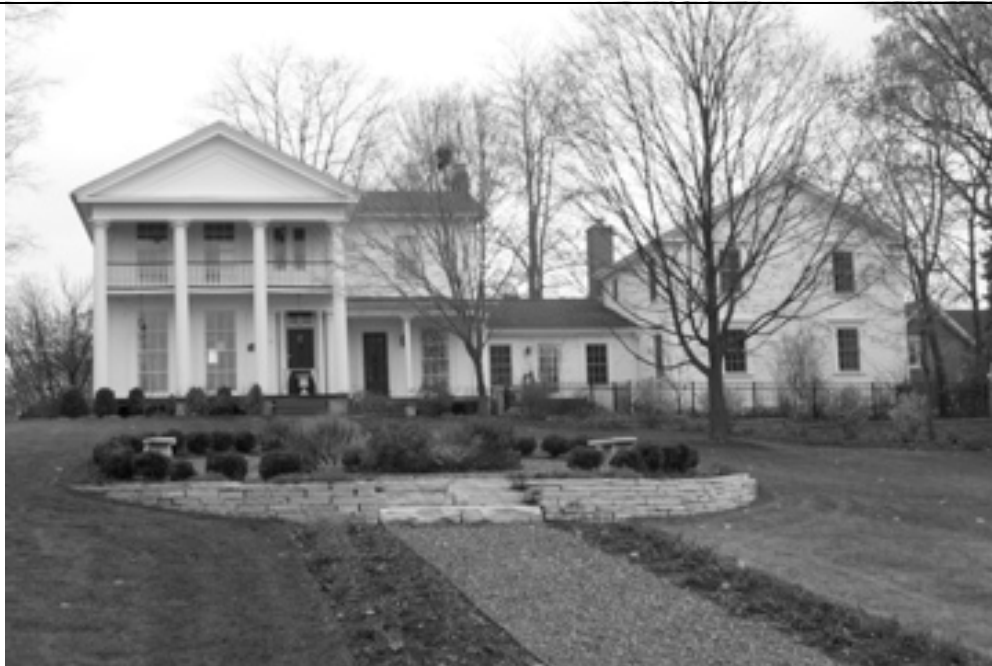
ADDRESS 19 South Fifth Street

- ☐ Excellent
- **Good**
- ☐ Fair
- ☐ Poor

ARCHITECTURAL FEATURES: Features a large 2 story gabled portico supported by stylized Greek Doric columns. There is a 2nd story balcony supported by the portico columns. The portico is designed in the Greek temple form. The house is sited on a hill, also typical of Greek temple planning. The window surrounds exhibit typically simple Greek detailing. The house is sided with narrow wood clapboards with a 5" exposure.

ALTERATIONS: There was a second floor section added over the dining room and parlor. The conservatory off the dining room and the closet off the first floor SE bedroom are also later additions. John A. Brown, who purchased the property in 1885, added French doors to the second floor porch during an extensive interior remodeling. In 2005, a two-story addition was connected to the original structure by a one-story wing. The addition is set back from the original structure and has a lower roof pitch, allowing the original elevation to retain its prominence. Window size and pattern, materials, and architectural style match the original structure, but the details are more simplified.

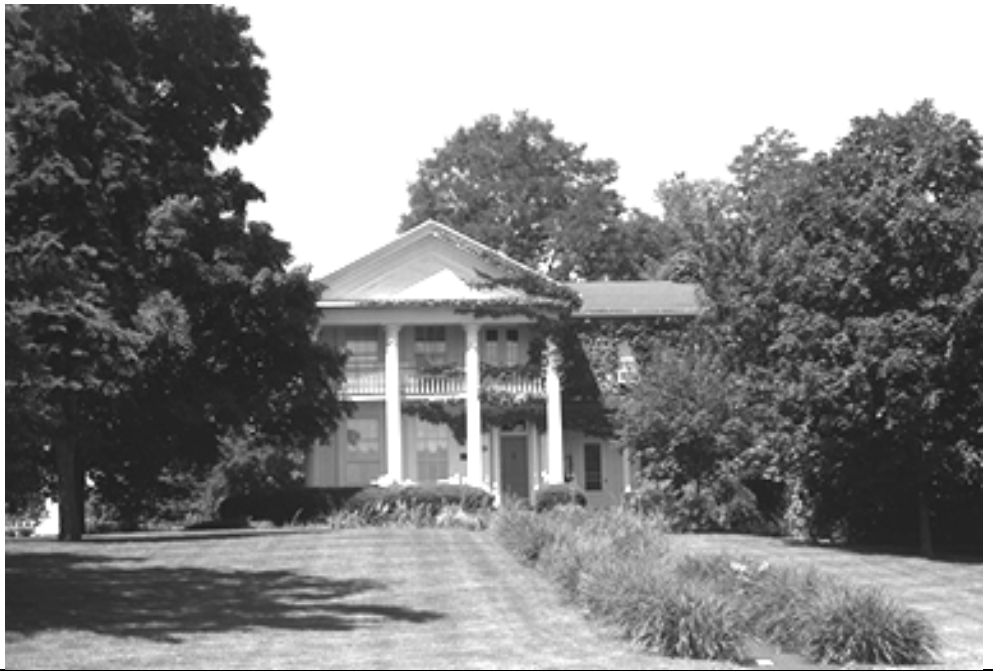
ROLL-IMAGE # 102 - 2

- ☐ Excellent
- **Good**
- ☐ Fair
- ☐ Poor

ARCHITECTURAL FEATURES: Features a large 2 story gabled portico supported by stylized Greek Doric columns. There is a 2nd story balcony supported by the portico columns. The portico is designed in the Greek temple form. The house is sited on a hill, also typical of Greek temple planning. The window surrounds exhibit typically simple Greek detailing. The house is sided with narrow wood clapboards with a 5" exposure.

ALTERATIONS: There was a second floor section added over the dining room and parlor. The conservatory off the dining room and the closet off the first floor SE bedroom are also later additions. John A. Brown, who purchased the property in 1885, added French doors to the second floor porch during an extensive interior remodeling.

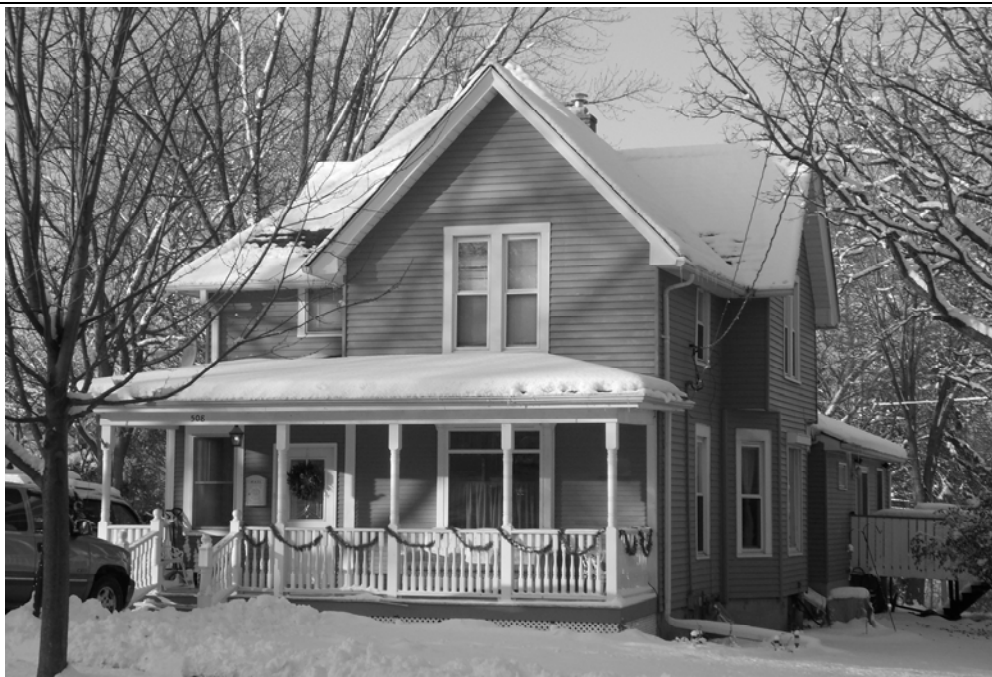
ADDRESS 508 Cedar Street

- ☒ Excellent
- ☐ Good
- ☐ Fair
- ☐ Poor

ARCHITECTURAL FEATURES: The roofs are steep and the house has typical massing for this style. The full width front porch is the prominent architectural feature of the front elevation. The paired double hung windows located on the 2F of the front gable are narrow and have no muntins.

ALTERATIONS: There is an addition to the rear of the house that has a shallow pitched roof and as elevated wooden deck. These additions are non-sympathetic to the original house. ~~The front porch has been filled in and is sheathed in vertical aluminum siding.~~ The windows feature a 3:1 muntin pattern. All of the aluminum trim, windows, and siding are new.

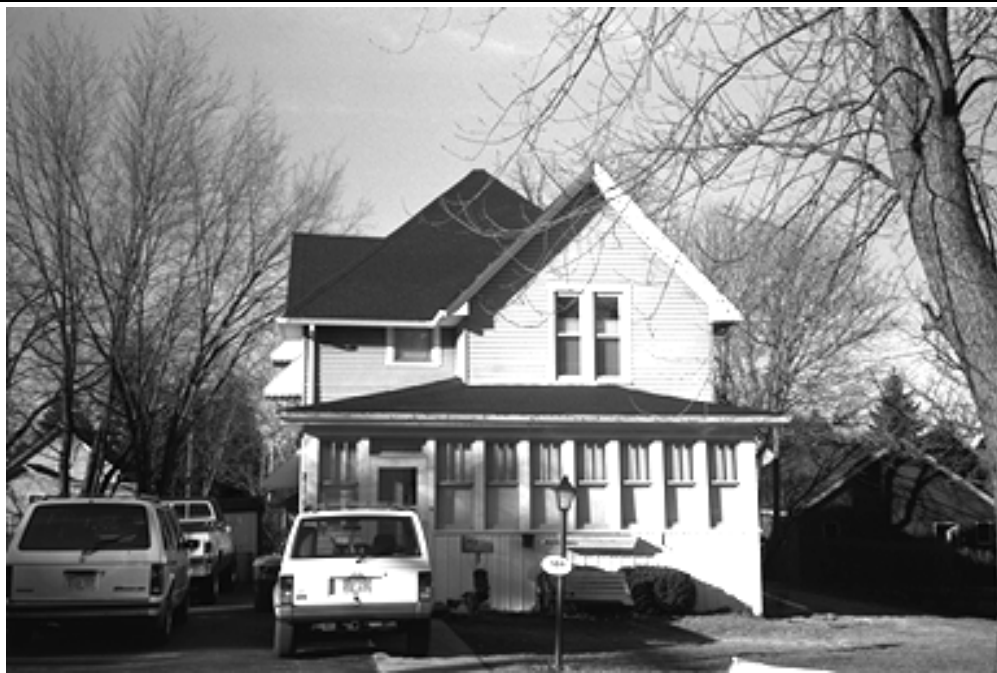
ROLL-IMAGE # 3432 - 28

- ☒ Excellent
- ☐ Good
- ☐ Fair
- ☐ Poor

ARCHITECTURAL FEATURES: The roofs are steep and the house has typical massing for this style. The full width front porch is the prominent architectural feature of the front elevation. The paired double hung windows located on the 2F of the front gable are narrow and have no muntins.

ALTERATIONS: There is an addition to the rear of the house that has a shallow pitched roof and an elevated wooden deck. These additions are non-sympathetic to the original house. The front porch has been filled in and is sheathed in vertical aluminum siding. The windows feature a 3:1 muntin pattern. All of the aluminum trim, windows, and siding are new.

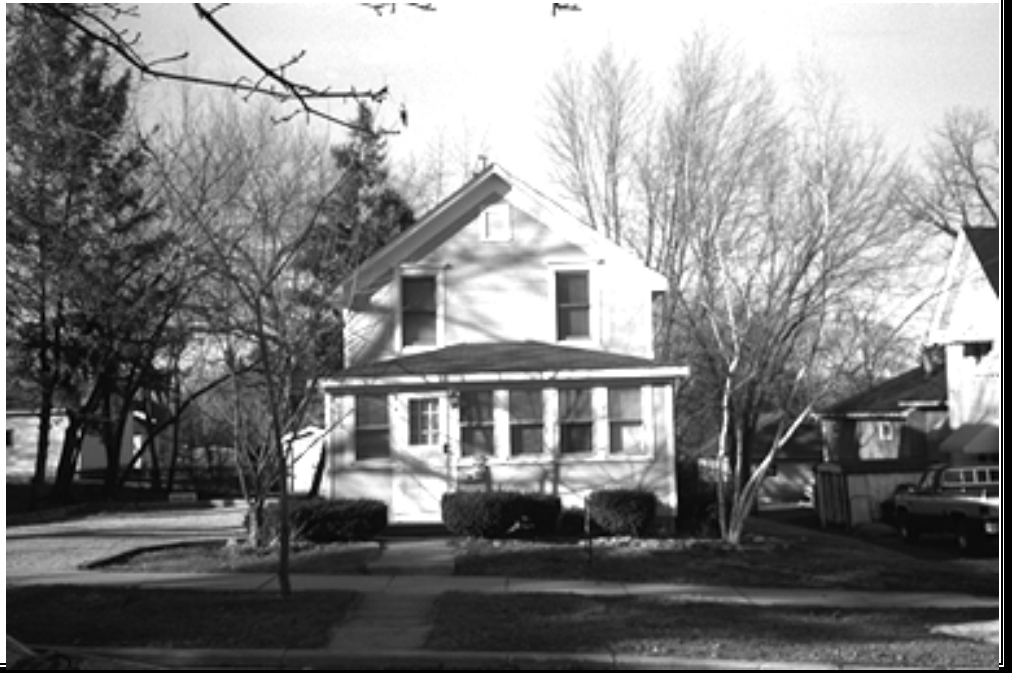
CD-IMAGE # 4367 - 27

- ☐ Significant
- ☒ Contributing
- ☐ Non-Contributing
- ☐ Potential for Individual National Register Designation

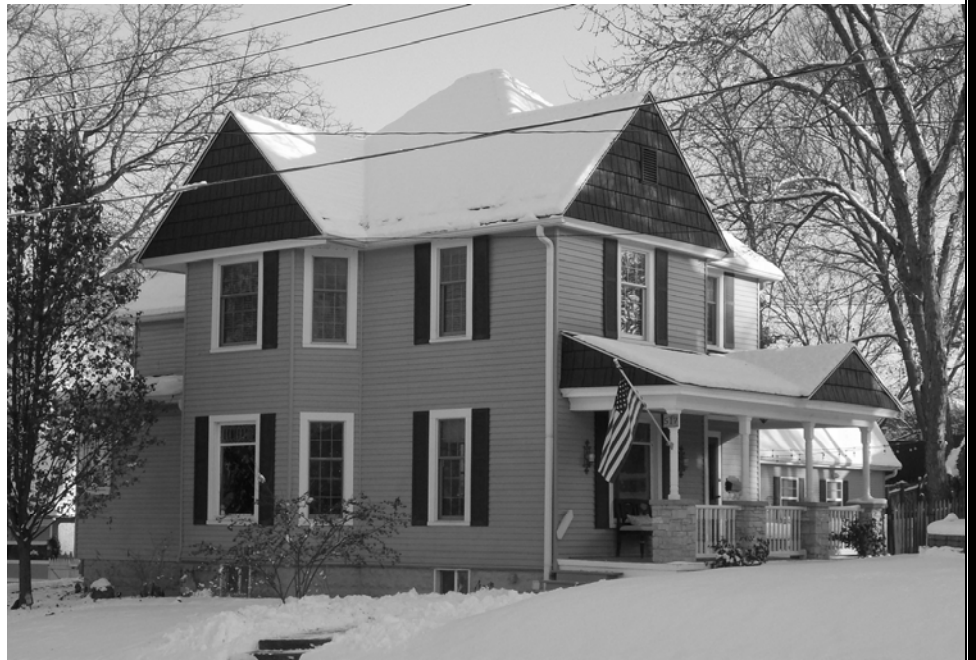
Architectural Style/Type:	Victorian/Queen Anne	Exterior Walls (Current):	Aluminum Vinyl /Wd Shingles
Architectural Features:		Exterior Walls (Original):	Clapboard/Wd Shingles
Date of Construction:	1915	Foundation:	Textured CMU
Source:	Township Assessors Office	Roof Type/Material:	Hipped w/ lower cross gables/ Asphalt Shingles
Overall Plan Configuration:	Simple w/Irregularities	Window Material/Type:	Vinyl /Dbl Hung

ALTERATIONS: The siding and windows have been replaced with ~~aluminum-vinyl~~(?). ~~There is~~ A small sun-porch located on

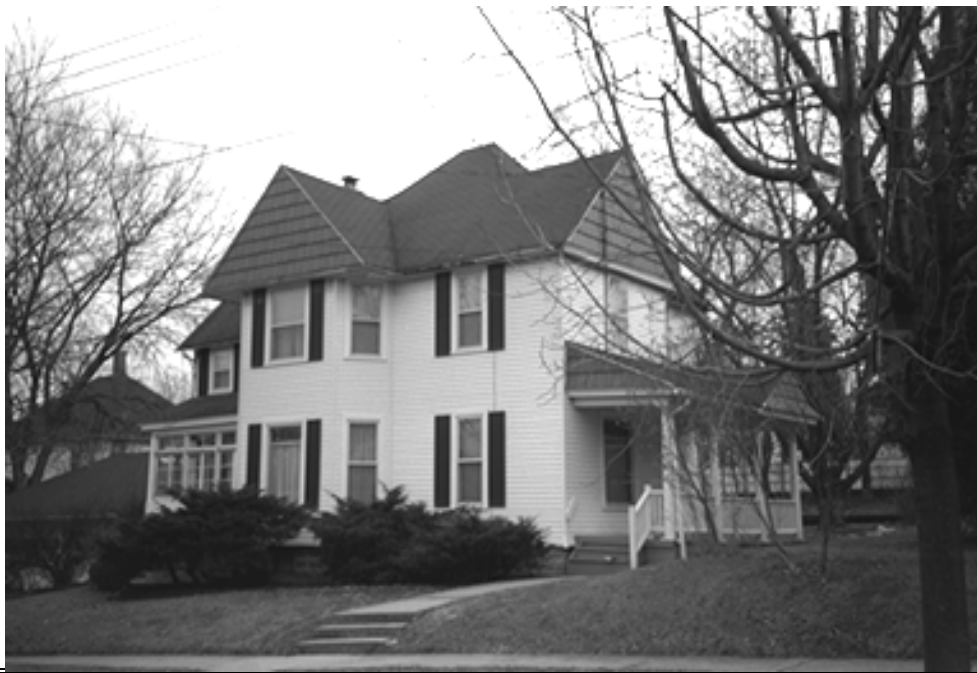
ROLL-IMAGE # 101 - 14

Architectural Style/Type:	<u>Victorian/Queen Anne</u>	Exterior Walls (Current):	<u>Aluminum/Wd Shingles</u>
Architectural Features:	<u></u>	Exterior Walls (Original):	<u>Clapboard/Wd Shingles</u>
Date of Construction:	<u>1915</u>	Foundation:	<u>Textured CMU</u>
Source:	<u>Township Assessors Office</u>	Roof Type/Material:	<u>Hipped w/ lower cross gables/ Asphalt Shingles</u>
Overall Plan Configuration:	<u>Simple w/Irregularities</u>	Window Material/Type:	<u>Alum/Dbf Hung</u>

ALTERATIONS: The siding and windows have been replaced with aluminum. There is a small sun-porch located on the street elevation that is ironic in that it is the northeast corner of the house.

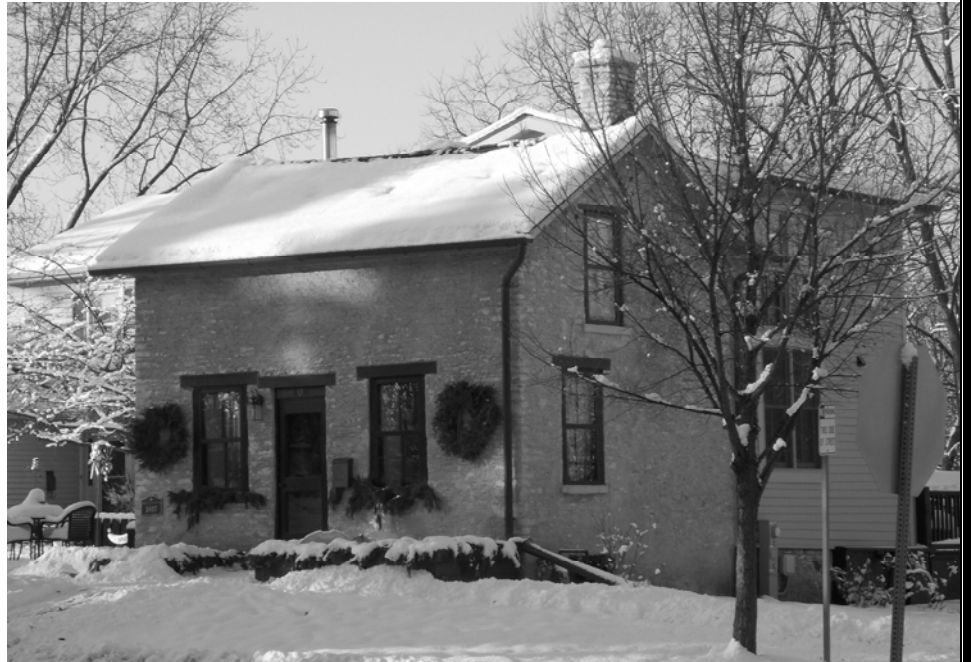
Architectural Style/Type:	National	Exterior Walls (Current):	Aluminum Limestone, clapboard (addition)
Architectural Features:		Exterior Walls (Original):	Clapboard Limestone
Date of Construction:	1837 Orig.	Foundation:	Stone / Orig., Conc. / Adds
Source:	Township Assessors Office Landmark Nomination	Roof Type/Material:	Side gable/Asphalt Shingle
Overall Plan Configuration:	Simple rectangle – Orig.	Window Material/Type:	Alum Wood/Dbl Hung

ALTERATIONS: ~~Little of the original house is revealed in its current condition. It appears that the aluminum siding and ill-conceived additions have concealed much.~~ The two-story addition to the rear does not relate to the original architecture in any way. ~~A two-story wooden deck that was added to the north of this addition does not relate to the addition or the original house.~~ A small one-story addition featuring an octagonal window was made to the west side of the house.

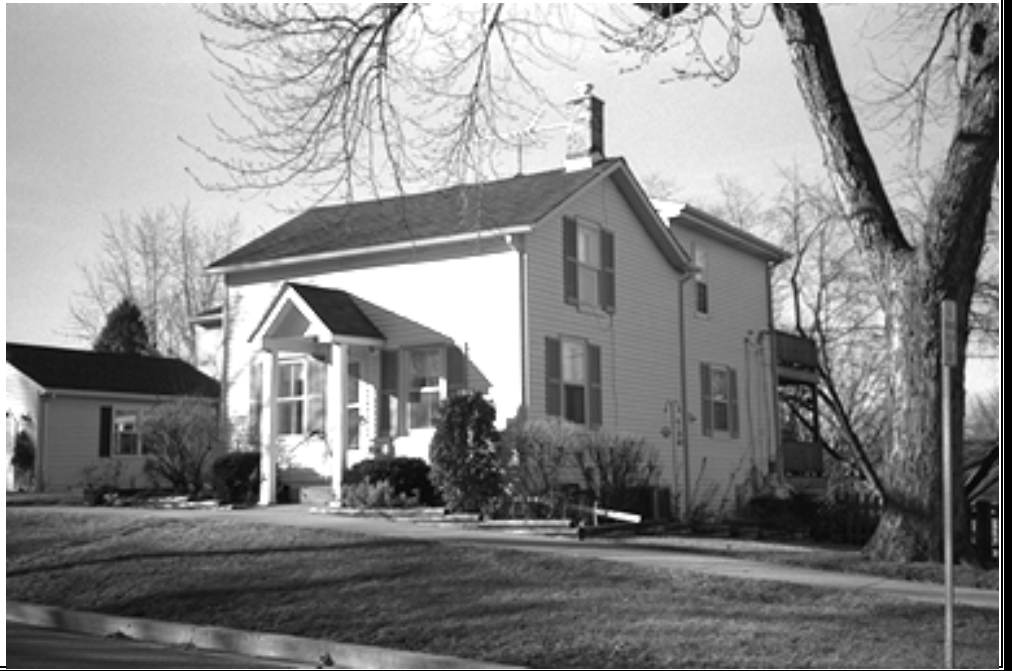
ROLL-IMAGE # 3432 - 25

ALTERATIONS: Little of the original house is revealed in its current condition. It appears that the aluminum siding and ill-conceived additions have concealed much. The two-story addition to the rear does not relate to the original architecture in any way. A two-story wooden deck that was added to the north of this addition does not relate to the addition or the original house. A small one-story addition featuring an octagonal window was made to the west side of the house.

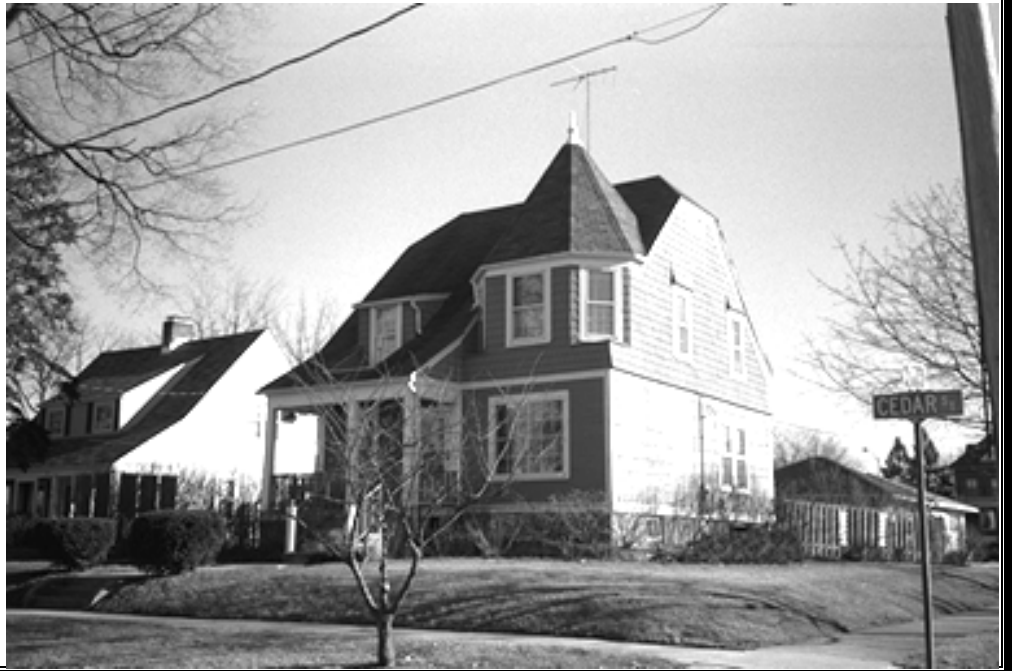
CD-IMAGE # 4367 - 20

- ☐ Significant
- ☒ Contributing
- ☐ Non-Contributing
- ☐ Potential for Individual National Register Designation

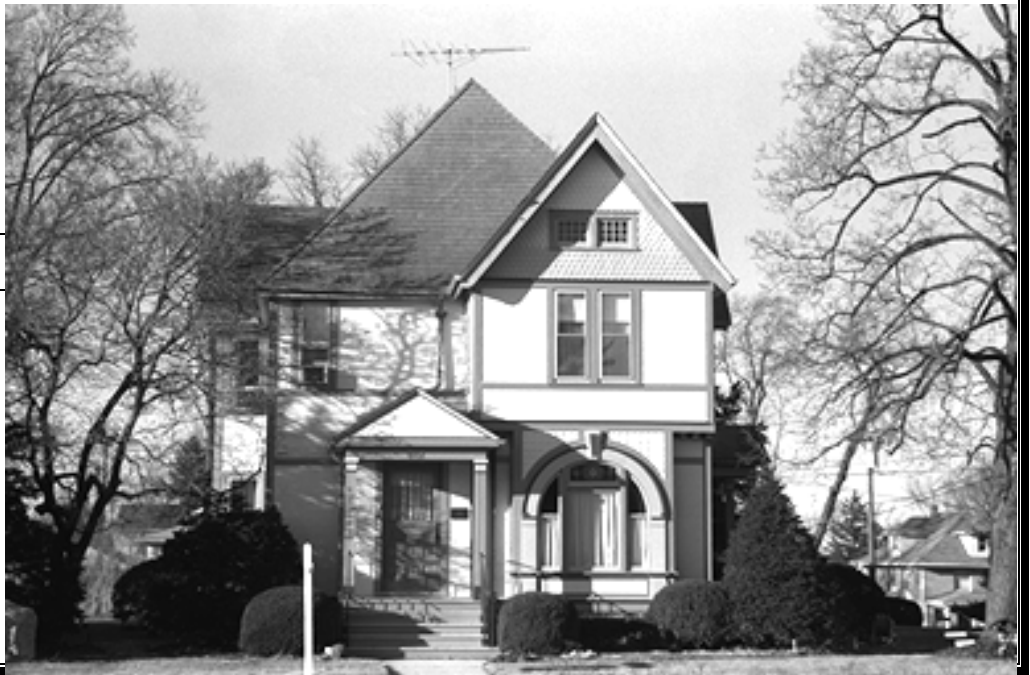
CD-IMAGE # 4367 - 33

► Significant
