ARCHITECTURAL SURVEY
MILLINGTON HISTORIC DISTRICT
ST. CHARLES, ILLINOIS
 Date of Survey: 2003

Primary Structure

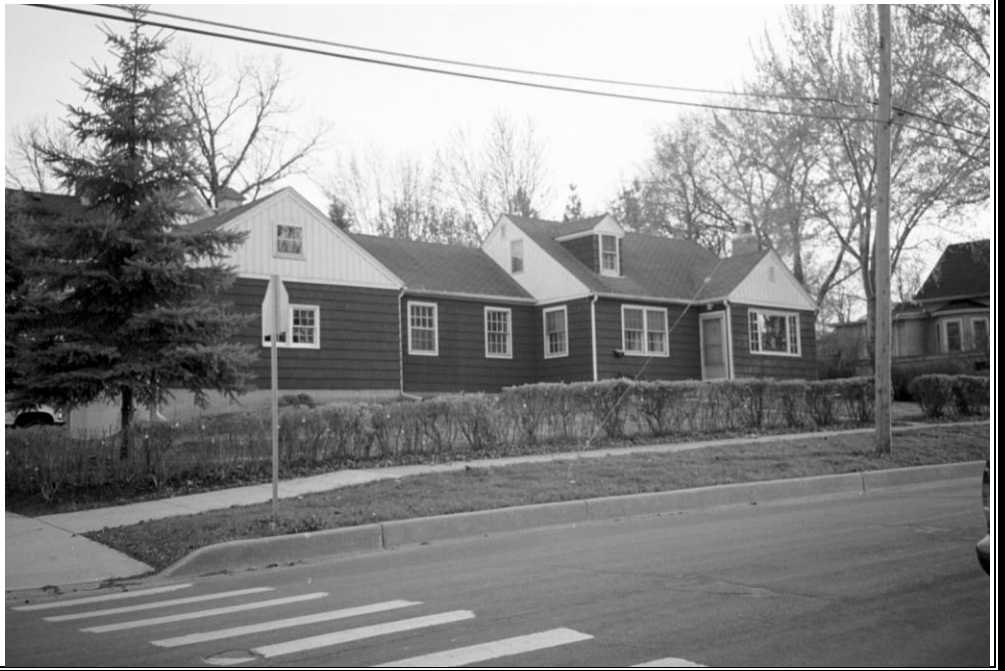
ADDRESS 501 State Street

Architectural Style/Type: <u>Colonial Revival/Cape Cod</u>	Exterior Walls (Current): <u>Cedar shingle</u>
Architectural Features: _____	Exterior Walls (Original): <u>Cedar single</u>
Date of Construction: <u>1930</u>	Foundation: <u>Concrete block/Concrete @ garage</u>
Source: <u>Township Assessor's Office</u>	Roof Type/Material: <u>Side gable/Asphalt shingle</u>
Overall Plan Configuration: <u>Simple rectangle</u>	Window Material/Type: <u>Alum/Wd/double hung</u>

ARCHITECTURAL FEATURES: There is a small dormer on the front of the house near the entrance. A small cupola was installed over the garage.

ALTERATIONS: This house was moved to this site in 1966 from the site of the Coca Cola plant. The foundation was built onsite using standard CMU and then the house was moved. The garage was built onsite on a concrete foundation.

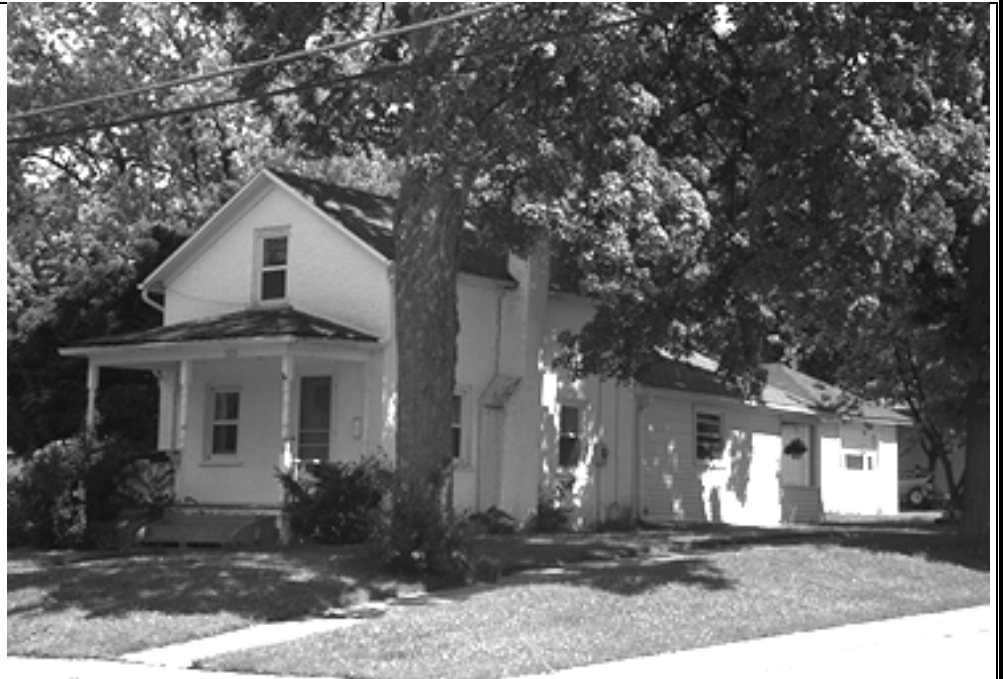
ADDRESS 523 State Street

Architectural Style/Type: <u>Folk Victorian</u>	Exterior Walls (Current): <u>Brick/Aluminum</u>
Architectural Features: _____	Exterior Walls (Original): <u>Brick</u>
Date of Construction: <u>1910</u>	Foundation: <u>Parged masonry</u>
Source: <u>Township Assessor's Office</u>	Roof Type/Material: <u>Front gable/Asphalt shingle</u>
Overall Plan Configuration: <u>Simple/rectangle</u>	Window Material/Type: <u>Alum/Double hung</u>

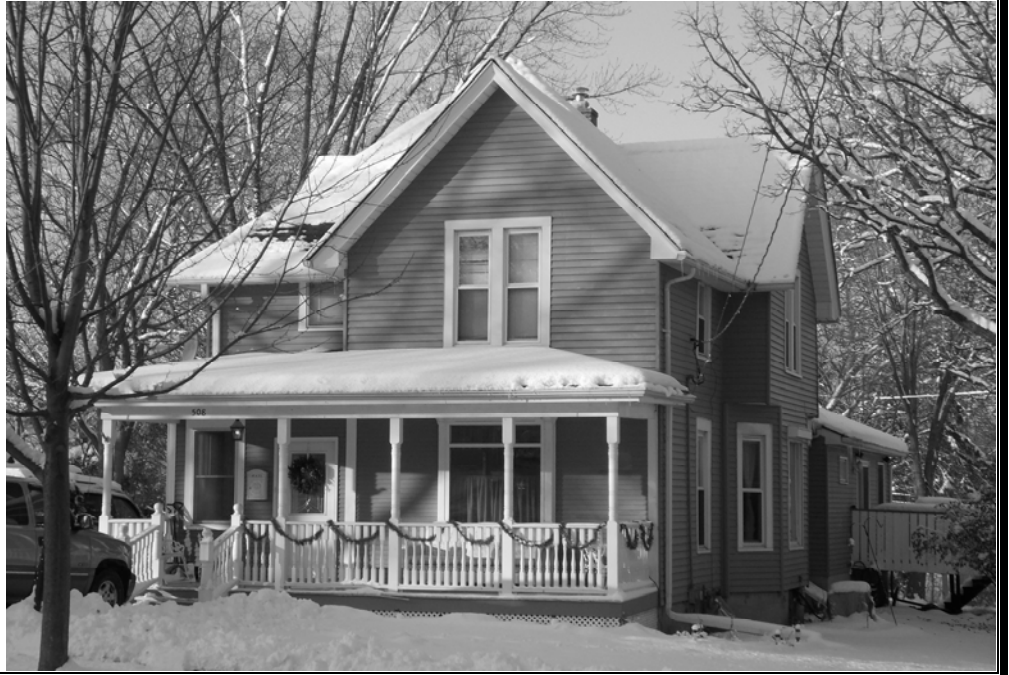
ADDRESS 508 Cedar Street

Architectural Style/Type: <u>Queen Anne</u>	Exterior Walls (Current): <u>Aluminum on wood frame</u>
Architectural Features: _____	Exterior Walls (Original): <u>Clapboard on wood frame</u>
Date of Construction: <u>1910</u>	Foundation: <u>Concrete</u>
Source: <u>Township Assessors Office</u>	Roof Type/Material: <u>Hipped w/lower cross gables</u>
Overall Plan Configuration: <u>Simple - massed</u>	Window Material/Type: <u>Alum/Double hung</u>

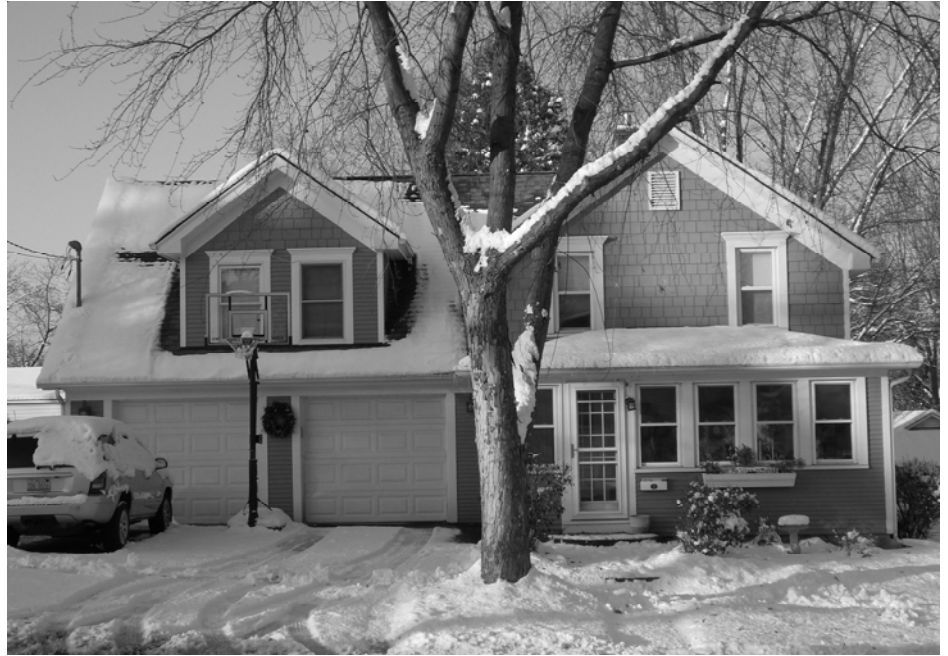
ADDRESS 514 Cedar Street

Architectural Style/Type: <u>National</u>	Exterior Walls (Current): <u>Clapboard</u>
Architectural Features: _____	Exterior Walls (Original): <u>Clapboard</u>
Date of Construction: <u>1910</u>	Foundation: <u>Parged masonry</u>
Source: <u>Township Assessors Office</u>	Roof Type/Material: <u>Front gable/Asphalt</u>
Overall Plan Configuration: <u>Simple - rectangle</u>	Window Material/Type: <u>Alum/Double hung</u>

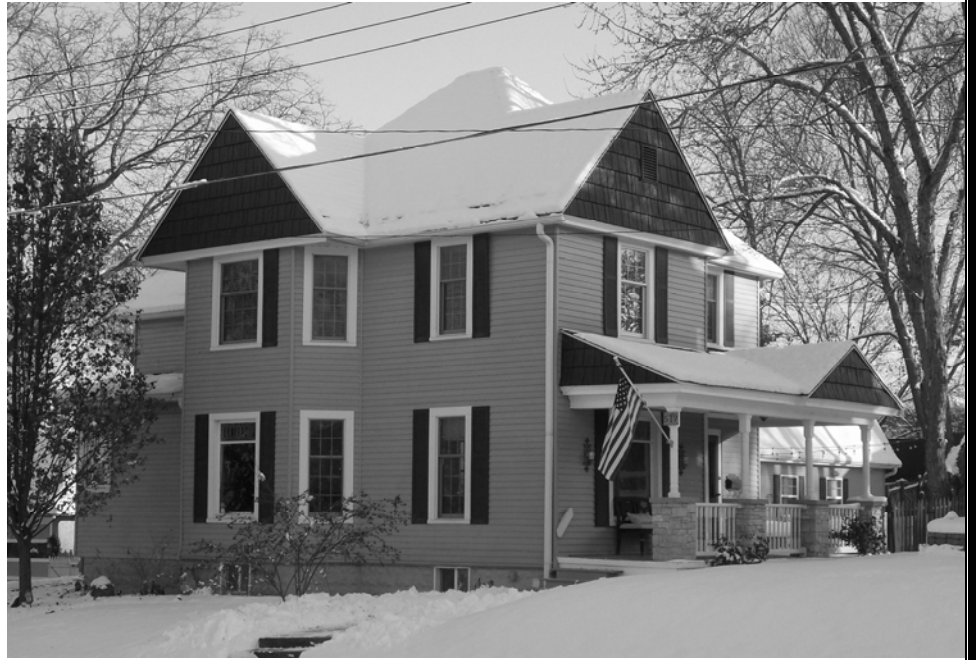
ADDRESS 517 Cedar Street

Foundation: Textured CMU

ALTERATIONS: The siding has been replaced with aluminum and the windows have been replaced with vinyl. A small sun-porch located on the street elevation at the northeast corner of the house has been enclosed. The porch columns rest on stone

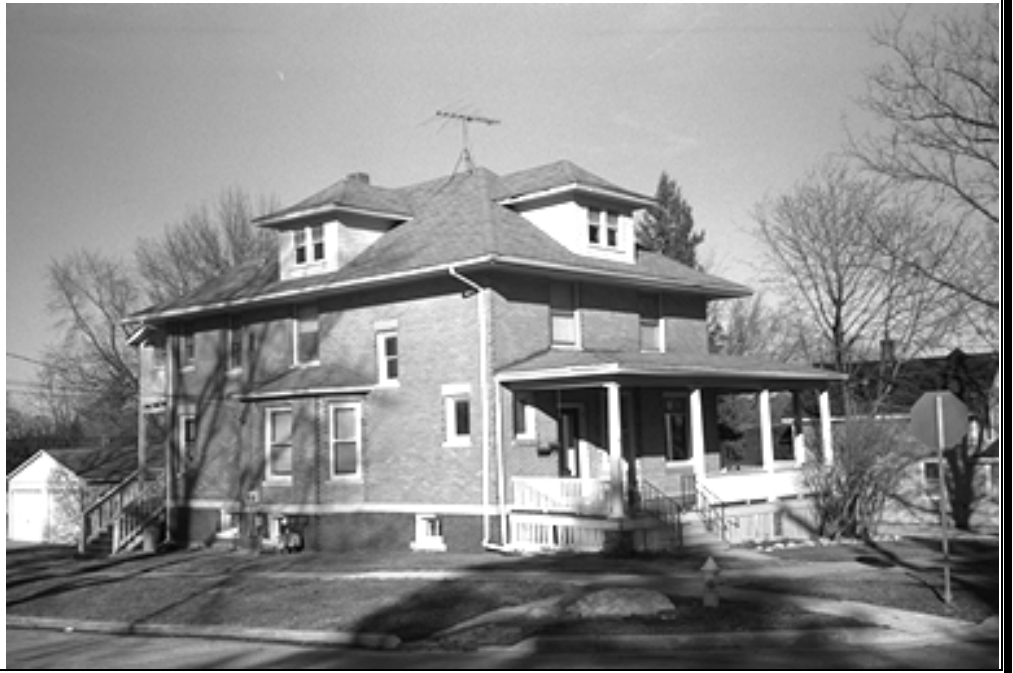
ADDRESS 522 Cedar Street

Architectural Style/Type: <u>Colonial Revival</u>	Exterior Walls (Current): <u>Brick</u>
Architectural Features: _____	Exterior Walls (Original): <u>Brick</u>
Date of Construction: <u>Circa 1912</u>	Foundation: <u>Brick/Concrete</u>
Source: <u>Landmark Nomination</u>	Roof Type/Material: <u>Hipped/Asphalt shingle</u>
Overall Plan Configuration: <u>Simple square</u>	Window Material/Type: <u>Wd Trim/Alum/DbI Hung</u>

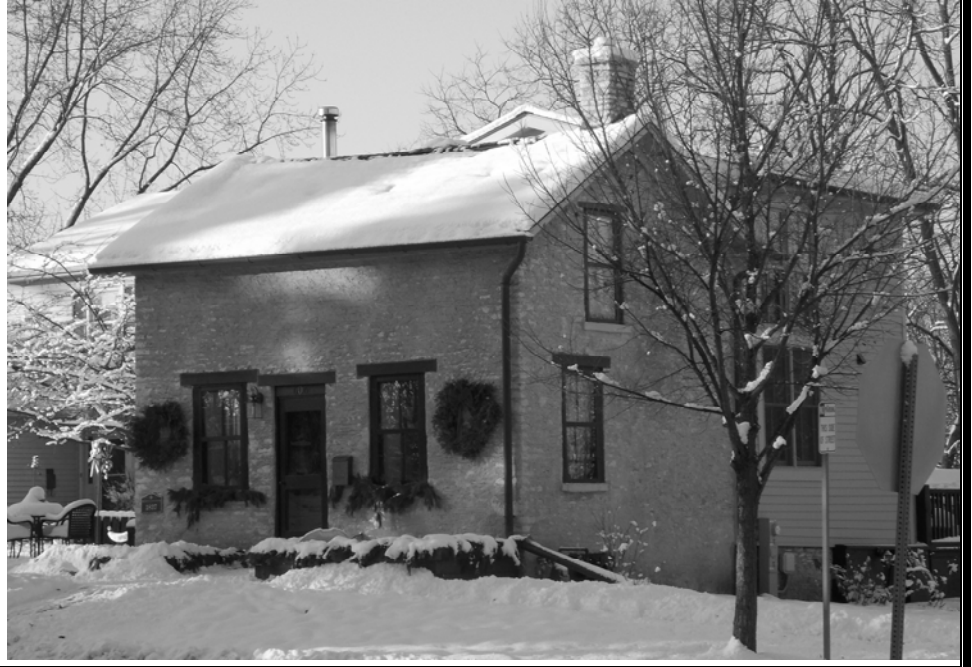
ADDRESS 606 Cedar Street

Architectural Style/Type: <u>National</u>	Exterior Walls (Current): <u>Limestone, wood clapboard (addition)</u>
Architectural Features: _____	Exterior Walls (Original): <u>Limestone</u>
Date of Construction: <u>Circa 1837 Orig.</u>	Foundation: <u>Stone / Orig., Conc. / Adds</u>
Source: <u>Landmark Nomination</u>	Roof Type/Material: <u>Side gable/Asphalt Shingle</u>
Overall Plan Configuration: <u>Simple rectangle – Orig.</u>	Window Material/Type: <u>Wood/Dbl Hung</u>

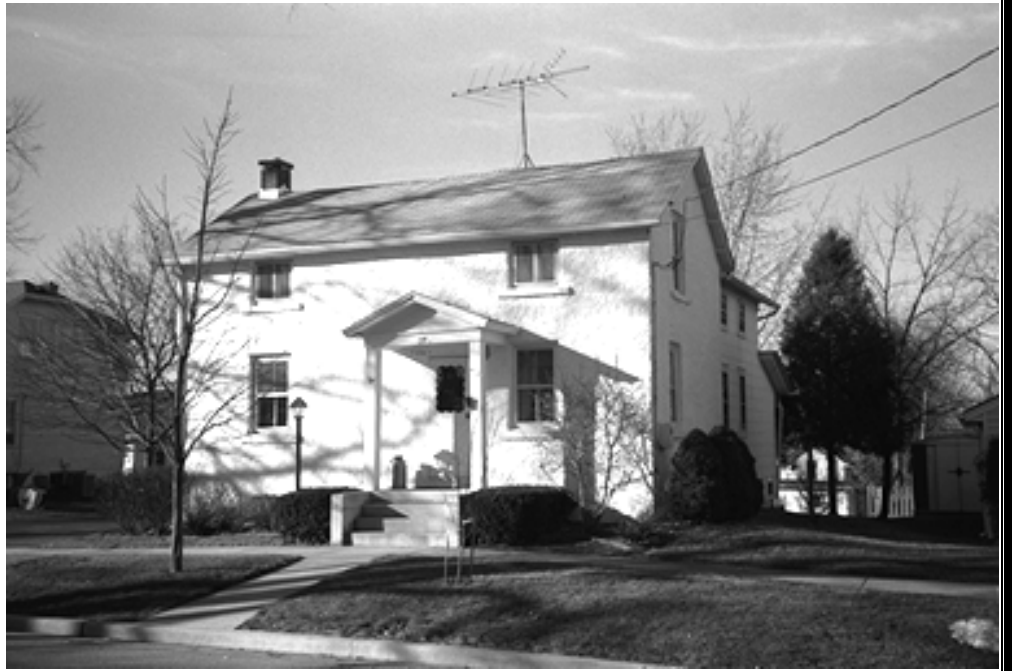
ADDRESS 612 Cedar Street

Architectural Style/Type: <u>National</u>	Exterior Walls (Current): <u>Stucco on masonry</u>
Architectural Features: _____	Exterior Walls (Original): <u>Masonry</u>
Date of Construction: <u>1860</u>	Foundation: _____
Source: <u>Township Assessors Office</u>	Roof Type/Material: <u>Side gable/Asphalt shingle</u>
Overall Plan Configuration: <u>Simple – Rectangle (orig)</u>	Window Material/Type: <u>Alum/Dbf Hung</u>

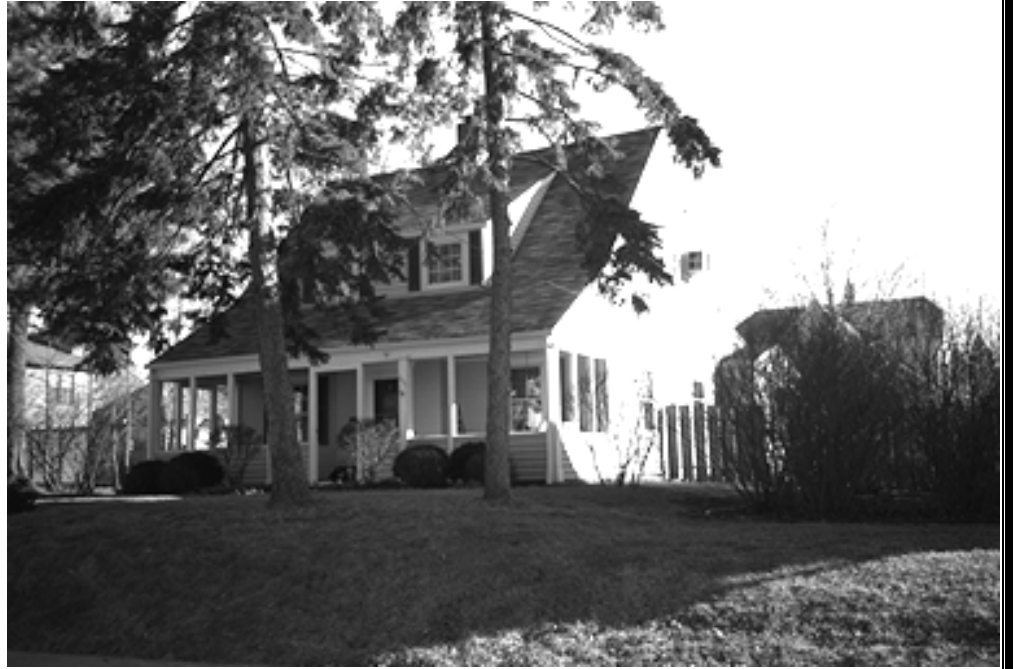
ADDRESS 615 Cedar Street

Architectural Style/Type: <u>Colonial Revival/Cape Cod</u>	Exterior Walls (Current): <u>Clapboard</u>
Architectural Features: _____	Exterior Walls (Original): <u>Clapboard</u>
Date of Construction: <u>1925</u>	Foundation: <u>Concrete</u>
Source: <u>Township Assessors Office</u>	Roof Type/Material: <u>Side Gable/Asphalt shingle</u>
Overall Plan Configuration: <u>Simple Rectangle</u>	Window Material/Type: <u>Wd Trim/Alum/Dbf Hung</u>

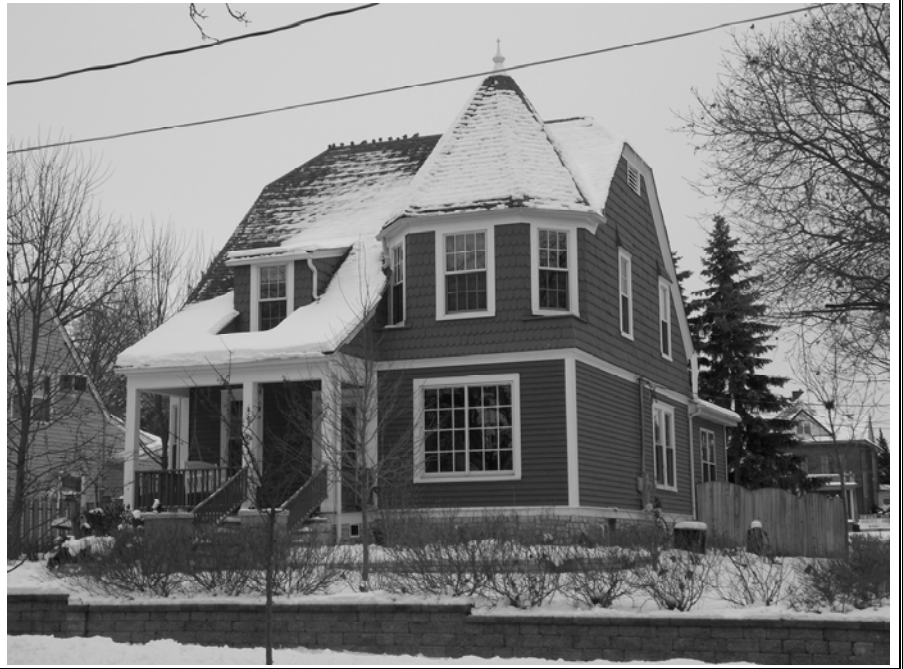
ADDRESS 621 Cedar Street

Architectural Style/Type: <u>Shingle Style</u>	Exterior Walls (Current): <u>Clapboard/Wood shingles</u>
Architectural Features: _____	Exterior Walls (Original): <u>Clapboard</u>
Date of Construction: <u>1925</u>	Foundation: <u>Concrete</u>
Source: <u>Township Assessors Office</u>	Roof Type/Material: <u>Hipped Side Gable / Asphalt shingle</u>
Overall Plan Configuration: <u>Simple Square</u>	Window Material/Type: <u>Wd trim/Alum/ Dbl Hung</u>

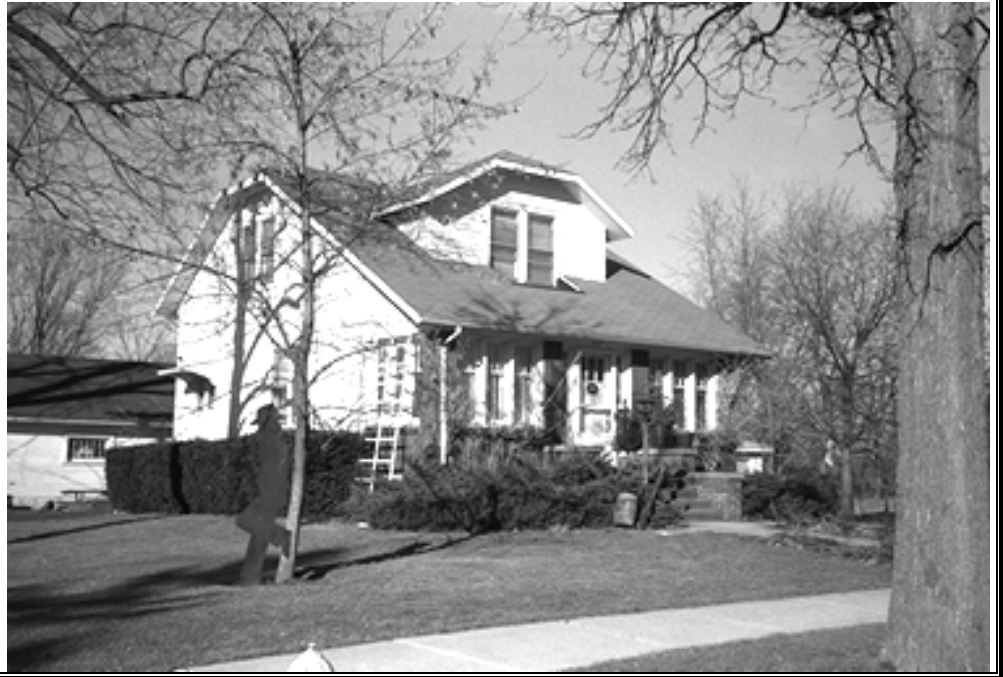
ADDRESS 622 Cedar Street

Architectural Style/Type: <u>Craftsman Bungalow</u>	Exterior Walls (Current): <u>Clapboard w/brick front porch</u>
Architectural Features: _____	Exterior Walls (Original): <u>Clapboard</u>
Date of Construction: <u>1925</u>	Foundation: <u>Parged masonry – Orig.</u>
Source: <u>Township Assessors Office</u>	Roof Type/Material: <u>Hipped Side gable/ Asphalt Shingle</u>
Overall Plan Configuration: <u>Simple rectangle</u>	Window Material/Type: <u>Alum/Dbf Hung</u>

ALTERATIONS: The brick appears to have been added when the front porch was closed in. There is a large 2-story addition to the rear that has a gable roof and detailing similar to the original house. The addition has a concrete foundation.

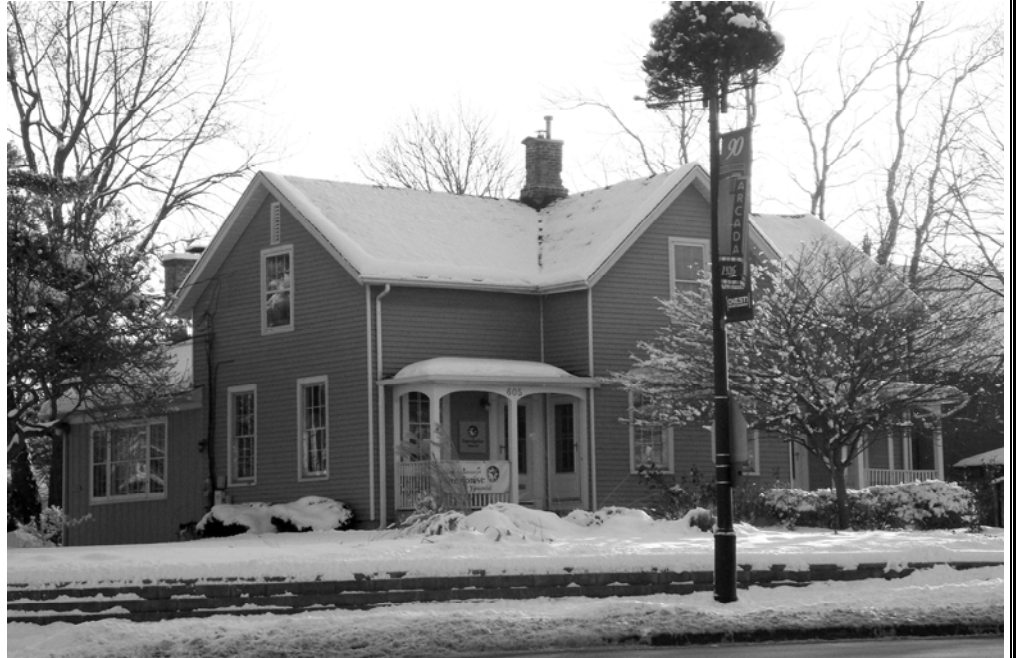
ADDRESS 605 West Main Street

Architectural Style/Type: <u>National</u>	Exterior Walls (Current): <u>Aluminum</u>
Architectural Features: _____	Exterior Walls (Original): <u>Clapboard</u>
Date of Construction: <u>1873</u>	Foundation: <u>Concrete</u>
Source: <u>Township Assessor's Office</u>	Roof Type/Material: <u>Cross gable/Asphalt shingle</u>
Overall Plan Configuration: <u>Compound</u>	Window Material/Type: <u>Alum/Wd. Double hung</u>

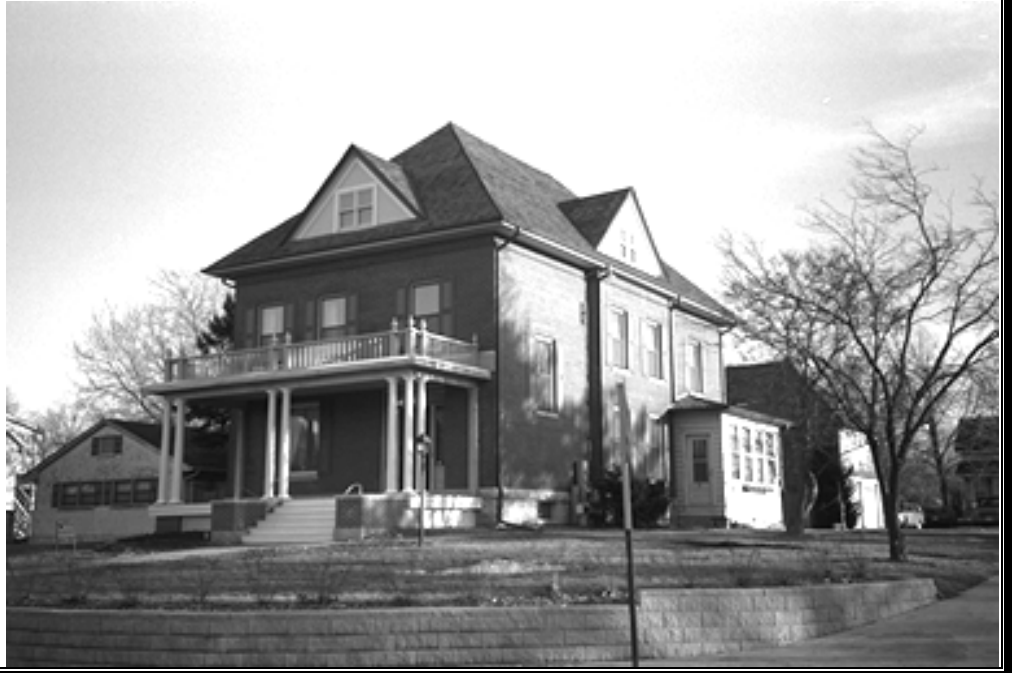
ADDRESS 619 West Main Street

Architectural Style/Type:	<u>Colonial Revival</u>	Exterior Walls (Current):	<u>Brick</u>
Architectural Features:	<u></u>	Exterior Walls (Original):	<u>Brick</u>
Date of Construction:	<u>1900</u>	Foundation:	<u>Stone(orig.),Conc.(Additions)</u>
Source:	<u>Township Assessor's Office</u>	Roof Type/Material:	<u>Hipped/Wood shingle (orig.)</u>
Overall Plan Configuration:	<u>Simple w/ additions</u>	Window Material/Type:	<u>Alum/Wd./Dbl. hung</u>

ARCHITECTURAL FEATURES: This is a large imposing façade accentuated by being elevated above the street level and by being located on a very prominent site. The roof is a simple hip with a long ridgeline and is articulated with large triangular roof dormers on the north, east, and west elevations. The east and west dormers crown a two story brick projection serving to break up what could have been an uneventful façade. The top of the stone foundation stops vertically at the first floor line and adds visual interest and character to the massive looking house.

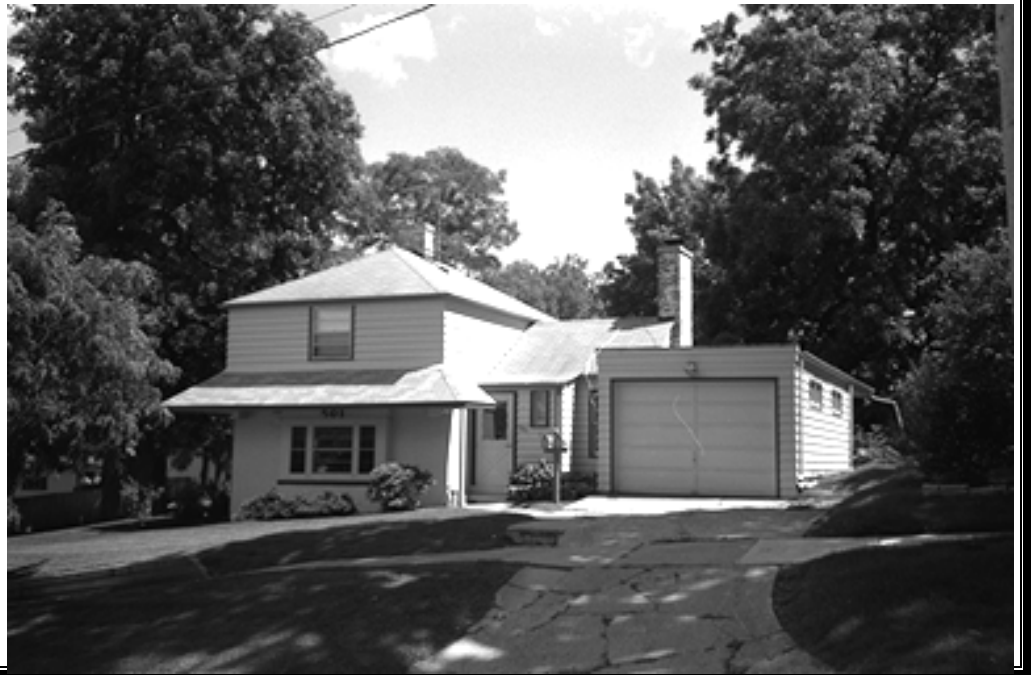
ADDRESS 501 Walnut Street

Architectural Style/Type: <u>Folk eclectic</u>	Exterior Walls (Current): <u>The garage is alum/brick and the house is clapboard/brick.</u>
Architectural Features: _____	Exterior Walls (Original): <u>Clapboard/brick.</u>
Date of Construction: <u>1940</u>	Foundation: <u>Concrete</u>
Source: <u>Township Assessor's Office</u>	Roof Type/Material: <u>Hipped with a lower side gable/asphalt shingle/flat with built-up roofing</u>
Overall Plan Configuration: <u>Compound</u>	Window Material/Type: <u>Alum/dbl. hung</u>

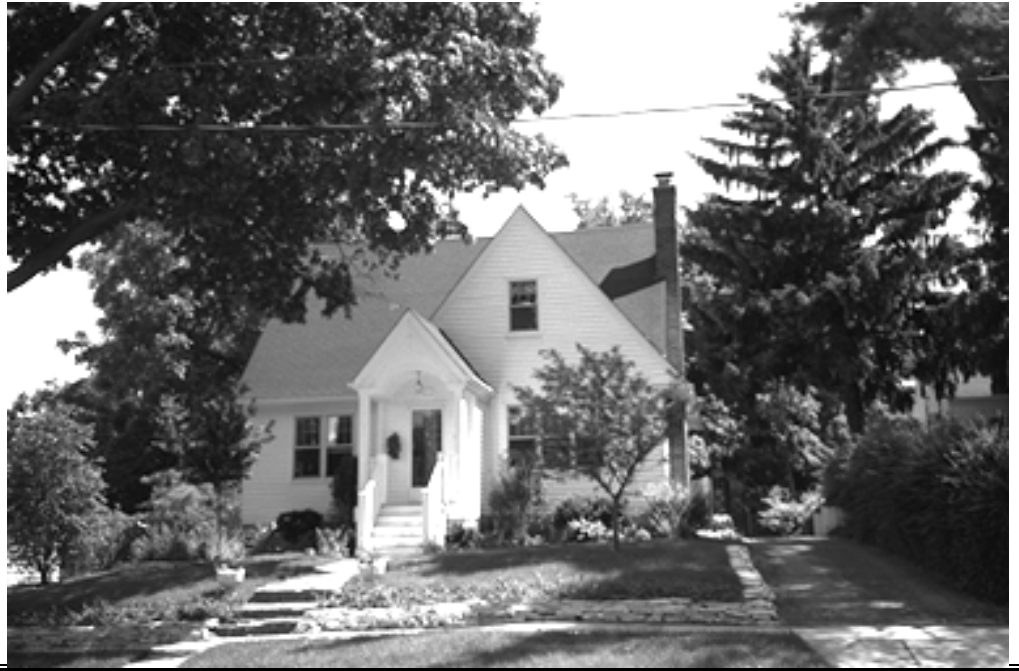
ADDRESS 509 Walnut Street

Architectural Style/Type: <u>English Cottage</u>	Exterior Walls (Current): <u>Clapboard</u>
Architectural Features: _____	Exterior Walls (Original): <u>Clapboard</u>
Date of Construction: <u>1932</u>	Foundation: <u>Concrete</u>
Source: <u>Township Assessor's Office</u>	Roof Type/Material: <u>Cross-Gable/asphalt</u>
Overall Plan Configuration: <u>Compound - L</u>	Window Material/Type: <u>Aluminum/Double hung</u>

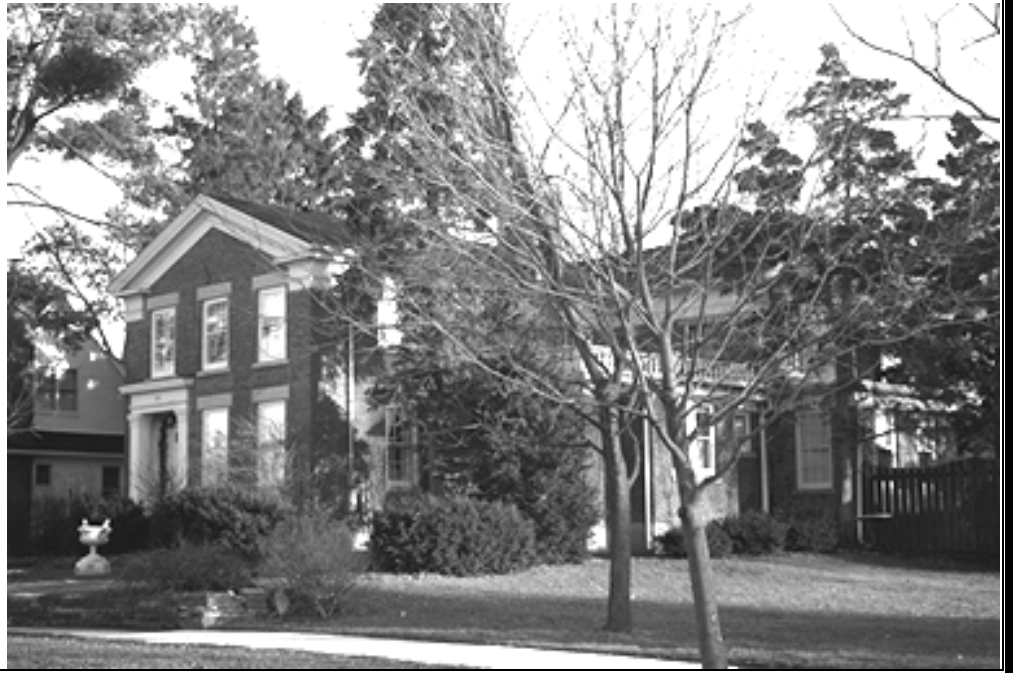
ADDRESS 515 Walnut Street

Foundation: Stone

ARCHITECTURAL FEATURES: A large front gable dominates the front of the house. A heavy frieze band located at the roof line is broken at the front elevation. There is a prominent entrance detailed in the classical tradition in wood. Stone lintels and sills are typical around the house. The window pattern is 6:6.

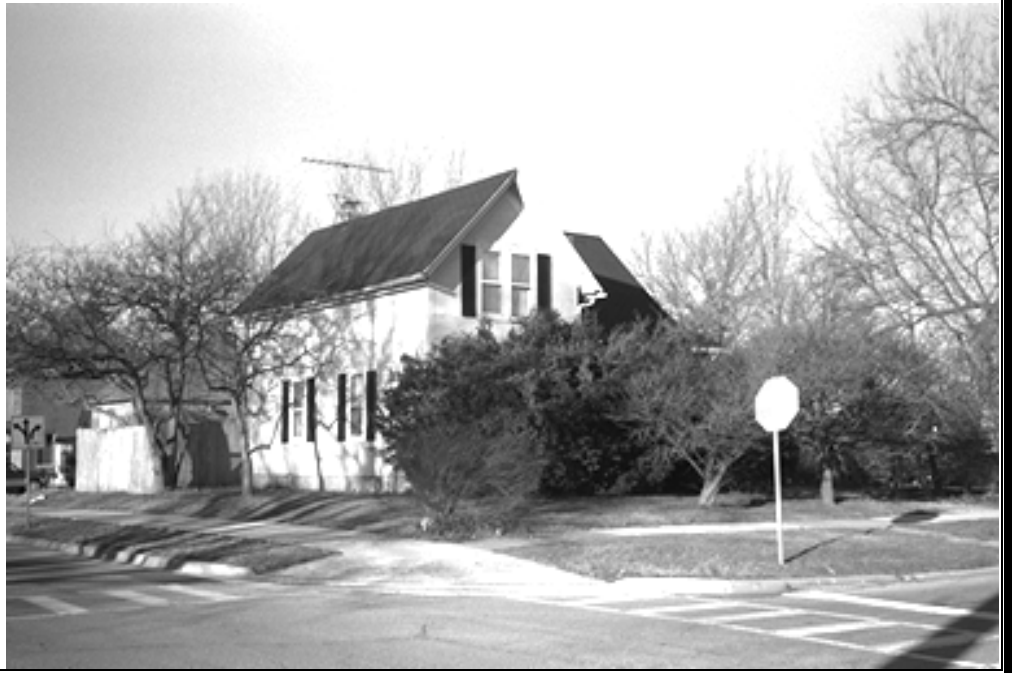
ADDRESS 622 Walnut Street

Architectural Style/Type: <u>Folk Victorian</u>	Exterior Walls (Current): <u>Clapboard</u>
Architectural Features: _____	Exterior Walls (Original): <u>Clapboard</u>
Date of Construction: <u>1900</u>	Foundation: <u>Parged Masonry</u>
Source: <u>Township Assessor's Office</u>	Roof Type/Material: <u>Cross gable/Asphalt</u>
Overall Plan Configuration: <u>Compound L</u>	Window Material/Type: <u>Aluminum/Double hung</u>

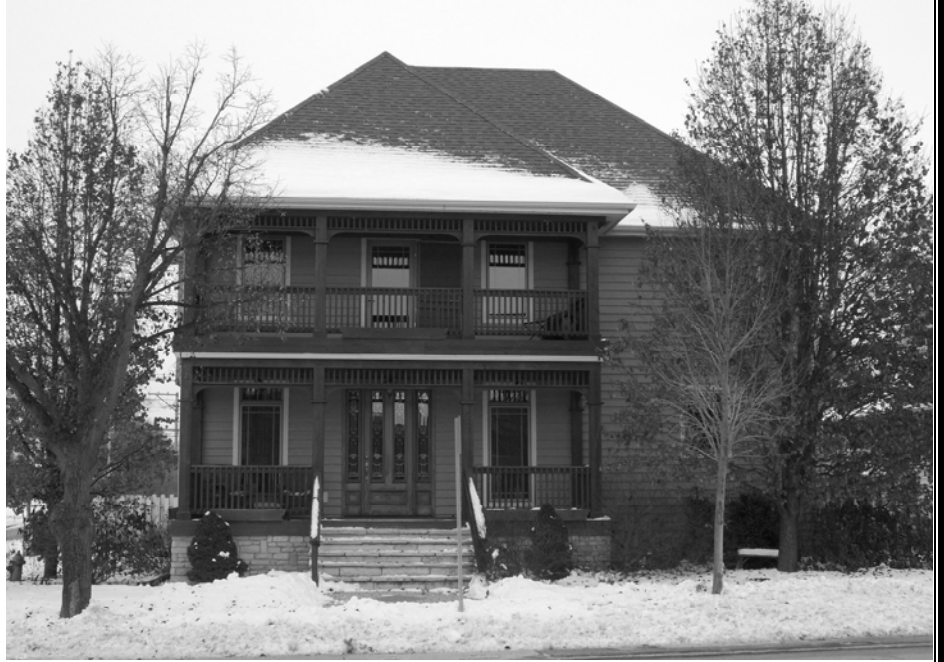
ADDRESS 623 Walnut Street

Architectural Style/Type: <u>Neoclectic</u>	Exterior Walls (Current): _____
Architectural Features: _____	Exterior Walls (Original): <u>Clapboard</u>
Date of Construction: <u>2007</u>	Foundation: <u>Concrete</u>
Source: <u>Township Assessor</u>	Roof Type/Material: <u>Hipped/Asphalt</u>
Overall Plan Configuration: <u>Compound</u>	Window Material/Type: <u>Material unknown/Casement</u>

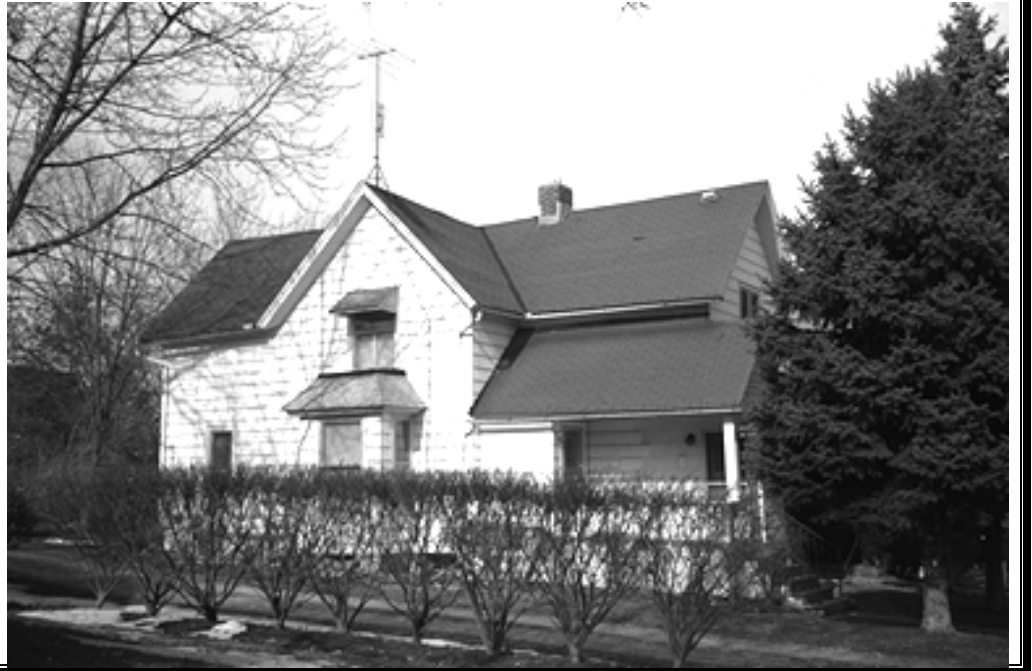
ADDRESS 115 North 5th Street

Architectural Style/Type: <u>Queen Anne</u>	Exterior Walls (Current): <u>Composition shingle</u>
Architectural Features: _____	Exterior Walls (Original): <u>Clapboard</u>
Date of Construction: <u>1900</u>	Foundation: <u>Parged masonry</u>
Source: <u>Township Assessor's Office</u>	Roof Type/Material: <u>Cross gable/Asphalt shingle</u>
Overall Plan Configuration: <u>Simple rectangle</u>	Window Material/Type: <u>Wd trimmed/Alum/Dbf Hung</u>
