<p>CITY OF ST. CHARLES ILLINOIS • 1834</p>	HISTORIC PRESERVATION COMMISSION AGENDA ITEM EXECUTIVE SUMMARY			
	Agenda Item Title/Address:	Review of Draft Pottawattamie Survey		
	Significance:			
	Presenter:	Rachel Hitzemann, City Planner		
	Project Type:	Survey		
	PUBLIC HEARING		MEETING 8/2/23	X
Agenda Item Category:				
	Preliminary Review		Grant	
	Certificate of Appropriateness (COA)		Other Commission Business	
	Landmark/District Designation	X	Commission Business	
Attached Documents:		Additional Requested Documents:		
Survey Report Drafts				
Project Description:				
<p>This is a review of a small portion of the Survey Pages. The Commission will continue to review pages of these drafts and should make comments or recommend changes to the drafts that can be reviewed later with the consultant.</p>				
Staff Comments:				
Recommendation / Suggested Action:				
Provide comments regarding the draft survey pages.

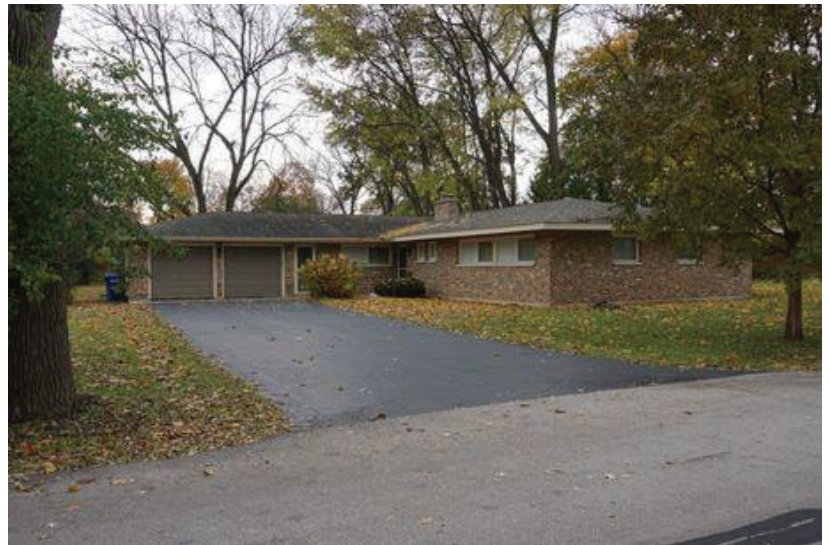
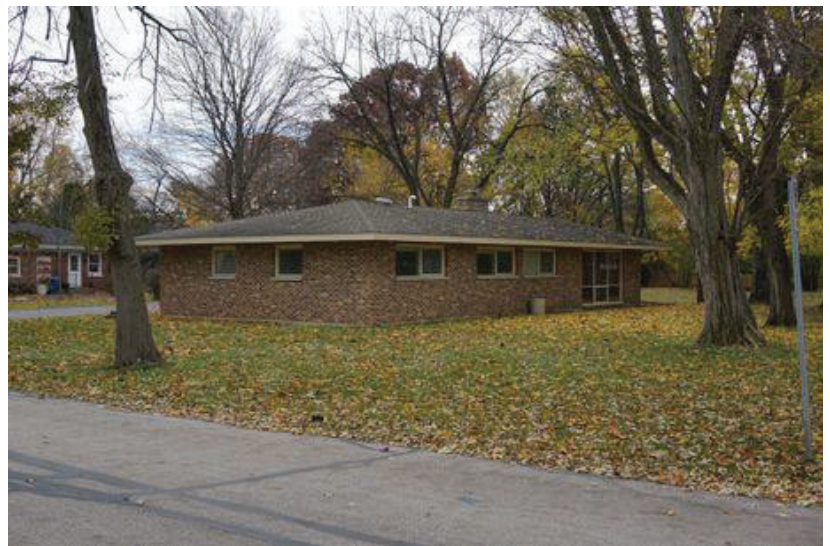
Raymond W. Law, Jr. Residence

Excellent

Crossed hipped roof form with wide eave overhangs.

Sliding windows (non-historic); Full-light awning or hopper windows (non-historic).

Main entrance door is not visible from the public right-of-way; Secondary entrance immediately west of the attached garage is a paneled door, material is difficult to see due to screen door.

Main entrance is located at the inner corner where the two hipped roofs meet, creating a covered entrance area.

Windows have been replaced.

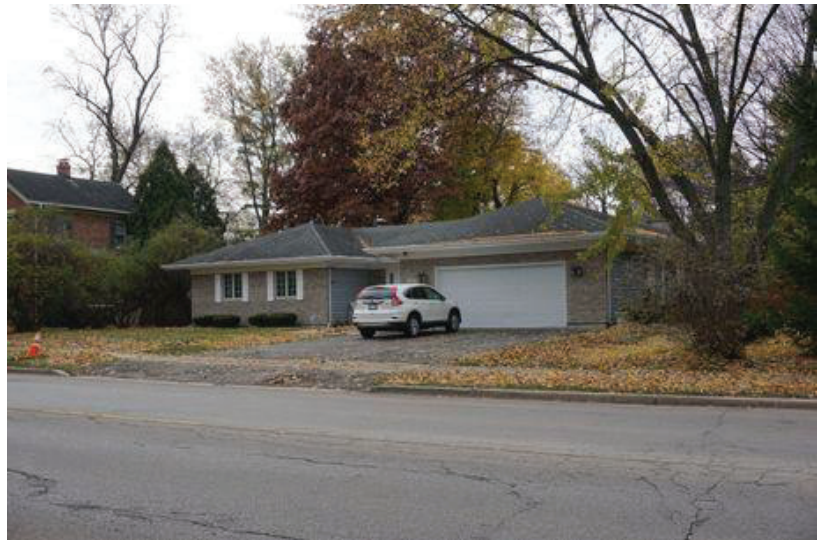
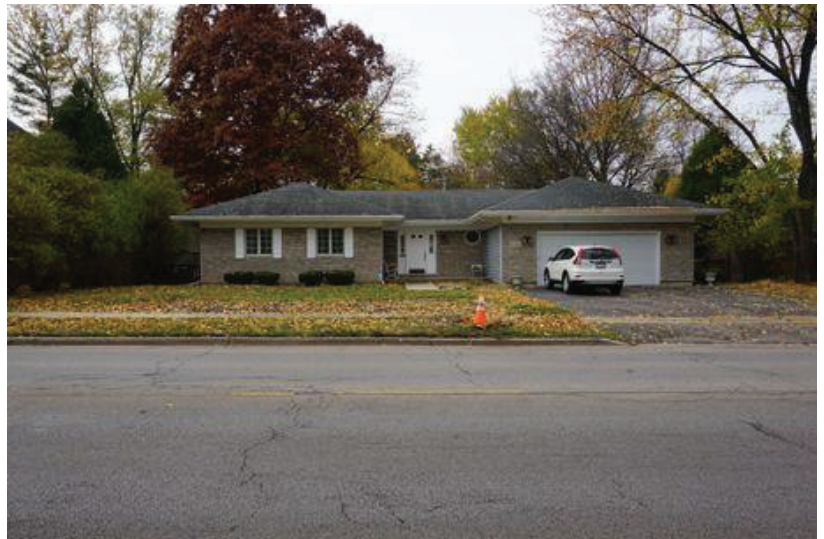
Excellent

Cross-hipped roof form with wide eave overhangs.

Six-light vinyl casement windows (non-historic); Nine-light fixed wood octagonal window (historic).

Shutters; Brick sills at casement windows; Brick surround at octagonal window.

Stile and rail wood door with four lower vertical rectilinear panels and two small upper lights (non-historic).

The main entrance door is flanked by sidelights, each with three upper lights and a lower decorative panel; The wide eave overhangs of the roof created a covered entrance at the main (east) entrance.

Doors and most windows have been replaced.

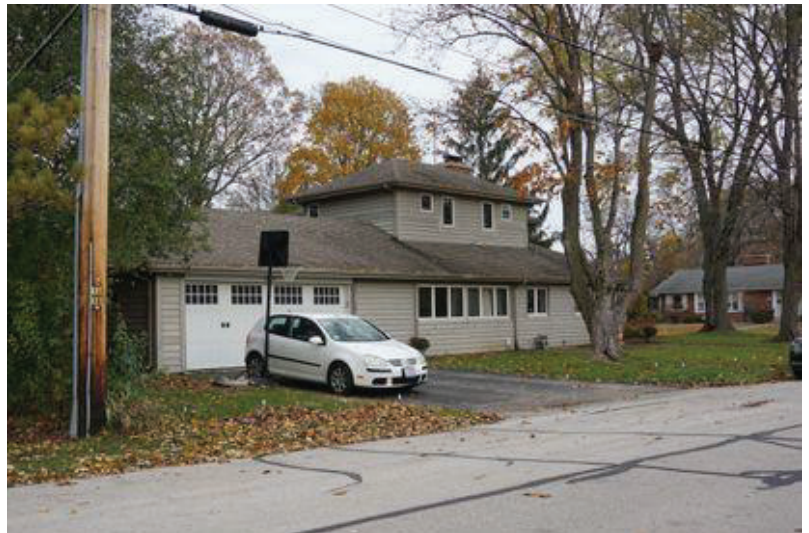
Agar and Margaret Brown Residence

Good

Cascading hip roof form at first and second floors with wide eave overhangs.

Full-light vinyl casement windows (non-historic).

The main (south) entrance was not clearly visible from the public right-of-way due to the storm door.

To the left (west) of the door is a five-light sidelights; The entrance is located at the inner corner where the two first floor hipped roofs intersect, creating a covered entrance area.

Windows have been replaced.

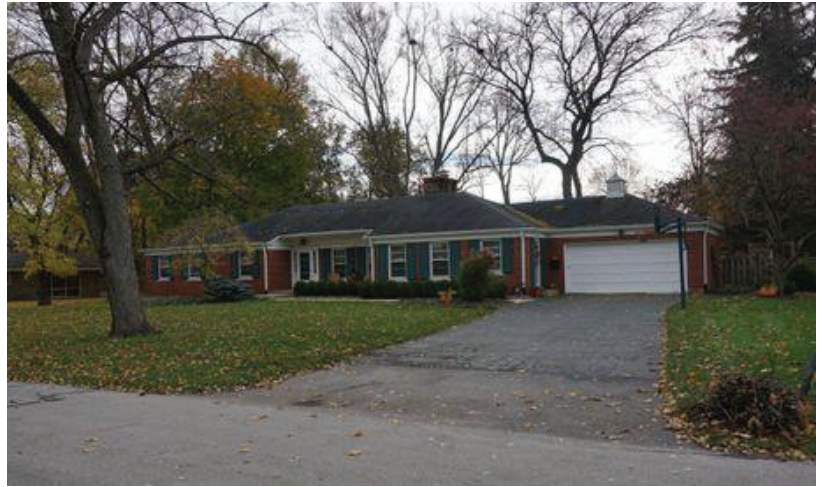
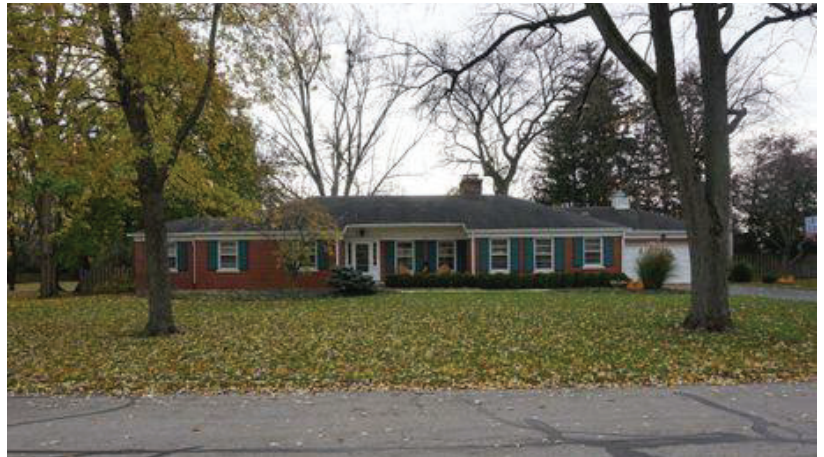
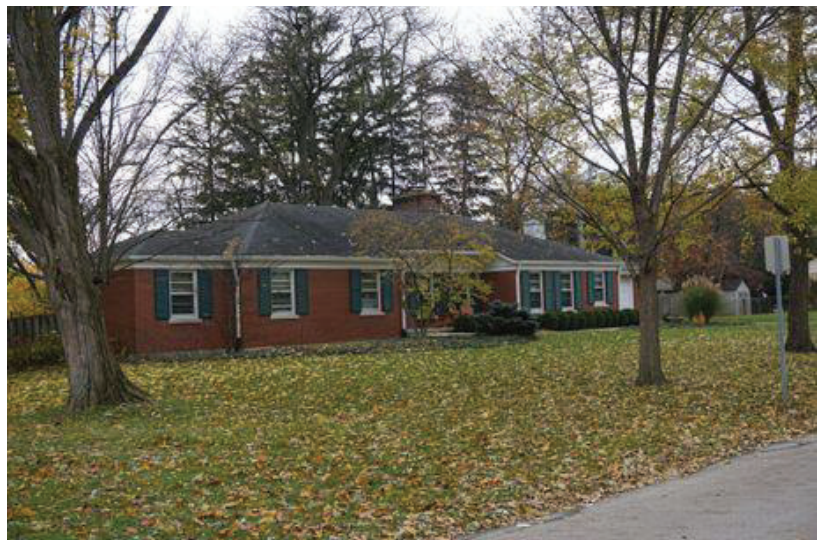
Olive L. Bergland Residence

Excellent

Cascading hip roof form with wide eave overhangs; The center portion of the north eave of the main hipped is recessed accentuating the main (south) entrance to the residence and features a dentillated fascia.

Two-over-two (horizontal mullions) wood double-hung windows (historic).

Stile and rail wood door with decorative panels.

The door is flanked by sidelights composed of four lights with a lower decorative panel; The entrance opening is embellished with a wood surround which mimics a classical entablature.

Overall Ranch form with applied Colonial Revival details; See feature descriptions in roofs, windows, and doors.

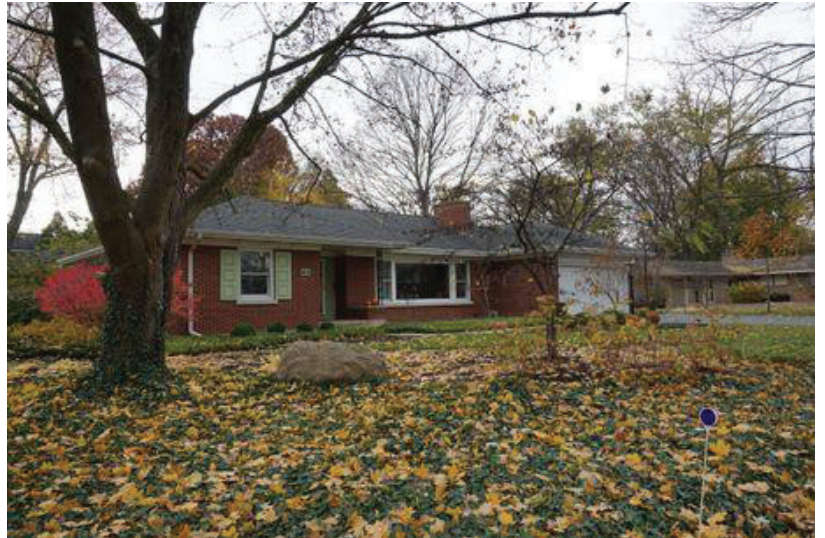
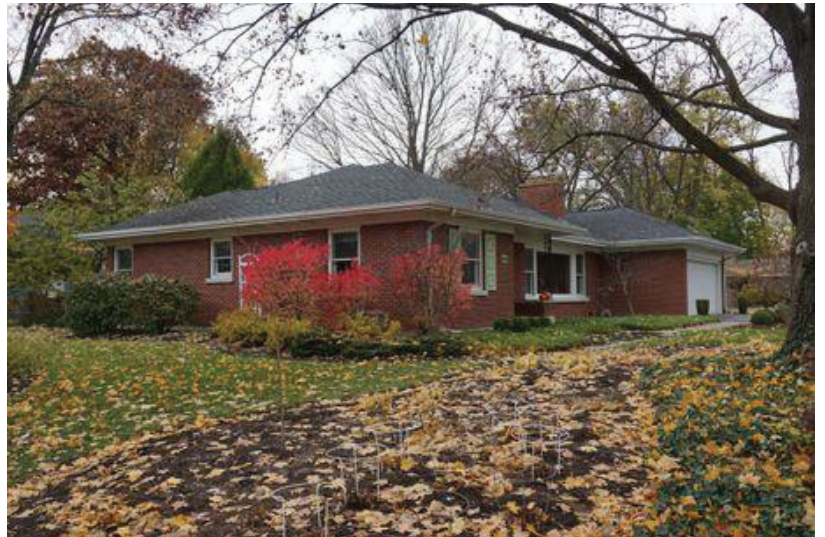
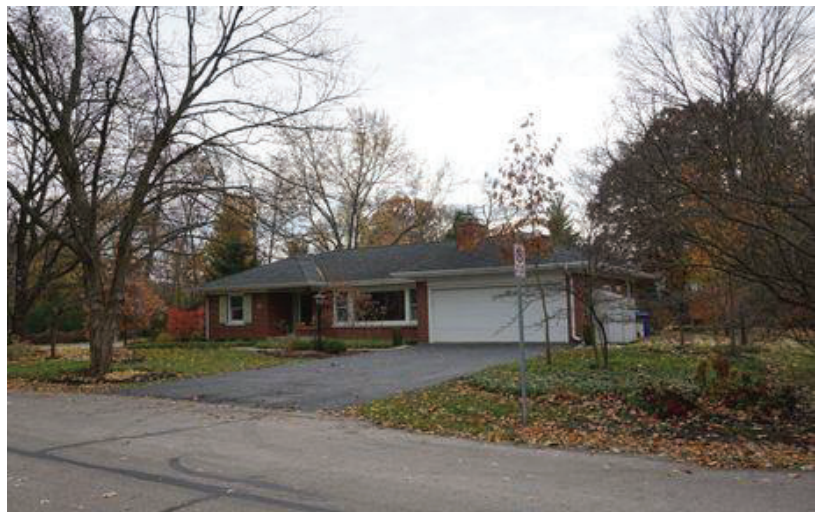
Excellent

Cross-hipped roof form with wide eave overhangs; At the intersection of the main hipped roof and the eastern cross hip a covered entrance area is created on the approach to main (north) entrance.

Fixed vinyl picture window (non-historic); One-over-one vinyl double-hung window (non-historic).

Wood shutters accentuated by compound square mouldings.

Stile and rail wood paneled door (possibly historic but difficult to confirm from the public right-of-way).

The entrance door is flanked by solid wood panels embellished with compound square mouldings to match the shutters.

Windows have been replaced.

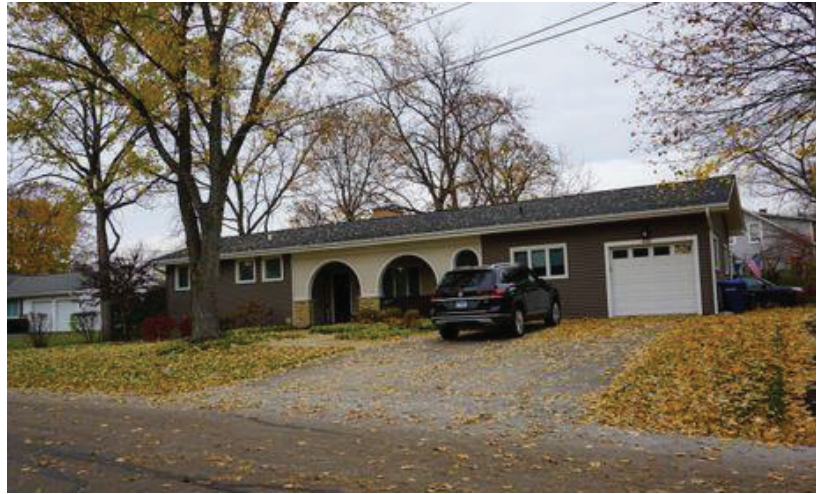
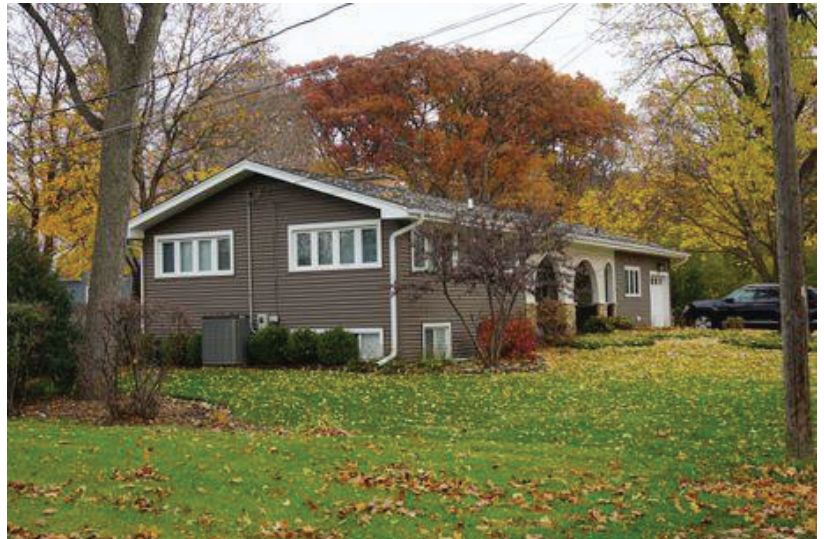
Frank Weinert Residence

Excellent

Side-gabled roof form with wide eave overhangs.

Full-light fixed and/or casement vinyl windows (non-historic).

Semi-enclosed entrance porch spans the central third of the width of the residence at the front (south) facade.

The central third of the main (south) facade is recessed creating a covered entrance area, this area is then semi-enclosed by an exterior arcade that is flush with the main plane of the south facade. Each arch in the arcade rests on a limestone pier and the spandrel of each arch is clad in stucco.

Windows have been replaced.

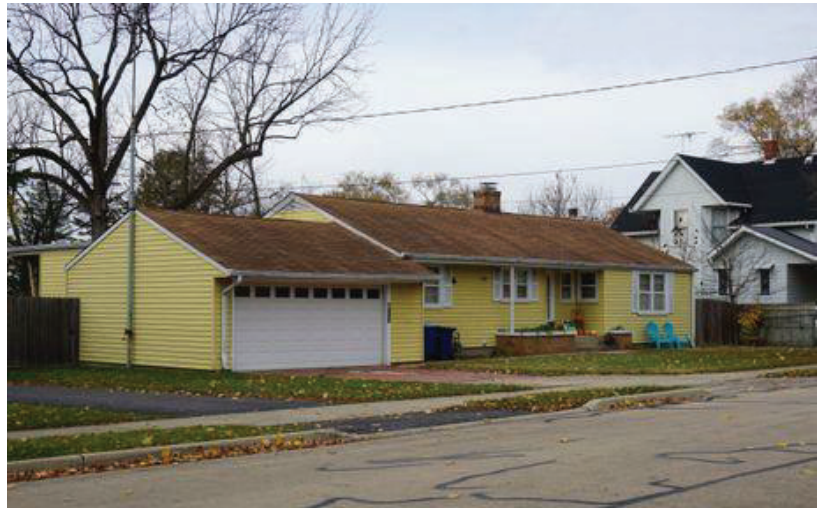
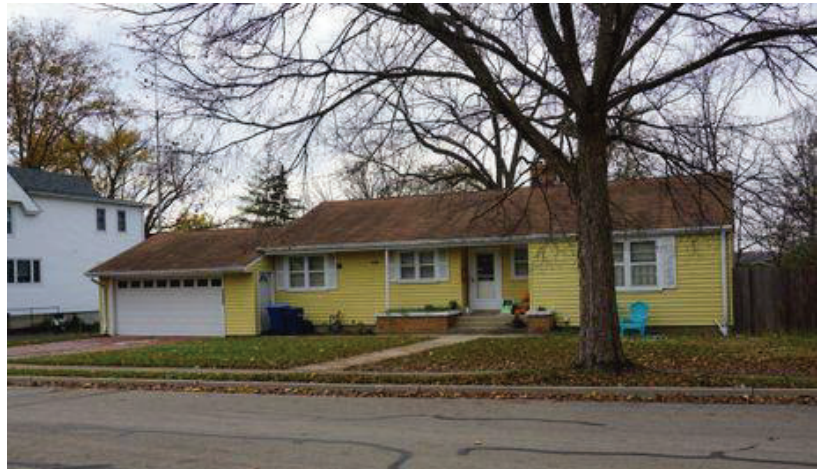
Richard and Edith Sitler Residence

Good

Side-gabled roof form with wide eave overhangs.

Two-over-two (horizontal muntins) wood double-hung windows (historic).

Aluminum paneled door with a large upper rectangular light at the main (east) entrance;
Aluminum paneled door with upper fanlight at the exterior entrance to the attached garage.

The entrance/door are recessed from the main plane of the front (east) facade creating a covered entrance area below the main roof.

Exterior has been re-sided; Shutters added; Doors have been replaced.

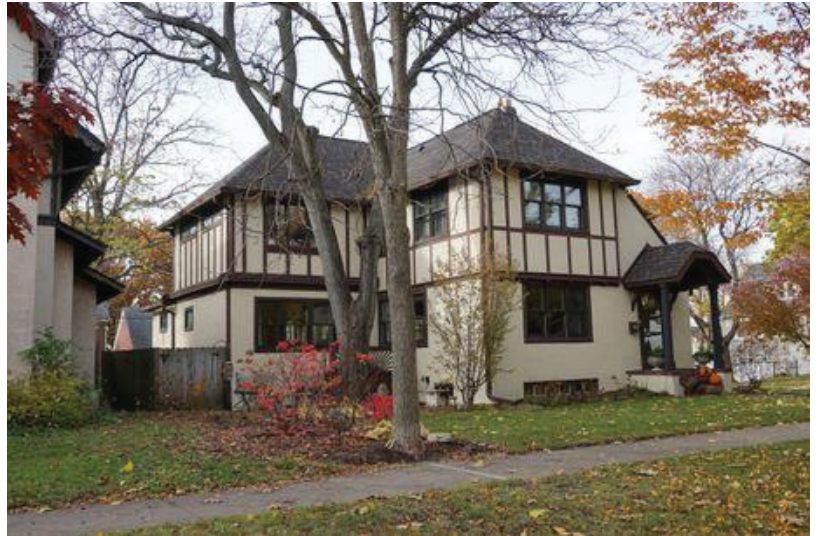
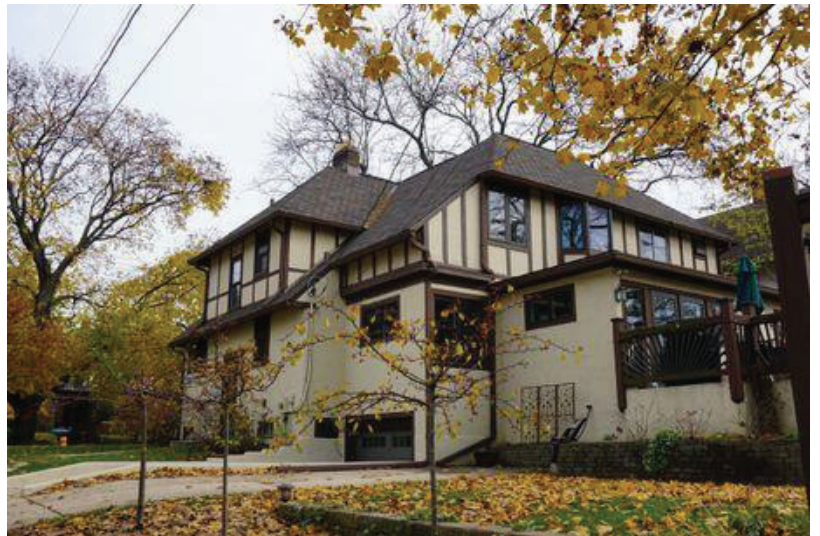
James H. Andrews Residence

Excellent

Main cross-hipped roof with a hipped wall dormer at the north face of the main roof and shed roof extensions over spaces which deviate/project from the main floor plan.

One-over-one double-hung; Full-light casement; Full-light fixed; Full-light awning at the basement (possibly wood).

Hexagonal bay window near the center of the west facade at the second floor.

Covered entrance porch at the north end of the front (east) facade.

The porch is covered with a Jerkinhead roof supported by two square wood columns resting on a low kneewalls which are clad in stucco with brick coping and flank either side of the entrance stair.

Windows and doors have been replaced; Internal garage constructed.

Below-grade internal garage was constructed within the existing building footprint at the west end of the north facade.

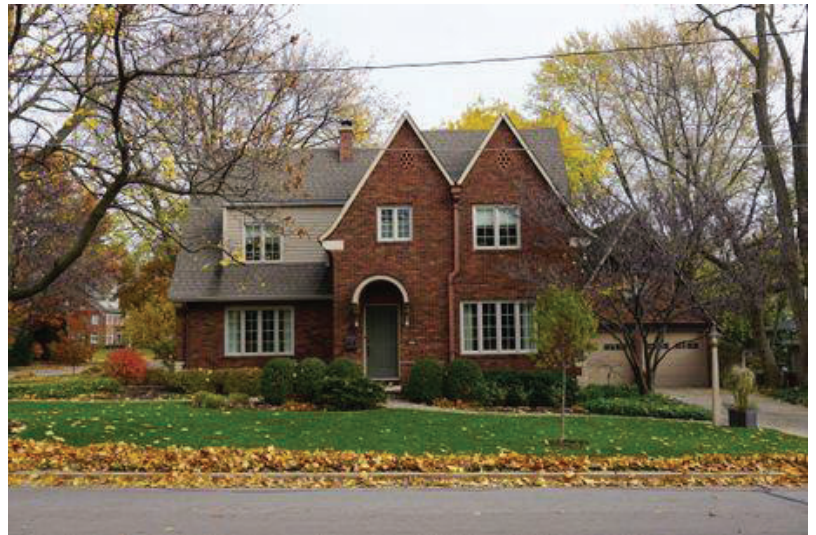
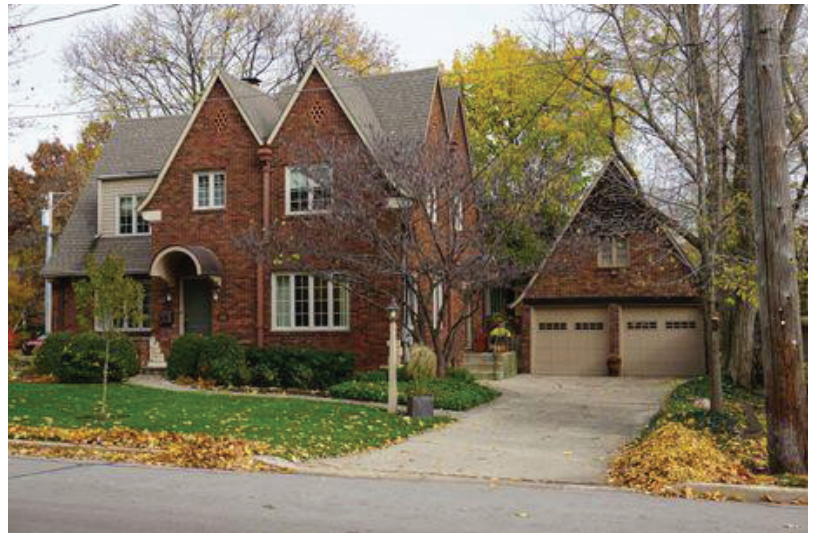
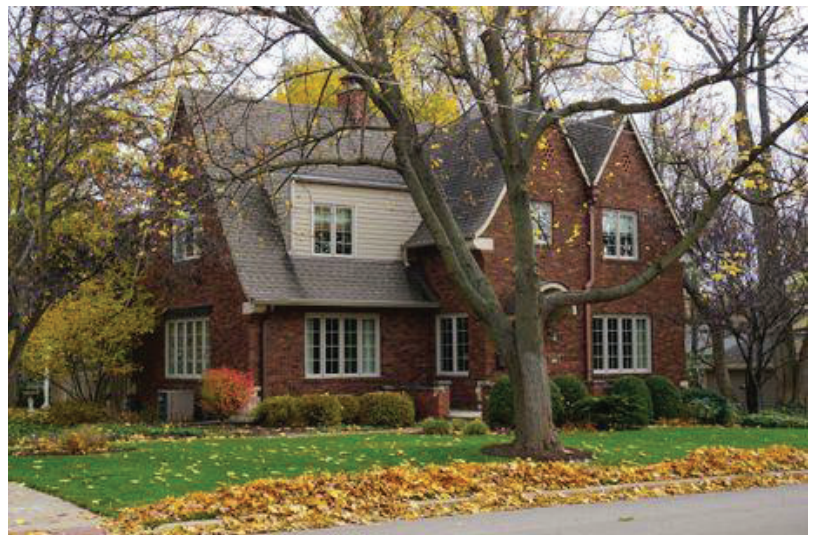
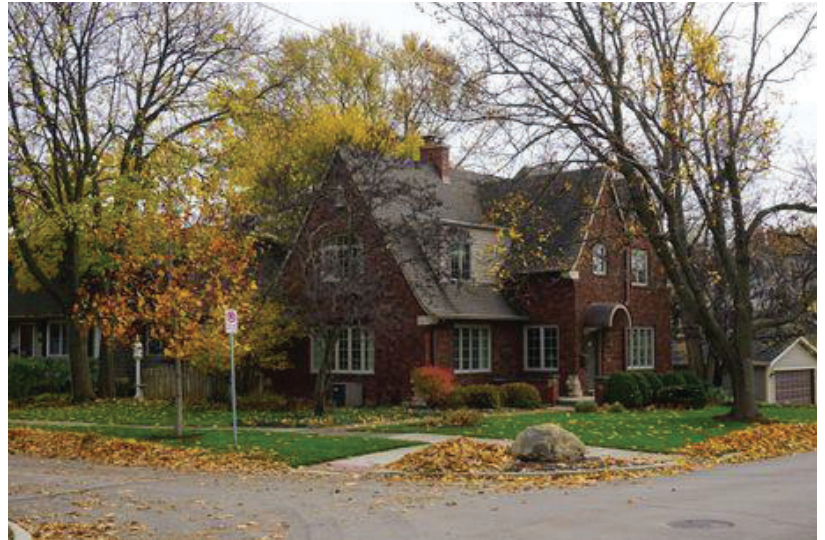
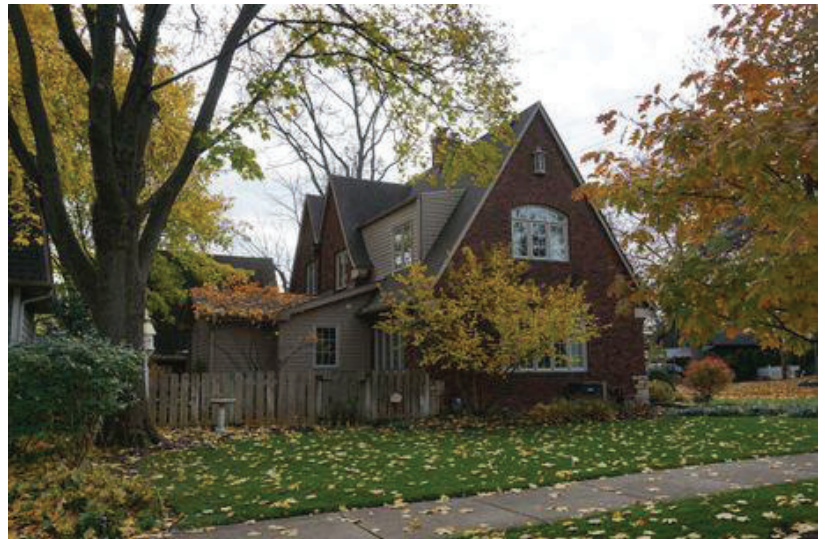
Steeply-pitched side-gabled form with a pair of cross gables at the front (west), south, and east facades; Flared eaves at all roofs; Below the pick of each gable is a diamond-shaped opening infilled with a terra cotta grille featuring nine circular openings which help vent the attic.

Eight-light vinyl casement windows (non-historic).

Stile and rail wood door (non-historic).

Windows and doors have been replaced; Shed dormers were added at the west and east faces of the main roof.

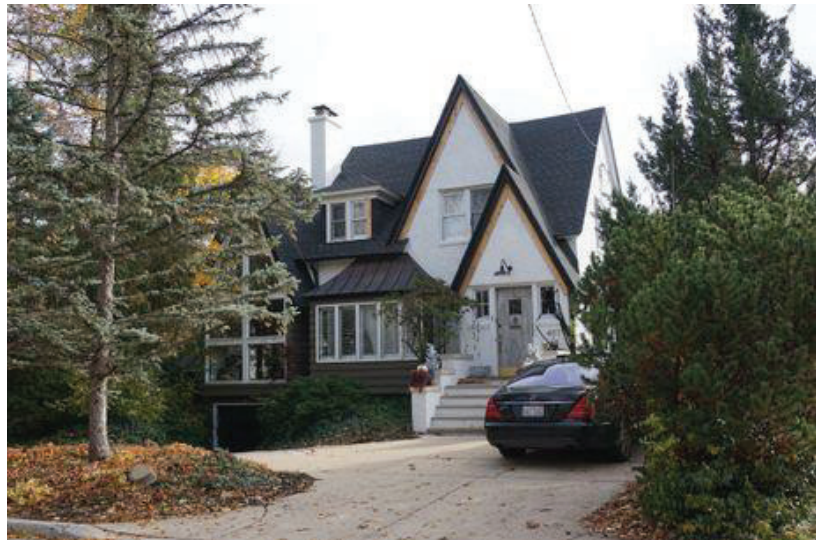
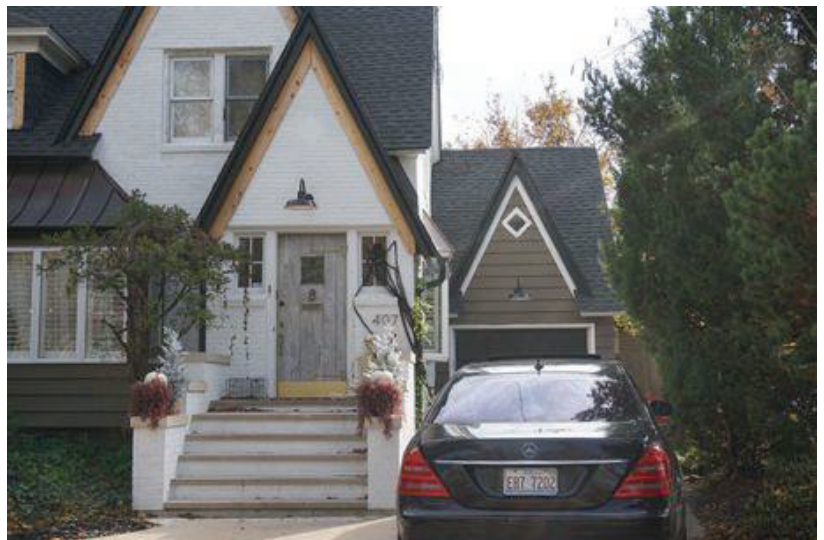
A modern front-facing addition with a below-grade garage was added at the east end of the residence; The original brick exterior has been painted; Most windows have been replaced; The front entrance stair which historically was an organic/curving concrete stair has been replaced with the existing brick and cast stone rectilinear stair; The historic light fixture above the main entrance has been replaced with a gooseneck light fixture; and the raking cornice at the front-facing gabled ends has been replaced.
