ST. CHARLES SINCE 1834 Agenda Item Title/Address: Proposal: Petitioner:		HISTORIC PRESERVATION COMMISSION Agenda Item Executive Summary				
			605-619 W. Main St. & 622 Walnut St.			
		Discuss redevelopment of properties Millington Square LLC				
PUBLIC HEARING				MEETING 10/4/17	X	
AGI	ENDA ITEM	CATEGORY:				
	Certificate o	of Appropriateness (COA)		Faç	Façade Improvement Plan	
Х	Preliminary	Review		Lar	Landmark/District Designation	
	Discussion 1	ltem		Co	mmission Business	
	CACHMENT	S:	1	ľ		
AII		anantiaa				
Aeri Cone	al image of proceed of proceed of the second structure of the second structure of the second se	an

NEAR WEST HISTORIC DISTRICT ST. CHARLES, ILLINOIS

619 West Main Street - Continuation Sheet

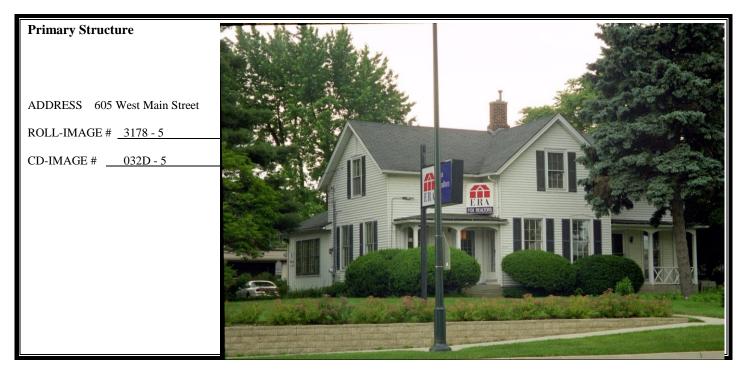
- Excellent
- ► Good
- 🗆 Fair
- Poor

Architectural Style/Type:	National Gable front & wings	Exterior Walls (Current):	Aluminum
Architectural Features:		Exterior Walls (Original):	Clapboard
Date of Construction: Source:	1873 Township Assessor's Office	Foundation: Roof Type/Material:	Concrete Cross gable/Asphalt shingle
Overall Plan Configuration:	Compound	Window Material/Type:	Alum/Wd. Double hung

ARCHITECTURAL FEATURES: This is an unusual front elevation featuring two front porches that are supported by shallow arches springing from simple full height square column. Classically detailed fluted pilasters flank both of the front entrances.

ALTERATIONS: The addition to the rear is one story and has a roof that has a shallower pitch that the main house. The aluminum siding is typically horizontal, but is vertical at the addition. There is another addition that has a shed roof that is accessed by an exterior site built wooden stair. This addition has horizontal aluminum siding. There is currently a commercial tenant occupying the building.

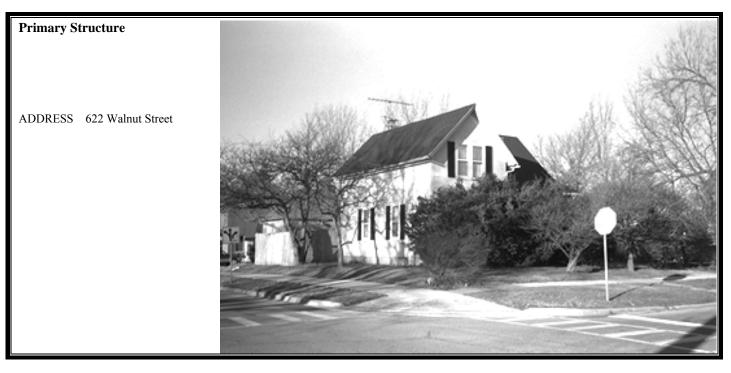
- Excellent
- Good
- 🗆 Fair
- ► Poor

Architectural Style/Type:	Folk Victorian	Exterior Walls (Current):	Clapboard
Architectural Features:		Exterior Walls (Original):	Clapboard
			*
Date of Construction:	1900	Foundation:	Parged Masonry
Source:	Township Assessor's Office	Roof Type/Material:	Cross gable/Asphalt
Overall Plan Configuration:	Compound L	Window Material/Type:	Aluminum/Double hung

ARCHITECTURAL FEATURES: The front gable has distinct vertical proportions & steep roof slope. There is a partial width front porch that has a shed type roof that is supported by turned columns. All of the windows have simple wood trim. The siding has relatively wide trim @ the eaves and corners. There is a small rear entry that retains the detail character of the front porch. The eaves are open by are soffited in line w/ the roof slope.

ALTERATIONS: This roof probably had wood shakes or shingles originally.
